# Screening assessment for the President Park x6 site

2 June 2020

# Wetland assessment for the President Park x6 site

November 2020

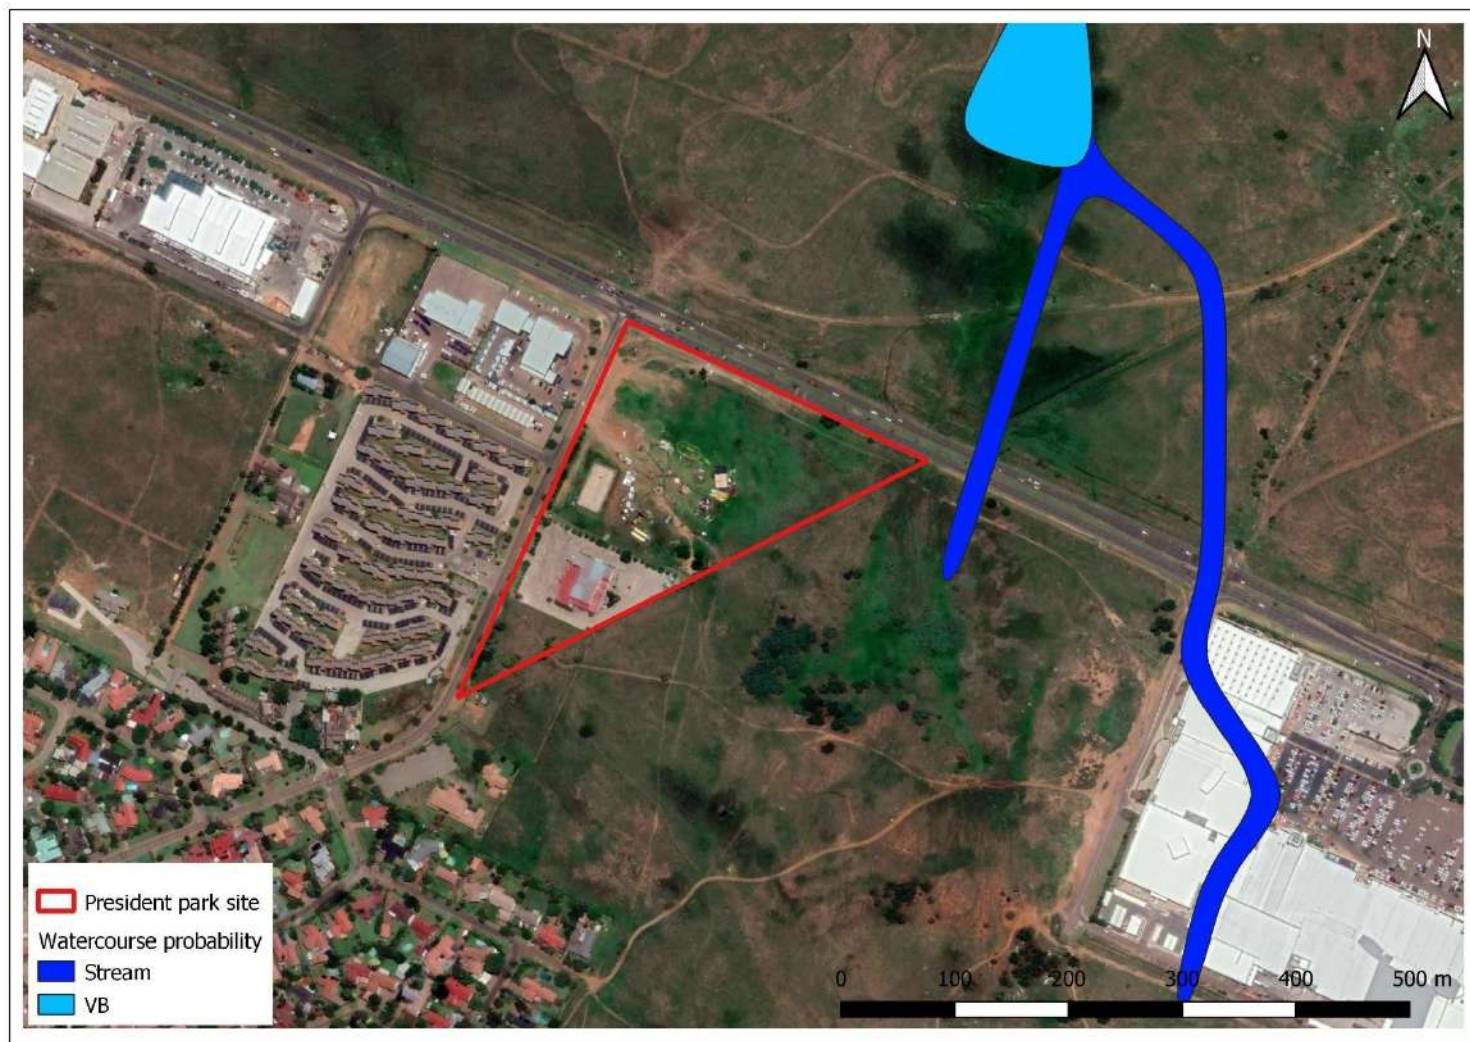
Figure 2: Predicted watercourses according to the NBA (2018).

The site is located in quaternary catchment B11J. Watercourses are indicated to the north of the site on the topographical map of the site, north of Mandela Street (Figure 2). The indicated watercourses enter a tributary of the Olifants River to the north of the site.

According to the NBA database wetland units are expected to the east and north of the site (Figure 2) and the NFEPA database also indicate wetland units to the east and north of the site (Figure 3). The NBA database mainly focus of valley bottom wetlands and streams and poorly represent other wetland systems. The NFEPA database are notoriously inaccurate and poorly represent temporary and seasonal wetness zones. Both of these databases indicate the possibility of wetlands to the east of the site, which may extent into the site.

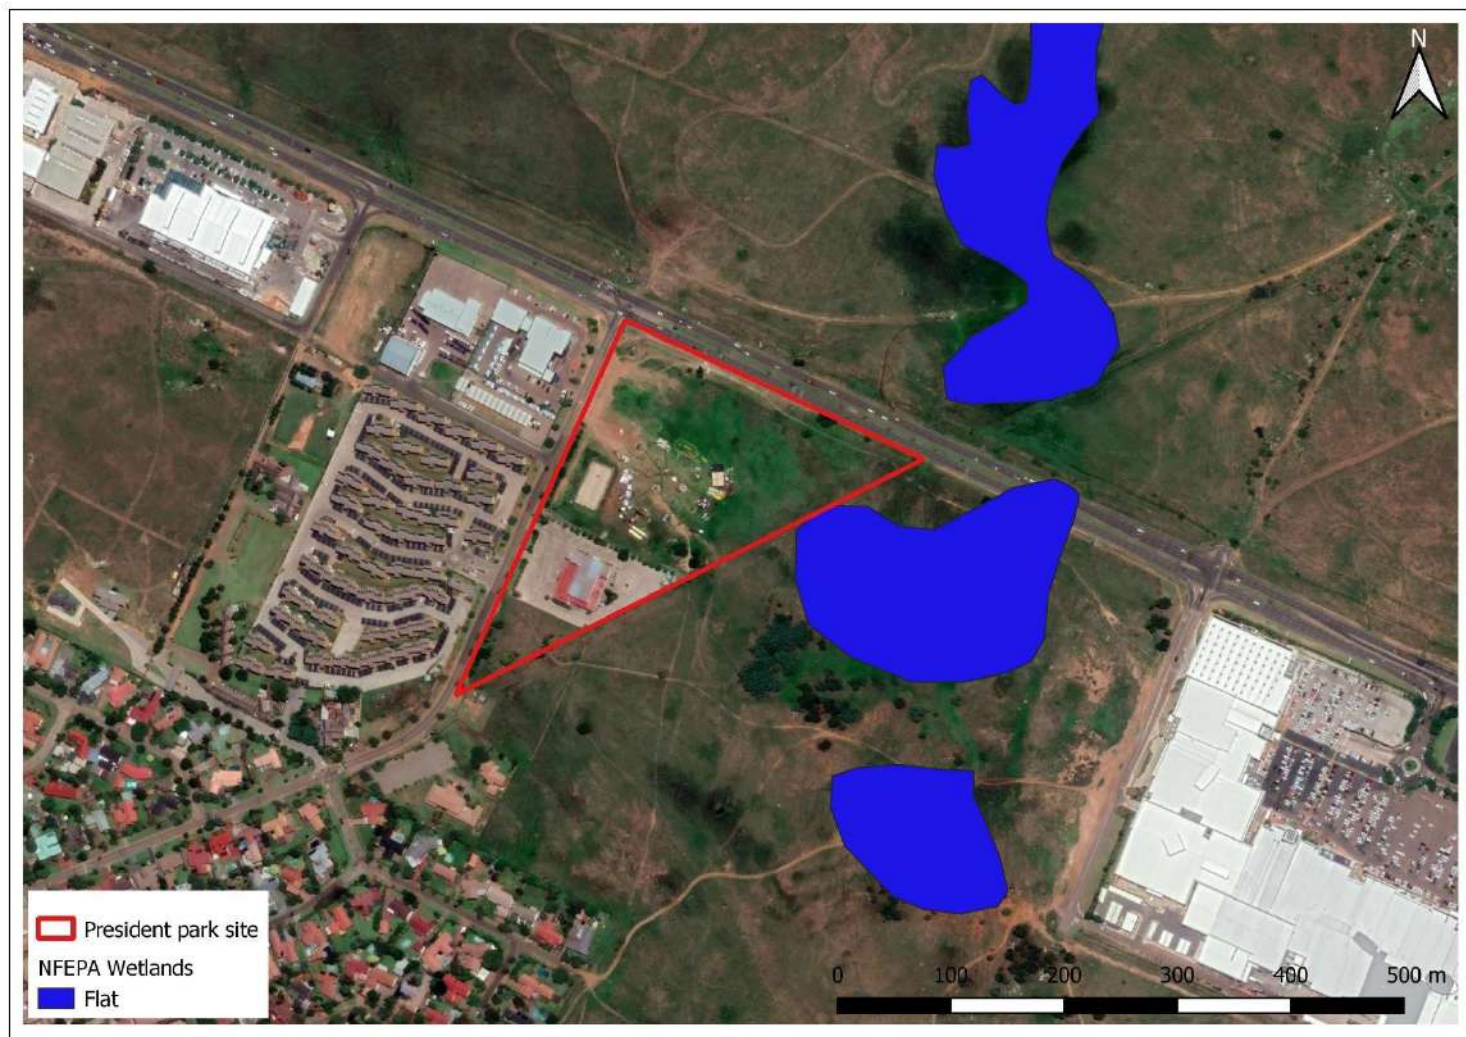
Figure 3. Wetland areas identified in the NFEPA database around the sites.

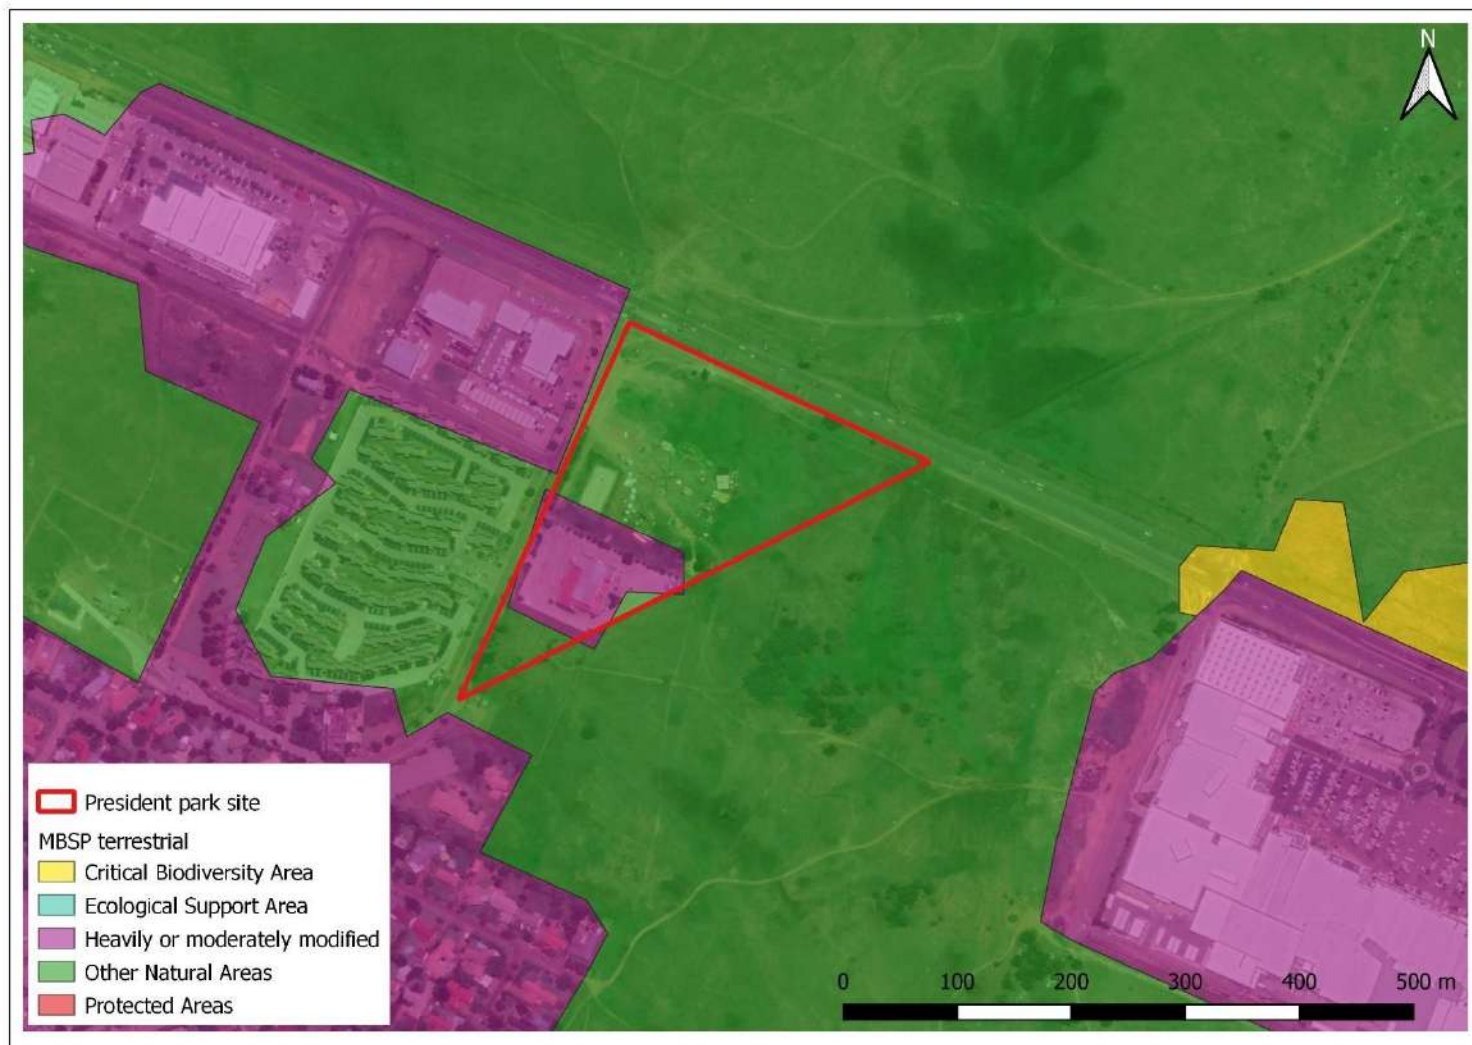
Figure 5: Ecological categories according the MBSP terrestrial database.

The development on site falls within the heavily or moderately modified unit of the MBSP terrestrial database while the remainder of the site is classified as other natural areas (Figure 5).

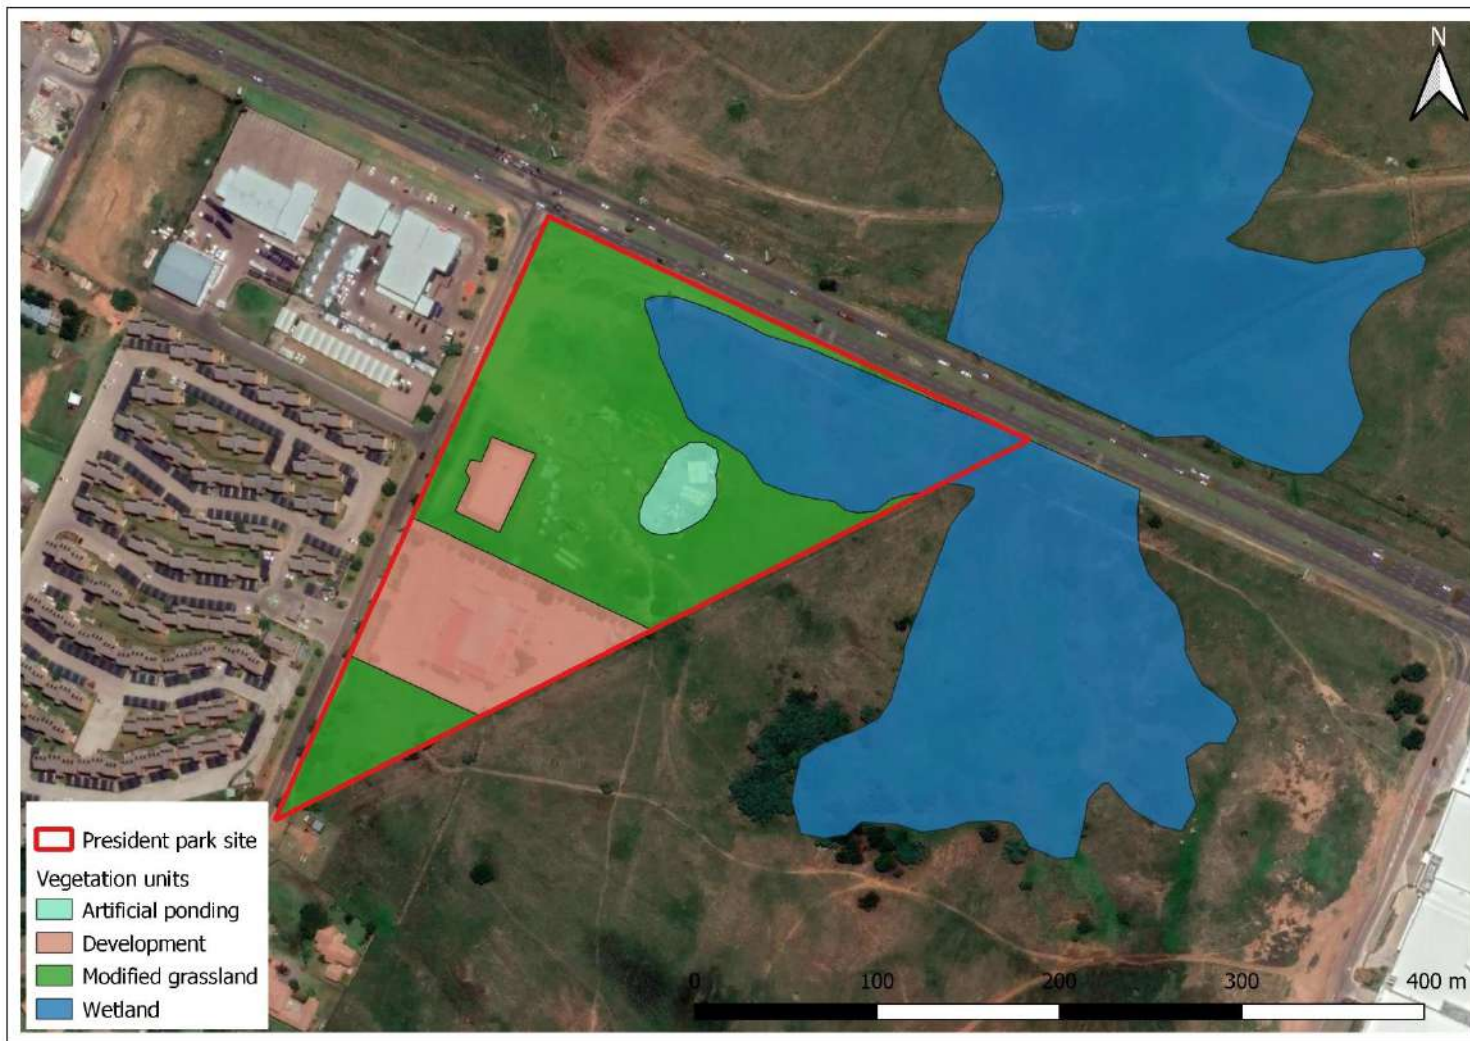
Figure 7: Desktop delineation of vegetation and wetland units on site.

1. Modified grassland
2. Artificial ponding
3. Wetland

In addition to these wetland units, the central portion of the site are developed, and this area is completely transformed. Any vegetation associated with the development is garden areas and does not resemble the natural vegetation at all.

The modified grassland unit consist of a mix of alien and invasive species with a few common indigenous plant species present. The high level of disturbance is present across the site, up to the boundary. *Pennisetum clandestinum* (Kikuyu) is present in patches throughout most of the site and appears to be informally harvested for sale on site. Numerous other weeds are also present and the remaining terrestrial vegetation no longer resembles the Rand Highveld Grassland vegetation type. This is partially as a result of the infill on the northern portion of the site, but also reflects past disturbances on site. The vegetation on site is therefore of low sensitivity and a full vegetation assessment should not be required on site.

An area where water ponds artificially is present on the northern portion of the site, on the existing infill on site. This has result in the establishment of some wetland species and the area is dominated by *Pennisetum clandestinum*, *Cyperus congestus* and *Trifolium repens*. Although mottling is present in the soil, the soil is clearly imported to the site and the origin of the mottling is therefore unknown and not necessarily due to the ponding taking place on site. Although this area has some wetland species present the unit should not be considered a wetland area, since it is unlikely to provide any wetland function. The ponding taking place in this area is due to the artificial modifications to the topography of the site.

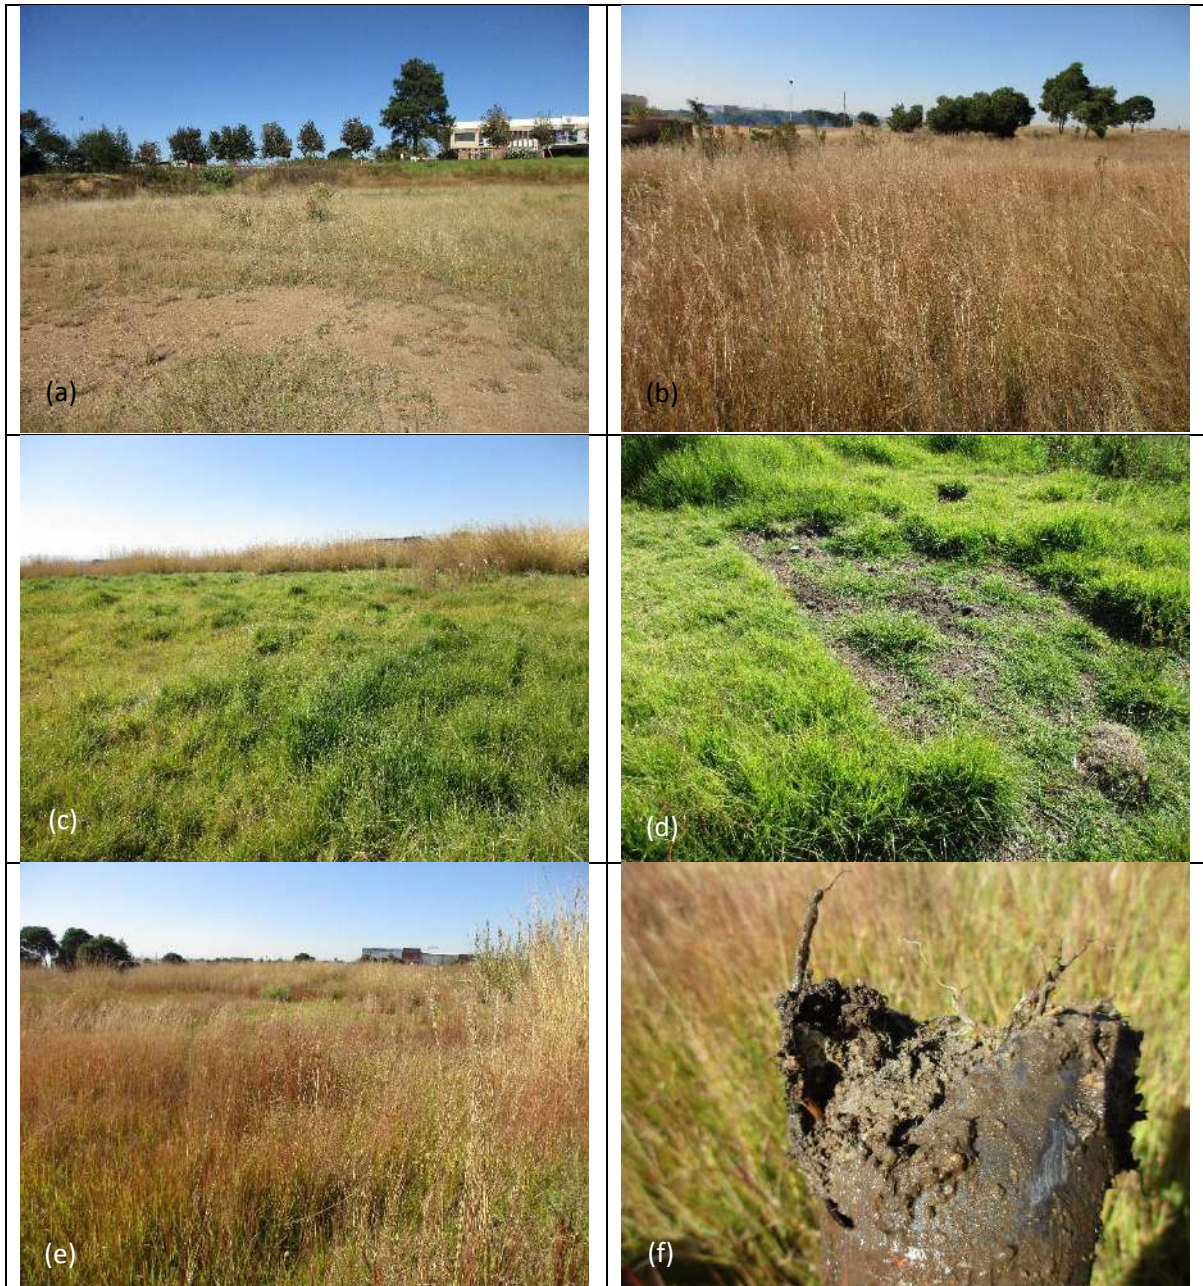
Figure 9: Photographs of (a) and (b) the modified grassland unit on site, (c) the artificial ponding area, (d) informal harvesting of kikuyu on site, (e) the wetland unit on site and (f) the grey soil in the wetland unit.

should be completed on site to address the wetland, impacts on the wetland and potential buffer zones.

At present, for the screening phase of the assessment it should be assumed that no development can take place in the wetland unit and that a buffer zone between 15 and 30m will likely be necessary.

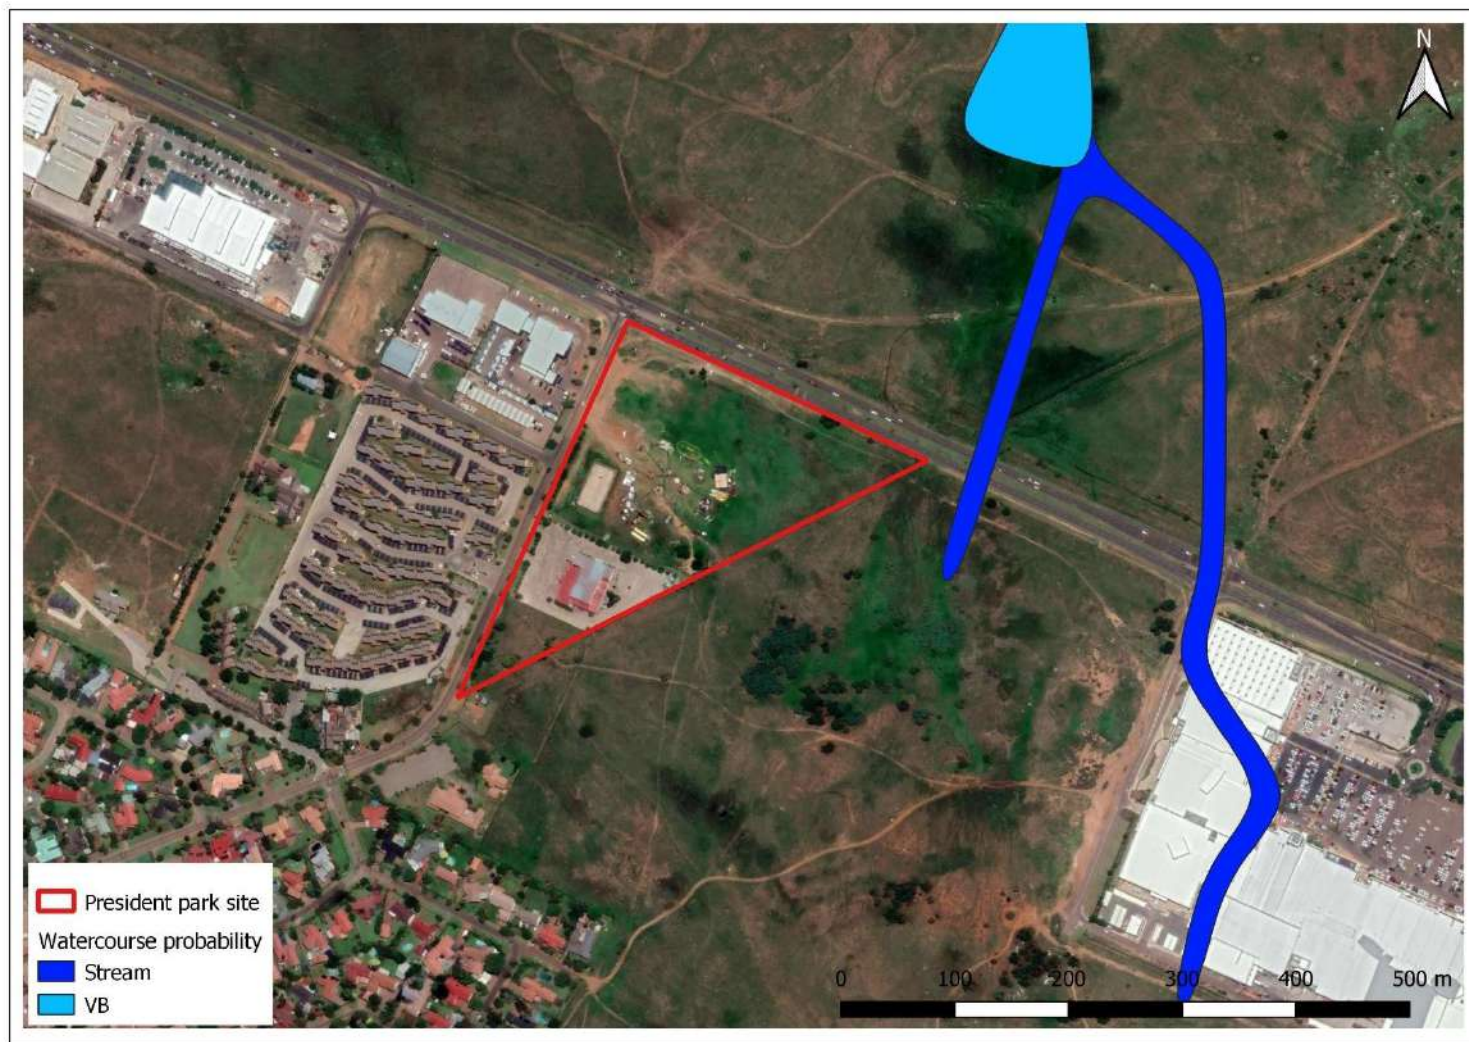
Figure 2: Predicted watercourses according to the SAIIAE (2018).

The site is located in quaternary catchment B11J. Watercourses are indicated to the north of the site on the topographical map of the site, north of Mandela Drive (Figure 2). The indicated watercourses enter a tributary of the Olifants River to the north of the site.

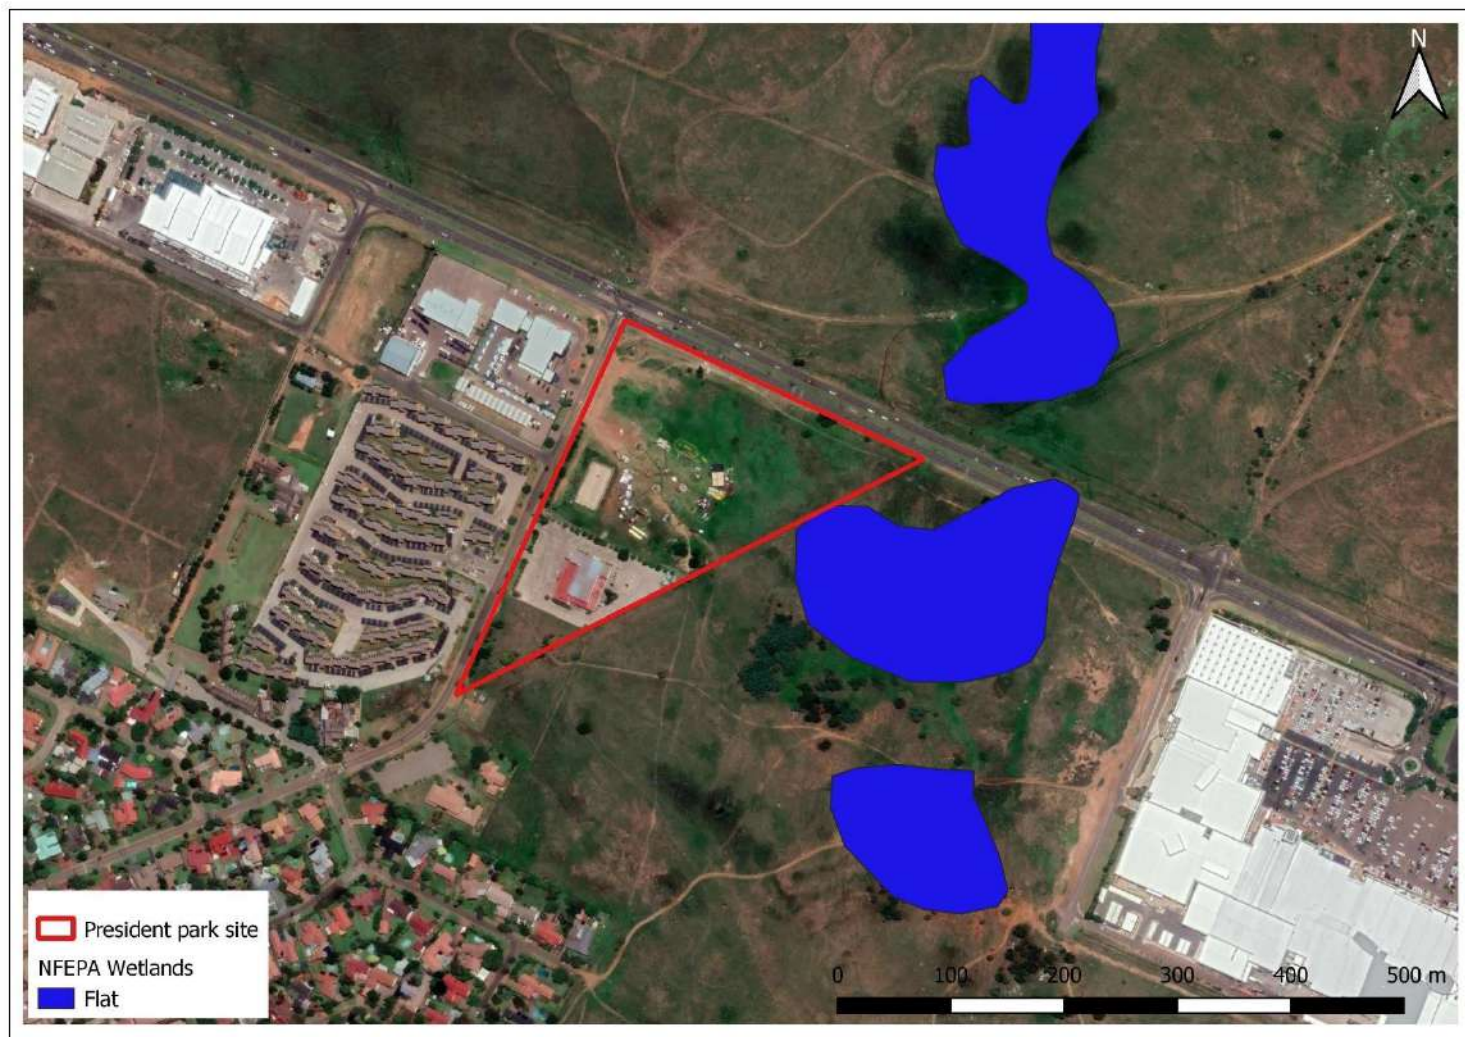
Figure 3. Wetland areas identified in the NFEPA database around the sites.

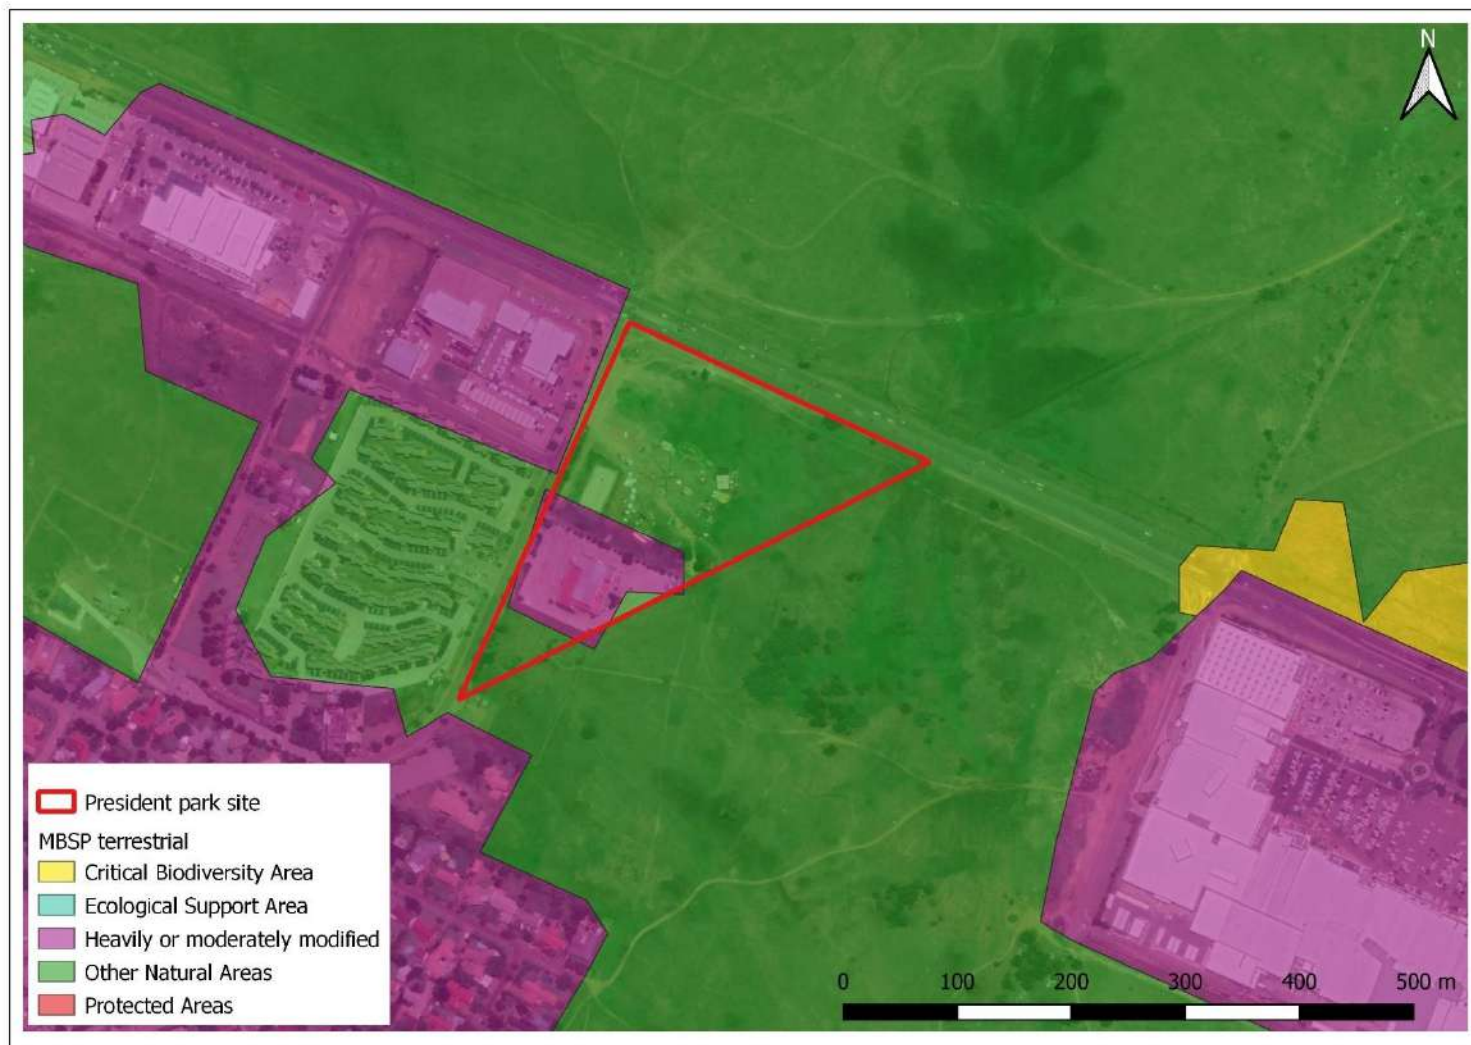
Figure 5: Ecological categories according the MBSP terrestrial database.

The development on site falls within the heavily or moderately modified unit of the MBSP terrestrial database while the remainder of the site is classified as other natural areas (Figure 5).

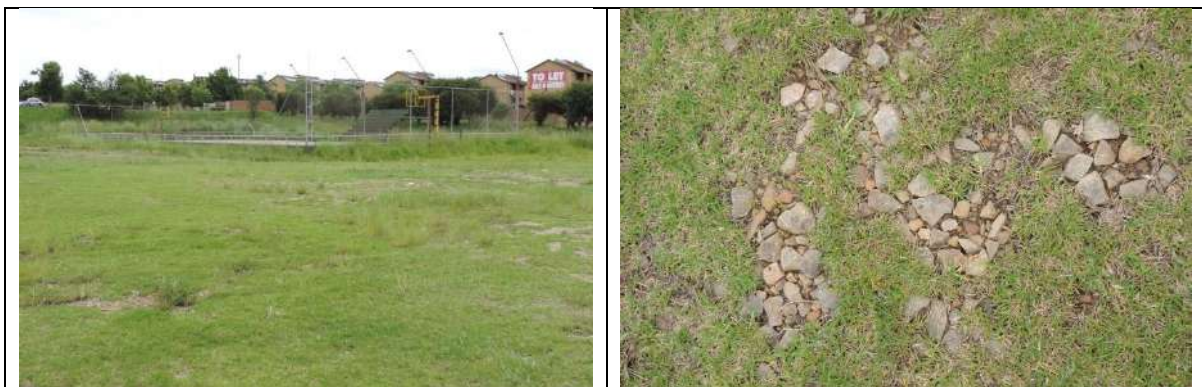
Figure 7: Basketball court and parking terrace classified as the Johannesburg soil form (left) and imported materials covering the soil surface of the Johannesburg soil form, Technosol Group (right).

The site is characterised by Technosols and Anthrosols. The area where the Portuguese Club and the paving around it is located as well as the nearby basketball court (Figure 7), falls within the Technosol group. Soil profiles are covered by concrete structures, cement and waste materials including building gravel (see Figure 7). These areas all classify as the Johannesburg soil form.

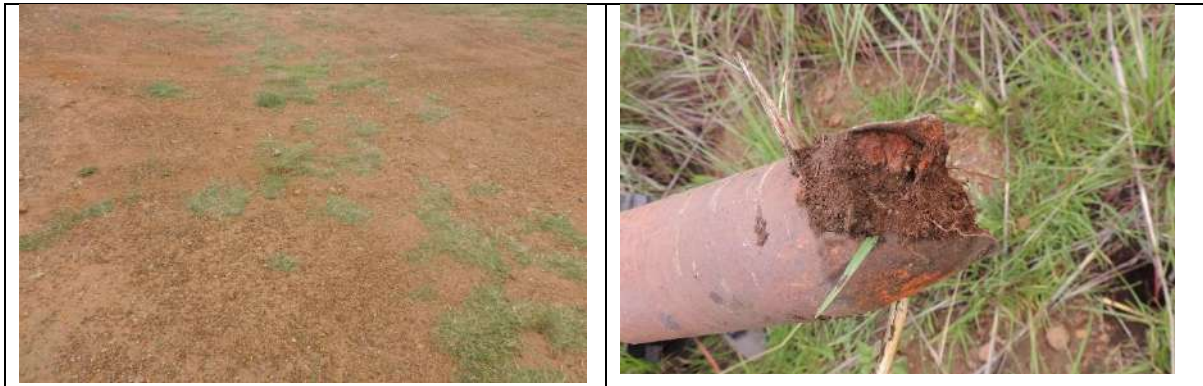
*Figure 8: Compacted soil of the Grabouw form (Anthrosol Group) located in the northern corner of the site (left) and (right) orthic topsoil with weathering imported gravel at 0.35m.*

The north-western corner of the site consists of the Grabouw soil form which represent soil profiles that may resemble some of the original horizon organisation but with degrees of disturbance that include significant compaction (Figure 8). Rainwater infiltration in these areas is very limited as a result of the compacted surfaces and will instead increase the stormwater volumes that will seep into the surfaces across Mandela Drive (further north and north-east).

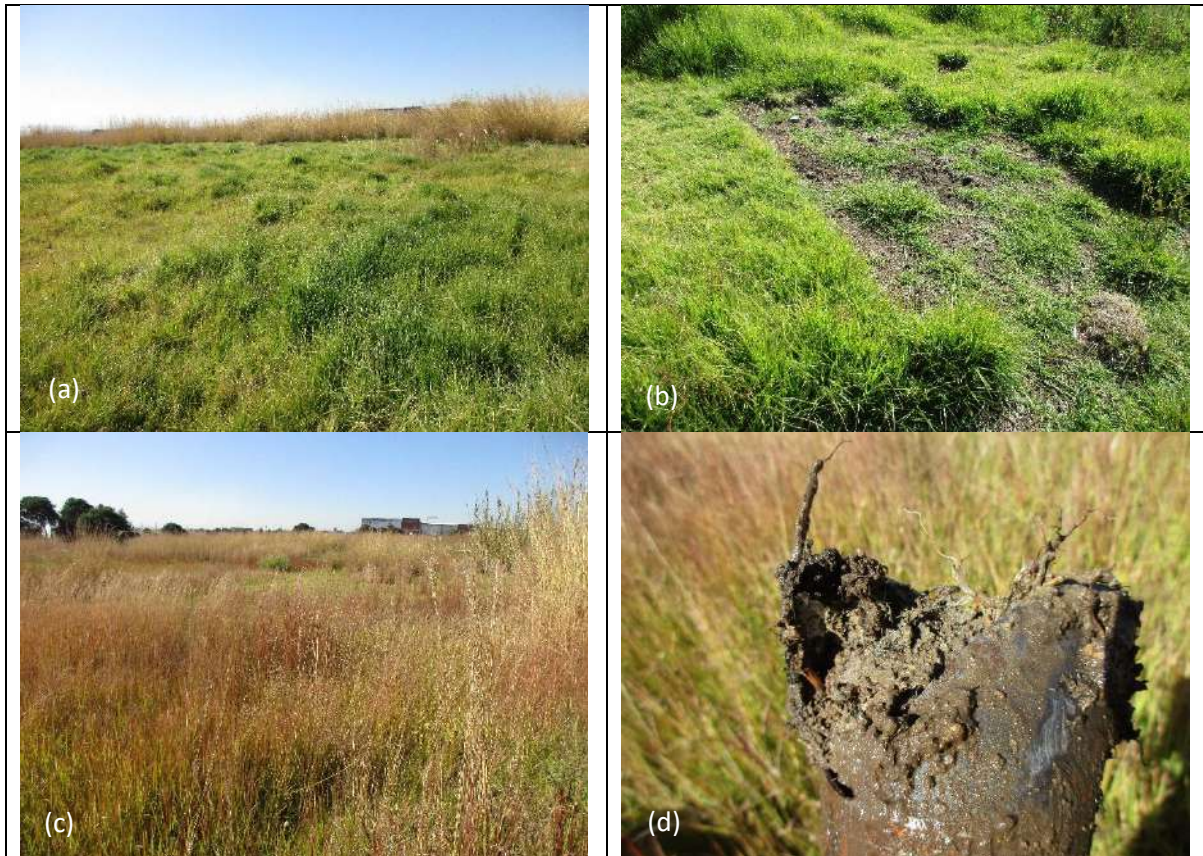
*Figure 9: Photographs of (a) the artificial ponding area, (b) informal harvesting of kikuyu on site around and in the ponding, (c) the artificial wetland unit on site and (d) the grey soil in the wetland unit.*

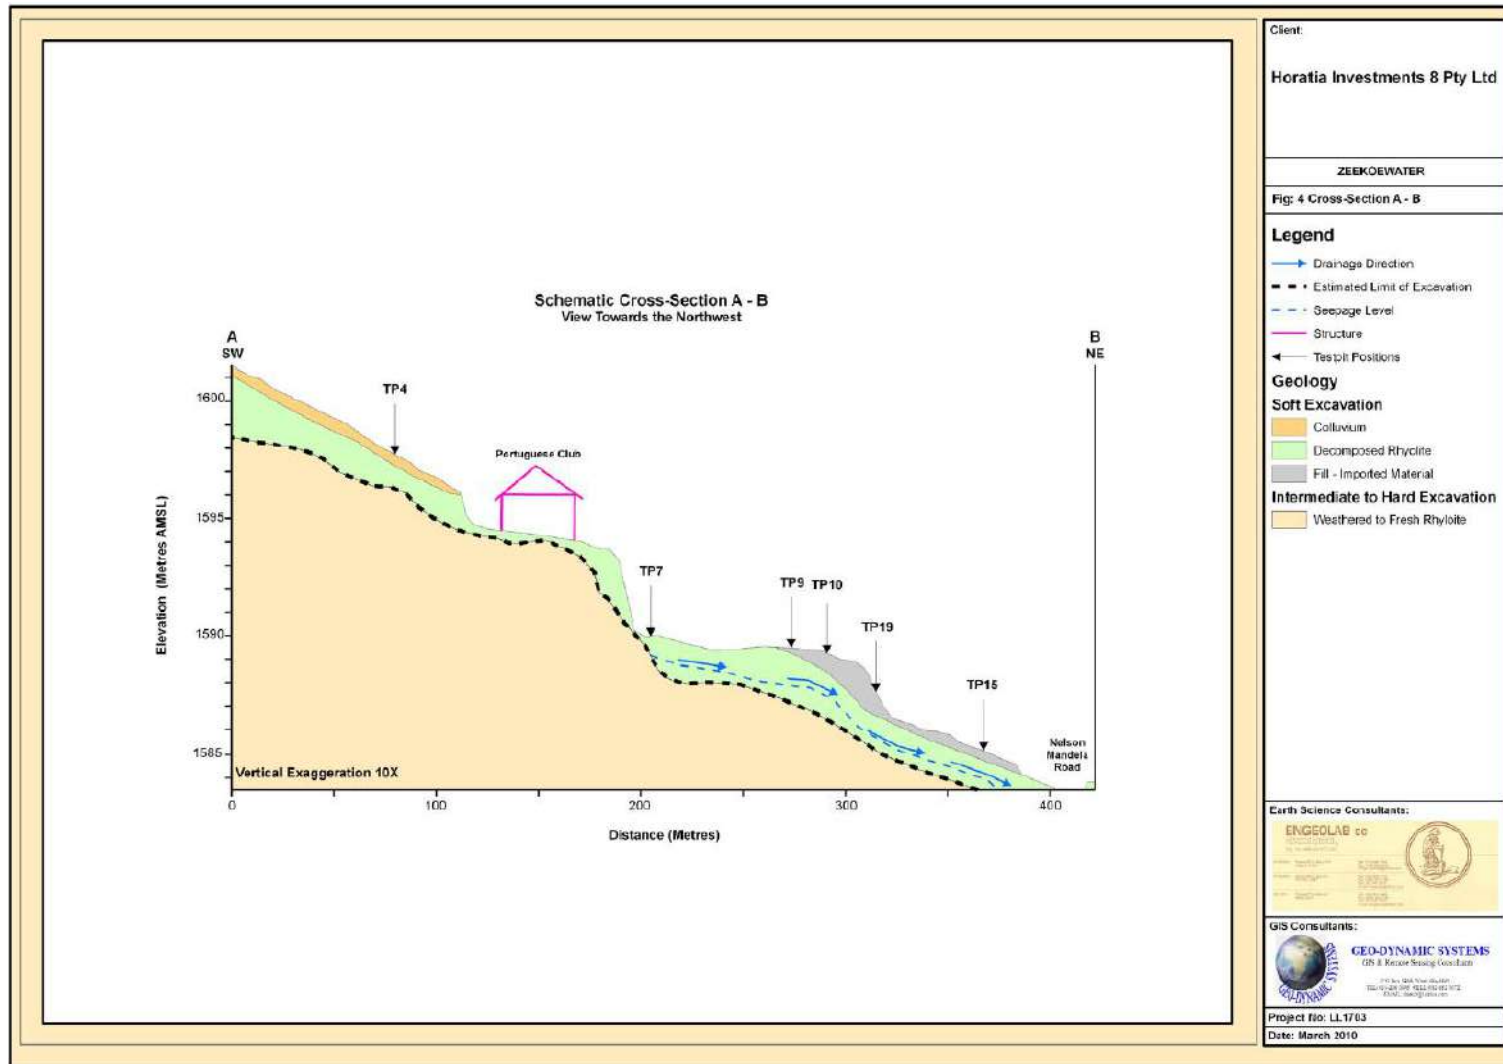
Figure 13: Cross-sectional profile included in the geotechnical report by Engeolab (2010) indicating the altered cut-and-fill profile of the site and the sub-surface water flow.

During rainfall events, water infiltrates the shallow topsoil horizon but vertical movement is then limited by the presence of the rocky material and hard plinthite. This will create temporary wetness on these compacted surfaces before moving in a lateral direction towards the lower-lying landscape positions.
