HERITAGE IMPACT ASSESSMENT FOR THE PROPOSED BOEGOEBERG HYDROPOWER STATION NEAR GROBLERSHOOP, NORTHERN CAPE

(Assessment conducted under Section 38 (8) of the
National Heritage Resources Act (No. 25 of 1999) as part of an EIA)

AURECON SOUTH AFRICA (PTY) LTD

Jayson Orton & Lita Webley

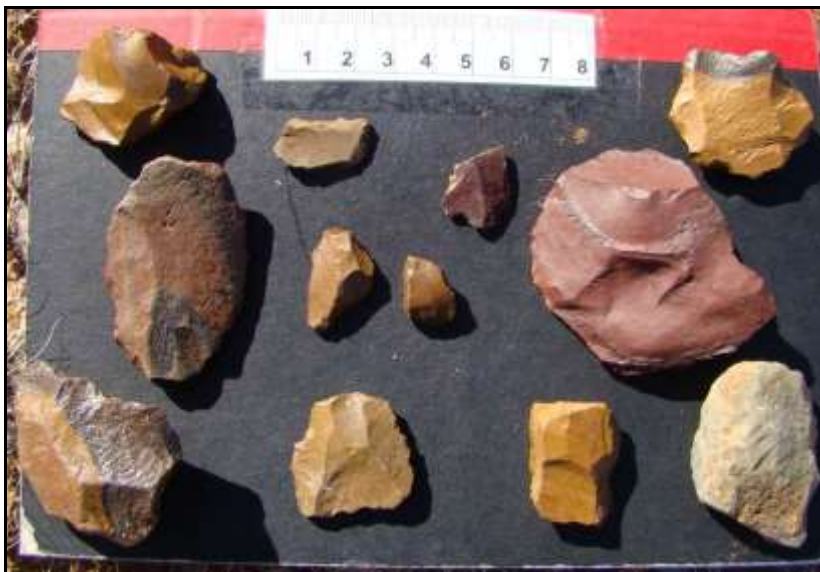
Above the cliff at the Boegoeberg Weir an extensive scatter of stone artefacts was recorded (site ZKB2013/001). Most are likely to be MSA in age (Figure 12 & 13) but a few grindstones (Figure 14 & 15) and other isolated flaked artefacts are probably LSA. There is no obvious occupation site but the position offers an excellent view over the valley and was no doubt repeatedly used for short periods. One area of this scatter (point 014) was particularly dense. Similar, but less dense and more weathered material was recorded on the hill where the proposed transmission line would cross the river (point 076).

Figure 12: Banded ironstone artefacts from ZKB2013/001.

- Archaeological mitigation should be carried out at site ZKB2013/001 on the platform at the top of the cliff prior to construction; and
- The stone structures at BDW2013/001, specifically the one near the road, should be avoided during and after construction. Careful placement of pylons will be required to ensure that these structures are spanned but care should be taken to avoid damage to them during construction.

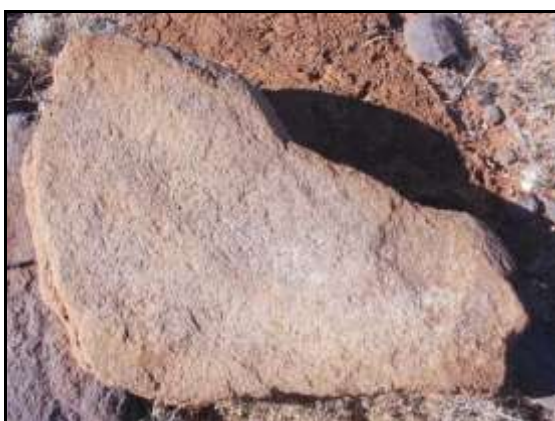
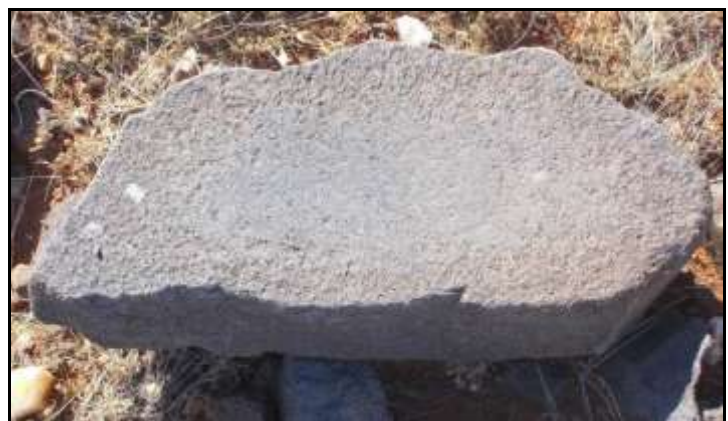
Figures 14 & 15: Two quartzite lower grindstones from ZKB2013/001.

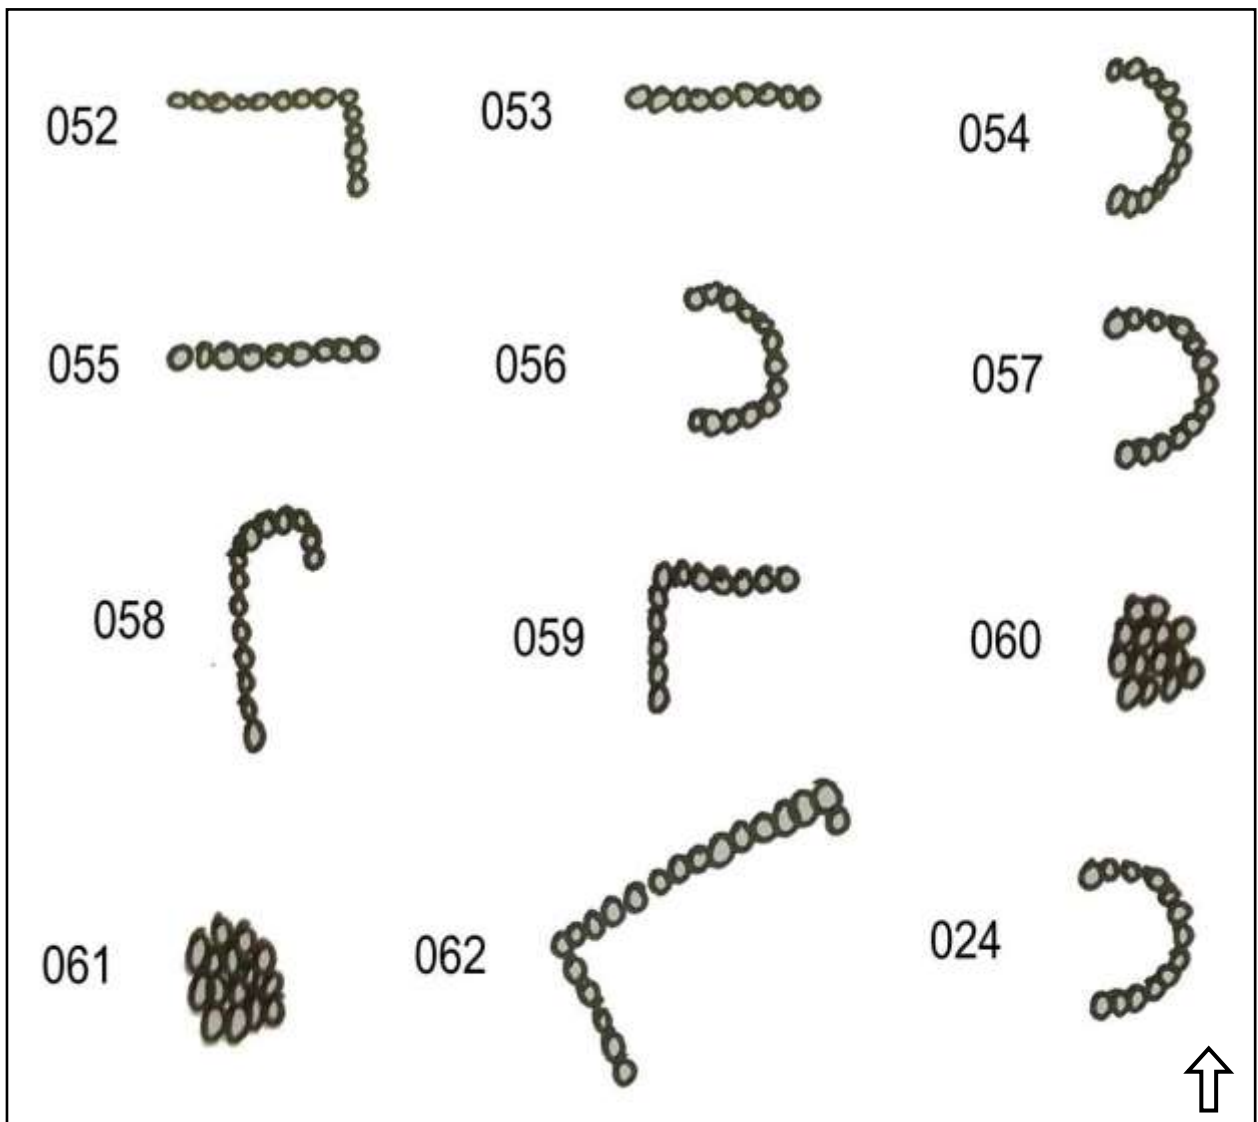
Figure 21: Schematic plans of all the stone features at BDW2013/001. Scales vary, GPS points as labelled, the arrow indicates north.

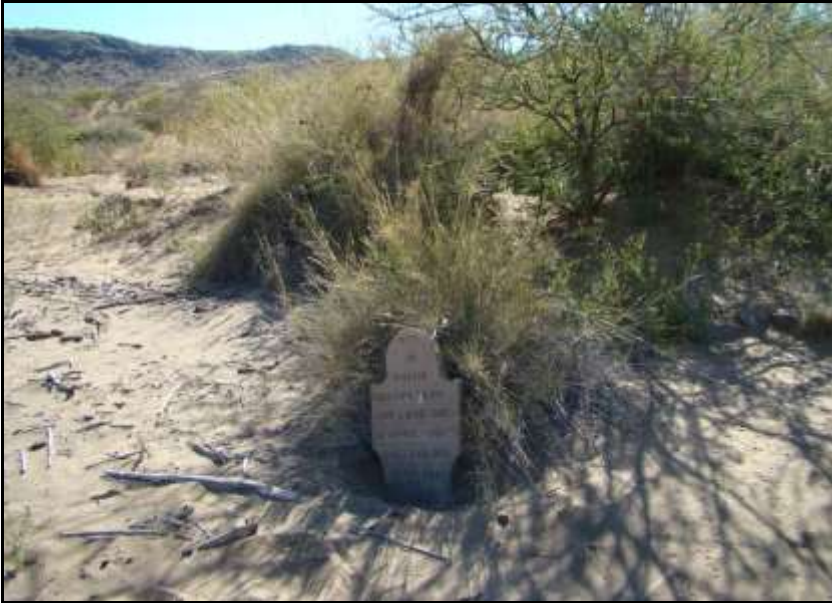
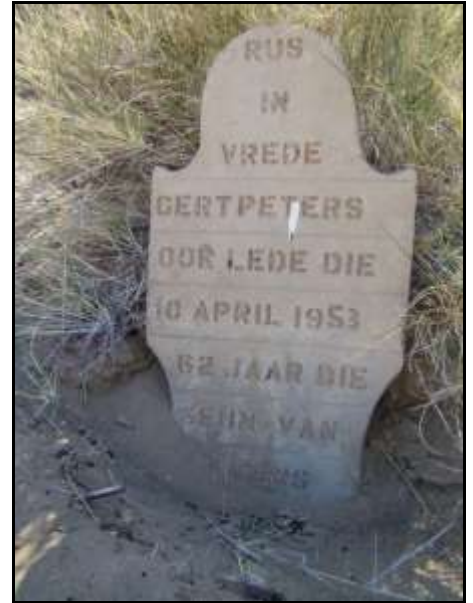
Figures 23 & 24: Headstone at ZKB2013/003.

- The gravestone (ZKB2013/003) and stone cairn (ZKB2013/002) immediately downstream of the power station site should be temporarily cordoned off and carefully avoided throughout construction work;

- Excavation in the silts immediately below the weir should be carefully monitored by the ECO just in case there are other burials, or the cement headstone has been washed downstream from another location during floods;

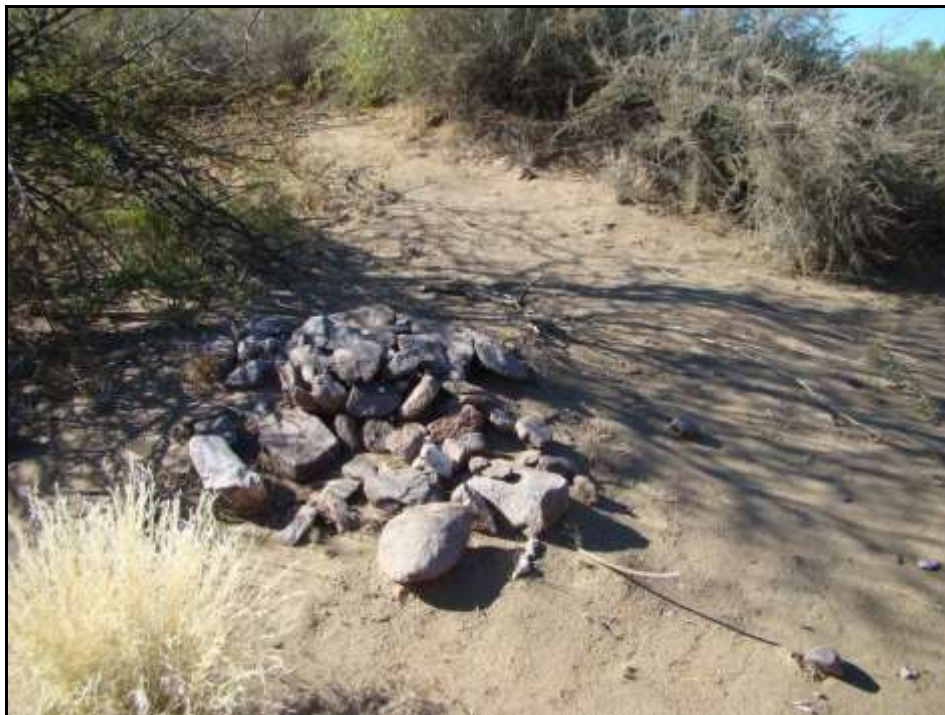
Figure 25: Stone cairn at ZKB2013/002.
