**GEOTECHNICAL INVESTIGATION**  
Magatle Filling station Development

**REF NO.:** NK-0108

| <b>Document Title:</b> | Geotechnical investigation for Magatle Filling station development |

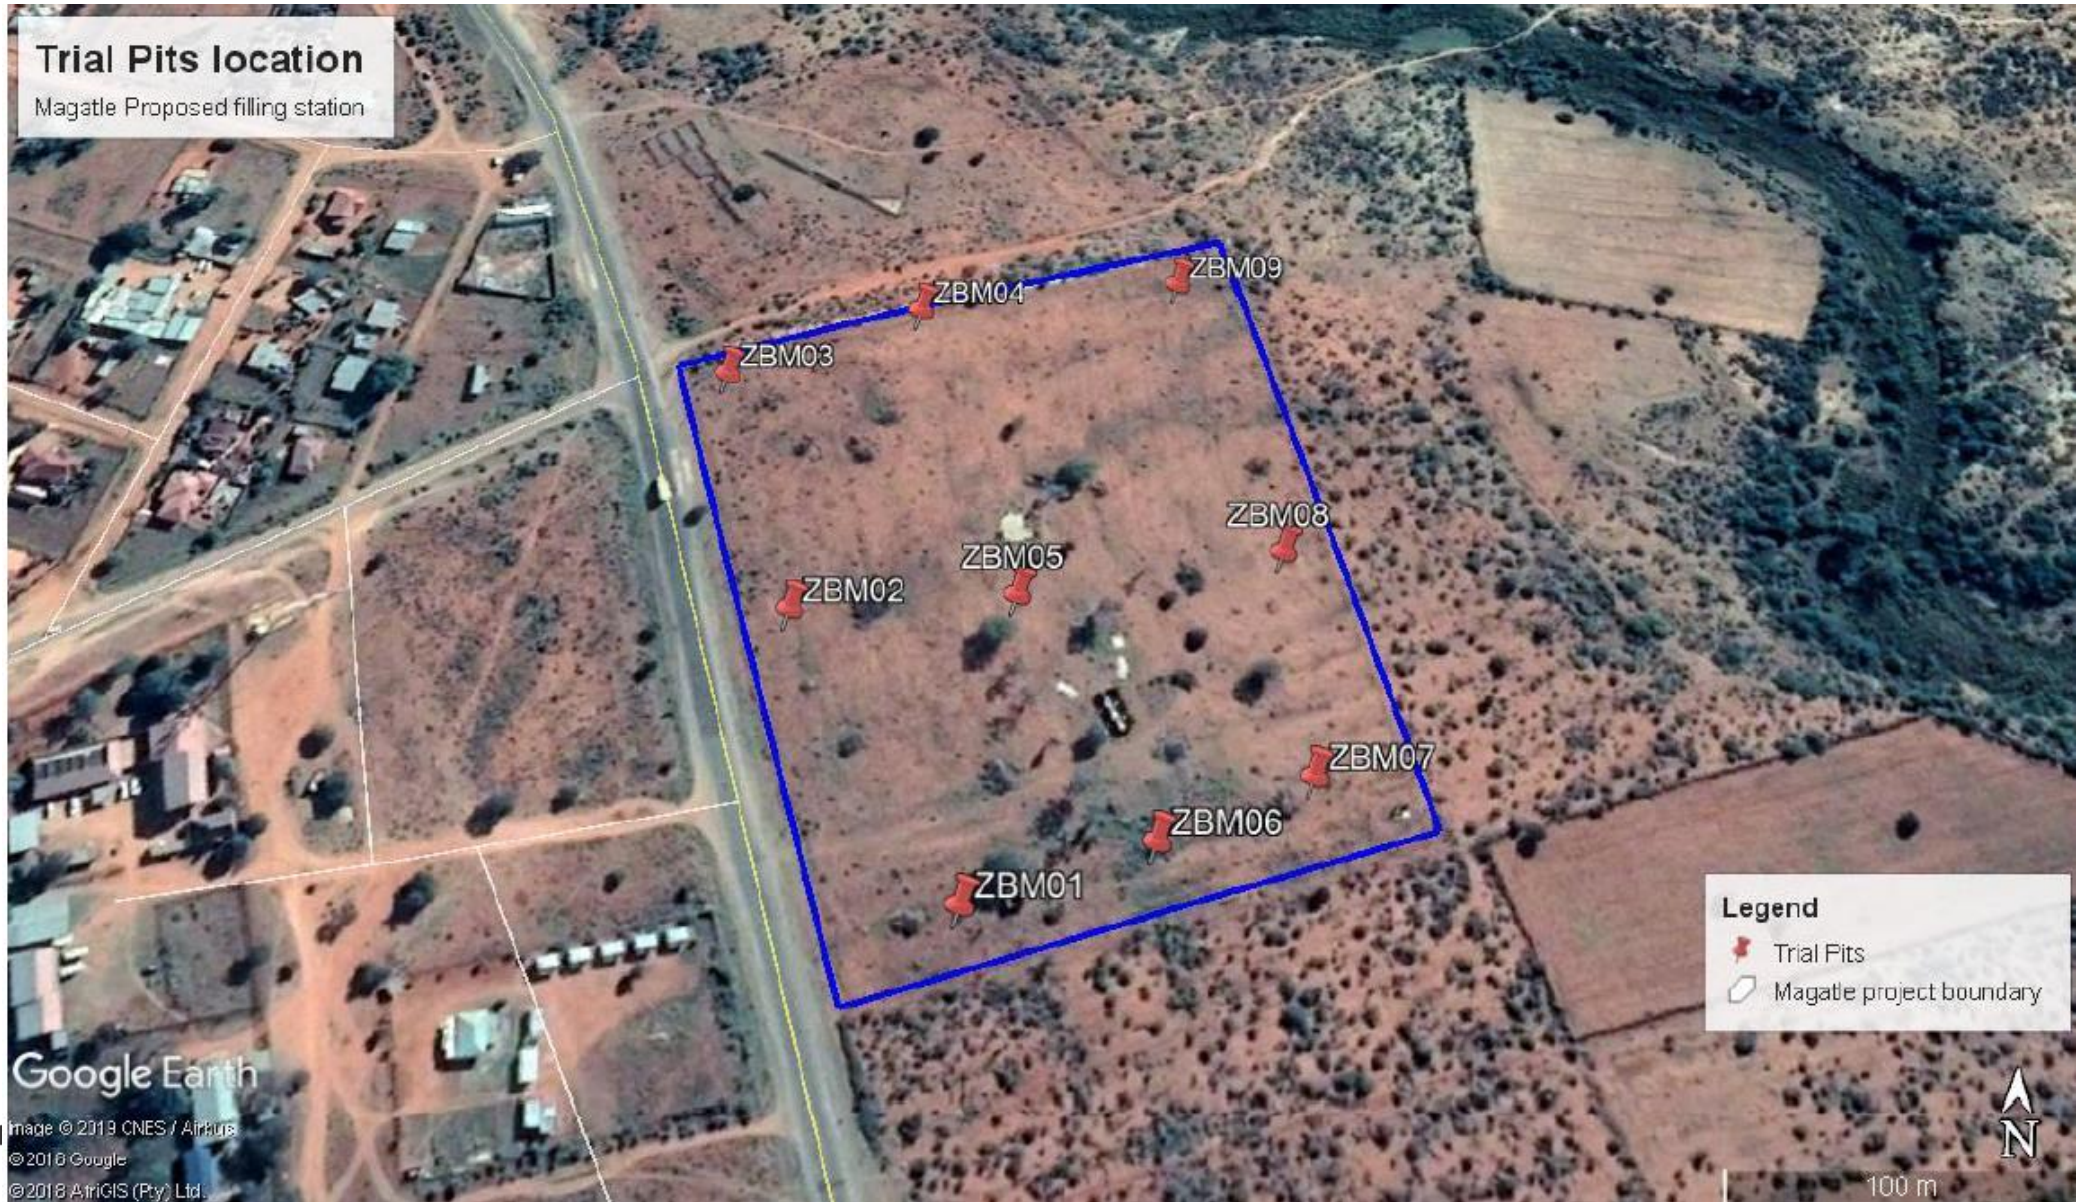
## Appendix A: Test Pit Location

profiling. The location of the test pits is indicated on the test pit locality plan available in Appendix A. Detailed soil profiles are attached in Appendix B.

The field investigation was carried out by a Nkhophole holdings engineering geologist on the 27 June 2019. A total of nine (9) test pits were excavated across the site. The test pitting indicates that the site is underlain by a cover of transported colluvial material occurring as sand with sparse to abundant fragments of gravel. The material encountered in the test pits is described below and detailed test pit logs are available in Appendix B.

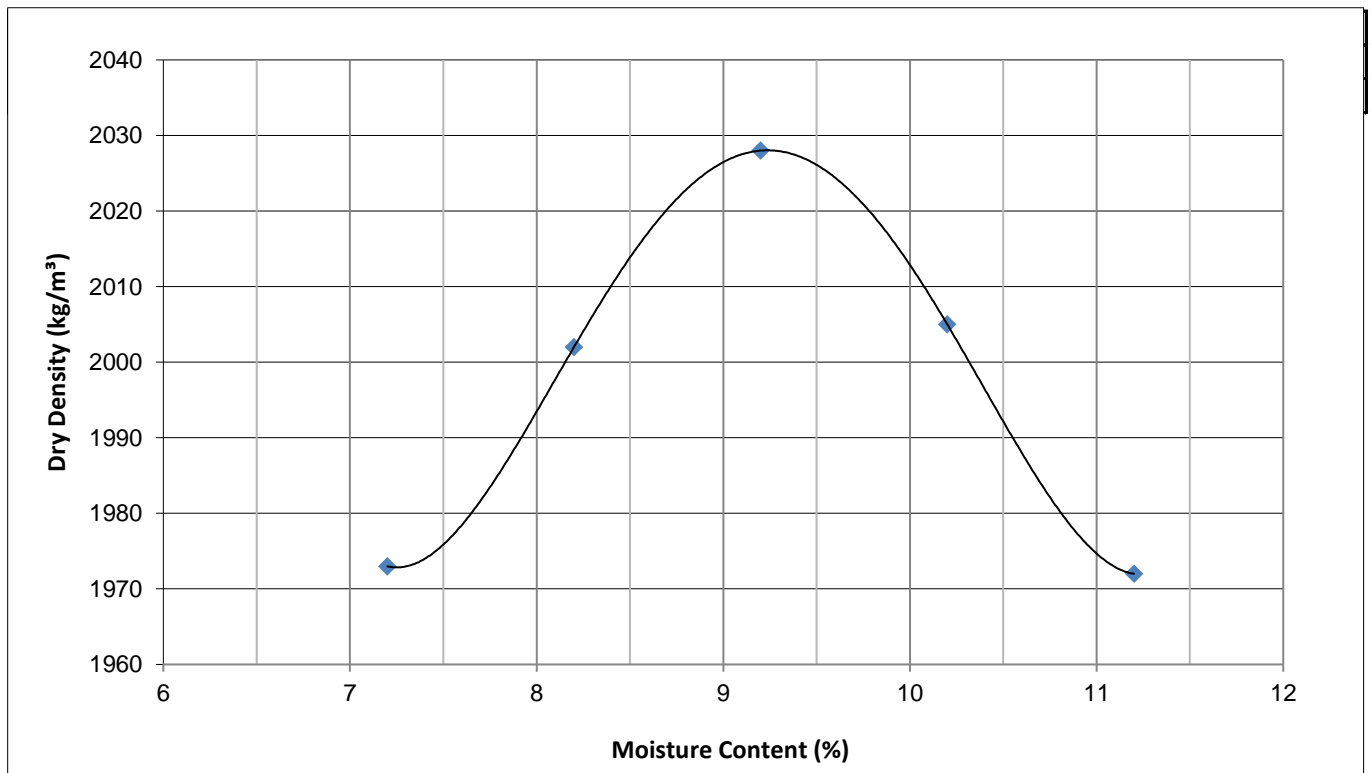
### Maximum Dry Density & Optimum Moisture Content - SANS 3001 GR30

| Max. Dry Density | kg/m <sup>3</sup> | 2028 |
| Optimum Moisture | % | 9.2 |
