AUGRABIES
PROPOSED NEW CEMETERY

REPORT ON
STORM WATER DRAINAGE &
GEOTECHNICAL CONDITIONS

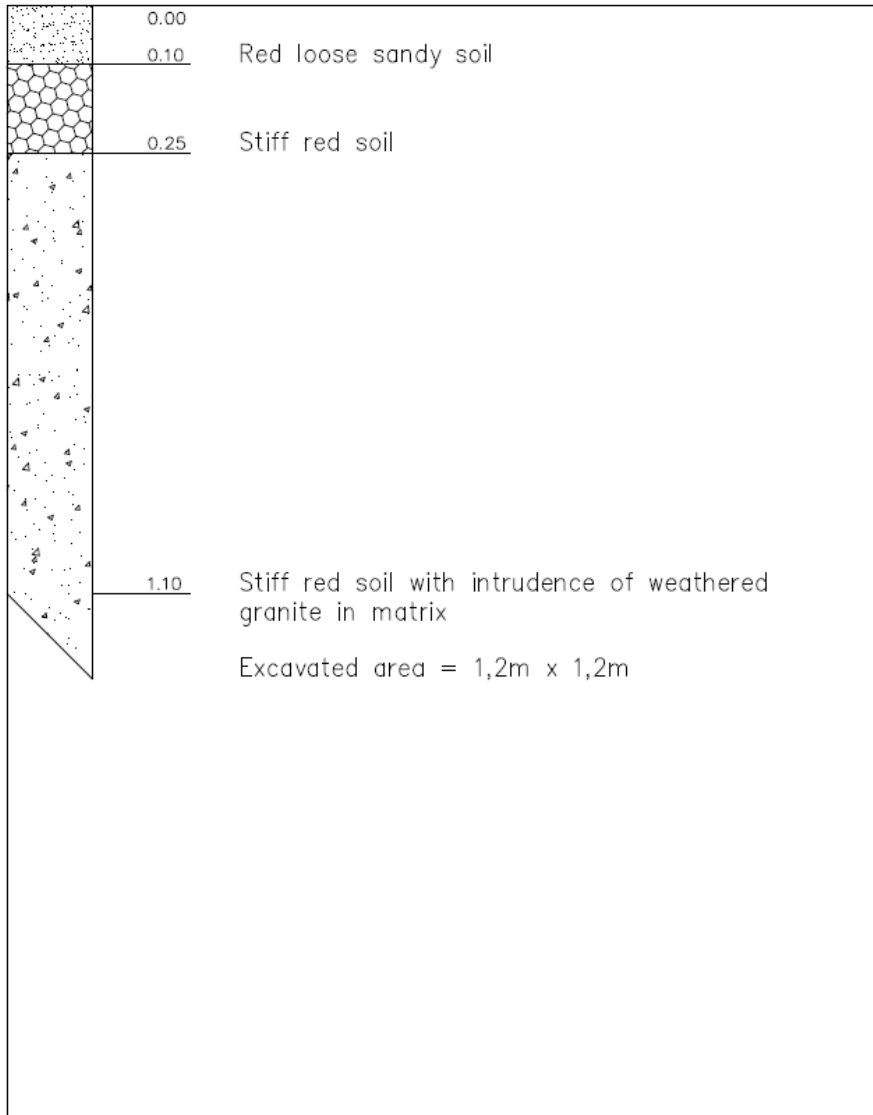
TEST HOLE PROFILE

The test hole was excavated up to a depth of approximately 1,1 meter below natural ground level without any difficulty. The upper 350 mm was identified as stiff red soil and the next 650 mm in the profile weathered granite with some calcrete gravel. The excavated test hole indicated stable soil conditions with stiff red sandy soil at the upper zone of the test hole.

Intermediate material or hard rock may be encountered below a level of 1,2m.

The profile of this test hole is shown in Annexure B.

As far as the geotechnical conditions are concerned, the site is suitable for the development of a new cemetery, but it is recommended that the graves be pre-excavated to the required depth of 1,8 meter. The pre-excavation of the graves are normally done where hard materials are encountered and the cost thereof is then part of the development costs of the cemetery.

The test hole excavated on the site indicated that hard material may be encountered at a depth of more than 1,20 meter below natural ground level. This material is typical of this area and therefore it is recommended that the graves be pre-excavated as part of the development of the new cemetery.
