**PROPOSALS FOR A SOIL EROSION MANAGEMENT PLAN: PROPOSED SKYWALK PROJECT –  
GOD’S WINDOW. SITUATED ON THE FARMS DE HOUT 503 KT AND PORTION 2 OF THE FARM  
LISBON 531 KT: THABA CHWEU LOCAL MUNICIPALITY, EHLANZENI DISTRICT MUNICIPALITY:  
MPUMALANGA PROVINCE: APPROXIMATELY 2.0 HA: SEF PROJECT CODE 505201**

**KZN 3867 : August 2014**

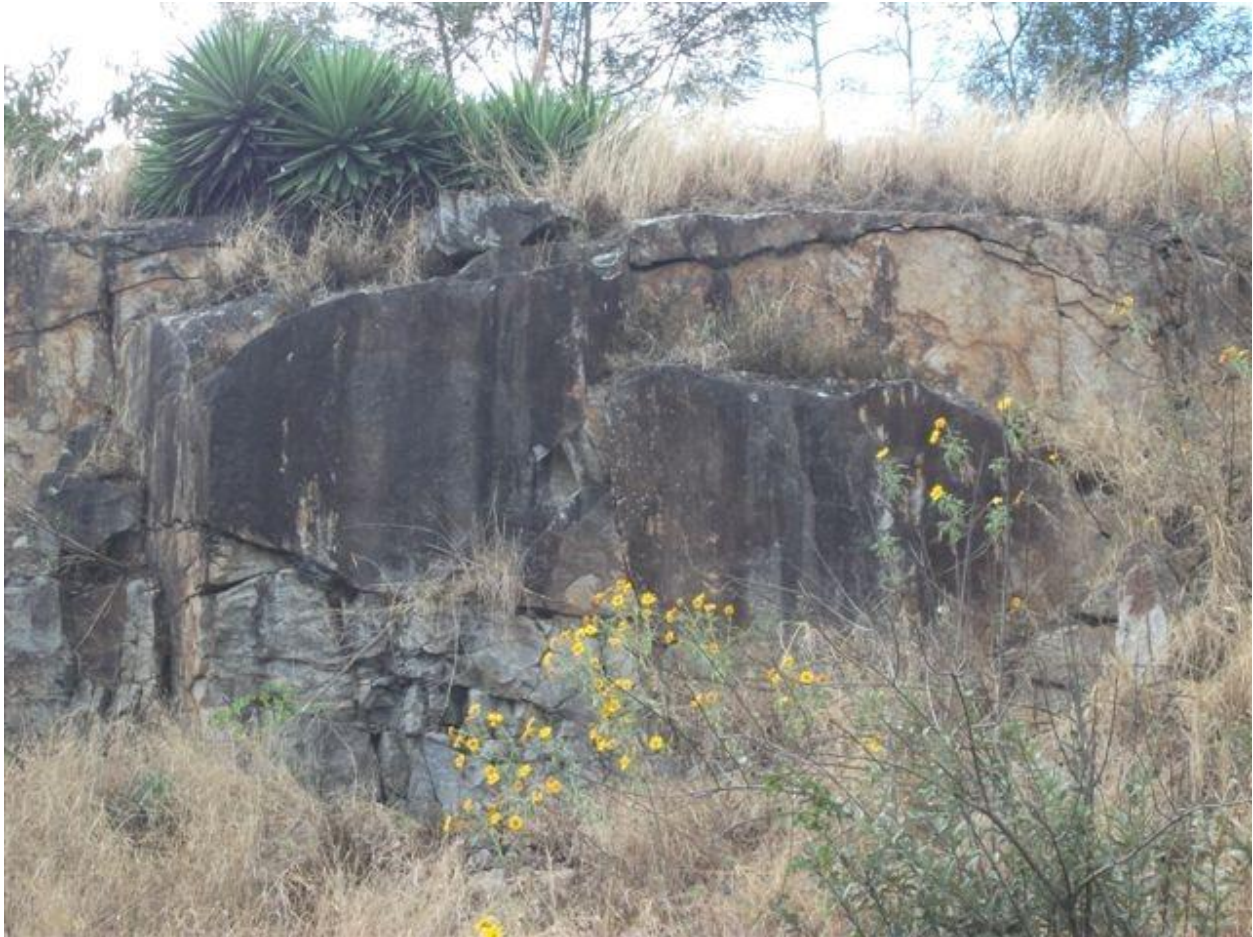
As it has not been feasible to obtain a full soil profile at the target site, the Mispah Soil Form profile illustrated below, but photographed at another site, illustrates the soil profile status at the target site.

The limited topsoil evident in this photograph is sufficient to support poor quality grasses and some sisal plants as well as a few eucalyptus trees, all shallow rooted plants. The sandy topsoil has devolved mainly from weathering of the rock over great periods of time, by means of chemical reactions. Depending on conditions, this process typically creates one mm of topsoil every 15 to 25 years.

For illustrative purposes a typical Mispah Soil Form profile is illustrated overleaf.

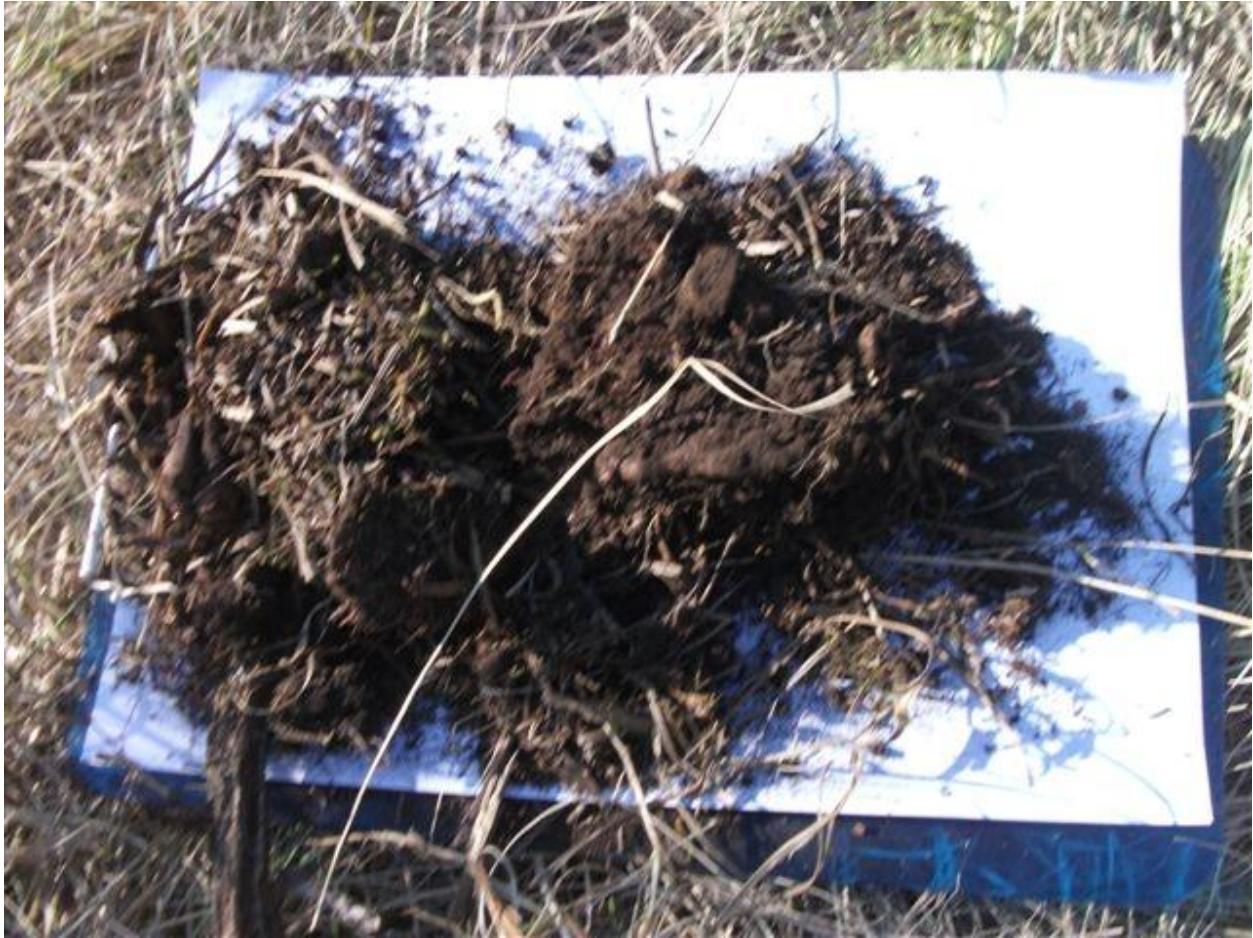
The photograph below illustrates the challenges associated with the poor quality of the limited 'topsoil' there is present at the target site. The formation and consequent structure of what has to be termed, for want of a better word, 'topsoil' has been brought about by a virtual composting of surface moss and abundant *Erica* (fynbos) detritus.

The outcome has been an unstructured 'quasi-soil' that has no inherent binding strength and no ability to store moisture for more than a few hours. When handled, it fragments into fine dust and semi-decomposed plant matter.

The samples reflect the surface facing up and the surface inverted. The samples are so loosely bound that neither tool nor hand pressure was needed to lift them. It is this 'topsoil' that could be a major nuisance dust hazard during the construction phase.

The process that has occurred at the target site is the rapid decomposition of organic matter that has fallen onto and between the surface rocks, thus forming layers of humus. This rapid process is mainly the result of the local micro-climate rather than the slow weathering of rock. The main natural resource factors have been high rainfall, frequent and heavy mist and dense vegetative ground cover. The resulting humic topsoil is illustrated overleaf.

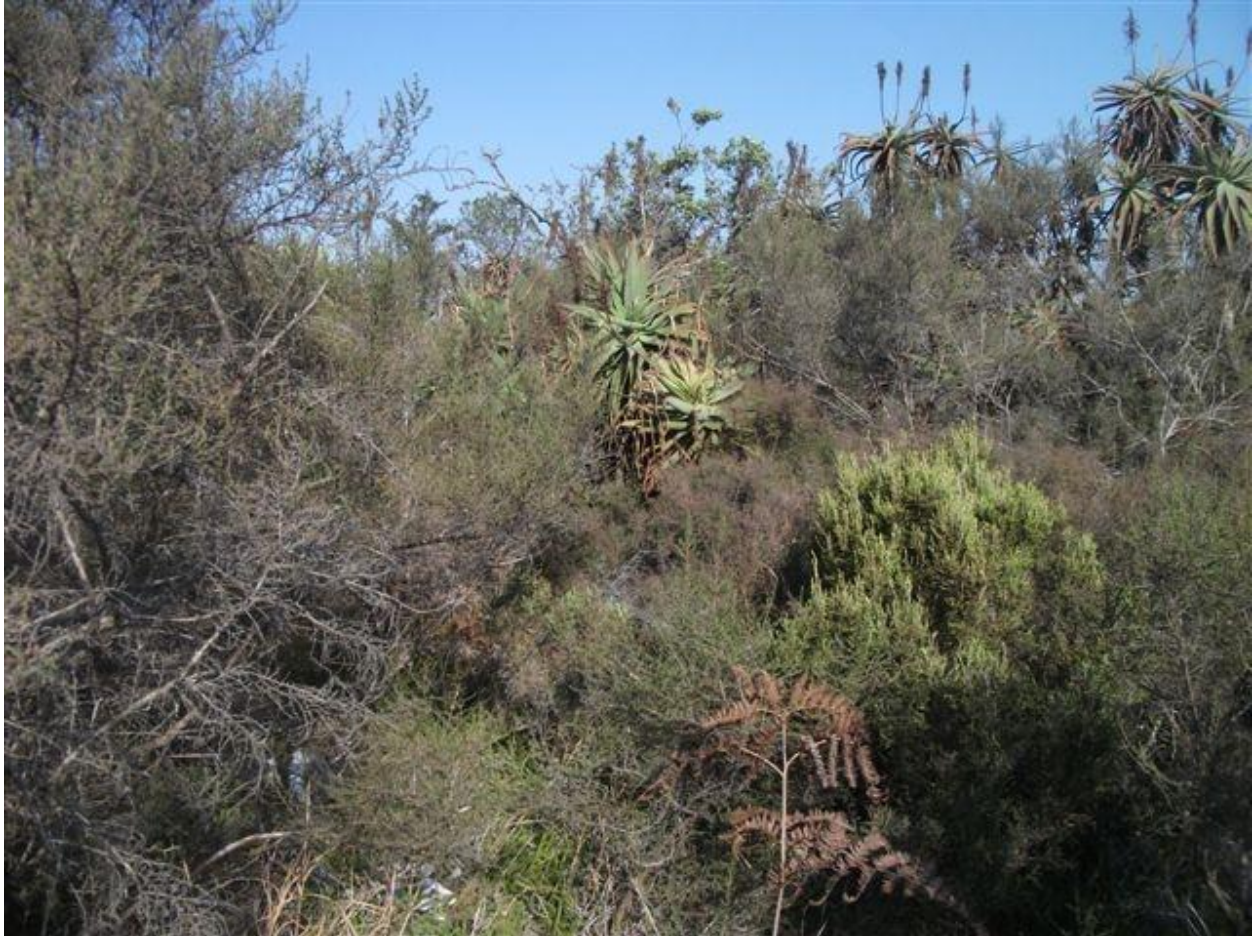
This photograph, taken at S 24.52.39'4" and E 30.53.15'4" at an elevation of 1650 m, facing towards the escarpment, amply illustrates the diversity and density of the woody vegetative cover. Although the author hereof is not well versed in montane vegetation, the predominant shrubs appeared to be *Erica caffrorum* (Mountain Tree Heath).

This cover will need to be removed immediately prior to the commencement of construction, leaving the mosses and grasses that constitute the non woody surface cover exposed to the elements.

This latter stratum, plus the humic soils that are covering the surface rocks and that are intruding down between the surface rocks, will need to be moved from the target site as soon as possible.

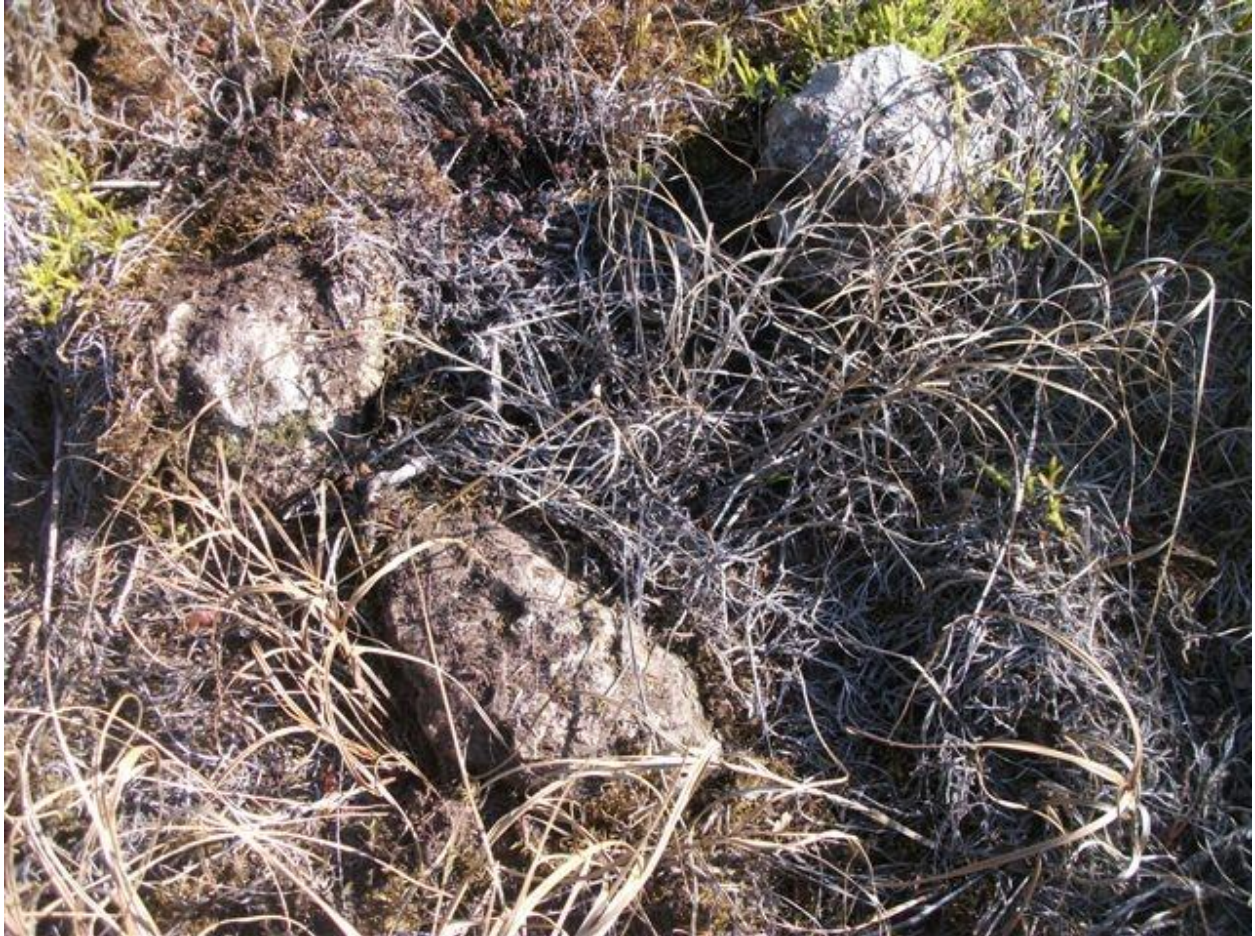
The rocks in the foreground and top right of the photograph below were not visible until surface moss had been brushed off.

The rocks in the top left corner are still covered by mosses and other scrub vegetation

Attempts to find pockets of deeper soil were frustrated by the auger jamming in the gap between the rocks at depths of less than 150 mm. The leading edge of the auger is 25 mm wide.

It would appear that the most effective means of clearing the site will be through brush cutting and then removing the humic component manually, using hard brooms and rubber rakes.
