**WEST END OFFICE PARK
Top Soil survey
ECO-1**

SEF Reference No: 505449

February 2014

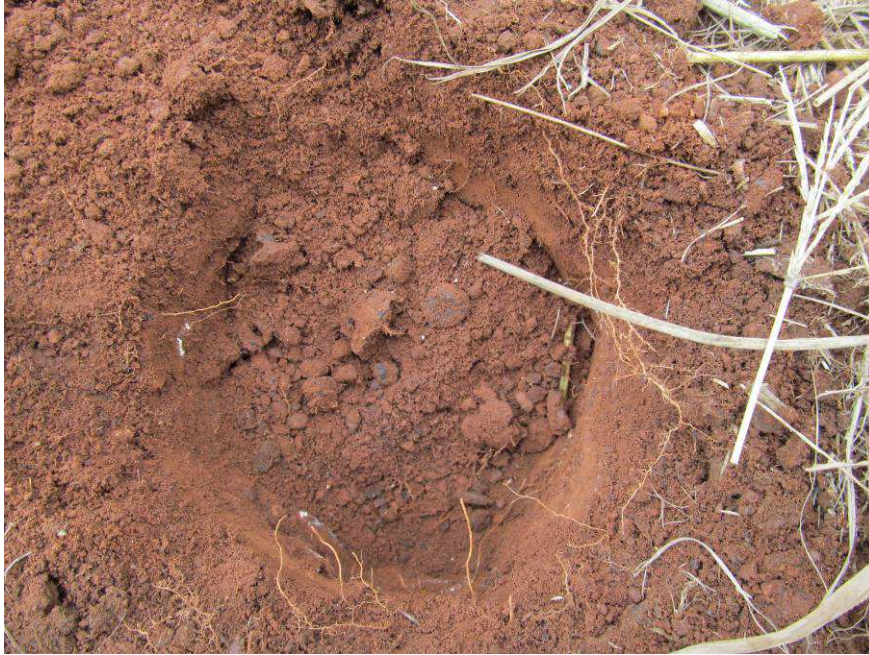
One soil type was identified on site and recorded as the Hutton soil form (Photograph 1). The Hutton soil form occurred with varying depths and was in all cases underlain by hard rock. The Hutton soil form was further classified to soil family level according to the Taxonomic Soil Classification System for South Africa (1991), as illustrated in Table 1 below.

Photograph 1: Hutton soil form identified on site.

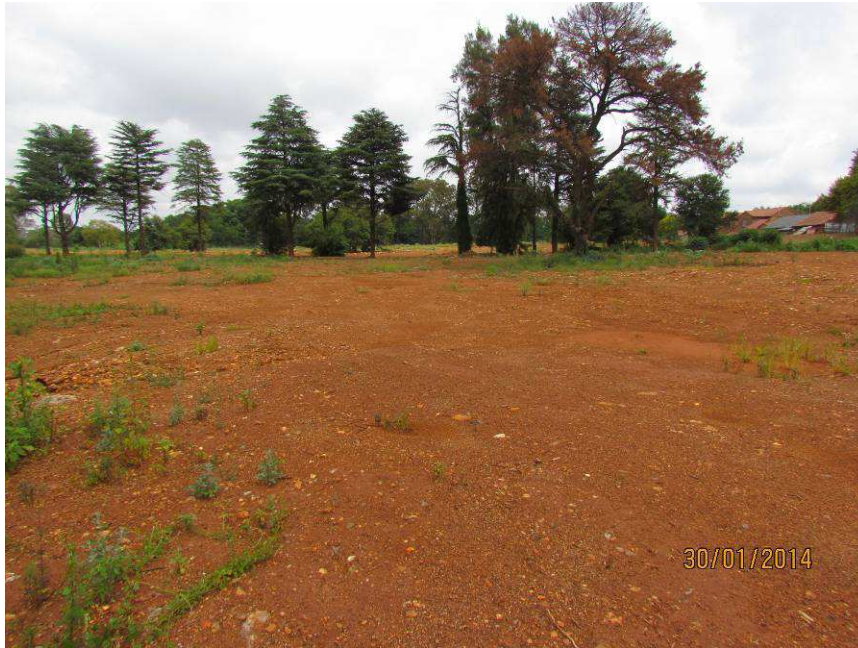
The soil observations conducted within the site showed that the soil had been disturbed to a great extent in the past. Soil observations indicated shallow soil, soil loss, and the mixing of original soil horizons. Eight soil observation points were made within the area to be developed and the soil depth recorded is shown in Table 2. The maximum soil depth reached was 80mm in observation point 6 and 7. The majority of profiles examined were less than 30mm in depth and were directly underlain by hard rock. In all profiles examined the original soil horizon sequence was absent with the orthic A horizon and apedal sub horizon mixed. This is as a result of disturbances within the site including the reshaping of the topography of the area, and the removal of soil (Photograph 2). Original topsoil from the site has therefore been lost. The soil was also observed to have undergone marked removal of colloidal material, including organic matter and silicate clay. This has an effect on the quality of soil present on site and makes the soil not productive without the additions of appropriate fertilisers or nutrient supplements.

Photograph 2: Site topography including the removal and mixing of soil.
