## DRAFT BASIC ASSESSMENT REPORT

**PROPOSED REHABILITATION OF A SECTION OF  
THE EXISTING ROAD D684, AND THE PROPOSED  
CONSTRUCTION OF A NEW SECTION OF ROAD TO  
LINK THE R104 AND THE D684, AT THE  
SIKHULULIWE VILLAGE, NEAR MIDDELBURG,  
MPUMALANGA PROVINCE**

**MARCH 2023**

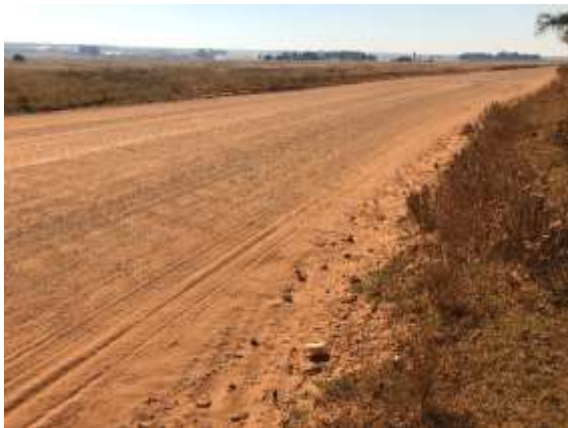
**Photo 7:** A section of the existing gravel road to be rehabilitated.

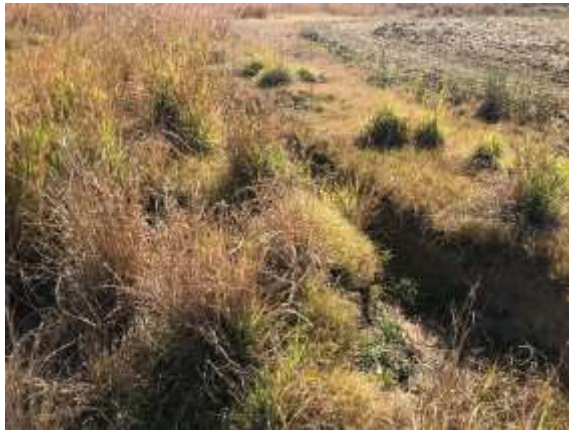
**Photo 11:** Excavated trenches are commonplace within the project area that have been historically established to control surface water runoff patterns and to prematurely drain wetland areas.

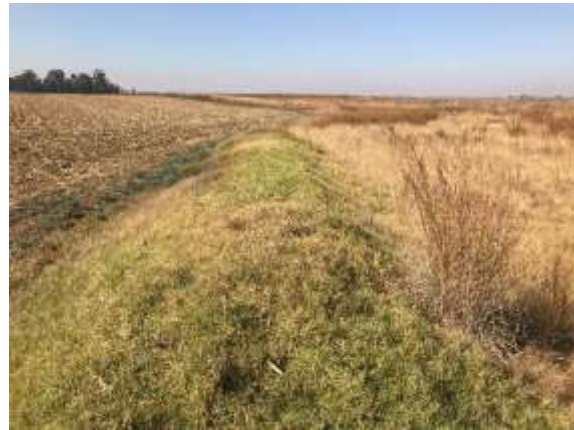
**Photo 12:** Earth berms are commonplace within the project area that have been historically established to increase the cultivation potential of the agricultural sector.

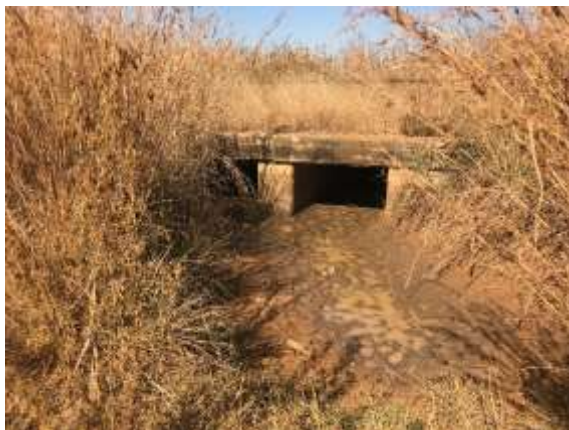
**Photo 13:** Existing bridge/culverts. This allows surface water drainage beneath the existing railway.

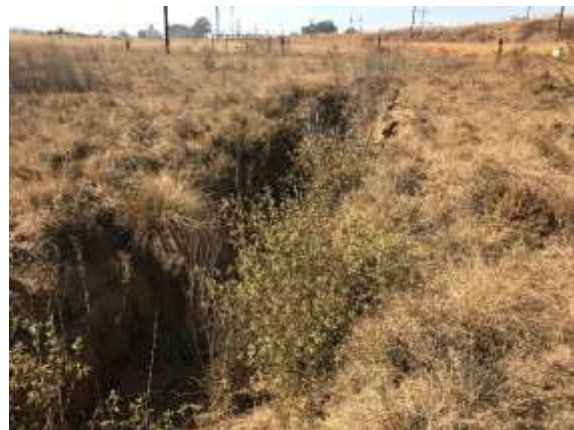
**Photo 14:** Another trench that was established to manipulate surface water drainage, which has prematurely drained the wetland units within many areas. Land use and the resultant alteration of the hydrological features of the wetland units are regarded as a dominant driver of ecological change.

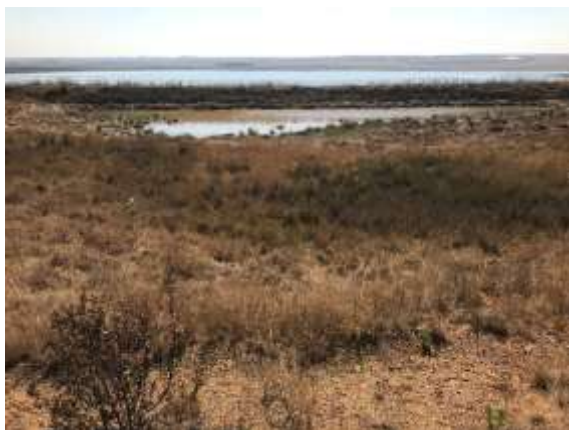
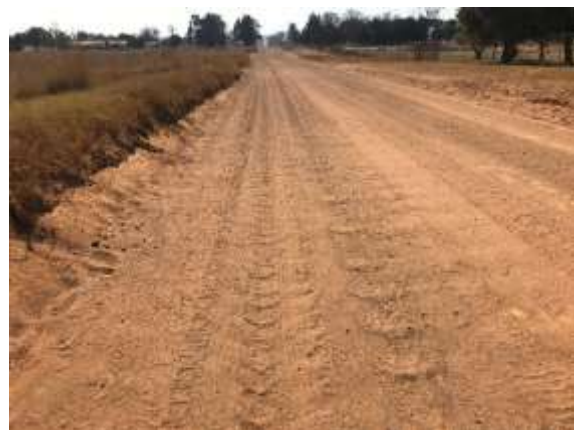
**Photo 15:** An impoundment captures surface water runoff before it enters the large depression wetland unit.

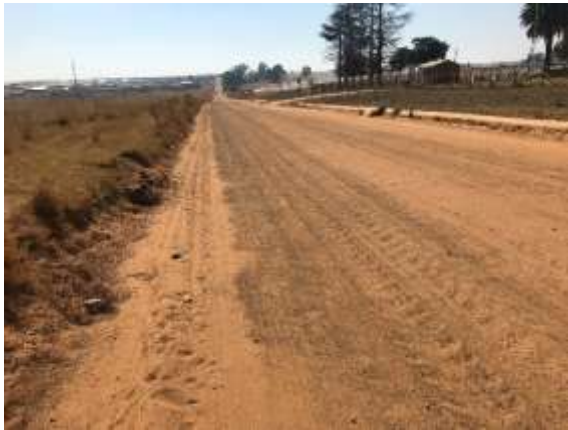
**Photo 16:** Another section of the existing roadway that is to be rehabilitated.

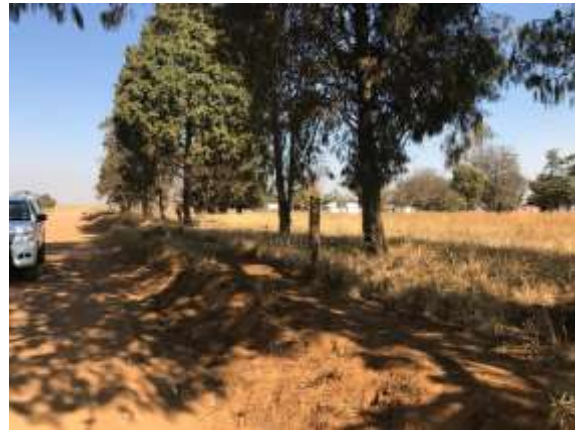
**Photo 17:** Part of the road section to be rehabilitated. The village can be seen in the distance on the left side of the road.

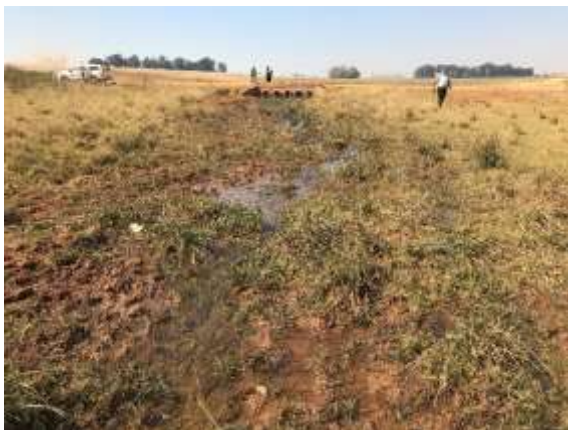
**Photo 19:** The main wetland watercourse within the survey area that runs from east to west.

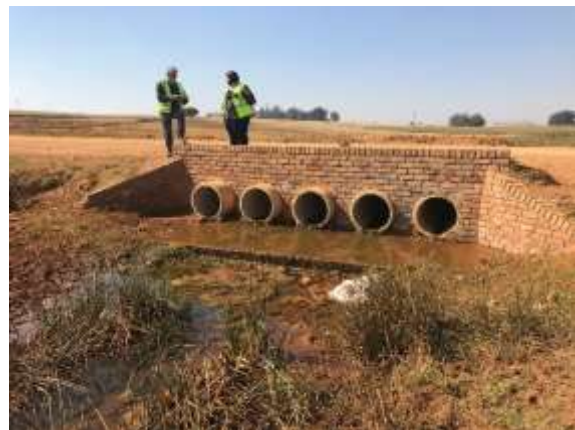
**Photo 20:** The bridge design of the main watercourse, showing the series of side-by-side culvert pipes.

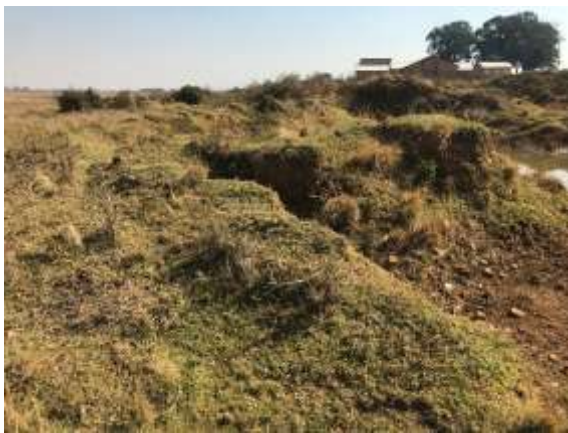
**Photo 23:** Another view of the excavated area showing the level of landscaping.

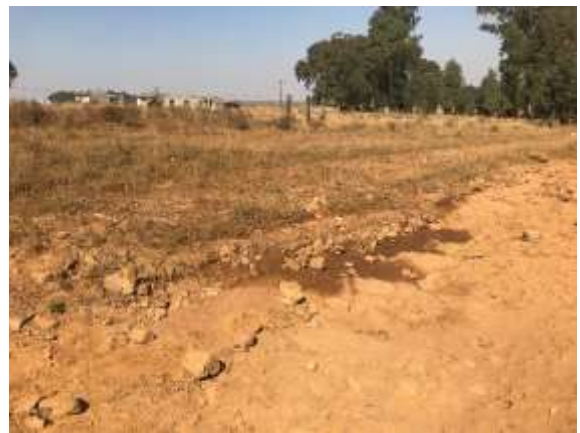
**Photo 24:** A section of the road that was constructed within wetland habitat that has completely altered the functionality of the wetland area. Wetland seepage still occurs within some areas to drain within the road reserve.

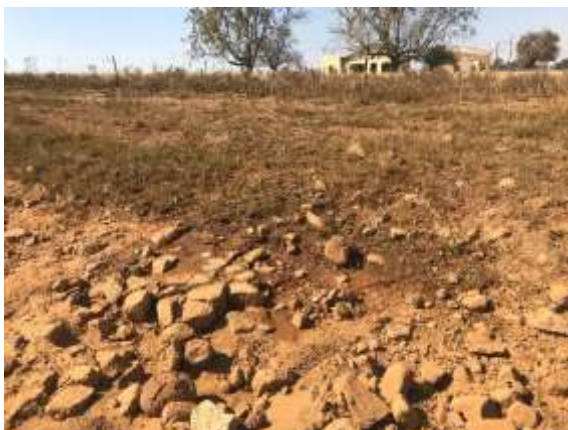
**Photo 26:** Wetland seepage zones occur along the eastern side of the existing road, but ecological function within this section of wetland has been lost.

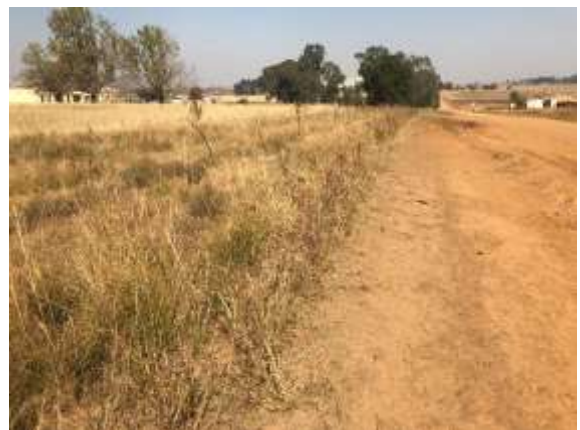
**Photo 27:** A view of the road section looking to the south. Vegetated wetland zones can be seen on the eastern side (left) and seep zones within the road drain can be seen in the distance.

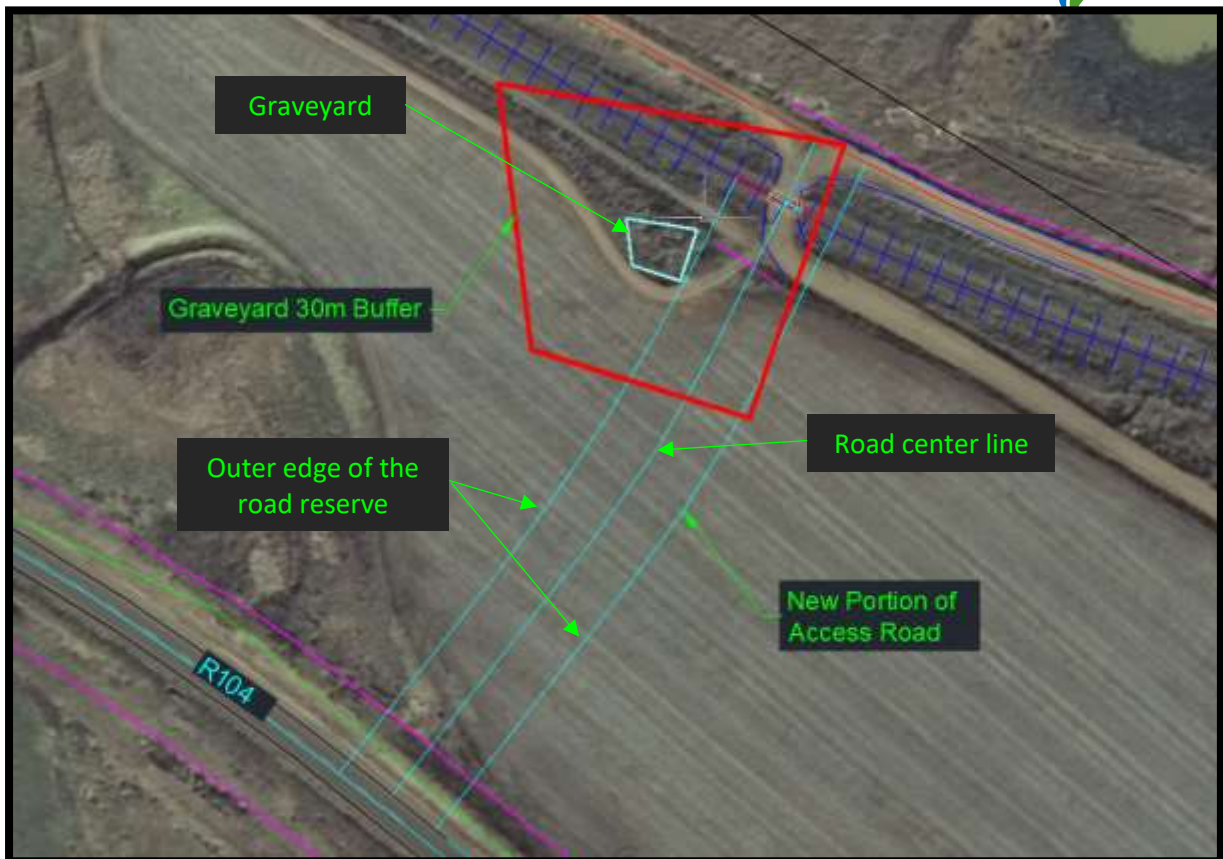
*Figure 11: Graveyard buffer vs propped new section of road*

There is an informal cemetery situated near the proposed new section of road. The reserve of the proposed new section of road will be in close proximity to the informal cemetery. Refer to Figure 11.
