APPENDIX D3: FLOODLINE DELINEATION

Floodline Delineation of a Reach of the T- Goob se Laagte River for the proposed Pella Bulk Water Pipeline Project

Pella, Northern Cape, South Africa

January 2020

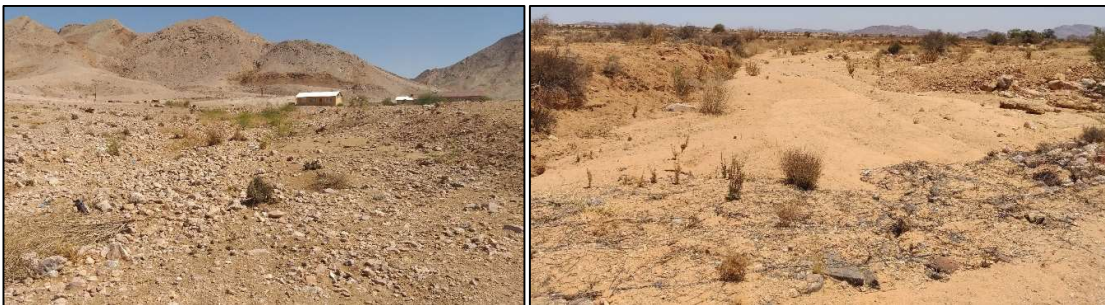
Figure 3: The watercourses of the project area (January 2020). Note the sand substrates with intermittent rocky areas

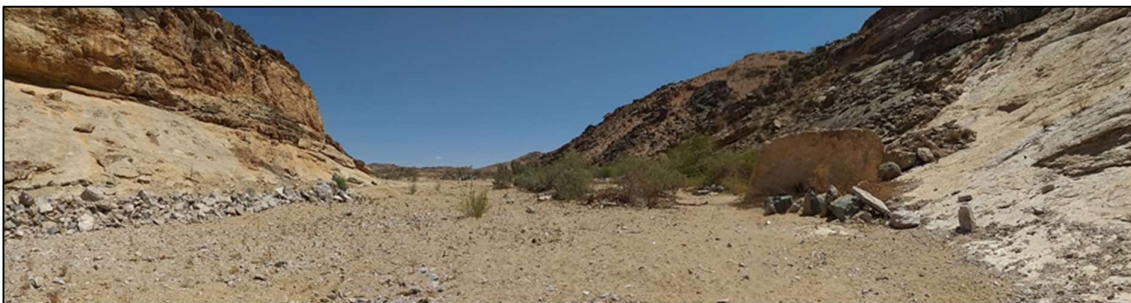
Figure 4: The largest watercourse near the pipeline source at the Orange River (January 2020). Note the slope of the embankments and isolated riparian area.

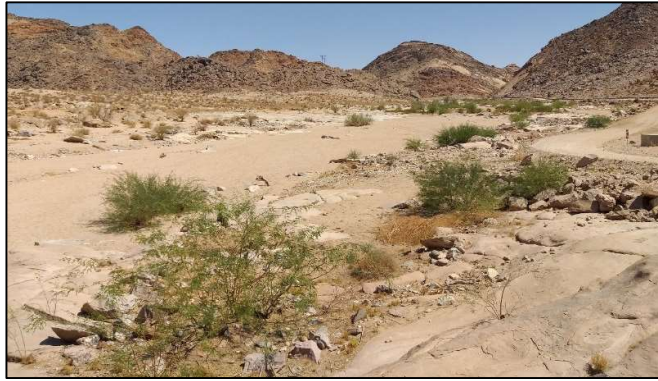
Figure 5: Riparian area of a drainage line comprised of patches of vegetation within bare soils (January 2020)

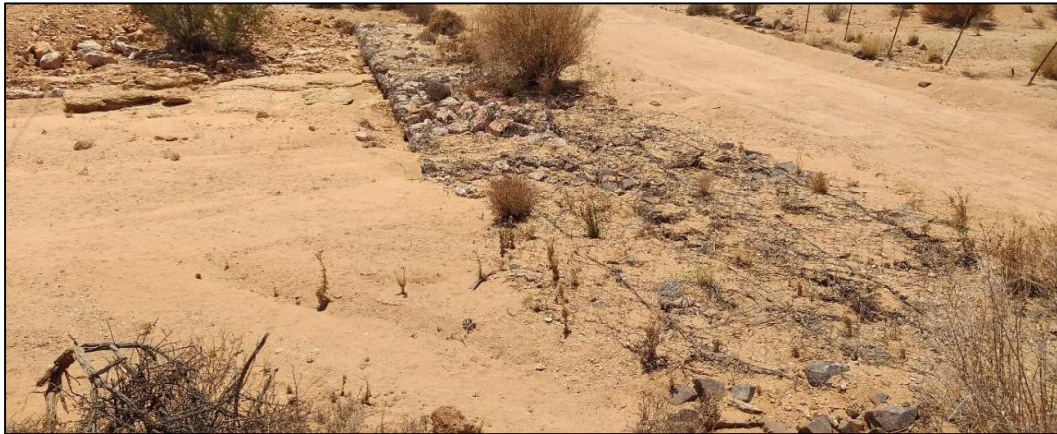
Figure 15: Ephemeral river crossing the dirt road (January 2020)

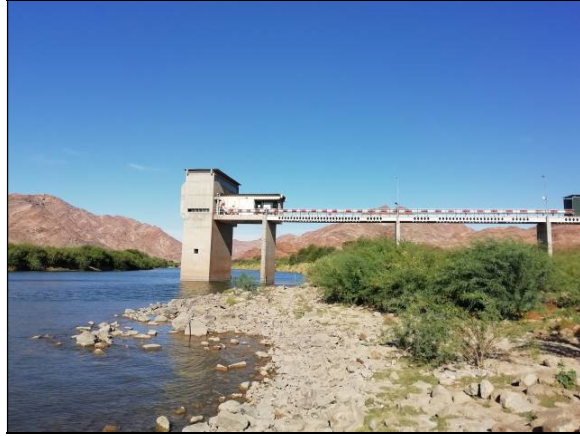
Figure 8. Abstraction tower at the Orange River
