KAMALUNDO PROPERTY INVESTMENTS (PTY) LTD

**ERF 1051, ROCKDALE, MIDDELBURG,
MPUMALANGA**

Wetland Delineation Report

Issue date: November 2018

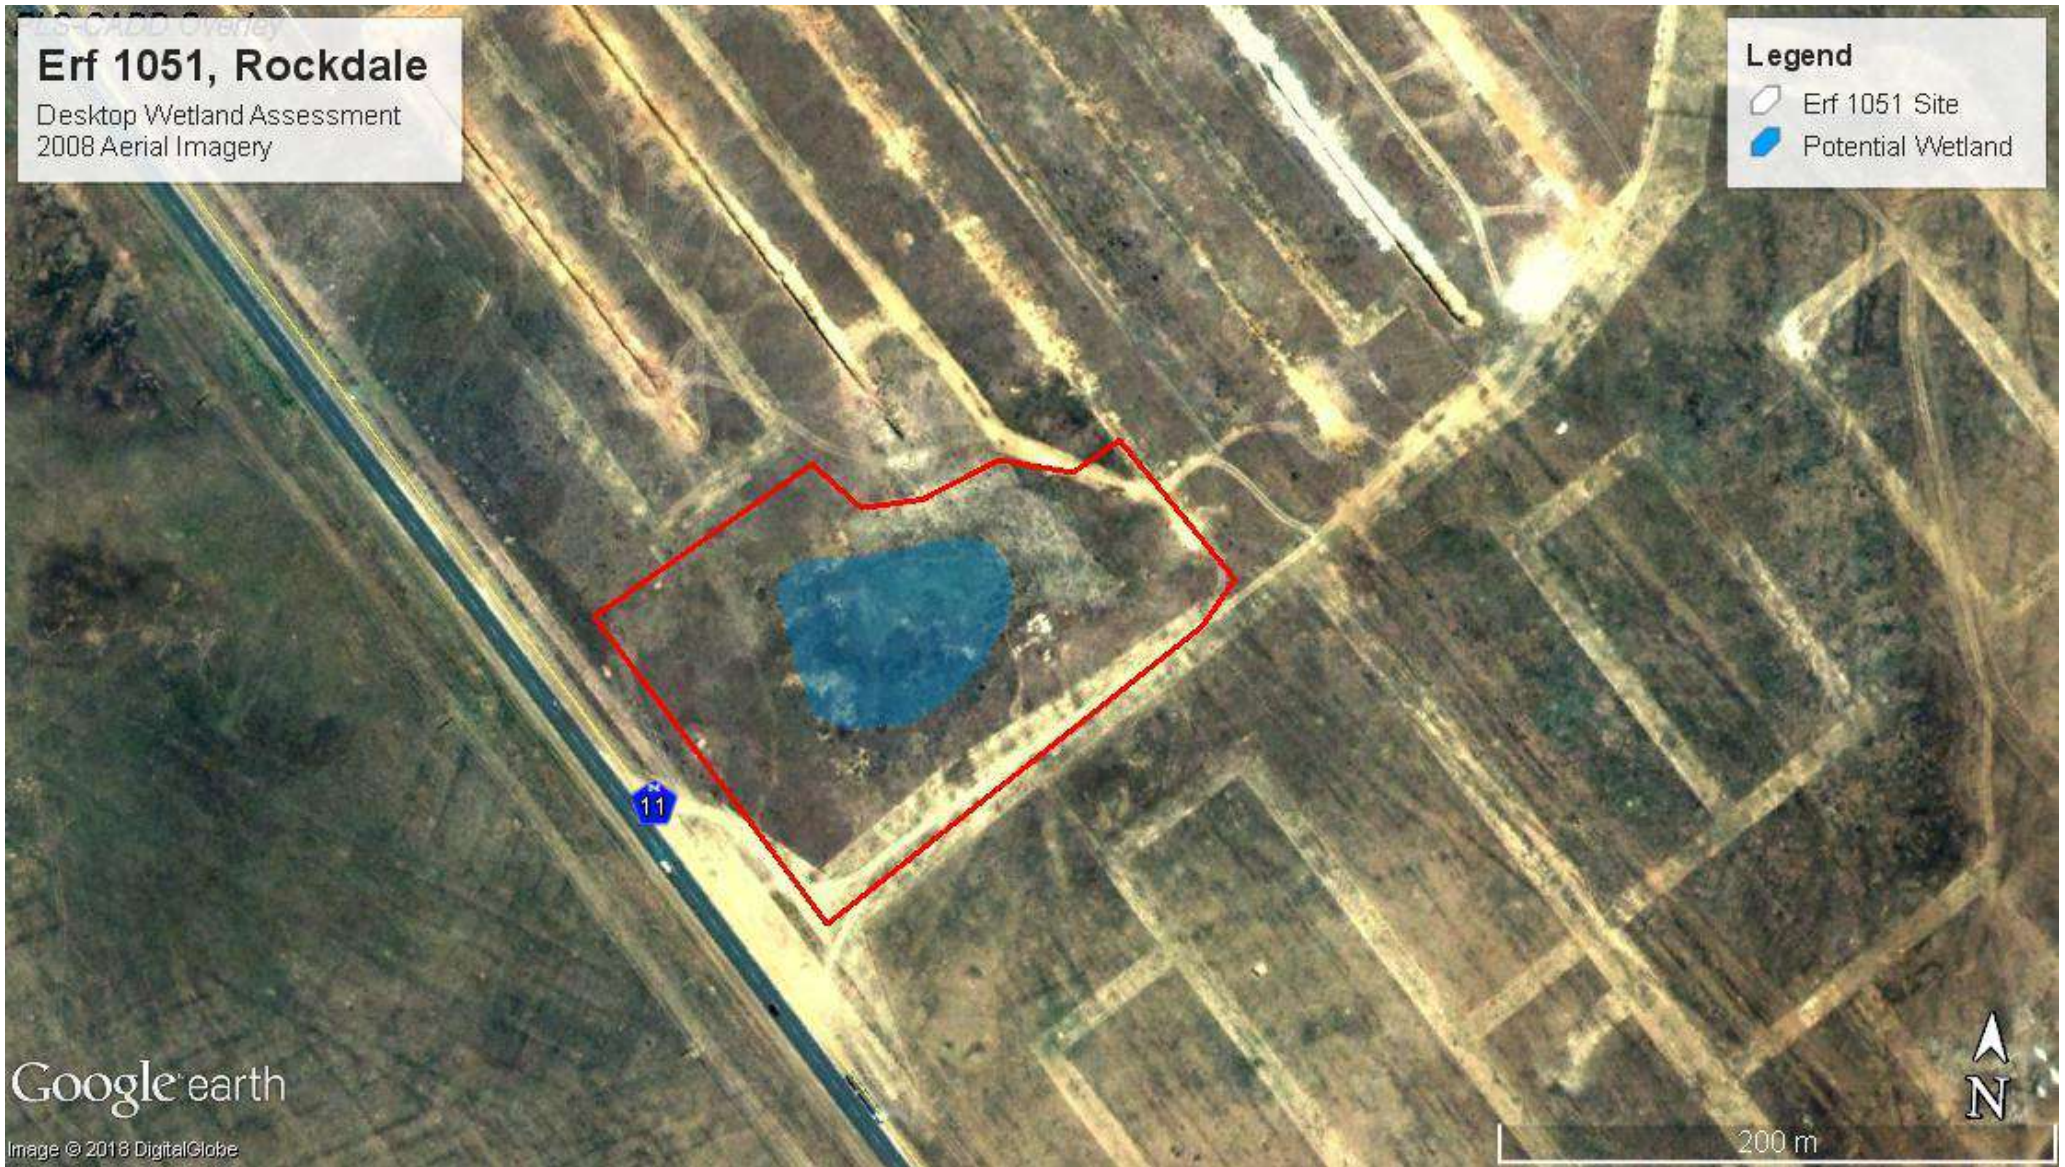
Figure 1: 2008 Aerial Imagery Desktop Assessment Map

An assessment of the site via historical 2008 aerial imagery (**Figure 1**) shows an area in the centre of the site that is potentially wetland, and would probably be a depression wetland being fed by stormwater from the N11.

The desktop wetland assessment showed historically there may have been wetland on site, and that it appeared to be a depression fed by stormwater from the N11 adjacent to the site. However, the site has been used extensively for illegal dumping of spoil material and building rubble, and the onsite investigation showed that no wetland soils, or wetland vegetation was present on site during the site visit. It is possible that a wetland may have existed historically, but it cannot be verified, as no trace of wetland currently exists on site.

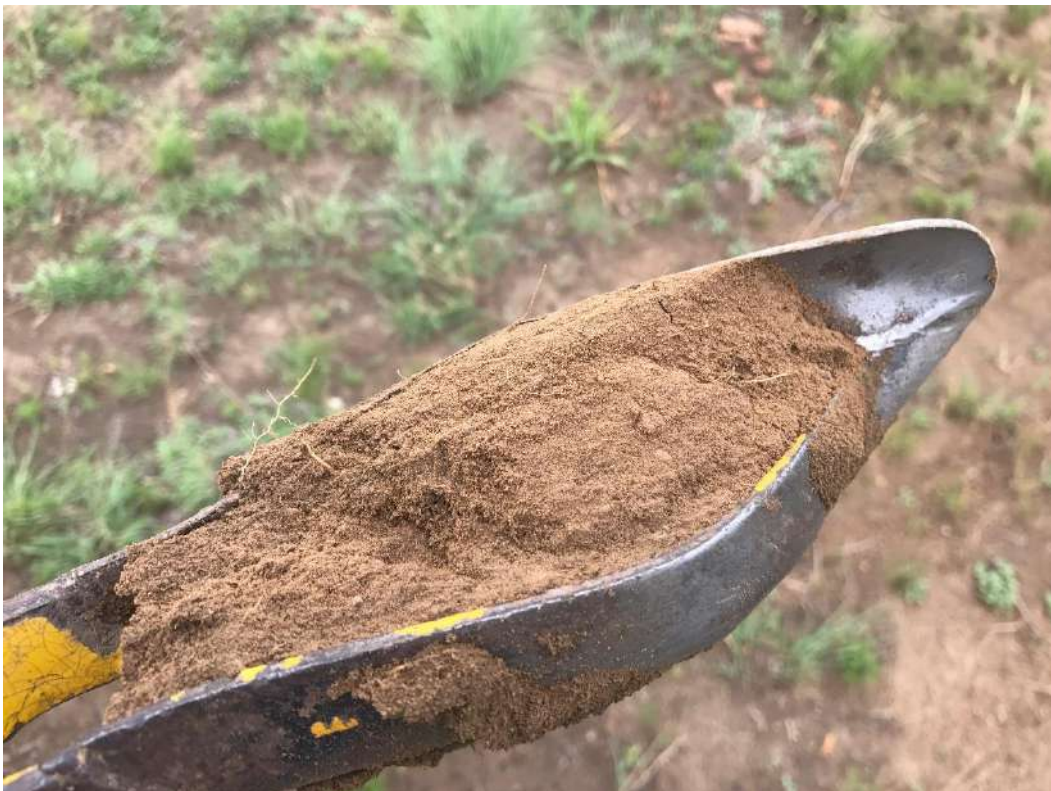
Figure 3: Soil from a depth of 40-50 cm showing NO wetland indicators.

Soils across the site, and to a depth of 500mm (**Figure 3**) indicate that the area has been extensively disturbed historically, and this is potentially occurred through the construction of the N11 adjacent to the site, as well as through the illegal dumping of building rubble and spoil material (soil) across the site (**Figure 4**).

The lack of wetland soils indicates that either there was never wetland on the site, or the illegal dumping has buried the wetland soils to a depth greater than 500m below the current surface. While either situation may be true, there is no evidence of any wetland soils or vegetation across the site.

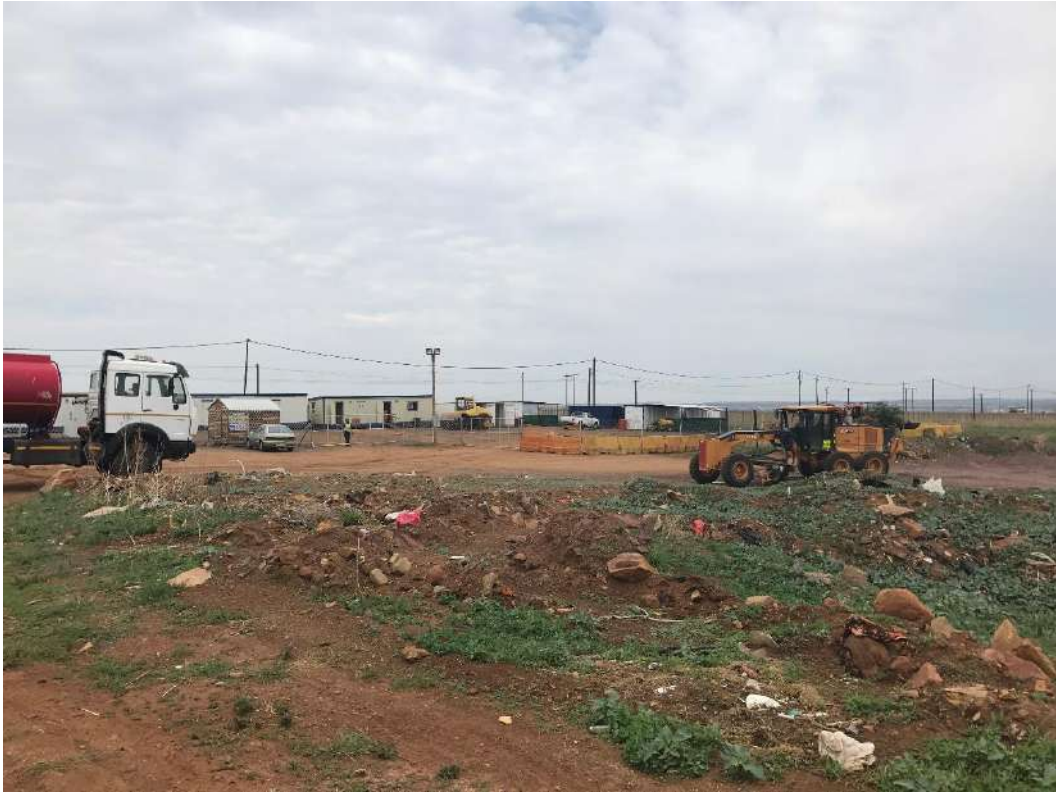
Figure 5: Road construction site camp on the western portion of the site.

The site is currently still covered partially in piles of rubble as pictured above (**Figure 4**), and a portion of the site is being used for a site camp for road construction (**Figure 5**). In addition, a portion of the site is currently being used for stone storage for the road construction (**Figure 6**).

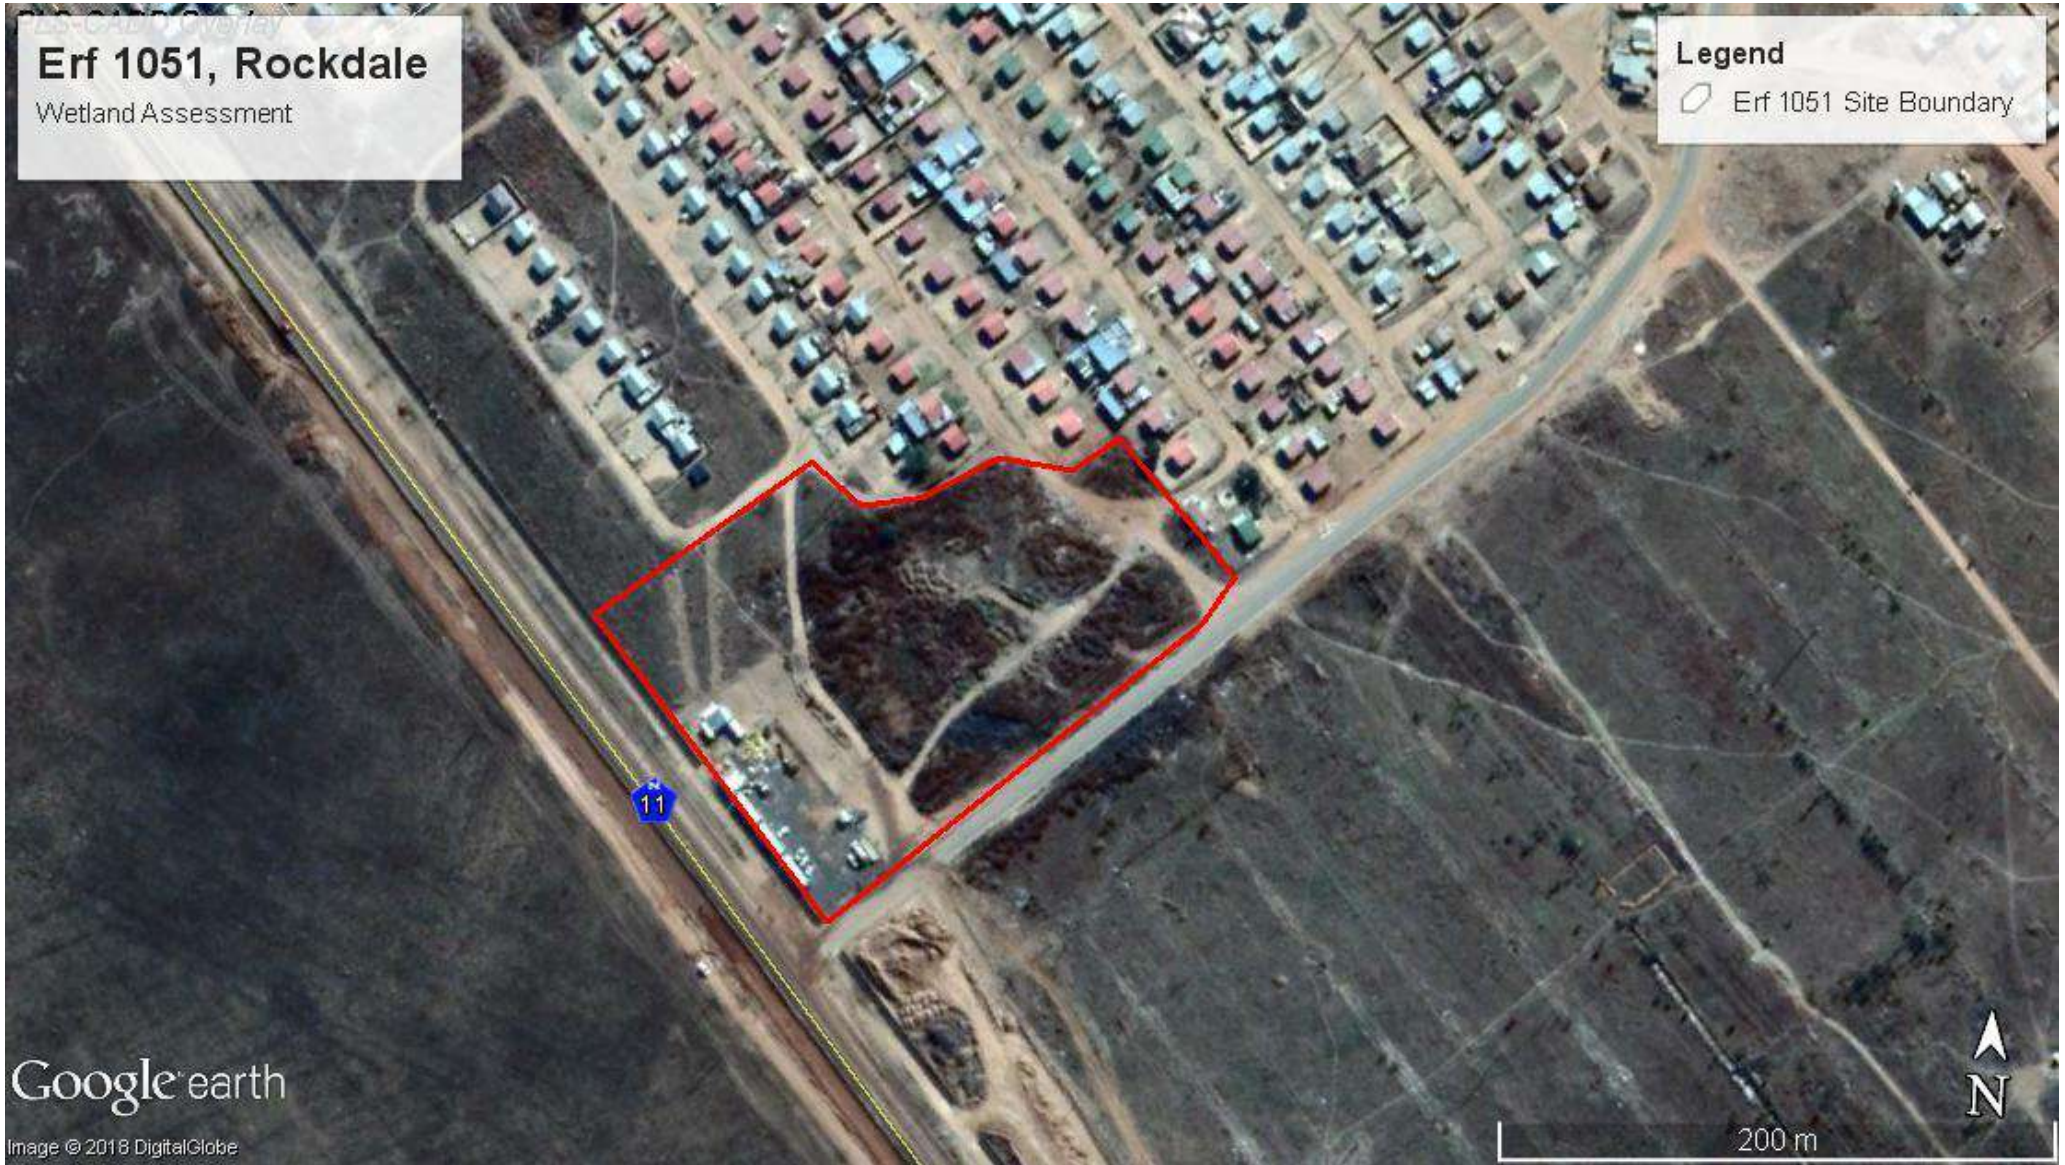
Figure 7: Wetland for the study area

A wetland delineation assessment was undertaken for the proposed project area. As noted in **Figure 7** below, there is no evidence of wetland on the site. Intensive soil sampling of numerous points across the site, and to a depth of 500mm below surface level, yielded no wetland soils, and the vegetation of the site is alien invasive, and pioneer in composition.

No wetland is currently present on site.
