REPORT TO
ILISO CONSULTING ENVIRONMENTAL
MANAGEMENT (PTY) LTD
ON A
SPECIALIST PRELIMINARY
GEOTECHNICAL INVESTIGATION
FOR THE PROPOSED
ESKOM MKUZE SUBSTATION

Ref № 31833

JULY 2017

DRENNAN MAUD (PTY) LTD
GEOTECHNICAL ENGINEERS &
ENGINEERING GEOLOGISTS

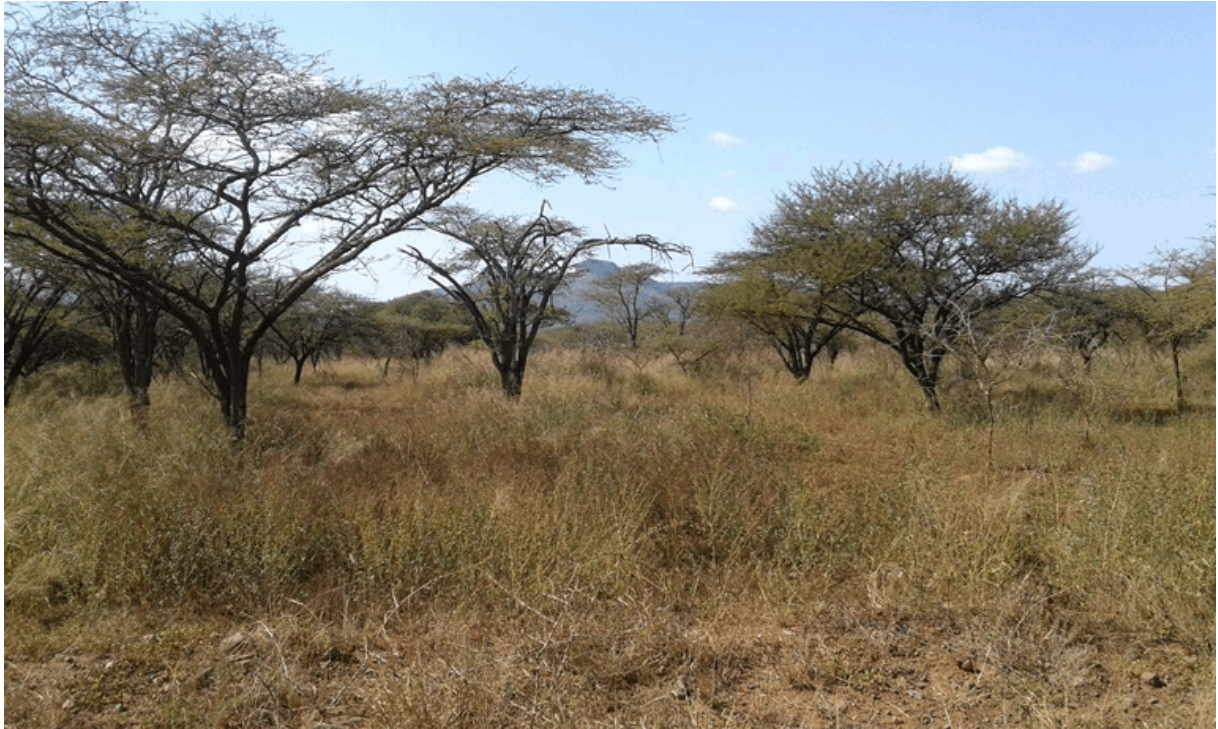
Plate 1: Iphiva 4

A mantle of colluvial material was encountered across the site. It was encountered from surface to depths ranging between 0.30 to 1.00 m below EGL with an average depth of **0.70 m**. The colluvium generally comprises dry to slightly moist, brown to dark brown, stiff to hard, slightly sandy silty clay with trace gravels of basalt.

Residual basalt was encountered in all the test positions except IP1. It was encountered below the colluvium and extended to depths ranging from 1.10 m below EGL to beyond the final depths of the inspection pit (namely beyond 3 m). Therefore, average depths of **1.20 m in the north, 2.20 m in the central region and > 3.00 m in the south (estimated 3.50 to 4.00 m on average) with no residual basalt in the northern most region** can be expected. The residual soils generally comprise dry to slightly moist, brown to orangey brown, hard / very dense, slightly sandy silty clay to slightly clayey silty sand with abundant gravels of basalt and amygdales.

The residual soils are generally underlain by basalt bedrock; however, bedrock was observed directly below colluvial material in IP1. The contact between bedrock and the overlying soils dips toward the south as the inspection pits revealed relatively shallow bedrock to the north (0.70, 1.10 and 1.30 m below EGL at IP1, 7 and 2, respectively) and deeper soils to the south (greater than 3 m below EGL at IP6, 10, 5, 4 and 3). The basalt bedrock encountered comprises brown, completely weathered, soft rock basalt of the Letaba Formation with slightly weathered, hard rock corestones. The abundance and size of the hard rock corestones is expected to increase rapidly with depth grading down into hard rock bedrock.

Iphiva 4 and 5 are relatively flat areas. The basalt bedrock is generally known to be a fairly stable rock formation. There is no evidence of existing slope failures (i.e no hummocky topography indicative of mass movement downslope).

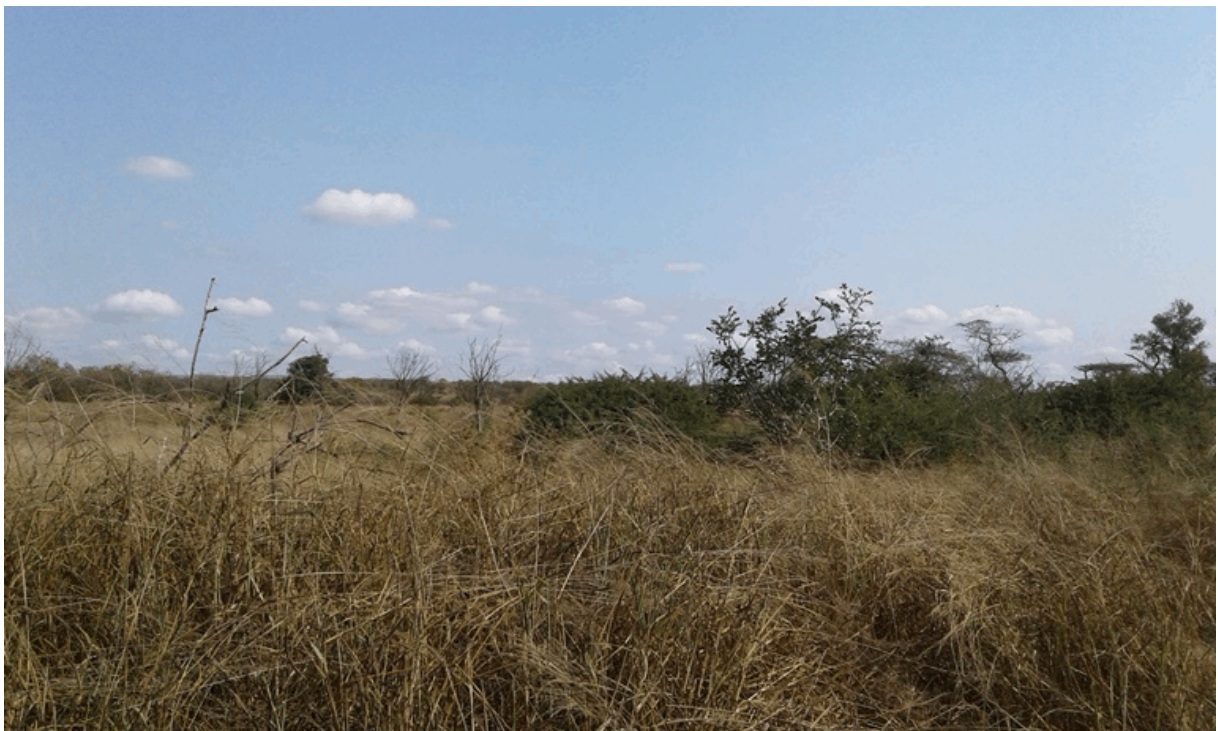
Plate 2: Iphiva 5

The residual soils are generally underlain by basalt bedrock except in IP2 and IP3 where bedrock was observed directly below the colluvial material. The contact between the basaltic bedrock and the overlying soils appears to dip toward the east / northeast as the thicker soils are observed in the east and shallow bedrock in the west (0.40, 0.90 and 1.40 m below EGL at IP3, 2 and 5, respectively). The bedrock generally comprises brown, completely to highly weathered, soft to medium hard rock basalt of the Letaba Formation with slightly weathered, hard rock corestones and fragments. The abundance and size of the hard rock corestones is expected to increase rapidly with depth grading down into hard rock bedrock.

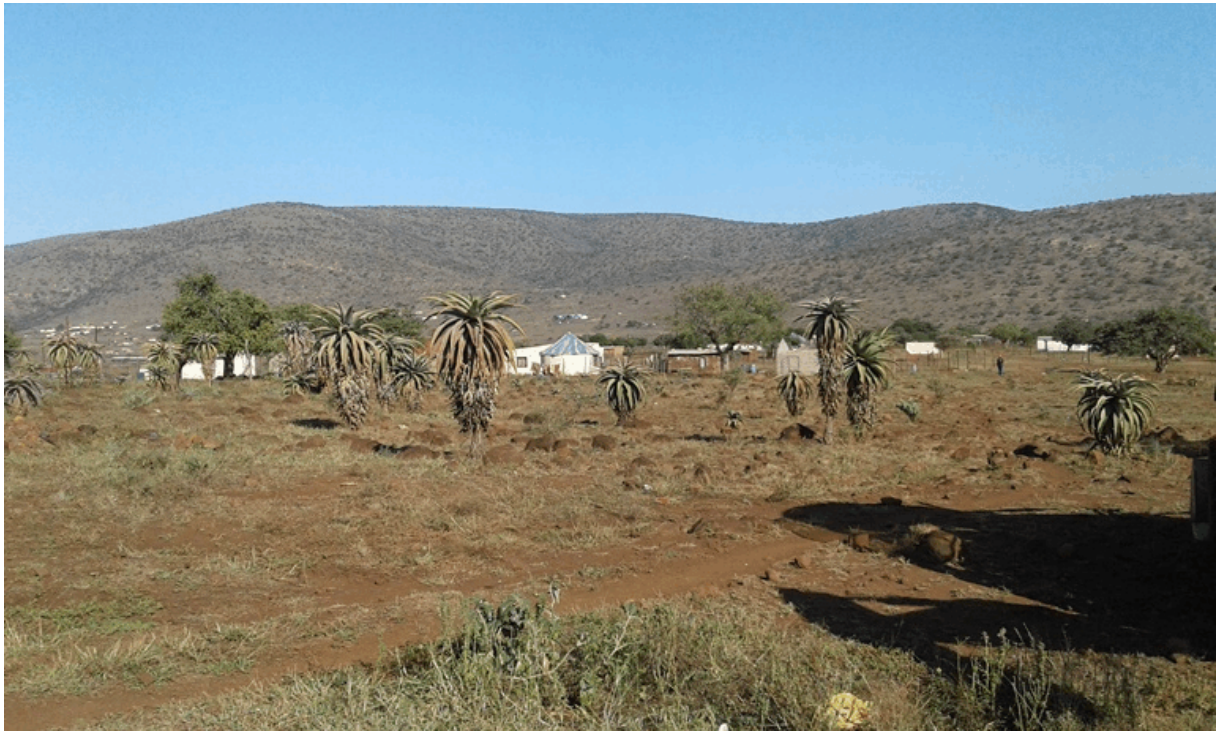
Plate 3: Iphiva 6

A thin mantle of hillwash was encountered in all the inspection pits. It was encountered from surface to depths ranging between 0.10 and 0.60 m below EGL with an average depth of **0.30 m**. The hillwash generally comprises dry to slightly moist, brown to dark brown, stiff to very stiff, sandy clay with abundant gravels, cobbles and boulders of dolerite.

Iphiva 6 is relatively level to gently sloping toward the south and the dolerite bedrock is known to be fairly stable. Again, no evidence of existing slope failures were observed during the investigation.

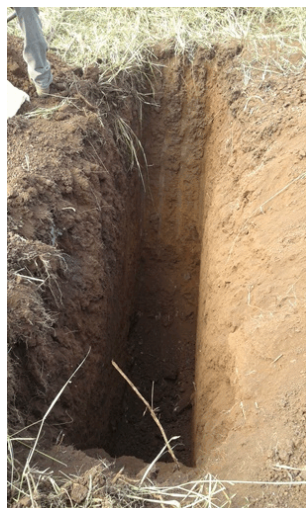
Plate 4: Typical shallow subsoil profile of Iphiva 4 (as observed in IP8)

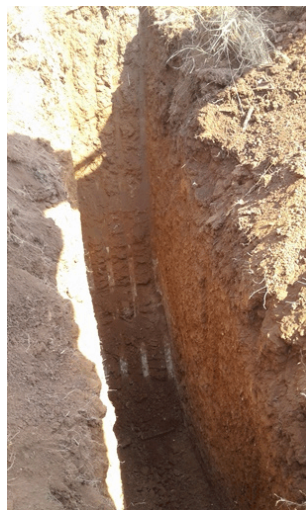
Plate 5: Typical shallow subsoil profile across Iphiva 5 (as observed in IP7)

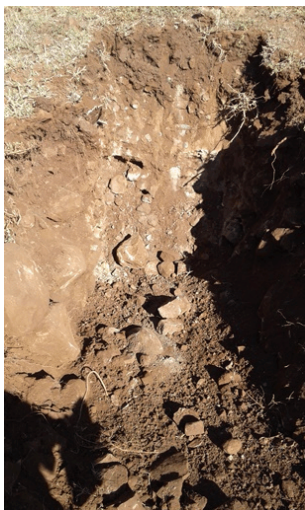
The hillwash material is underlain directly by dolerite bedrock which extends beyond refusal depths of the inspection pits. The dolerite bedrock comprises light brown, completely to highly weathered, very soft to soft rock dolerite with slightly weathered hard rock corestones and fragments, rapidly becoming blue grey, medium to slightly weathered, medium hard to hard rock dolerite with depth.

Plate 6: Typical profile of very soft to soft rock dolerite with hard rock corestones at Iphiva 6 (as observed in IP9)

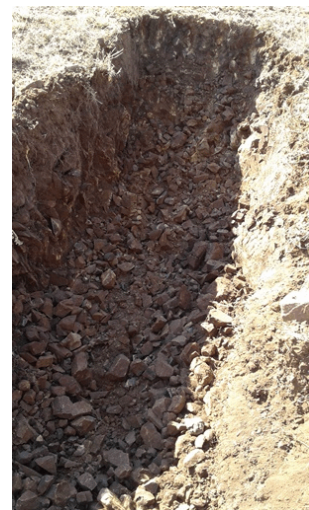
Plate 7: Typical profile of medium hard to hard rock dolerite at Iphiva 6 (as observed in IP8)

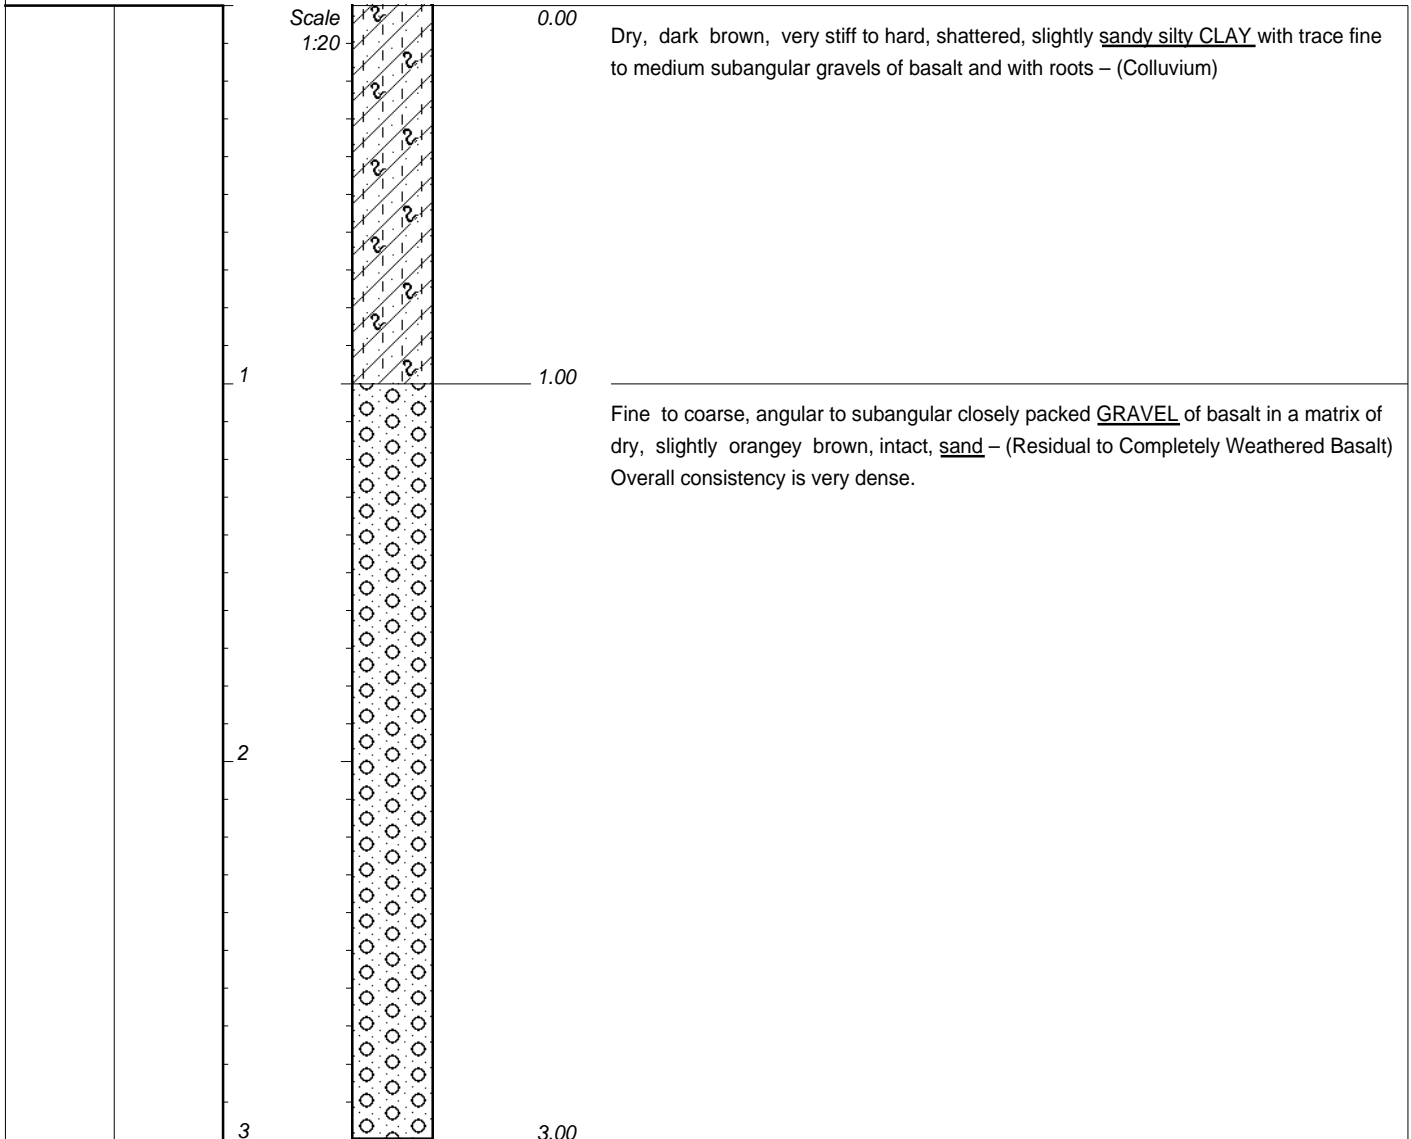
- 1) Final depth at 3.00m. No refusal but TLB struggling.
- 2) No groundwater seepage.
- 3) No sidewall collapse.
- 4) Same position as DCP6.
- 5) No samples taken.

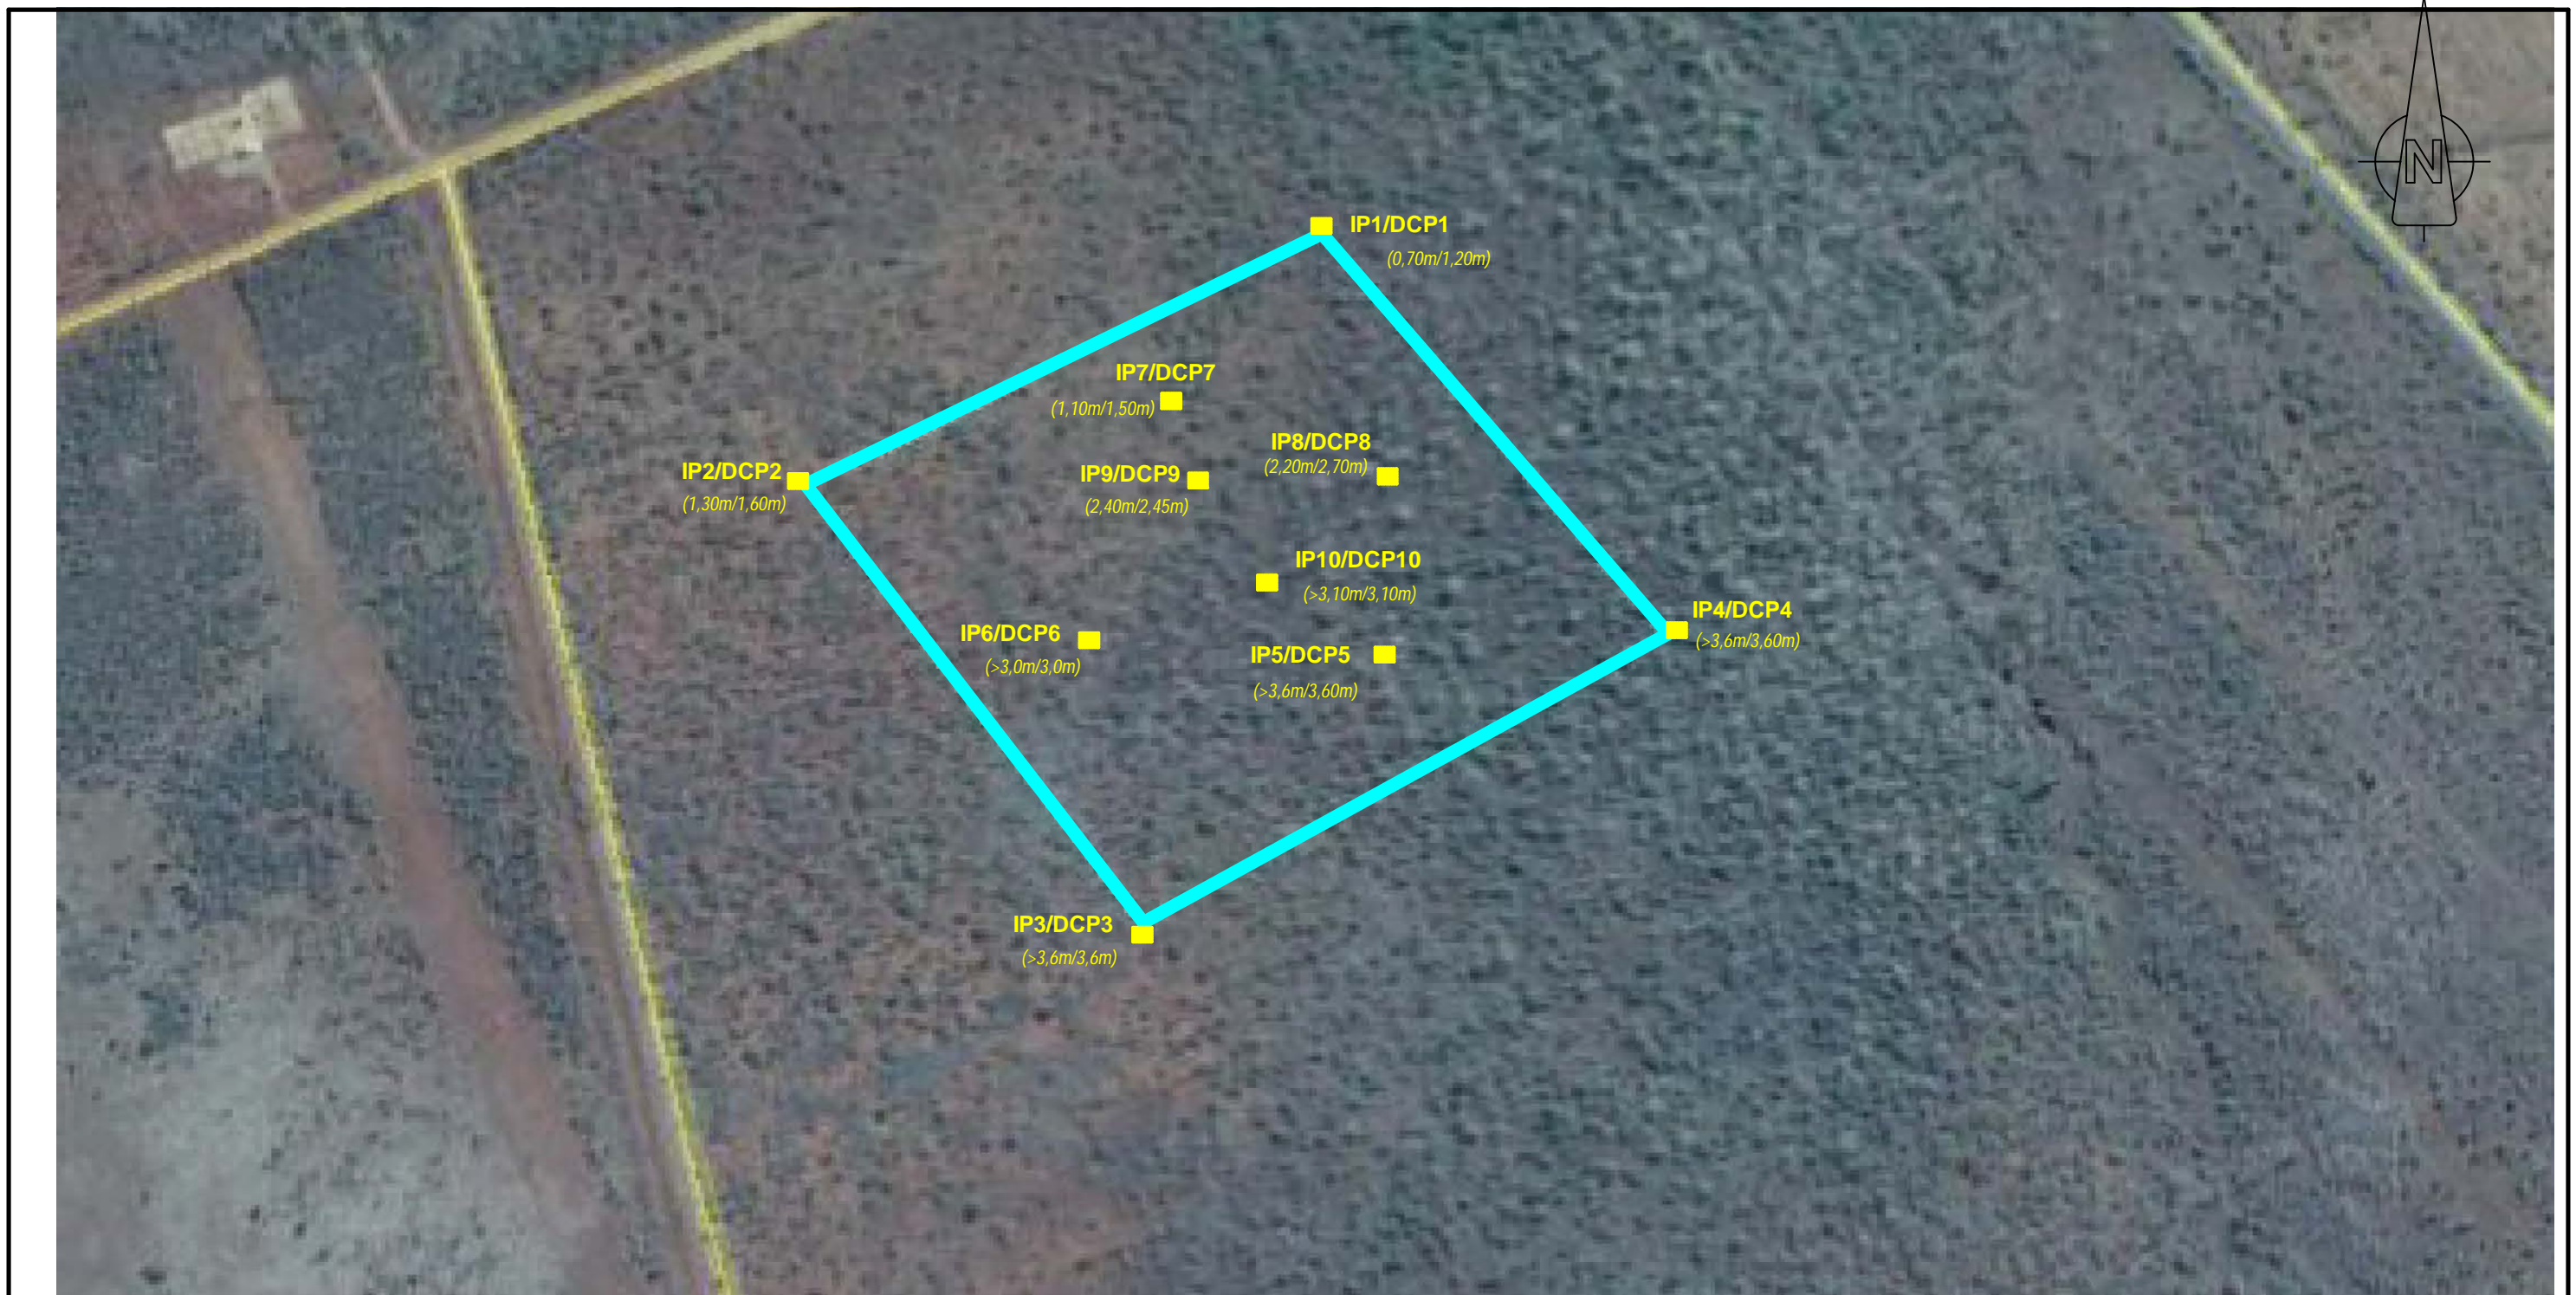
DRAWING NO.
31833-02A

**PRELIMINARY GEOTECHNICAL INVESTIGATION
 MKUZE SUBSTATION
 IPHIVA 4**

IP1/DCP1 (>3,30m/3,30m) ■ **APPROX. POSITION OF INSPECTION PITS/
DYNAMIC CONE PENETROMETER TESTS**
(INFERRED BEDROCK DEPTH / FINAL DEPTH)

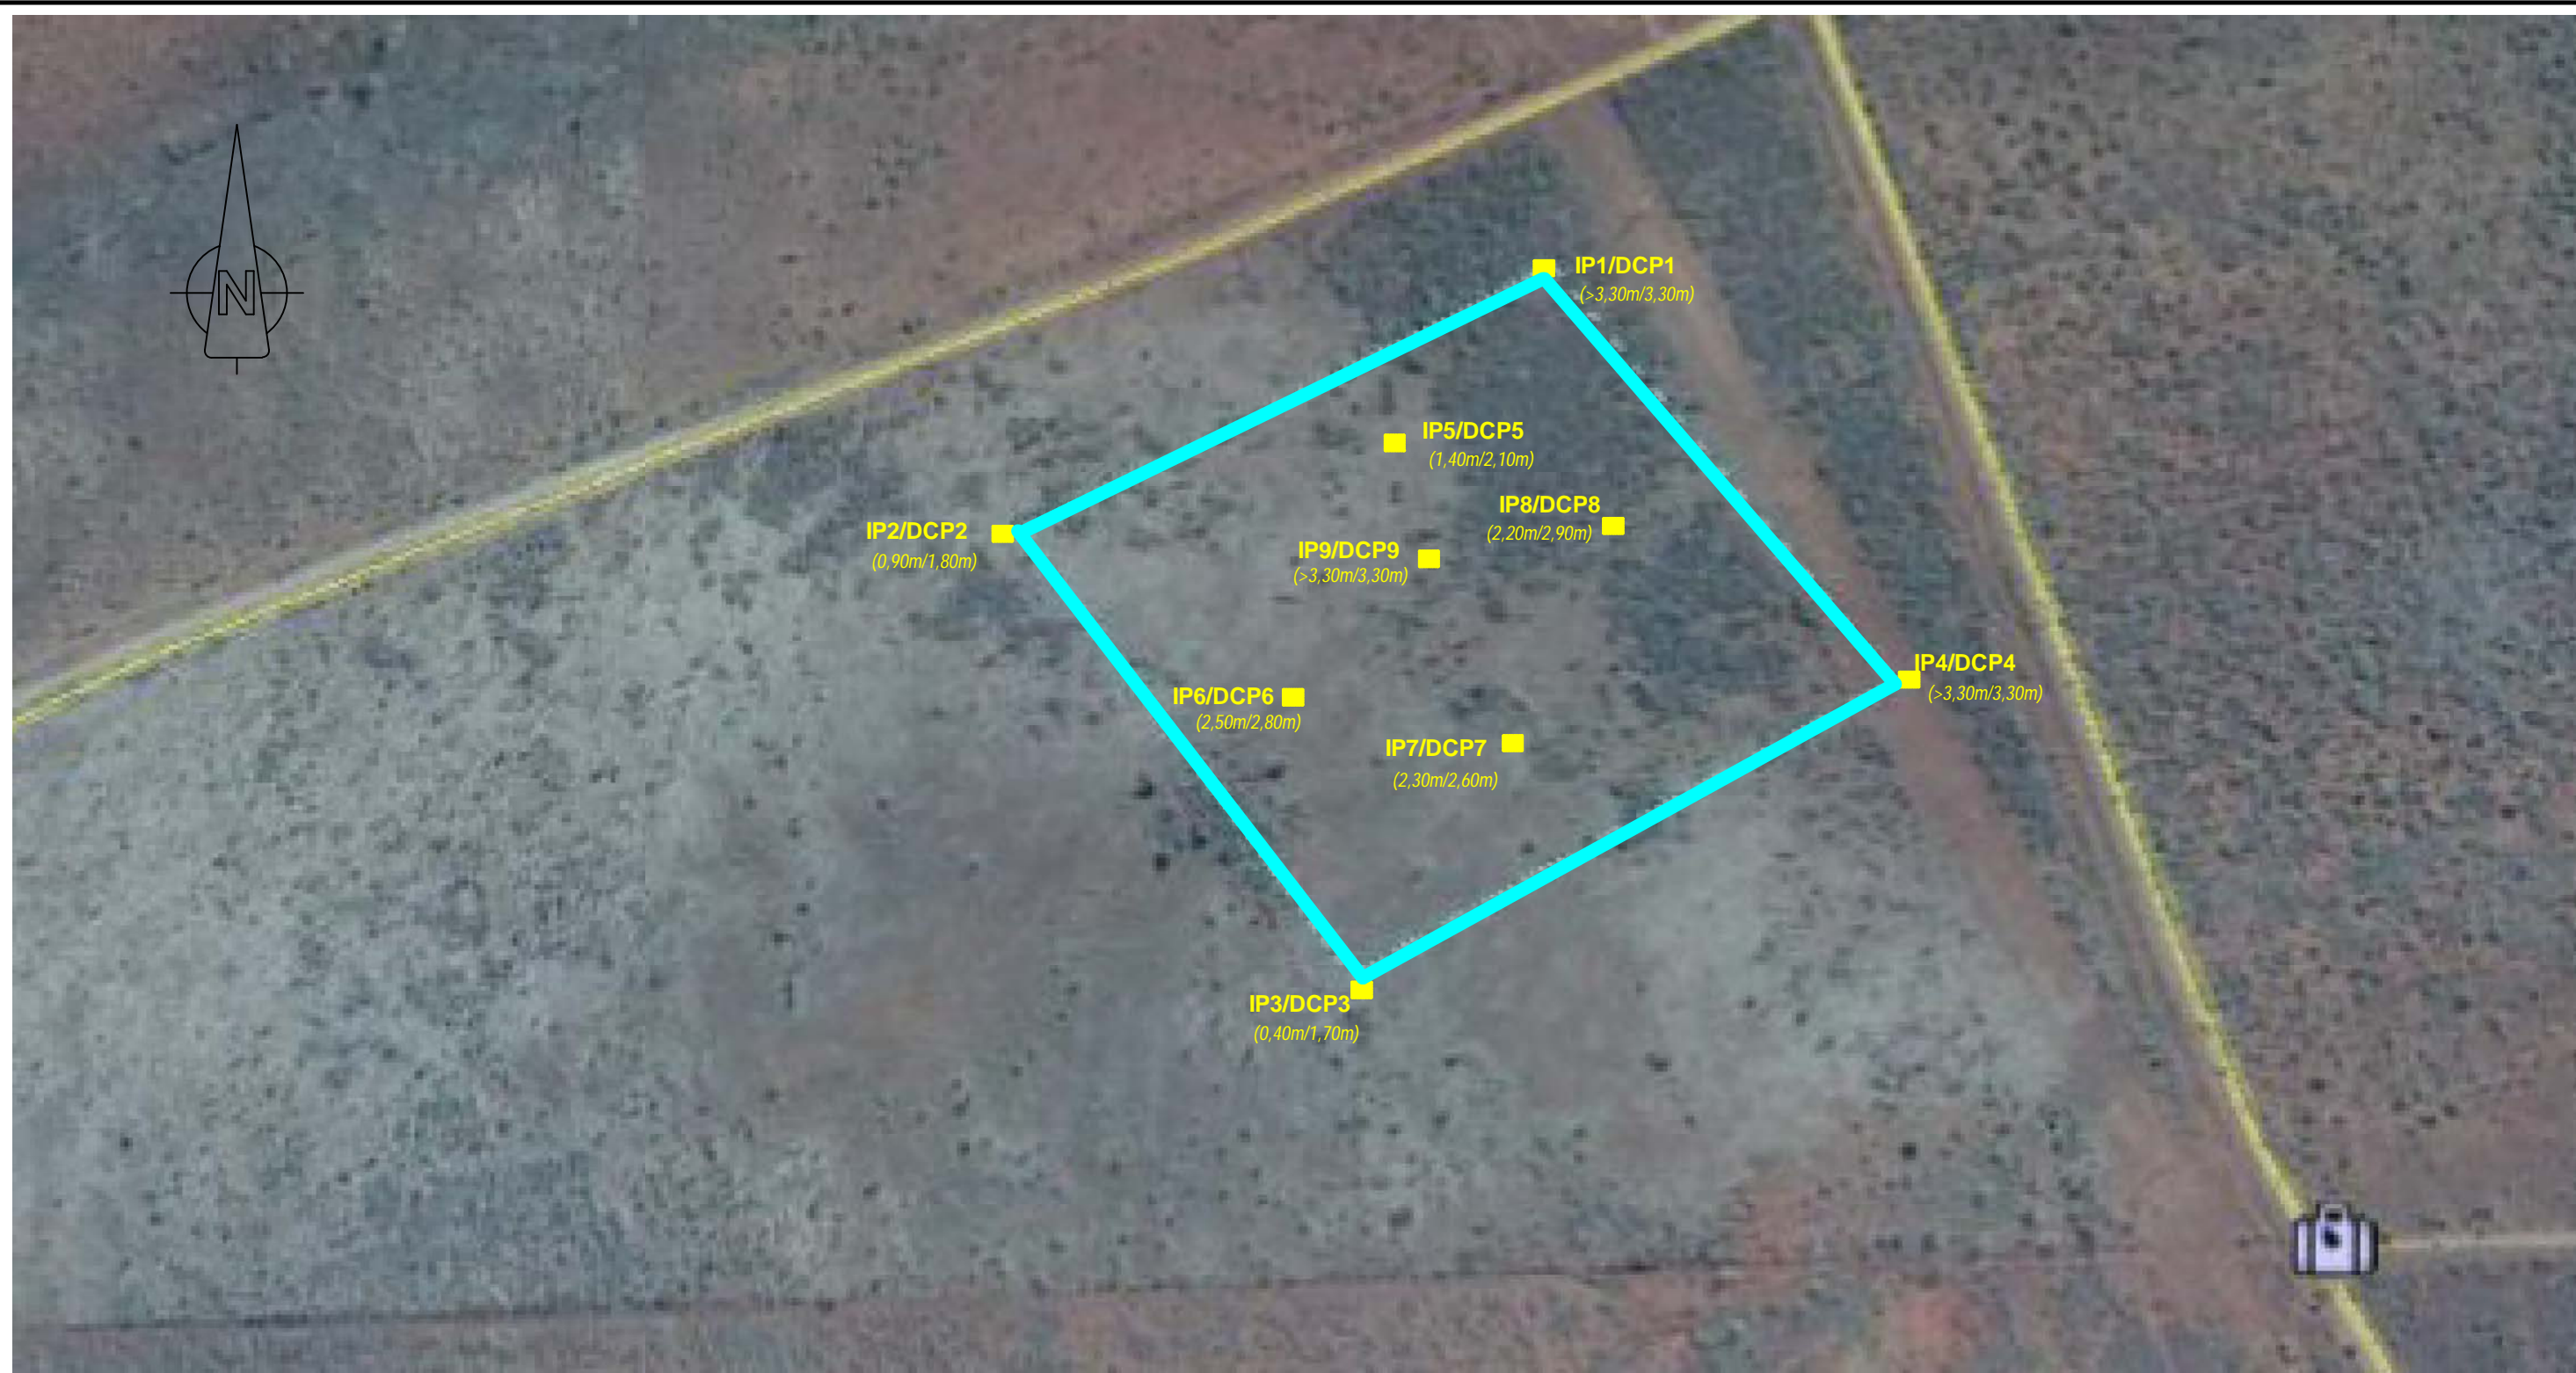
DRAWING NO.
31833-02B

**PRELIMINARY GEOTECHNICAL INVESTIGATION
MKUZE SUBSTATION
IPHIVA 5**

IP1/DCP1
(>3,6m/3,6m) ■ APPROX. POSITION OF INSPECTION PITS/
DYNAMIC CONE PENETROMETER TESTS
(INFERRED BEDROCK DEPTH / FINAL DEPTH)
