REPORT TO
MDT ENVIRONMENTAL (PTY) LTD
ON A
SPECIALIST PRELIMINARY
GEOTECHNICAL INVESTIGATION
FOR THE PROPOSED
ESKOM MKUZE SUBSTATION,
IPHIVA 3A

Ref № 31833-1

SEPTEMBER 2017

DRENNAN MAUD (PTY) LTD
GEOTECHNICAL ENGINEERS &
ENGINEERING GEOLOGISTS

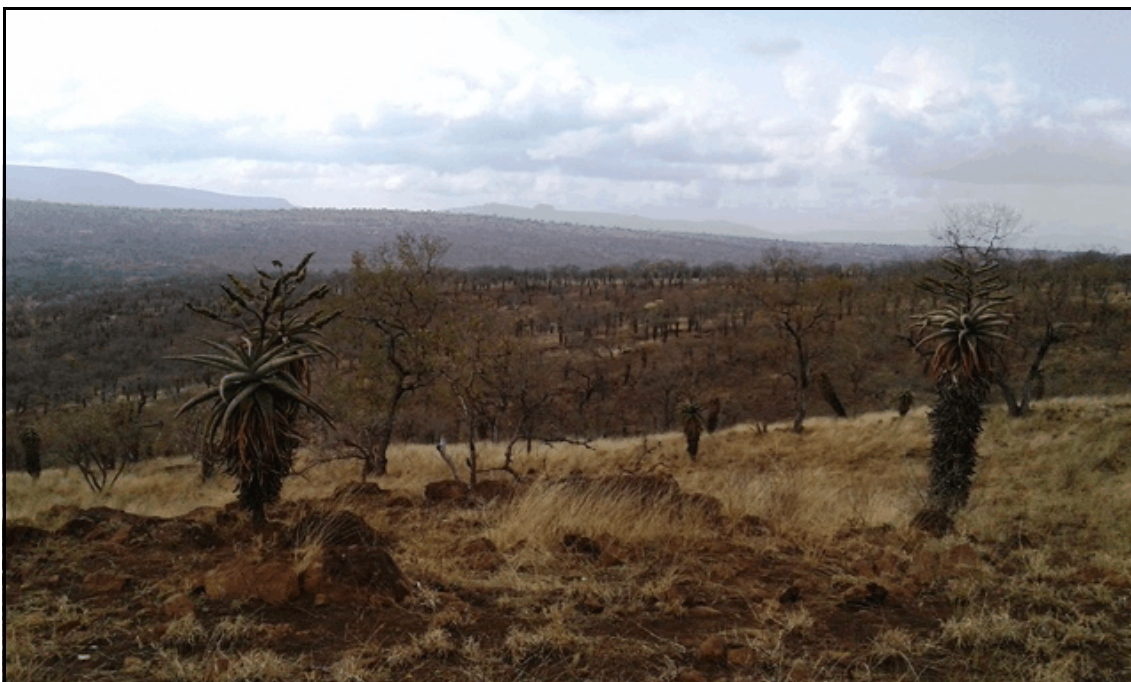
Plate 1: View along the northern boundary toward the east, photograph taken from position DCP12.

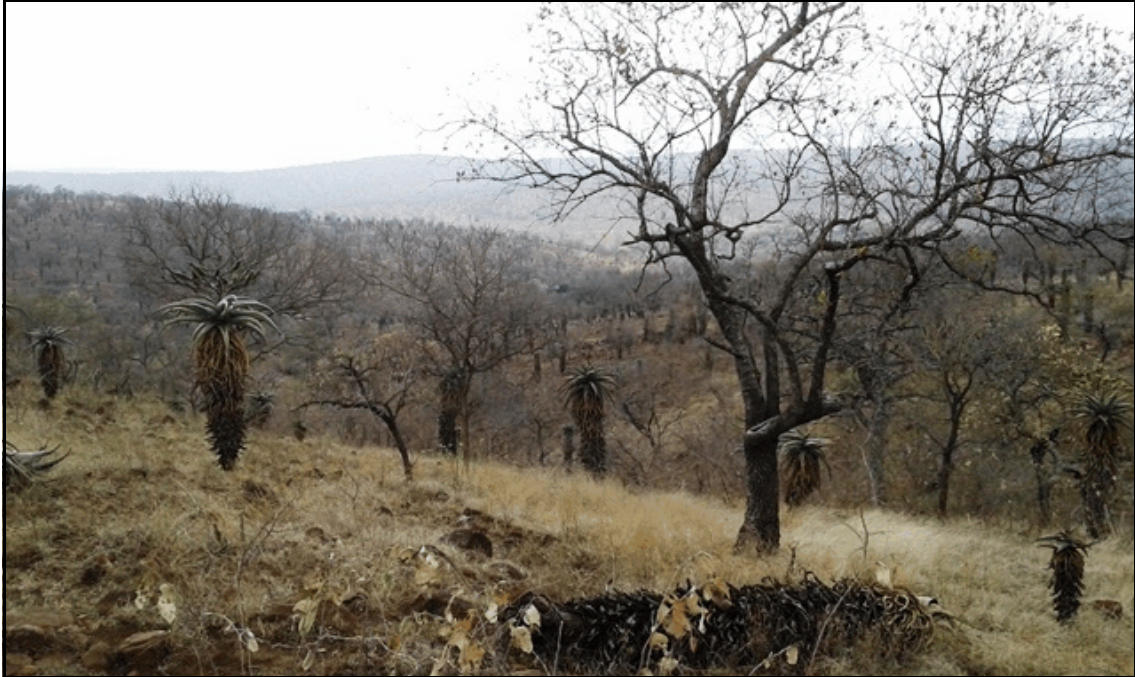
Plate 2: Photograph of one of the northern drainage lines, namely the one within which EXP1 was profiled.

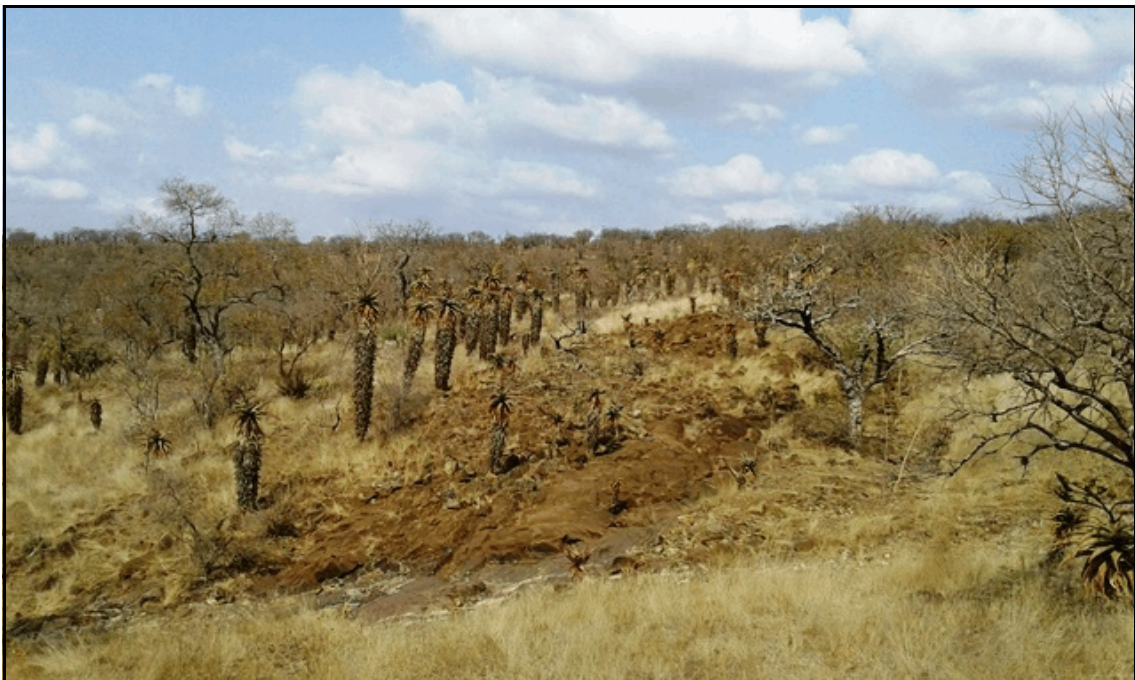
Plate 3: Photograph of one of the eastern drainage lines, namely the position where EXP3 was profiled.

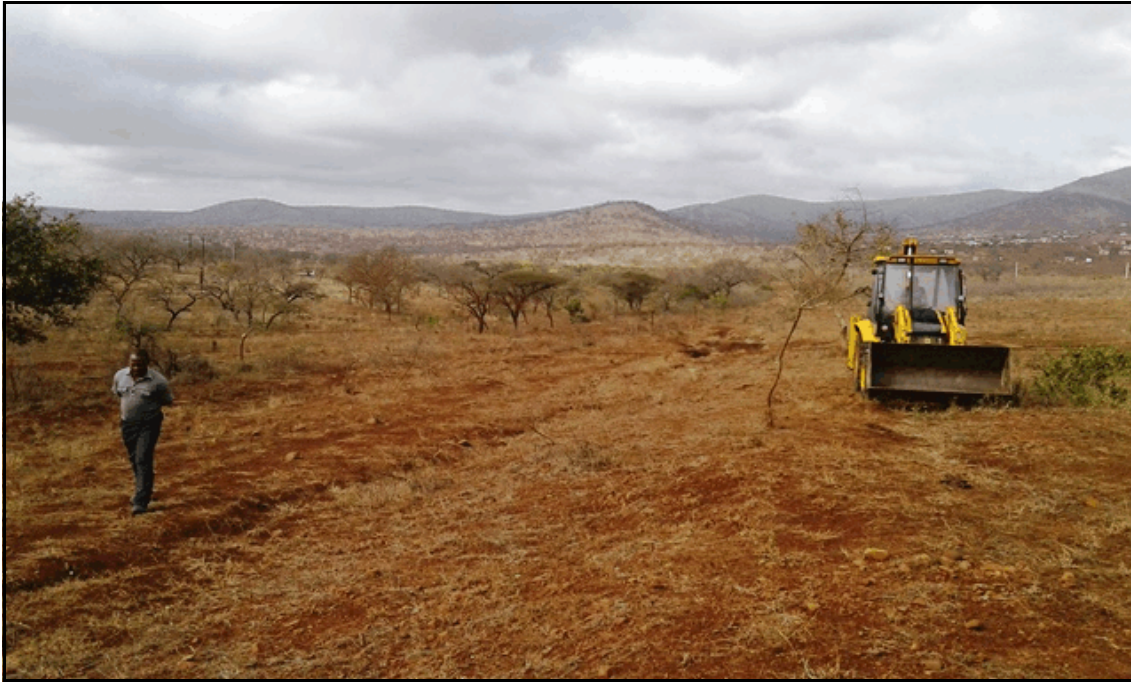
Plate 4: The western drainage line parallel to the western boundary.

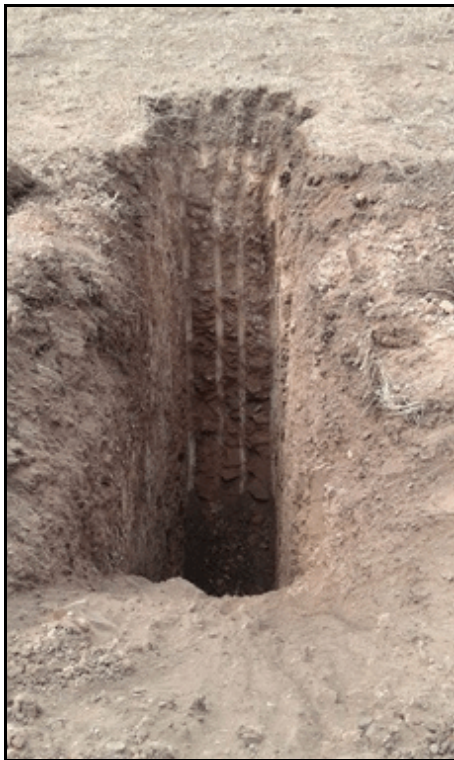
Plate 5: Typical subsoil profile of hillwash and residual basalt overlying basalt bedrock (IP1).

Exception to the above general geology is the northwestern area of the site (vicinity of IP1) where a residual soil horizon is observed between the hillwash and bedrock layers:

0.50 to 1.30 m	Dry to slightly moist, light brown mottled white, dense to
Only in the northwestern area of the site	very dense, slightly clayey gravelly SAND - (Residual Basalt)

Plate 5 and 6 below show the typical profiles for the residual basalt overlying basalt bedrock and for hillwash directly overlying bedrock as encountered across the site.

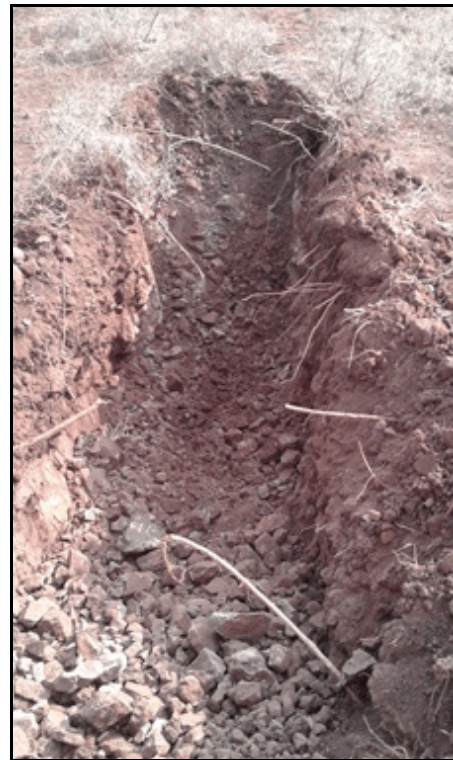
Plate 6: Typical shallow subsoil profile of hillwash directly overlying basalt bedrock (IP6).

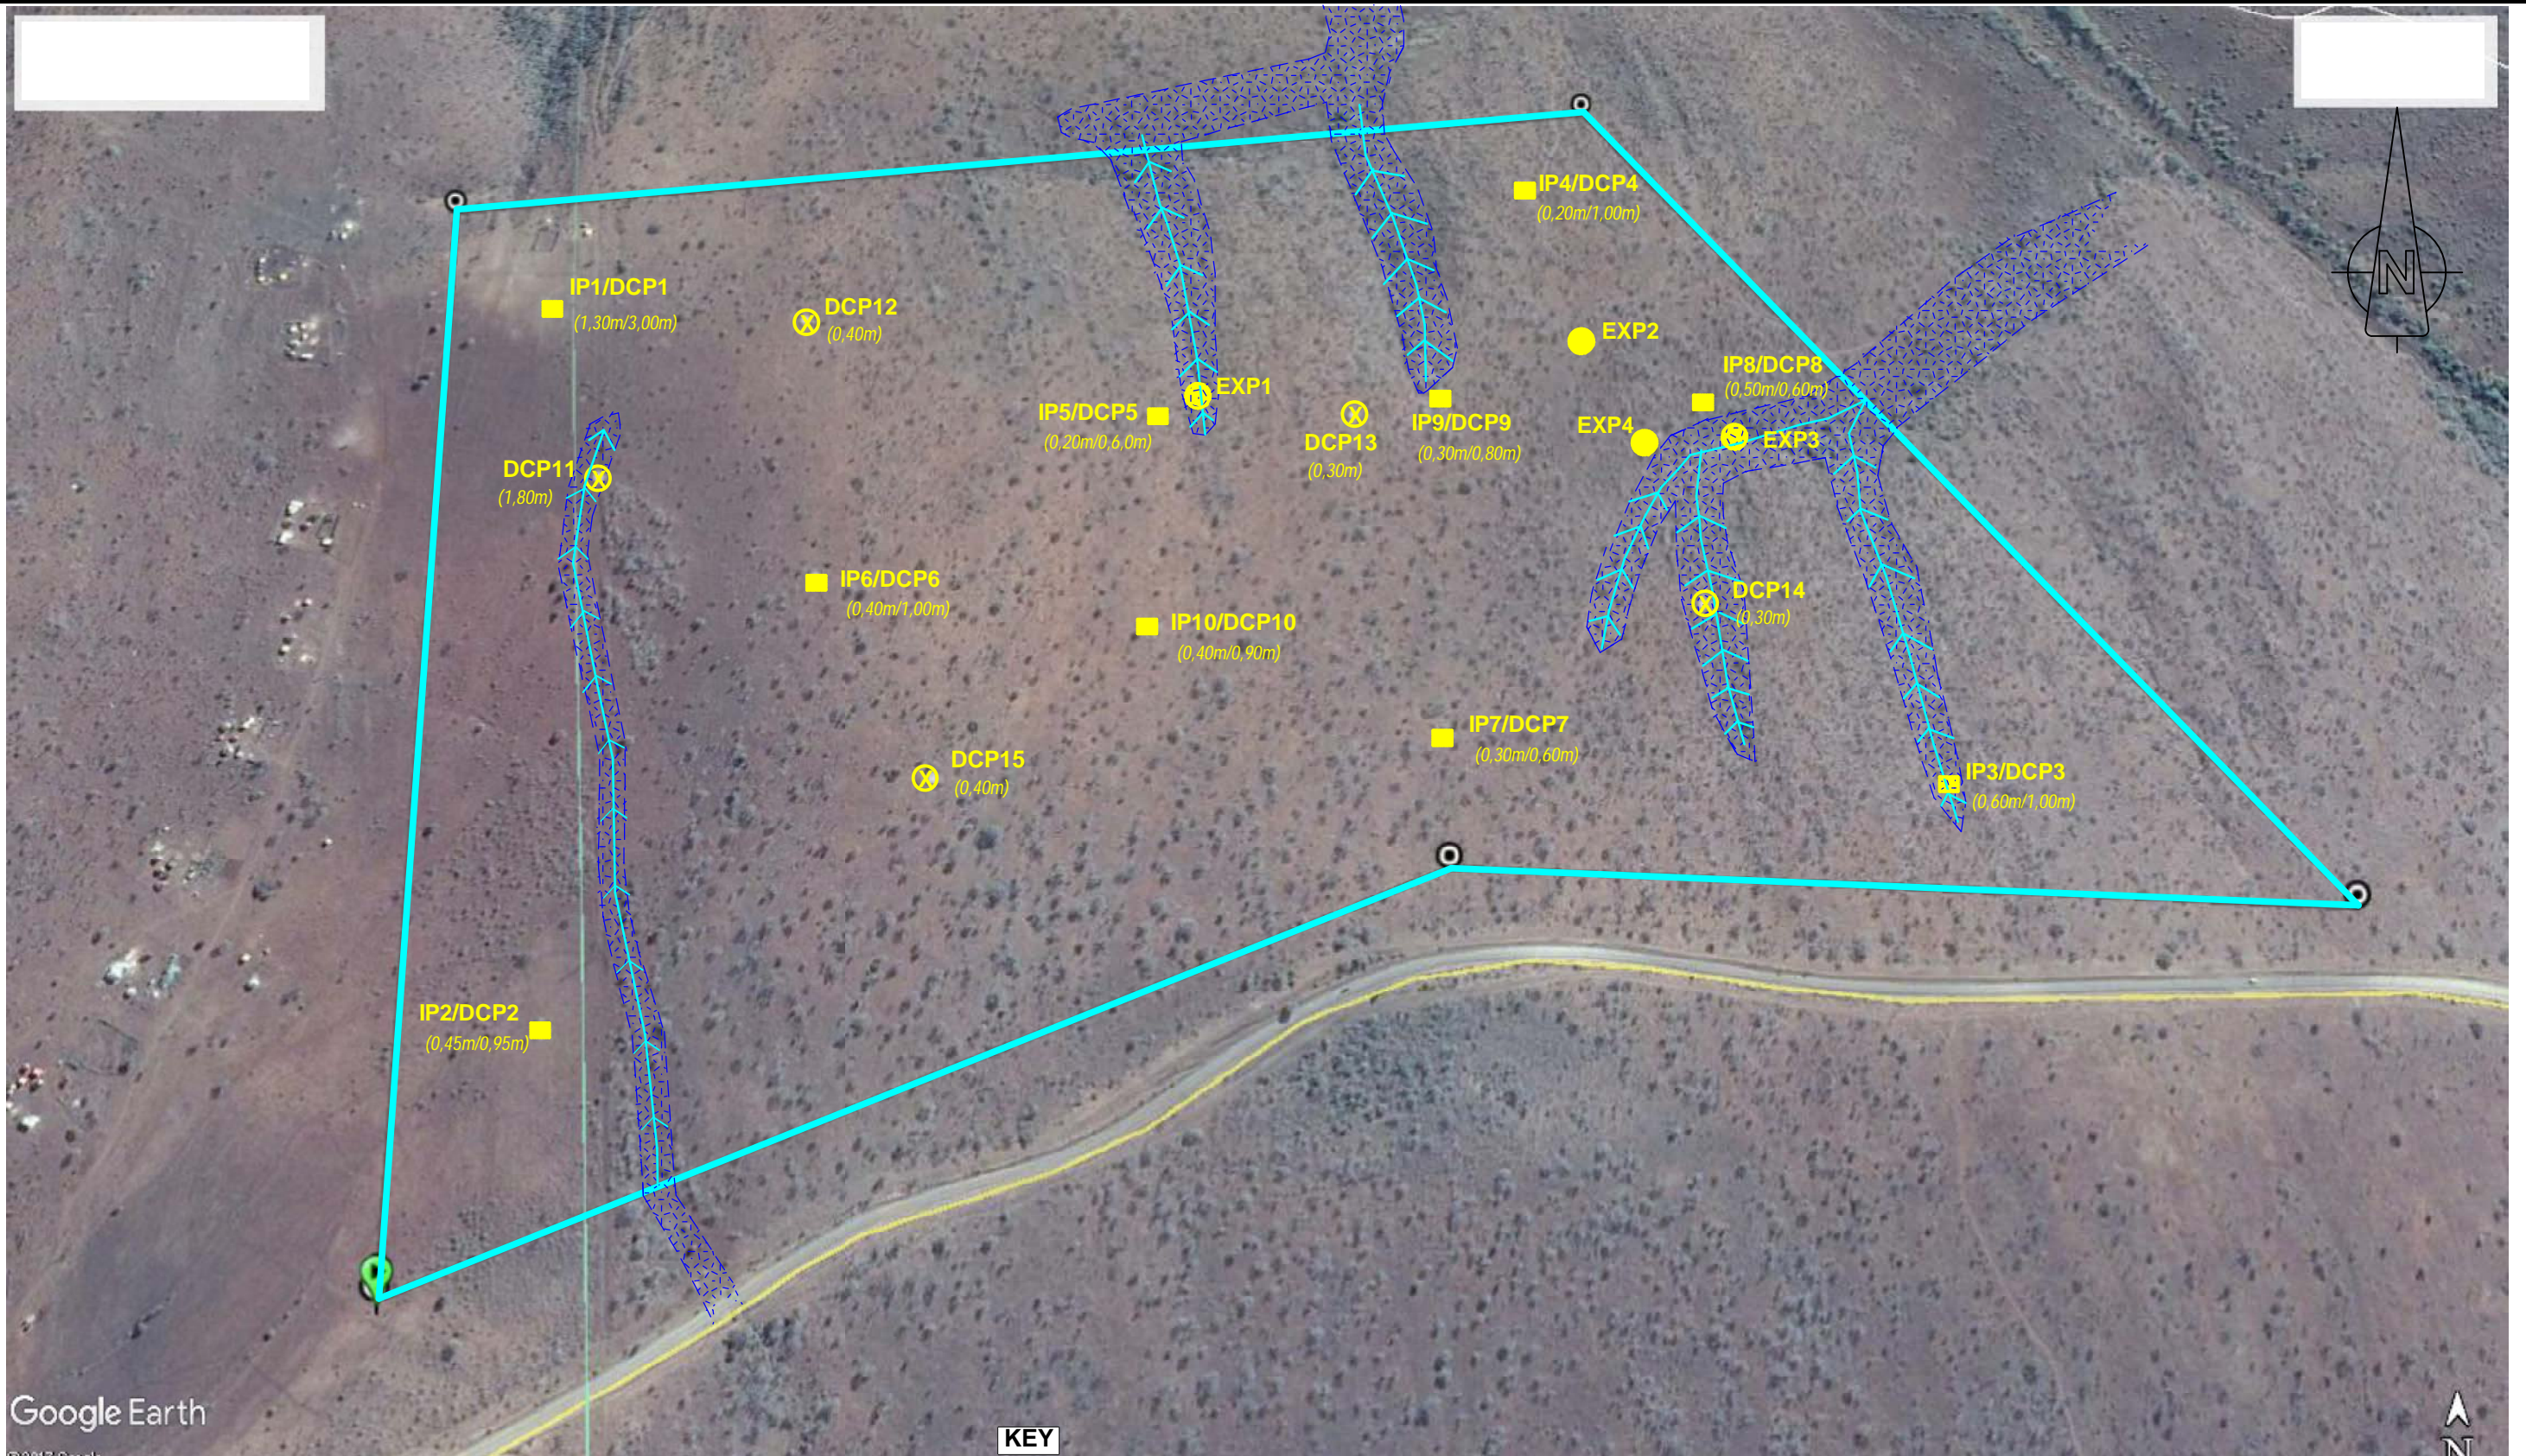
DRAWING NO.
31833-1/02

- IP1/DCP1 (1,3m/3,0m) ■ APPROX. POSITION OF INSPECTION PITS/
DYNAMIC CONE PENETROMETER TESTS
(INFERRED BEDROCK DEPTH / FINAL DEPTH)
- EXP4 ● APPROX. POSITION OF EXPOSURES
- DCP15 (0,40m) ⊗ APPROX. DYNAMIC CONE PENETROMETER
TESTS
(FINAL DEPTH)
- SEEPAGE AREAS
- RECOMMENDED HERRINGBONE
SUBSOIL DRAINAGE BENEATH FILLS

As discussed in Section 8.3 above, seepage areas occur in valley / channel depressions which are going to be filled over. In order to maintain stability and avoid water tables / pore water pressures building up in the fills, it is recommended that herringbone subsoil drainage be constructed in the depressions prior to filling at approximate positions shown in the Site Plan, Drawing No 31833-1/02.
