***Report to Escongweni BPH Engineers (Pty) Ltd on the
Results of a Geotechnical Investigation for the Proposed
Construction of the Thokozani Water Supply Scheme,
uMshwathi Local Municipality, uMgungundlovu
District Municipality, Kwa-Zulu Natal***

Reference: 085-20.R02 Revision 0

Dated: 15 June 2020

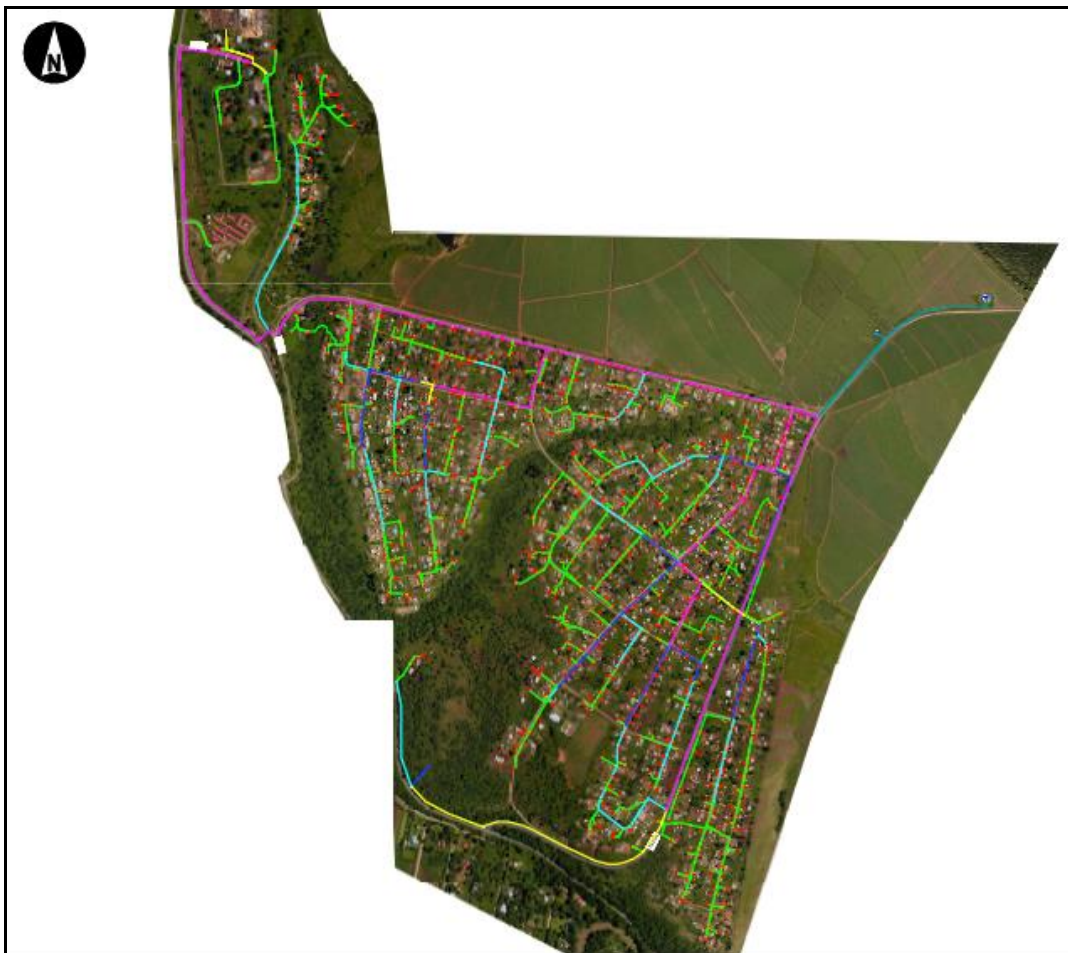
Plate 3: Aerial image showing overall water layout at the site

Plate 3 depicts the aerial image and proposed overall layout of the bulk and reticulation pipelines at the site.

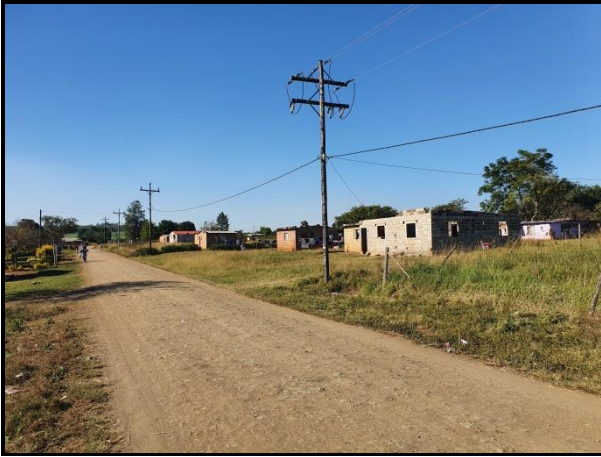
Plate 4: General view of route of bulk pipeline

It is understood from information indicated by a representative of Escongweni BPH Engineers (Pty) Ltd to Geosure personnel at the site that the proposed bulk pipeline is aligned along the edge of an existing gravel road formed along hillside terrain in the eastern portion of the site and generally displaying mild to moderate gradients to the southeast and southwest.

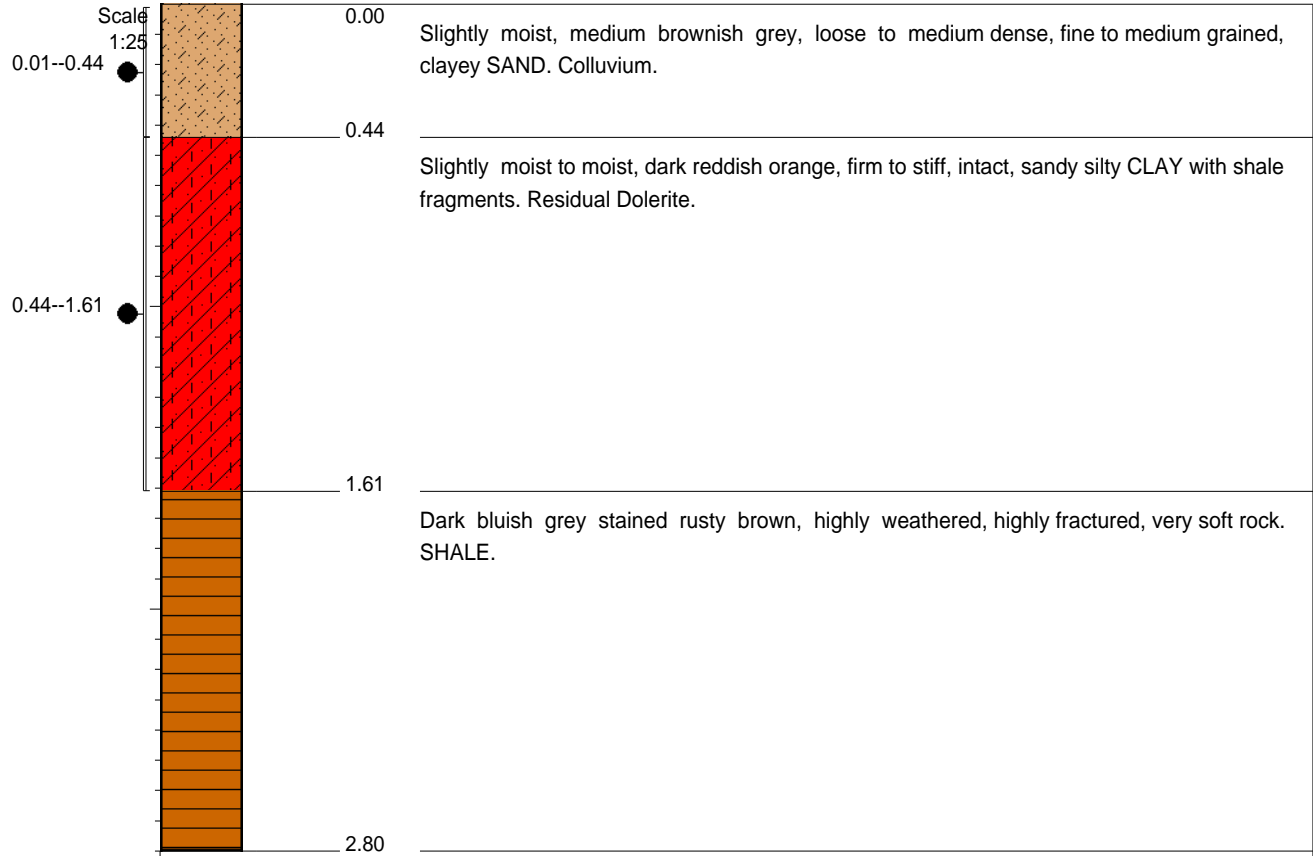
HOLE No: IP7
 Sheet 1 of 1

- 1) No groundwater seepage observed.
- 2) Samples taken at:
 S1 0,01--0,44 (1 x Bulk)
 S2 0,44--1,61 (1 x Ind)
- 3) Refusal depth at 2,80m.

However, the occurrence of deep residual dolerite clay soils, e.g. at IP1 – IP5, IP10 - IP12, IP15 and IP16 to at least 3.5m below EGL, and stained shale rock where rock was profiled, is indicative of intermittent perched groundwater activity.

The risk of encountering such a condition is also considered to increase towards any low-lying/weakly to poorly drained areas near drainage lines and/or geological contacts. Conversely, the risk of encountering perched groundwater activity is generally assessed to decrease across well-drained/elevated portions of the site associated with hillside terrain where underlain by rock within depths of 1m – 1.5m below EGL e.g. IP6 IP8 and IP13.

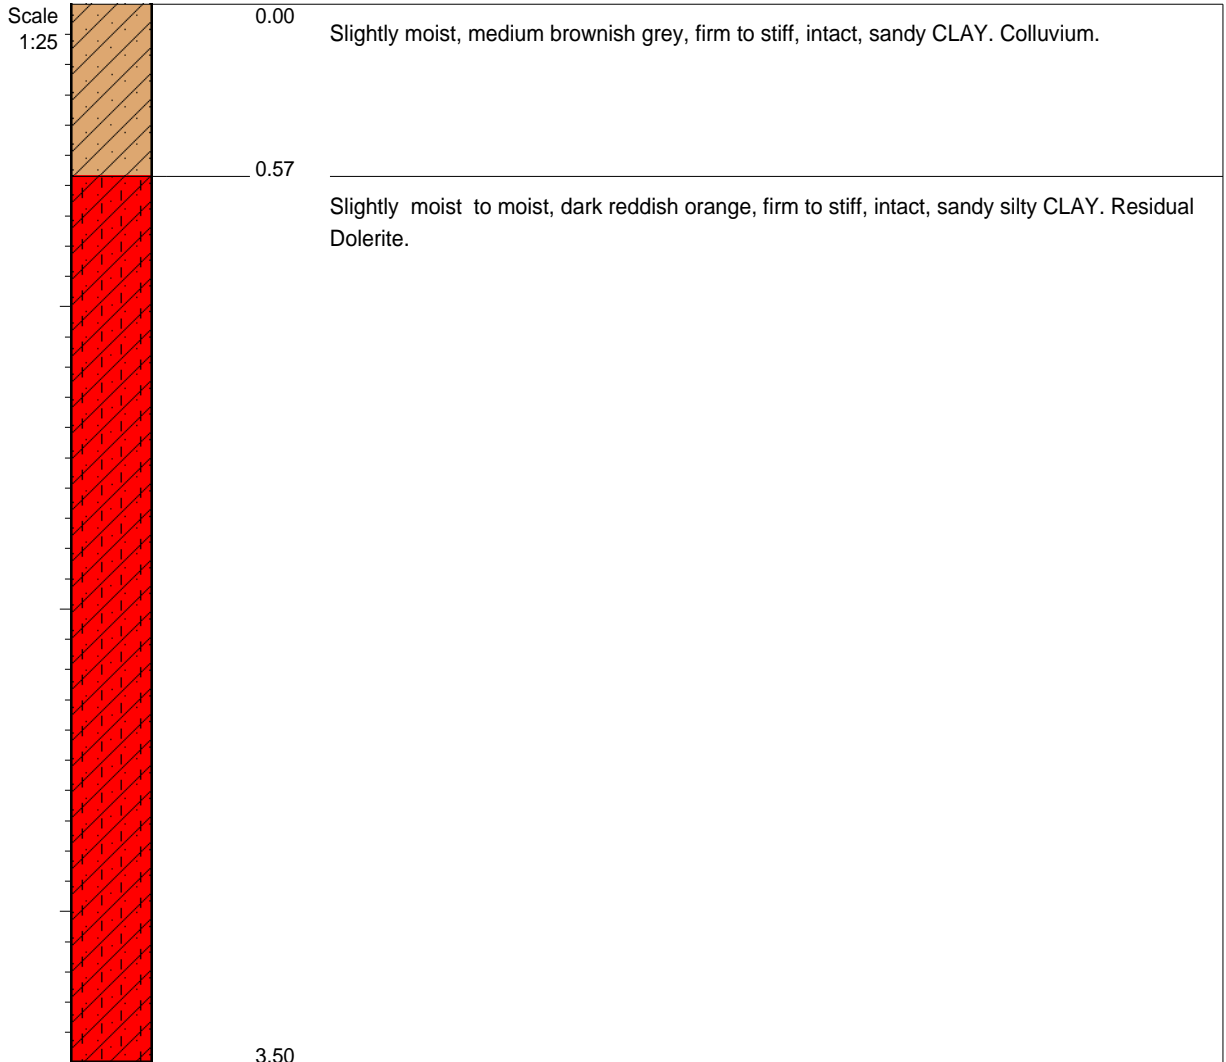
HOLE No: IP10
 Sheet 1 of 1

- 1) No groundwater seepage observed.
- 2) Final depth at 3,50m.

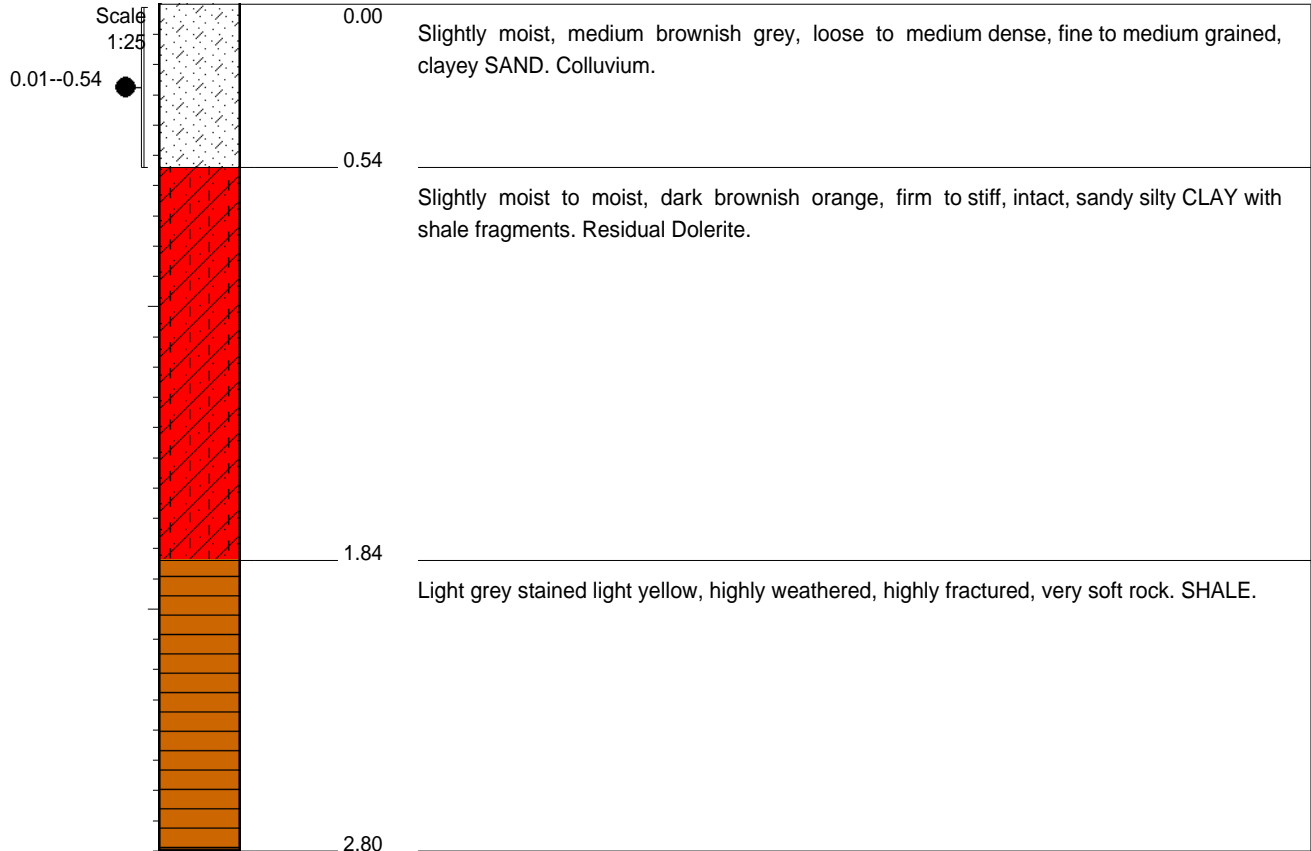
HOLE No: IP23
 Sheet 1 of 1

- 1) No groundwater seepage observed.
- 2) Sample taken at:
 S1 0,01--0,54 (1 x Bulk)
- 3) Refusal depth at 2,80m.

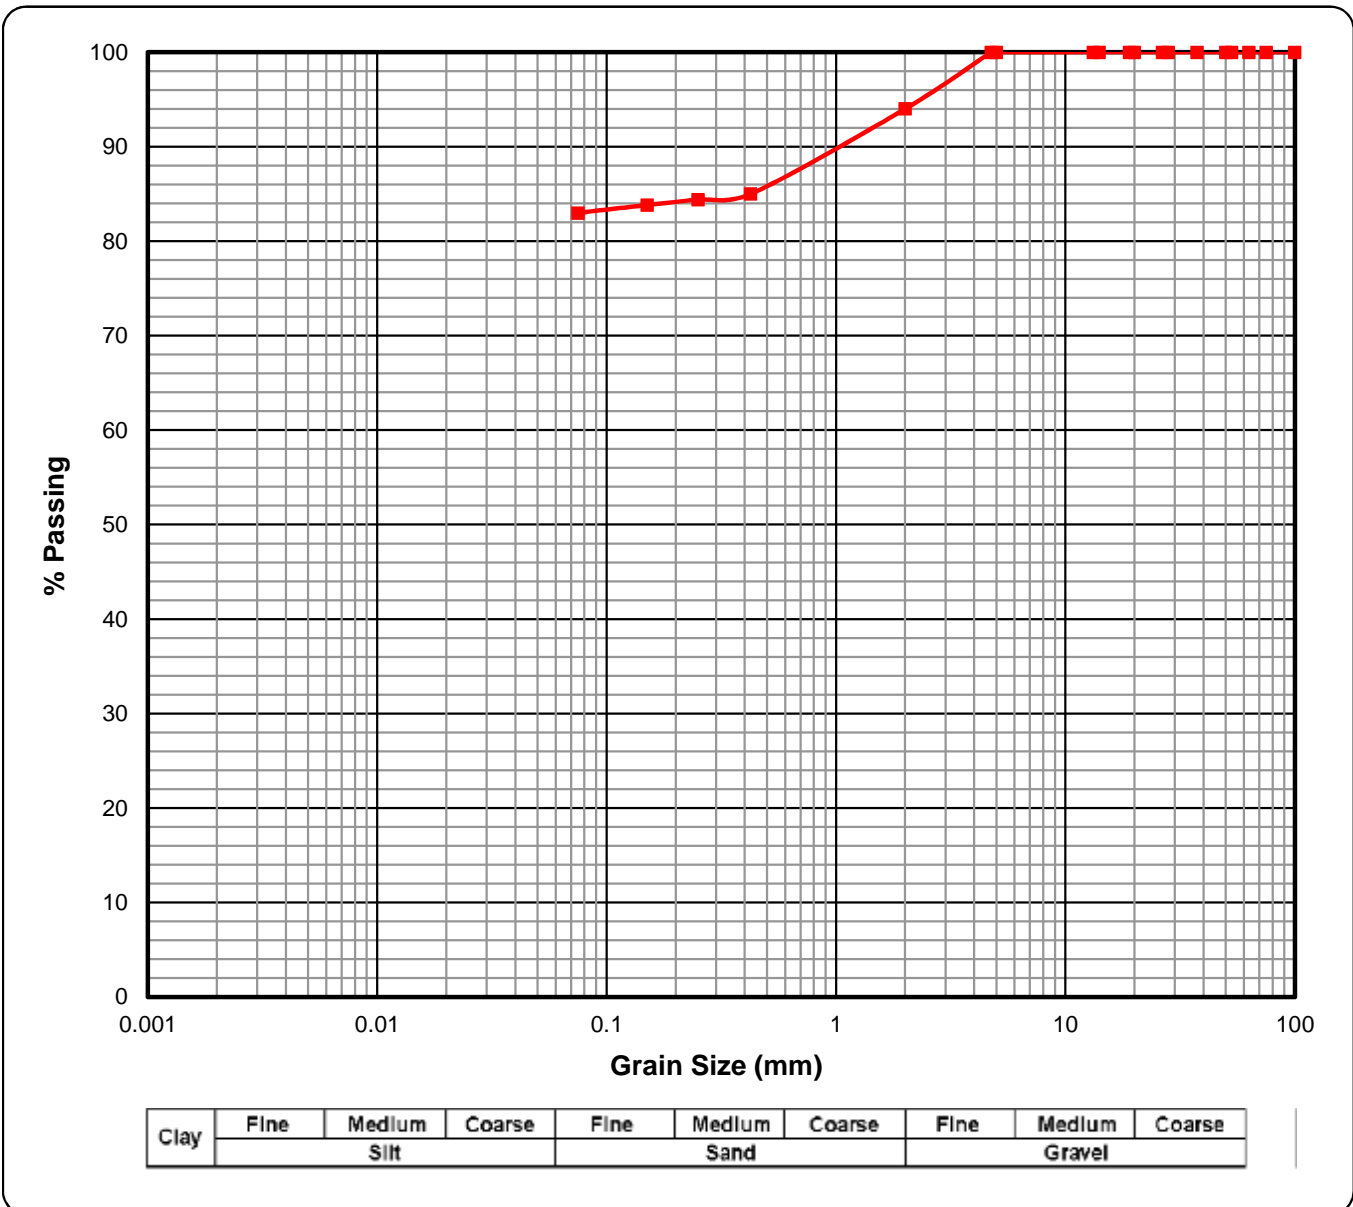
Grading Curve for Sample T25108 – SANS 3001

ck Red Line is the Grading Curve (COLTO Classification = Cannot be Determined) (TRH 14 Classification = Poorer than G1

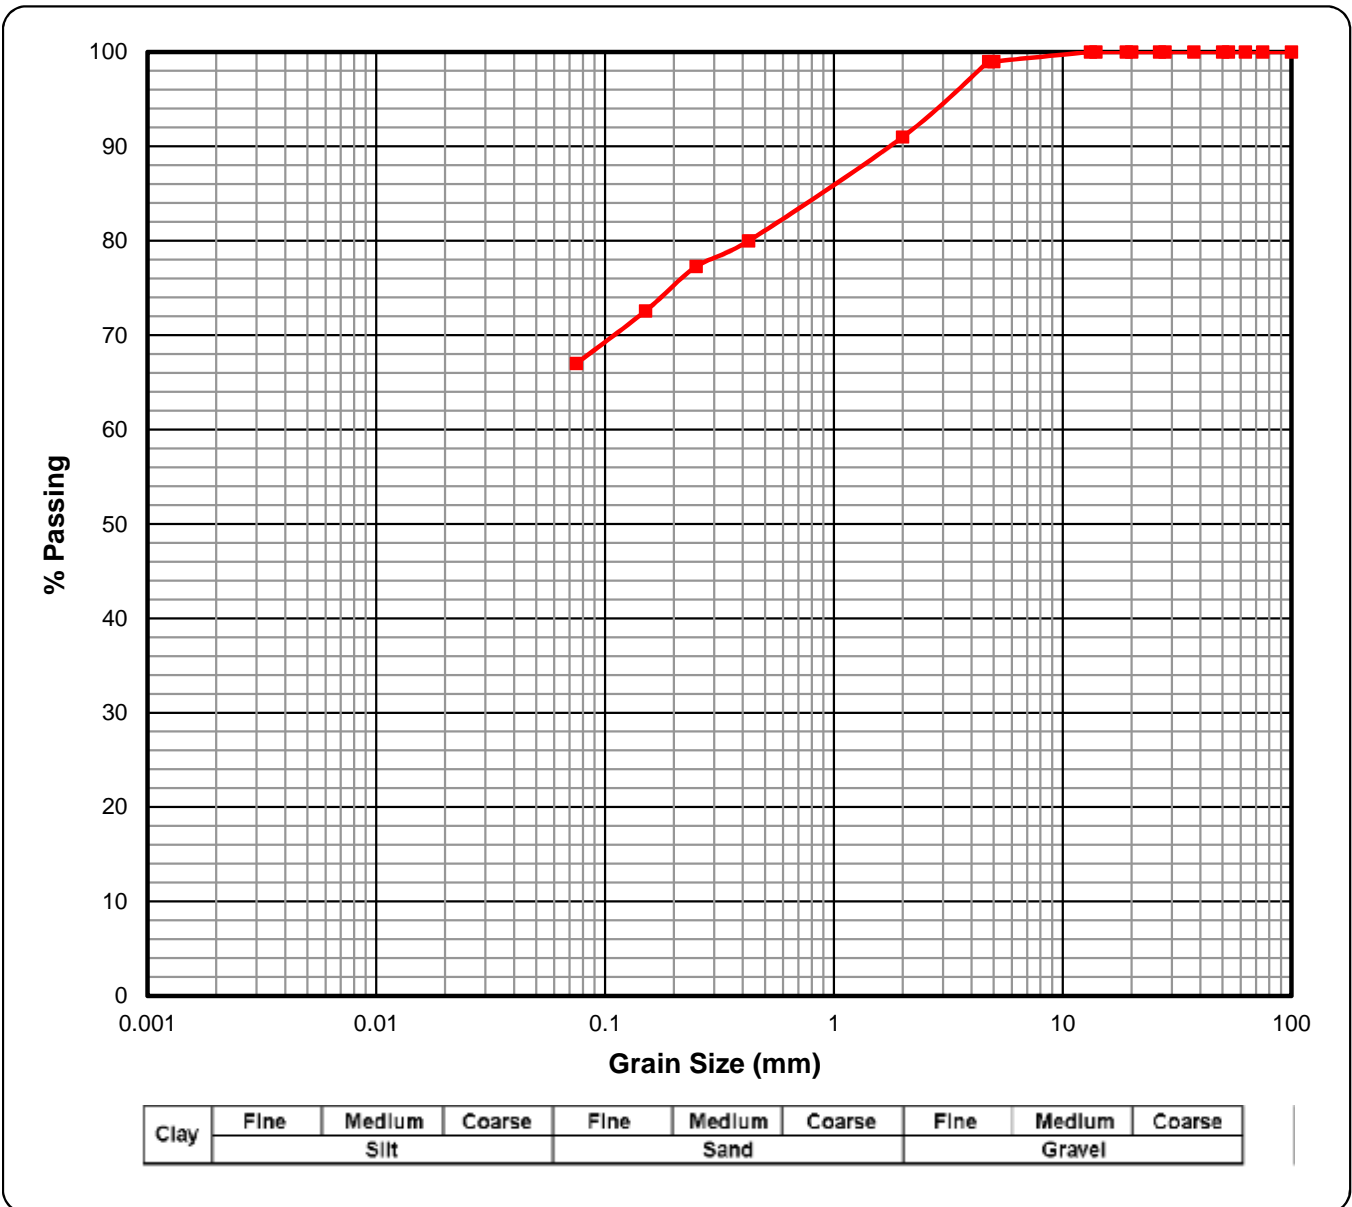
Grading Curve for Sample T25109 – SANS 3001

Thick Red Line is the Grading Curve (COLTO Classification = Cannot be Determined) (TRH 14 Classification = G8)

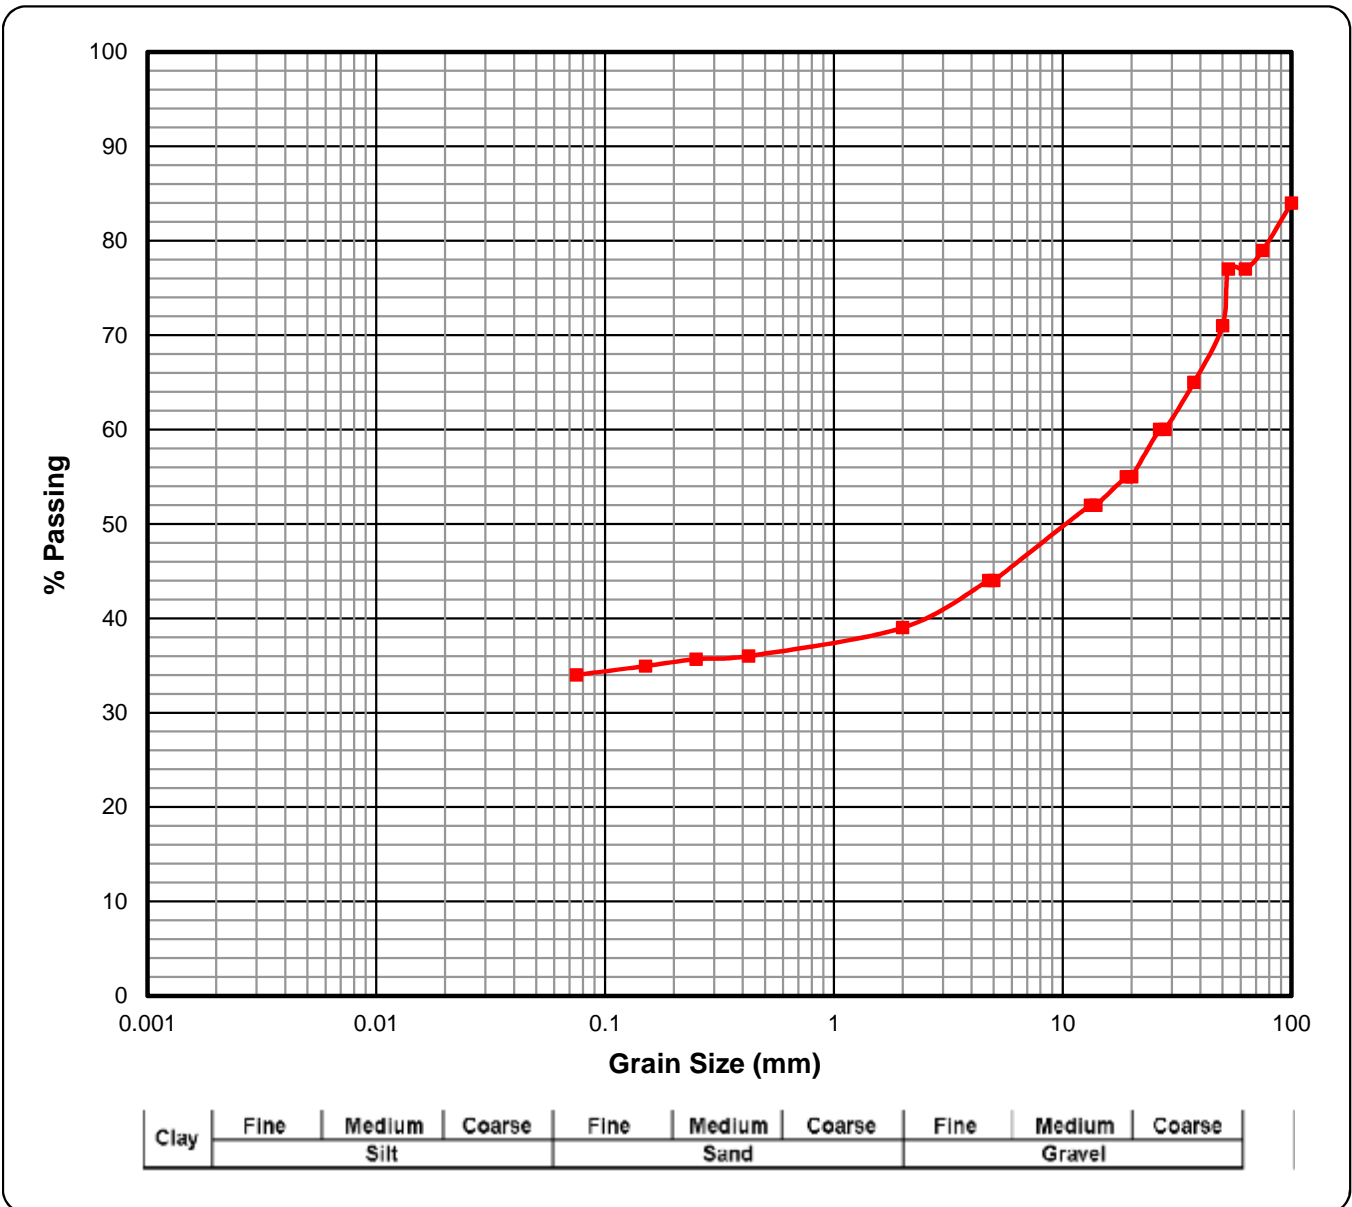
Grading Curve for Sample T25110 – SANS 3001

Thick Red Line is the Grading Curve (COLTO Classification = G8 (#)) (TRH 14 Classification = G8)

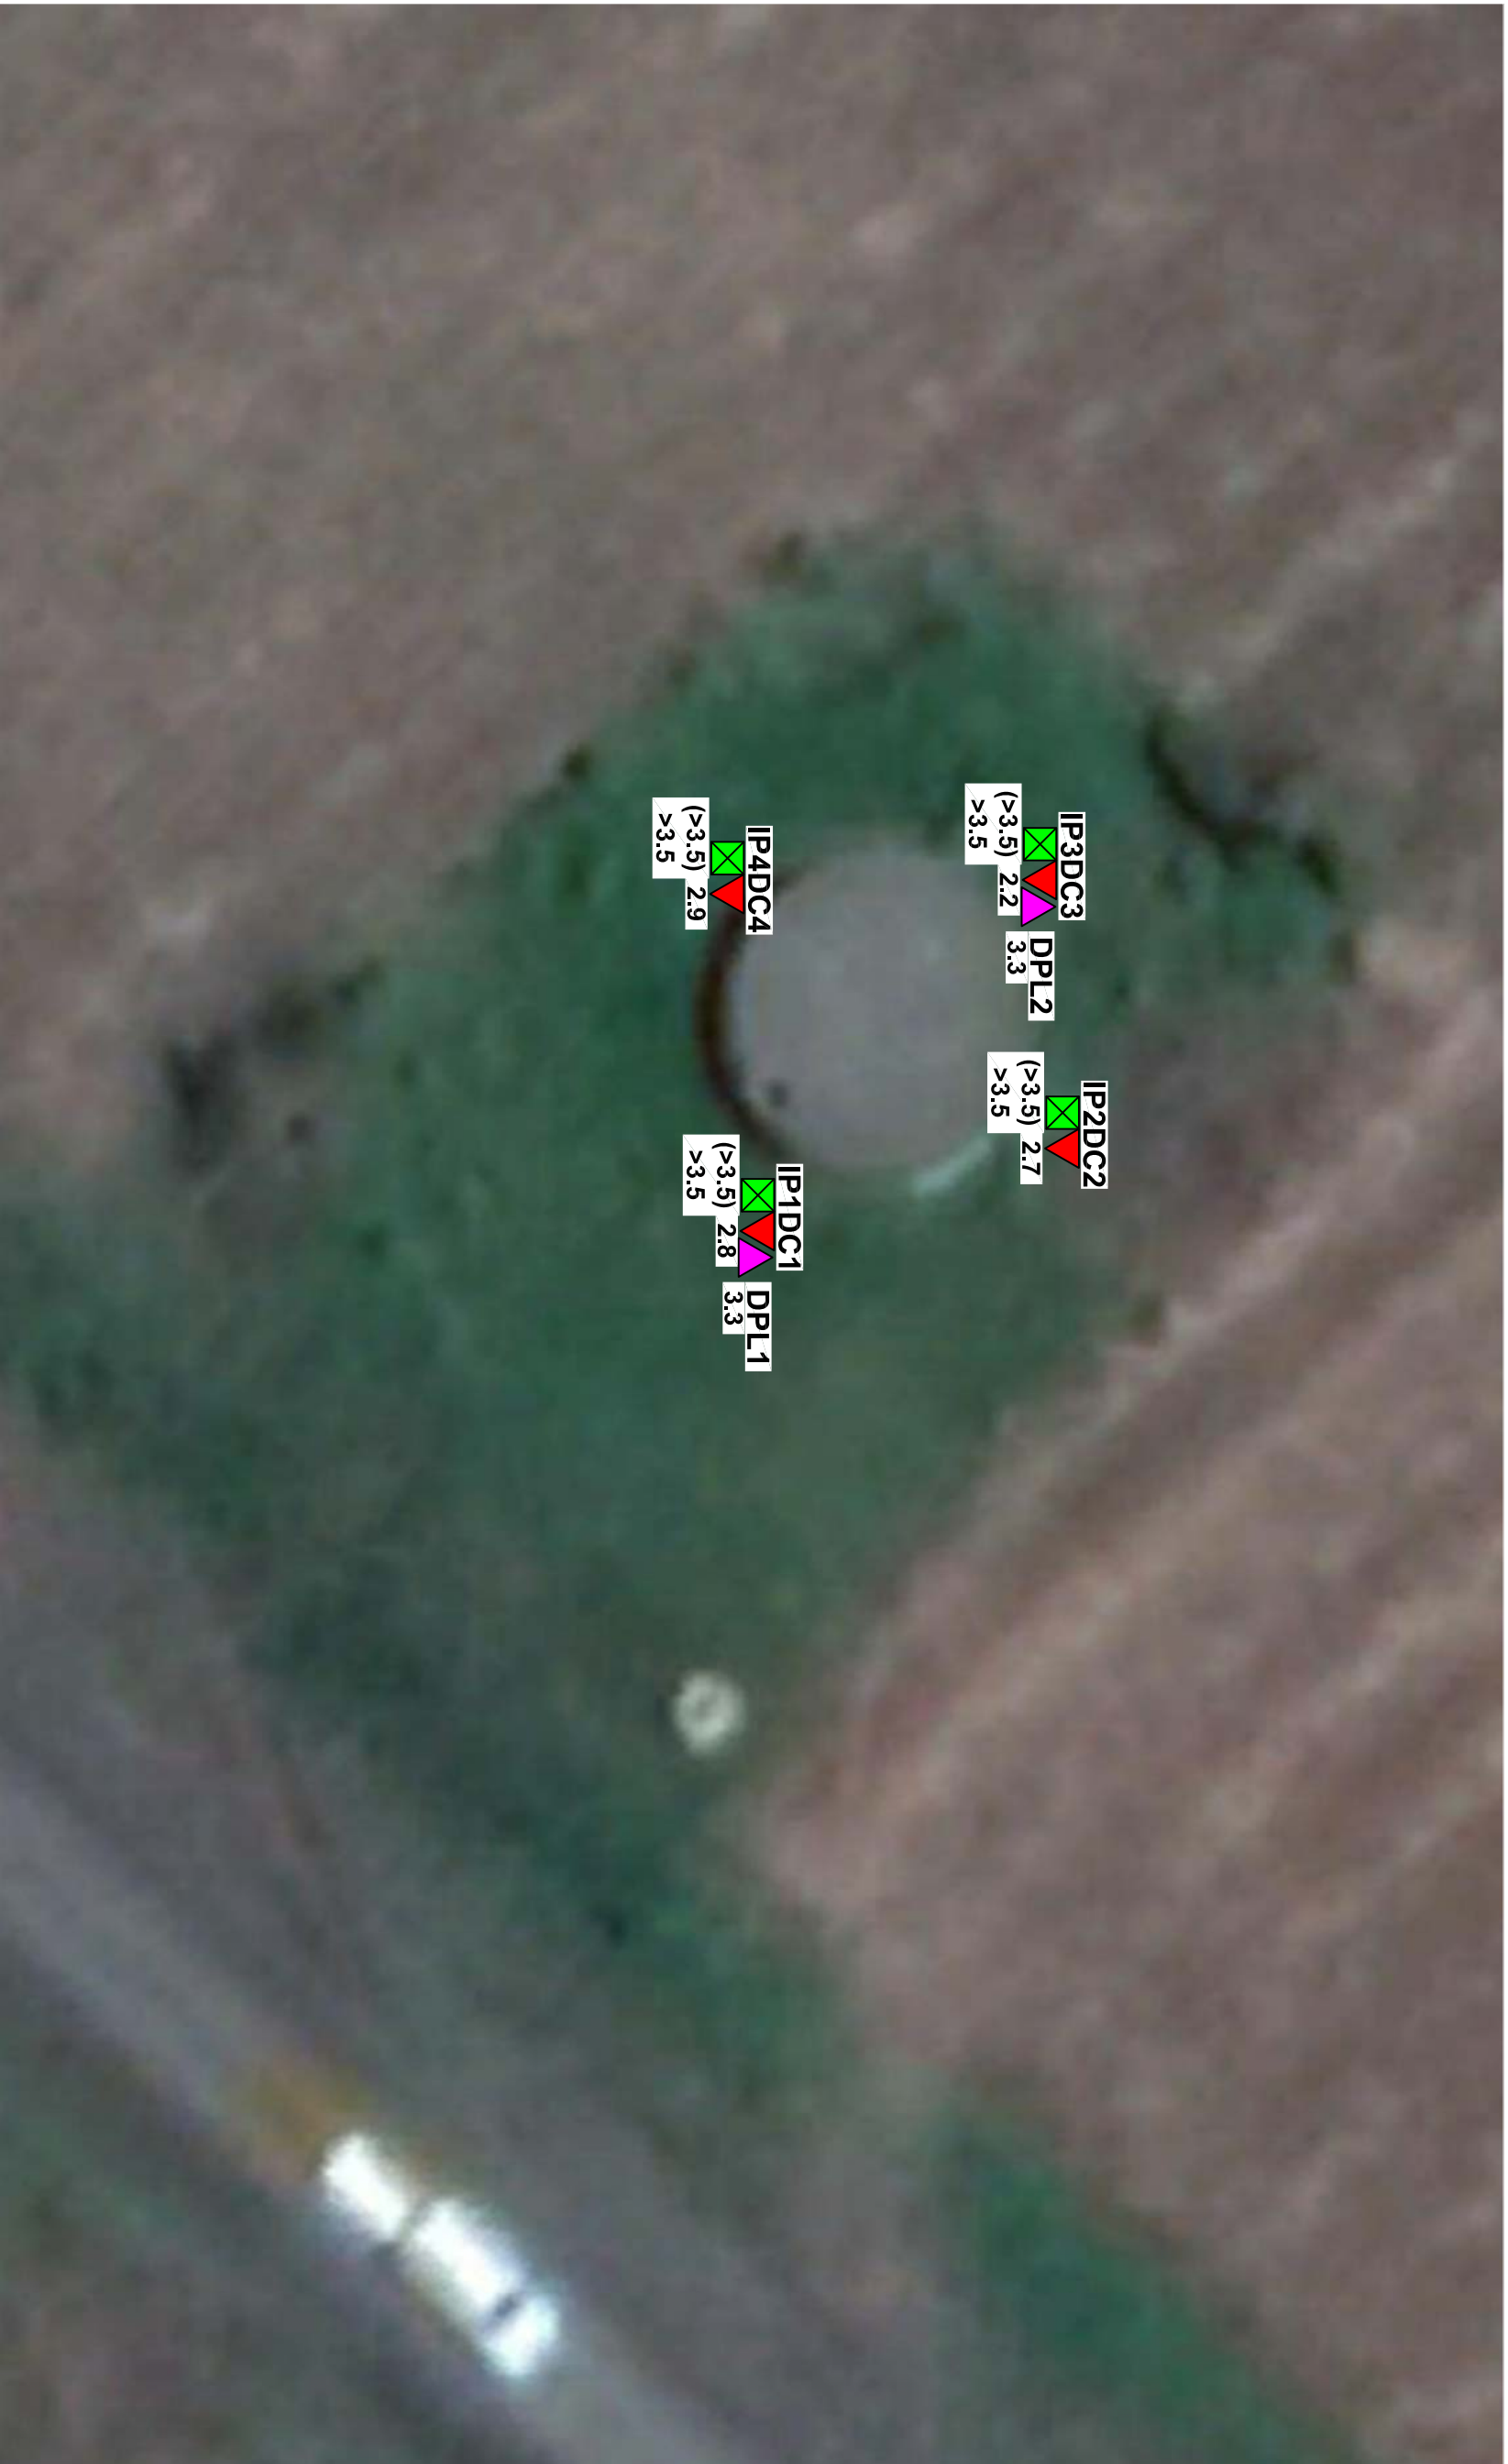
**SITE PLAN
(1ML RESERVOIR)**

- IP1** (3.5) >3.5
Approximate position of Inspection Pit showing depth to rock () and depth to refusal in metres below existing ground level.
- DC1** 2.8
Approximate position of CBR Dynamic Cone Penetrometer Test showing depth to refusal in metres below existing ground level.
- DPL1** 3.3
Approximate position of Dynamic Cone Penetrometer Light (DPL) Test showing depth to refusal in metres below existing ground level.
