BLUESTONE QUARRY WALL RESTORATION PROJECT

IMPLEMENTATION PLAN

(AHSA) Archaeological and Heritage Services Africa (Pty) Ltd
Reg. No. 2016/281687/07

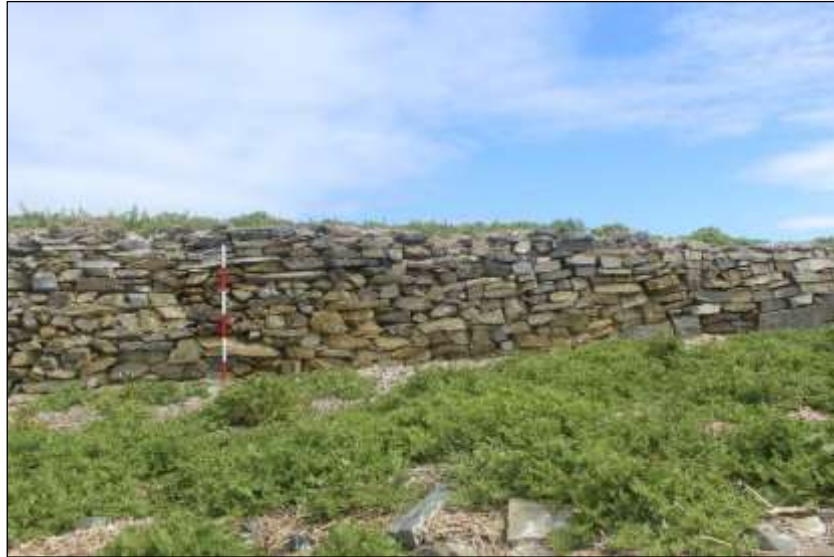
Figure 1: Sections of the wall that are standing and intact will be preserved

The walls that are still standing at the BSQW site will be preserved in their original state with very little treatment necessary except that they will join and flush with the portions to be restored so that they form a single unit.

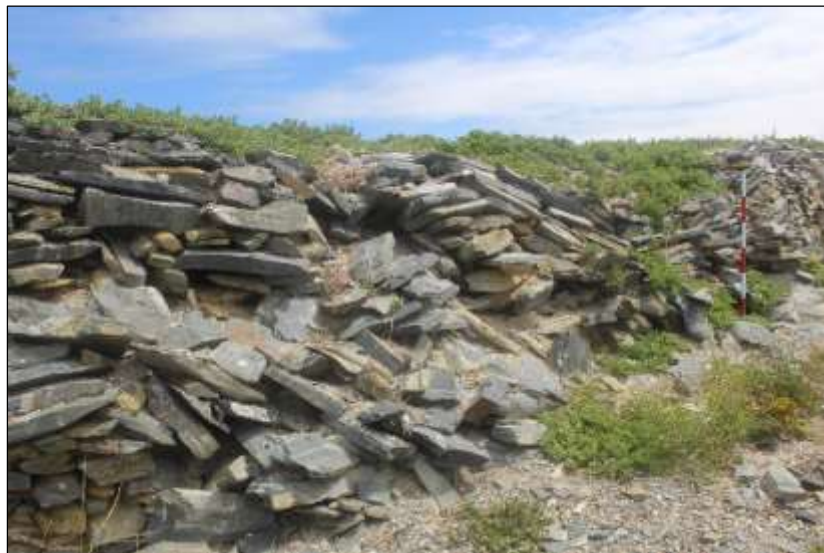
Figure 2: Partially collapsed sections will be restored using the same material which has been displaced

- (ii) **Restoration** means returning a *place* to a known earlier state by removing accretions or by reassembling existing elements without the introduction of new material. A radical engineering proposal placing emphasis on the endurance of the wall (structural durability) though the introduction of a cement, grouting or geotextile reinforcement grid has been ruled out as untenable since the spirit and essence of the Bluestone Quarry Walls were that they were purposefully built without mortar as punishment.

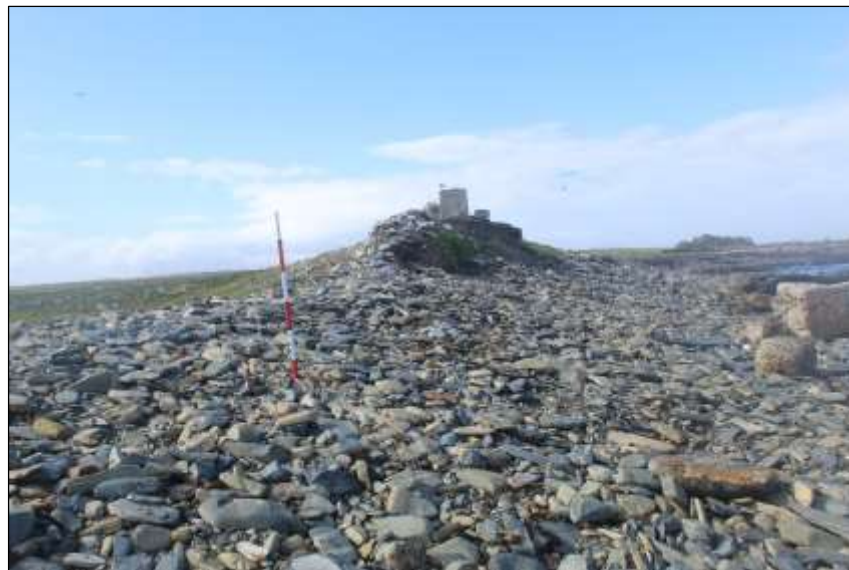
Figure 3: Collapsed section of the main wall, will be rehabilitated by anastylosis

- (iv) **Anastylosis** is a reconstruction technique whereby a ruined building or monument is restored using the original architectural elements (material) to the greatest degree possible. In the collapsed sections it is impossible to put back the stones in their original positions. While anastylosis may also involve disassembly of standing structures that may have been condemned as unstable, this is not the intention in this Implementation Plan. The target are walls that have collapsed and the debris (original constituent blocks) can be retrieved and recycled. In other words this process is to an extent a restoration since an attempt is made to put back the wall on the basis of existing photographs of the original wall and an opportunity that the material can be retrieved, although there is no guarantee that the building blocks will take back their original positions (Figure 3).

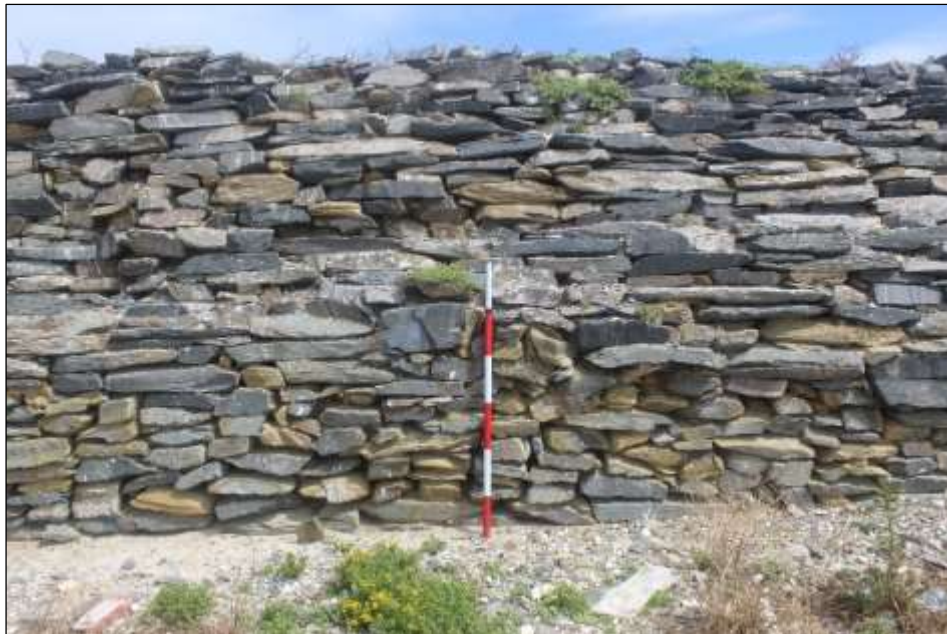
Figure 4: Example of P style wall

The main wall in the precinct which is a long dyke laid between the seashore and quarry is a freestanding wall, meaning that the two façades of the wall rise above the ground. The east facing side facing the quarry has a “skin” built by staking stones of different sizes and irregular shape, resulting in a coarse finish or texture (now called **P style**). Face stones are rarely laid in courses, and where an attempt at coursing is made they are short and occur haphazardly in the façade. They are called “false courses”.

ACTION: In the planned restoration work the P style finishing of the façades will be imitated.

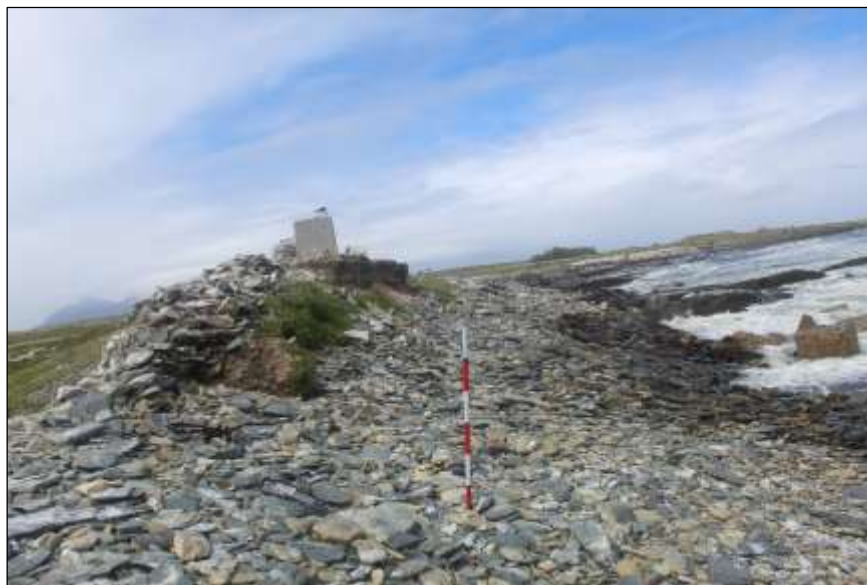
Figure 5: Scree of collapse facing the sea. It is possible that there was no wall on the seaside of the dyke.

To our knowledge there is no photographic record of the form or appearance of the west façade of the main wall, i.e. the side facing the sea. In 2004 ex-political prisoners testified that the seaside face was built in the same way as the side facing the quarry i.e. with a “skin” of stacked stones in close resemblance to the south façade (Matenga 2004, p8). By then there was no trace of the façade, but a scree slope ending in the sea (Figure 5).

ACTION: The matter as to whether there was a solid wall façade on the side facing the sea requires further consultation with EPPs and confirmation before a decision is made about what form it will take in the restoration/reconstruction.

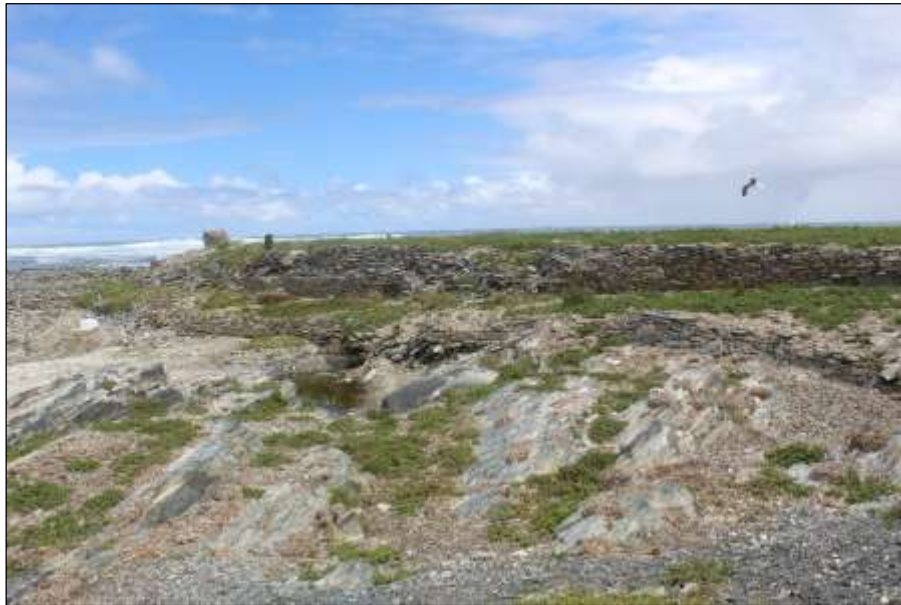
Figure 6: Revetment wall can be seen in the middle ground.

The rim of the quarry was stabilised by a semi-circular ring of revetment wall (east and north sides). The western and southern half of the rim is not protected. A revetment wall looks pretty much the same as a free standing wall described above, except that a revetment wall has one façade while the backside is filled up with soil and other material to create a terrace or platform. The revetment wall at

the site is broken by collapse into many sections and buried under soil wash in other sections (Figures 6-8).

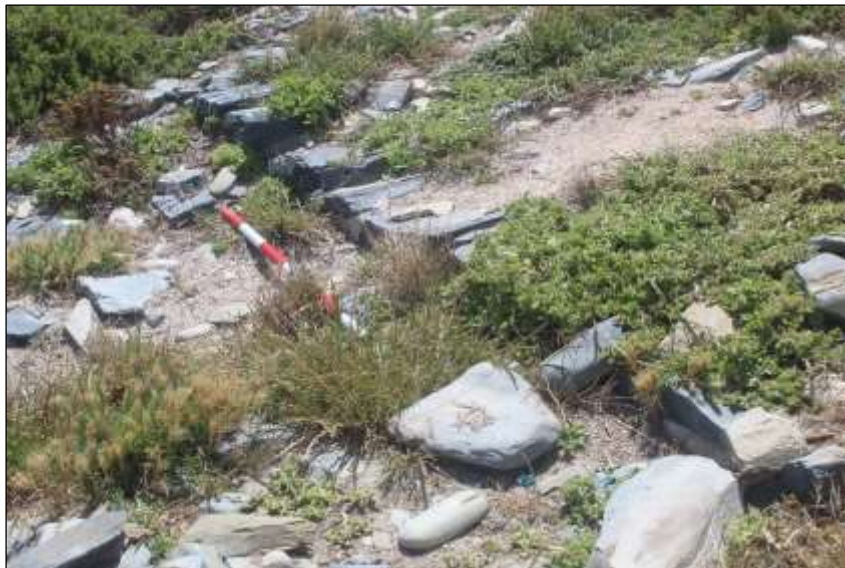
Figure 8: One course of revetment wall exposed, the wall appears to be buried by stones and soil wash.

ACTION: The revetment wall will be traced under the earth/rubble cover. The process is an archaeological investigation in which minimum professional standards will be followed. When the wall has been exposed appropriate treatment procedures will be taken. One existing section of the wall is built with blocks of more or less regular size and demonstrates refined workmanship. This will provide guidance for the rehabilitation of this section of the revetment wall (Figure 8).

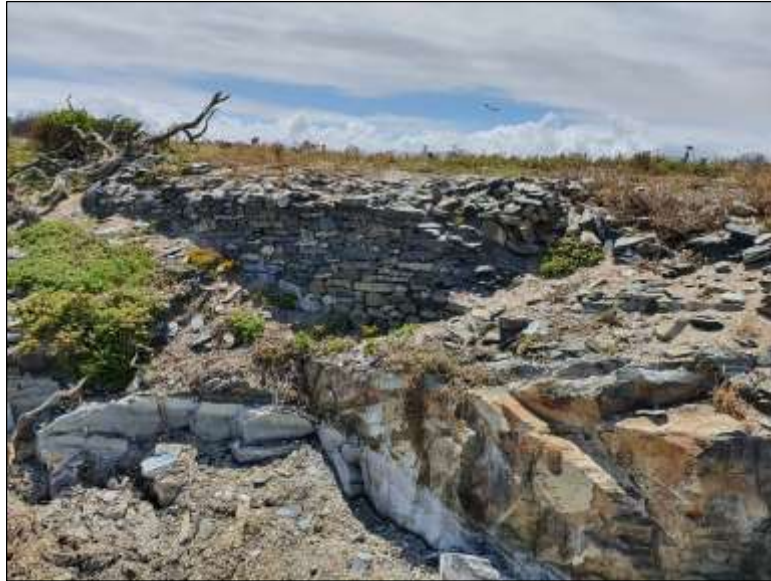
Figure 9: This revetment wall is of refined workmanship.

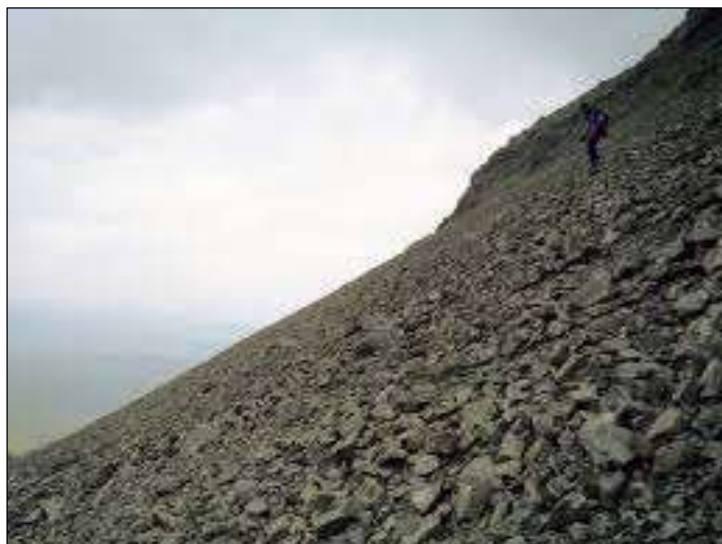
Figure 11. Stock image of a natural scree slope

There was no wall or skin on the side facing the sea. Instead a gentle slope had been created towards the shoreline, which may be described as a “scree slope” (Figure 11).
