TRAFFIC IMPACT STATEMENT

PROPOSED BELMONT VALLEY GOLF COURSE IN GRAHAMSTOWN

March 2012

DOCUMENT TITLE: **TRAFFIC IMPACT STATEMENT FOR THE PROPOSED BELMONT VALLEY GOLF COURSE**

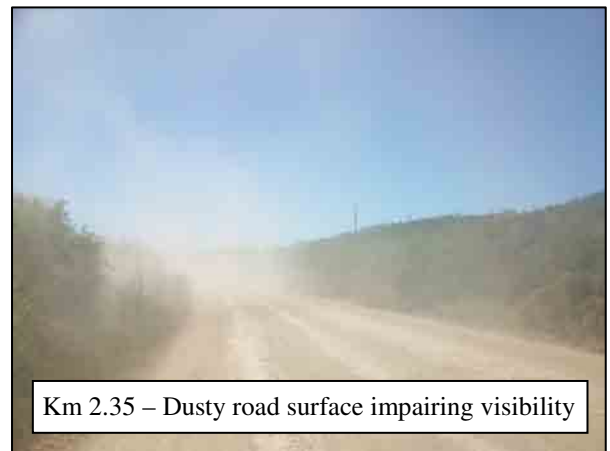
Drawing Title:
FIGURE 02 - TRAFFIC SAFETY & ROAD CONDITION ASSESSMENT OF MN50685 - LOCATION OF PROBLEMS

Vegetation encroaching on the road at km must be cleared in order to improve sight distance at km 2.5 and km 9.0.

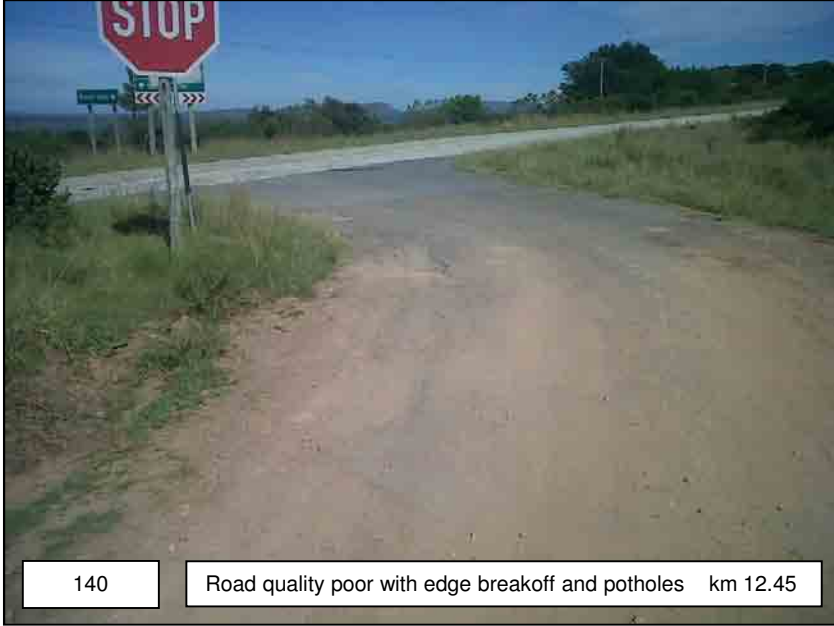
140

Road quality poor with edge breakoff and potholes km 12.45
