**A REPORT**

**A FEASIBILITY INVESTIGATION**  
**FOR A PROPOSED RESIDENTIAL DEVELOPMENT**  
**ON STANDS 862, 863, 865 AND 866**  
**IN MAPLETON EXTENSION 10,**  
**EKURHULENI METRO MUNICIPALITY,**  
**GAUTENG.**

**RELLY, MILNER AND SHEDDEN**  
PRETORIA

**DATE:** June 2016

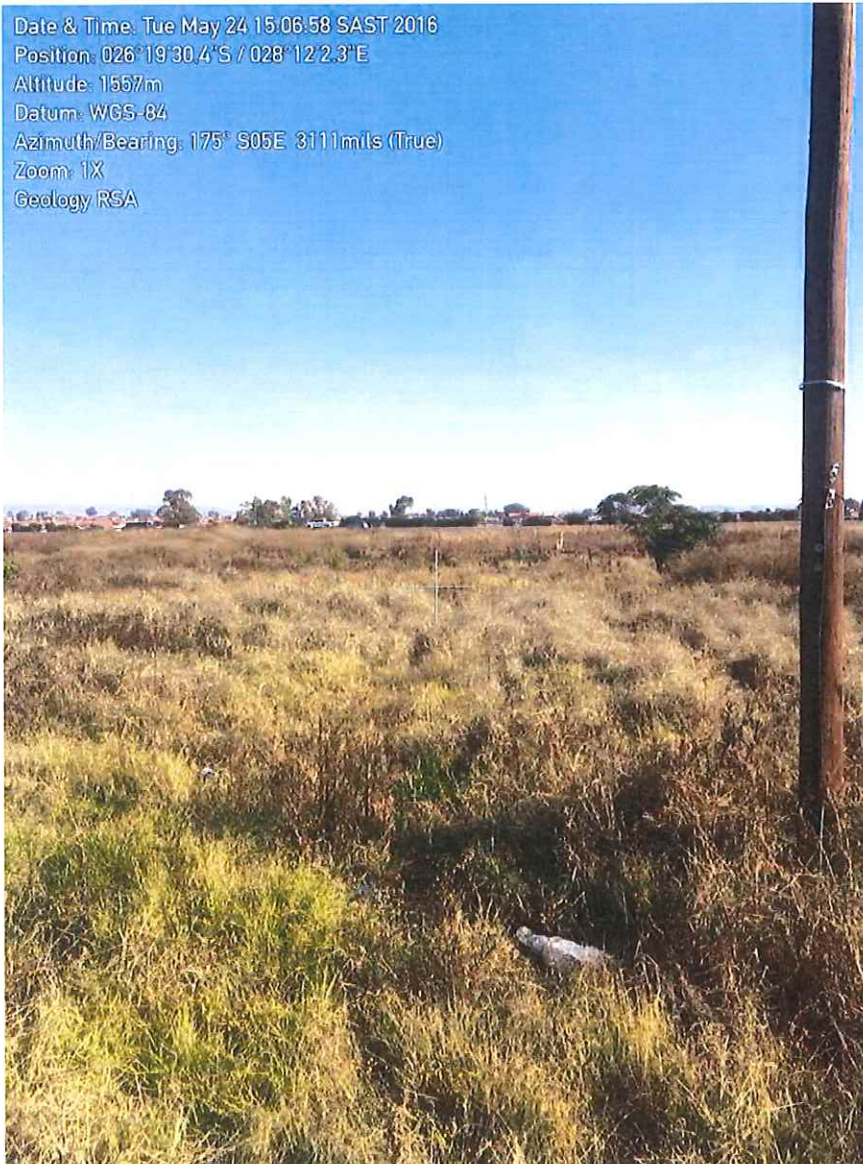
Photograph 1: View diagonally across site to the south. Vehicle in distance is on the N3 highway.

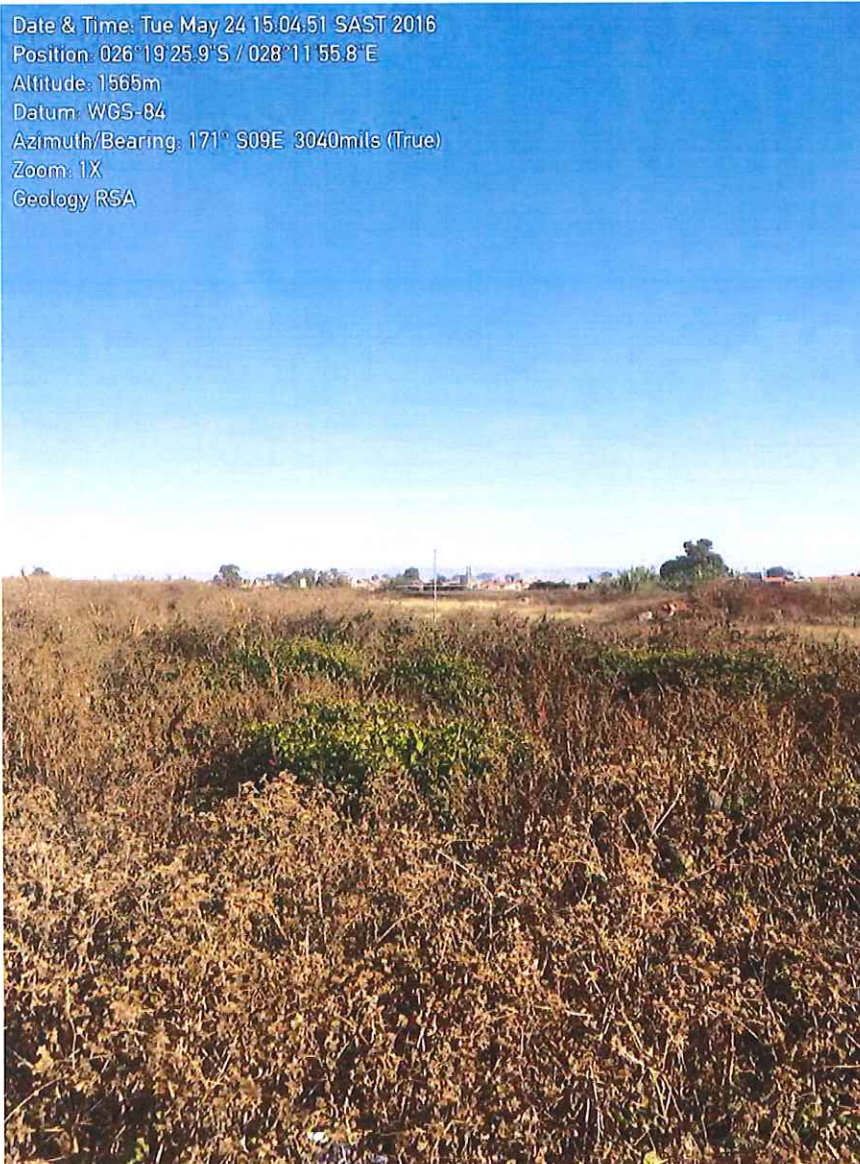
Vegetation is a mixture of veld grass and dense "khakibos" weeds throughout the site. Access onto the site is severely restricted because of the abundance of waste material that has been dumped on the properties over the years. Illegal dumping is presently continuing on the site.

Photograph 2: View diagonally across the site to the south from a different position on Luvuyo Street.  
Weed covered waste heaps.

5.4 **Highly compressible soil (normal settlement):** Excessive normal settlement often occurs where structures are placed on loose, moist, sandy soil. These conditions may occur where thick deposits of sandy/silty colluvium or residuum have developed such as seen in TP 10. Excessive differential settlement as a result of founding partly on boulders of solid chert and partly on loose (soft) sand/silt is likely to occur throughout of the site. The abundant waste heaps pose a problem for foundations. The waste should be completely removed before the properties can be considered suitable for development.

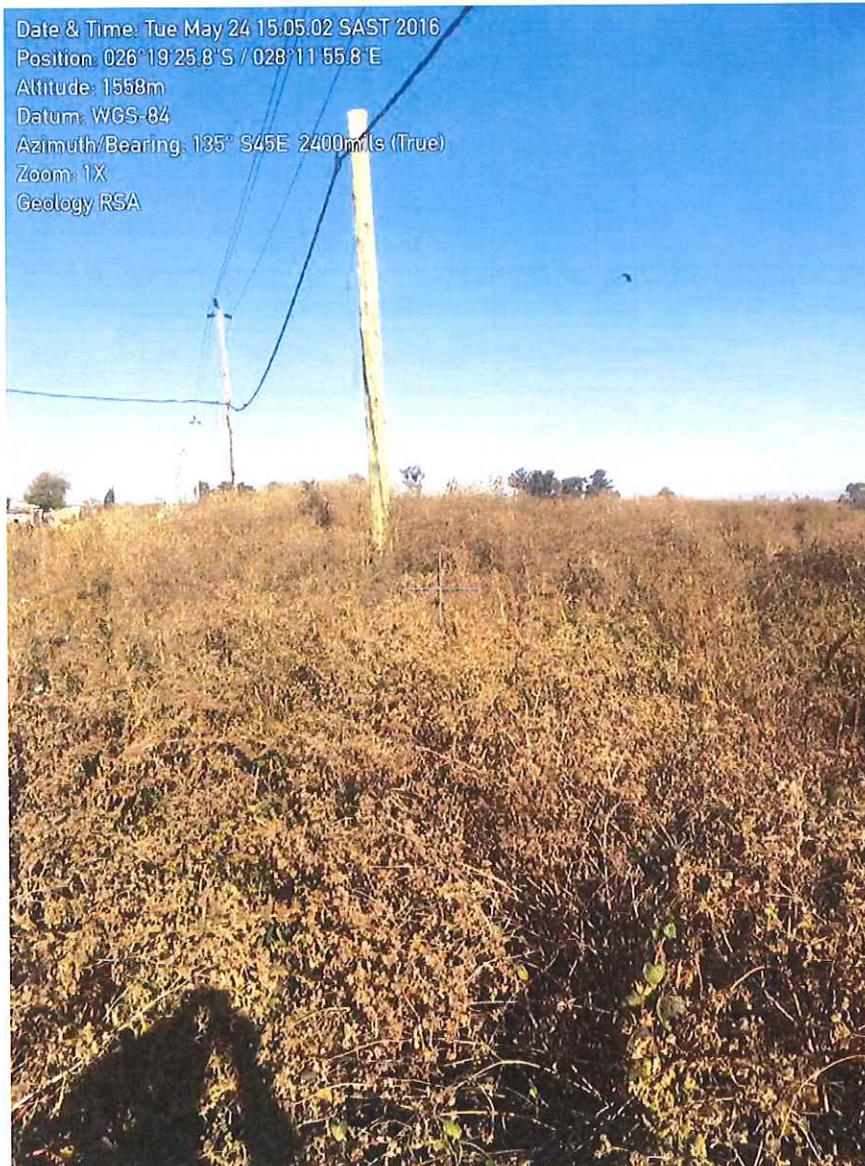
Photograph 3: View along edge of Luvuyo Street. Prolific growth of weeds on waste heaps.
