SUBMITTED BY: Archaeology, Palaeontology and Meteorites Unit

DATE: 14/03/2022

Title: Site assessment of Black Rock Koppie Mine, Santoy, Northern Cape Province

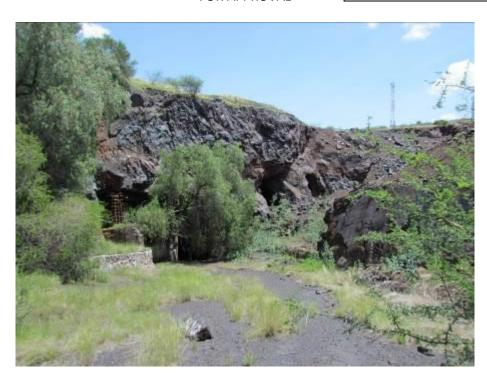
Figure 3: Entrance to historical mine

The historical mine entrance is in good condition with no signs of severe degradation. The BRMO monitor the water within the old mine site twice a year. Bats and porcupines often live in the shafts and tunnels. The condition of the tunnels was not assessed due to health and safety reasons (See Figure 3 to Figure 6).

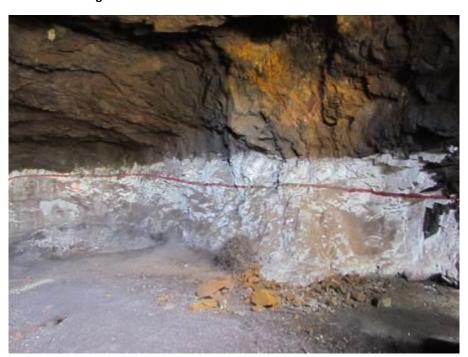
Figure 6: Historical mine shaft with a small rock fall

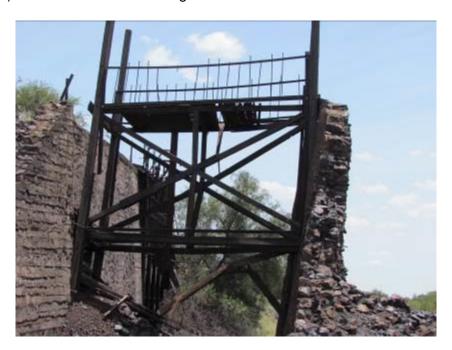
Figure 7: Old shoot

The old shoot is in poor condition, and it seems as it may fall over at any point (See Figure 7 and Figure 8). The area is restricted to general mine workers.

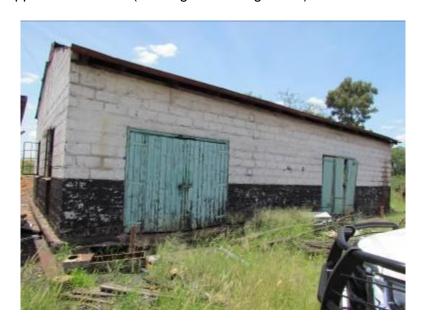
Figure 9: Historical Substation

The substation (noted as the power station in the HIA) is in an average state; however the walls and roof appear to be intact (See Figure 9 to Figure 11).

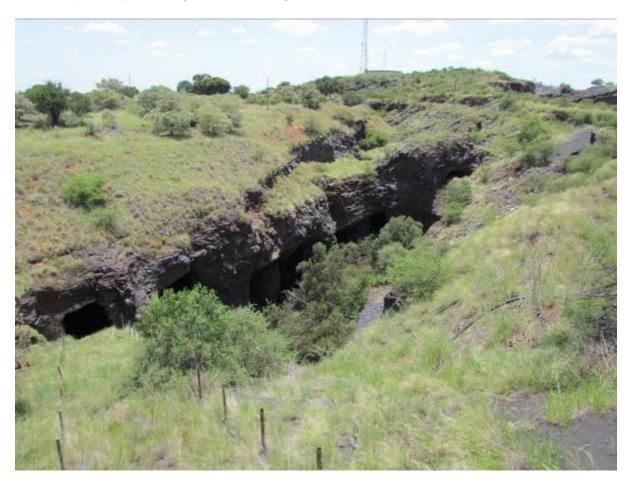
Figure 12: View of additional historical mine shafts with the koppie in the background

The viewpoint (Figure 12) provided us with a good view of the old mining methods, where tunnels were dug at an angle into the earth, often on top of each other. This was noted to be not a unique way of mining, but interesting.

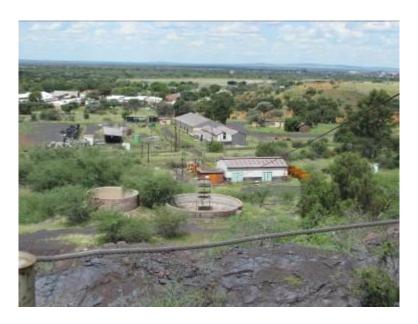
Figure 13: View of water reservoirs in the middle of the photograph

The water reservoirs (Figure 13) were viewed from a distance and appear to be in an average condition.

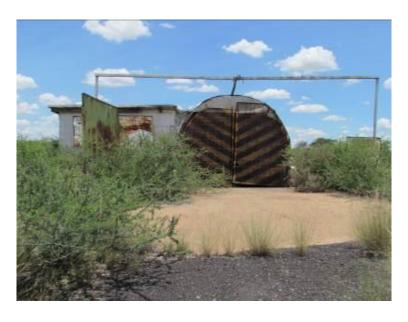
Figure 14: Surface structure of decline shaft

The surface structure for the decline shaft (Figure 14) is in a good condition, and it closed off.

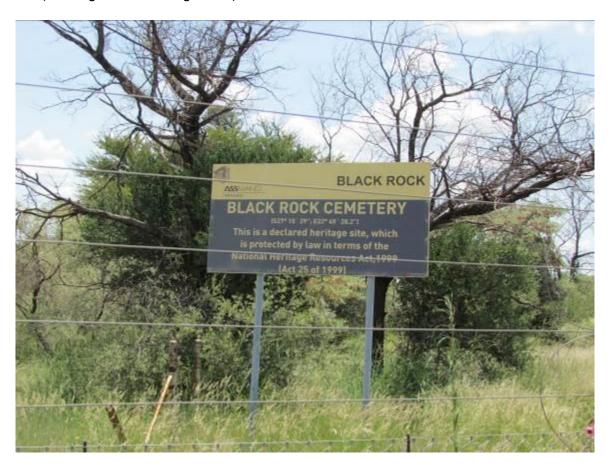
Figure 15: Information sign at cemetery

The mine workers cemetery is fenced with an entrance and an information sign stating that it is a heritage site protected by the NHRA (Figure 15 and Figure 16). The cemetery is overgrown but the graves are still in good condition, with no trees or bushes growing though them (See Figure 16 and Figure 17).

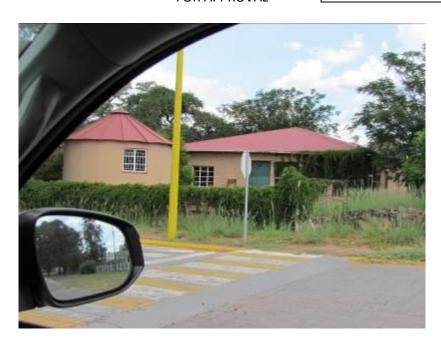
Figure 18: Historical house in mine village

We took a short drive through the mine village and noted one of the original houses within the village (Figure 18). It was viewed from the road and the preservation of the house was not assessed; however, it appears to be in good condition from the road.
