## Dagsoom Twyfelaar Coal Mining Project near Ermelo, Mpumalanga

### Aquatic Biodiversity and Impact Assessment Report

DAG5603

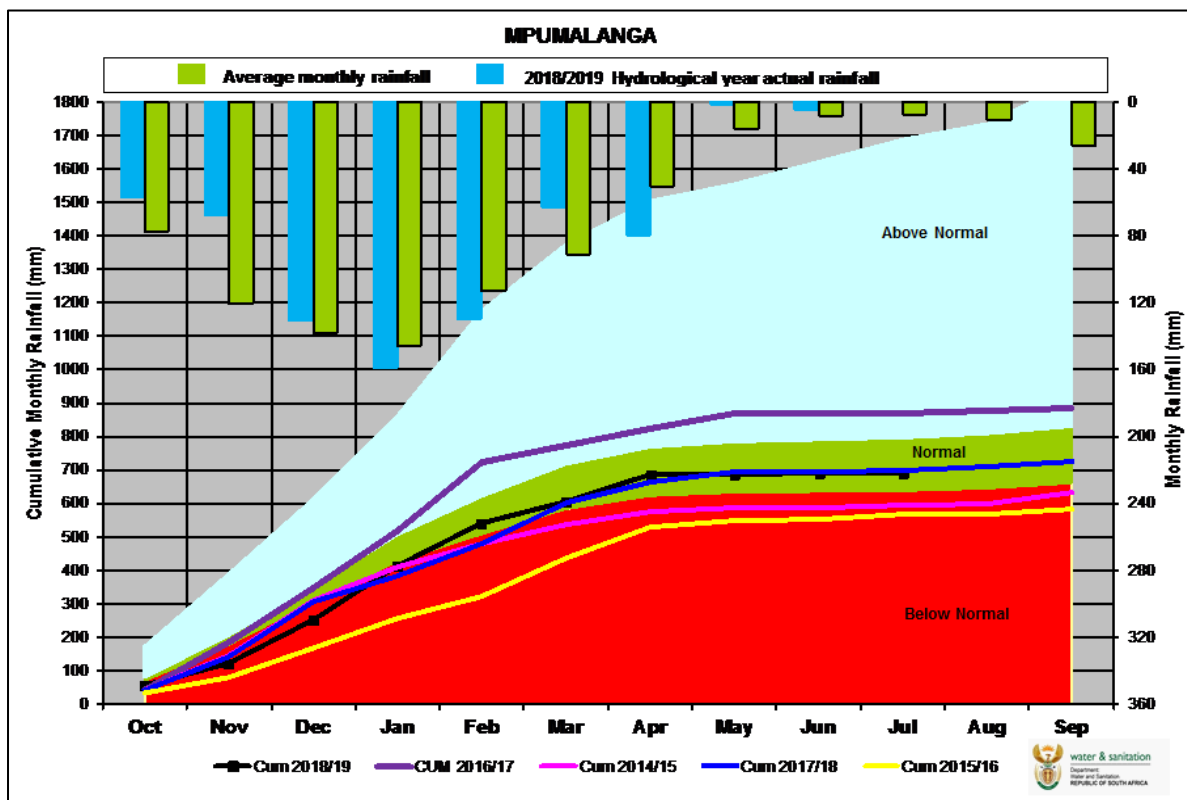
Figure 5-1: Annual Rainfall Trend for the Mpumalanga Province (DWS, 2019)

Figure 5-1 displays the rainfall trend for the province of Mpumalanga (DWS, 2019). This serves to outline the general dry conditions expected for the province and thus, Study Area. Reference conditions required by the various EcoClassification indices utilised in the Aquatic Study have been altered in attempt to align with the dry conditions of the aquatic ecosystems.

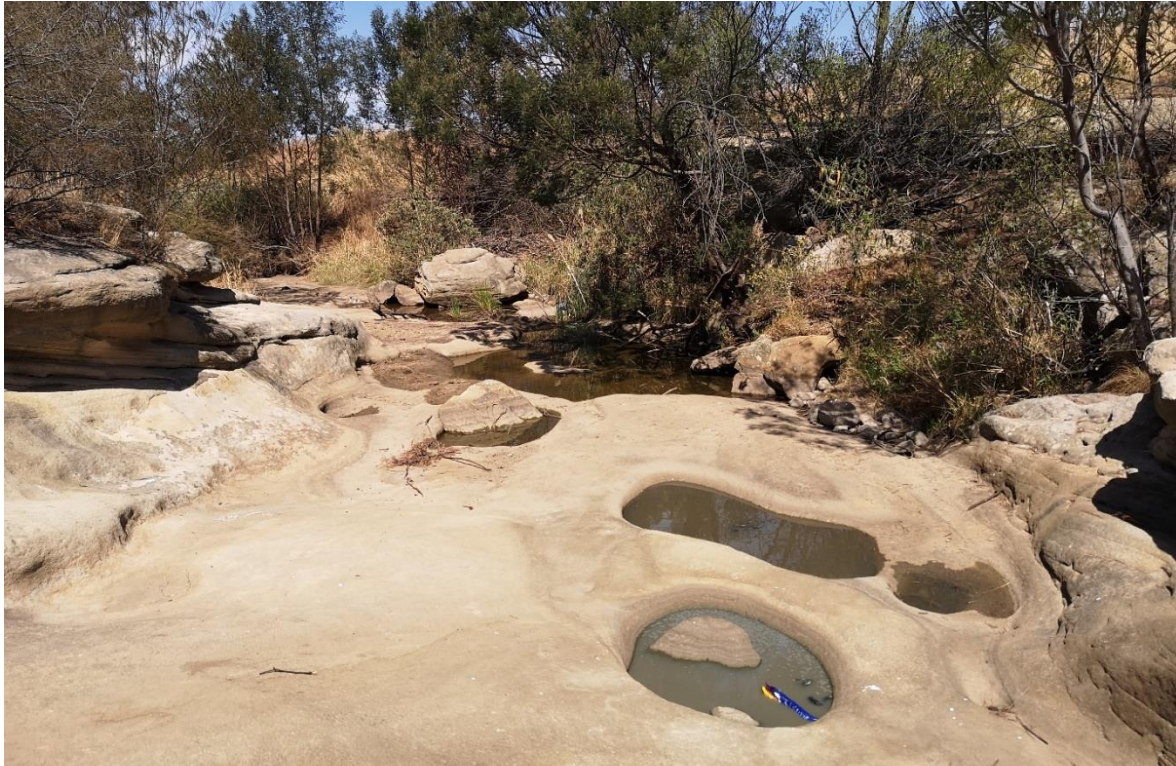
**Figure 6-1: Limited amounts of water available for sampling at Site ST1c**

the upper reach of the Southern Tributary. A site-based MIRAI has also been applied at Site ST1c in attempt to determine the PES of the watercourse draining into the Southern Tributary. It must however be noted that Site ST1c consisted of low water levels and small pools for sampling, as discussed in the IHAS section (see Figure 6-1). Therefore, the MIRAI findings are expected to be largely skewed as a result of the poor conditions.

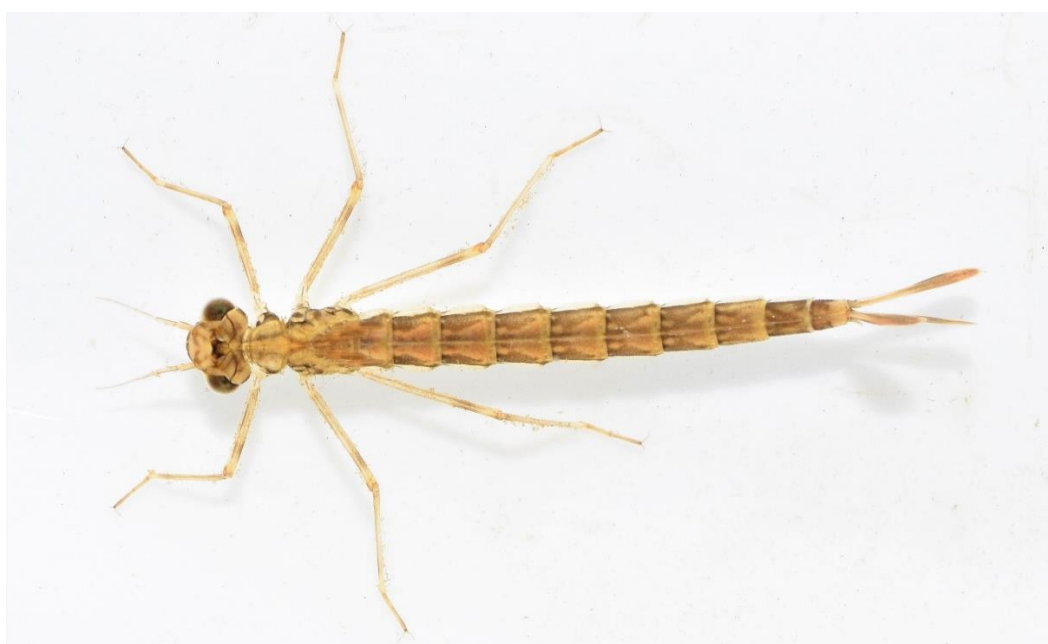
**Figure 6-2: Chlorolestidae individual sampled at Site ST1a**

The presence of this small individual sensitive taxa could indicate early signs of colonisation. It is expected that vegetation dependent taxa will diversify come an increase in rainfall and water levels.

Before interpreting the MIRAI findings for Site ST1a, it should be noted that the determined scores were based solely on the presence or absence of macroinvertebrate families within the site. Not all families are expected to be frequent within the entirety of the reach. Therefore, the overall Ecological Category could be negatively skewed as “missed” taxa may be present within additional sites along the watercourse. None the less, the MIRAI scores for the relevant metric groups categorised the macroinvertebrate assemblage at Site ST1a as largely modified/Ecological Category D. The habitat metric scored the lowest for this assessment whereas the habitat score for the site was classified as Good according to the applied IHAS. Looking closer at the habitat metric, it appears that vegetation dependent taxa were mostly absent from this site where the Good IHAS classification was mainly due to the abundance of cobbles at the site. A sensitive vegetation dependent Odonata (i.e. dragonfly and damselfly) individual was sampled at the site (Figure 6-2).

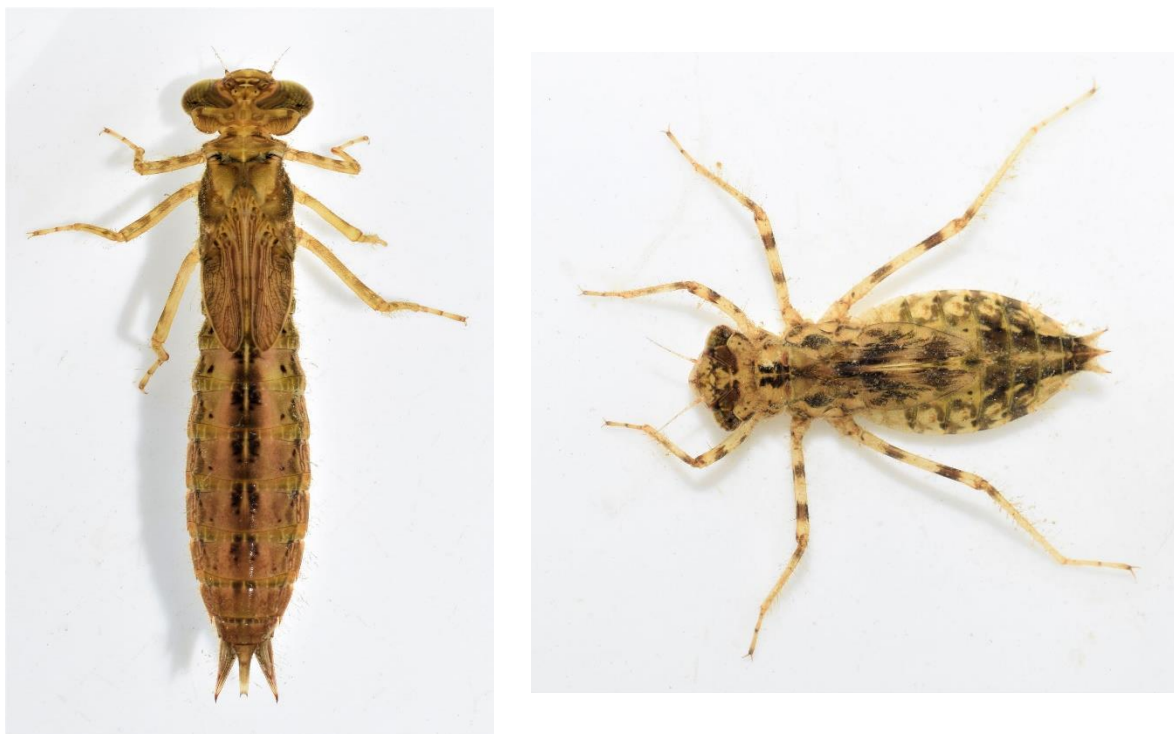
**Figure 6-3: Aeshnidae (left) and Libellulidae (right) individuals sampled at Site ST1c**

The presence of these taxa could also indicate the onset of early colonisation at the site which will only increase during the rainy season. Sampling later in the season is expected to observe better macroinvertebrate and overall aquatic health findings.

Based solely on the presence/absence findings, the MIRAI scores indicate that the macroinvertebrate assemblage at Site ST1c is in a seriously modified state/Ecological Category E. This to some extent could be accurate based solely on the severe dry conditions of the site (Figure 6-1). However, interpretations of the metrics will not truly be accurate as the SASS5 assessment is not applicable at the shallow, pooled site. It is clear though, that the flow modifications metric, which is suspected to reflecting the complete lack of flow observed at the site, has largely driven the sampled macroinvertebrate assemblage. The Chlorolestidae family (Figure 6-2) was also sampled at this site together with the moderately flow dependent Aeshnidae and Libellulidae Odonata larvae (Figure 6-3).

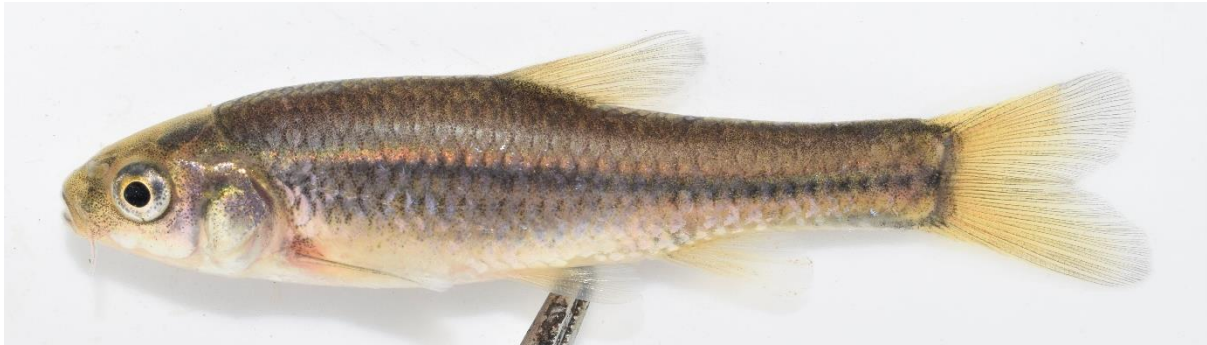
**Figure 6-4: *Enteromius cf. anoplus* sampled at Site MS2**

Only the tolerant *Enteromius cf. anoplus* was sampled within the MRA and Sandspruit (Figure 6-4). In addition to this barb species, a potentially undescribed barb was sampled downstream from Site MS3 at a road crossing which was briefly assessed in passing when searching for the fish conservation species of importance in the reach (i.e. GPS coordinates: 26°44'38.01"S 30°23'48.02"E). According to a study done by Dr Albert Chakona (2015), this species of fish (suspected to be *Enteromius pallidus*; ) shows species-level genetic divergence between two populations (i.e. northern and southern), which could represent the sampled species shown by the IUCN distributions to occur in the MRA and Study Area as a whole (Chakona, 2018).

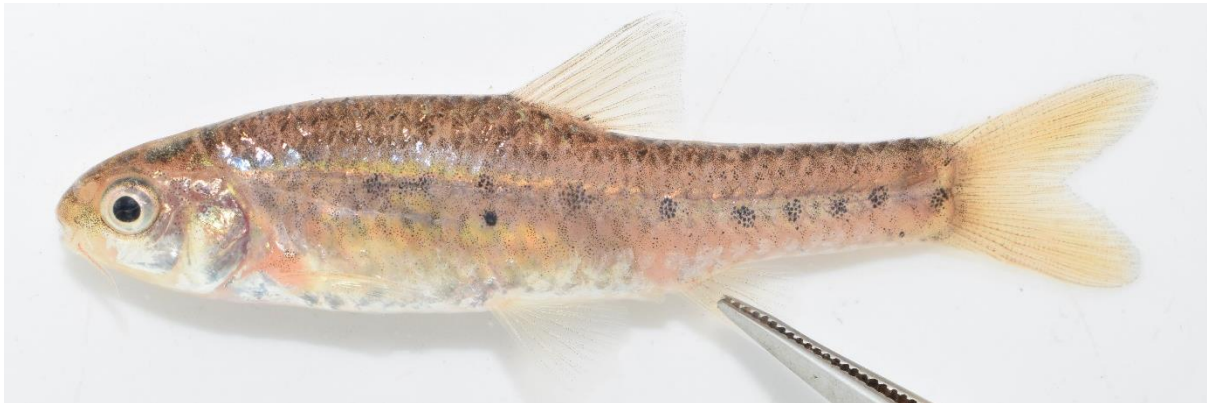
**Figure 6-5: *Enteromius cf. pallidus* sampled within the Sandspruit**

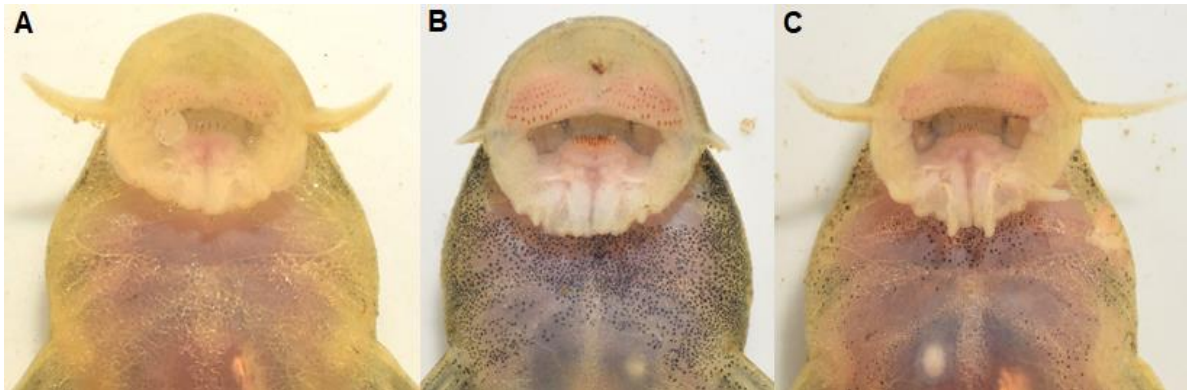
**Figure 6-6: Photographs of the sampled *Chiloglanis* species mouth parts (A: *C. emarginatus*; B: *C. anoterus*; C: *C. cf. emarginatus*)**

Photographs of the *Chiloglanis* species are presented in the following figures. It is worth discussing the distinguishable teeth characteristics between the sampled fish. It is possible that a third/undescribed species is present at the site (labelled C in Figure 6-6 and Figure 6-7 below) as three of the specimens were more representative of *C. emarginatus* from a lateral view, although they keyed out to *C. anoterus* except for the elongate barbels (Skelton, 2001). For this study they have been referred to as *Chiloglanis* cf. *emarginatus*, needing confirmation.

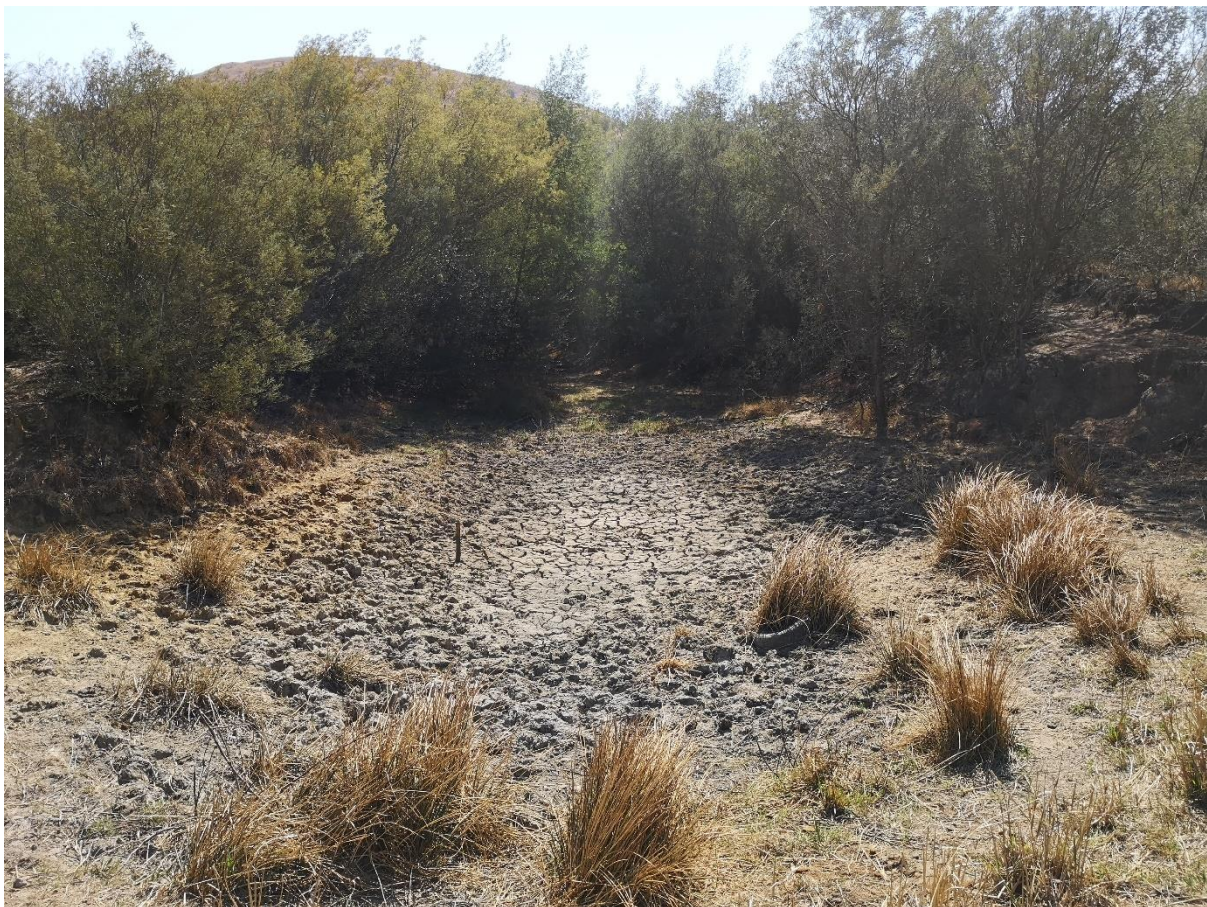
**Figure 8-2: Site photograph of a dry muddy bed associated with Site ST1d**

From the figure above, it is visible that the depth of water draining from the site is not great. However, based on the width of the channel, there could be a fair amount of water present during the rainy season.

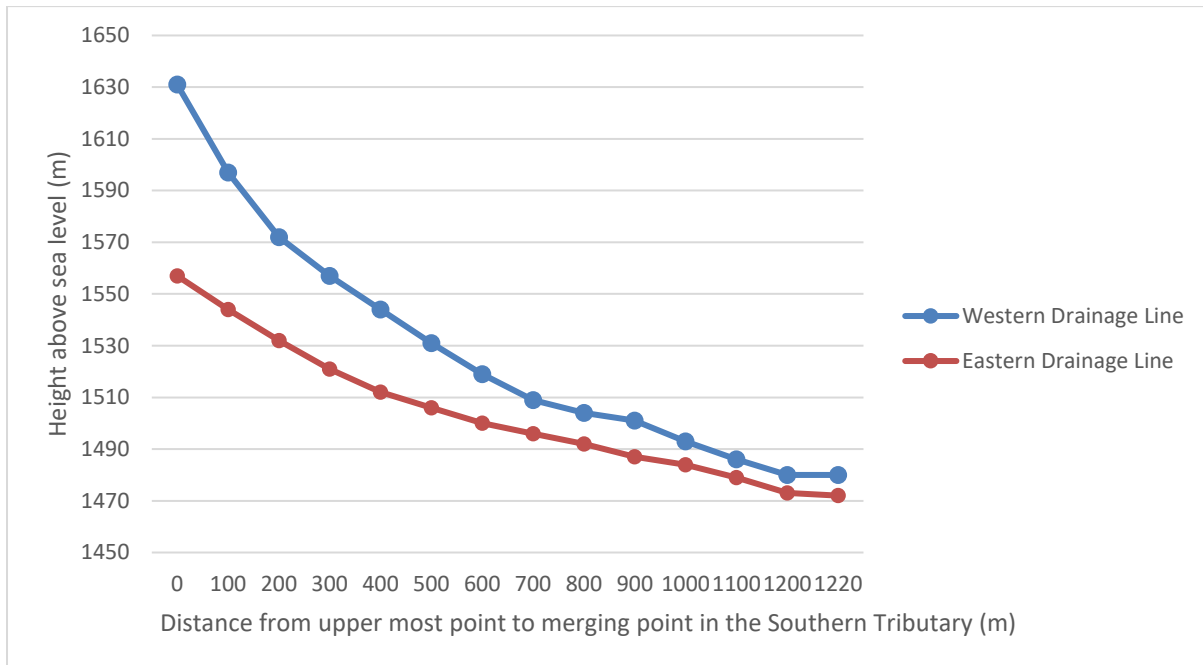
**Figure 8-3: Elevation profile of the drainage lines associated with the proposed infrastructure associated with Block A**

The upper sections of the drainage lines vary in gradient. The slope of the Western Drainage Line (i.e. for the first 500 m of the assessment) equates to 20 % with the slope of the Eastern Drainage Line (i.e. also for the first 500 m) as 10.2 %. A steep slope is regarded as a gradient of  $\geq 15\%$ . Therefore, runoff or flow in these systems in proximity to the proposed infrastructure is expected to be high during heavy rainfall periods, especially in the Western Drainage Line. This could make storm management a difficult task. Again, this deduction is limited as the MRA was assessed during the dry season.

Elevation profiles were also developed for the drainage line associated with Site ST1d (i.e. Eastern Drainage Line) and for the drainage line flowing directly through the proposed infrastructure footprint area (i.e. Western Drainage Line). This was done from the upper most visible sections of the drainage lines from a desktop level to where the watercourses merge with the Southern Tributary. Both assessments were approximately 1.2 km in length. The elevation profiles are displayed in Figure 8-3.
