Water Resource Risk Assessment for the proposed Atholl Gardens Emergency Sewer Pipe Replacement

SANDTON, GAUTENG

CLIENT: JOHANNESBURG WATER

Atholl Gardens Sewer Pipeline Replacement

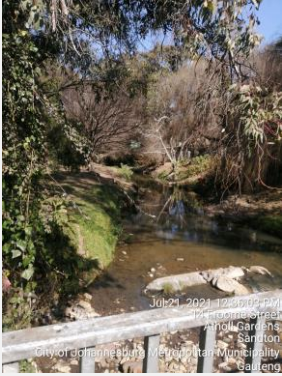
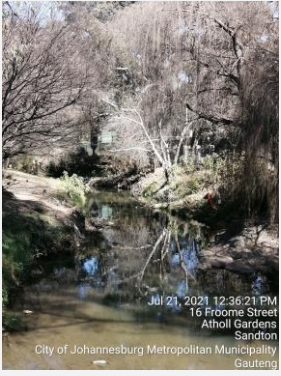
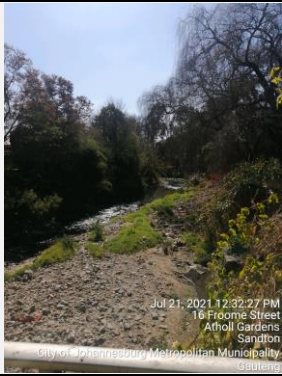
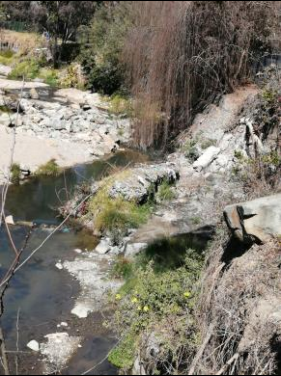
Table 3-1: Photos, co-ordinates and descriptions for the sites sampled

Upstream		Downstream	
Upstream

GPS	26° 6'30.94"S 28° 4'26.11"E			
Downstream

GPS	26° 6'23.42"S 28° 4'22.90"E

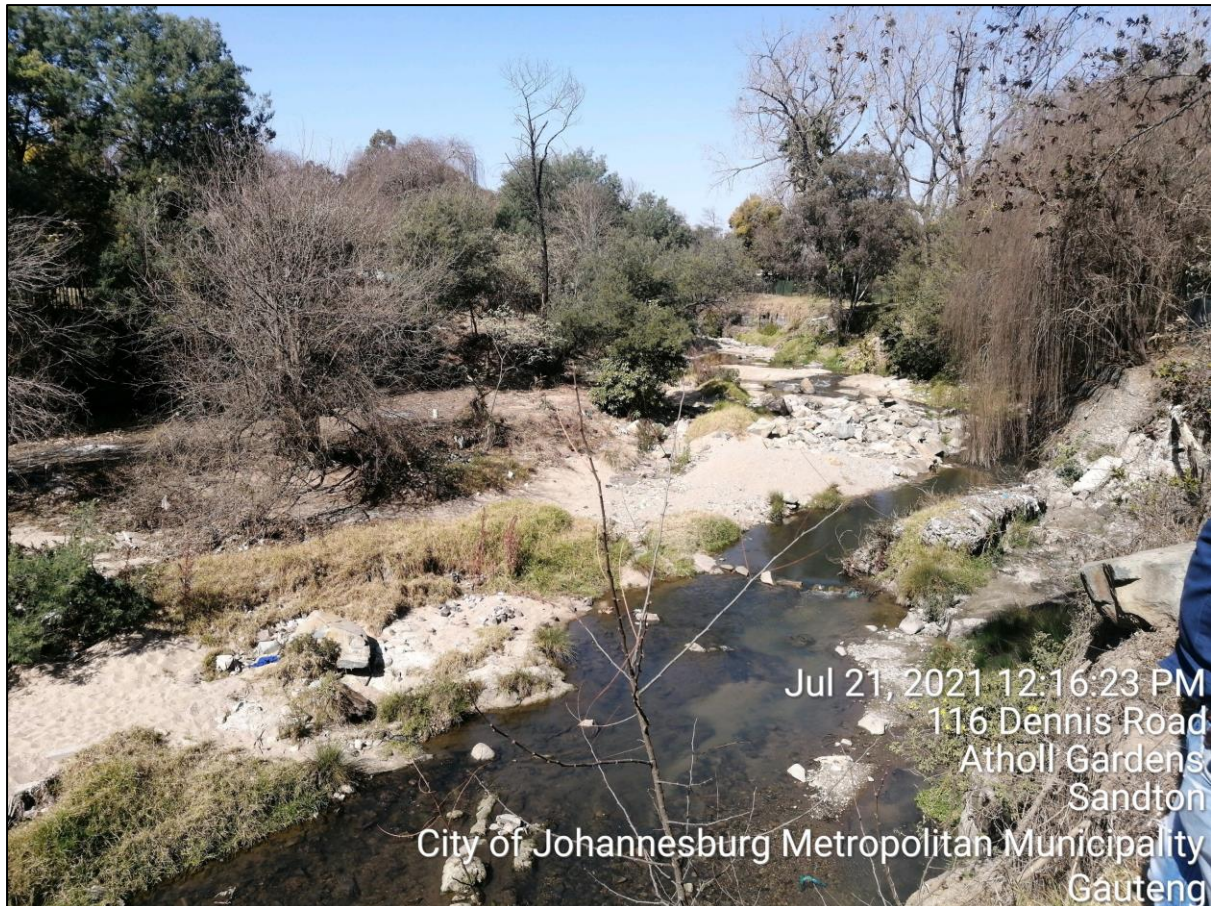
Figure 7-3: Observed terrain unit setting of a channelled valley bottom

The project area is characterised by a modified topography with hardened surfaces in the form of buildings and highways. The wetland within 500m of the project area was determined to be a valley bottom. The terrain setting observed in the project area was a channelled valley bottom as presented in Figure 7-3.

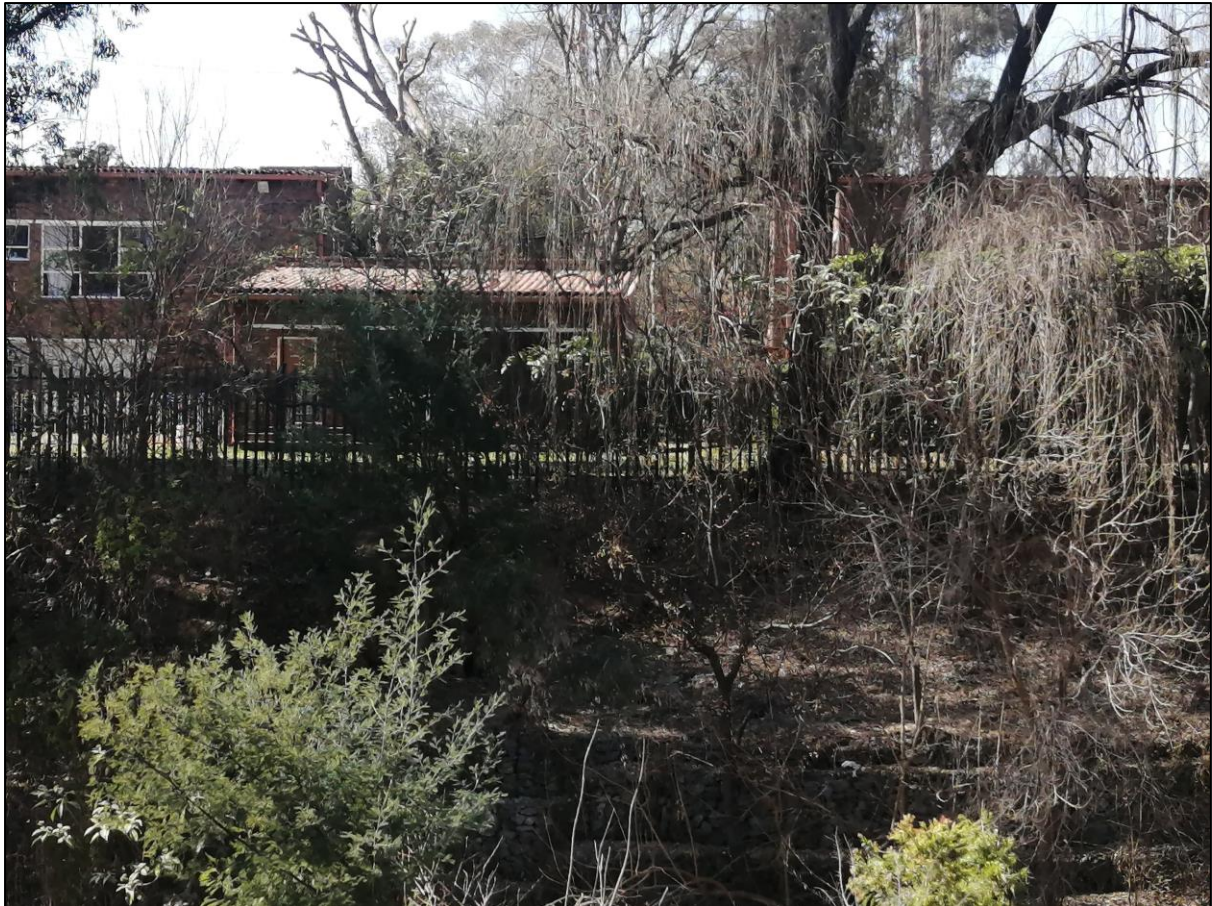
Figure 7-5: Impacts to the hydrology – Increased hardened surfaces as a result of the spread of residential dwellings and office parks

- ❖ The hydrological component for the HGM has been modified largely by the development and spread of the residential dwellings and office parks in the wetland catchment. These developments have increased hardened surface within the area which have altered the flow paths into the wetland. Furthermore, areas of low vegetation cover are prevalent in the wetland area which further alters the flows of water in the wetland leaving the wetland susceptible to erosion. The spread of invasive species and large trees in the wetland areas have resulted in the reduction of water available for the wetland and wetland plants. The development of roads and related stormwater management systems has largely contributed to the disturbance of the wetland and altered flood peaks and flows. The impacts to the wetland hydrology can be seen in Figure 7-5.

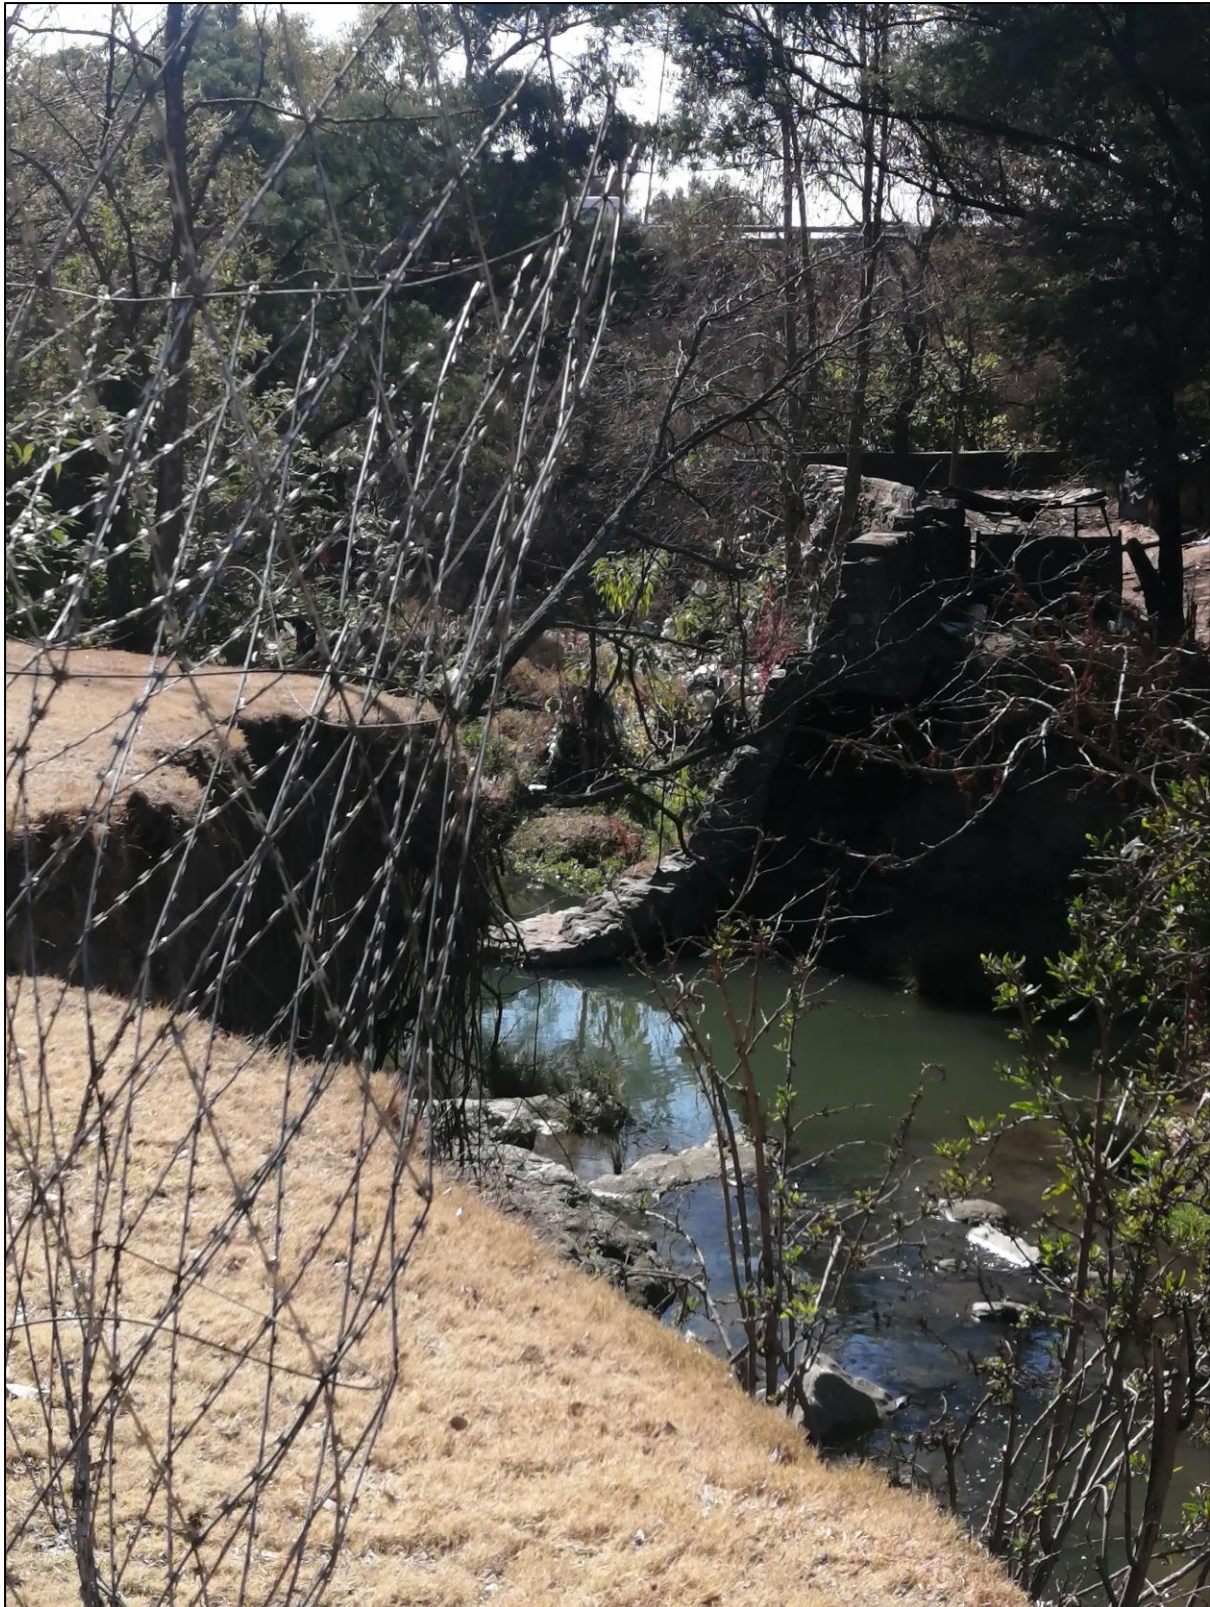
Figure 7-6: Impacts to the geomorphology – erosion and incision as a result of the stormwater runoff intensities

- ❖ The geomorphology component for the HGM was impacted largely by the altered hydrology of the wetland which resulted in intensified flows in the wetland. The wetland has become susceptible to erosion as a result of the intensified flows. Impacts to the soils within the wetland are presented in Figure 7-6. The wetlands area has been impacted by previous landuses which include agriculture, trenches and gravel roads.

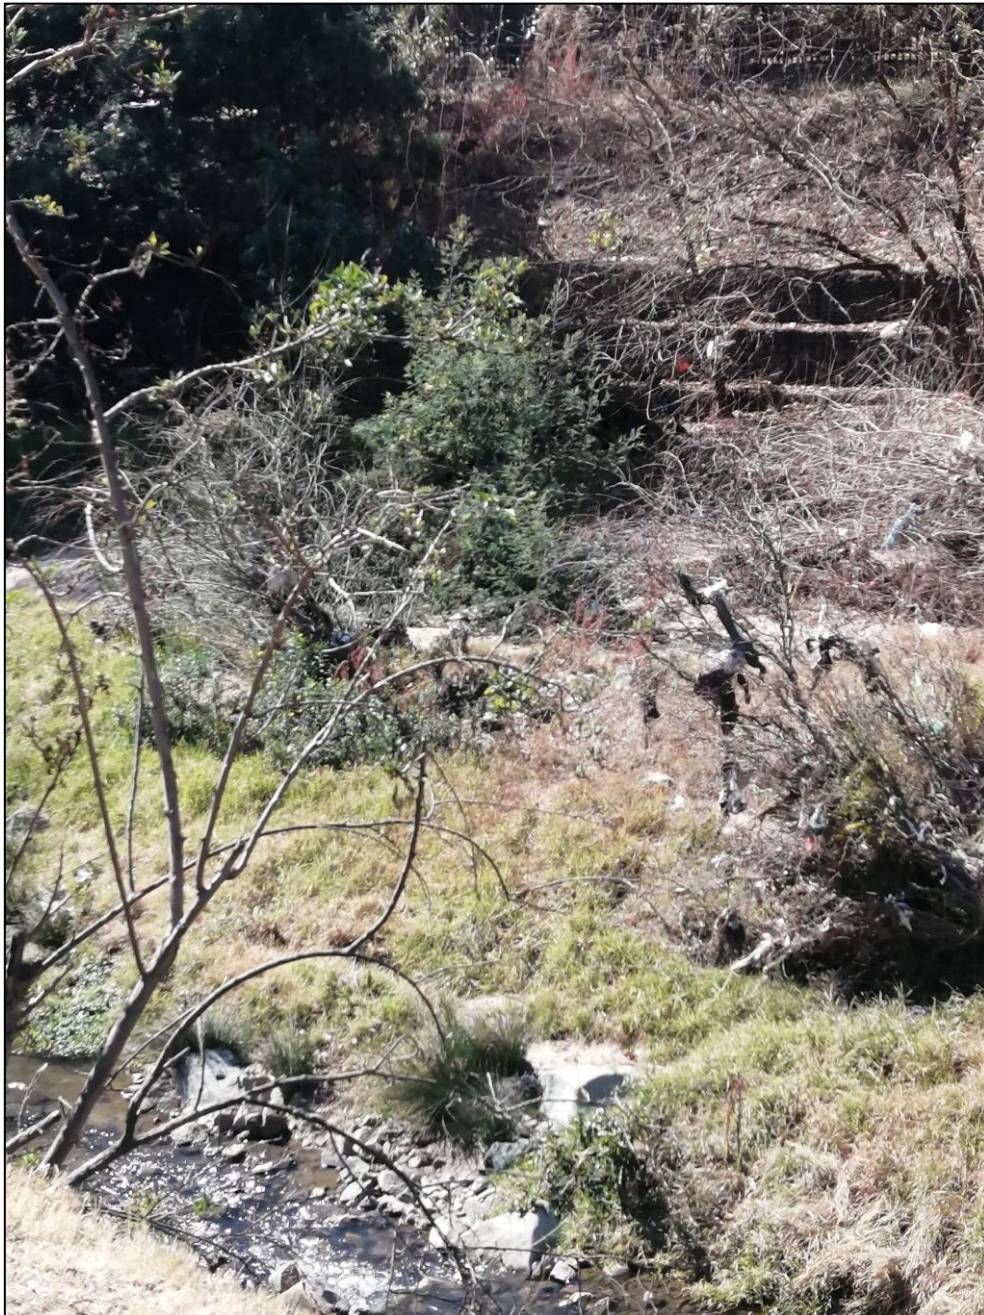
Figure 7-7: Impacts to wetland vegetation.

- ❖ The vegetation component for HGM 1 was largely impacted as a result of the decreased vegetation cover on the wetland catchment and the banks, and the prevalence of large woody trees in the area. The vegetation has been altered as a result of soil destabilisation and erosion within the wetland. The vegetation has been altered due to physical disturbance and dumping within the wetland area. *Acacia mearnsii* was identified within the wetland area which indicated alien invasion within the wetland area as presented in Figure 7-7.

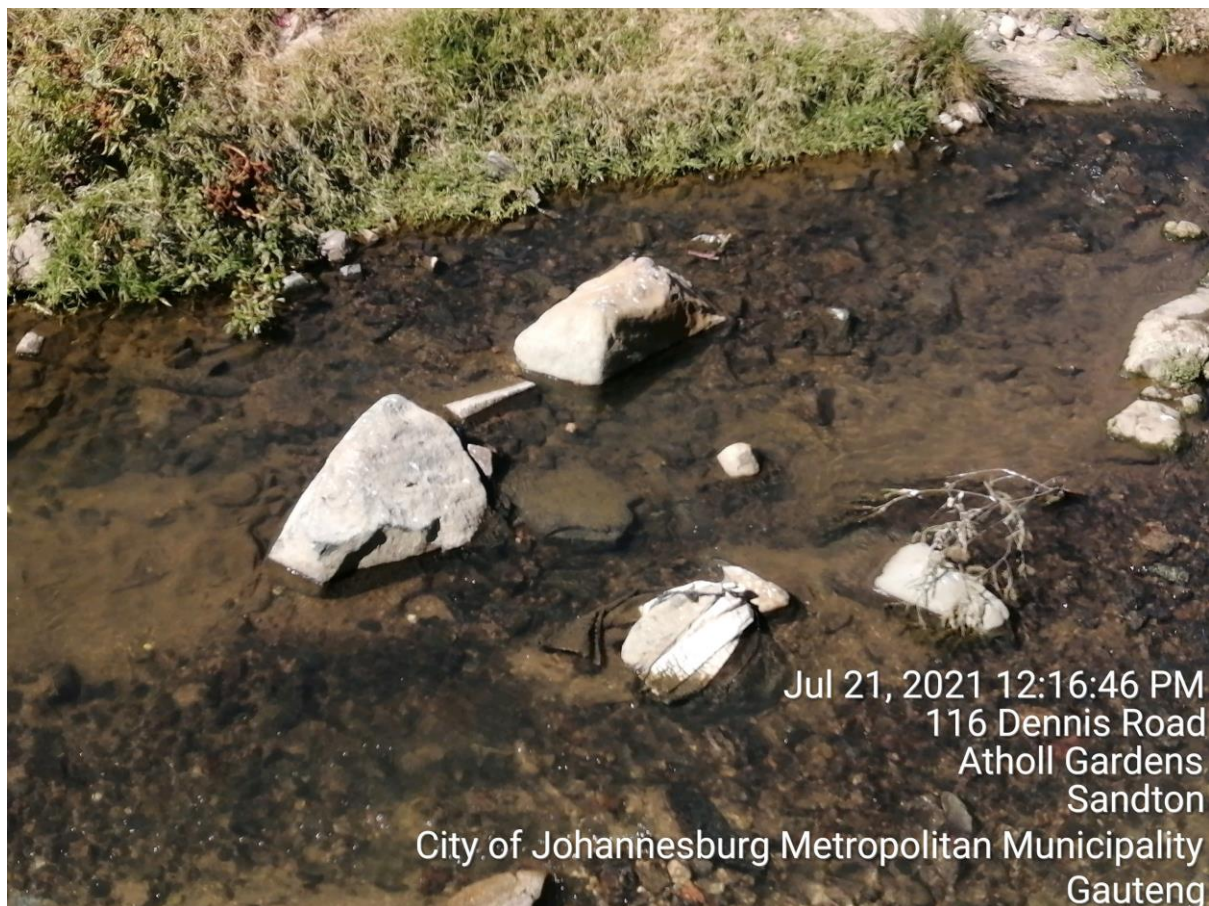
Figure 7-10: Raw sewage and solid waste flowing within the watercourse.

In situ water quality for the watercourse indicates modified conditions. Although the pH, Electrical Conductivity (EC) and temperature were compliant with target Water Quality Ranges (TWQR), the dissolved oxygen (DO) was found to be below the TWQR. Raw sewage was observed flowing into the system and is corroborated by the DO values. Sewage contains high levels of organics which have a high oxygen demand to break down. This creates highly anoxic conditions within the system. While not a tested parameter the sewage also produced an awful odour which residents have

The results of the instream and riparian habitat assessment in the associated watercourse indicates a seriously modified state (class E) in the riparian habitat and largely modified (class D) in the instream habitat. Instream condition indicate large

losses to natural habitat, biota and basic ecosystem functions have occurred. The largest contributors to this state were in the form of waste, where solid waste was found to line the river bed as well as raw sewage flowing into the reach as seen in Figure 7-10. There is clear evidence of channel modification in the form of gabion baskets limiting the natural meandering nature of the river as seen in Figure 7-11. The seriously modified state of the riparian habitat indicates extensive losses of natural habitat, biota and basic ecosystem functions. The major contributors were water quality, flow modification and channel modification. Water quality was influenced by multiple factors in the riparian area such as waste dumping. Flow modification occurs through the form of inlets of sewage flowing into the reach. Increased amounts of water increase the flow rates which cause increased erosion.

It is the opinion of the specialists that the project be considered and allow for the proposed pipeline replacement to proceed, should all prescribed mitigation measures and recommendations be implemented. As far as possible the project must be expedited to alleviate the flow of sewage into the system.
