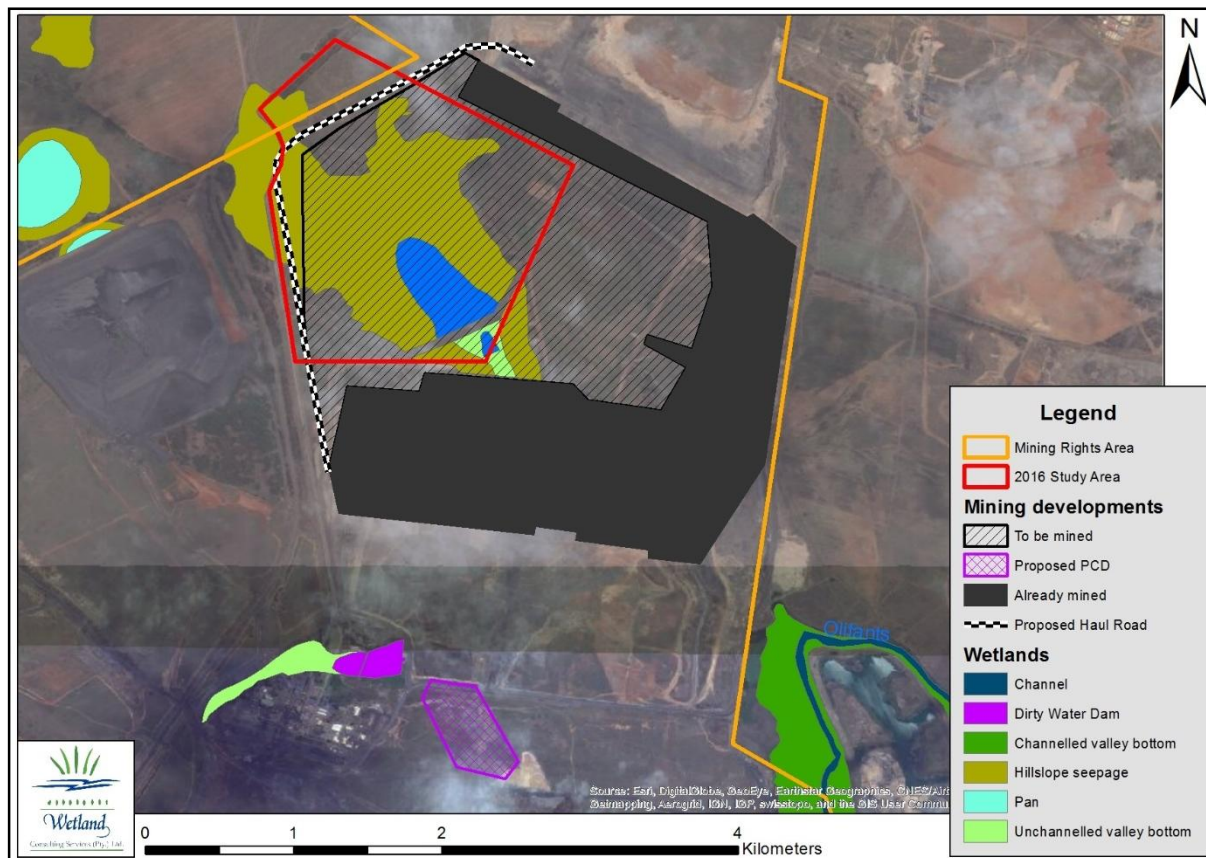
Figure 47: Map showing the delineated and classified wetlands within the study area and surrounds. Delineation of wetlands outside the study area is based on existing information (WCS, 2013) and/or desktop mapping.

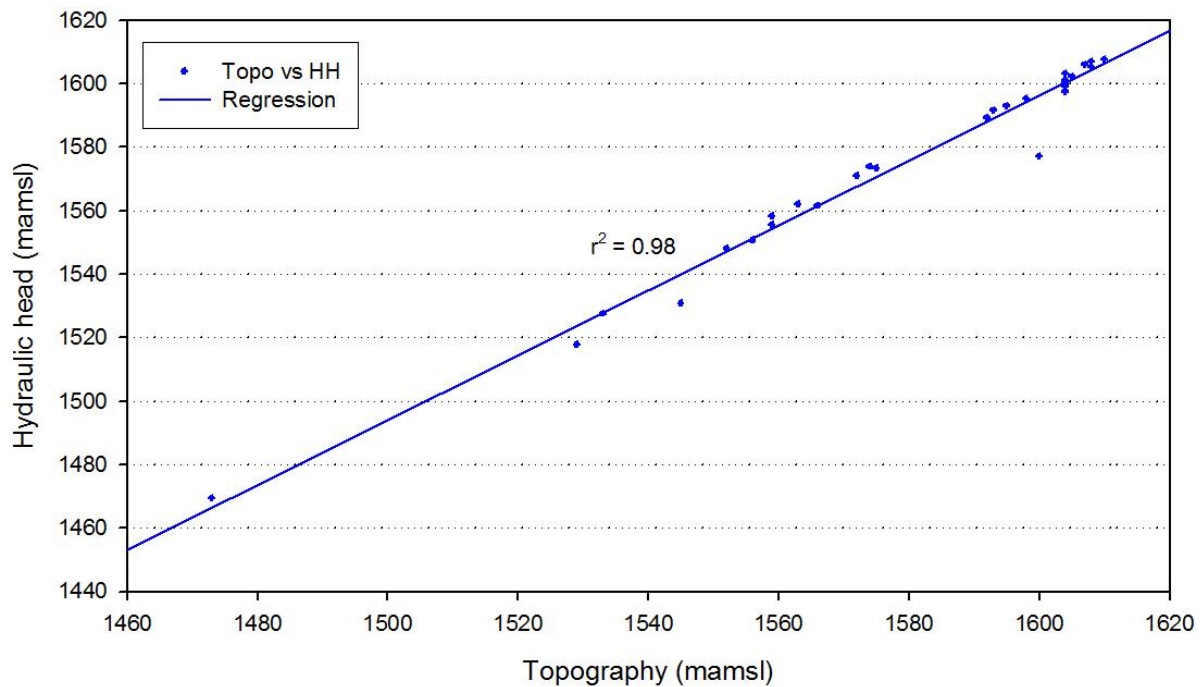
Figure 53: Correlation between the hydraulic head elevation and the corresponding topography ($r^2 = 98\%$)

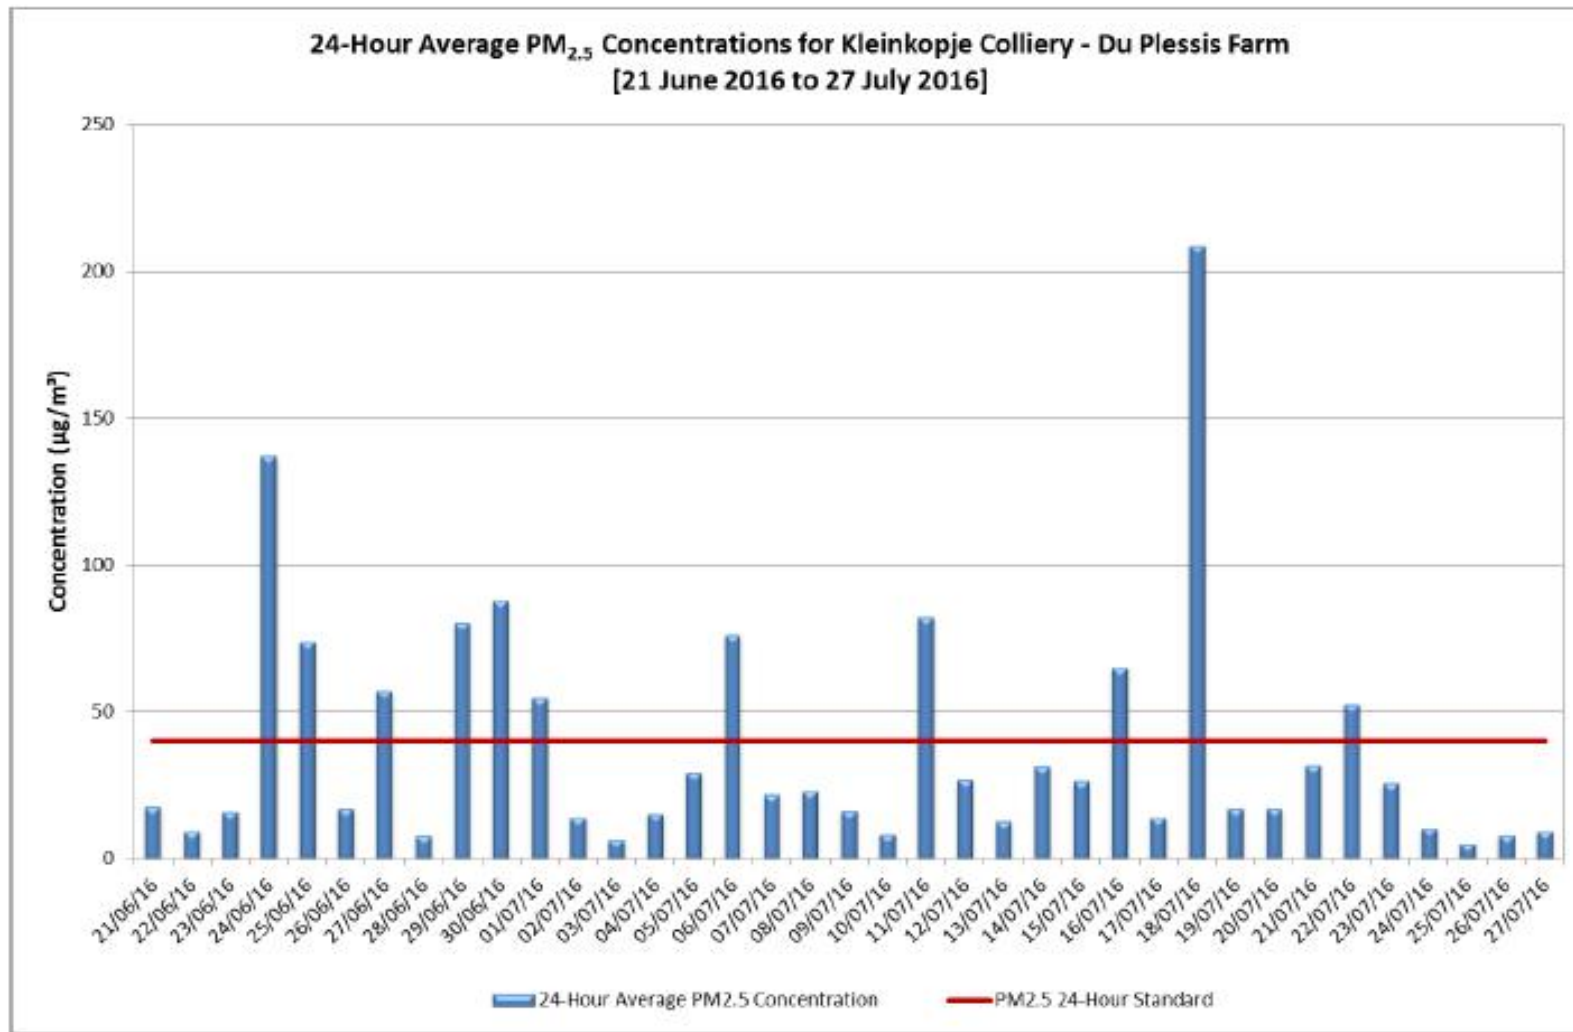
Figure 62: Daily average PM_{2.5} measured at Du Plessis Topas Monitor for the monitoring period (source: WSP Environmental; July 2016)

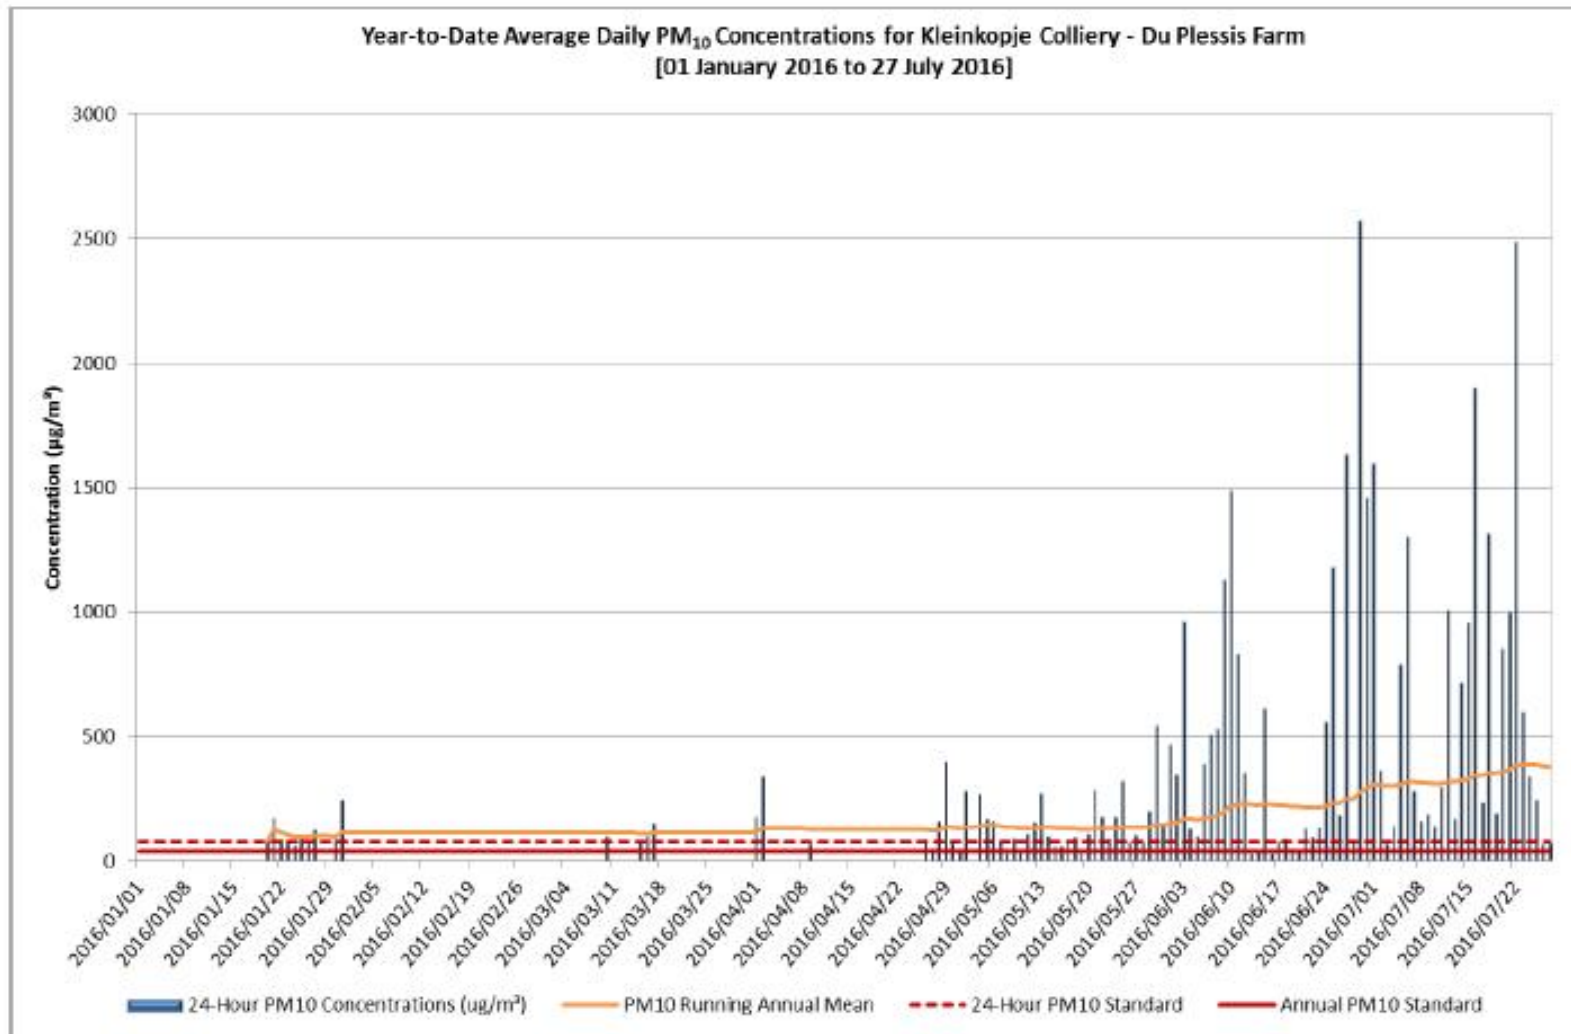
Figure 63: Year-to-date daily average PM₁₀ concentrations at the Du Plessis Topas Monitor (source: WSP Environmental; July 2016)

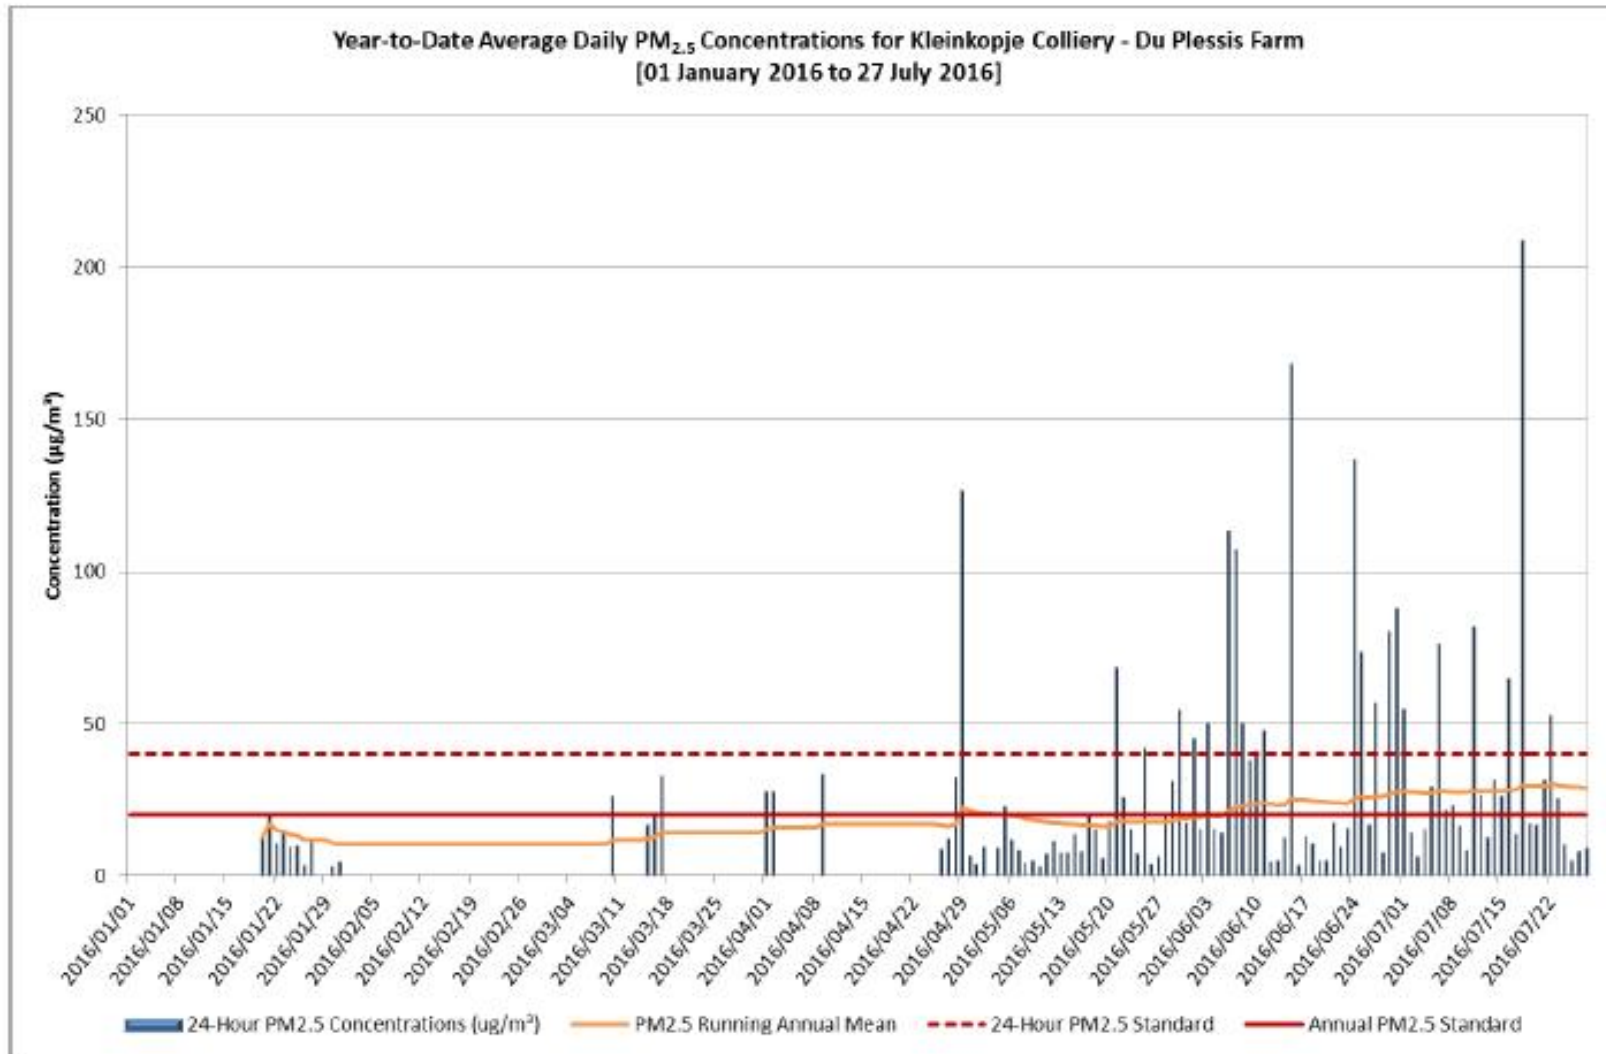
Figure 64: Year-to-date daily average PM_{2.5} concentrations at the Du Plessis Topas Monitor (source: WSP Environmental; April 2016)

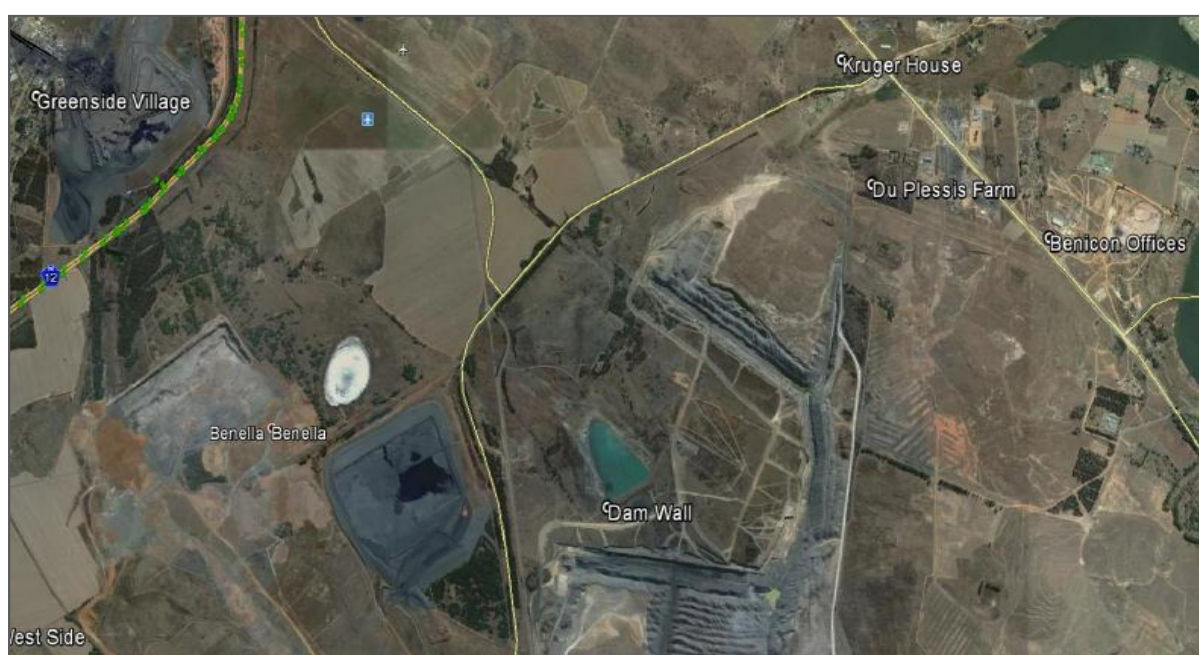
Figure 65: Ground Vibration and Air Blast monitoring locations (source: Blast Management and Consultin, September 2016))

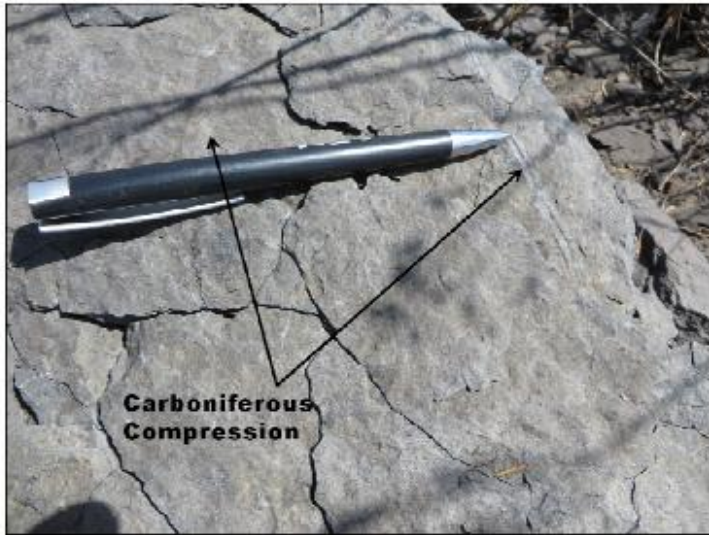
Figure 76: Photograph of pale, micaceous sandstone bearing carbonaceous compressions of plant stem segments (Waypoint KK3). The stem segments are up to 10 cm in length.

No *in situ* fossil materials were located during the conduct of the survey. However, at Waypoints KK3 and KK4 (see Figures 76 and 77) scattered carbonaceous stem compressions and fragmentary *Glossopteris* leaves were identified in loose blocks of rock that were not *in situ*. The material is highly fragmentary, unidentifiable to species level and is not *in situ*, thus, has little scientific significance. However, Mr Ncima (of Kleinkopje Colliery) informed Prof Millstead that the site underlying the proposed

PCD had previously been Ramp 1 of the initial colliery pit void and had been subsequently rehabilitated. The rock material that had been used for the infilling of the void had been sourced from later excavations of the mine pit void. Thus, while the fossil materials are not *in situ* they indicate that the Vryheid Formations rocks that are being mined in the colliery are indeed fossiliferous.

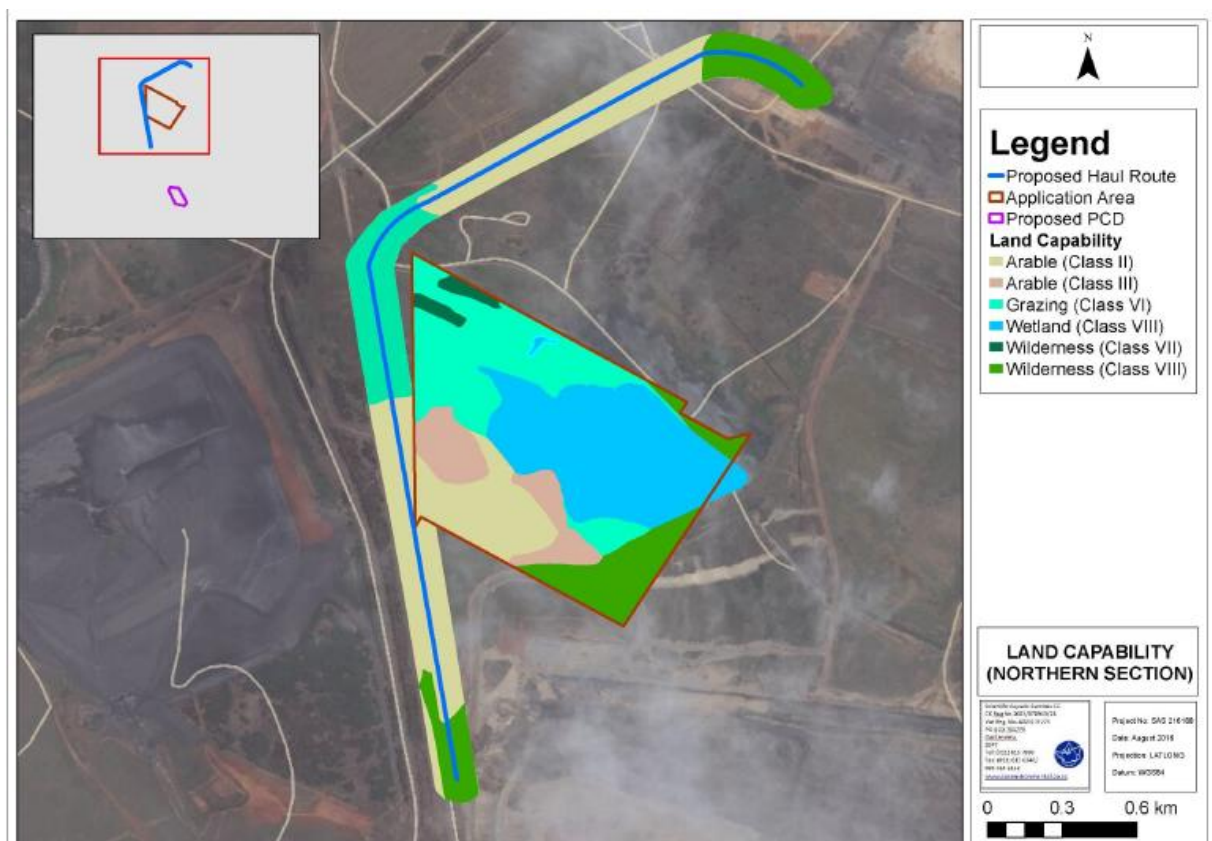
Figure 82: Land capability classification of the identified soils within the on the northern section of the proposed development areas (SAS, 2016)

The identified soils were classified into six land capability classes as presented in Figures 82 and 83 below. The identified land capability limitations for the identified soils are discussed in comprehensive dashboard summary tables presented in Tables 6 to 11 of Annexure E9.

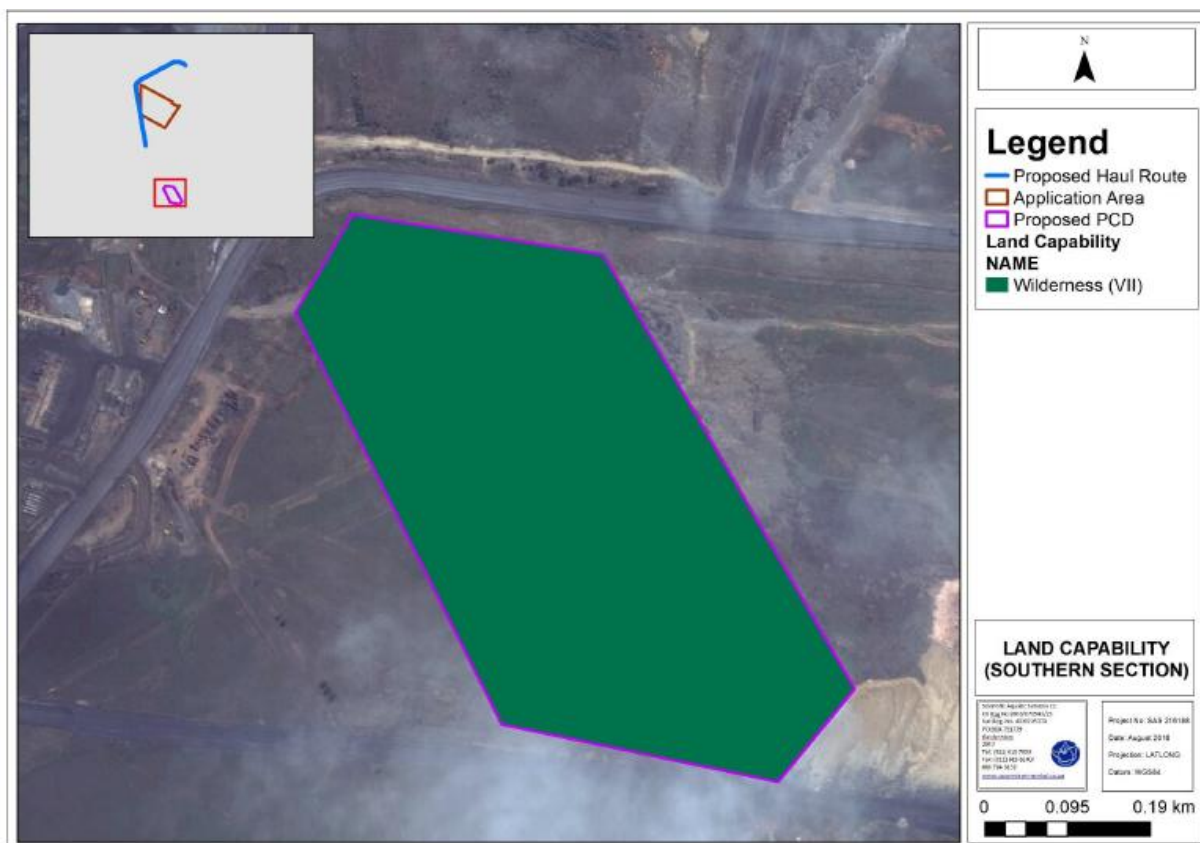
Figure 83: Land capability classification of the identified soils within the proposed PCD area (SAS, 2016)
