## ANNEXURE A

Photographs of existing building and surrounding context

## 5. Documentation and description of existing buildings of Ptn 3 of 498 – outside

### 5.1 Portion 3 of Erf 498 (4 Roseveare Road, Scottsville)

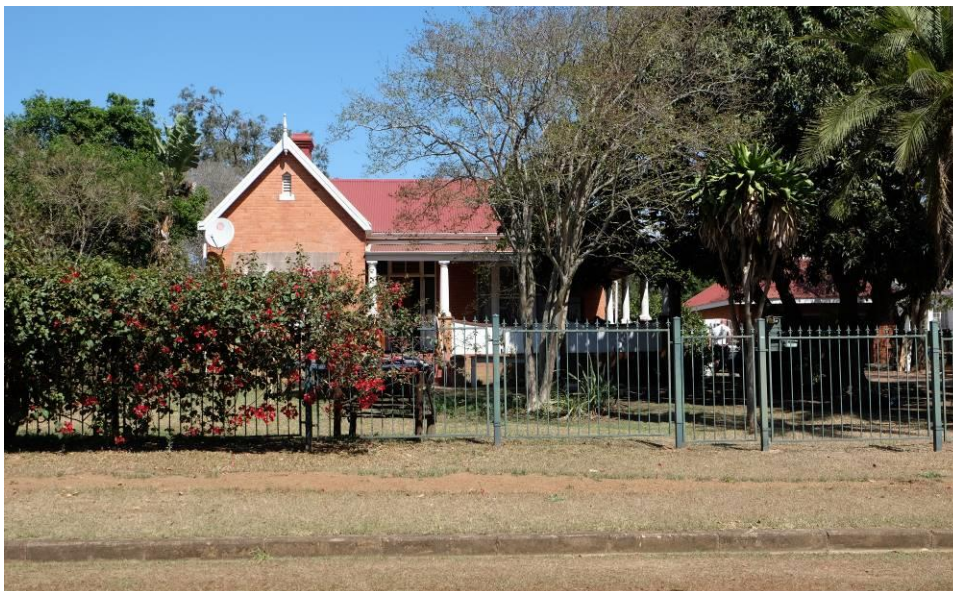
Fig. 7\_Street elevation with main entrance to Roseveare Road, single storey red brick and corrugated roof residence with triangular gable and corner verandah supported by columns  
(Source: tsica heritage consultants, 22.09.2020)

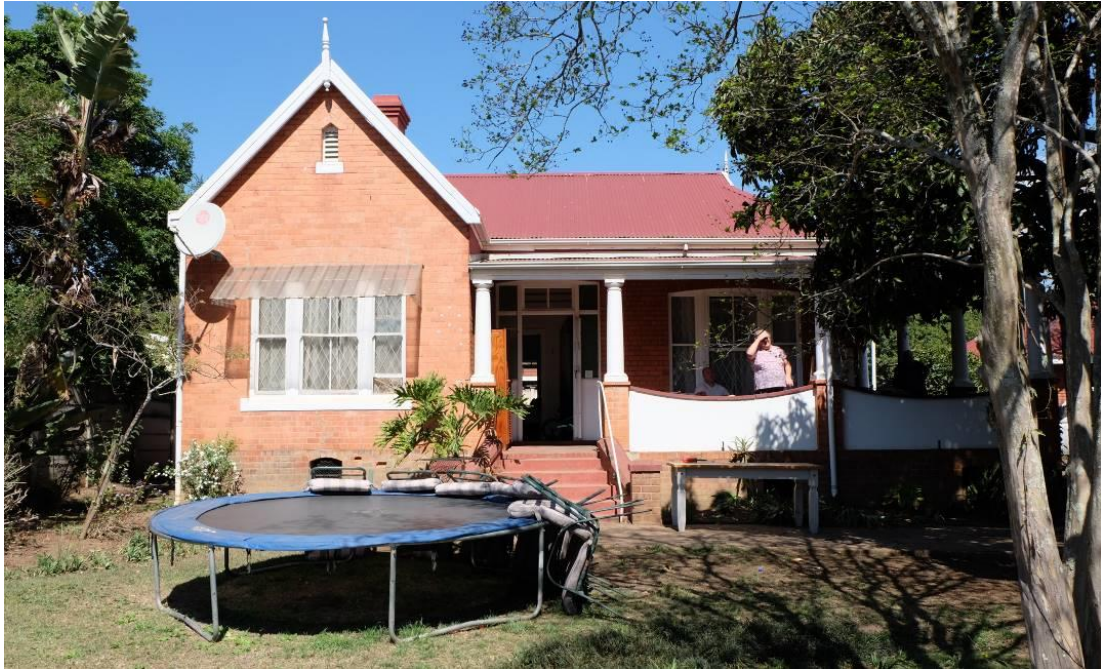
Fig. 8\_North-eastern street elevation with main entrance to Roseveare Road  
 (Source: tsica heritage consultants, 22.09.2020)

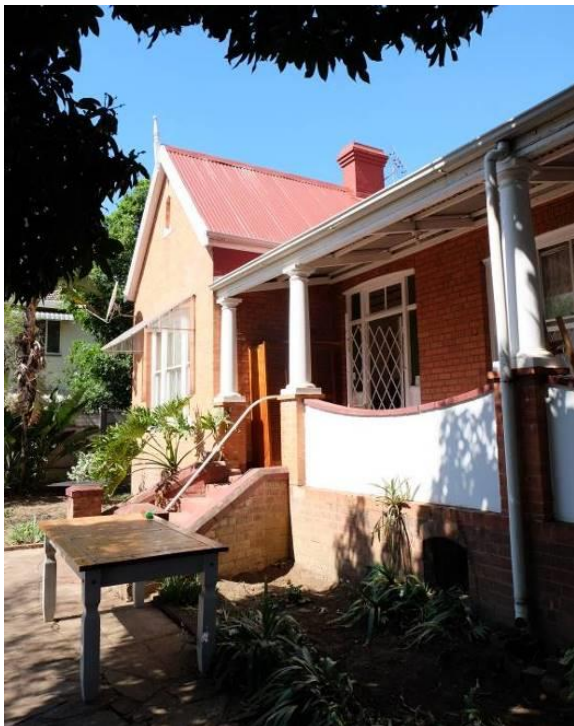
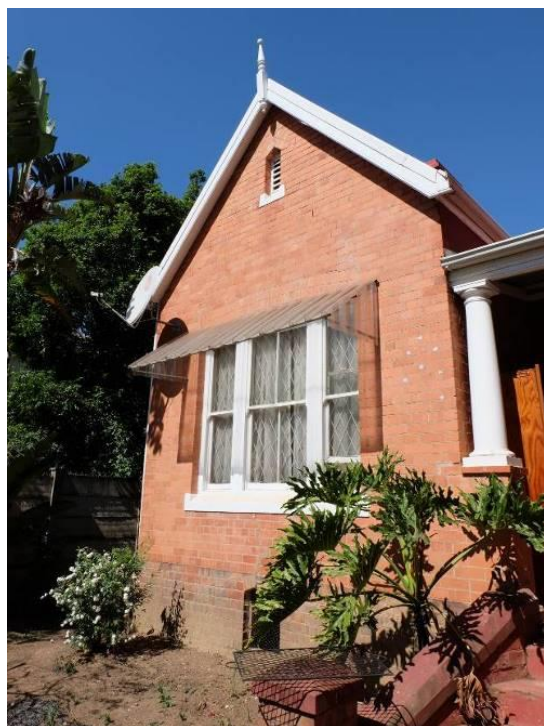
Fig. 9 & 10\_View towards main entrance with original wooden entrance door (left); main pitched roof with original red brick façade and wooden sash windows (right)  
 (Source: tsica heritage consultants, 22.09.2020)

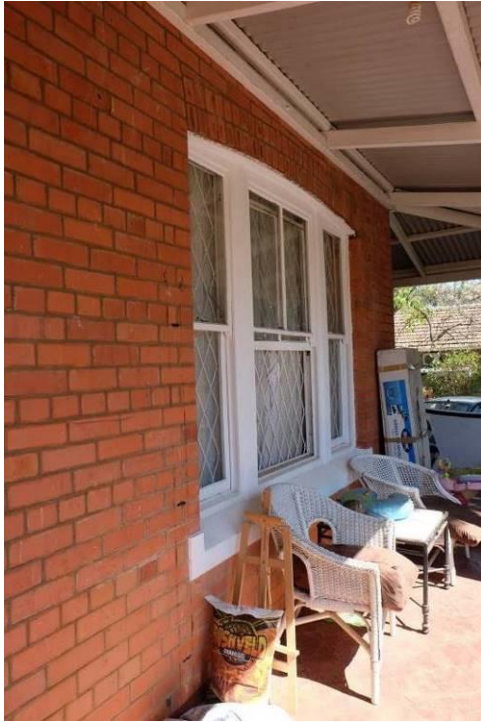
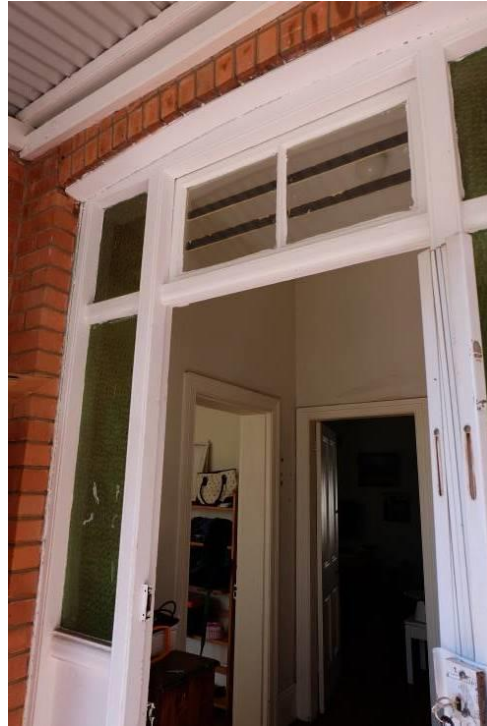
Fig. 11 & 12\_Original wooden sash windows towards the verandah (left); original wooden main entrance door (right)  
(Source: tsica heritage consultants, 22.09.2020)

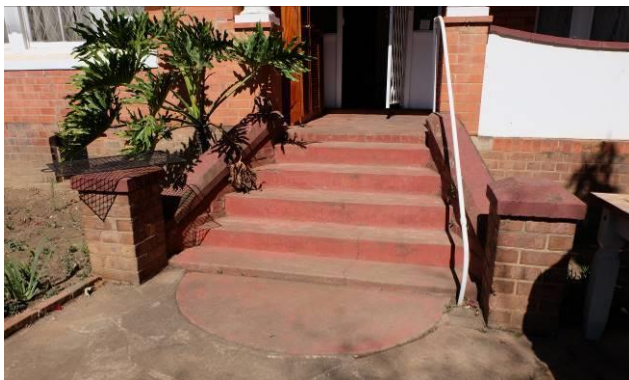
Fig. 13\_Main staircase along Street elevation to verandah  
(Source: tsica heritage consultants, 22.09.2020)

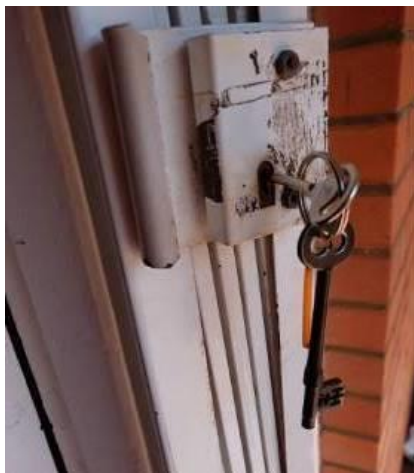
Fig. 14\_Original main door key  
(Source: tsica heritage consultants, 22.09.2020)

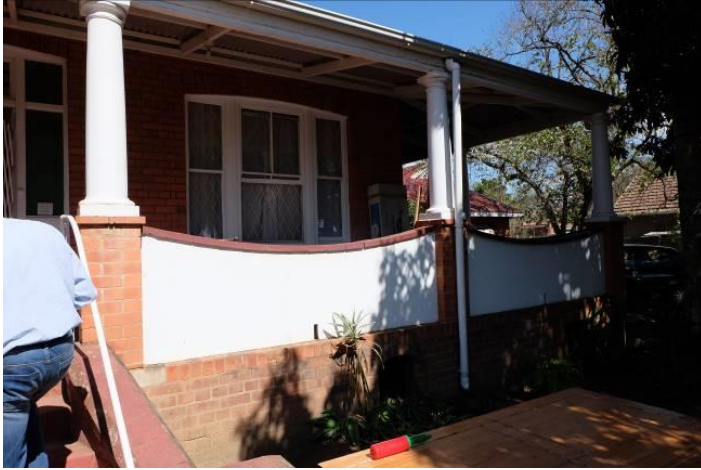
Fig. 15\_Verandah roof supported by columns  
(Source: tsica heritage consultants, 22.09.2020)

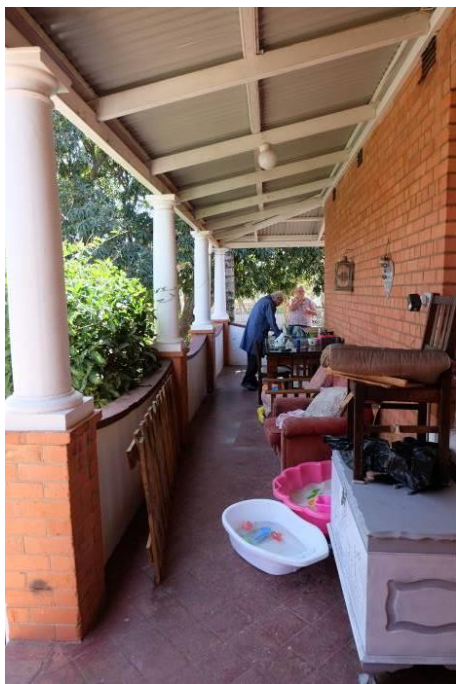
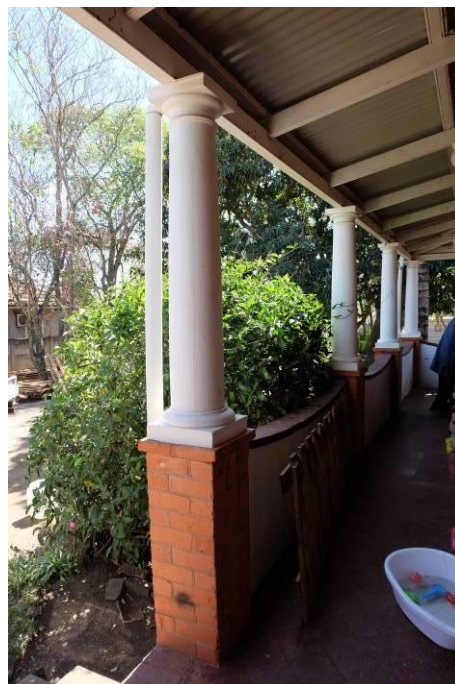
Fig. 16 & 17\_Verandah wrapped around the corner (left); Verandah roof is supported by a row of columns (right)  
(Source: tsica heritage consultants, 22.09.2020)

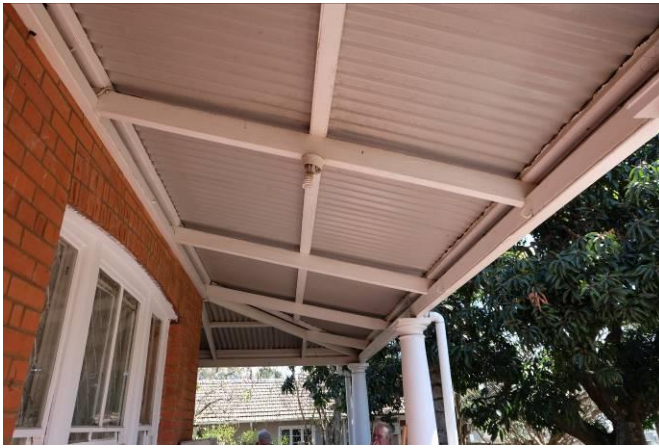
Fig. 19\_ Verandah roofing with wooden trusses  
(Source: tsica heritage consultants, 22.09.2020)

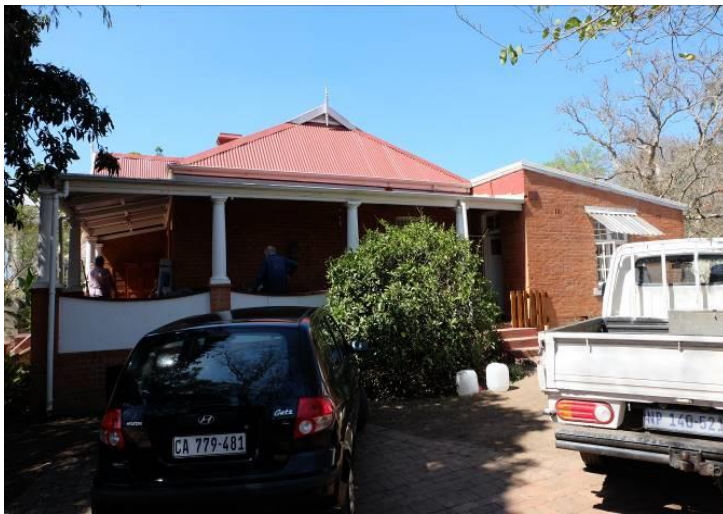
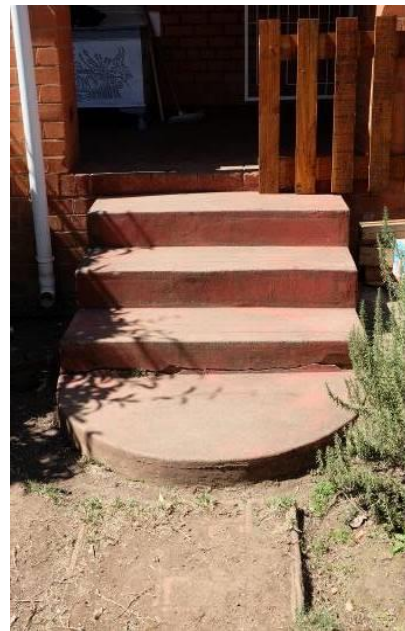
Fig. 20 & 21\_ North-western elevation (left); staircase to verandah from garage side (right)  
(Source: tsica heritage consultants, 22.09.2020)

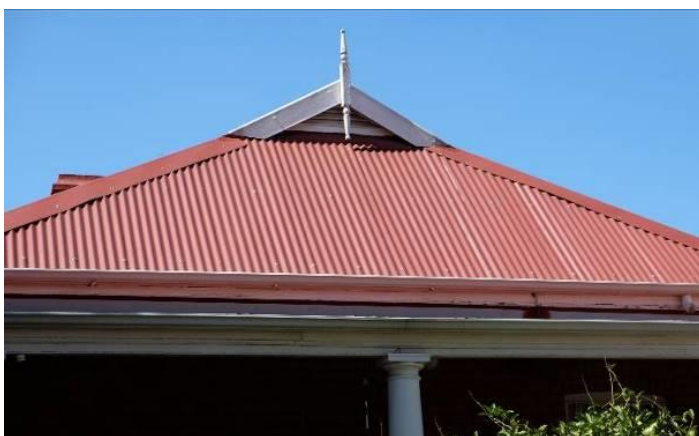
Fig. 22\_ Roofing detail with air vent and fine detailing  
(Source: tsica heritage consultants, 22.09.2020)

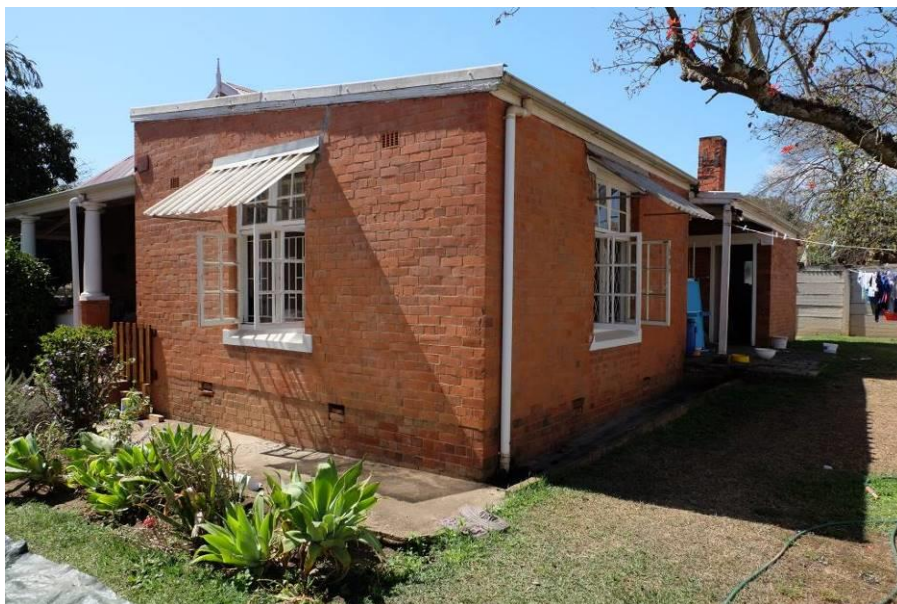
Fig. 23\_South-western corner which was later added to the original house  
(Source: tsica heritage consultants, 22.09.2020)

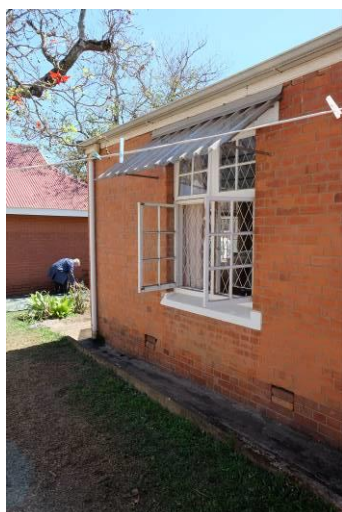
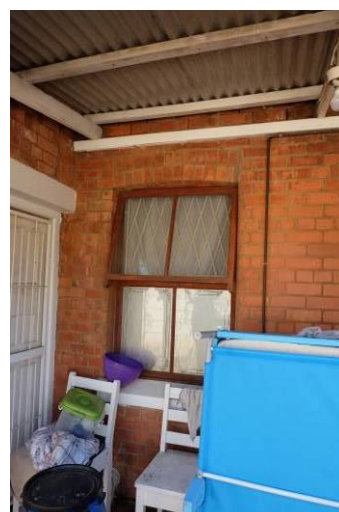
Fig. 24 to 25\_Southern elevation towards the garden with windows and doors opening on to the back stoep  
(Source: tsica heritage consultants, 22.09.2020)

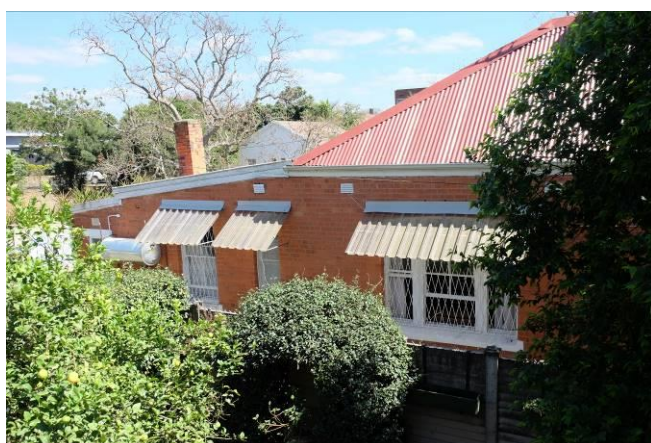
Fig. 26\_South-eastern elevation with later extended section towards the garden side  
(Source: tsica heritage consultants, 22.09.2020)

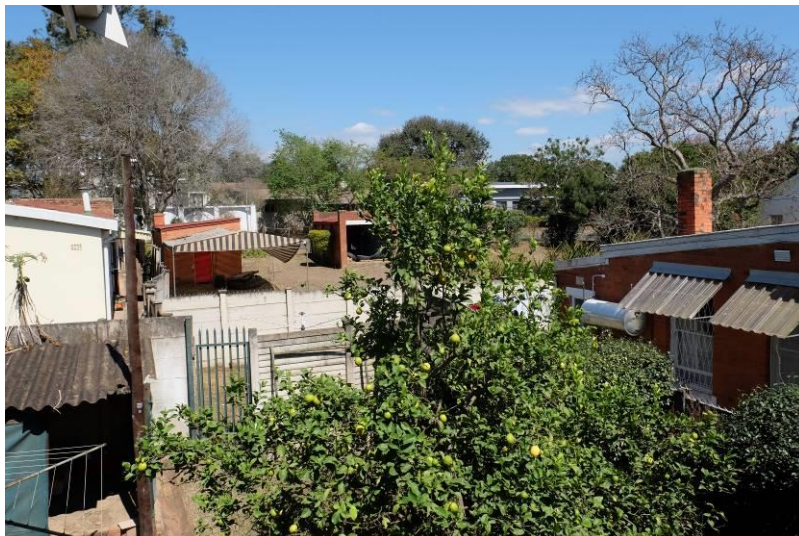
Fig. 27\_View from neighbouring property towards the garden side with a number of outbuilding structures (Source: tsica heritage consultants, 22.09.2020)

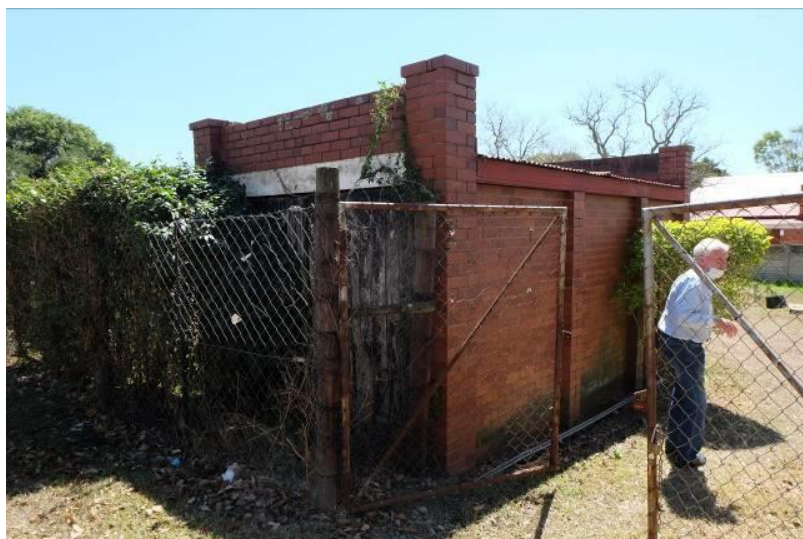
Fig. 28\_Original garage red brick structure to be accessed from Carbis Road (Source: tsica heritage consultants, 22.09.2020)

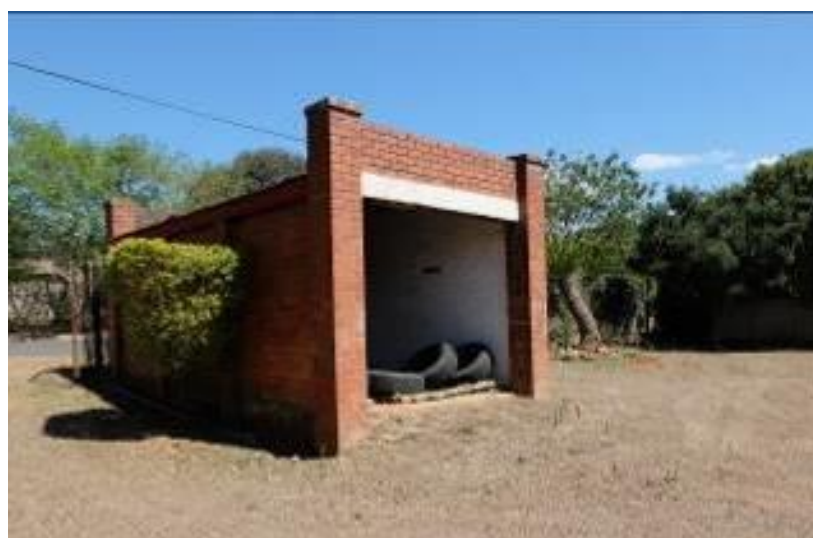
Fig. 29\_Original garage red brick structure located along the boundary line towards Carbis Road (Source: tsica heritage consultants, 22.09.2020)

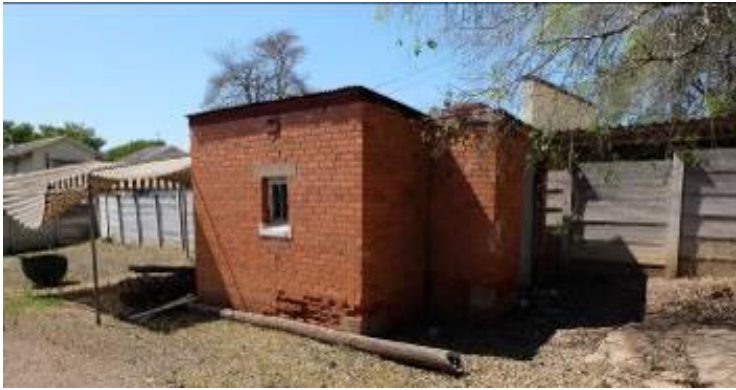
Fig. 30\_Original red brick structure used as cow stable  
(Source: tsica heritage consultants, 22.09.2020)

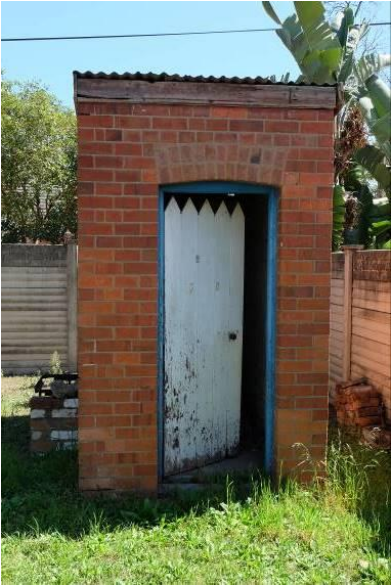
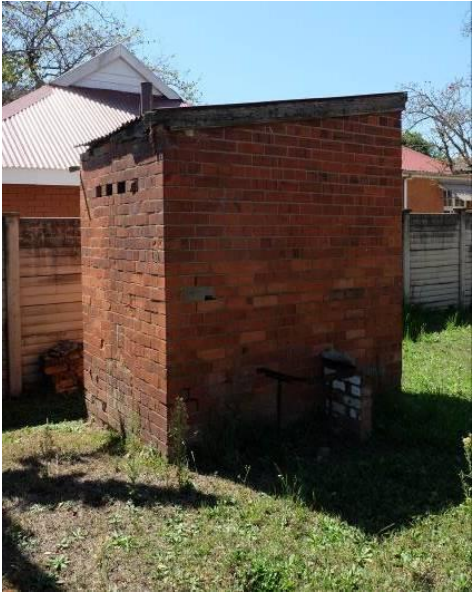
Fig. 31 & 32\_Original red brick structure used outside toilet  
(Source: tsica heritage consultants, 22.09.2020)

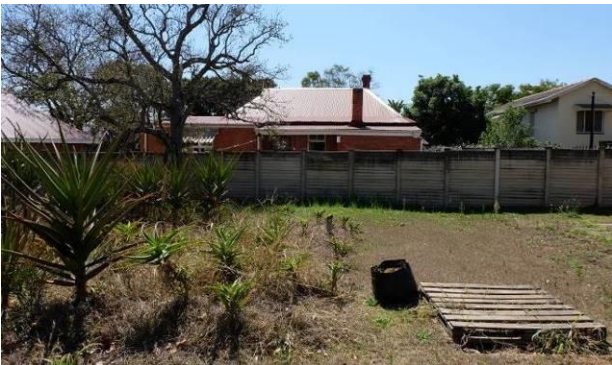
Fig. 33\_View towards main residence from garden side  
(Source: tsica heritage consultants, 22.09.2020)

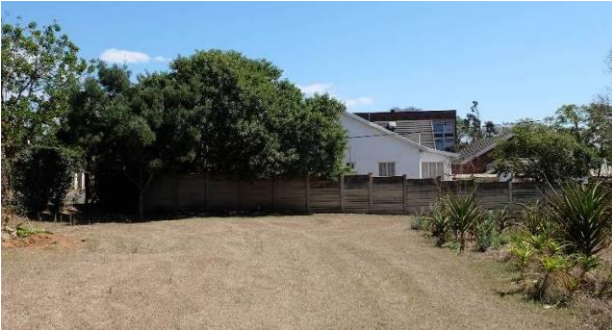
Fig. 34\_View along the garden in north-western direction  
(Source: tsica heritage consultants, 22.09.2020)

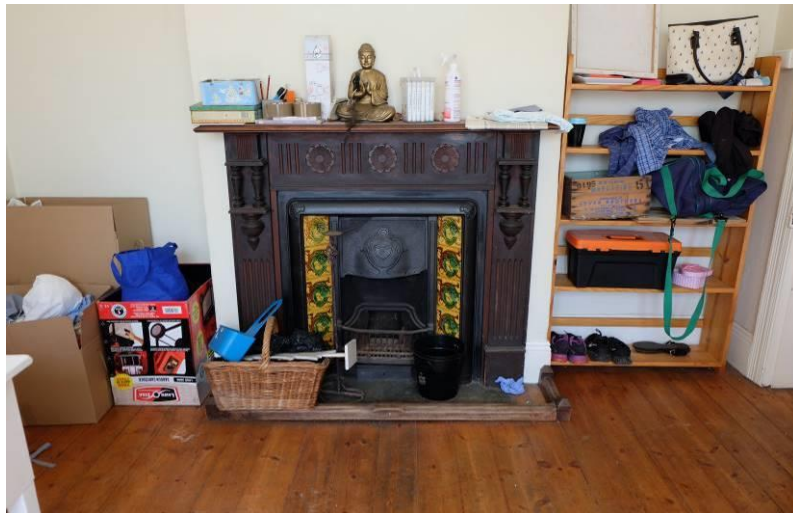
Fig. 35\_Original fireplace and wooden floor boards in bedroom  
(Source: tsica heritage consultants, 22.09.2020)

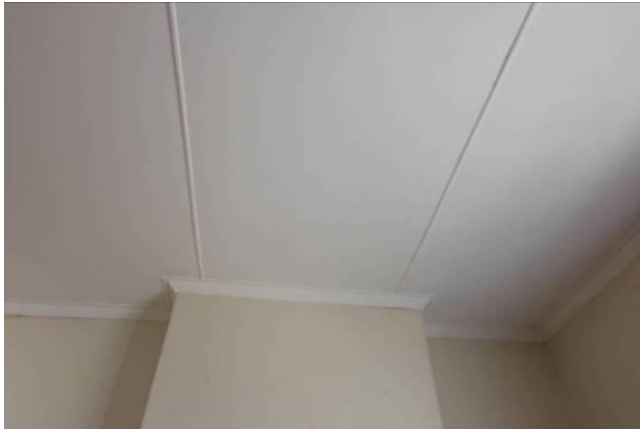
Fig. 38\_Original ceiling boards in lounge area  
(Source: tsica heritage consultants, 22.09.2020)

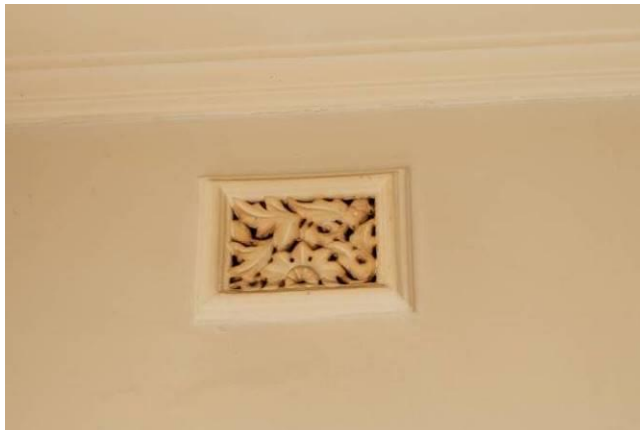
Fig. 39\_Original air vent with floral pattern  
(Source: tsica heritage consultants, 22.09.2020)

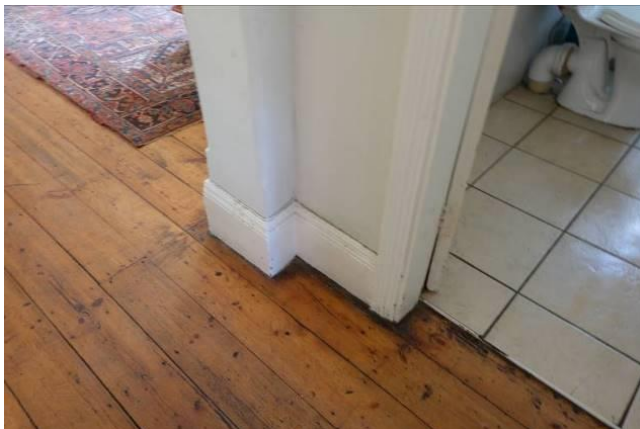
Fig. 40\_Original wooden skirtings and Oregon pine floor boards along the passage and lounge area  
(Source: tsica heritage consultants, 22.09.2020)

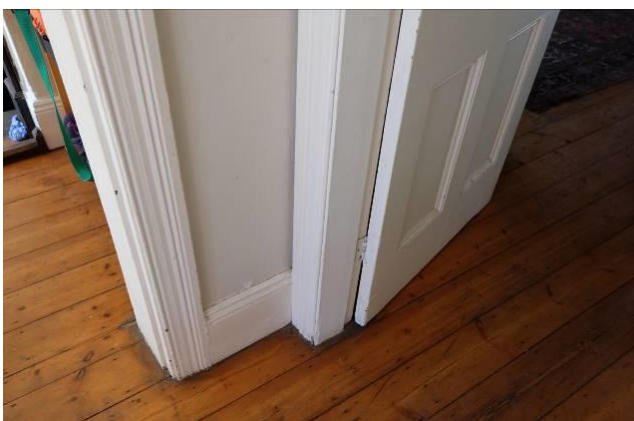
Fig. 41\_Original wooden skirtings and door frames in most of the rooms still in good condition  
(Source: tsica heritage consultants, 22.09.2020)

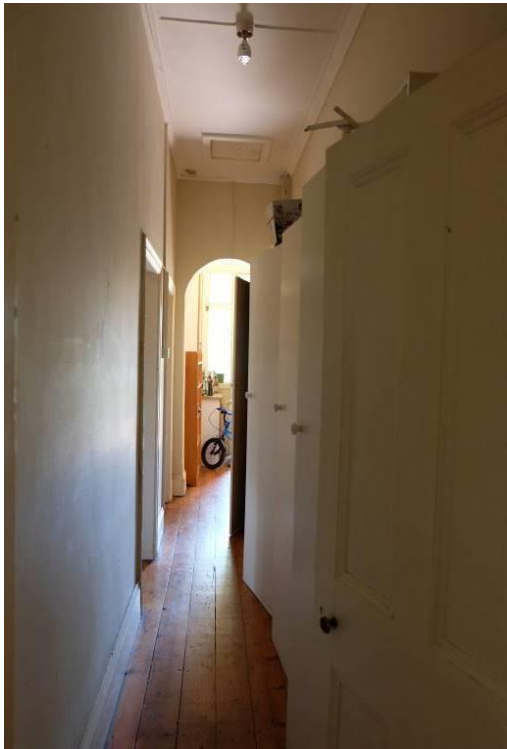
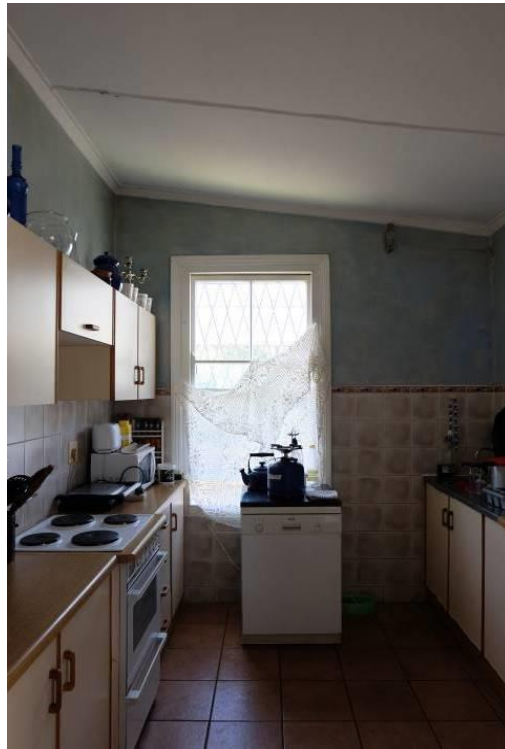
Fig. 42 & 43\_View along the passage with high ceilings and original Oregon pine floor boards (left); view into added on kitchen along the south-western side of the residence (right)  
(Source: tsica heritage consultants, 22.09.2020)

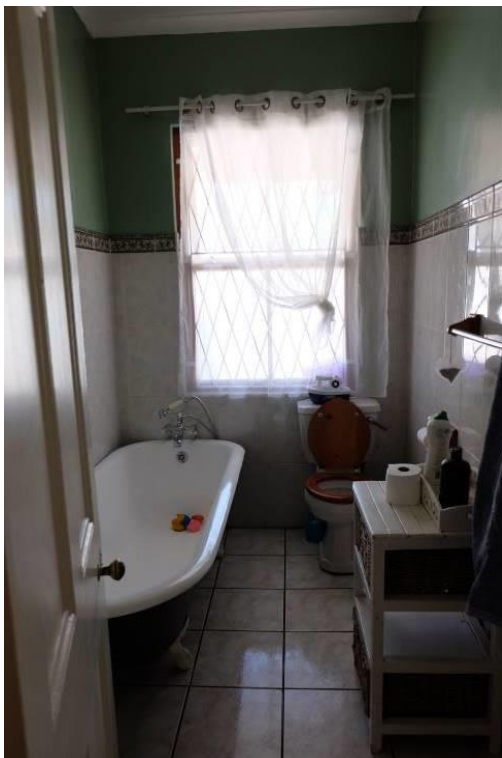
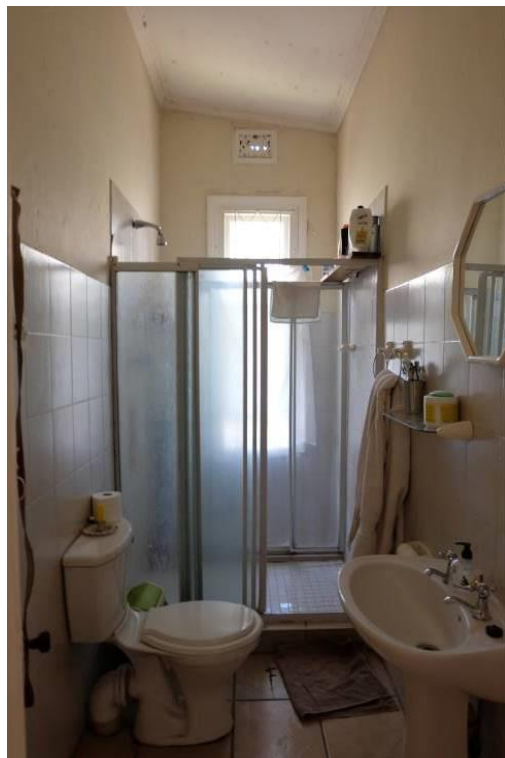
Fig. 44 & 45\_View into bathroom which was later altered and added (left); view into second bathroom which was later altered and added (right)  
(Source: tsica heritage consultants, 22.09.2020)

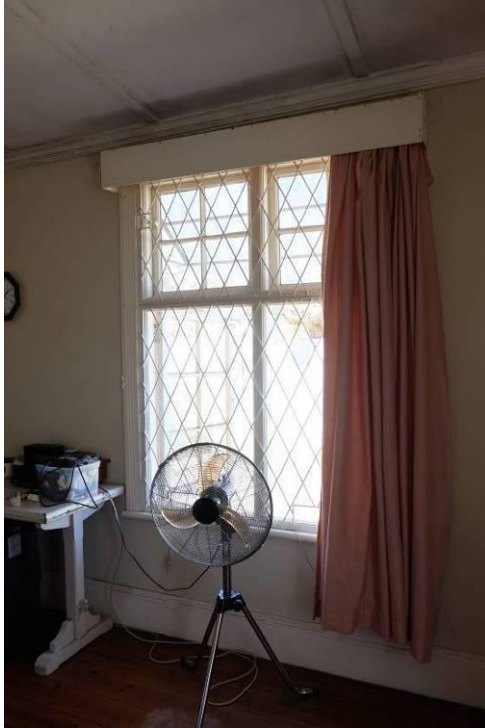
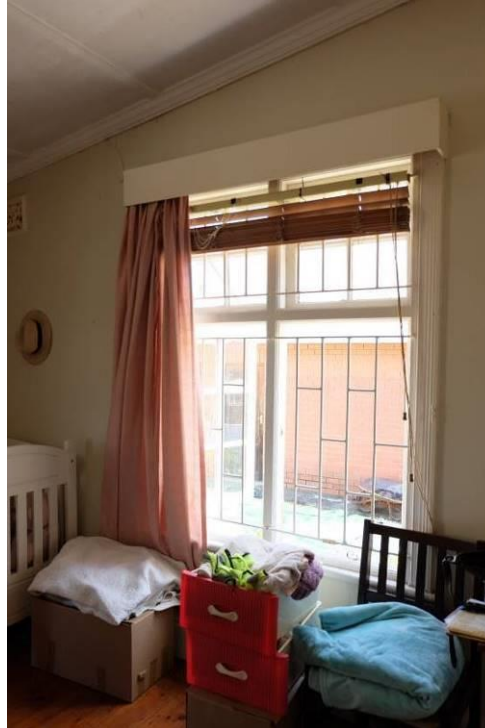
Fig. 46 & 47\_Bedroom which was later added in south-western section of the house (left); window in bedroom which was later added in south-western section of the house (right)  
 (Source: tsica heritage consultants, 22.09.2020)

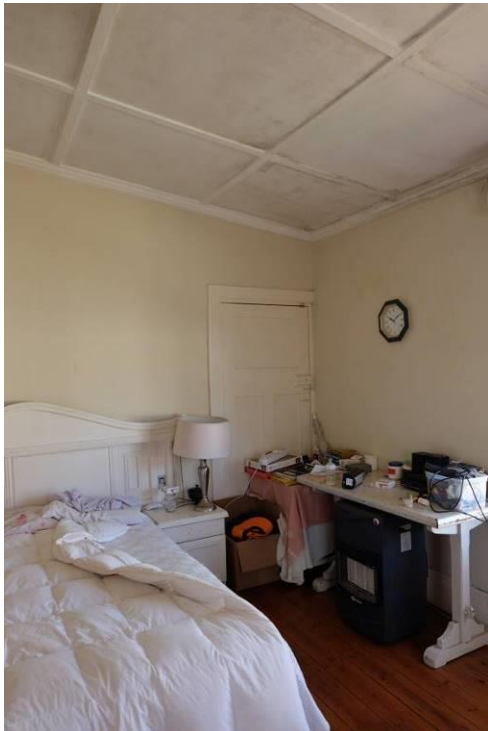
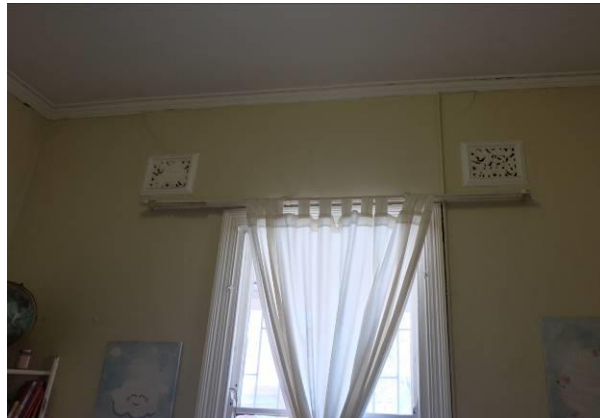
Fig. 48 & 49\_Main bedroom which was later added to the house (left); original bedroom with air vents and sash window towards the street side of the house (right)  
 (Source: tsica heritage consultants, 22.09.2020)

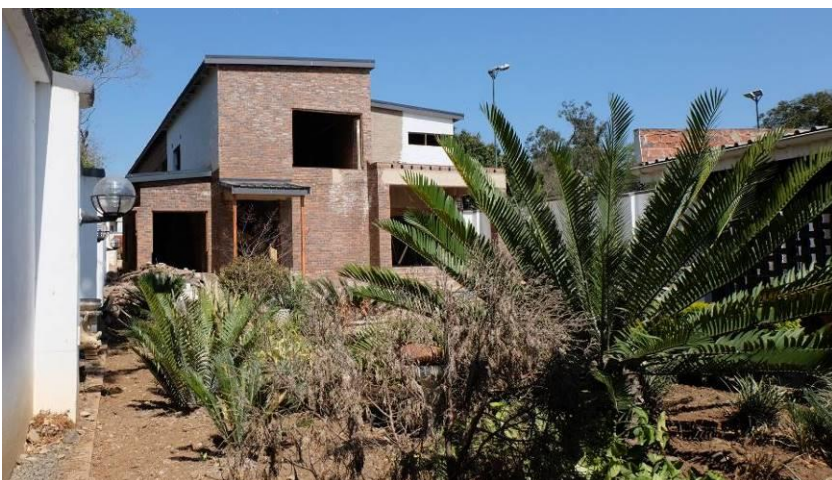
Fig. 63\_New double storey development along Carbis Road  
(Source: tsica heritage consultants, 22.09.2020)

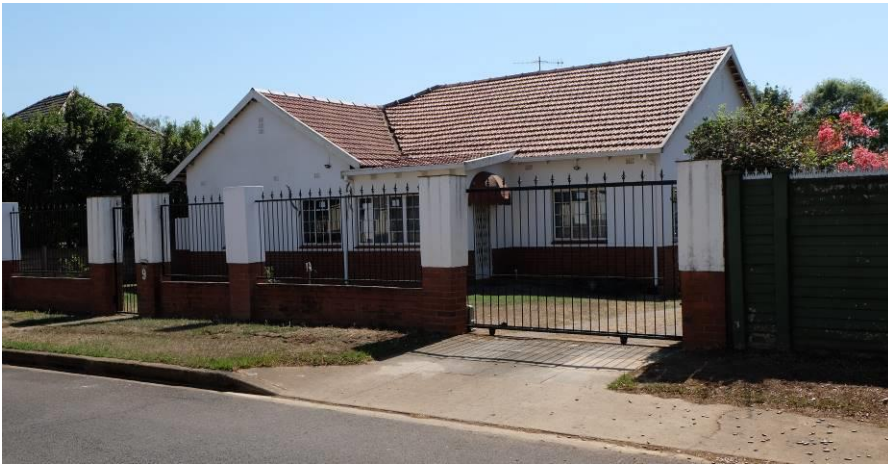
Fig. 64\_ Typical single storey tiled roof residence from around 1950s along Roseveare Road  
(Source: tsica heritage consultants, 22.09.2020)

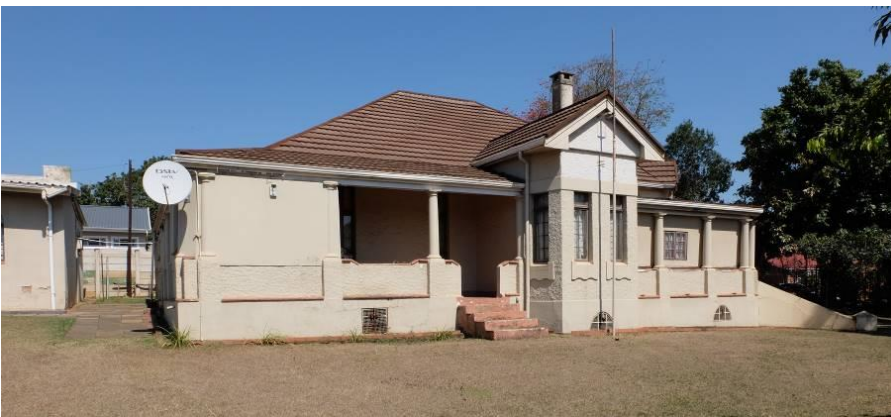
Fig. 65\_ Typical historical residence from around 1910 with front verandah supported by columns with newly added roof tiles  
(Source: tsica heritage consultants, 22.09.2020)

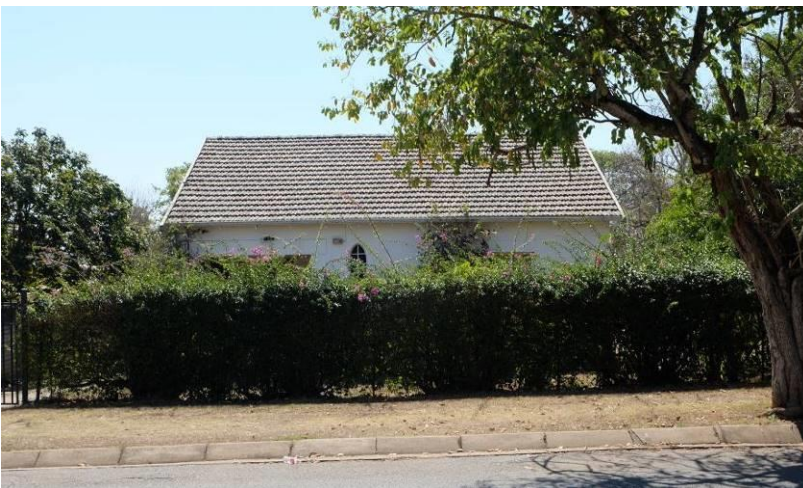
Fig. 66\_ Single storey tiled roof residence from around 1930s along Carbis Road  
(Source: tsica heritage consultants, 22.09.2020)

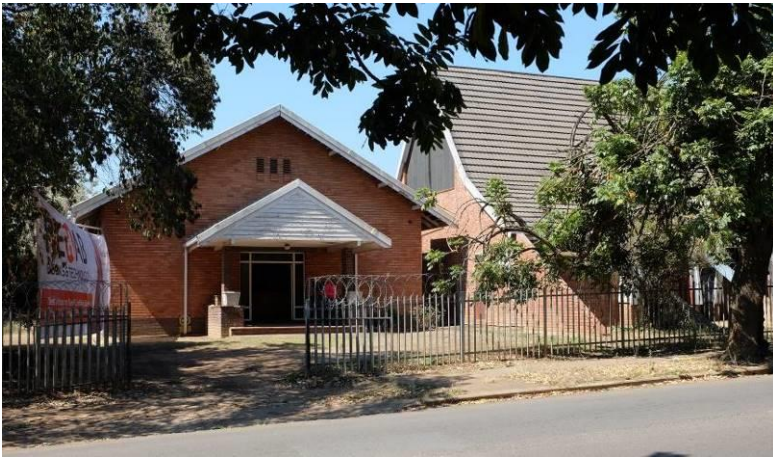
Fig. 67\_Church building on the corner of Ridge Road and Carbis Road from around 1950s  
(Source: tsica heritage consultants, 22.09.2020)

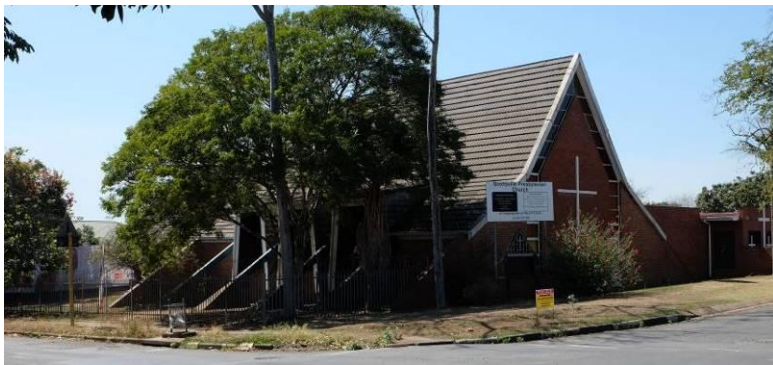
Fig. 68\_Church building on the corner of Ridge Road and Carbis Road from around 1950s  
(Source: tsica heritage consultants, 22.09.2020)

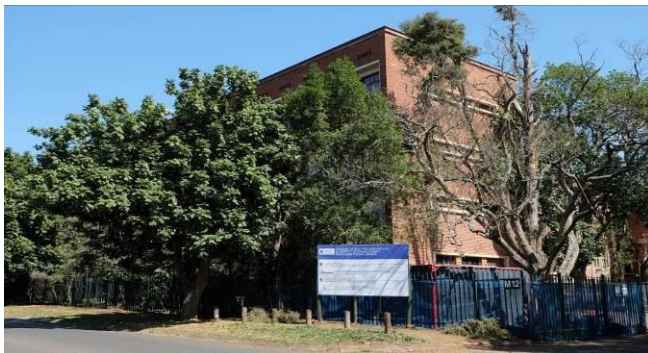
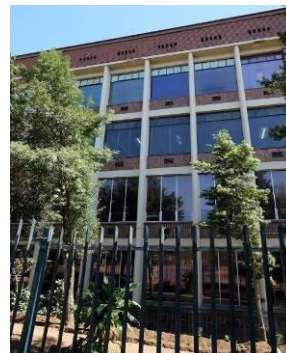
Fig. 69\_Multi storey university building in north-western direction along Ridge Road  
(Source: tsica heritage consultants, 22.09.2020)

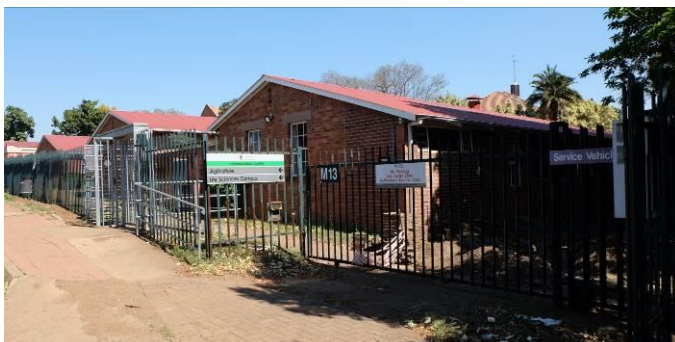
Fig. 70\_Single storey University building along Ridge Road  
(Source: tsica heritage consultants, 22.09.2020)
