BO-KAAP MUSEUM CONSERVATION MANAGEMENT PLAN

ERF 115963, 71 WALE STREET BO-KAAP, CAPE TOWN

20 JULY 2018

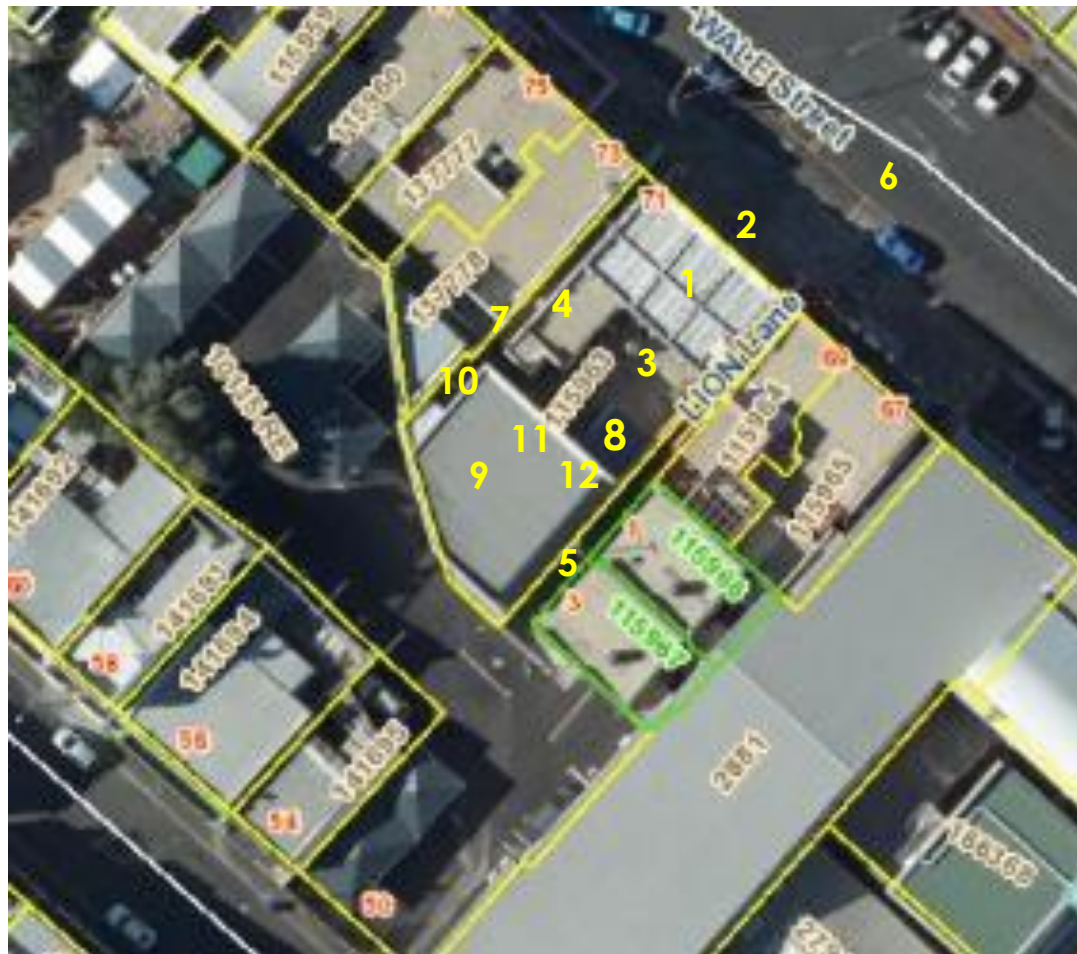
FIGURE 4: Naming of Parts

The house (1), with its front stoep (2) and the courtyard behind (3). The attached staff quarters (4) facing the courtyard. There is an east alley (5) which joins Wale Street (6) with the parking area to the south. There is a partial west alley (7).

A toilet block (8) is situated on the south east corner of the courtyard. A community hall (9) is located at the rear of the site, on the irregular boundary and faces the courtyard on the north. It is accessed by a stair (10) on the west. A covered stoep (11) below the north edge of the hall gives access to the kitchen store (12) and toilets (8)

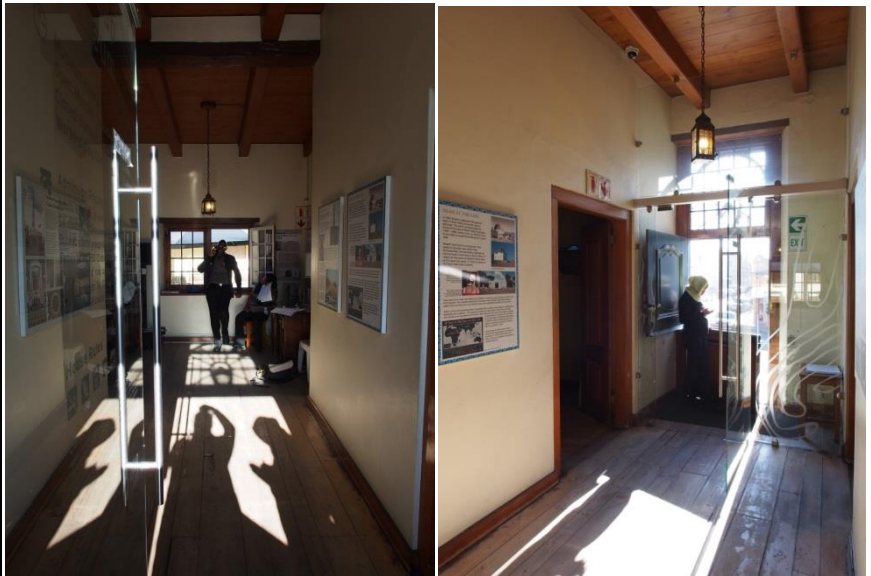
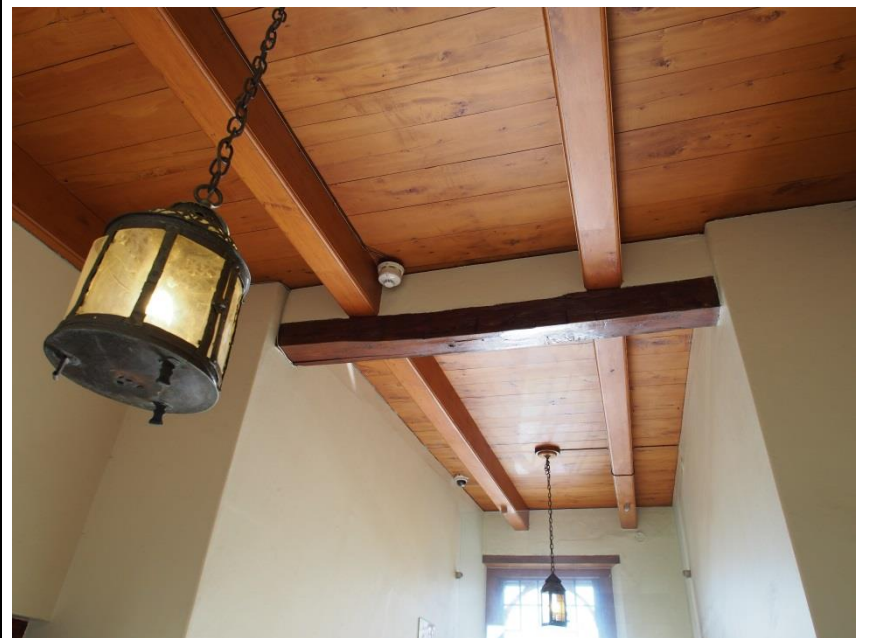
Walls:
Pale yellow smooth plaster.
Small cracks at splay at front door.
Plaster repairs for chasing evident.
Damp, peeling paint at door.
Exposed wiring around doors.
Conduit above and below skirting.
Surface mounted plug point on south wall and exposed wiring.

Condition:
Ceiling good
Walls: fair, damp at entrance, need painting.
Floors: worn.
Skirtings: worn.
Window: inside reasonable outside needs maintenance.
Front door: needs re-finishing and painting.

Issues
Floors worn, damp at entrance, exposed wiring.

Recommendation:
Internal painting
PR 6,4
Remove surface wiring and chase if necessary

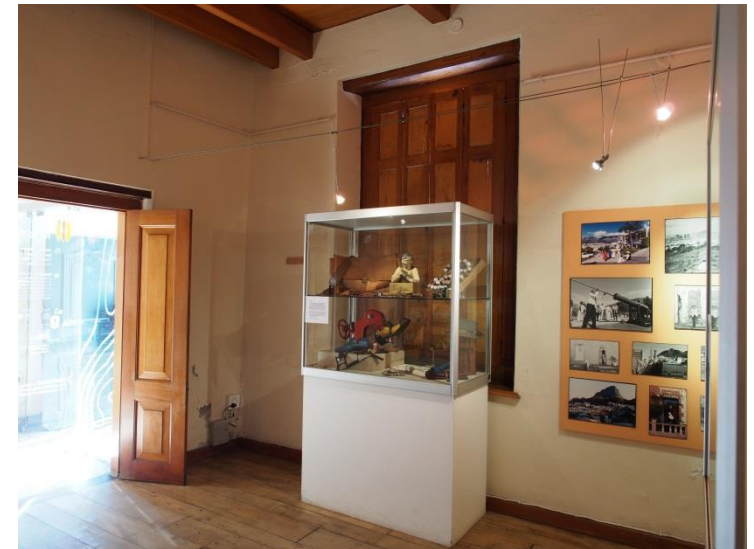
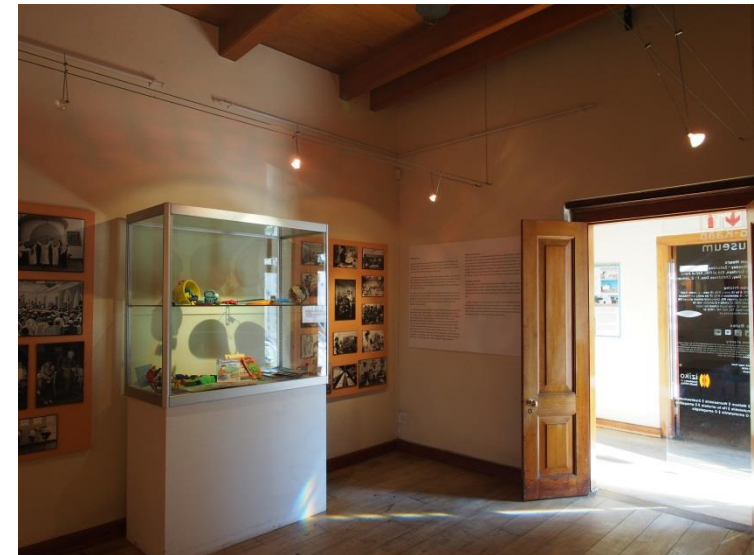
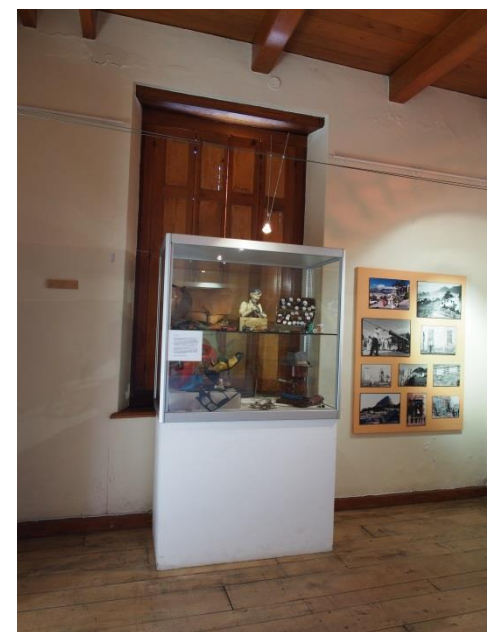
East Room / Exhibition Room 3

Walls:
Simple timber skirting
Picture rail.
Signs of damp on east and north.
Cracks above window on left.

Condition:
Ceiling good.
Walls damp, cracks needs repair and painting.
Floor reasonable.
Skirting reasonable
Window not possible to inspect
Door: good.

Recommendation:
Possibly re-arrange room so that window is not blocked by display case.
PR 4,6

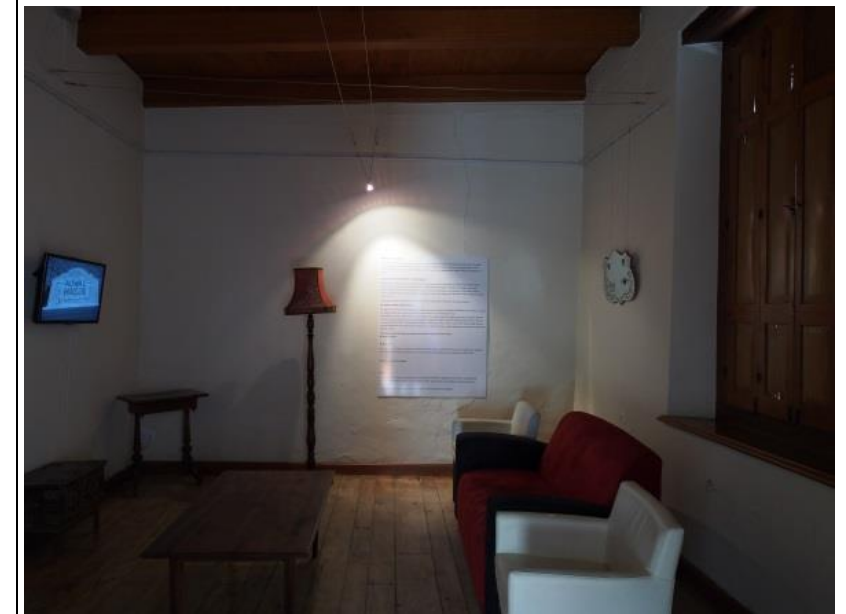
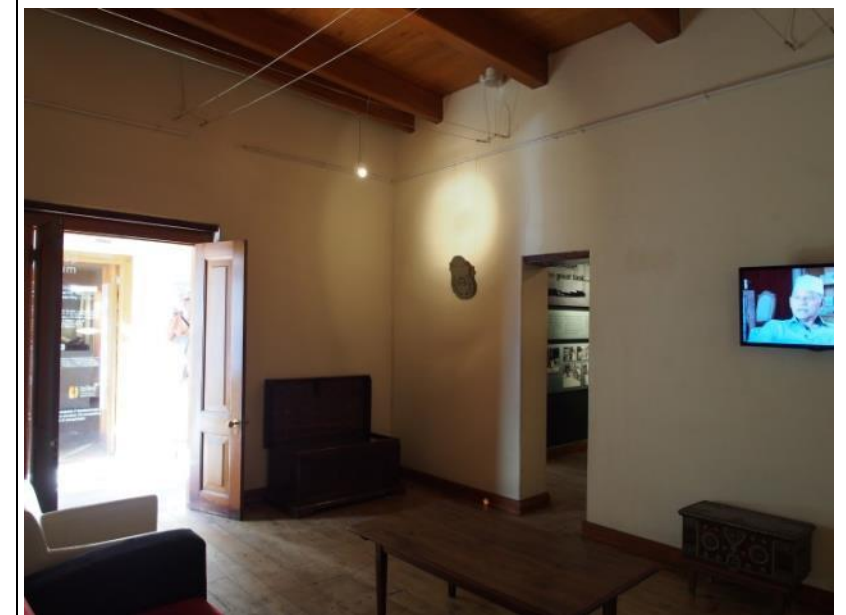
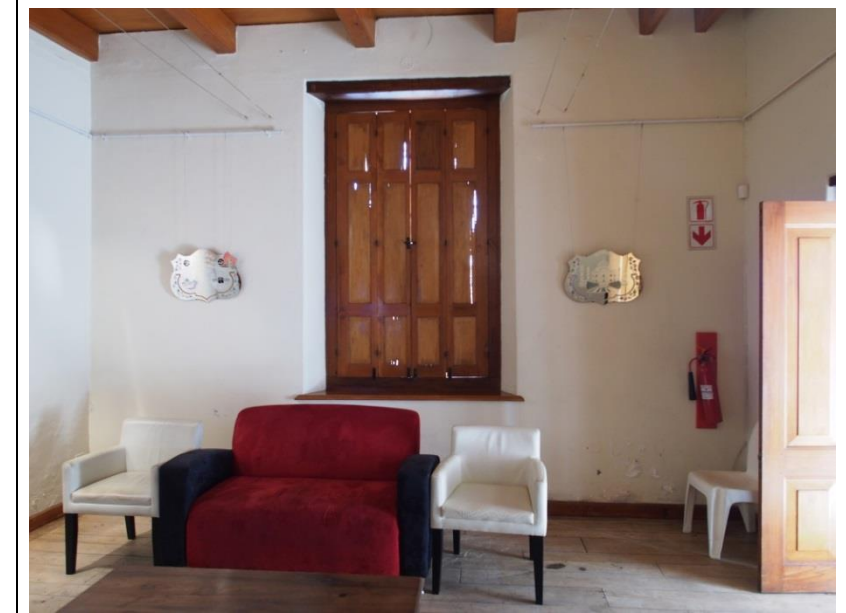
Right Hand Room /
Exhibition Room 1

Walls:
Crack on west wall
Same as other room; damp on N & W? wall

Doors/Windows:
Folding shutters with central latch and lower latches.
Cracks in panels in folding screen.

Ceiling: good
Walls: Cracks and damp, poor
Skirting: Good condition
Windows: Good inside, poor outside

Action:
Routine cleaning and maintenance.
Waterproofing required.
Attend to wall cracks
Painting

Recommendation:
PR 4,6

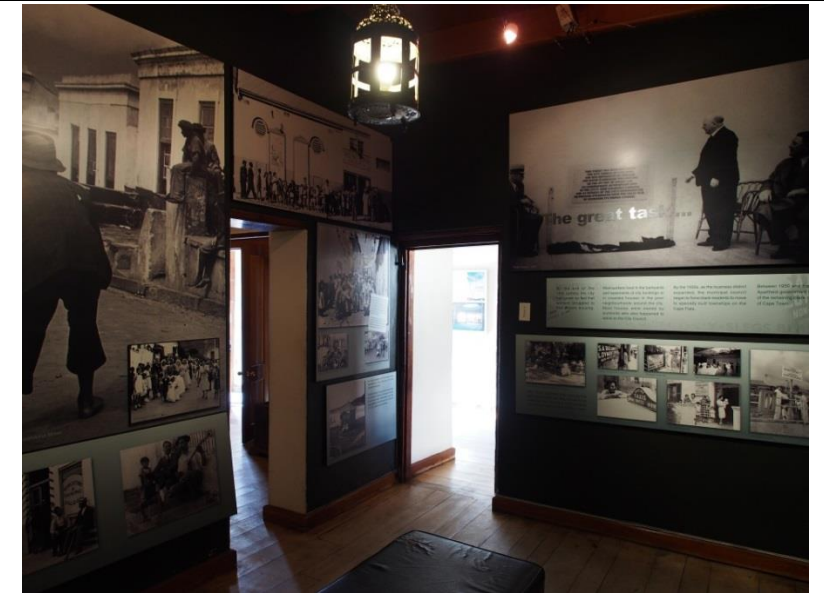
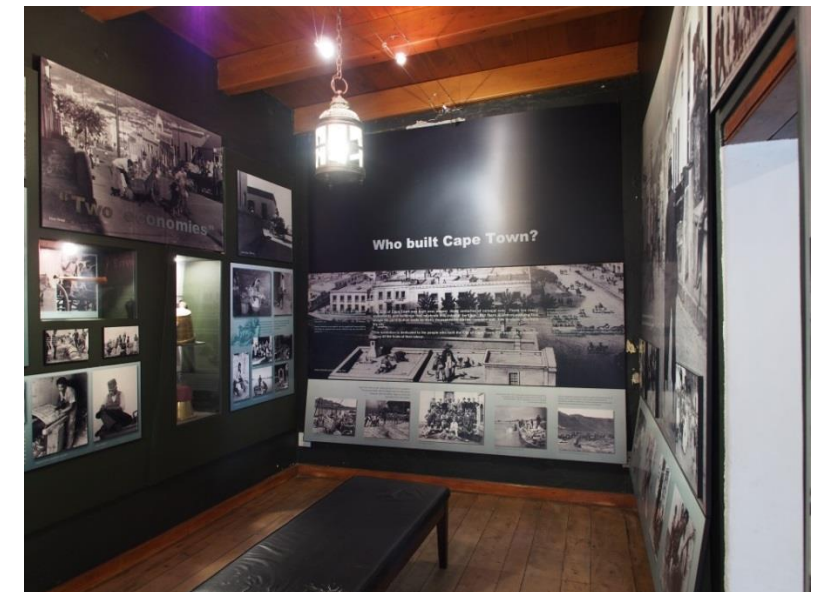
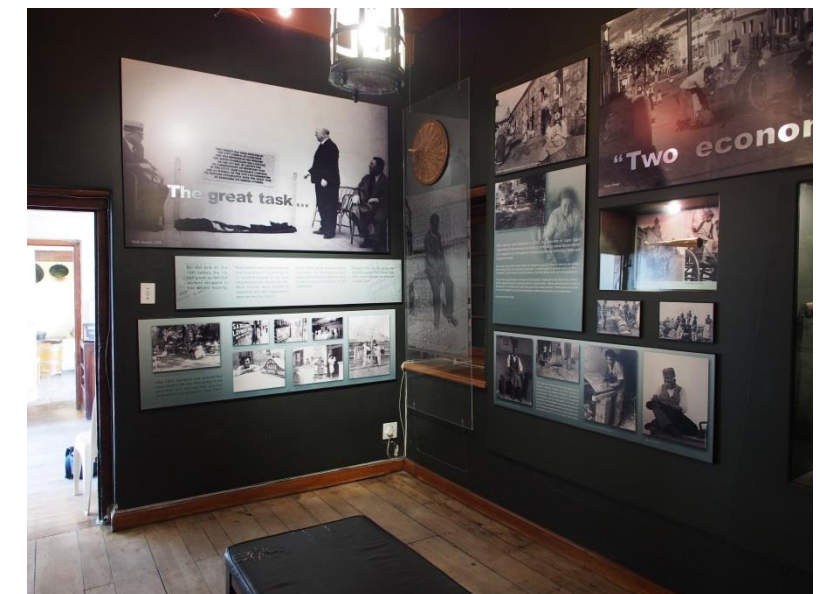
Rear Room Display Room 2

Walls:
Damage to walls

Detailed Description:
Bench in centre.
Exposed wiring above skirting and at south east corner.
Untidy skewly mounted transformer.
Missing door

Condition:
Floor: Good worn
Skirting: Good
Walls: Needs repair
Ceiling: Good
Windows: Obscured by display

Action:
Routine cleaning and maintenance.
Repair damage to walls.
Attend to exposed wiring

Recommendation:
PR 4,6
Conceal exposed wiring

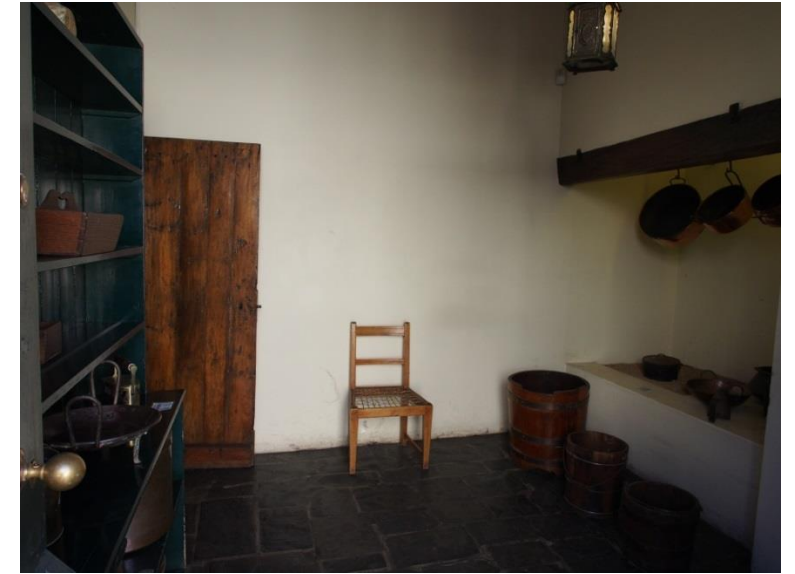
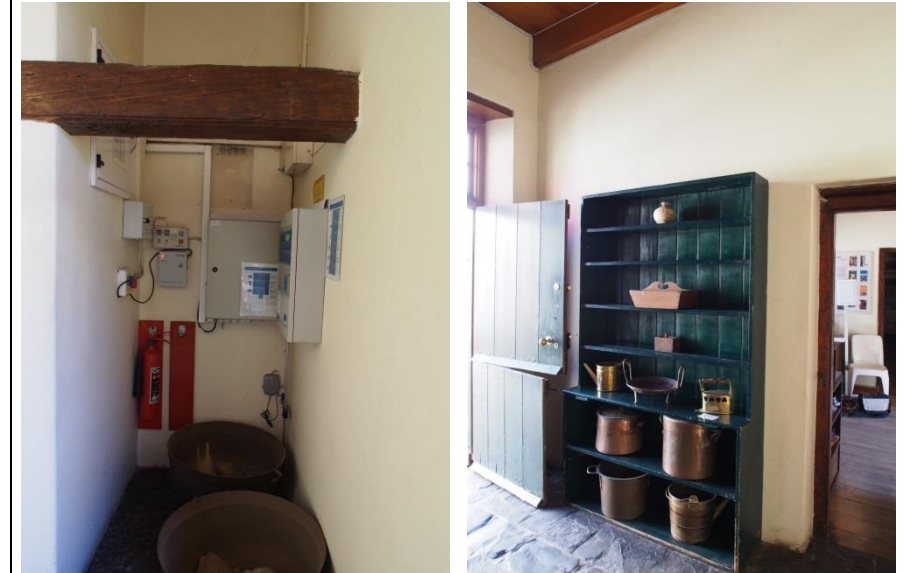
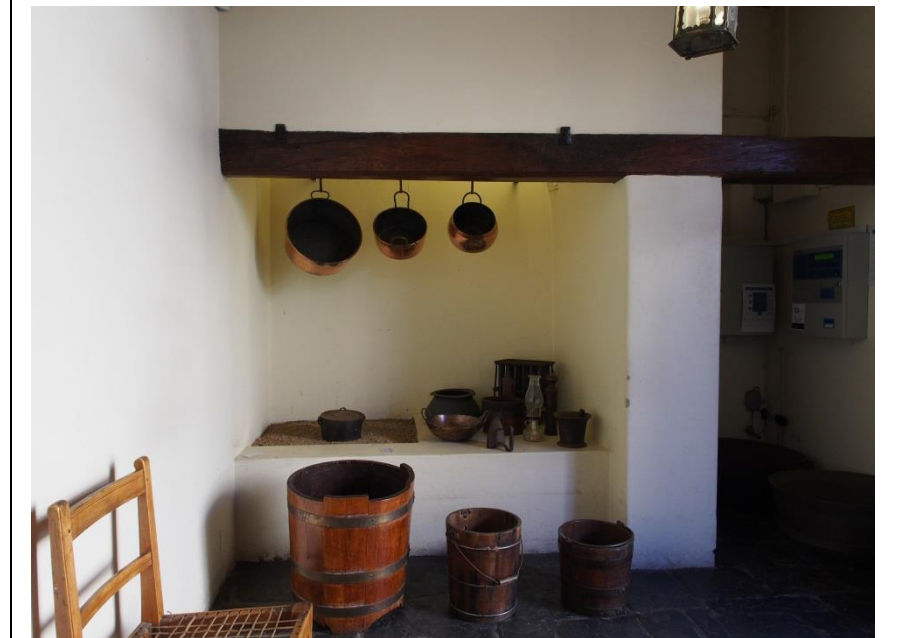
Kitchen/ Exhibition Room 4

Floor: Good
Walls: Generally good, except for spalling on internal wall.
Doors: Good, worn threshold
Ceiling: Good

Routine cleaning and maintenance.
Repair wall, painting.
Attend to exposed wiring

PR 4,6
Conceal exposed wiring

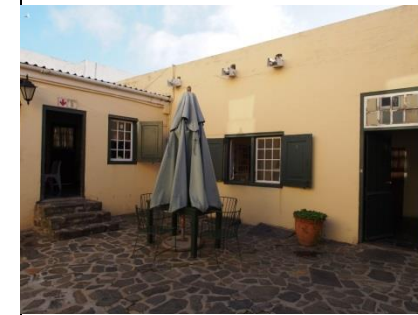
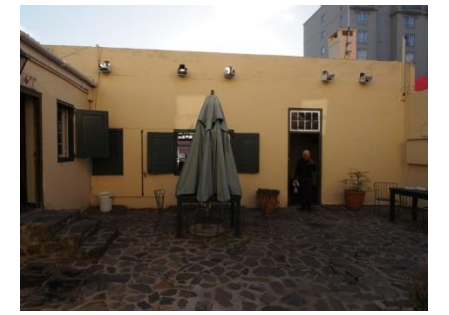
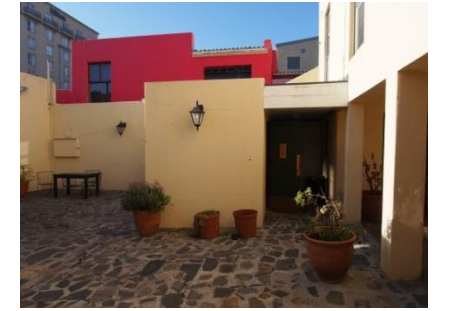
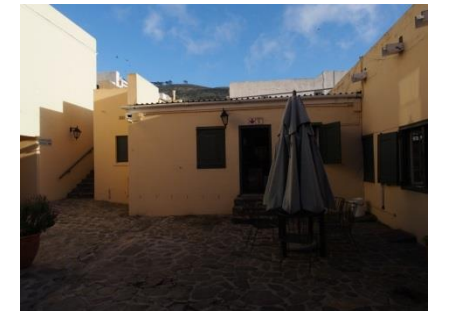
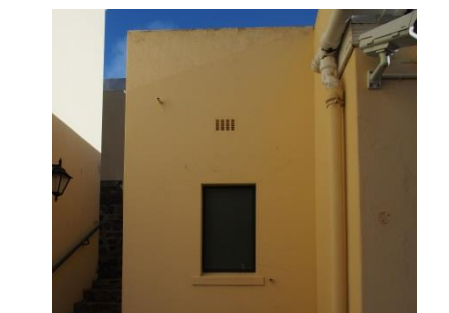
Courtyard

Floor:
 Irregular slate paving falling to shallow dished channel which runs next to north side of toilet block to sump on south side of door to east alley. Cracked paving.

Walls:
 Plastered, cracks.

Detailed Description:
 Many cracks to walls of courtyard. On rear of building , east wall, toilet block, on hall, bathroom off staff quarters.
 East wall – surface conduiting, wall lamp, emergency exit.

Condition:
 Floor: Cracked
 Walls: Poor
 Rainwater goods need attention

Action:
 Routine cleaning and maintenance.
 Repair cracks in paving.

Recommendation:
 PR 4,2
 Investigate limited planting.
 Investigate removing toilets to consolidate space.

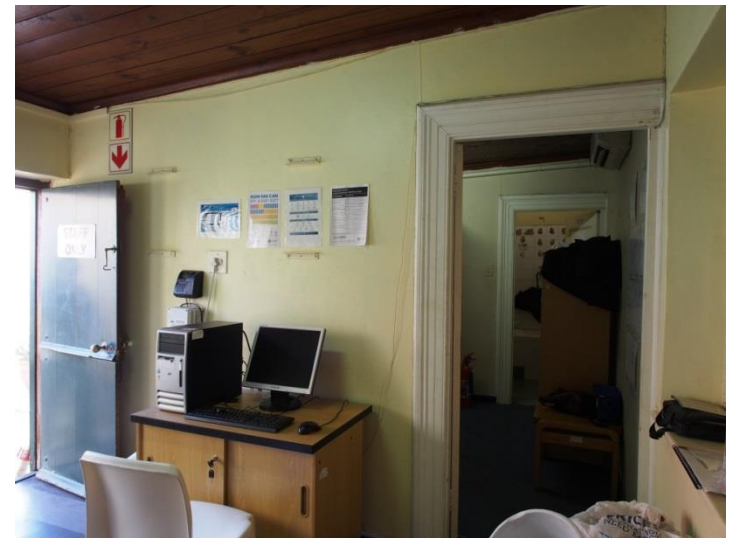
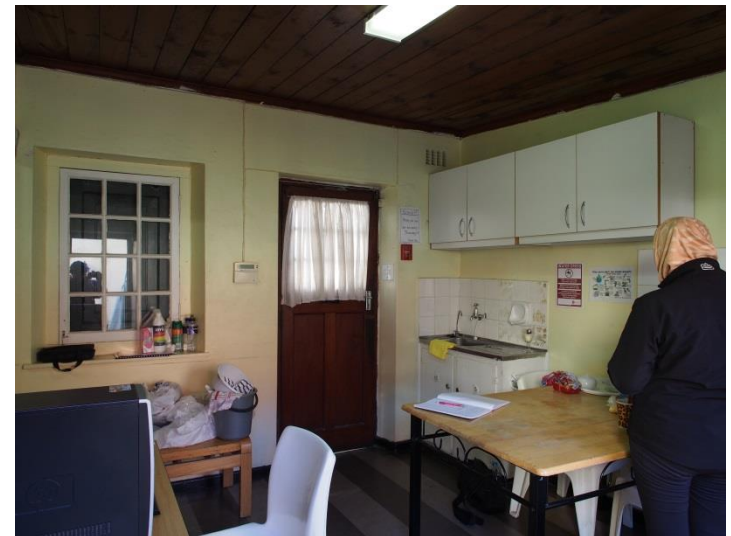
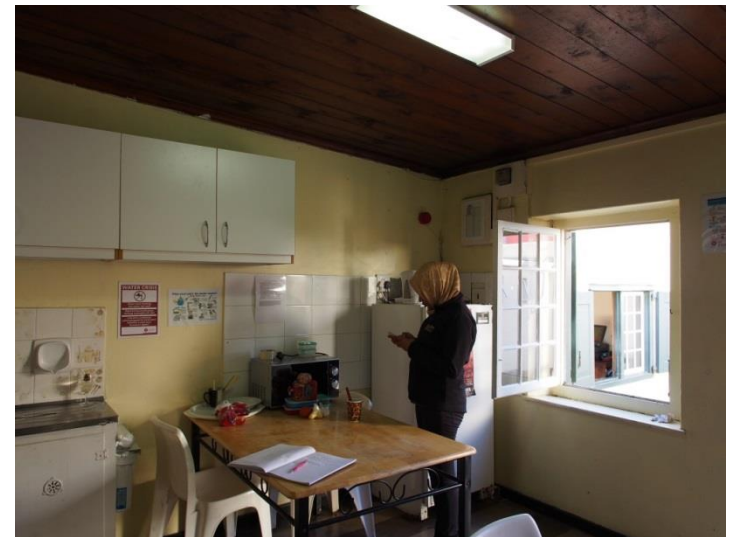
Staff Room/Staff Kitchen

Walls:
Plastered, painted walls, crack around west window

Doors/Windows:
Front door is stable door planked.
Rear; later glazed back door, doesn't close.
Crack in one of the lower panels.
Architrave to bedroom odd.

External:
Parapet on the south.
Gutter and fascia need repair.
Wall light. Camera on south west corner, exposed conduiting below fascia
Ceiling wall. IBR roof, half round asbestos cement gutter on plain painted timber fascia.

Floor: Reasonable
Skirting: Reasonable
Walls: Damp problems
Doors: Reasonable, threshold worn. Alley door needs attention.
Ceiling: Reasonable

Recommendation:
PR3,4,5,6

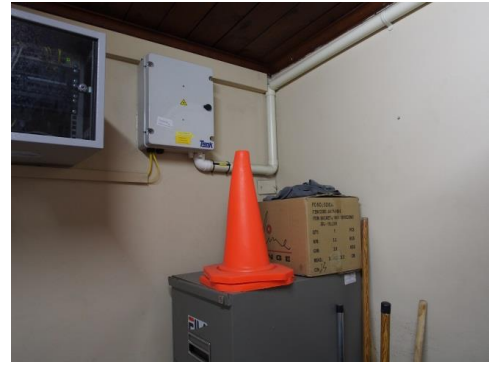
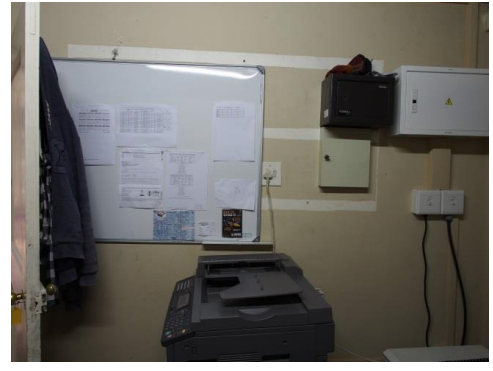
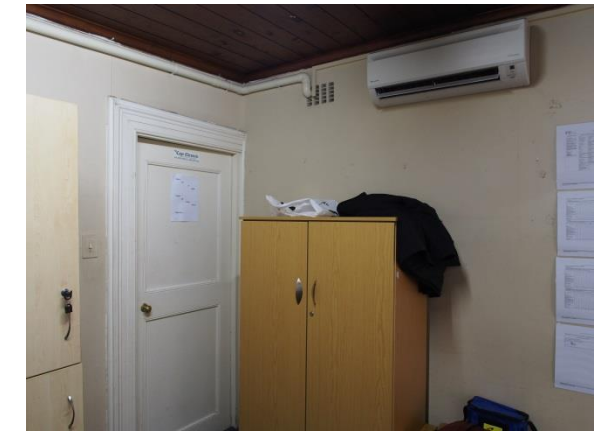
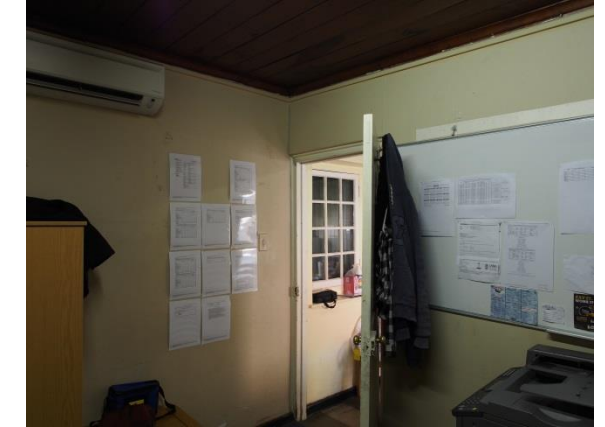
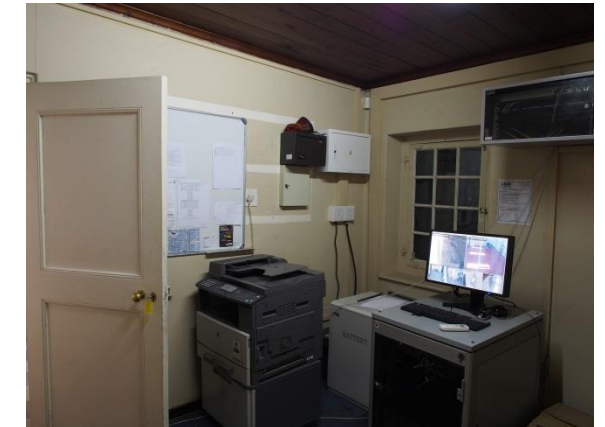
Bedroom /Office/ Server Room

Space:
Small rectangular room
Aircon, photocopier, bin, filing cabinet, server
Stained blue felt carpet.
Surface plugs, surface conduits

Condition:
Fair
Floor – worn
Skirting – fair
Walls: Poor. Damp penetration
Ceiling: Reasonable
Doors, windows: Good internally, needs repair, maintenance externally.

Action:
Routine cleaning and maintenance.
Consider painting ceiling white to increase light level.
Attend to waterproofing.
Replace carpet.

Recommendation:
PR 3,4,5,6

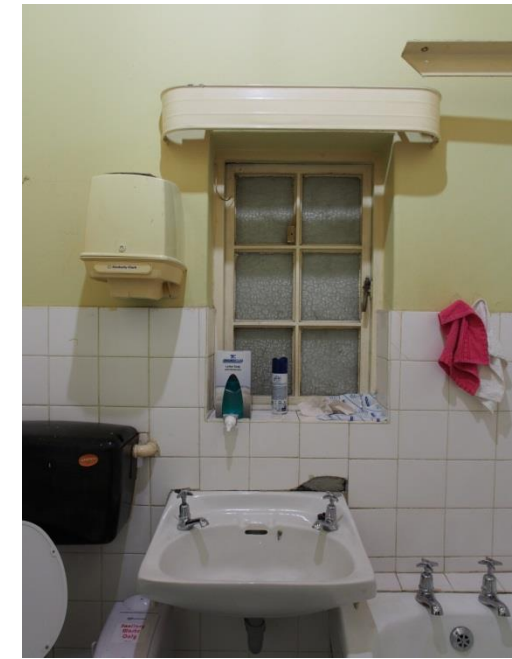
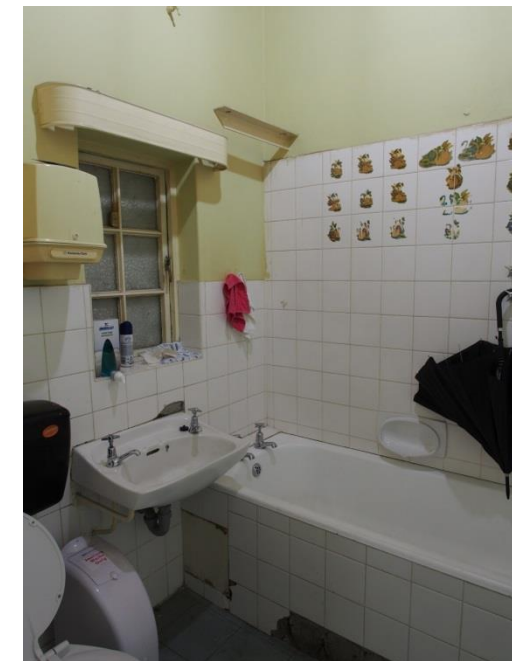
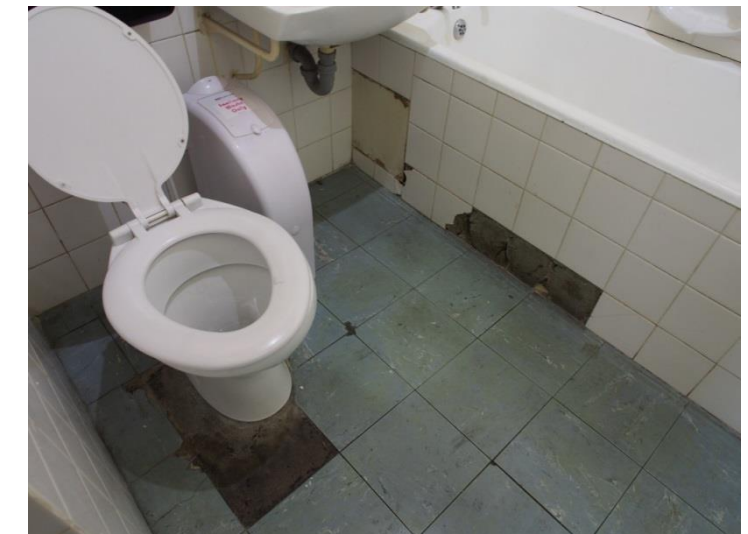
Bathroom/wc

Floor:
Vinyl tiles, some missing

Walls:
Missing tiles against bath and broken tile above whb
'Bandage' plaster ' on south wall
Surface cracks in staff quarters especially south and south west corner.

Detailed Description:
Toilet, whb, bath. Remnants of brackets for removed HWC
Missing light shade.
Damaged gutter and fascia on return of bedroom, south east corner

Condition
Poor

Recommendation:
PR 6,3,4

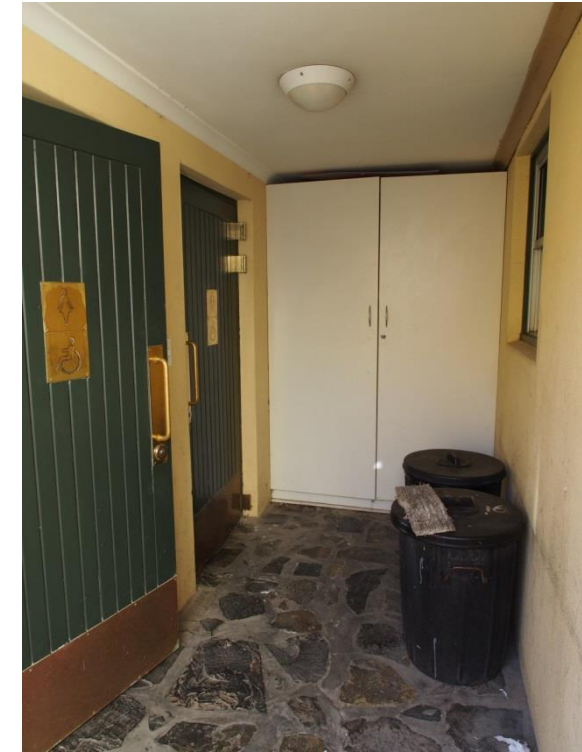
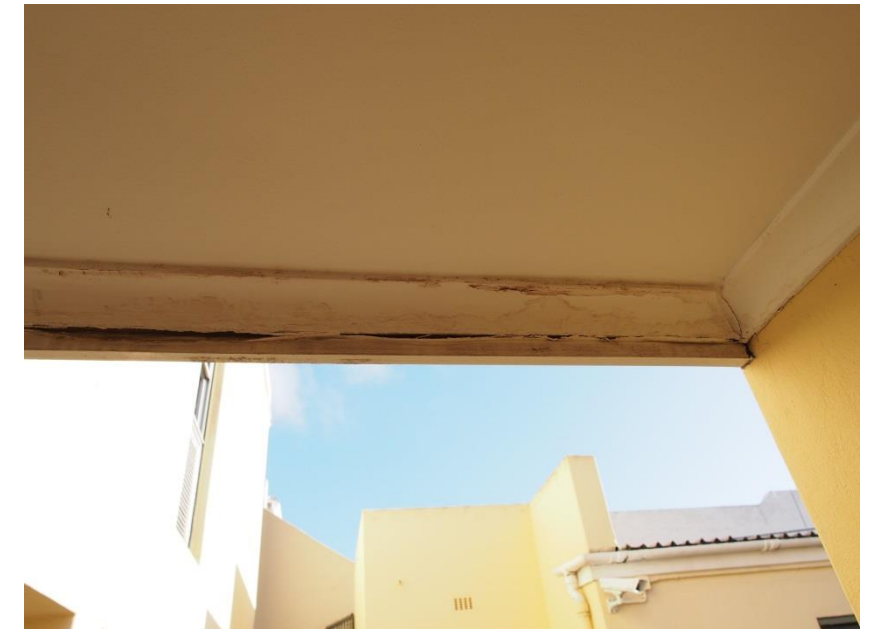
Lobby in Front of Disabled Toilets

Ceiling:
Plasterboard ceiling, coved cornice
Ceiling and cornice damaged
Section of plasterboard cornice replaced is not painted

Condition
Reasonable
Attend to ceiling

Action:
Routine cleaning and maintenance.
Flimsy cpds need repairs
Lobby to toilets need painting.
Repair and paint ceiling.

Recommendation:
PR 2,4,6

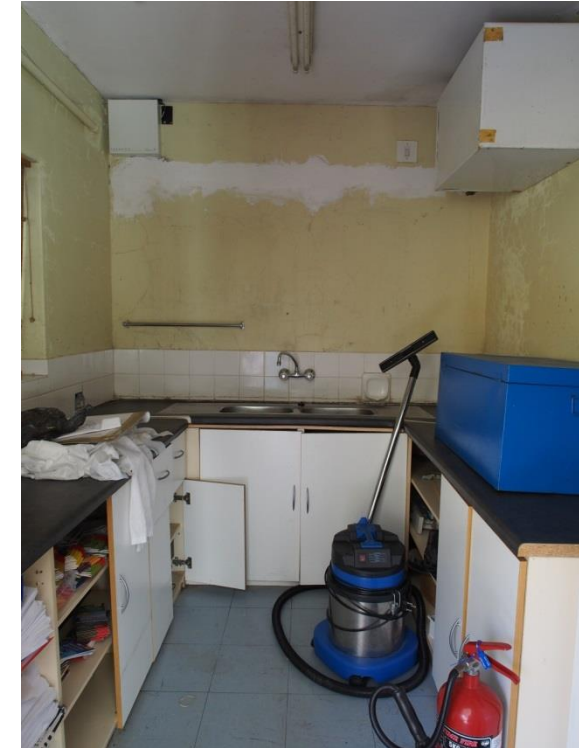
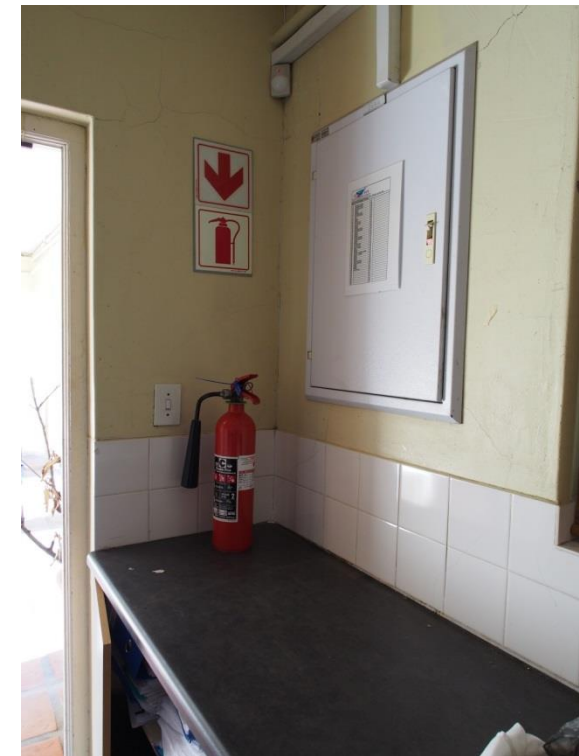
Kitchen Store off Loggia/ Covered stoep

Walls:
Wall: cracks, leaking

Doors/Windows:
Stable door, sash window
Worn threshold

Detailed Description:
Locker cpds, countertops, sink has damaged splashback.
Cracked tiling. DB board, missing cpd doors, damaged cpds.
Surface conduiting and pipes.
No cornice
Plug point with missing cover
Badly in need of repair and painting
Panelled stable door. Good condition

Recommendation:
PR2,6

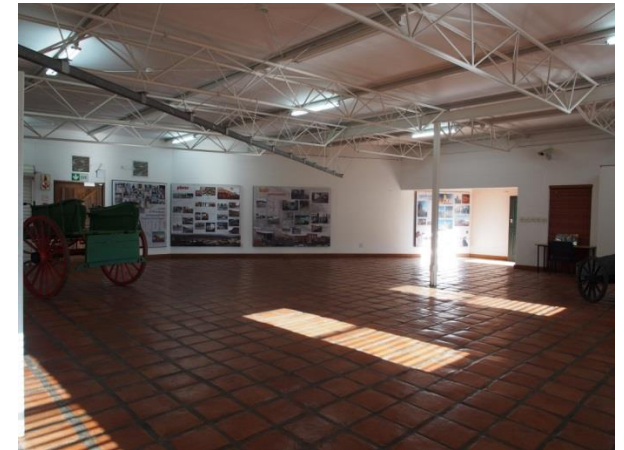
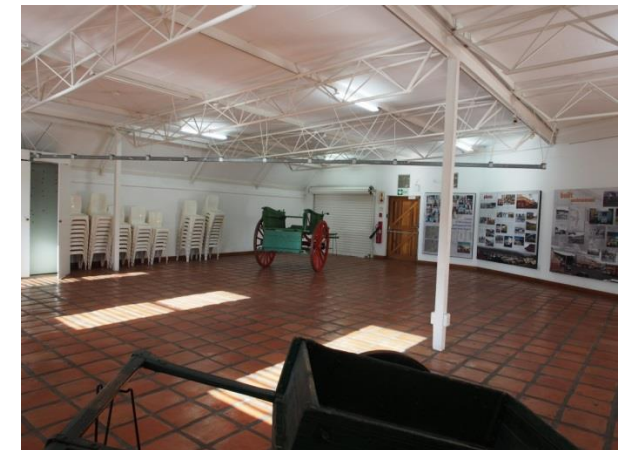
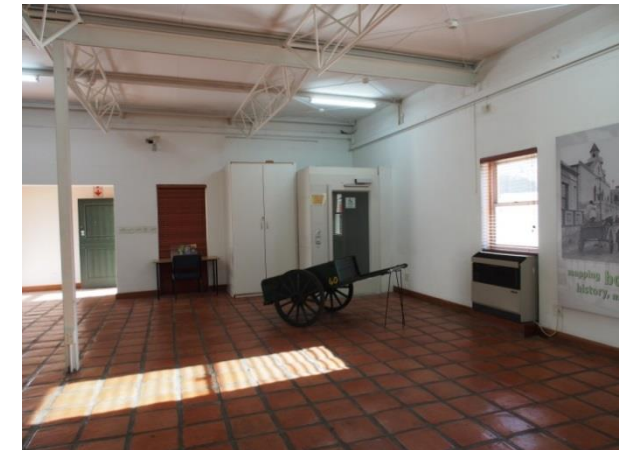
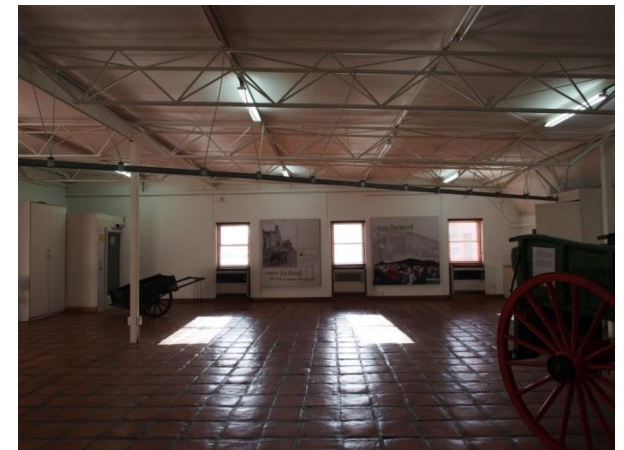
Community Hall

Walls:
Cracks on north wall of hall, also on parapet, moulding runs around.

Detailed Description:
Moveable partition arrangement roller shutter door on south east and flb escape door next to it. Six large display panels, 2 old carts, sink in north east corner.
3 aluminium windows with a.c. below on north wall. 2 extract fans on south wall.
Conduiting for cameras and surface ducting.
Timber vertical blinds
Slim pergola at entrance at top of stair.
Badly in need of painting
Door at top of landing next to entrance door leads to very narrow awkward 'slot', wall with crazing/cracks.

Action:
Routine cleaning and maintenance.
Attend to lift.
Attend to wall cracks.
Investigate improving hall edge onto courtyard.

Recommendation:
PR2,4,5,6
Promote social use of hall.

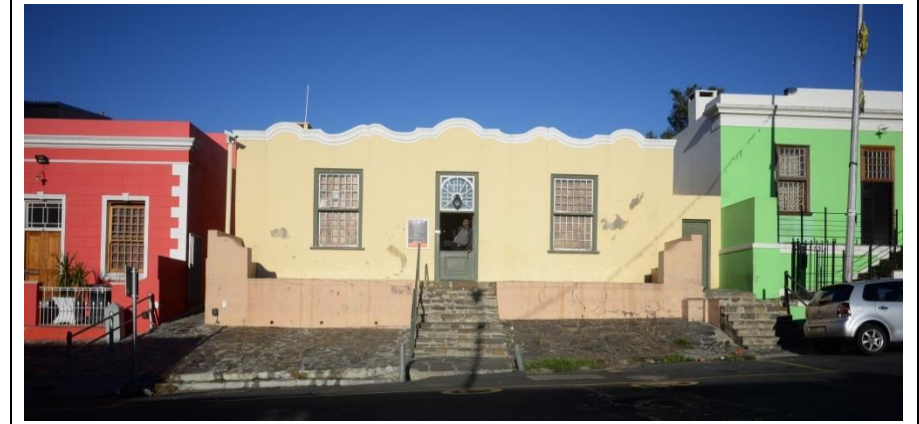
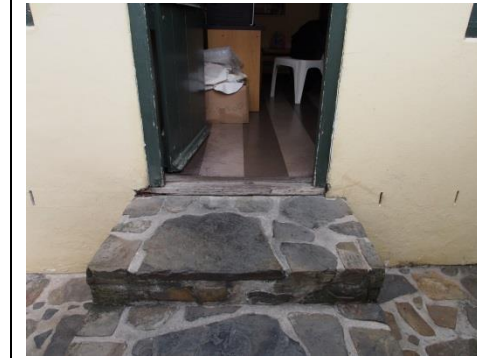
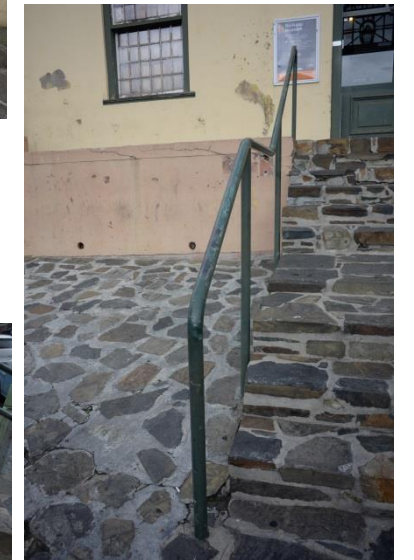
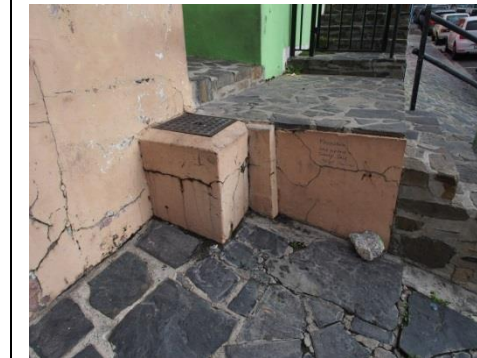
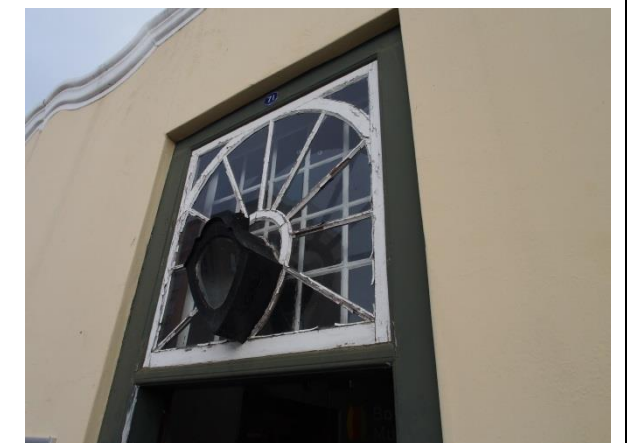
Wale Street Façade

Street front paving and gutter cracked.
Walls spalling with cracks (stoep and building)
Door and windows need repair and painting. Metal cap to lantern missing.
Waterproofing required.

Routine cleaning and maintenance.
Reconfigure stair because of uneven riser.
Investigate replacing unsuitable handrail.
Repair stoep.
Consider replacing front stoep wall, but must be weighed up against security issues. Consider painting stoep front a darker colour.
Repair and repaint front façade walls door and windows.
Consider front door bell/intercom.
Waterproofing required for wall and parapet.

PR 1,4

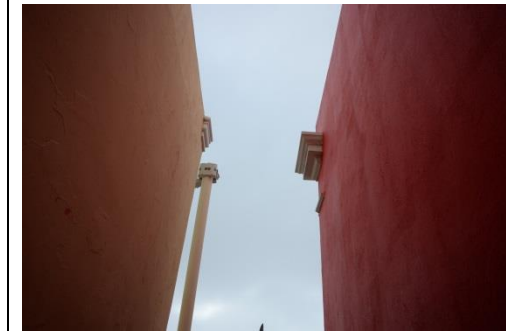
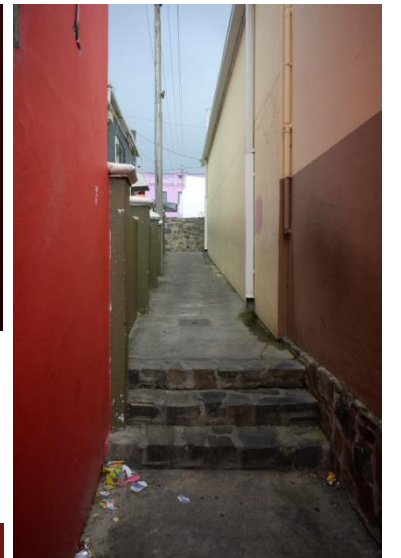
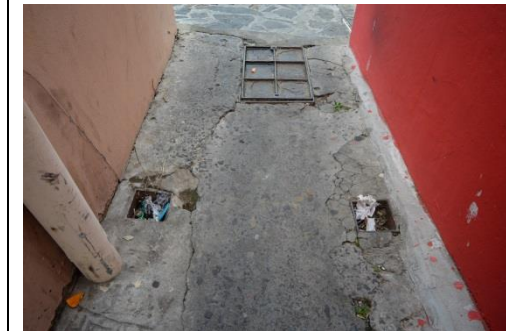
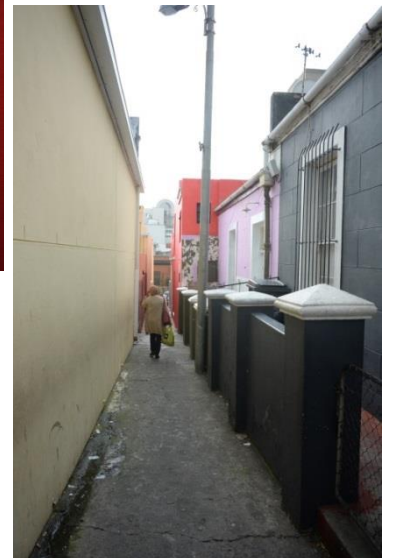
Lane on East Side

Detailed Description:
Narrow pedestrian lane that joins Wale Street with the private parking area.

Condition:
Reasonable

Action:
Routine cleaning and maintenance.
Clean gutters and drains, repair / replace damaged rainwater goods.
Service/repair/replace water valve, lids and manhole cover.
Cracks in cement floor surface.

Recommendation:
PR1,4,5

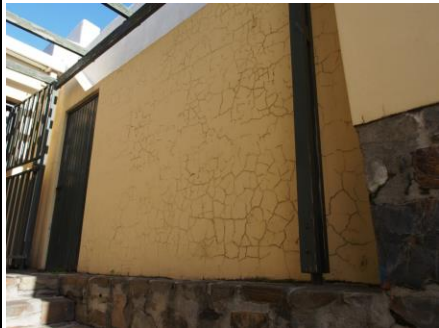
West Lane / Hall Steps

Narrow lane, steps, gates

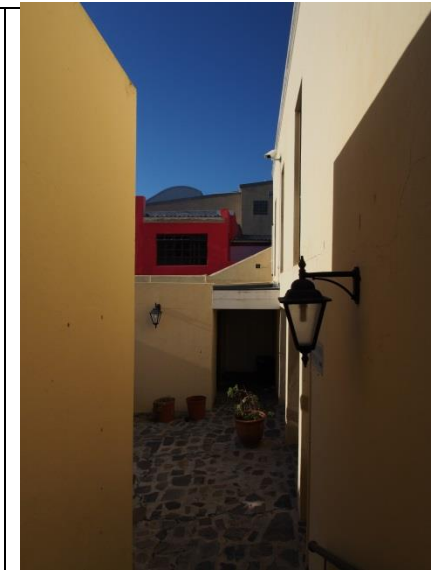
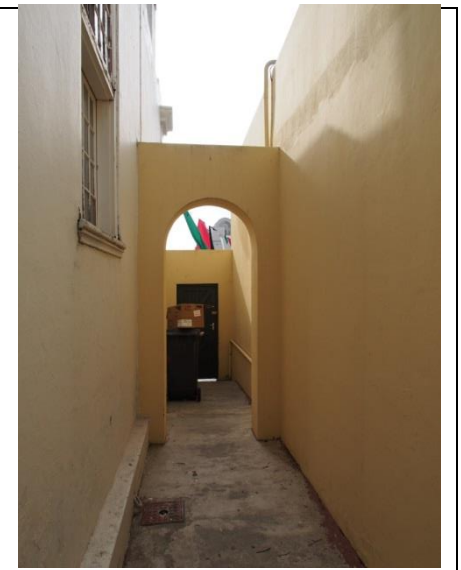
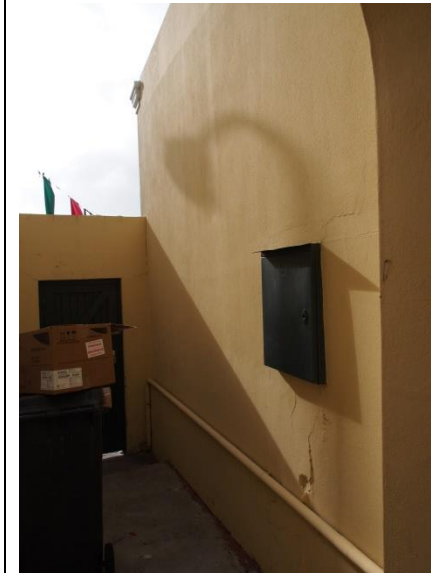
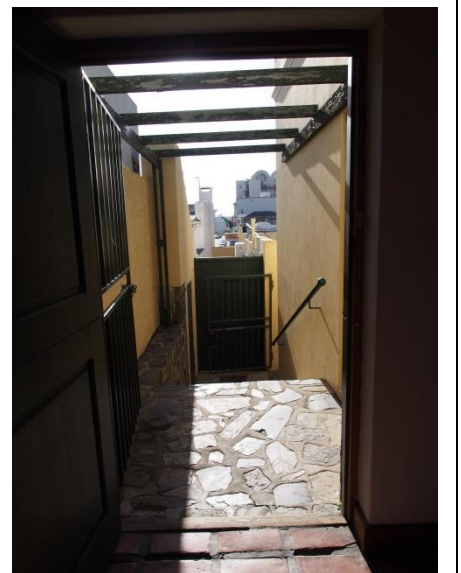
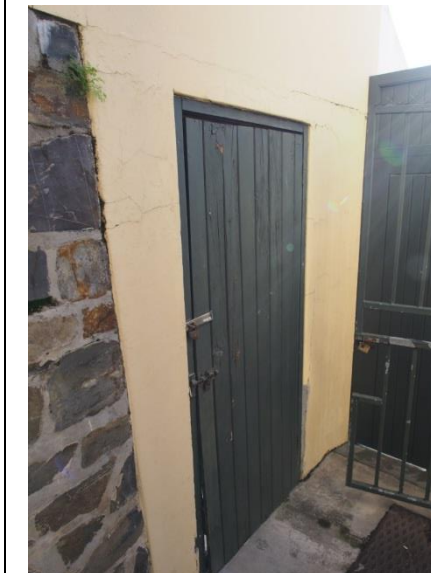
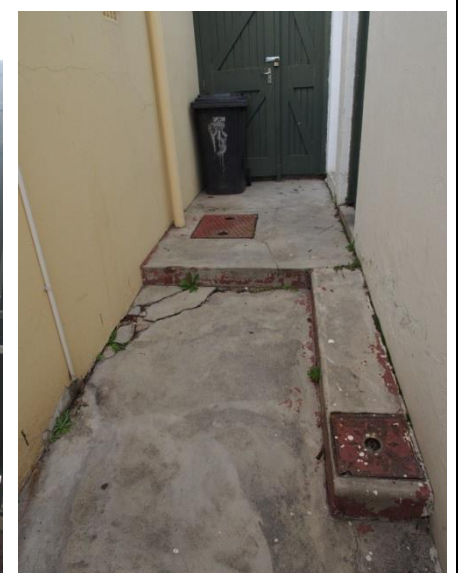
Plastered and painted.
Cracking

Cracks in wall and paving. Bin storage.

Cracks in walls, shutters require maintenance / repair and painting, pergola at entrance hall in poor condition. Cracks in cement floor surface.

Routine cleaning and maintenance.
Repairs of walls, paving and joinery.
Consider replacing existing flimsy pergola with another more suitable structure.

PR2,4,5

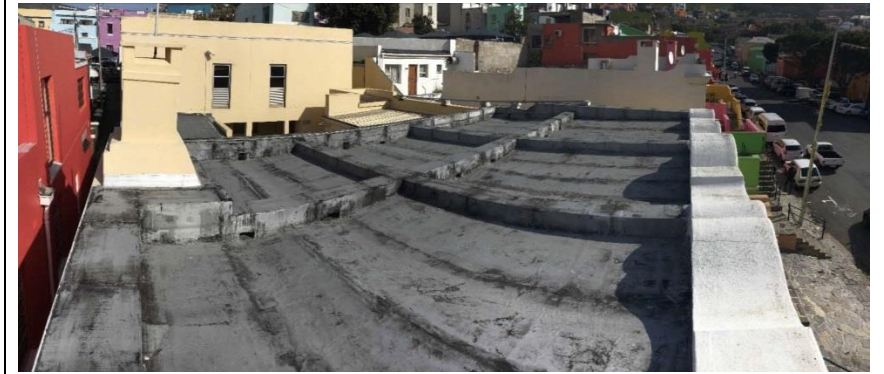
Roofs

The waterproofing and the flashings are worn and need repairs.

The other roofs are also flat mono-pitch with parapets, with IBR roofsheeting. All roofs and flashing are not in a good condition and require repair / replacement. Gutters and downpipes also need attention.

PR4,5
Repair of waterproofing of roofs and flashing required urgently
