ANNEXURE C:

EXTRACT FROM HERITAGE INVENTORY MAY 2011

Reference	0006		
Official name	Heliograph	Other names	7 Inch Equatorial; Centre of Dome (1932)

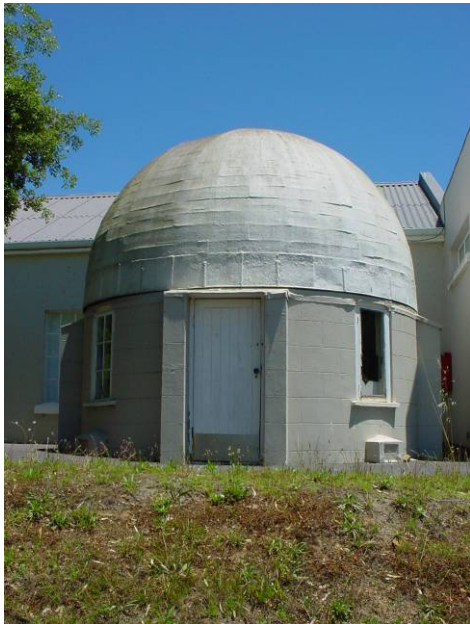
Photograph by Ian Glass (March 2010)

Construction date	1847	Date of alterations	
Original use	Originally housed 7 inch Merz telescope	Current use	Photoheliograph Public outreach
Architect/builder	Mounting manufactured by Troughton and Simms.		
Site description	Wooden dome runs on cannon balls.		
Major alterations	Altered to house photoheliograph. The original Merz mounting was replaced by one manufactured by Troughton & Simms.		
Historical background	<p>The wooden dome was prefabricated in England. Originally housed a 7inch telescope manufactured by Merz. The telescope is now the guider of the 18th inch telescope. The "Kew patter" photoheliograph was originally mounted in a wooden observatory (see # 32).</p> <p>According to Thomas Maclear, when constructing the dome of the 8.5 feet equatorial telescope, a stone (supposed to be the same that bore Lacaille's quadrant) was given to him by Mr Seawright, the then proprieter of the house in Strand Street, Cape Town. It was supposedly built into the recess to support the clock. The recess now has a concrete base (Warner 1988).</p>

Physical condition	Poor. The woodwork around the rim needs repair.
Opportunities & threats	Gradual decay of dome structure due to natural weathering. Part of potential heritage trail. Used for school groups.
Recommendations	Retain use for school groups. Maintain dome function. Undertake necessary work to stabilize the fabric and instruments from further deterioration. Refer to generic conservation management recommendations of Grade 3B structures.
References	Charles, Anne. SAAO Inventory of Buildings and Structures (February 2010) Glass, Ian. SAAO Royal Observatory Site. Extant and former buildings (March 2010) Glass, Ian. Notes prepared for Heritage Survey (Jan 2011) Interview with Brian Warner, Mike Feast and Anne Charles: SAAO, 15 December 2010
