**PROPOSED DEVELOPMENT OF 6 HOLIDAY HOUSES
Remainder of Portion 4 and Portion 8, Rietvley 28KU,**

DEDET Reference 17/2/3/E-240

APPENDIX B.3.5 VISUAL ASSESSMENT

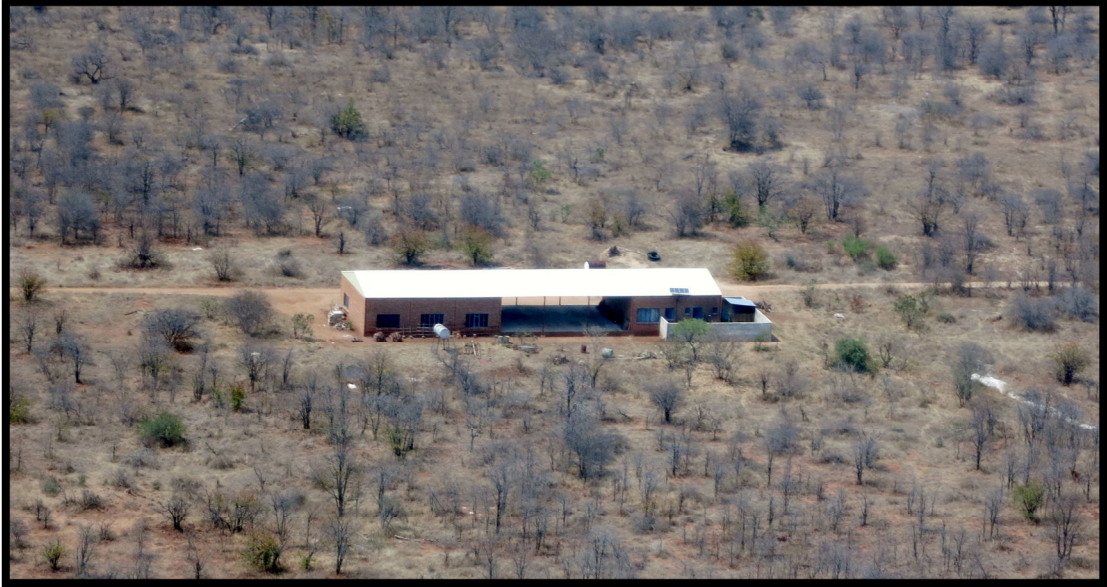
Photo 1: Typical site infrastructure – existing sheds and stores

The Remainder of Portion 4 and Portion 8 of Rietvley 28KU covers approximately 1331 ha of land, largely devoid of infrastructure, with the exception of a farmhouse and various outbuildings sheds and stores. Game drive tracks criss-cross the farm. See Figure 1.

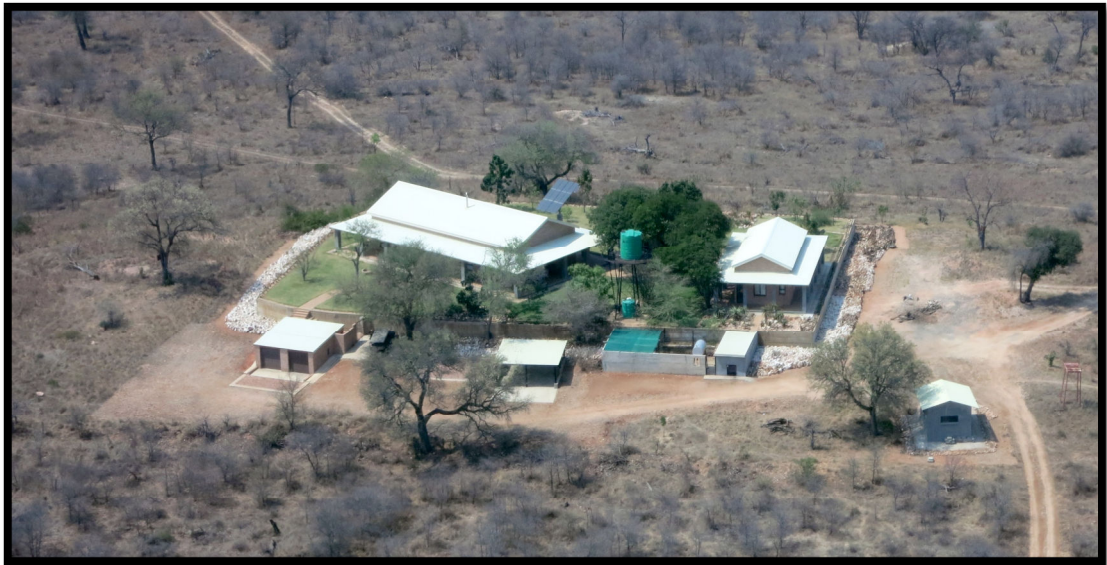
Photo 2: Typical site infrastructure – existing Rietvley farmhouse

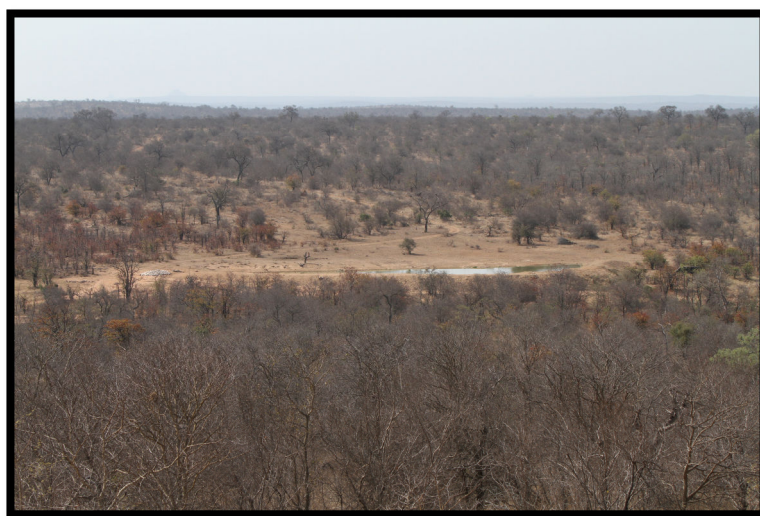
Photo 3: High visual absorption capacity of the Mopani Bushveld vegetation type.

The aforementioned plant communities and associated tree species provide for a *high Visual Absorption Capacity (VAC)*. The VAC would be very effective in absorbing the visual impact of the proposed houses. Photos 3 and 4 illustrate this high VAC.

Conclusion: Erring on the side of caution, and with due consideration of local knowledge and experience, it is estimated that the visual absorption capacity of the Mopane Woodland on the farm Rietvley, is very high and effectively screens visual impact over 500m, even in late winter conditions.

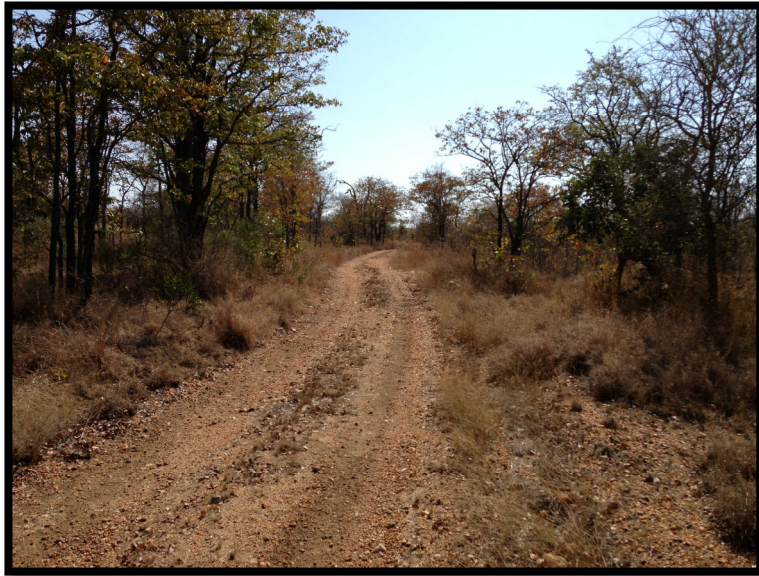
Photo 4: Typical two-spoor track through the Mopani Bushveld.

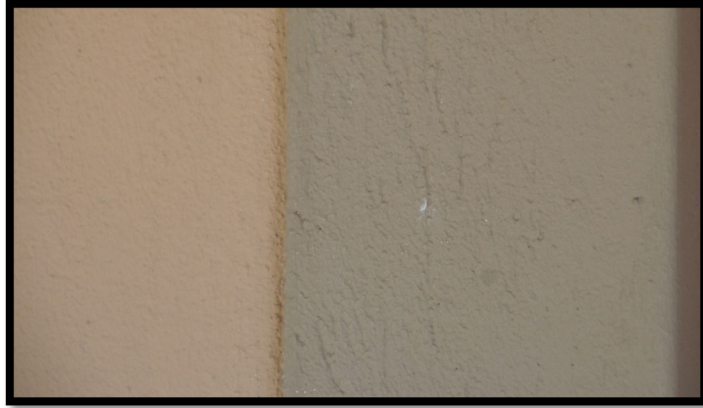
Photo 5: Proposed colour scheme (walls and roofs).

- Colours and textures
 - The colour and texture of the proposed structures must respond to the natural colours and textures of the environment. In this regard, a colour palette is provided for the treatment of all exterior walls (Photo 5).
