JACANA ENVIRONMENTAL

AMBIENT MONITORING

JUNE 2021 MONTHLY REPORT - #1

04 June 2021 - 05 July 2021

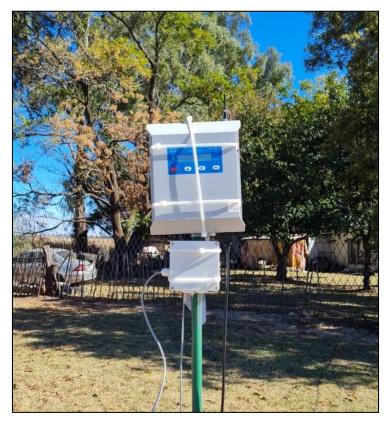
Figure 9-1: Air quality monitoring station installed at Rietkol.

The Beyond Wireless Ambient Station is a real-time particulate matter analyser that measures particulates through near-forward light scattering. Air is drawn into a sensing chamber where it passes through the visible laser light. Aerosols in the air scatter light in proportion to the particulate loading in the air. Scattered light is collected and focused on a PIN diode. Electronics measure the intensity of the focused light and output a signal to the CPU. The ambient station measures two particulate matter fractions, namely PM_{10} and $PM_{2.5}$ in real time.

Data is transferred via the cellular network to a database in Johannesburg. The data is available to view online at <u>www.rayten.co.za</u> (a client login and password is required). The ambient station is positioned on top of a steel pole and secured using cable ties in order to prevent theft and vandalism. The instrument is plugged into a secure power supply from the nearby farmhouse and an image of the ambient station at the site can be seen in Figure 9-1.
