DPR

Report on the ecological and wetland assessment for the proposed alluvial diamond mining operations on a portion of states land including a portion of the Vaal River near the town of Delportshoop, Northern Cape Province.

January 2019

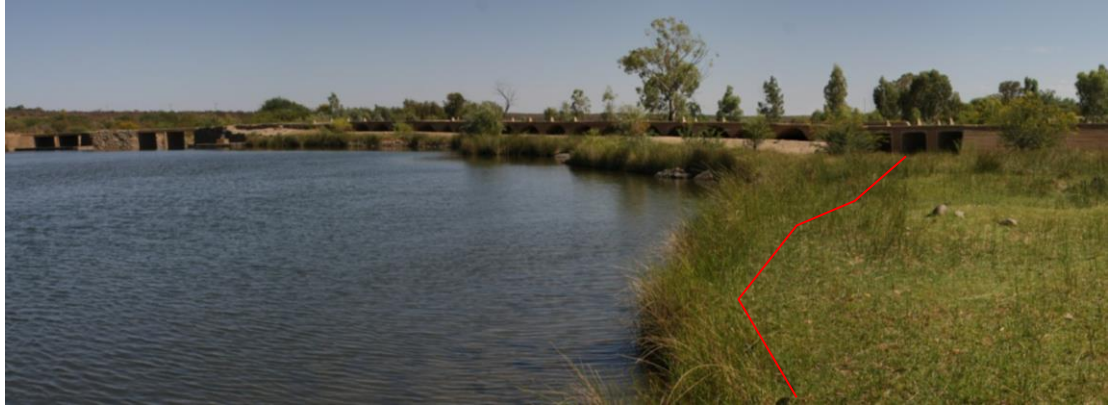
Figure 9: View of the marginal zone (red) at the western border of the site. Note that the zone is relatively narrow. Also the low water bridge immediately downstream of the site.

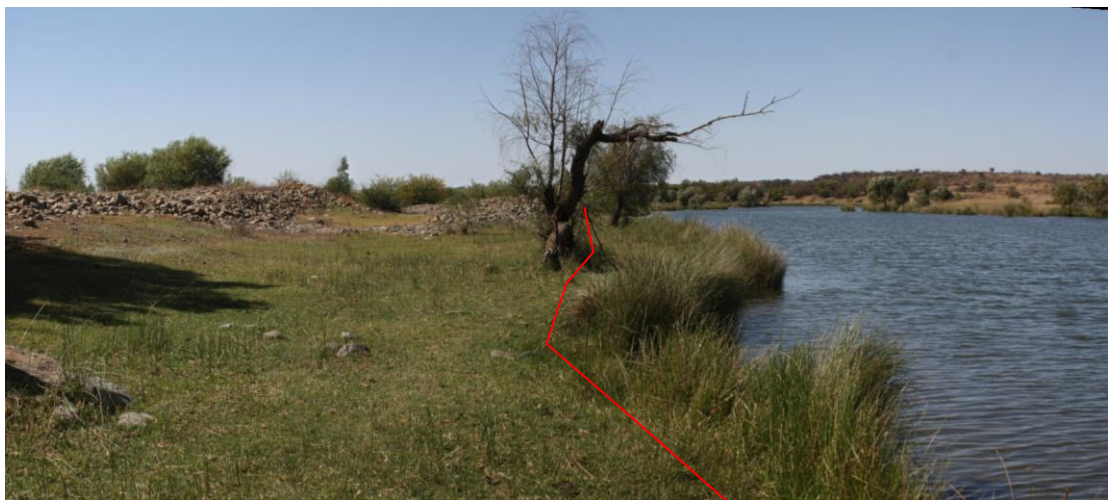
Figure 10: View of the marginal zone (red) at the western border of the site. Note mine tailings are evident in the upper zone.

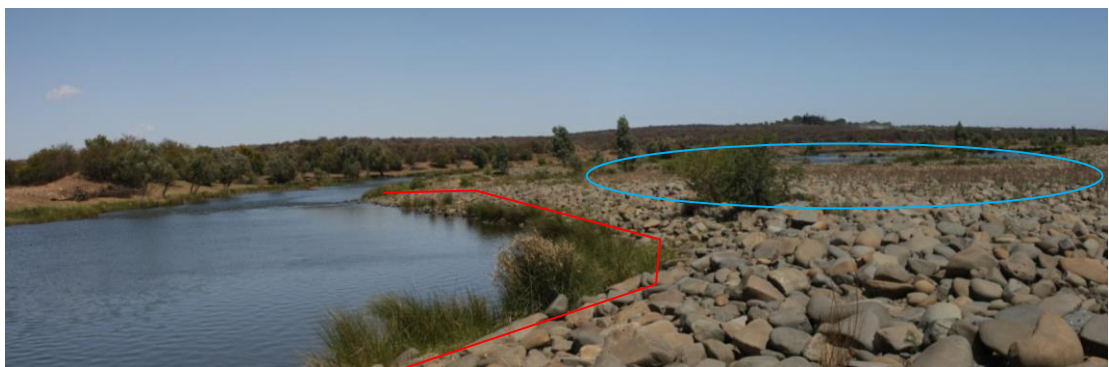
Figure 11: View of the marginal zone (red) in the middle section of the site. Note how mining has caused extensive transformation here. The lower zone is also dominated by exotic weeds (blue).

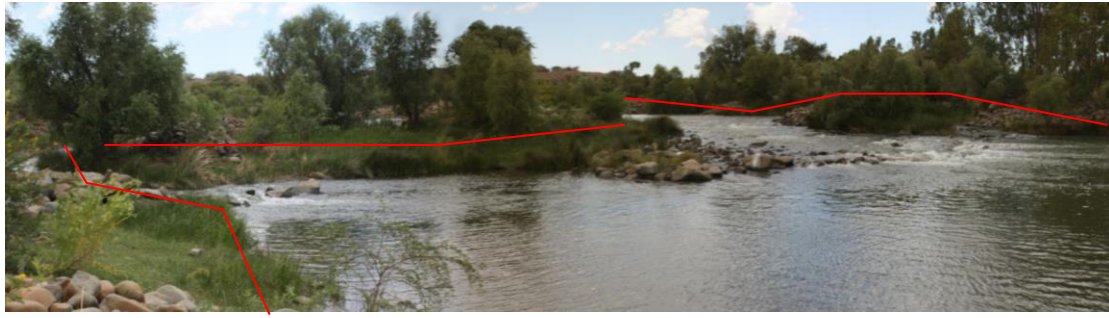
Figure 12: View of the marginal zone (red) at the eastern border of the site at the braided portion of the river. Note that the marginal zone is more extensive here and although mining impacts are visible this area is still considered a unique habitat.

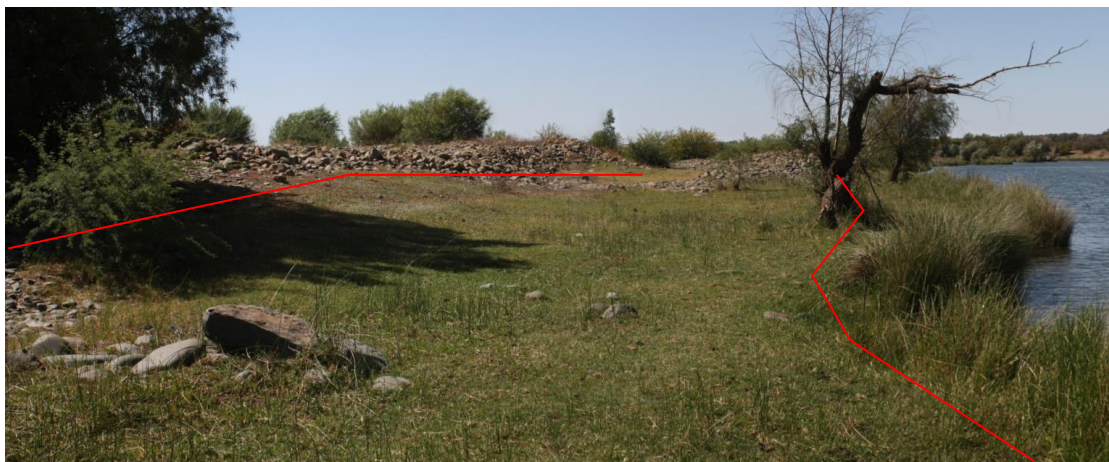
Figure 13: The lower zone (red) at the western border of the site is clearly wider than the marginal zone and dominated a short grass/herb layer.

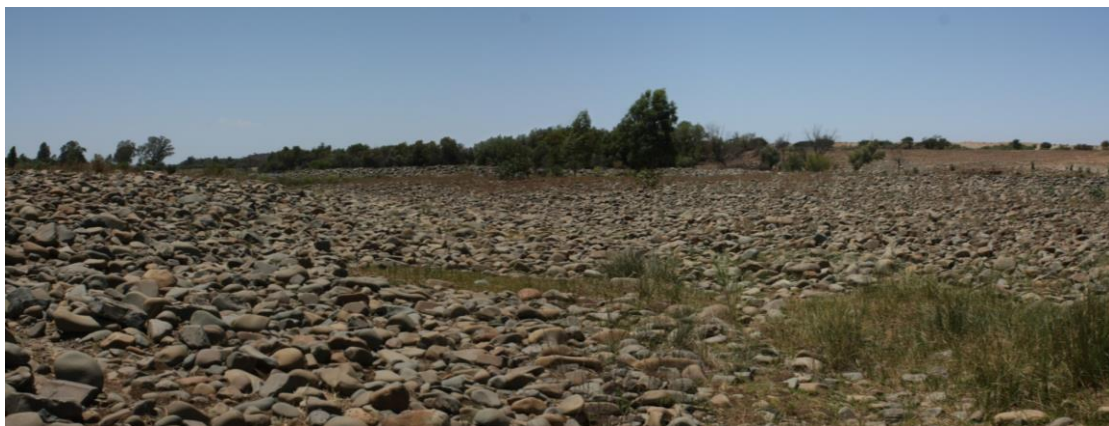
Figure 15: Another view of the same area as depicted in Fig. 14 illustrating extensive disturbance caused by mining.

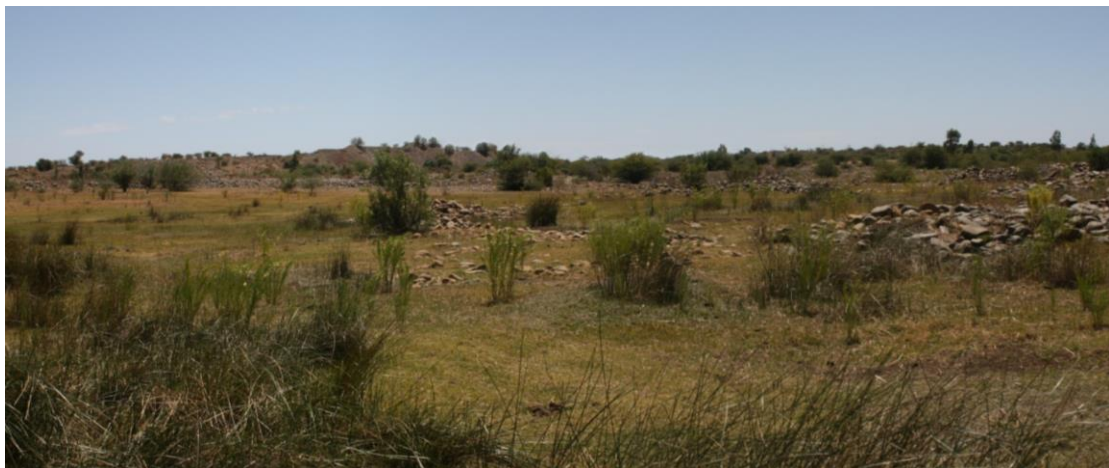
Figure 16: Another view of the lower zone in the central section of the site. Note that here vegetation is present and clearly indicative of wetland condition, albeit on a seasonal basis.

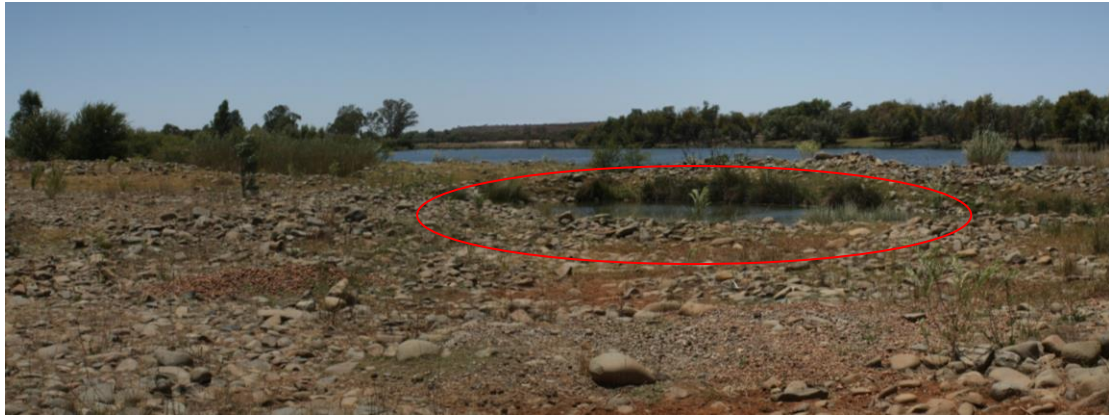
Figure 17: The lower zone (red) at the eastern portion of the site. Note again large-scale degradation caused by previous mining. A poorly rehabilitated excavation formed by mining (red) has also formed an artificial impoundment.

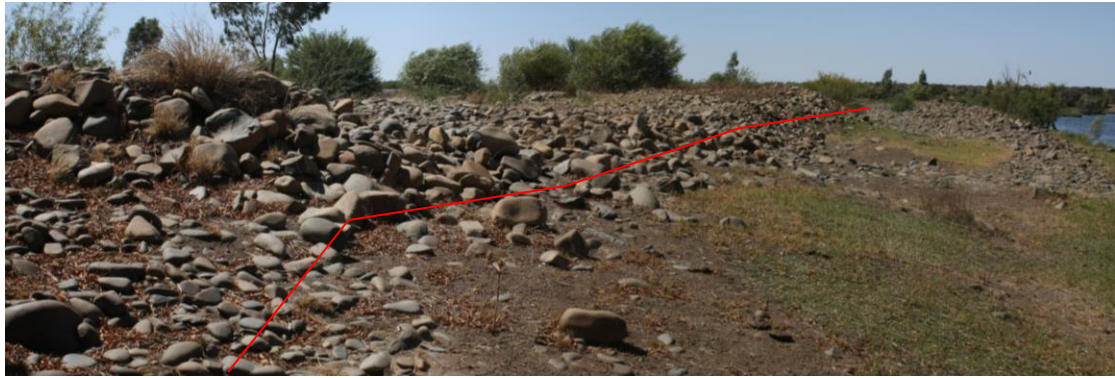
Figure 18: The upper zone (red) is clearly transformed but somewhat discernible where it levels off from the lower zone.

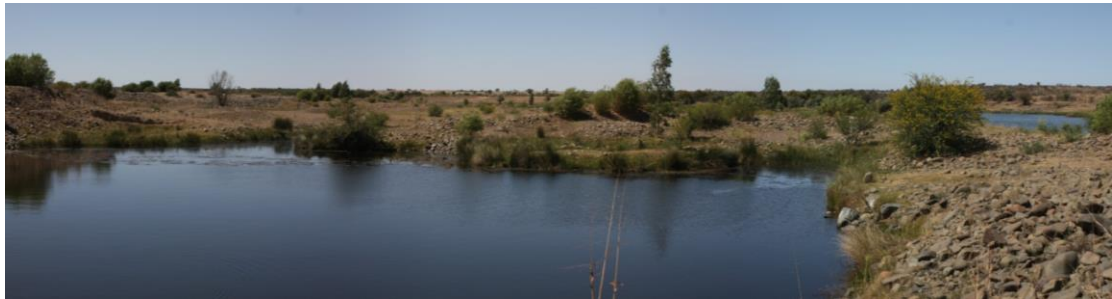
Figure 19: Mining in the upper zone has formed deep excavations which have become filled with groundwater and form artificial impoundments.

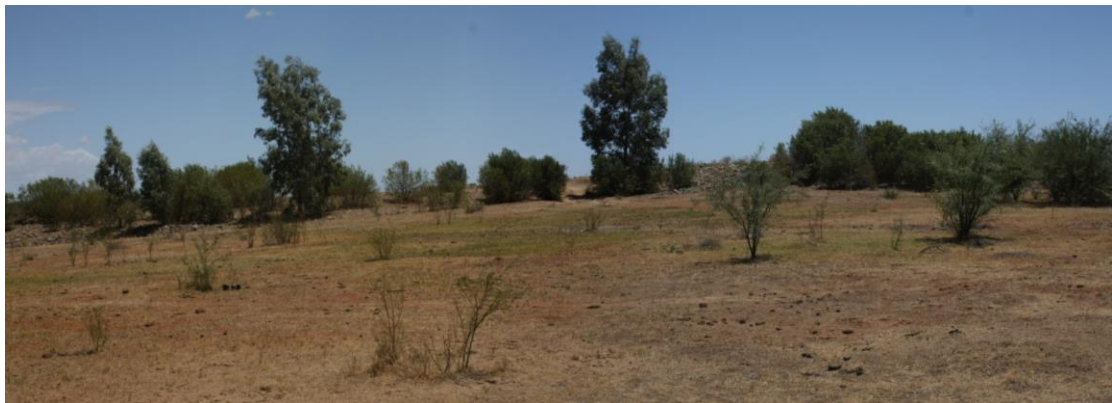
Figure 20: The upper zone in many areas is severely degraded and transformed from the natural condition.

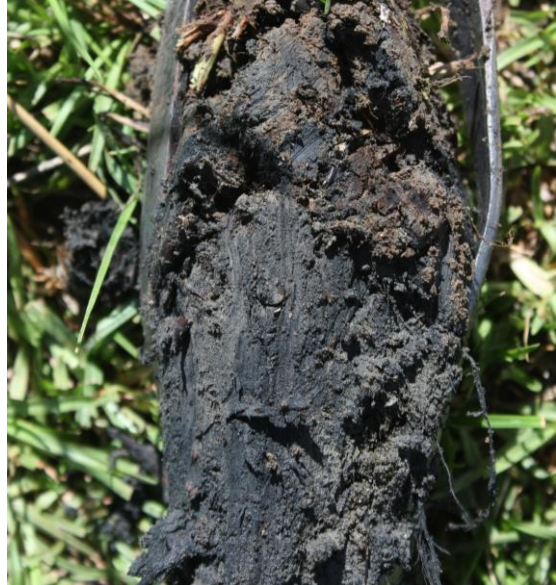
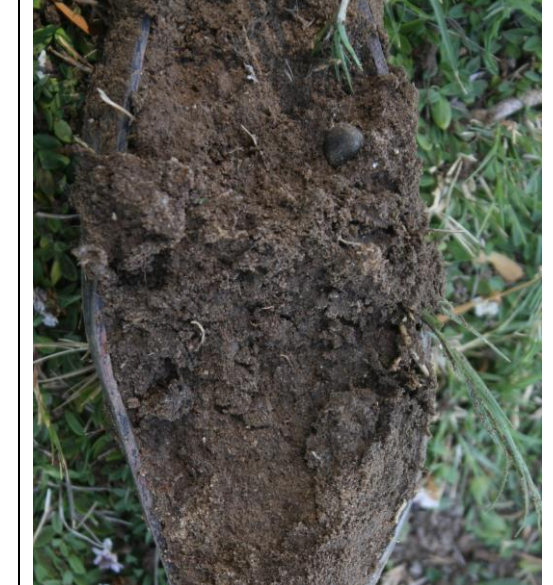
Table 1: Soil samples taken along a lateral transect of the Vaal River along the western portion of the site (S 28.451381°, E 24.327183°).

<p>Soil sample taken in the marginal zone of the river. A prominent grey matrix (>10%) is clear and mottling is present indicating a permanent zone of wetness. Wetland conditions are therefore clearly present.</p>	<p>Soil sample taken in the lower zone of the river bank. A grey matrix (<10%) is clear and mottling is present indicating a seasonal zone of wetness. Wetland conditions are therefore clearly present.</p>

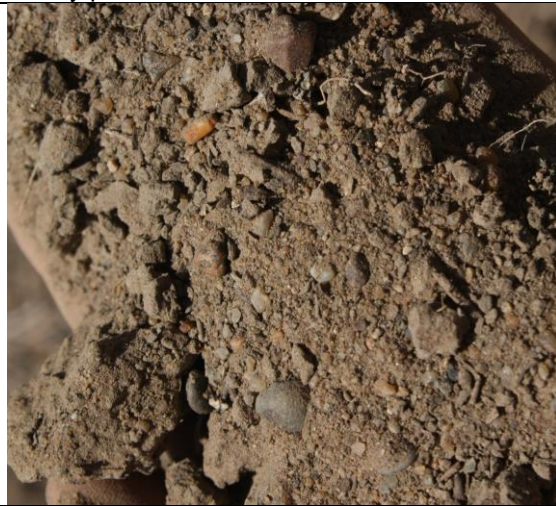
<p>Soil sample taken in the upper zone of the river bank. A grey matrix and mottling is clearly absent and wetland conditions are not present. A high silt content does indicate it still forming part of the floodplain.</p>

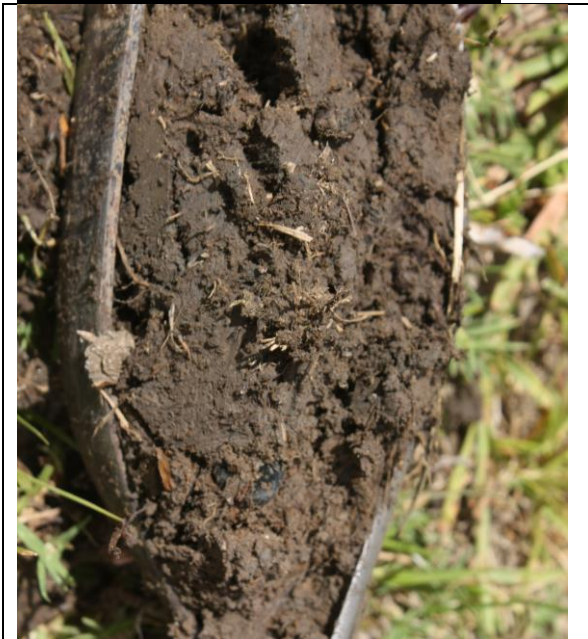
Table 3: Soil samples taken along a lateral transect of the Vaal River along the eastern portion of the site (S 28.456620°, E 24.333812°).

<p>Soil sample taken in the marginal zone of the river. A prominent grey matrix (>10%) is clear and mottling is present indicating a permanent zone of wetness. Wetland conditions are therefore clearly present.</p>
