DPR
Ecologists & Environmental Services

Ecological and Wetland Assessment for the proposed diamond prospecting operations on a portion of the Remainder of the farm Remhoogte 152 near Prieska, Northern Cape Province.

March 2019

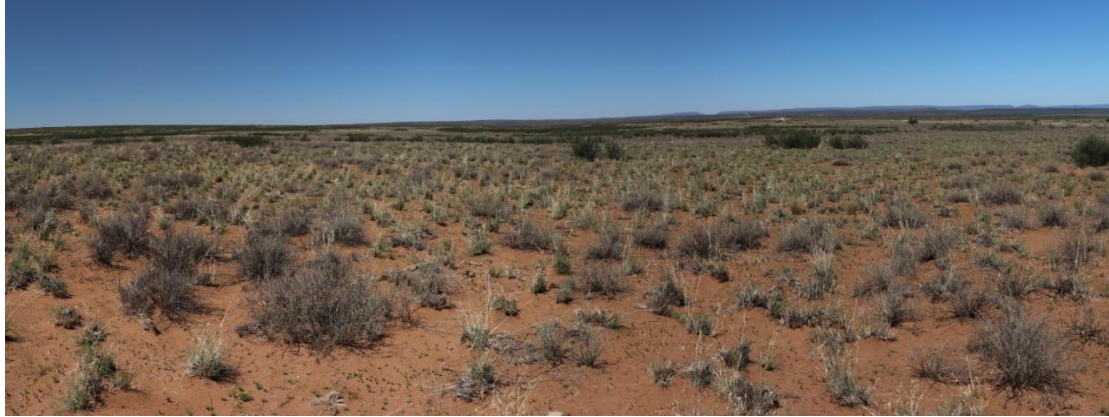
Figure 1: Panorama of the undulating plains portion. Note a relatively flat to gently sloping topography with a sparse but dominating grass layer. Darker patches in the background is dominated by the low shrub, *Rhigozum trichotomum*.

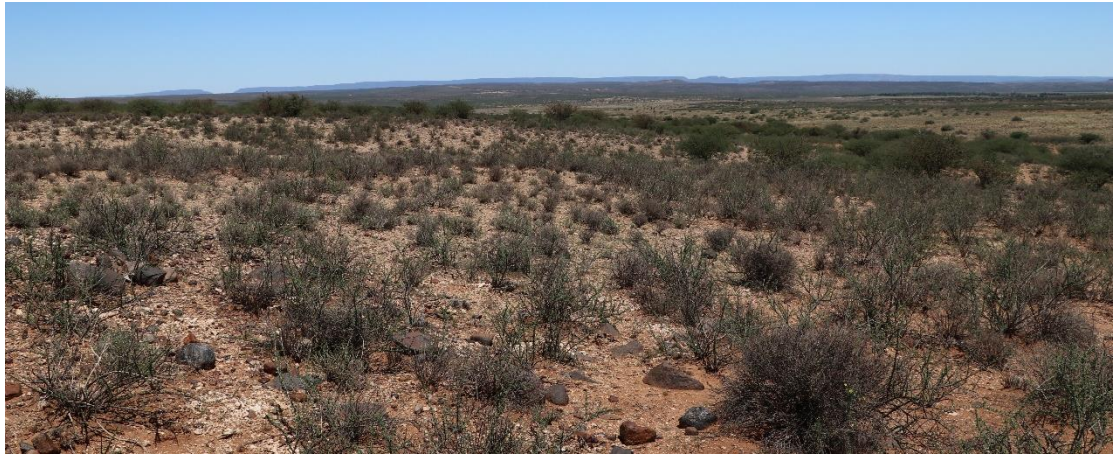
Figure 5: View of the calcrete ridge illustrating the high percentage surface calcrete and sparse but prominent dwarf karroid shrub dominance.

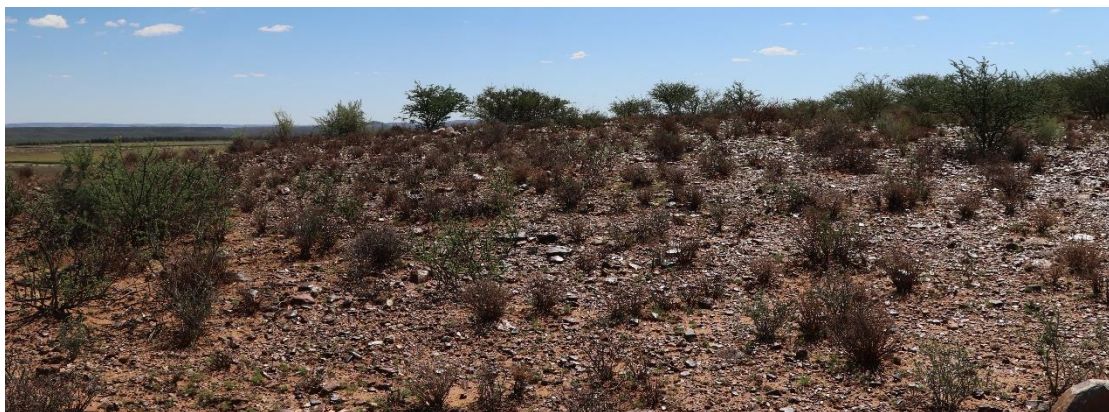
Figure 7: View of the small ridge which illustrates the high percentage surface rock and vegetation structure dominated by dwarf karroid shrubs and small trees.

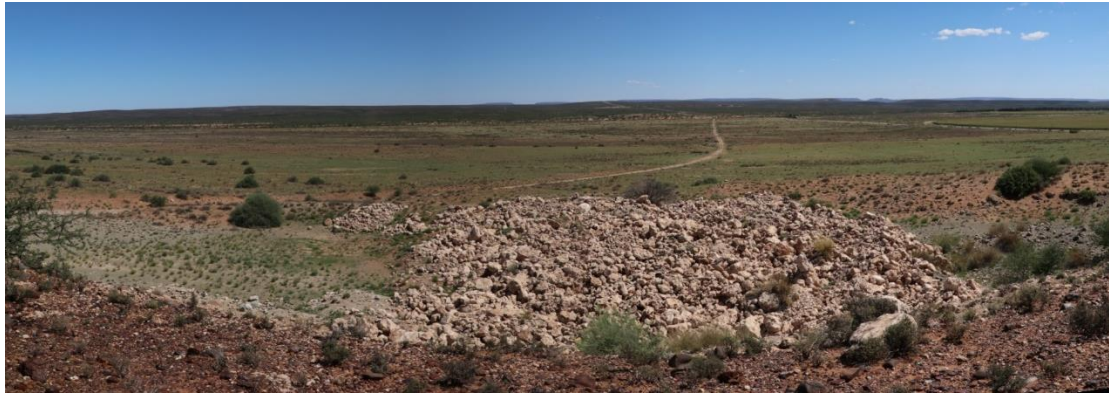
Figure 8: Panorama of the borrow pit which has evidently caused transformation of a portion of the ridge. Note the bottomlands portion adjacent to the ridge in the background.

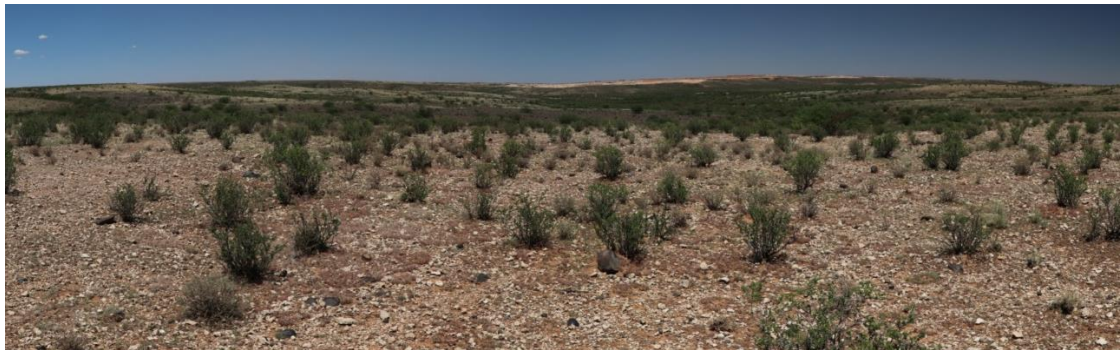
Figure 16: The geology in this area is also variable with some areas being dominated by surface calcrete.

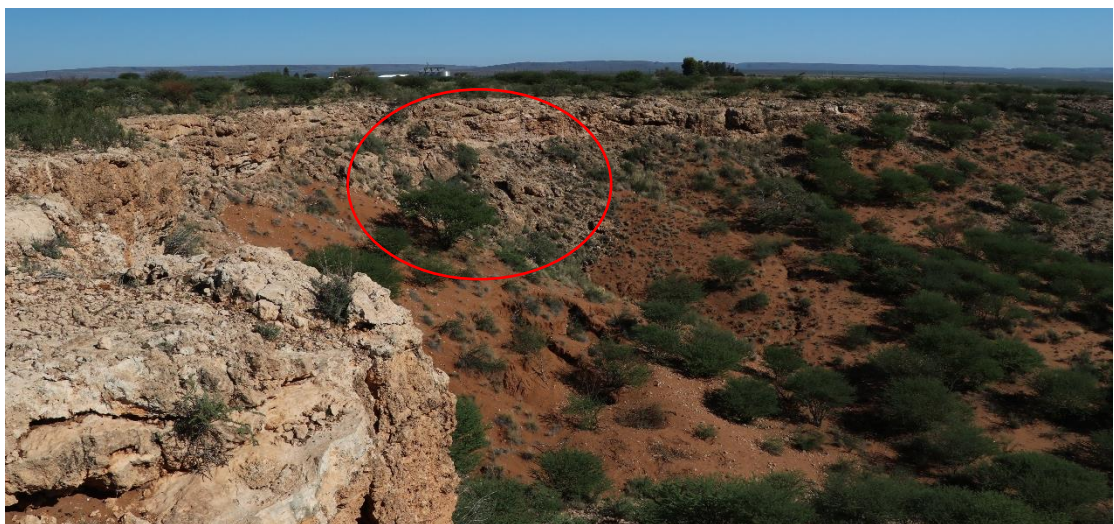
Figure 21: View of the calcrete cliff. It is evident that cliff collapse does occur periodically (red) and also confirms the unstable nature of this habitat.

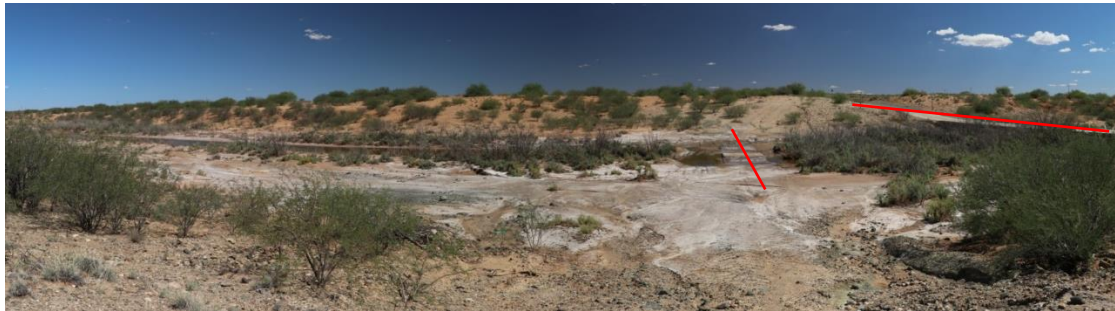
Figure 27: Panorama of the Brak River near the western border of the site. The two low water crossings are visible (red). Note also high level of salt residue (white colouration) and infestation by exotic Mesquite Trees along the banks.

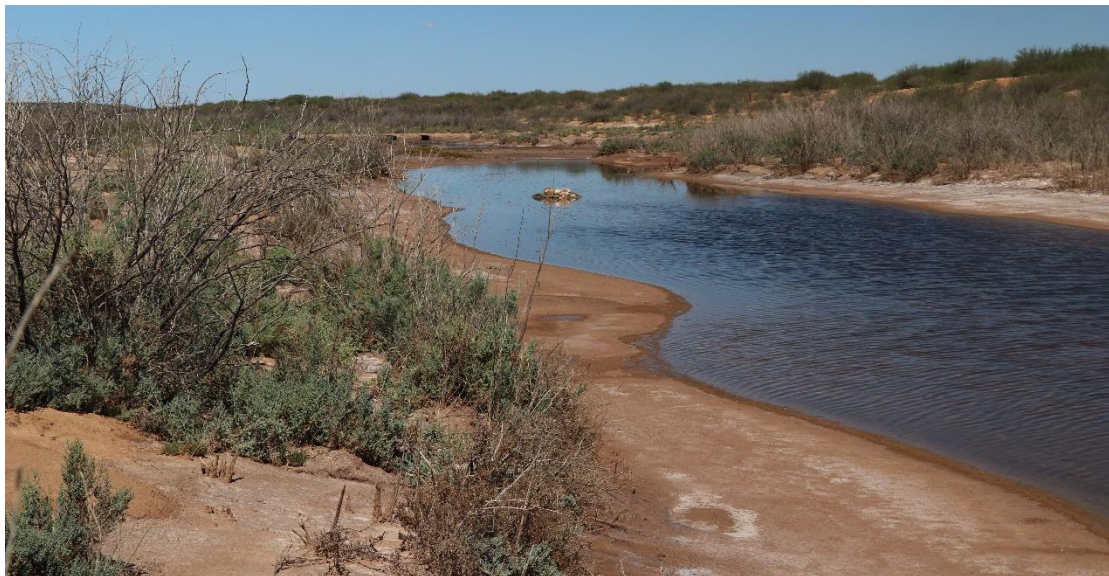
Figure 28: View of the main channel of the river. It should be clear that main channel flow occurs at least seasonally.

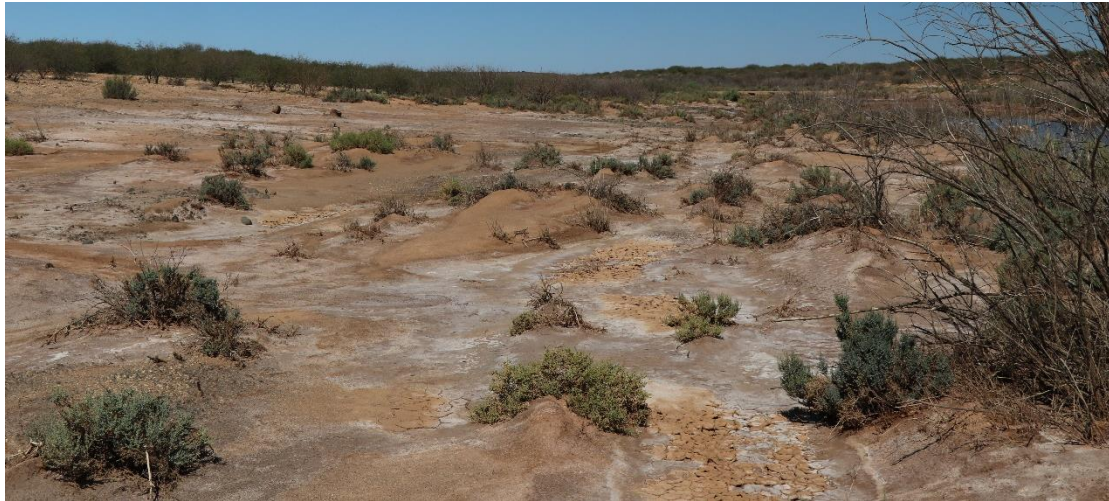
Figure 29: Close-up of the banks of the river which illustrates the high salt concentrations.

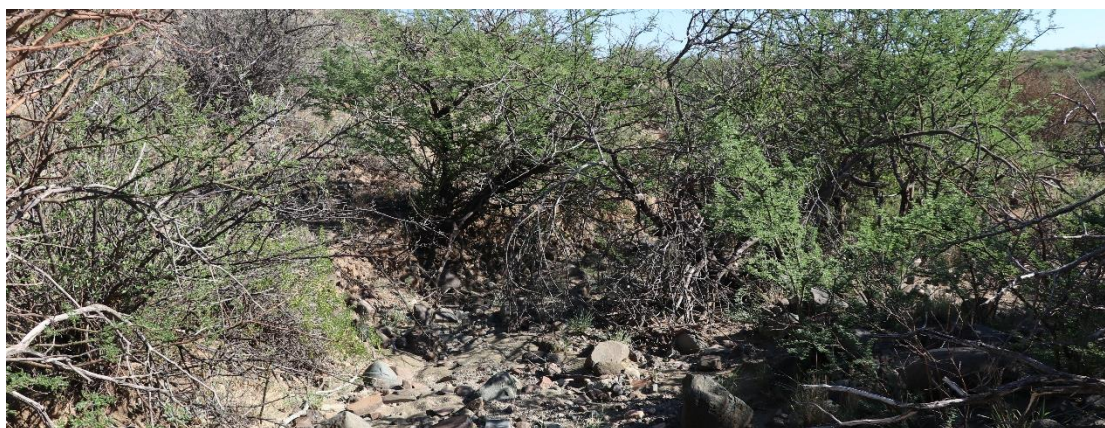
Figure 32: View of an upstream tributary near the origin. A main channel is prominent with terrestrial species dominating.

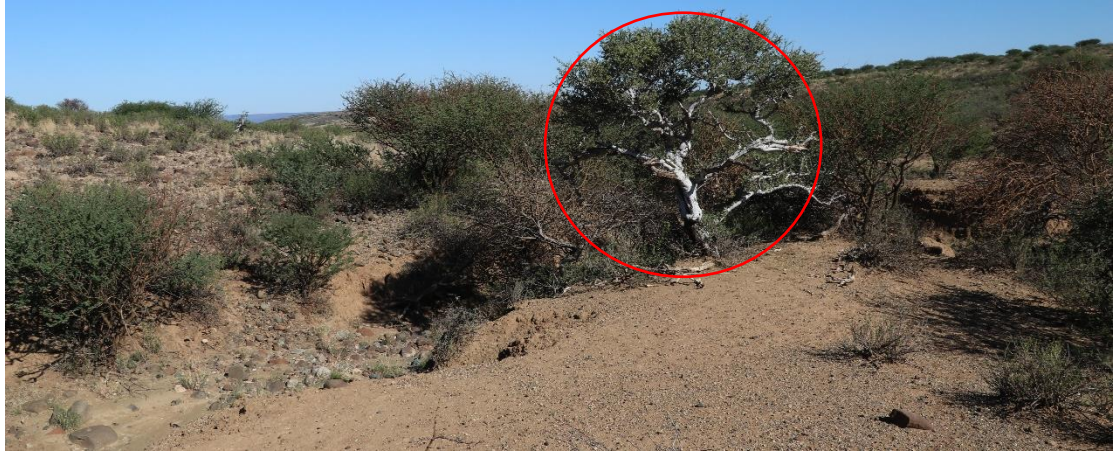
Figure 33: View of the upper reach of the stream. Note that the main channel is already quite large and a floodplain consisting of deposited sediment is already present. Note also the large specimen of the protected *Boscia albitrunca* (red).

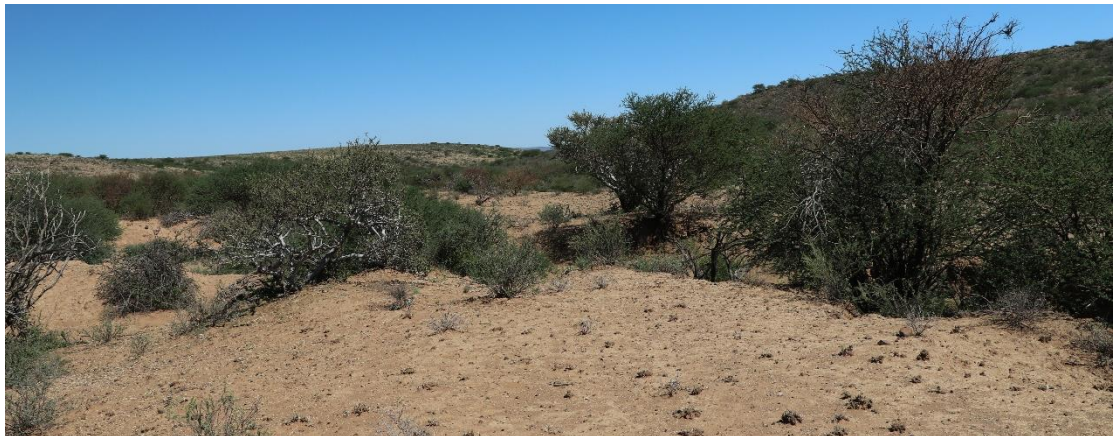
Figure 35: View of the floodplain in the same location as Fig. 34. Note that it already becomes quite extensive here.

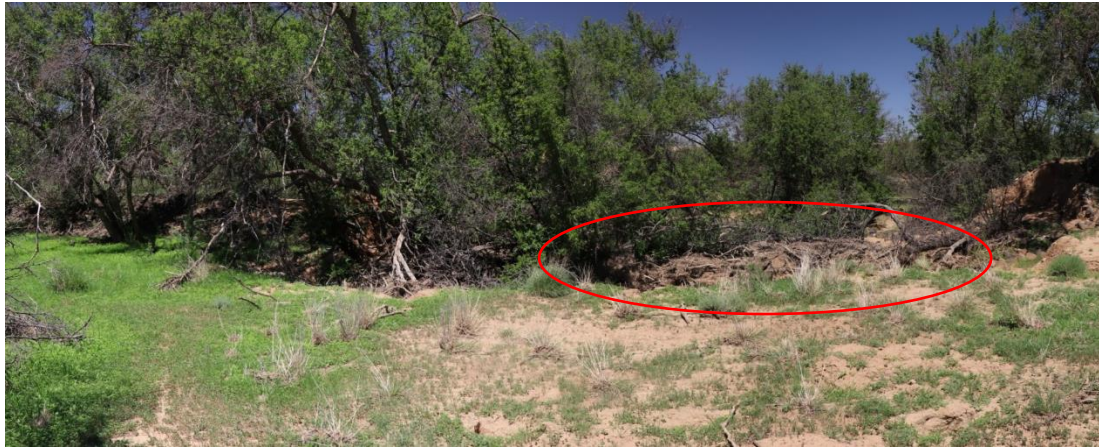
Figure 36: View of one of the small impoundments in the upper reach of the stream. The damwall has been breached and it is no longer functional. Note the large amount of flood debris (red) which should indicate that large water volumes are discharged during flash flooding.

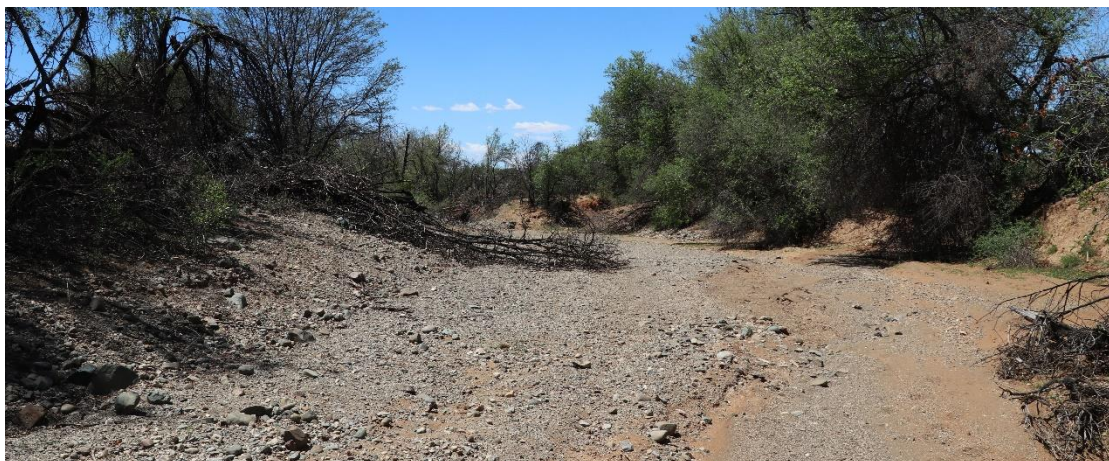
Figure 38: View of the stream in the downstream section. Note the large size of the main channel indicating large flooding events occurring from time to time.

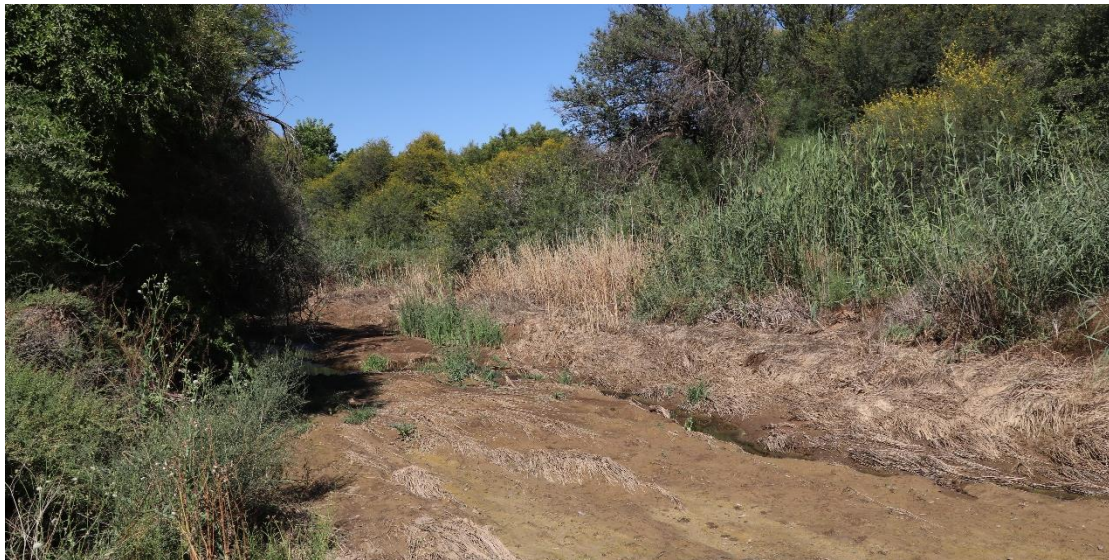
Figure 40: View of the Diepsloot where it exits the prospecting area. Note dense riparian vegetation and reed stands. The main channel exhibits visible residues and high algae concentrations which are most likely attributed to abundant nutrients resulting from the adjacent irrigation.

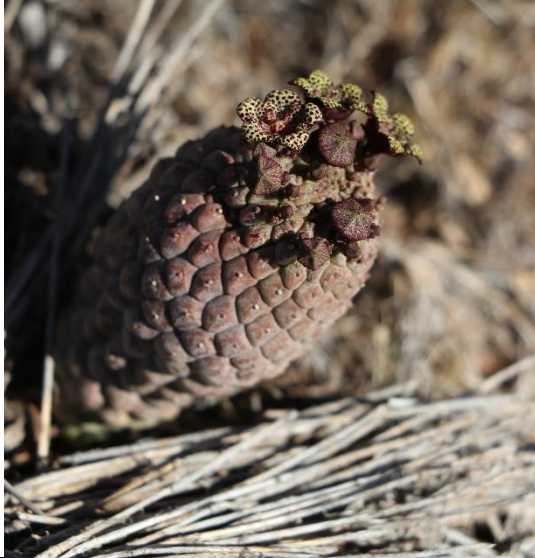
Larryleachia picta
Hondebal

Protected under the Northern Cape Nature Conservation Act (NCNCA)

National Red Listed Status: **Least Concern**

Method: **Rare in the uneven rocky portion in the northern prospecting areas. As long as the uneven rocky terrain is excluded from prospecting they should remain unaffected.**

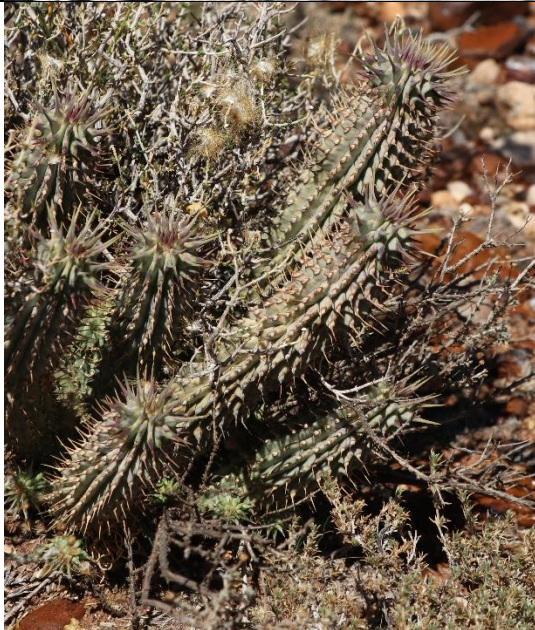
Hoodia gordonii
Hoodia/Bitterghaap

Protected under the Northern Cape Nature Conservation Act (NCNCA)

National Red List Status: **Data Deficient – Insufficient information**

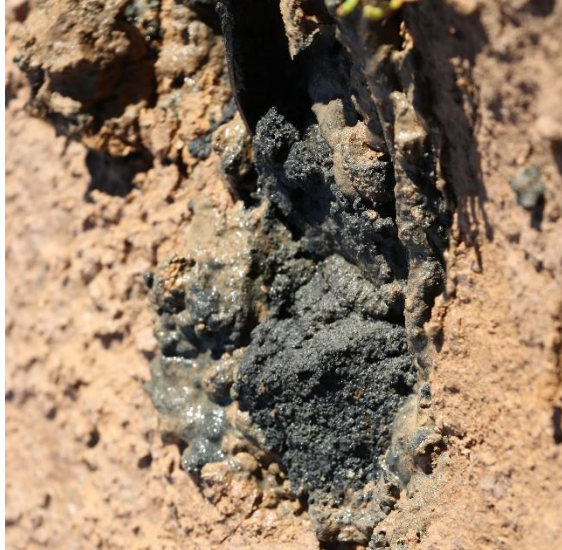
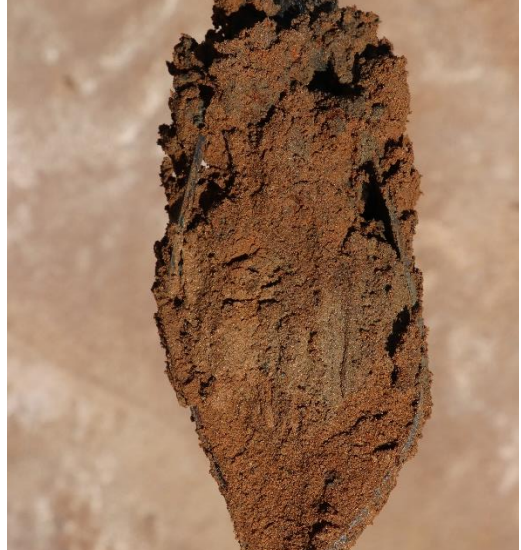
<p>Soil sample taken in the main channel of the Brak River near the western border of the site. A prominent grey matrix (>10%) is clear and mottling is present indicating a permanent zone of wetness. Wetland conditions are therefore clearly present.</p>	<p>Soil sample taken on the banks of the Brak River near the western border of the site. A grey matrix (<10%) is clear and mottling is prominent indicating a seasonal zone of wetness. Wetland conditions are therefore clearly present.</p>

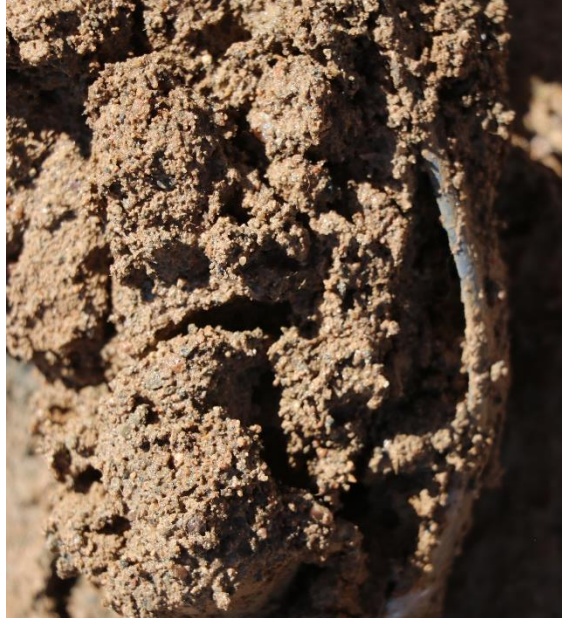
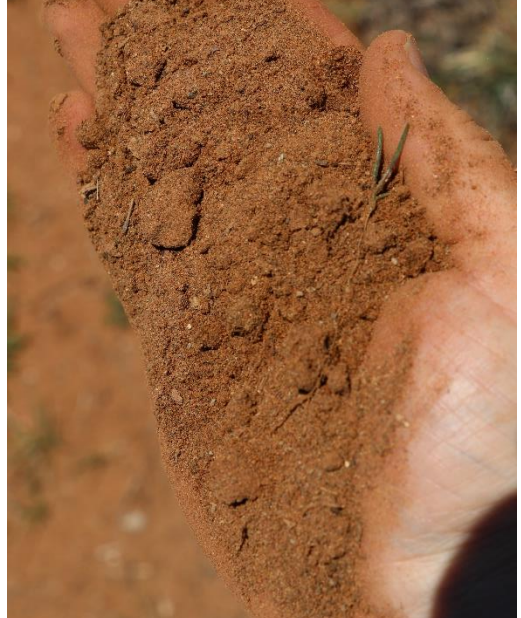
<p>Soil sample taken in the main channel of the Brak River in the central portion of the site. A prominent grey matrix (>10%) is clear and mottling is present indicating a permanent zone of wetness. Wetland conditions are therefore clearly present.</p>	<p>Soil sample taken in the main channel of the drainage line. Soils are dominated by a high sand content without any grey matrix or mottling and wetland conditions are clearly absent. The soil does exhibit a clearly higher moisture regime and indicates periodic water flow.</p>

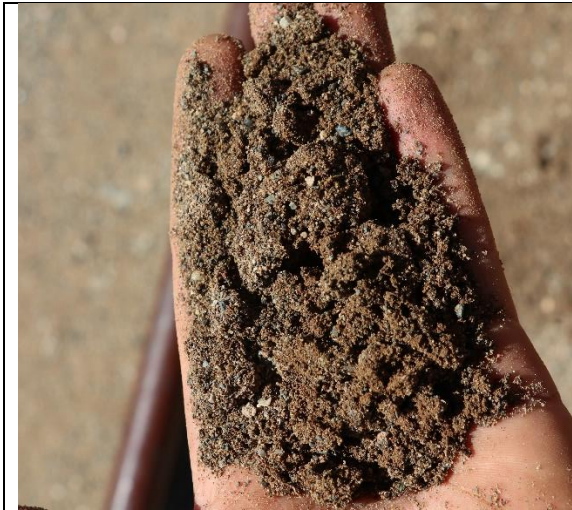
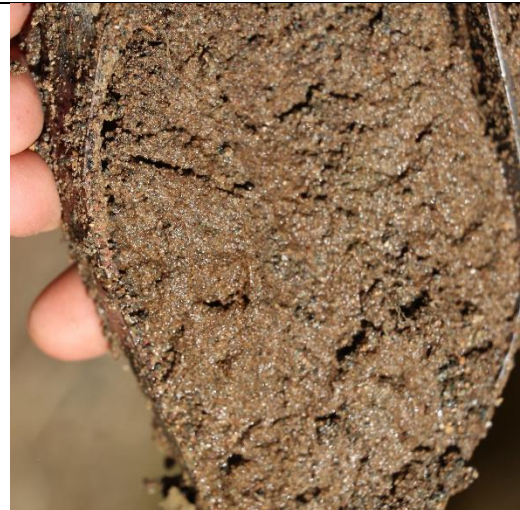
Soil sample taken in the lower reaches of the Diepsloot.
Moisture content becomes progressively higher although wetland conditions are still absent.
