**PRELIMINARY GEOHYDROLOGICAL
ASSESSMENT OF THREE (3 NO.) CANDIDATE
SITES FOR THE PROPOSED UMZIMKHULU
LANDFILL**

REFERENCE 41113R02

FINAL REPORT

MAY 2013

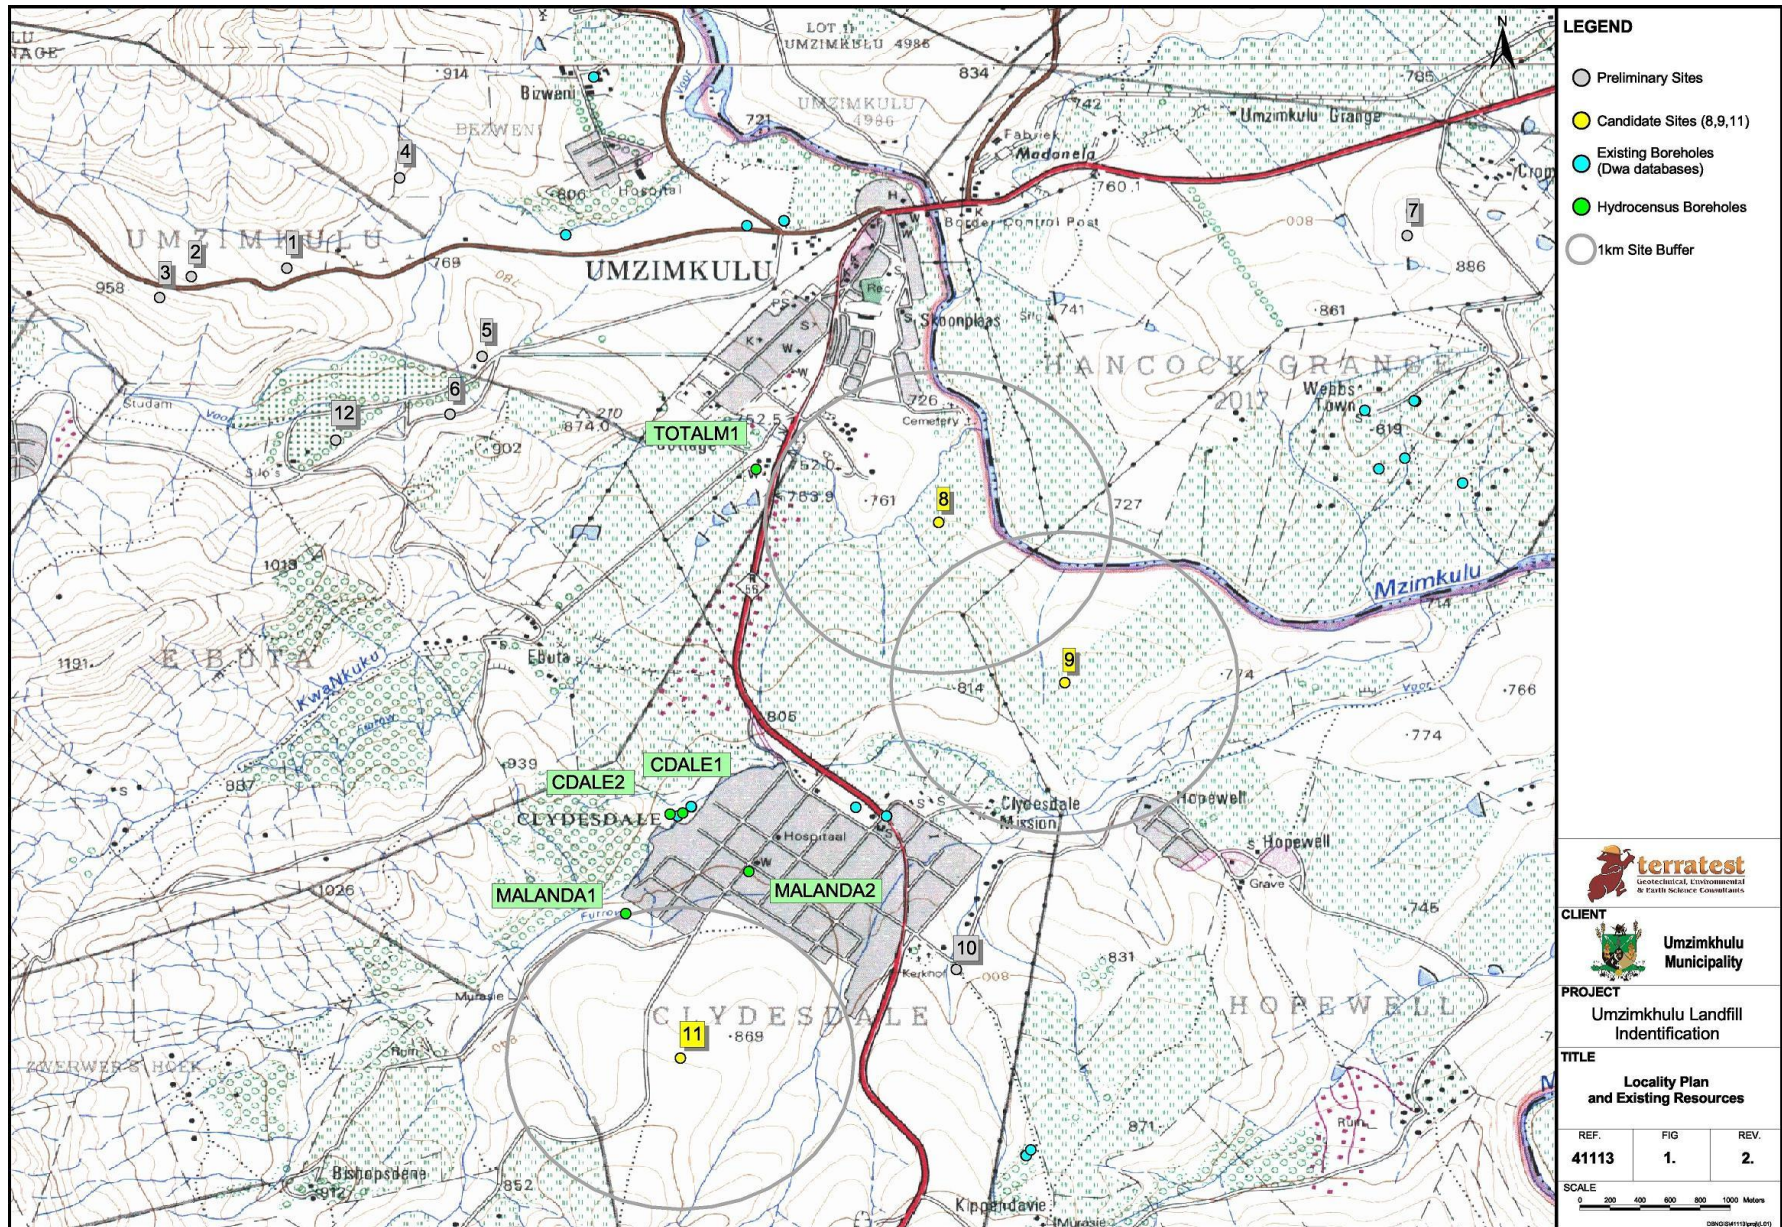
The National Groundwater Archive (NGA) and the KZN GRIP datasets of the DWA were interrogated to establish the existence of boreholes in the area and to review the expected geohydrological conditions and existing groundwater use in the project area. The NGA and GRIP datasets reported five (5 No.) resources within a 2km radius of the proposed sites. The borehole resource information is summarised in Table 5.2 and the approximate locations are shown in Figure 1.

During the site assessment, a hydrocensus was carried out. The results of the hydrocensus are summarized in Table 5.3.1 and the locations of resources are shown in Figure 1.

Proposed Site	Distance (m)	Resource	South	East	Type	Comments
8 East Clydesdale	1106	TOTALM1	30°16'28.50"	29°56'0.80"	borehole	Borehole upslope of site, equipped with submersible and in use Sample Taken
9 East Clydesdale	No resources identified within 1km					
11 South Clydesdale	1012	MALANDA1	30°18'4.10"	29°55'32.80"	borehole	Borehole downslope of site, equipped with submersible and in use Sample taken
	1293	MALANDA2	30°17'55.10"	29°55'59.30"	borehole	Borehole downslope of site, equipped with submersible and in use
	1621	CDALE2	30°17'42.70"	29°55'42.30"	borehole	DWA resource 3029BD0007 Borehole downslope of site, equipped with electric mono pump and in use
	1627	CDALE1	30°17'42.50"	29°55'45.00"	borehole	DWA resource 3029BD0008/20 Borehole downslope of site, equipped with electric mono pump and in use

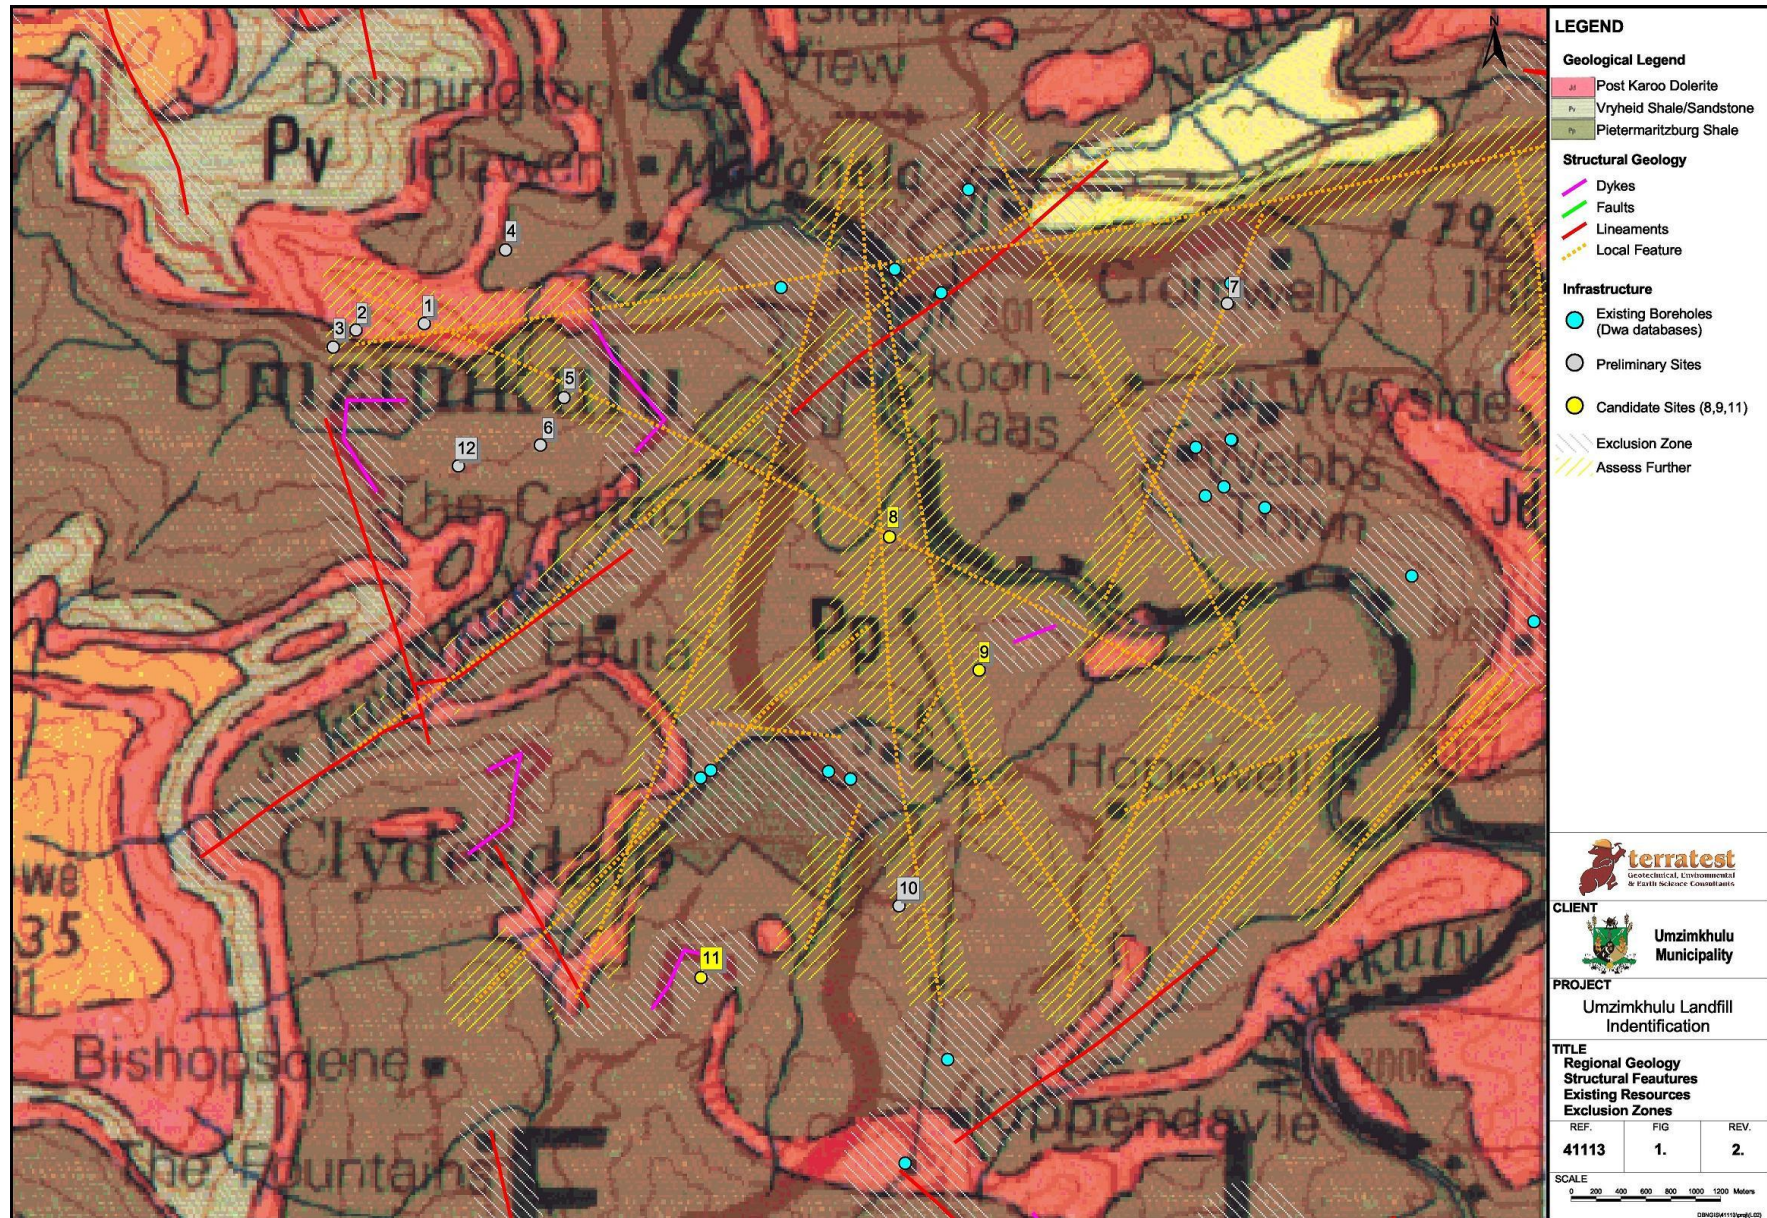
The regional geology underlying the project area is characterized by shale of the Pietermaritzburg Formation, with sandstone of the Vryheid Formation and shale of the Volksrust Formation to the west, all of the Eccca Group. Dark grey shale of the Pietermaritzburg Formation underlies sandstone and shale of the Vryheid and Volksrust Formations. The Pietermaritzburg Formation attains a maximum thickness of 400m in the southeast, thinning towards the north. The Vryheid Formation to the west thins towards the north, west and south from a maximum thickness of 500m. The Volksrust Formation further to the west reaches a thickness of 380m and thins to 250m towards the east. The Eccca Group is regionally intruded by Post Karoo Dolerite in the form of sills and dykes. The regional geology is presented in Figure 2,

Air Photo and satellite imagery interpretation was carried out to determine the presence of any geological structures in the area. The structural geology and air photo interpretation of the area is presented in Figure 2. Geological structures are often targeted during groundwater drilling programs as zones of heightened groundwater potential. Any structural features in close proximity to the candidate sites would present a potential fatal flaw due to the associated groundwater potential and preferential groundwater flow path. Structural features should be assessed further with geophysics and exploratory drilling.

The site is covered by colluvial soils which are underlain by the residual shale of the Pietermaritzburg Formation. The residual material is underlain by soft to medium hard rock shale. East Clydesdale 8 is surrounded closely by three notable structural features on the up and downslope sides. Due to their proximity and occurrence, these features would need to be assessed further with geophysics to determine groundwater potential beneath the site. The close proximity of these features is considered a negative aspect for site development due to possible groundwater contamination.

The site is covered by colluvial soils which are underlain by residual shale and subsequently weathered soft to medium hard rock shale. The host rock has been intruded locally by dolerite 350m on the downslope side to the east. Groundwater potential may be heightened along fracture zones associated with the dolerite intrusion. Groundwater flow in this area may be complex and multidirectional, but in general towards the Mzimkhulu River. East Clydesdale 9 is adjacent to one of the same structural features passing site 8 but 200m upslope of the site. The proximity of the dolerite intrusion is partly considered a negative aspect for site development due to possible groundwater contamination, however, groundwater flow is expected to be in a northerly direction bypassing this feature.

The site is covered by colluvial soils which are underlain by residual and soft to medium hard shale. Post Karoo dolerite has intruded the host shale to the north east and south east but in the range 350 to 450m. The host rock has further been intruded locally by dolerite 200m on the downslope side to the north. Groundwater potential may be heightened along fracture zones associated with the dolerite intrusion. Groundwater flow in this area may be complex and multidirectional. The dyke may further act as a cut off of groundwater flow in a northerly direction towards known groundwater users. No other structural features were evident near the site. The proximity of the dolerite intrusion is partly considered a negative aspect for site development due to possible groundwater contamination, however, groundwater flow may be cut off in a northerly direction, thus protecting down stream users.

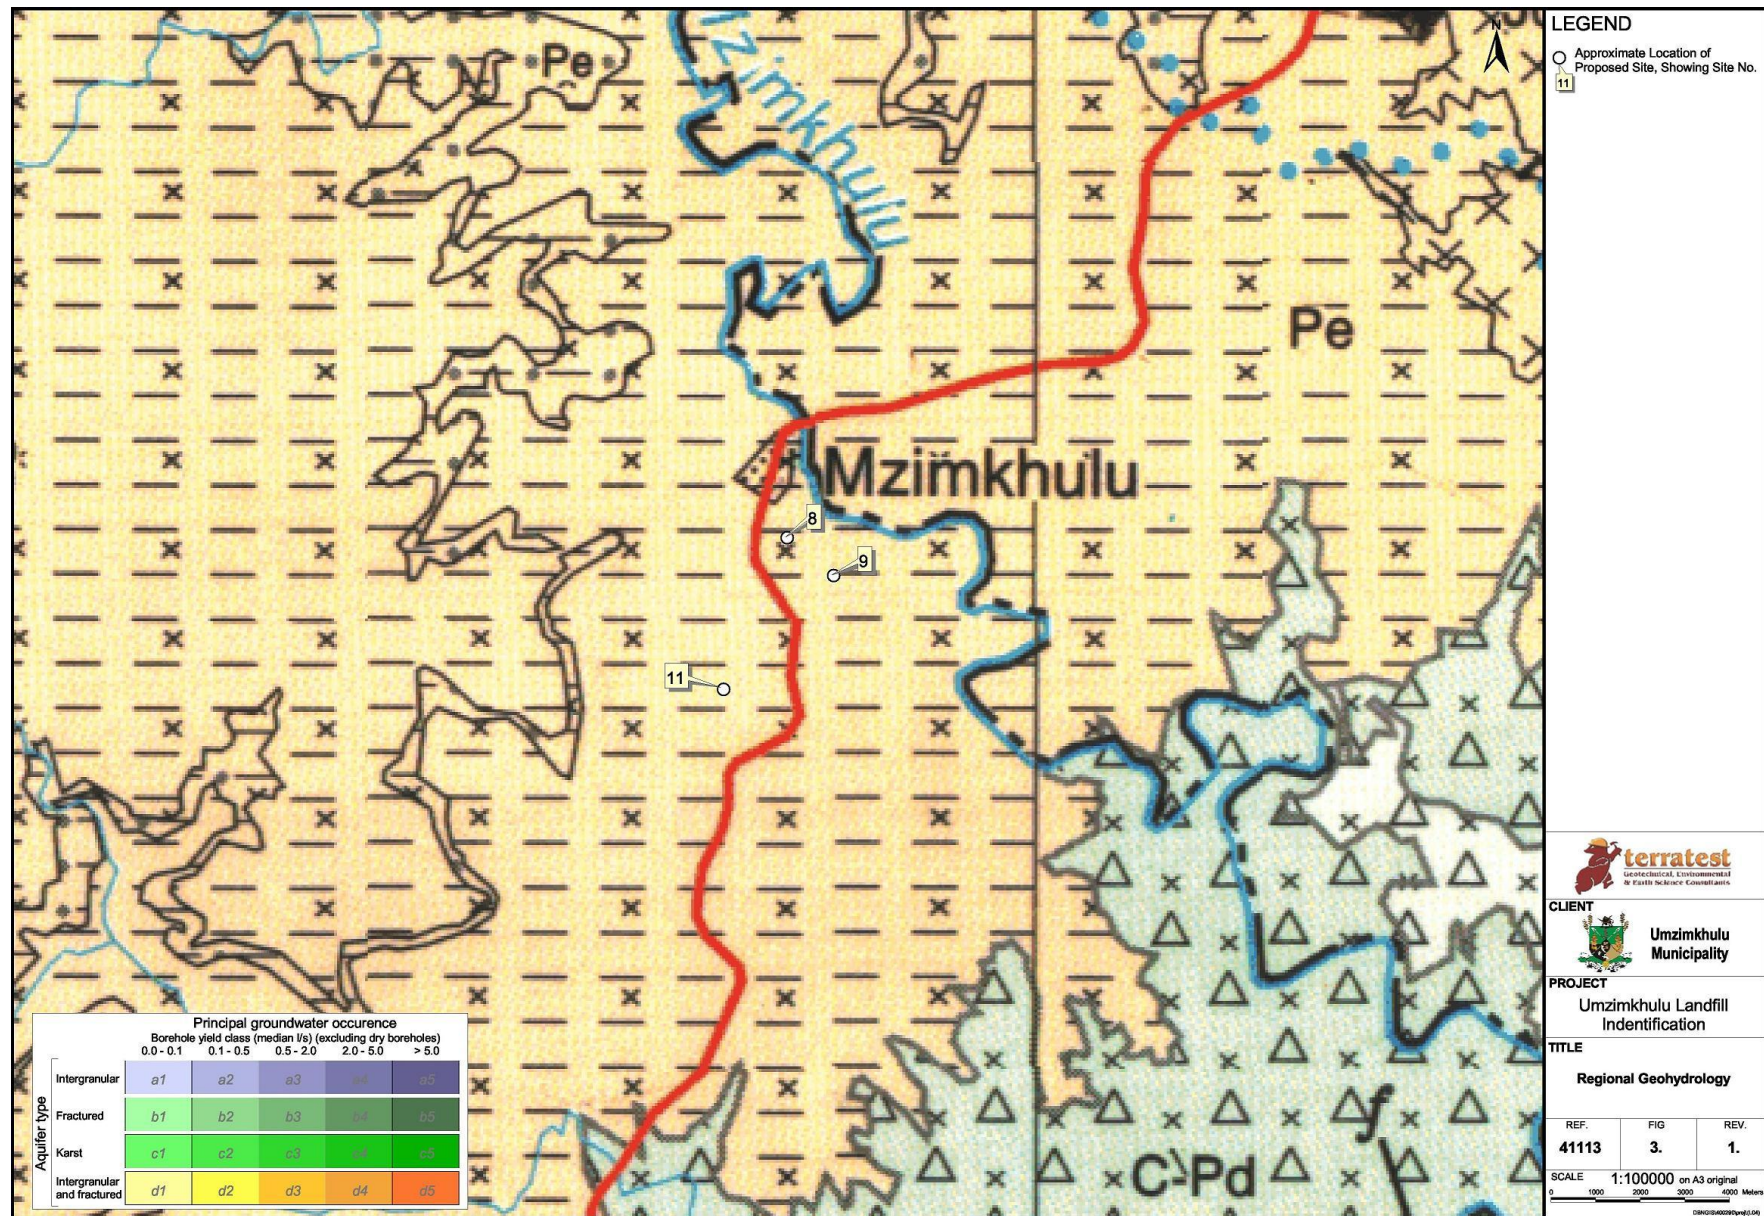
The regional geohydrology of the project area is described as predominantly argillaceous rocks comprising shale, mudstone and siltstone, with localised mafic intrusive rock comprising dolerite. The principle groundwater occurrence in the shale is from an intergranular and fractured aquifer with median borehole yields in the range 0.5 to 2.0 litres per second. The regional geohydrology of the area is presented in Figure 3.

Hydraulic conductivity in Eccca Group shale ranges from 0.05m/d in solid rock to 0.5m/d in fractured rock. Fractures usually constitute reasonable aquifers, however, fractures within fine grained rocks tend to close if dewatered. Iron Pyrite mineralisation along fractures is also common. The success rate for a properly sited borehole within the Eccca Group is between 65 and 80% of achieving borehole yields greater than 0.5 l/s. No major faulting is evident in the project area. Groundwater quality is generally bicarbonate, calcium, magnesium type which indicates recently recharged waters. Electrical conductivity is quite variable but generally acceptable (<70mS/m).
