Pampierstad Multi Land Use Development

Portion of ERF 312- Vaal-Harts Settlement B- Phokwane Local Municipality

Phase 1 Geotechnical Site Investigation

Date
13/12/2022

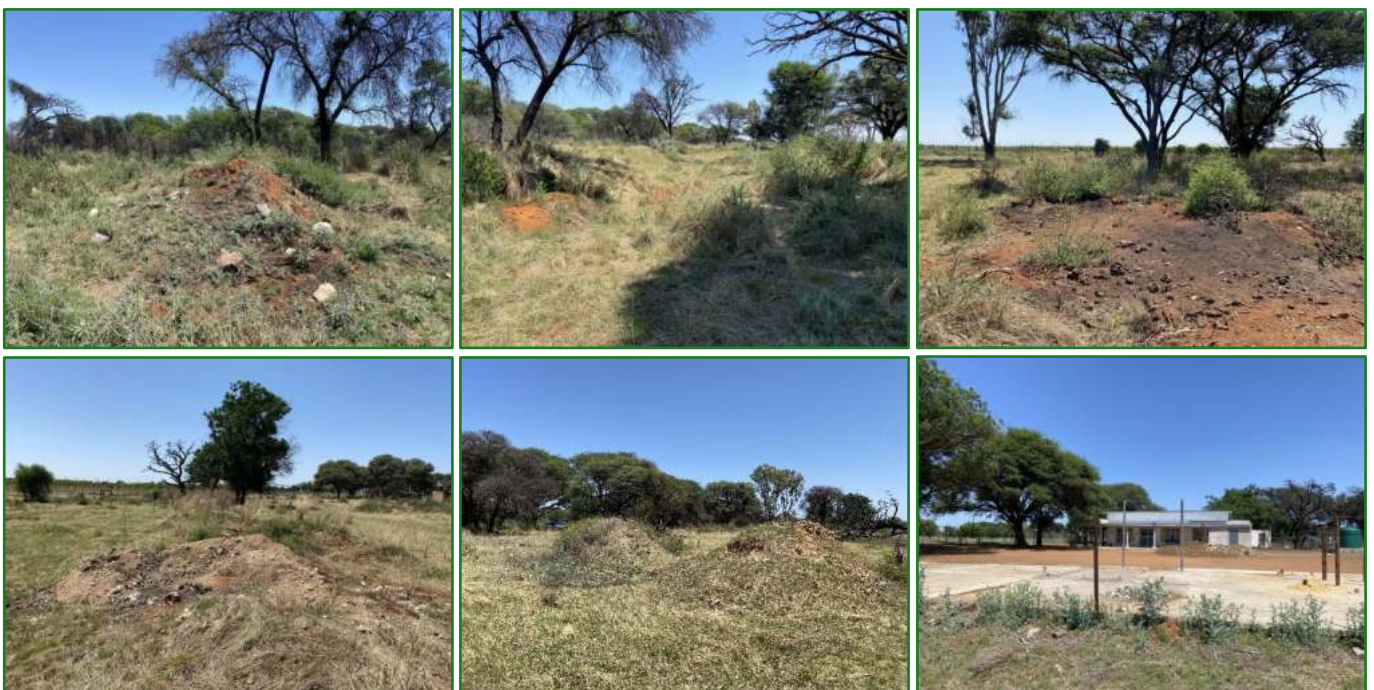
The sites surface was seen to display a **reworked nature** attributed to past and ongoing **human activities** in the area. This reworking was predominantly in the form of surficial fills, relict canals/foundations/structures and historic agricultural practices. The exact extent of the existing/past surface and subsurface infrastructure in this region is not known. The combination of the anthropogenic processes has affected the continuity of the sites' topographic nature as well as its' inherent geotechnical characteristics. The exact extent of the existing/past surface and subsurface infrastructure in this region is not known.

The photo series below depicts the reworked surficial nature of the site.

As for the removal of relict infrastructure, it is strongly recommended that this material be **selectively mined** and **removed** from within the footprint of the proposed development (extent determined by the design engineer). The location and extent of these anomalies can be mapped by the surveyor for the amalgamation into the local earthworks model.

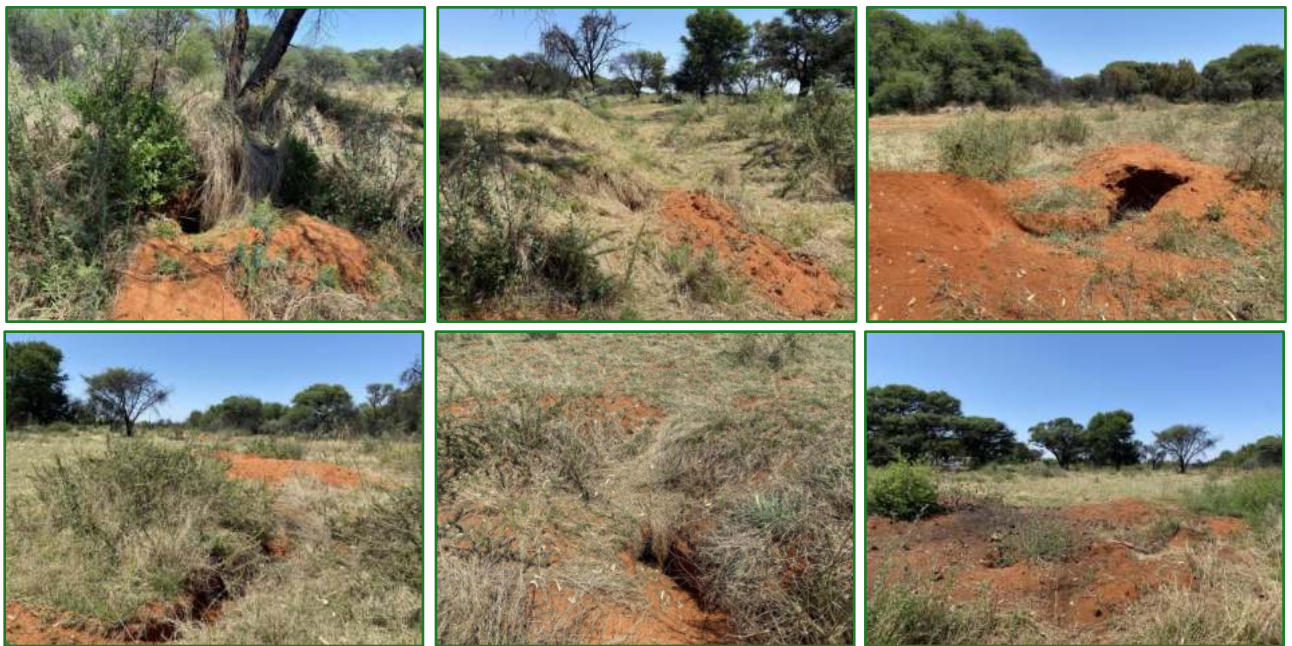
The site was seen to host **biological activity** in the form of localised- and somewhat scattered- biological tunnels and nests. Tunnelling- predicted to be as a result of warthogs- was more prolific in the western and north western portions of the site.

The photo series below depicts examples of the biological activity across the site:

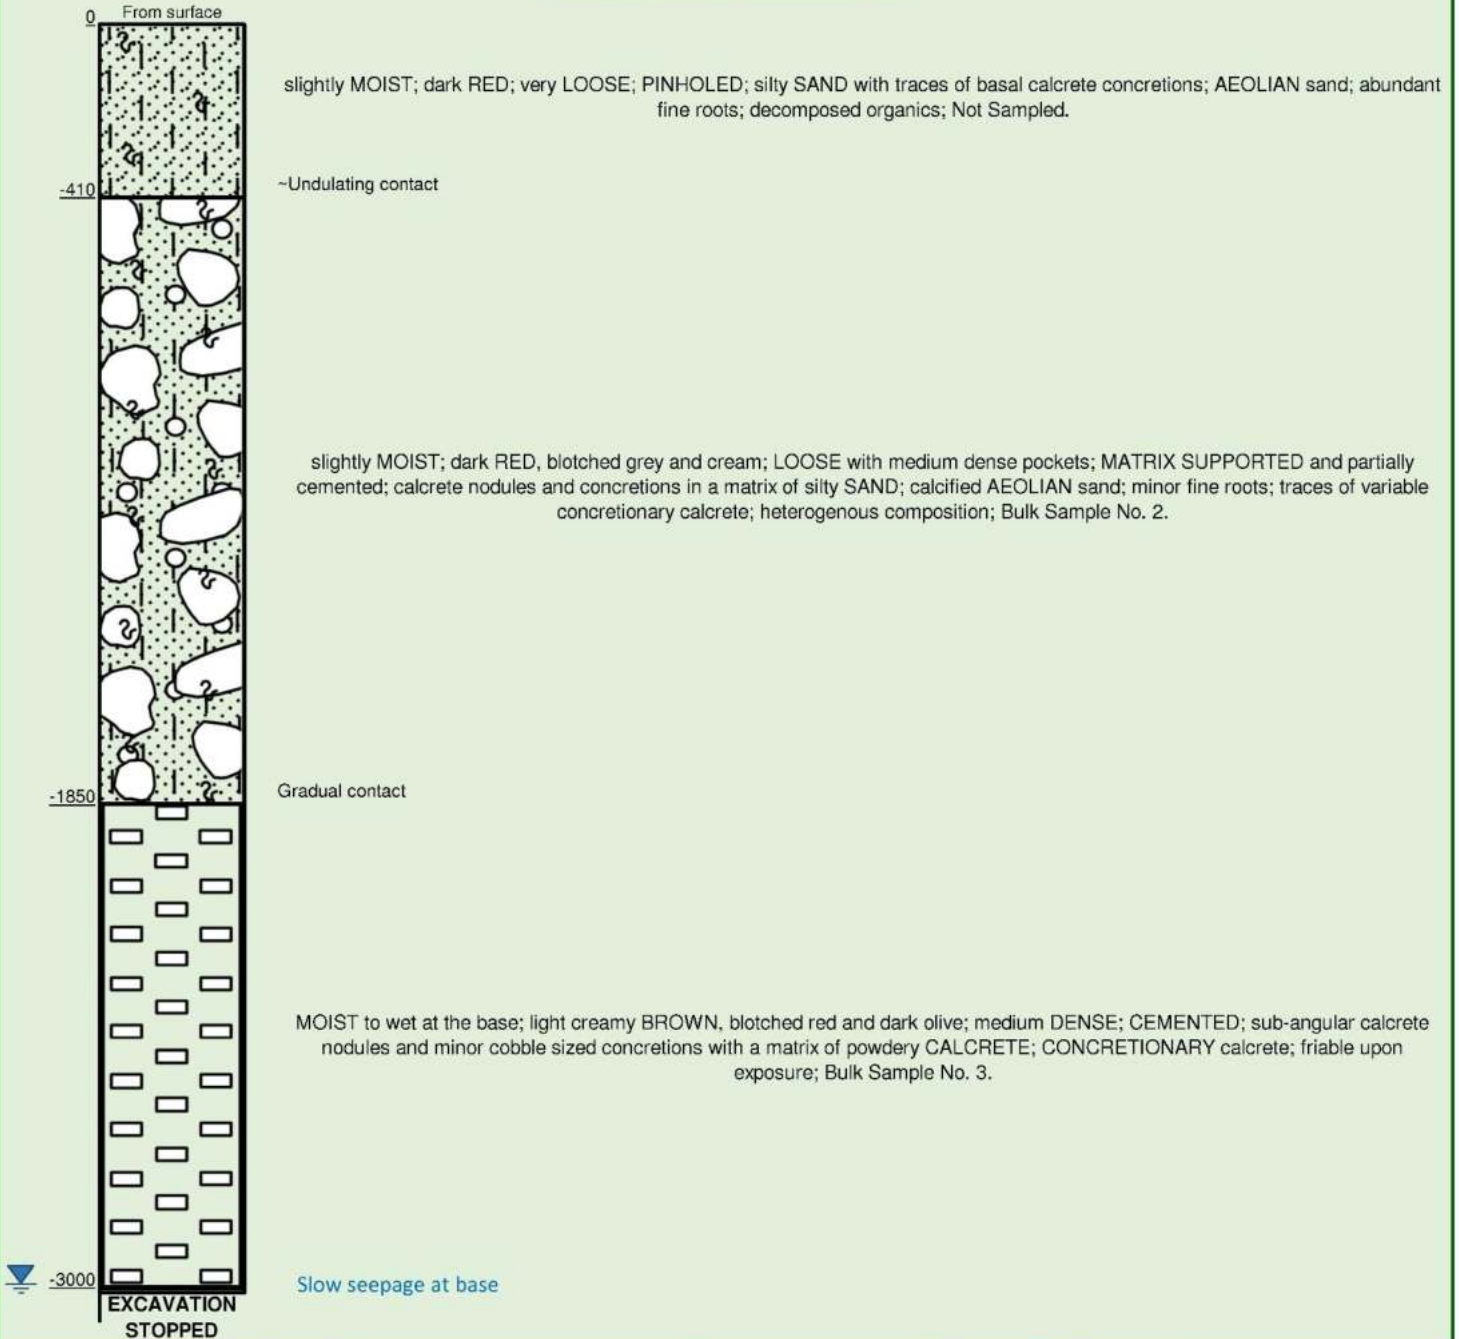
Soil Profile for Test Pit TP4

Profile Notes		Excavation Description	
Profiled by:	KS Coertzen (Pri.Sci.Nat)	Contractor:	Client Supply
Groundwater Seepage:	Slow seepage at 3,0 m	Machine:	TLB Type Light Mechanical Excavator-JCB 3CX
Excavation Stability:	Sidewalls stable	Excavation Character:	Excavation stopped due to maximum reach
Samples Extracted:	2 Bulk Samples	Date Profiled:	27/10/2022
Elevation (MAMSL):	1071	Coordinates:	27.789708°S 24.718469°E
