**AQUATIC CONSTRAINTS ANALYSIS & DWS RISK ASSESSMENT MATRIX FOR  
THE PROPOSED WRENCHVILLE PHASE 2 LOW-COST HOUSING DEVELOPMENT,  
KURUMAN, NORTHERN CAPE PROVINCE.**

**08 JULY 2019**

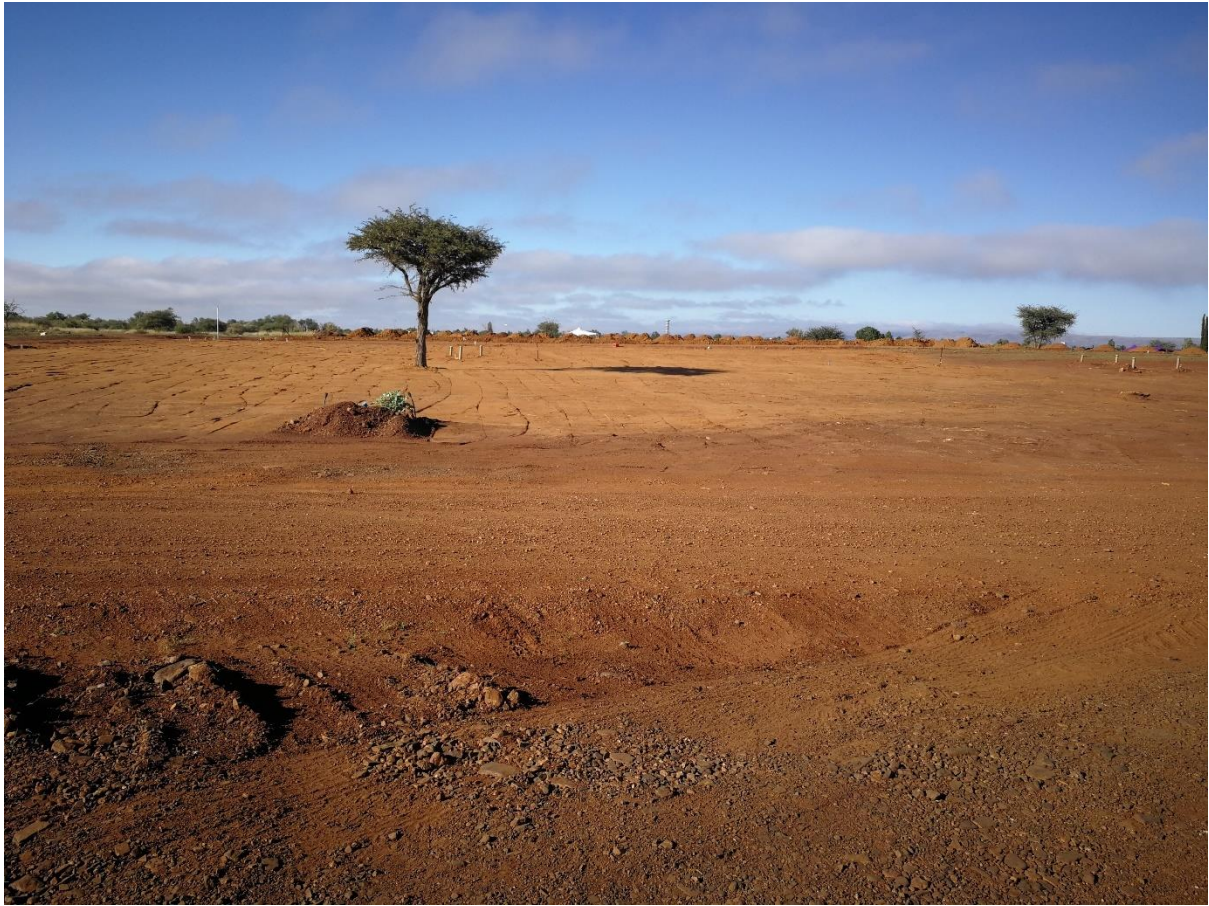
**Photo 1:** Earthworks pertaining to Phase 1 of Wrenchville Low-Cost Housing Development adjacent to concerned property. Direction: South

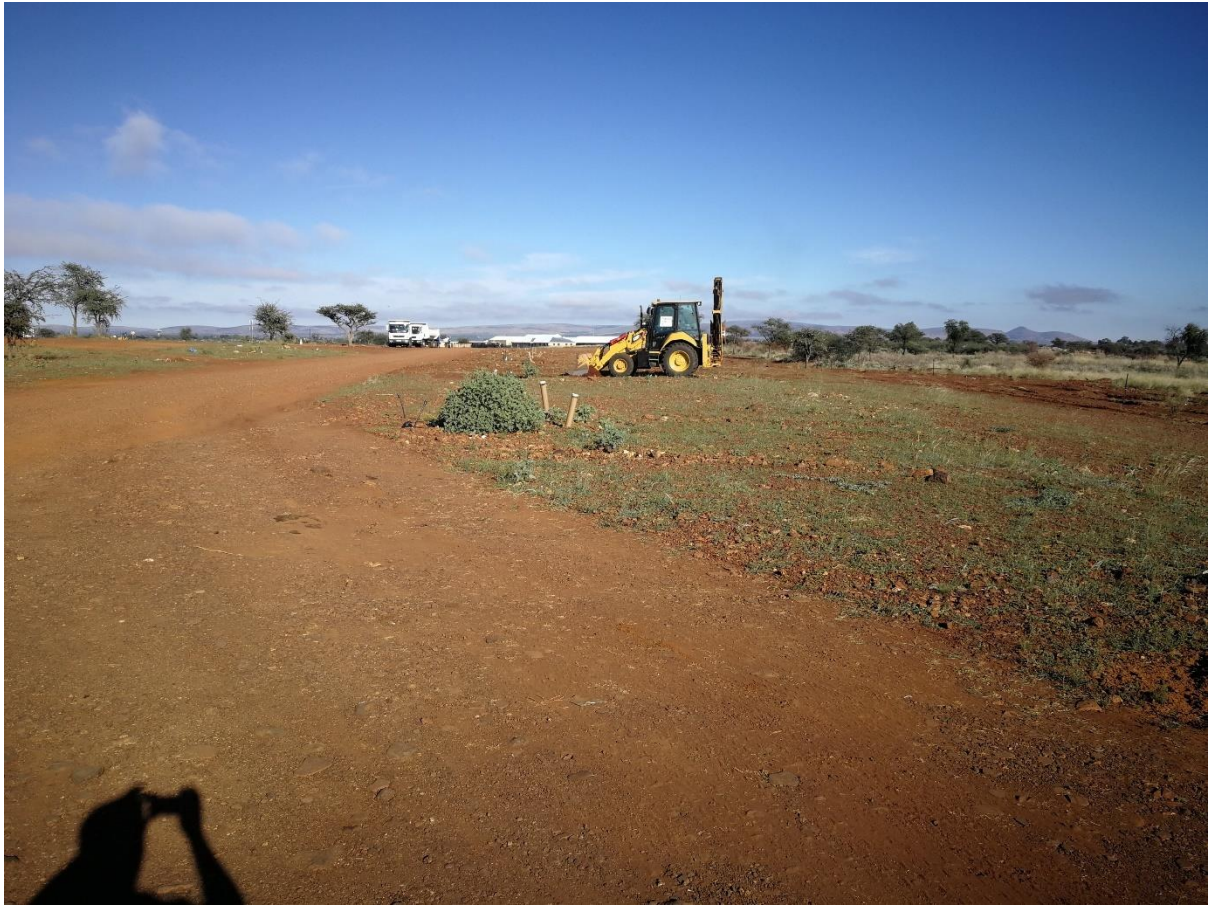
**Photo 2:** Earthworks pertaining to Phase 1 of Wrenchville Low-Cost Housing Development adjacent to concerned property. Direction: West

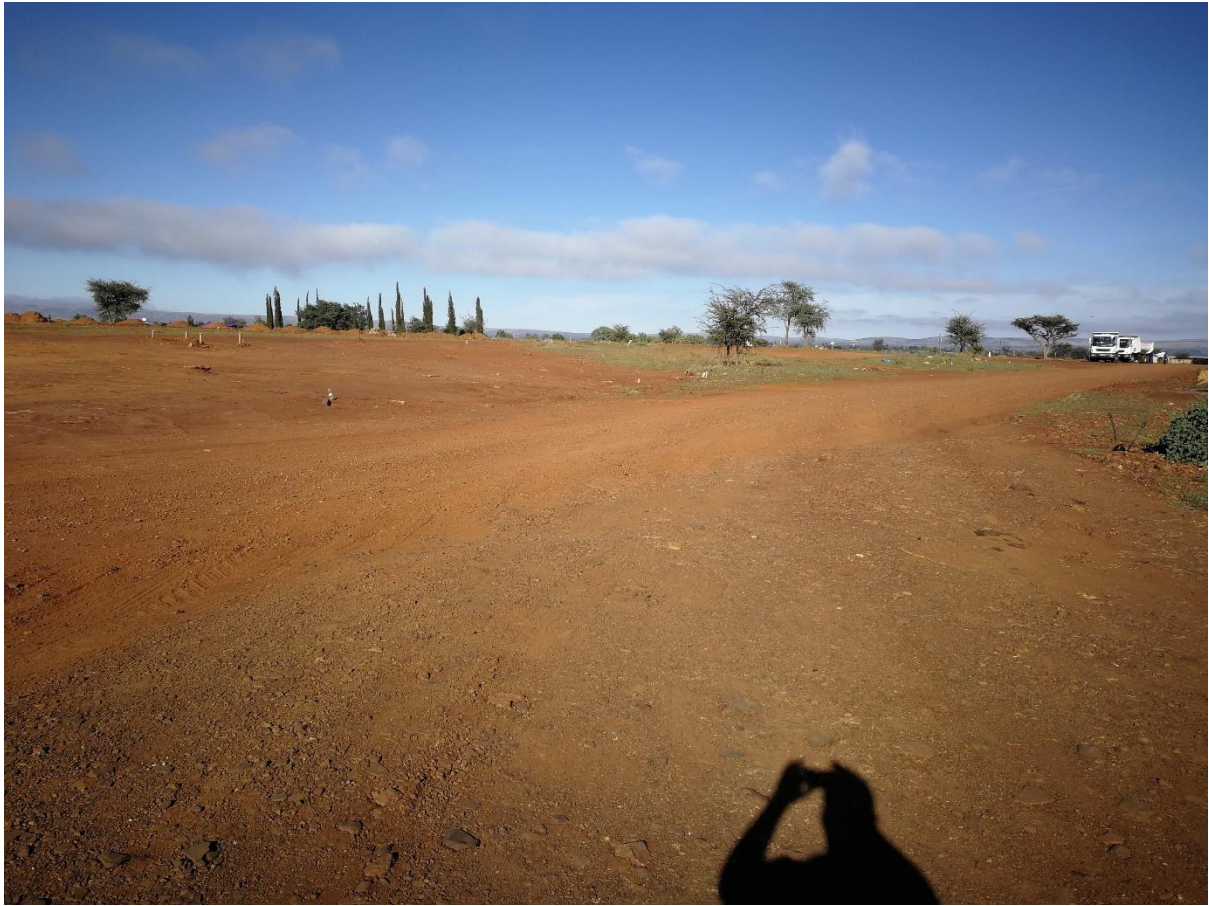
**Photo 3:** Earthworks pertaining to Phase 1 of Wrenchville Low-Cost Housing Development adjacent to concerned property. Existing graveyard visible in the background. Direction: South.

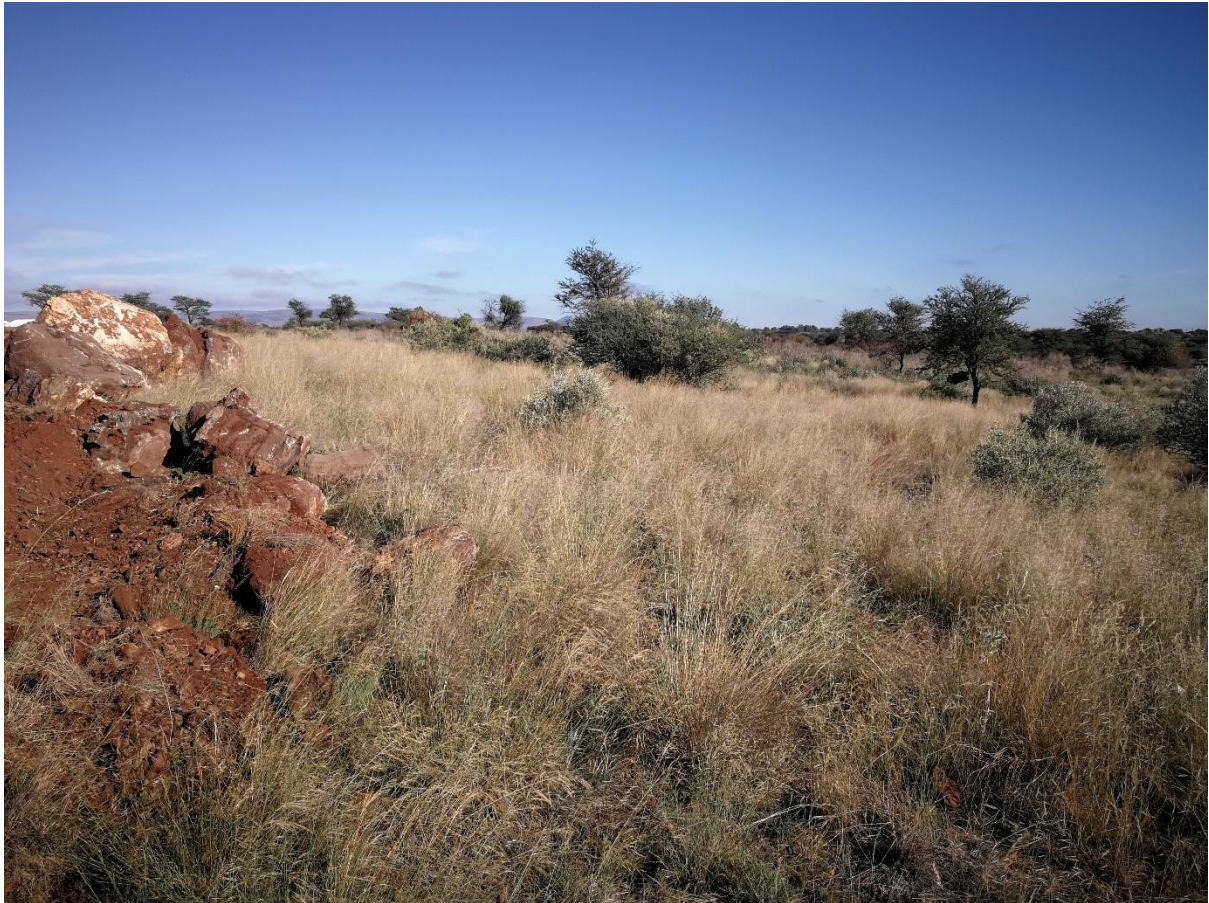
**Photo 4:** Concerned property proposed for development of Wrenchville Phase 2 Low-Cost Housing Development. Natural Kuruman Thornveld Vegetation. Direction: North-West

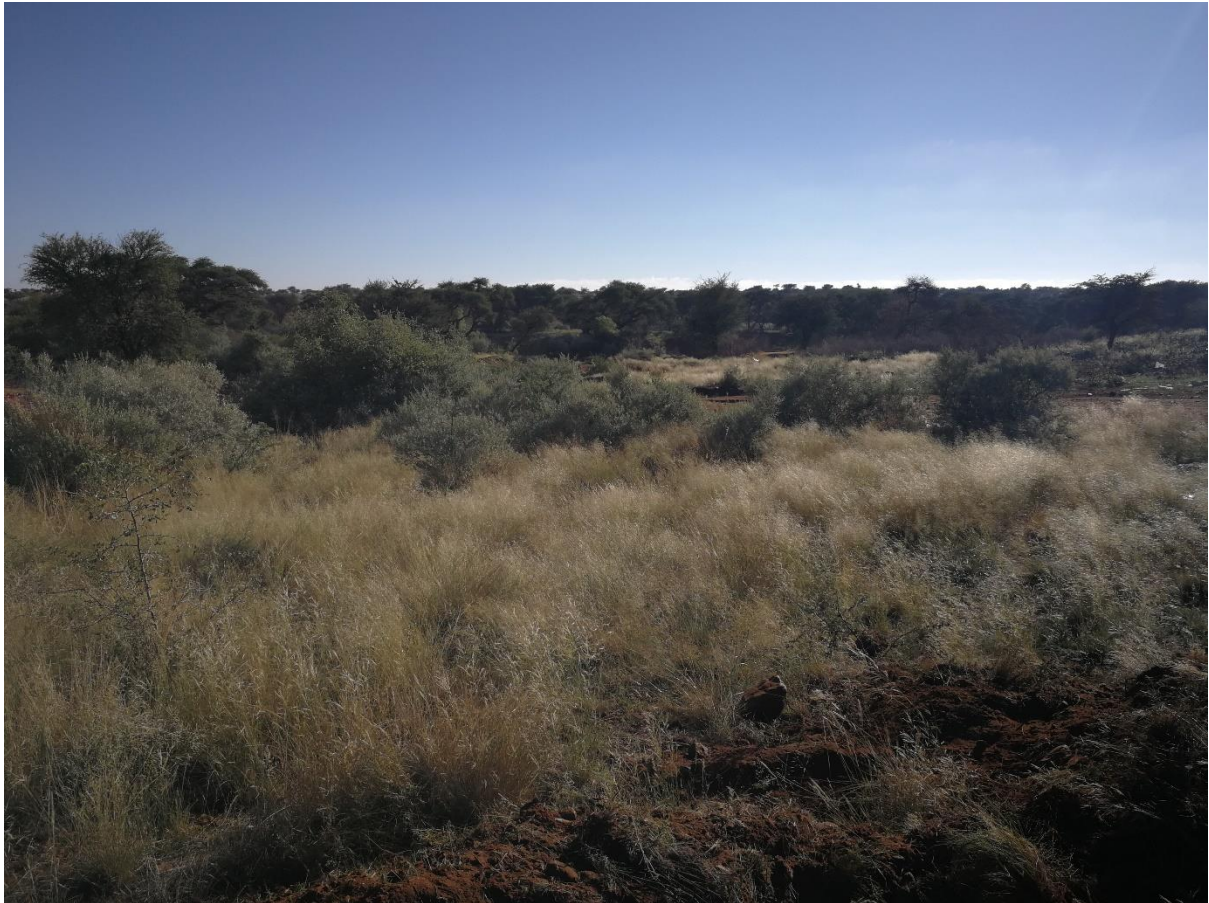
**Photo 6:** Concerned property proposed for development of Wrenchville Phase 2 Low-Cost Housing Development. Natural Kuruman Thornveld Vegetation. Riparian Area situated along the northern section of property visible in background. Direction: North-East

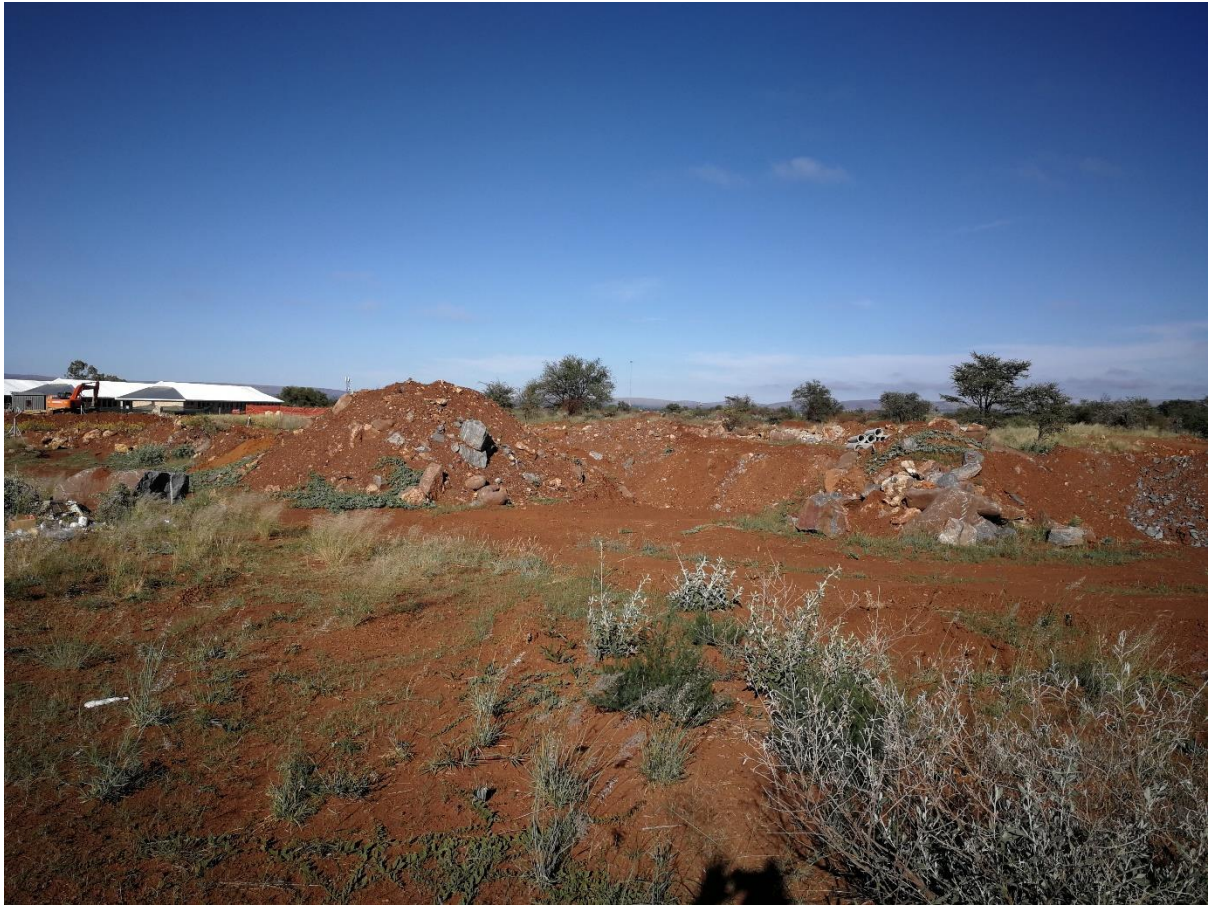
**Photo 10:** Concerned property proposed for development of Wrenchville Phase 2 Low-Cost Housing Development. Natural Kuruman Thornveld Vegetation. Signs of previous disturbance. Direction: South-West

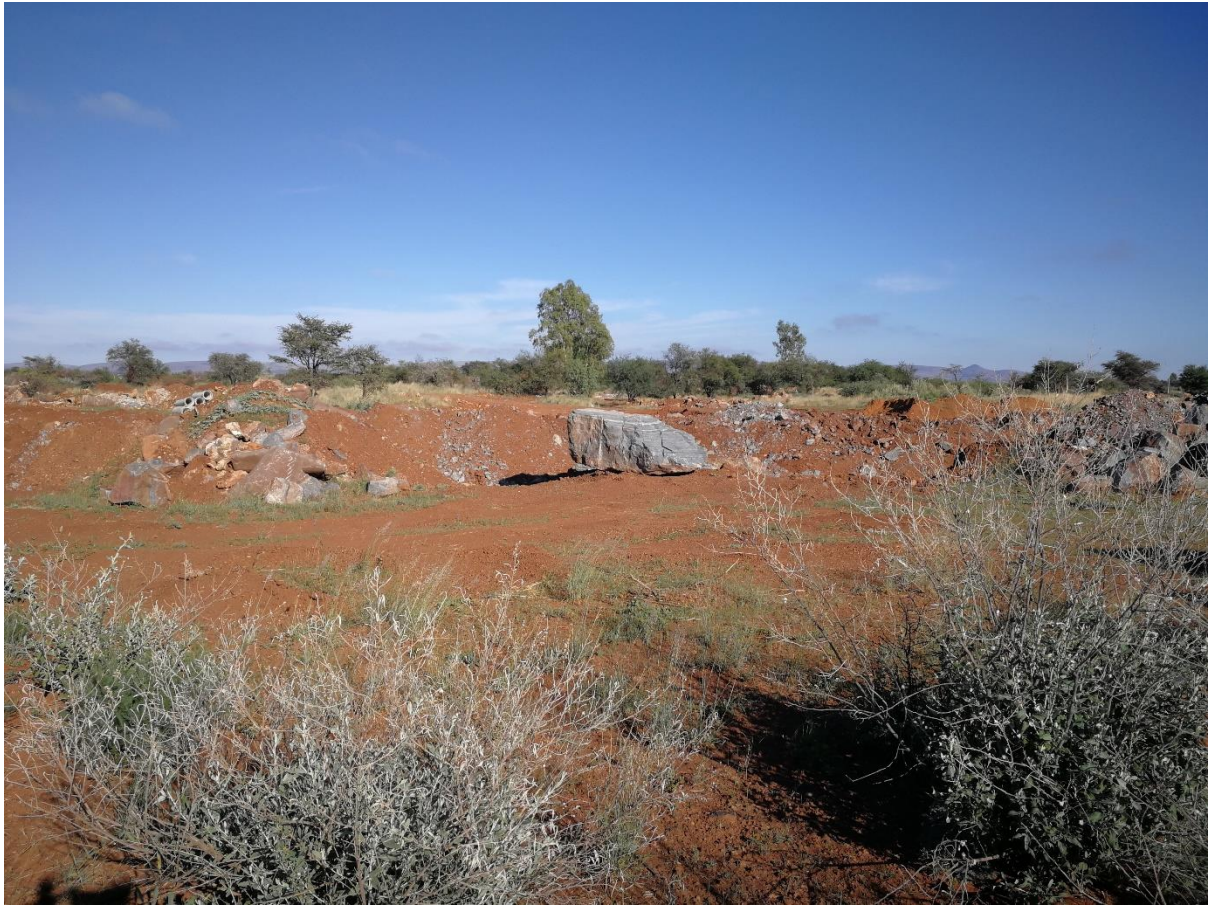
**Photo 11:** Concerned property proposed for development of Wrenchville Phase 2 Low-Cost Housing Development. Natural Kuruman Thornveld Vegetation. Signs of previous disturbance. Direction: West

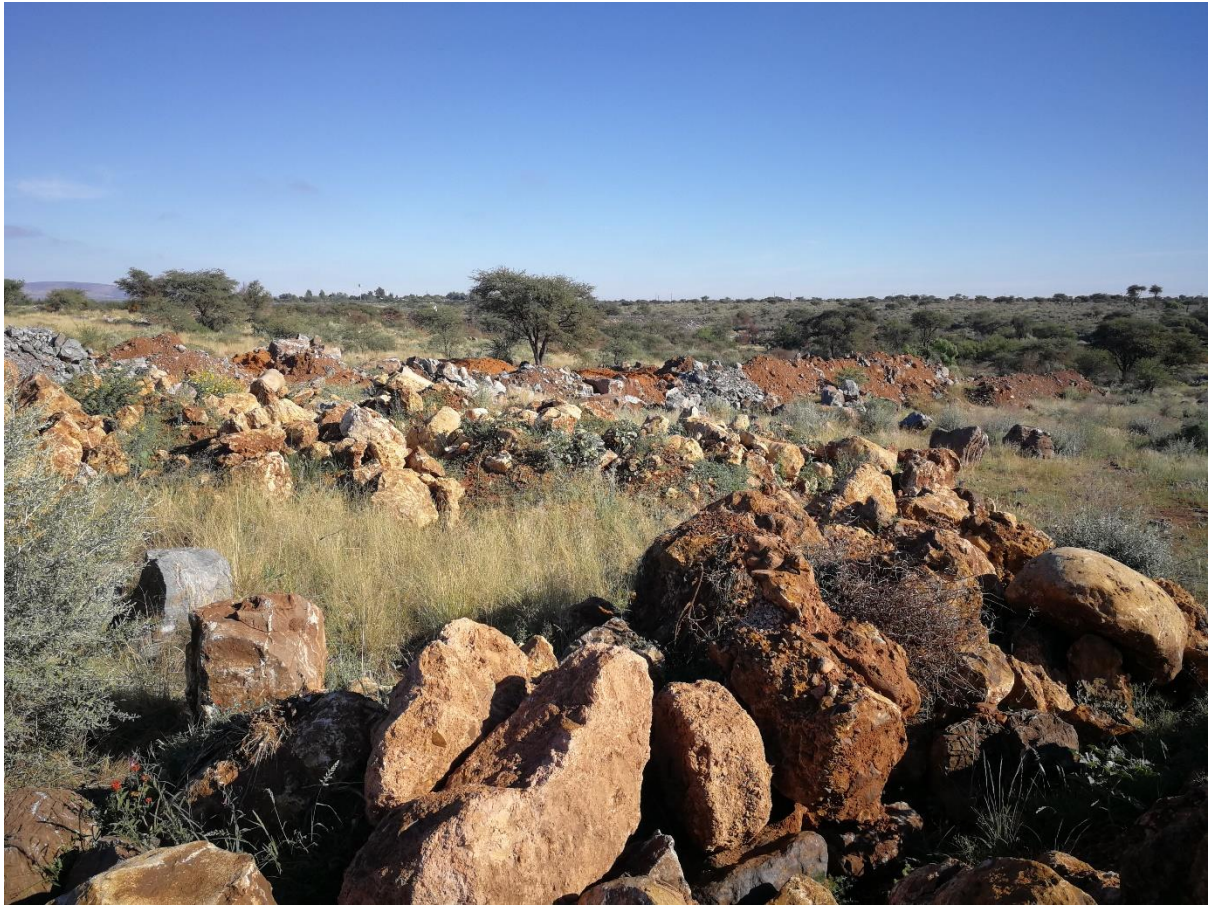
**Photo 12:** Concerned property proposed for development of Wrenchville Phase 2 Low-Cost Housing Development. Natural Kuruman Thornveld Vegetation. Signs of previous disturbance. Direction: West

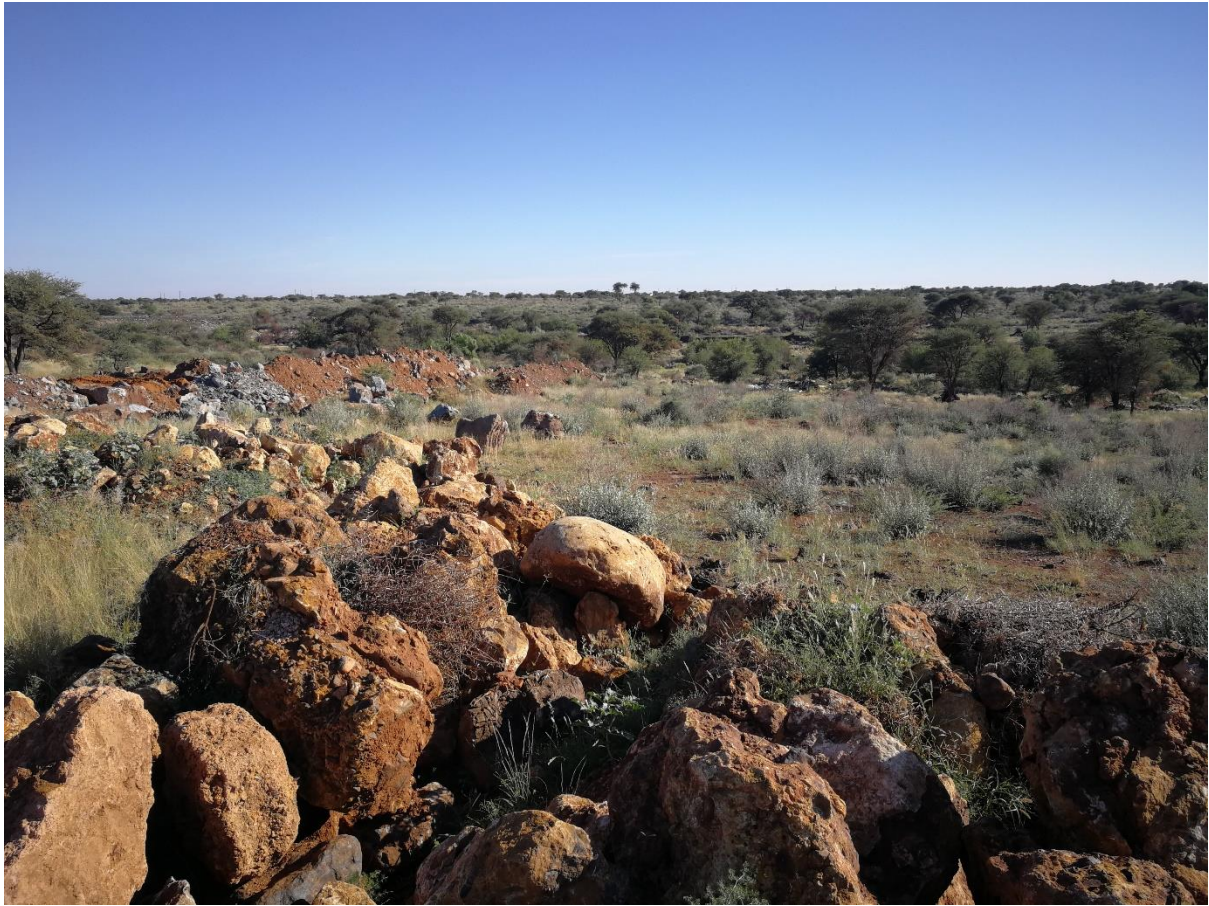
**Photo 13:** Concerned property proposed for development of Wrenchville Phase 2 Low-Cost Housing Development. Natural Kuruman Thornveld Vegetation. Signs of previous disturbance. Direction: North-West

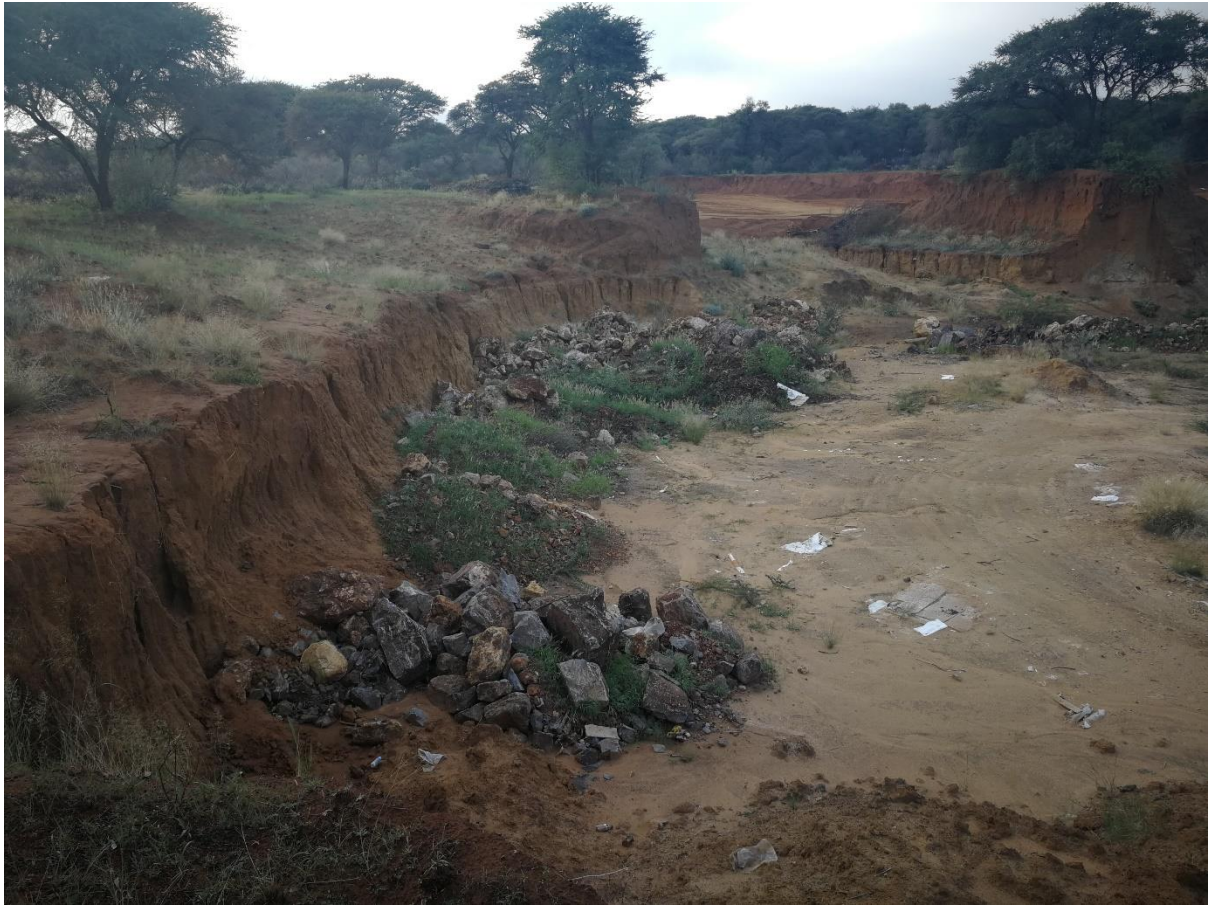
**Photo 17:** Sand quarry with rubble piles situated in the North-Eastern corner of the proposed development area. Situated within the concerned stream channel and associated Riparian Area. Natural Kuruman Thornveld Vegetation. Direction: East

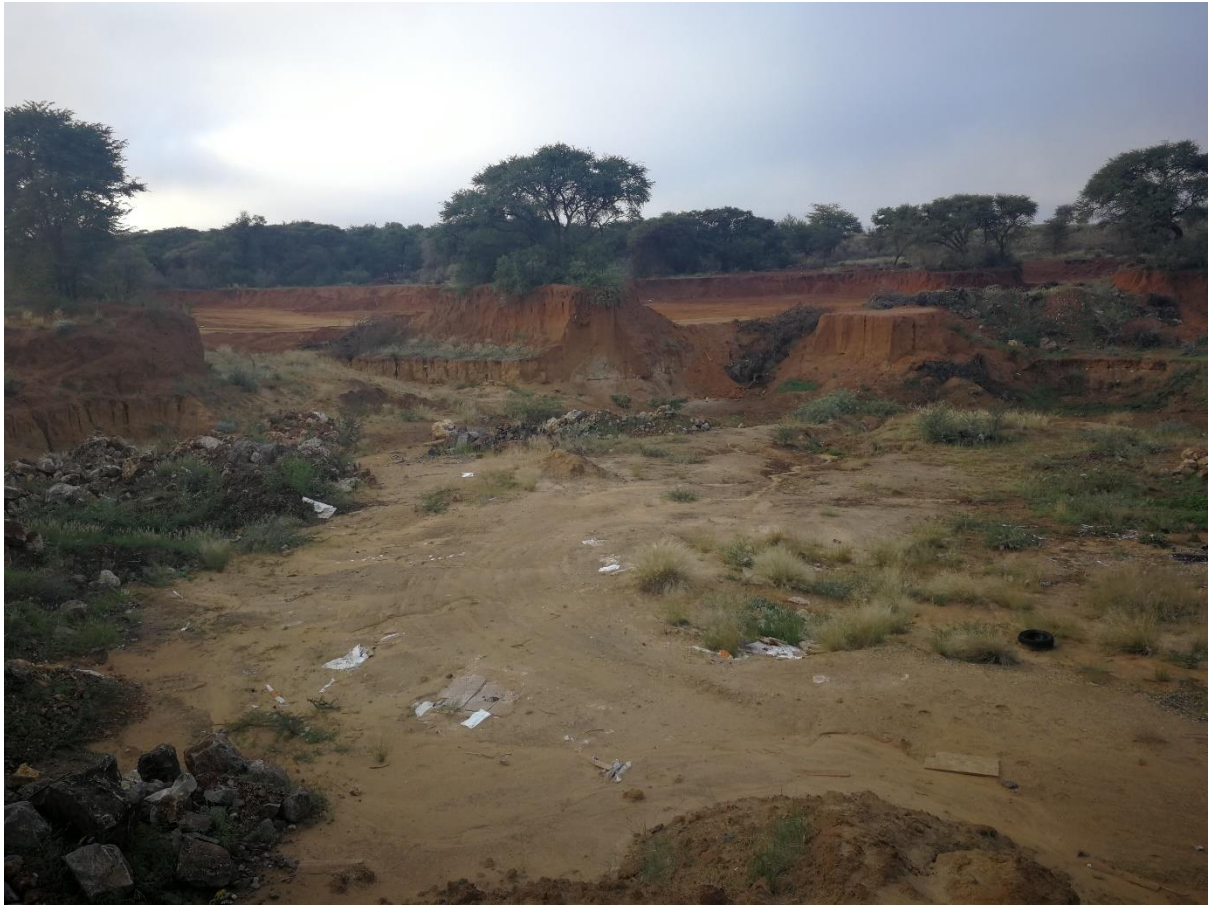
**Photo 18:** Sand quarry with rubble piles situated in the North-Eastern corner of the proposed development area. Situated within the concerned stream channel and associated Riparian Area. Natural Kuruman Thornveld Vegetation. Direction: East

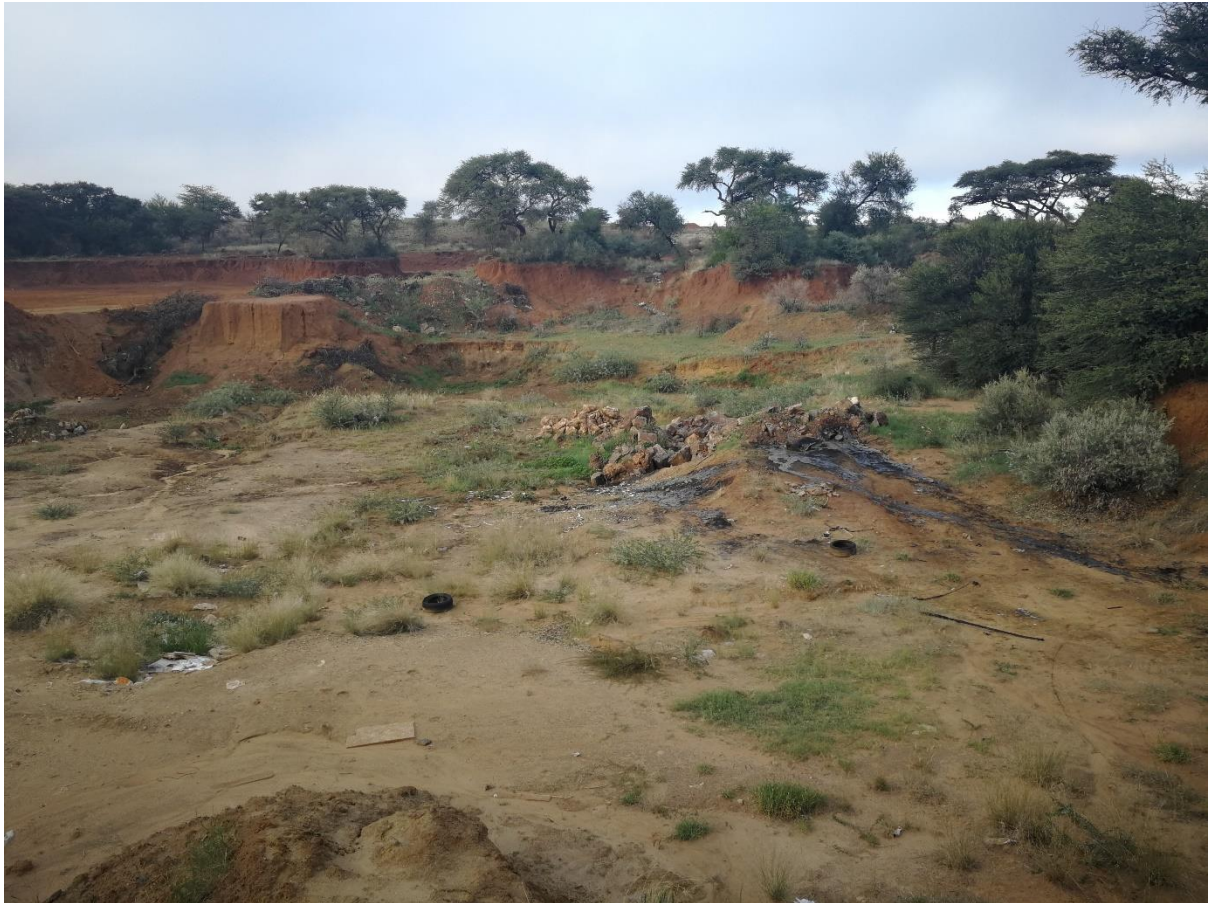
**Photo 19:** Sand quarry with rubble piles situated in the North-Eastern corner of the proposed development area. Situated within the concerned stream channel and associated Riparian Area. Natural Kuruman Thornveld Vegetation. Direction: South-East

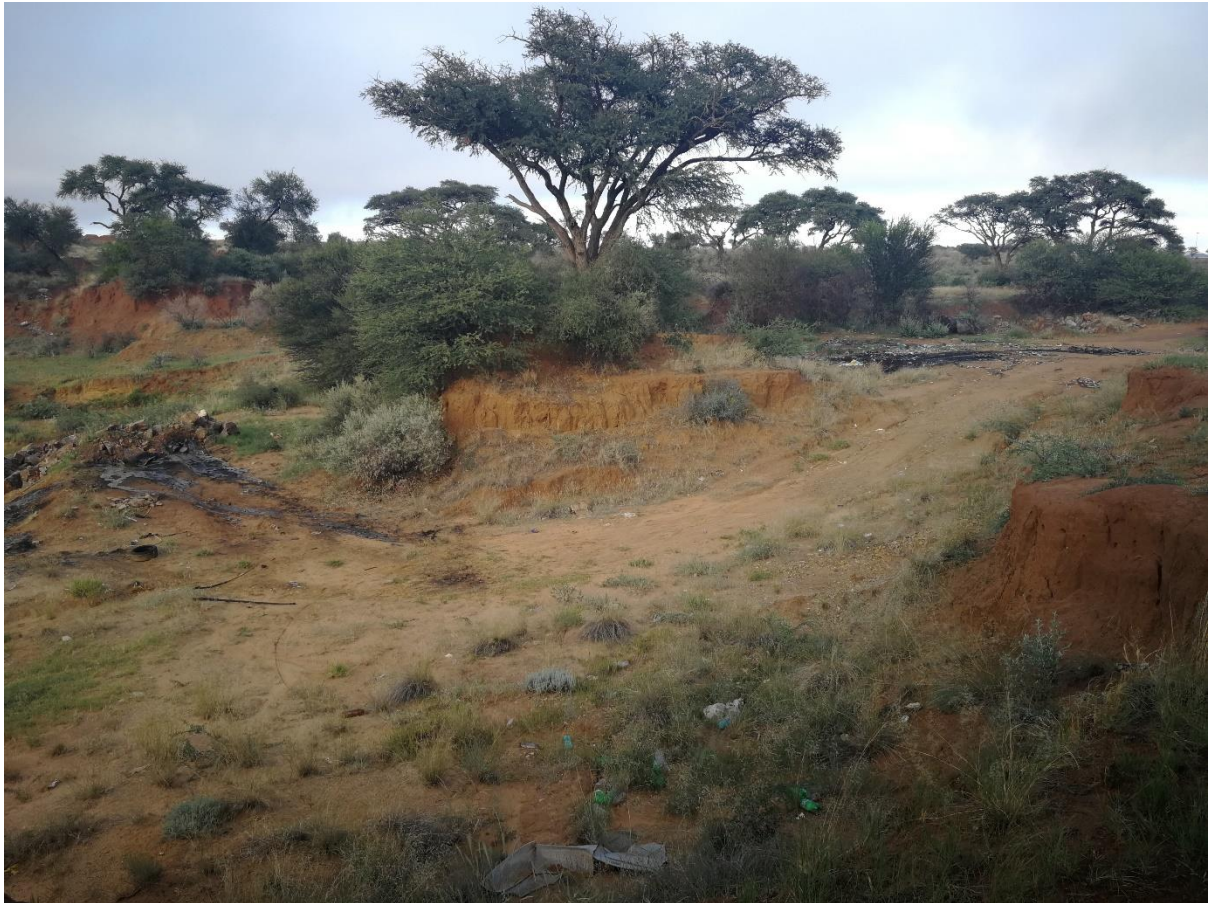
**Photo 20:** Sand quarry with rubble piles situated in the North-Eastern corner of the proposed development area. Situated within the concerned stream channel and associated Riparian Area. Natural Kuruman Thornveld Vegetation. Direction: South

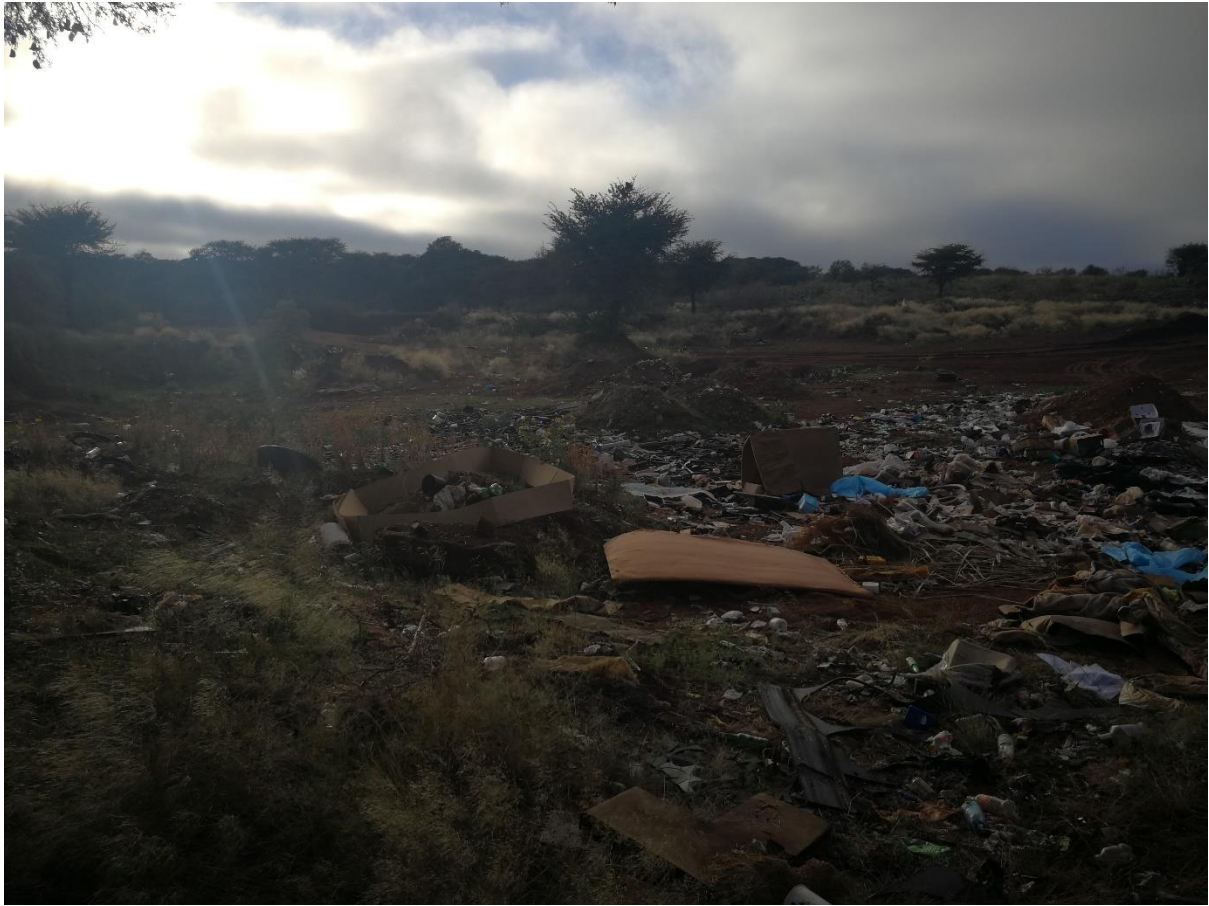
**Photo 21:** Rubble piles situated in the Riparian Area and 1:100 Floodline Delineation of the watercourse running along the northern boundary of the proposed development area. Natural Kuruman Thornveld Vegetation. Direction: South-West

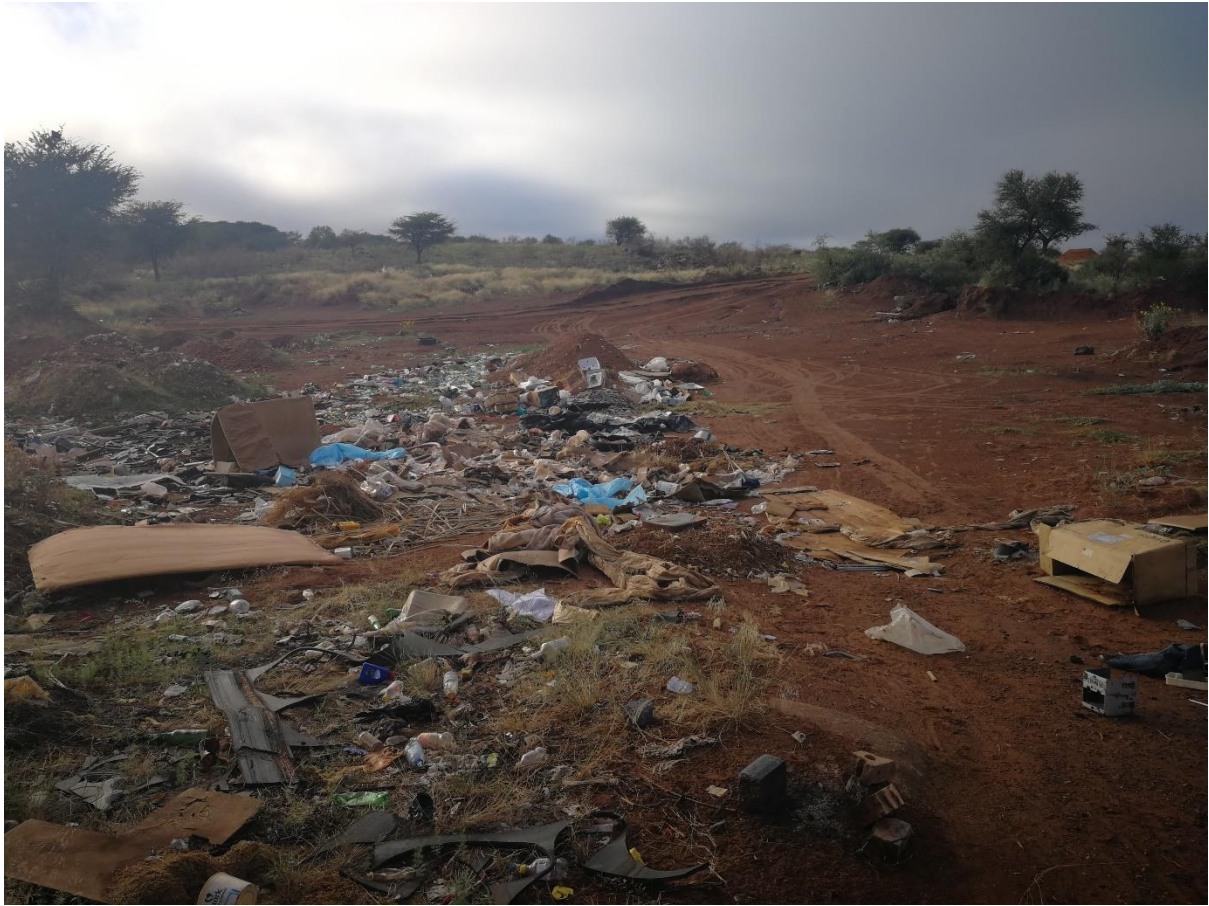
**Photo 22:** Rubble piles and gravel access roads situated within the 1:100 Floodline Delineation of the watercourse running along the northern boundary of the proposed development area. Natural Kuruman Thornveld Vegetation. Direction: South-West

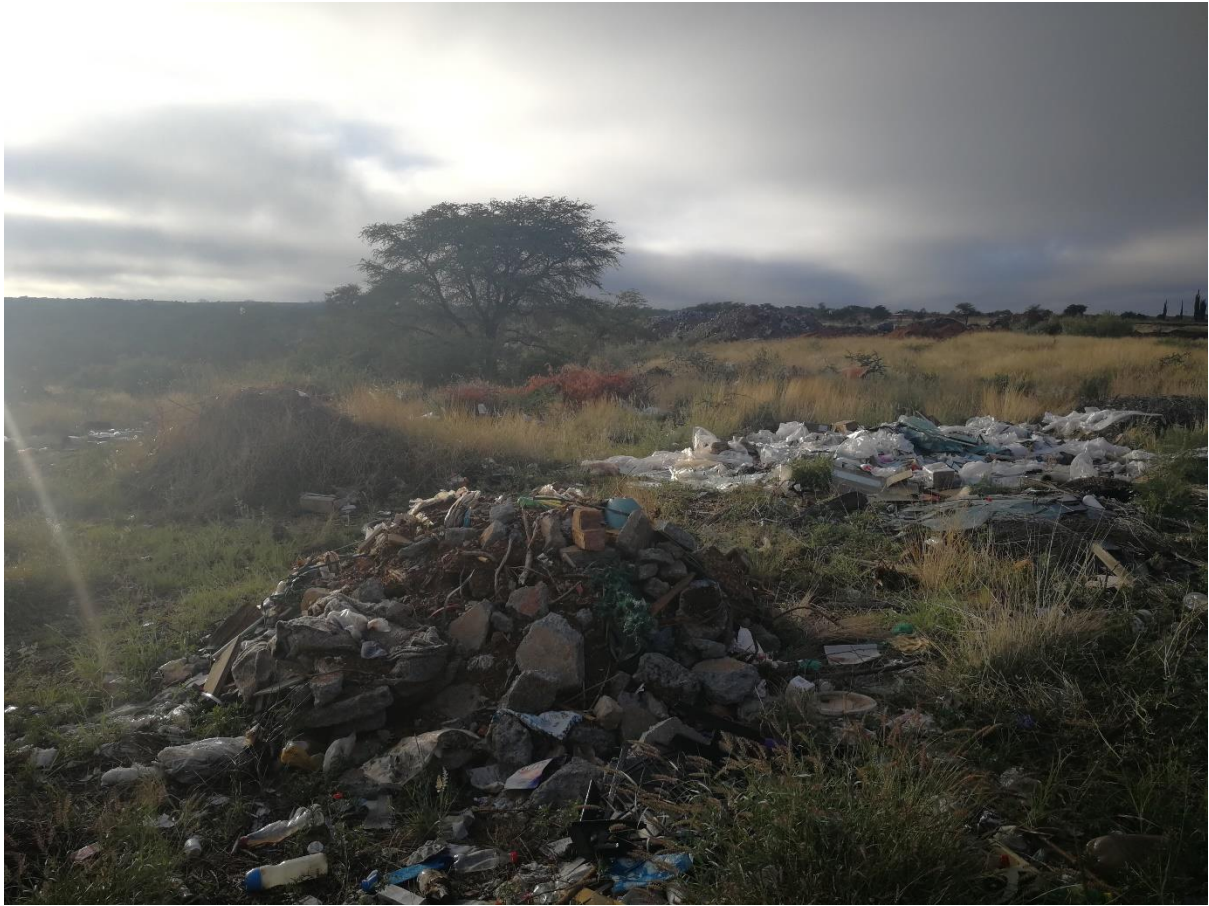
**Photo 22:** Rubble piles alongside gravel access roads situated within the 1:100 Floodline Delineation of the watercourse running along the northern boundary of the proposed development area. Natural Kuruman Thornveld Vegetation. Direction: South-West

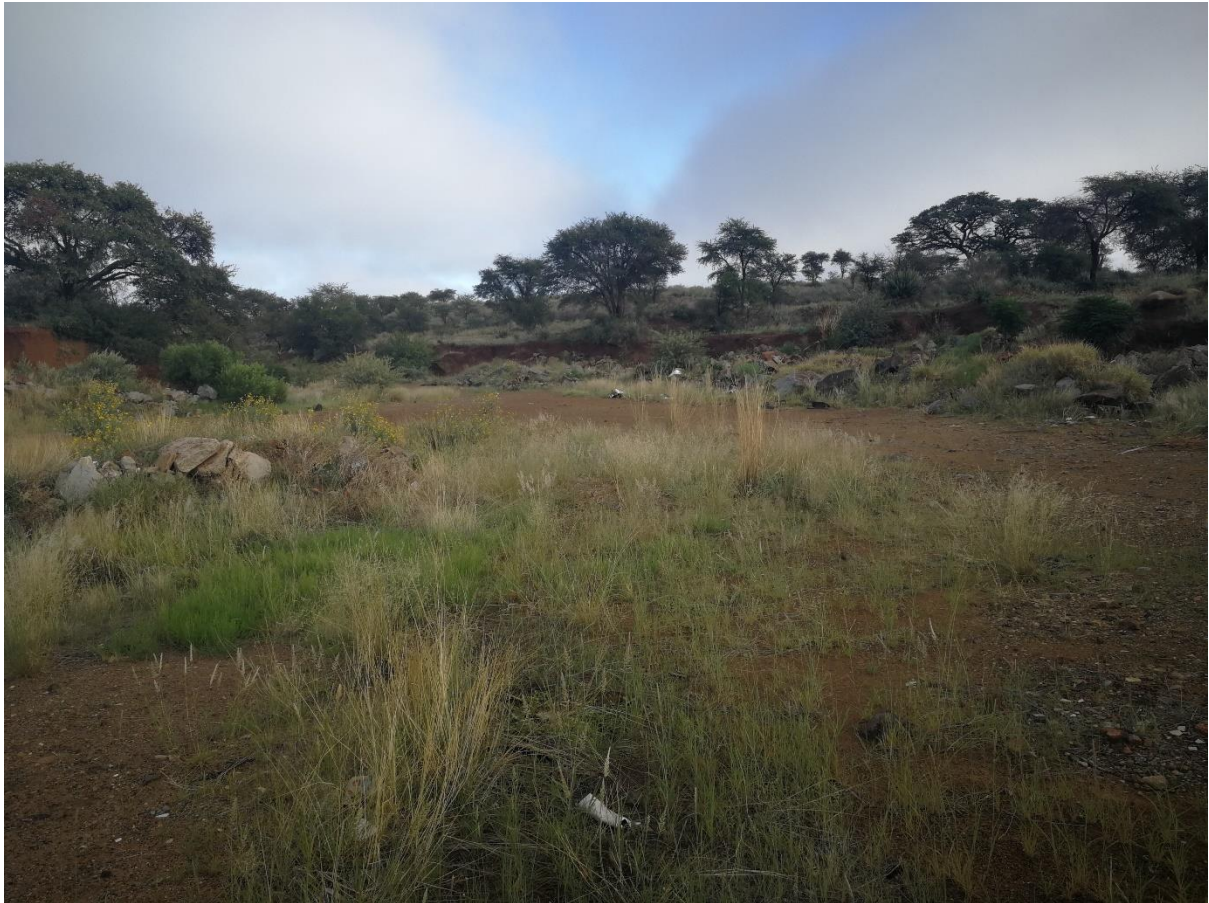
**Photo 23:** Centre of stream channel for watercourse running along the northern boundary of the proposed development area. Clear signs of numerous excavation activities. Natural Kuruman Thornveld Vegetation. Direction: North

Given the observations made by the Author within this area during the Site Inspection, the Author concurs with this notion, as the severely degraded and excavated nature of the area along the northern portion of the property will cause severe developmental constraints.

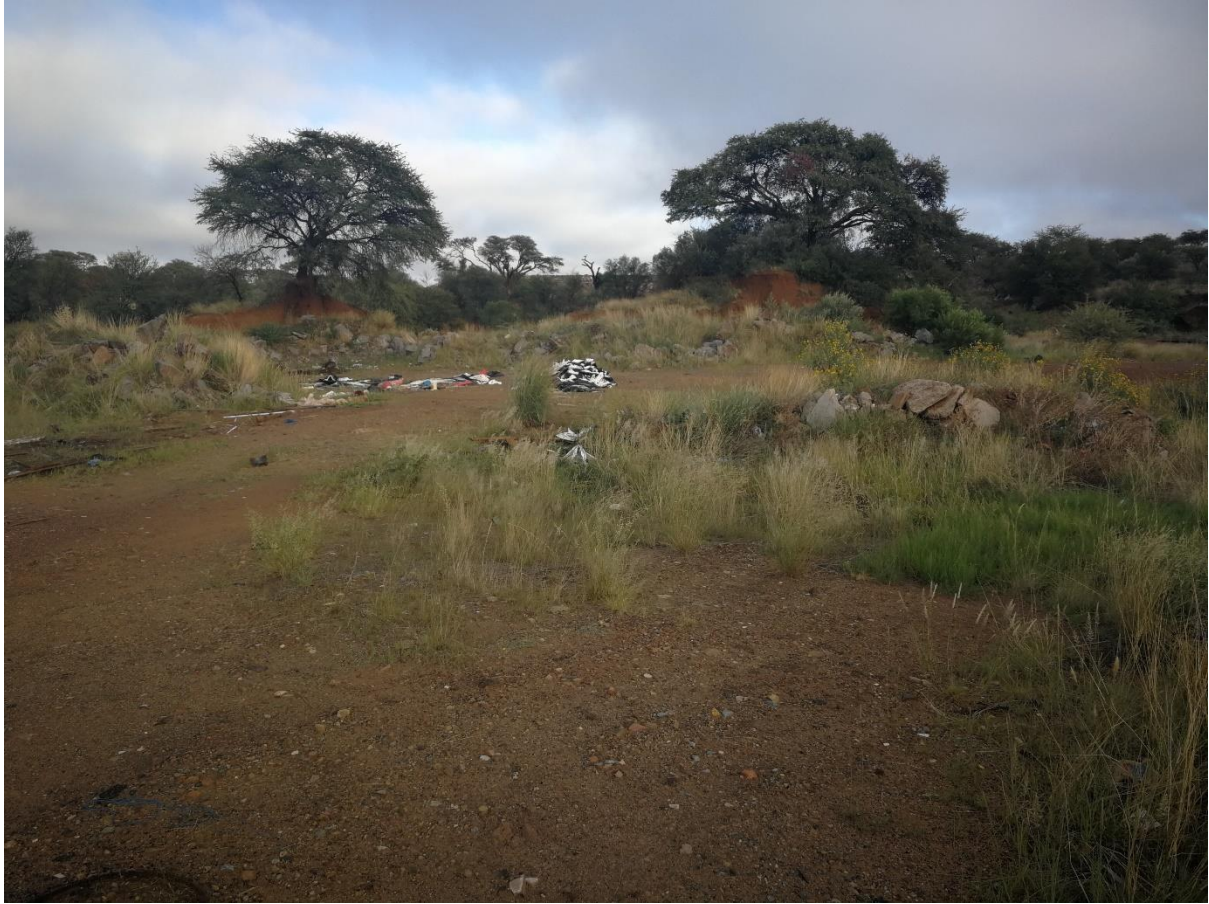
**Photo 24:** Centre of stream channel for watercourse running along the northern boundary of the proposed development area. Clear signs of numerous excavation activities and informal rubble dumping. Natural Kuruman Thornveld Vegetation. Direction: North-West

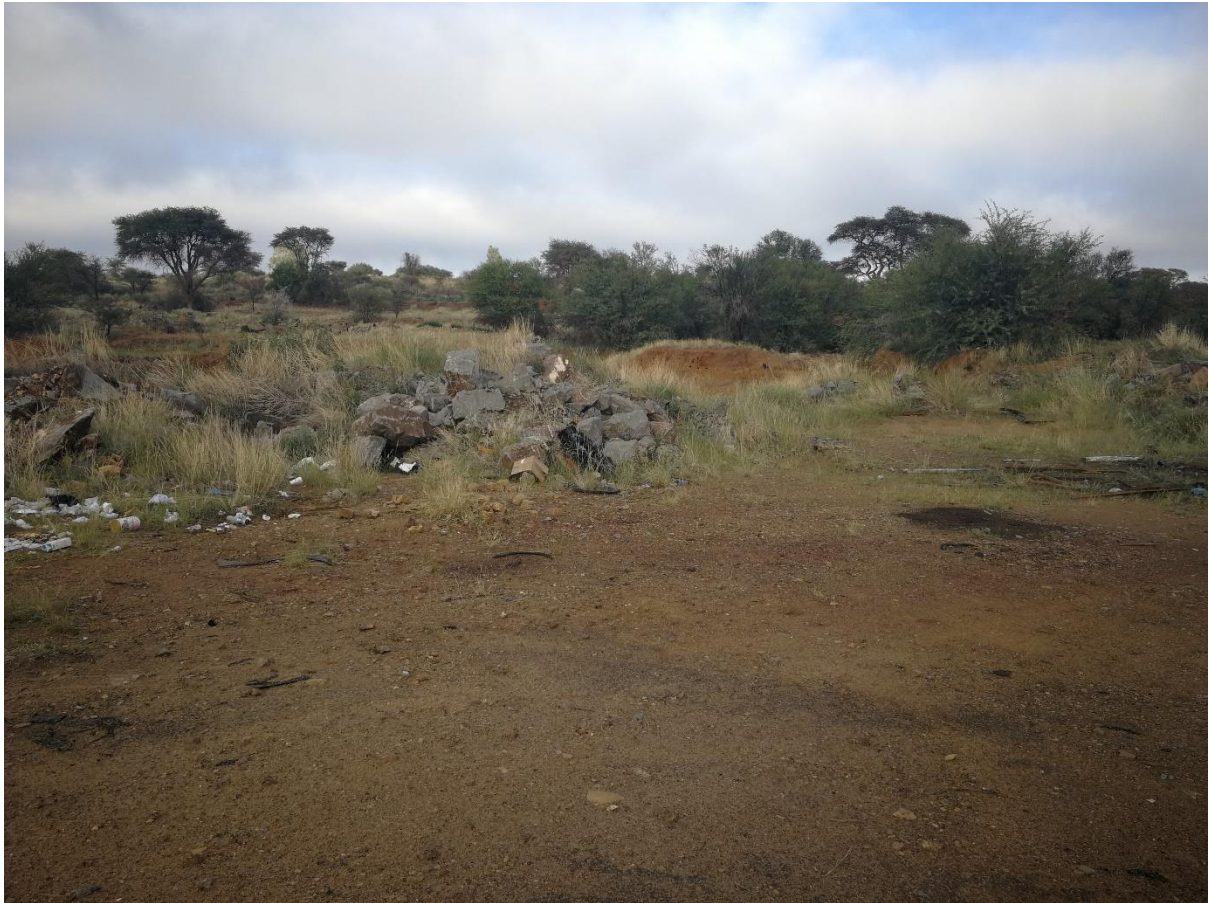
**Photo 25:** Centre of stream channel for watercourse running along the northern boundary of the proposed development area. Clear signs of numerous excavation activities and informal rubble dumping. Natural Kuruman Thornveld Vegetation. Direction: West

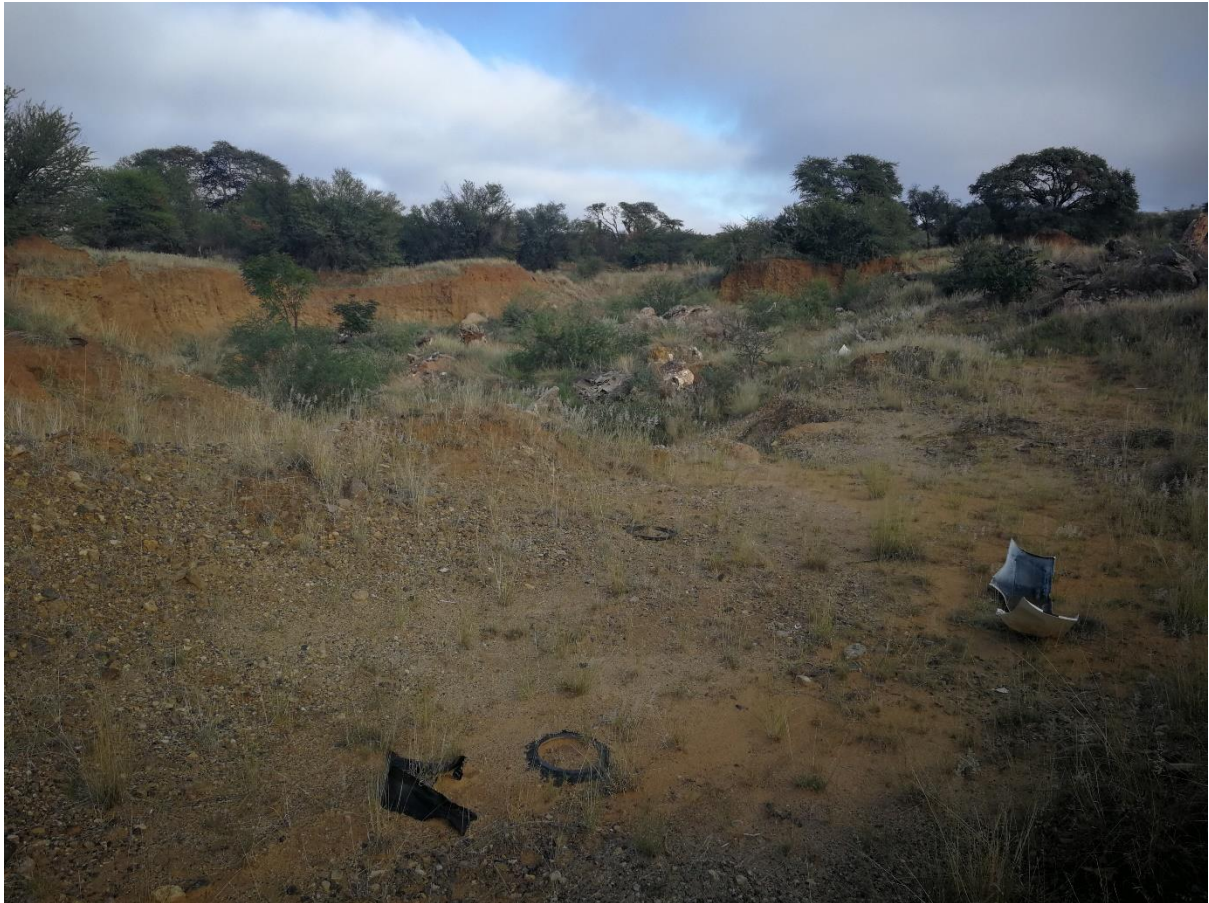
**Photo 26:** Centre of stream channel for watercourse running along the northern boundary of the proposed development area. Clear signs of numerous excavation activities and informal rubble dumping. Highly uneven landscape due to excavation activities. Natural Kuruman Thornveld Vegetation. Direction: West
