**AQUATIC CONSTRAINTS ANALYSIS & DWS RISK ASSESSMENT MATRIX FOR  
THE PROPOSED WRENCHVILLE PHASE 2 LOW-COST HOUSING DEVELOPMENT,  
KURUMAN, NORTHERN CAPE PROVINCE.**

**08 JULY 2019**

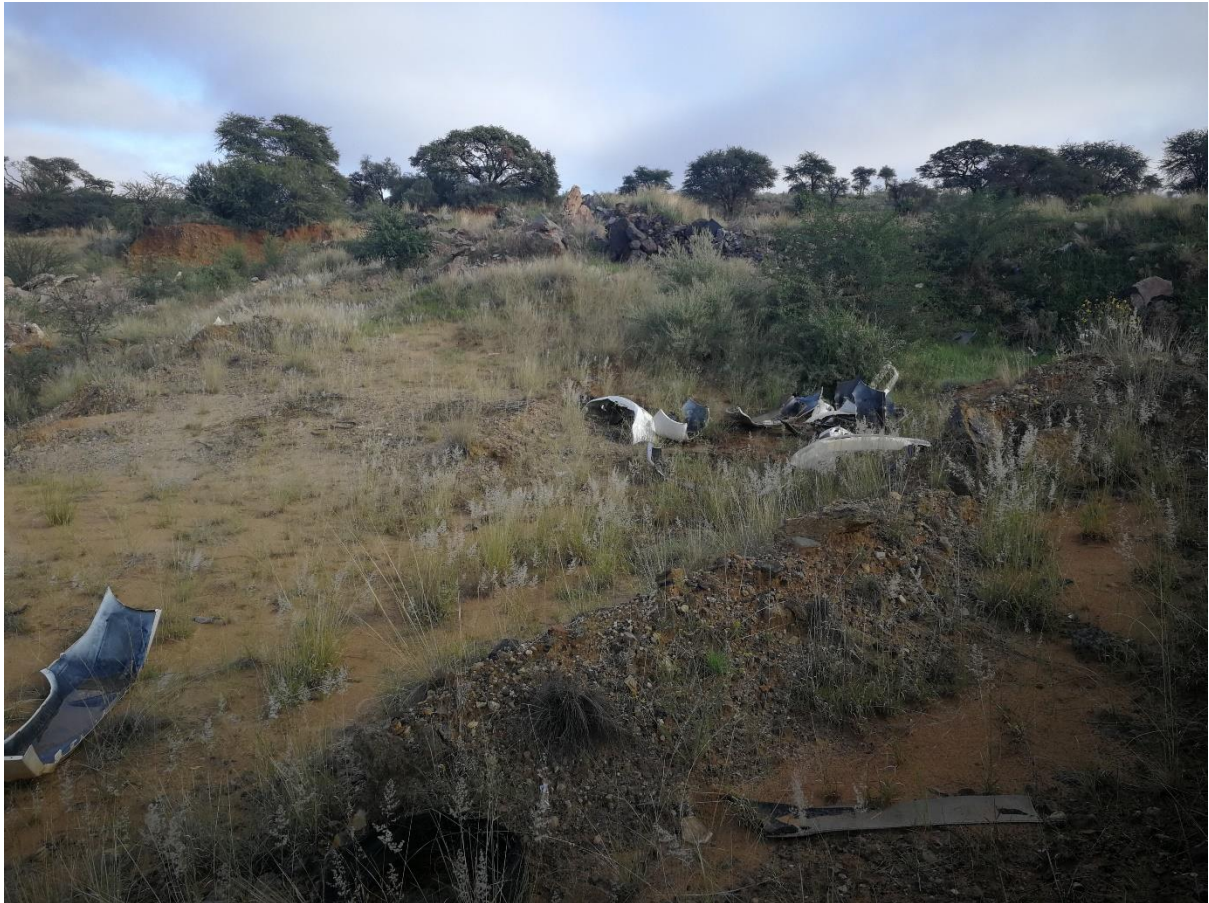
**Photo 27:** Stream Channel and associated Riparian Area for watercourse running along the northern boundary of the proposed development area. Clear signs of numerous excavation activities and informal rubble dumping. Highly uneven landscape due to excavation activities. Natural Kuruman Thornveld Vegetation. Direction: West

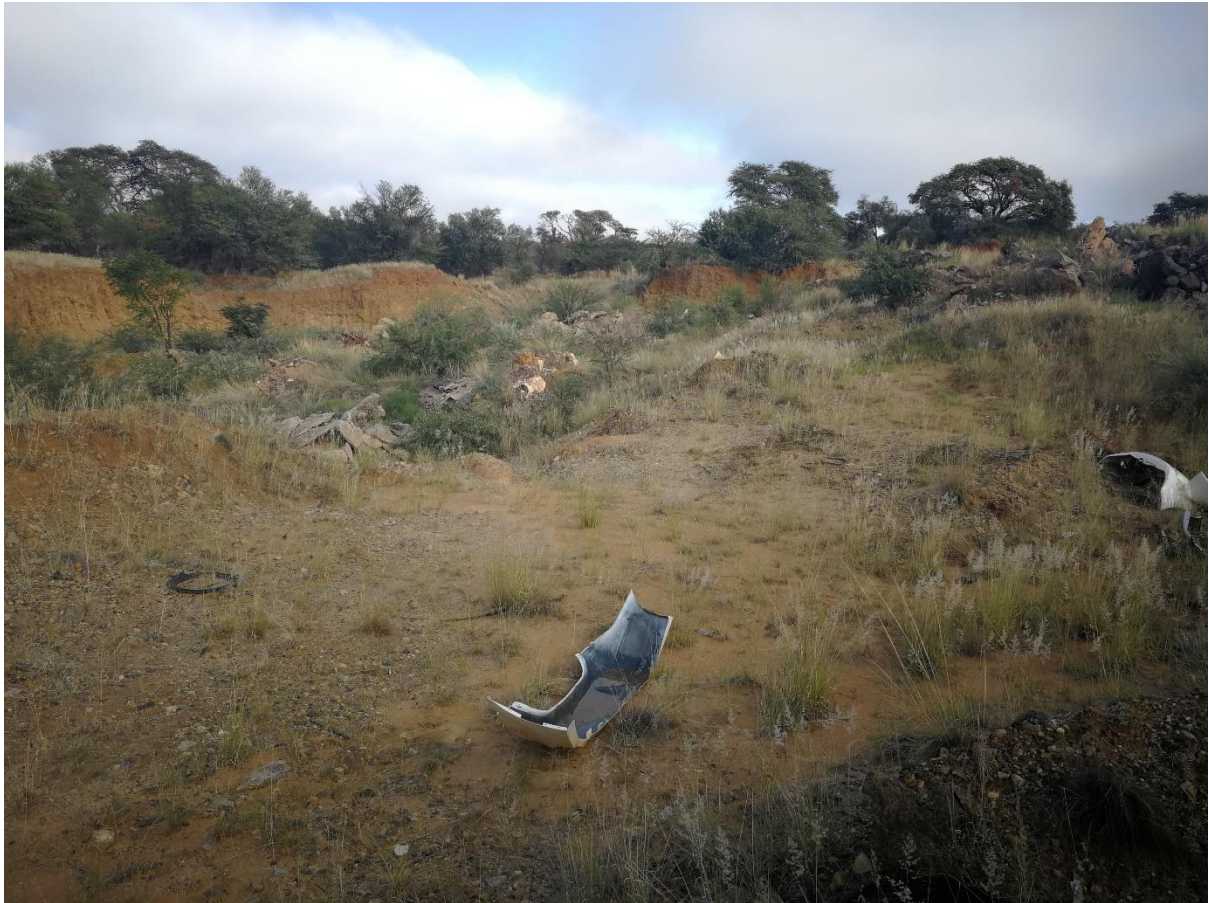
**Photo 28:** Stream Channel and associated Riparian Area for watercourse running along the northern boundary of the proposed development area. Clear signs of numerous excavation activities and informal rubble dumping. Note the highly uneven landscape due to excavation activities several metres deep. Natural Kuruman Thornveld Vegetation. Direction: West

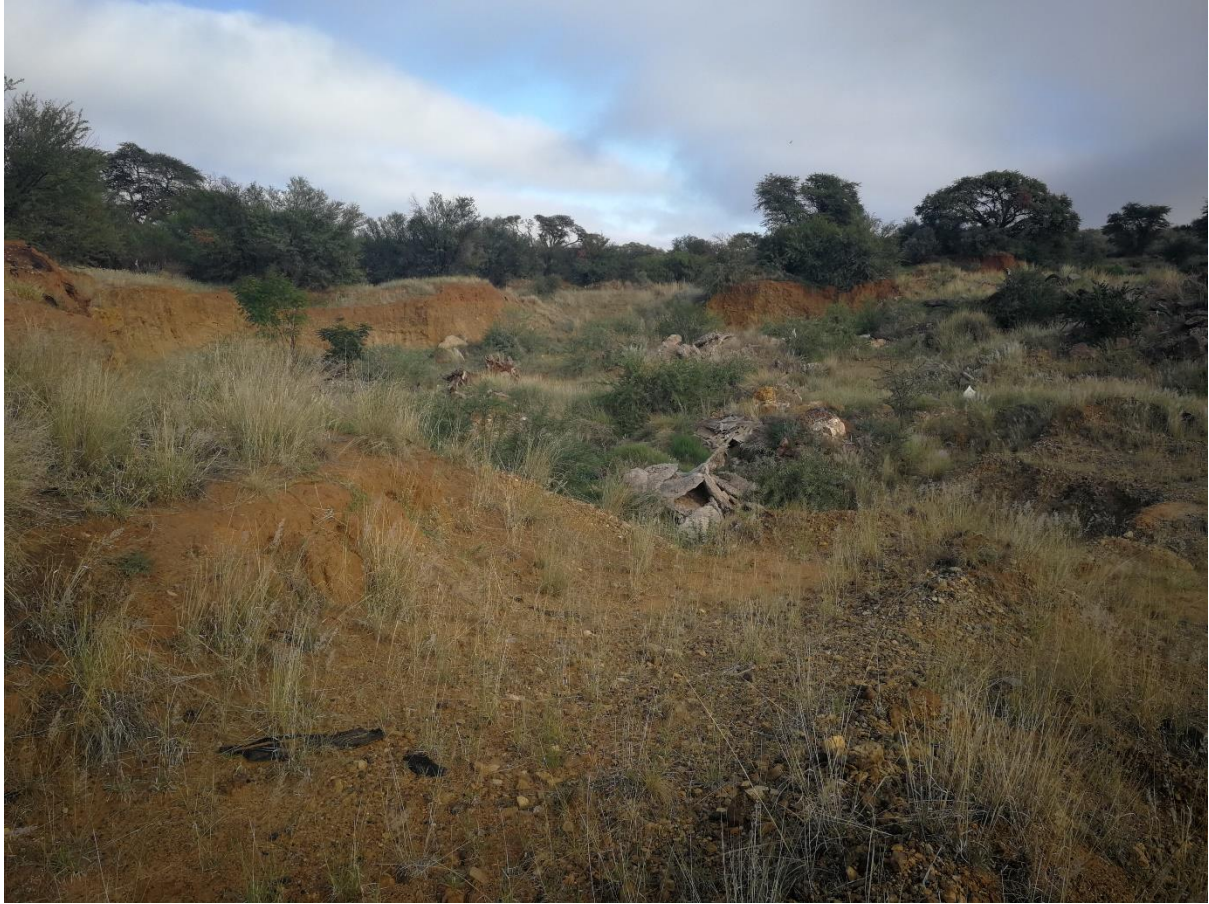
**Photo 29:** Stream Channel and associated Riparian Area for watercourse running along the northern boundary of the proposed development area. Clear signs of numerous excavation activities and informal rubble dumping. Note the highly uneven landscape due to excavation activities several metres deep. Natural Kuruman Thornveld Vegetation. Direction: West

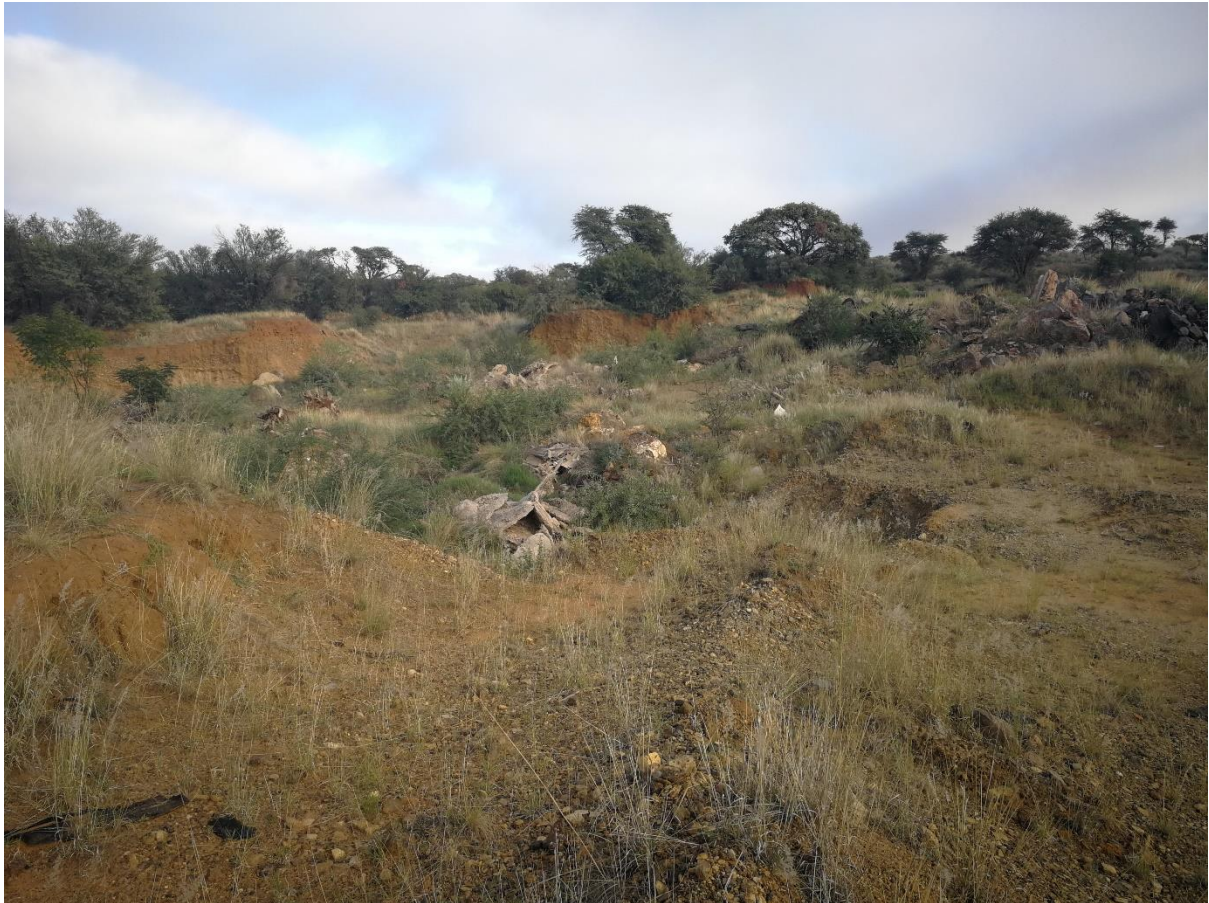
**Photo 30:** Stream Channel and associated Riparian Area for watercourse running along the northern boundary of the proposed development area. Clear signs of numerous excavation activities and informal rubble dumping. Note the highly uneven landscape due to excavation activities several metres deep. Natural Kuruman Thornveld Vegetation. Direction: West

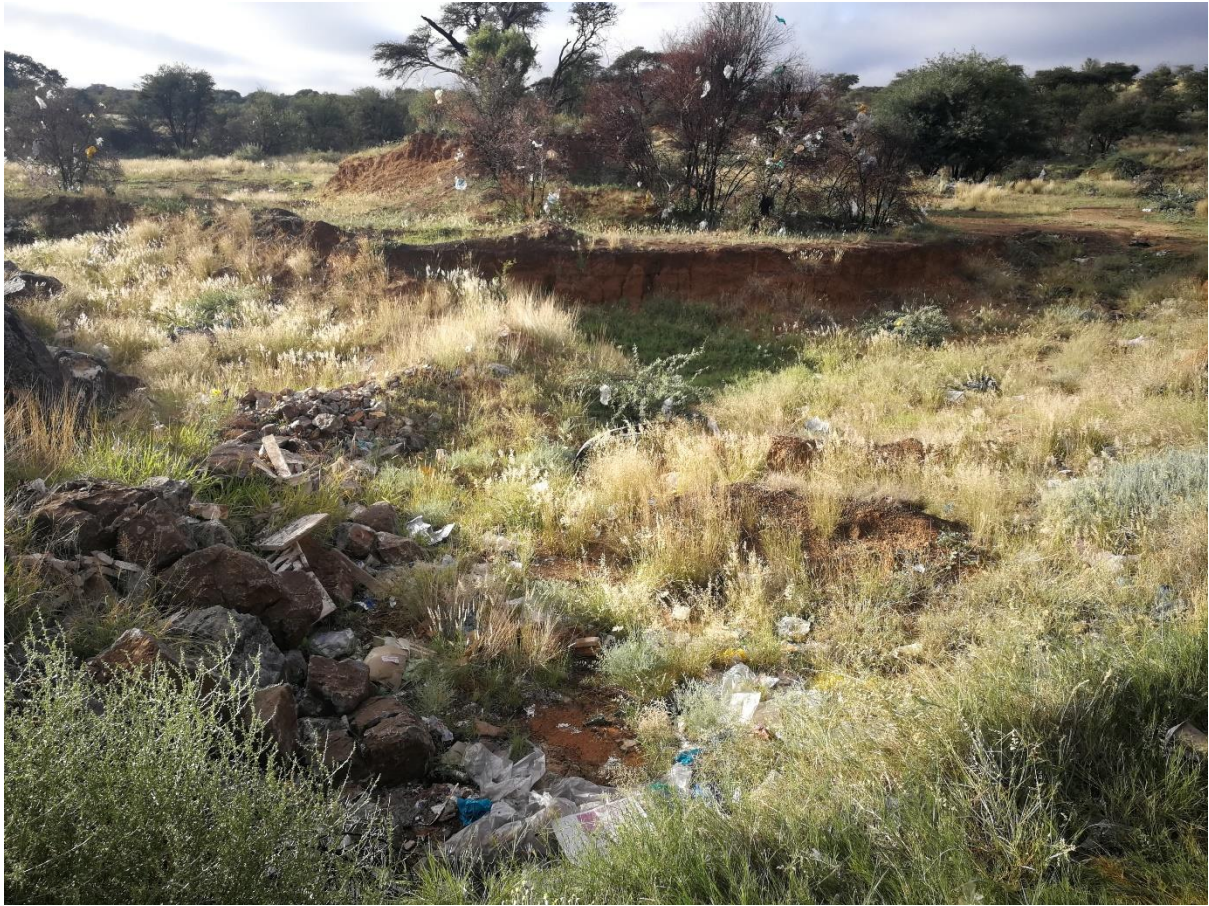
**Photo 31:** Stream Channel and associated Riparian Area for watercourse running along the northern boundary of the proposed development area, adjacent to the formal landfill site. Clear signs of numerous excavation activities and informal rubble dumping. Note the highly uneven landscape due to excavation activities several metres deep. Natural Kuruman Thornveld Vegetation. Direction: South-East

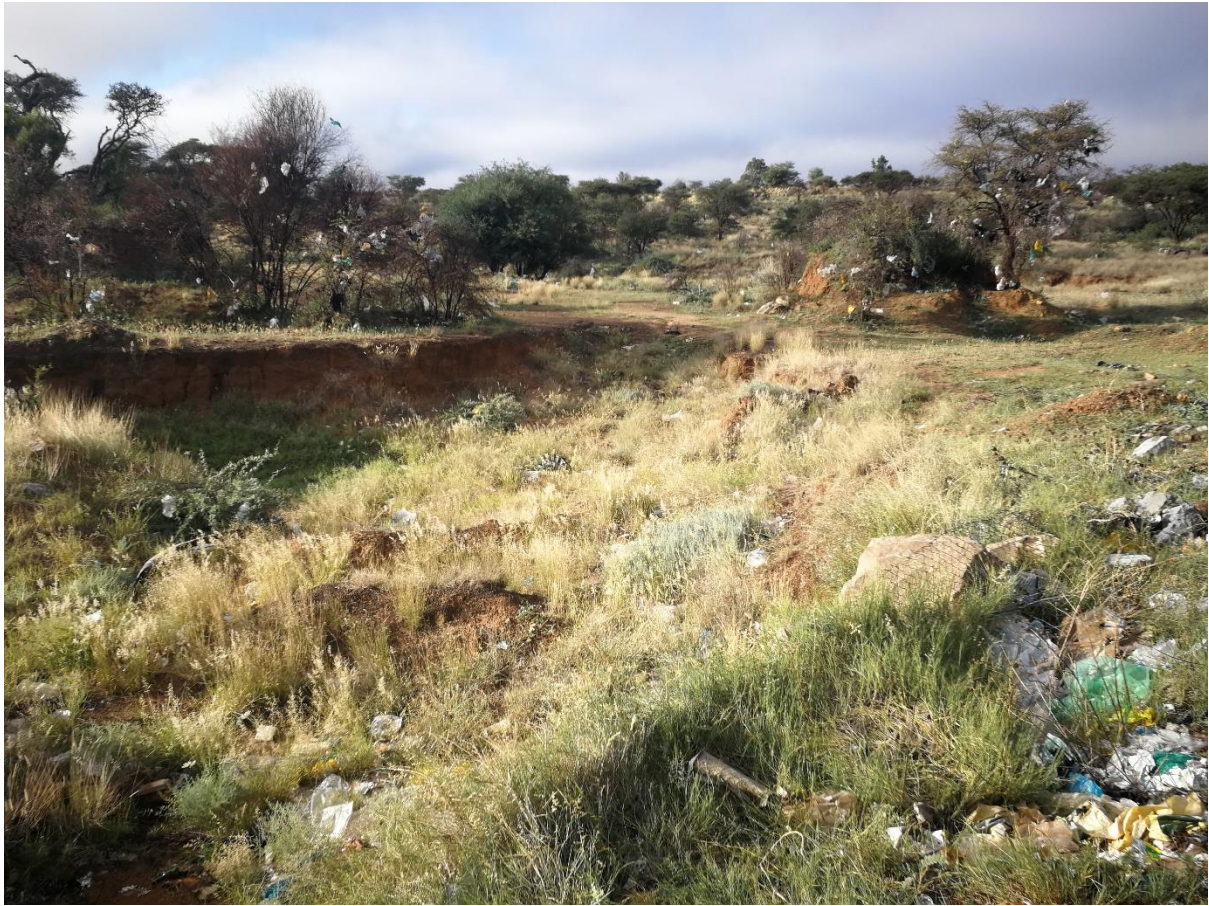
**Photo 32:** Stream Channel and associated Riparian Area for watercourse running along the northern boundary of the proposed development area, adjacent to the Kuruman Formal Landfill site. Clear signs of numerous excavation activities and informal rubble dumping. Note the highly uneven landscape due to excavation activities several metres deep. Natural Kuruman Thornveld Vegetation. Direction: South-East

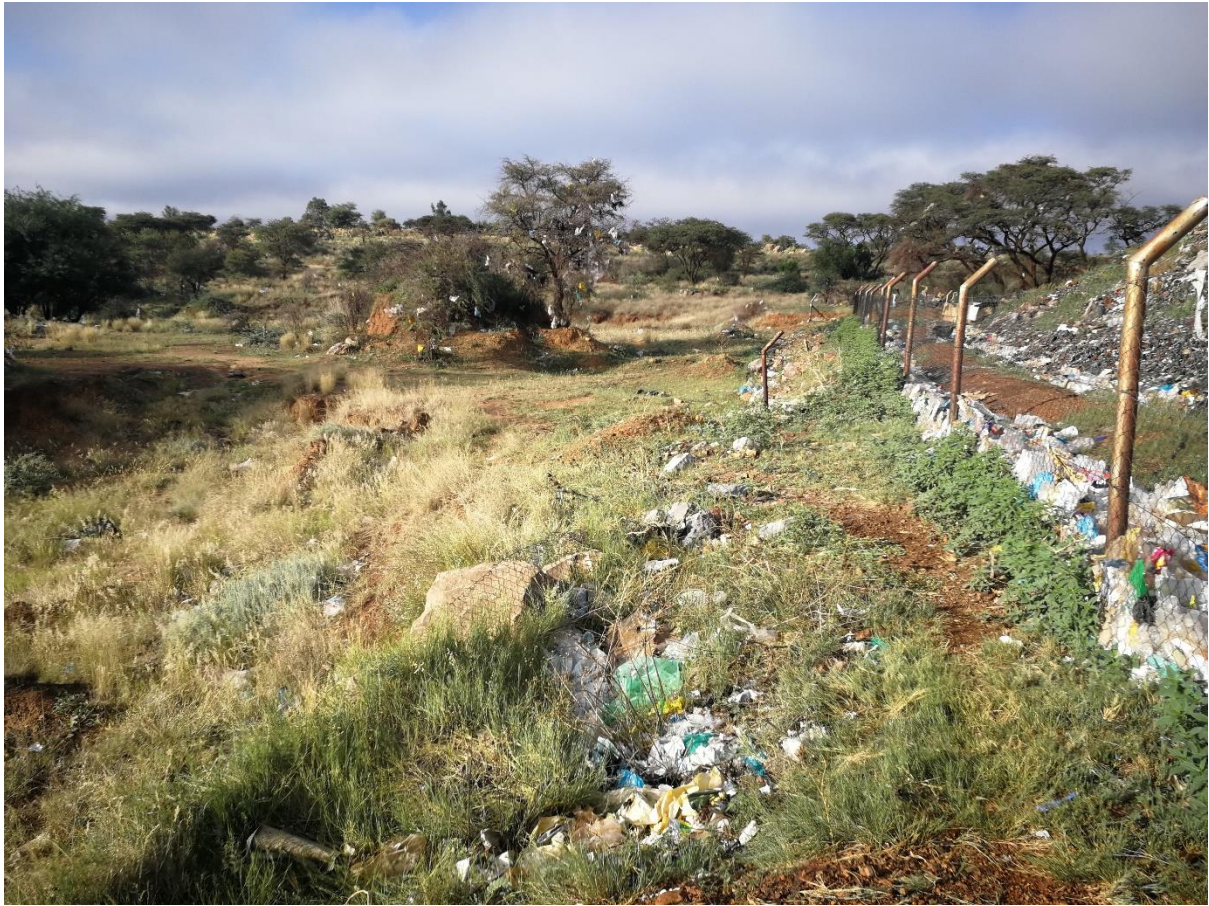
**Photo 33:** Stream Channel and associated Riparian Area for watercourse running along the northern boundary of the proposed development area, adjacent to the Kuruman Formal Landfill site. Clear signs of numerous excavation activities and informal rubble dumping. Note the highly uneven landscape due to excavation activities several metres deep. Natural Kuruman Thornveld Vegetation. Direction: South

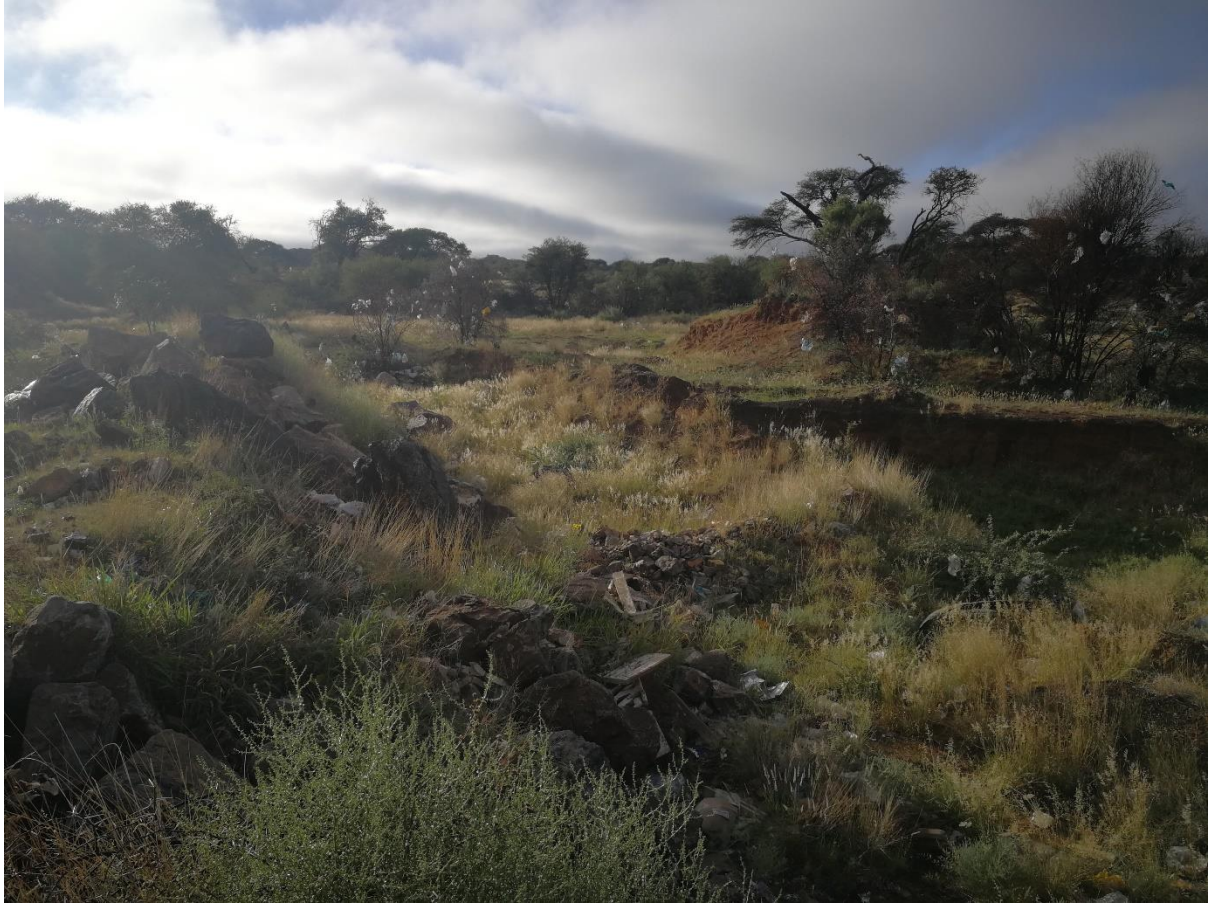
**Photo 34:** Stream Channel and associated Riparian Area for watercourse running along the northern boundary of the proposed development area, adjacent to the Kuruman Formal Landfill site. Clear signs of numerous excavation activities and informal rubble dumping. Note the highly uneven landscape due to excavation activities several metres deep. Natural Kuruman Thornveld Vegetation. Direction: North-East

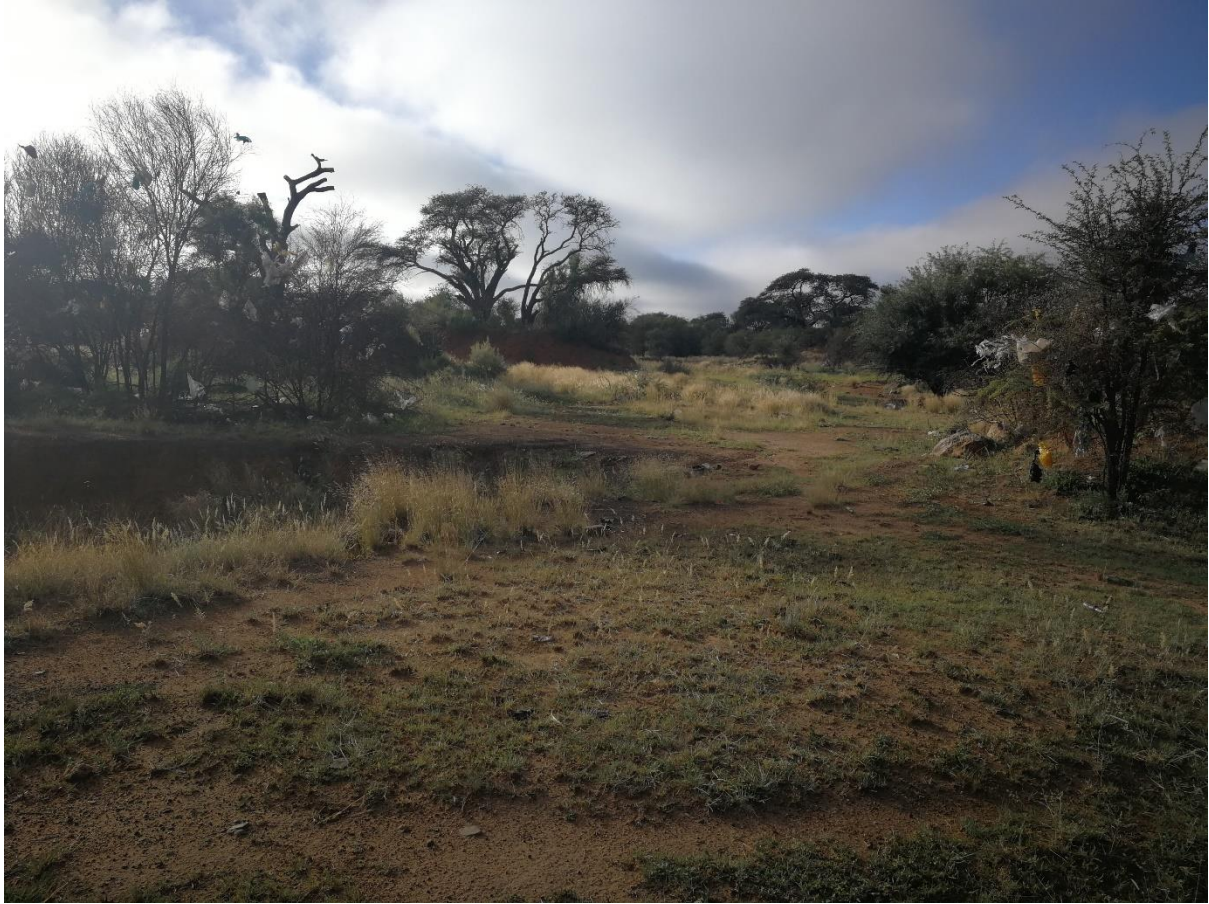
**Photo 35:** Stream Channel and associated Riparian Area for watercourse running along the northern boundary of the proposed development area, adjacent to the Kuruman Formal Landfill site. Clear signs of numerous excavation activities and informal rubble dumping. Note the highly uneven landscape due to excavation activities several metres deep. Natural Kuruman Thornveld Vegetation. Direction: East

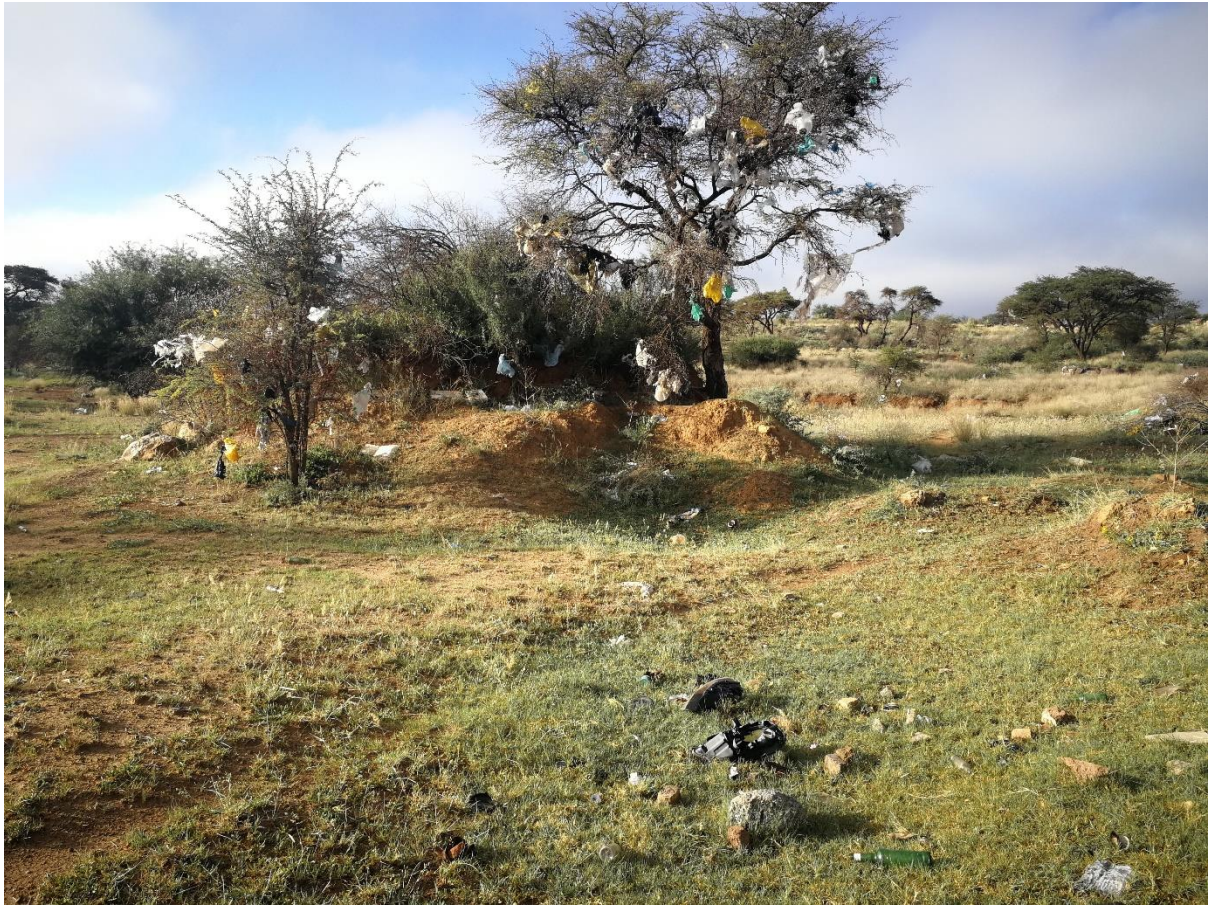
**Photo 36:** Stream Channel and associated Riparian Area for watercourse running along the northern boundary of the proposed development area, adjacent to the Kuruman Formal Landfill site. Clear signs of numerous excavation activities and informal rubble dumping. Note the highly uneven landscape due to excavation activities several metres deep. Natural Kuruman Thornveld Vegetation. Direction: East

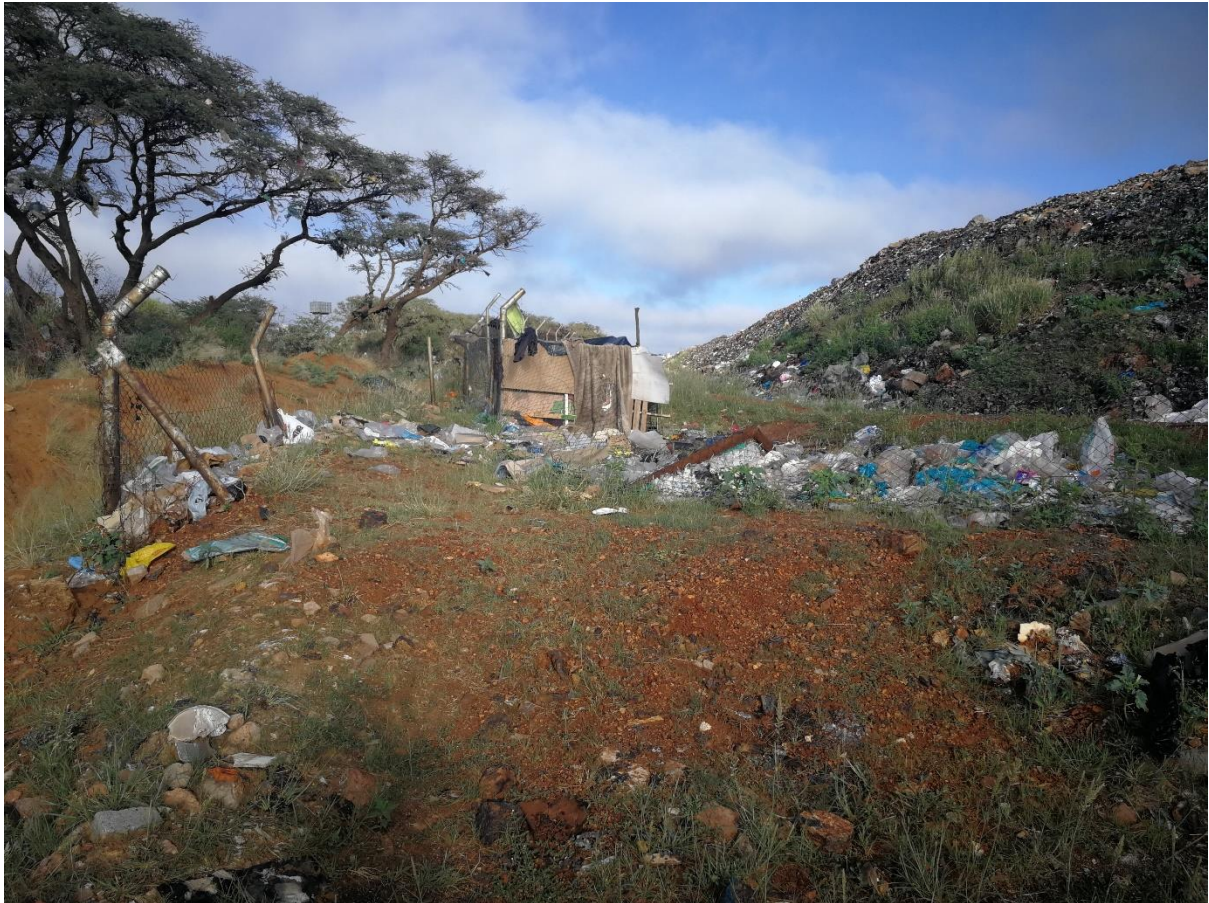
**Photo 37:** Stream Channel and associated Riparian Area for watercourse running along the northern boundary of the proposed development area, adjacent to the Kuruman Formal Landfill site. Clear signs of informal rubble dumping. Note the highly uneven landscape due to excavation activities several metres deep. Natural Kuruman Thornveld Vegetation. Direction: West

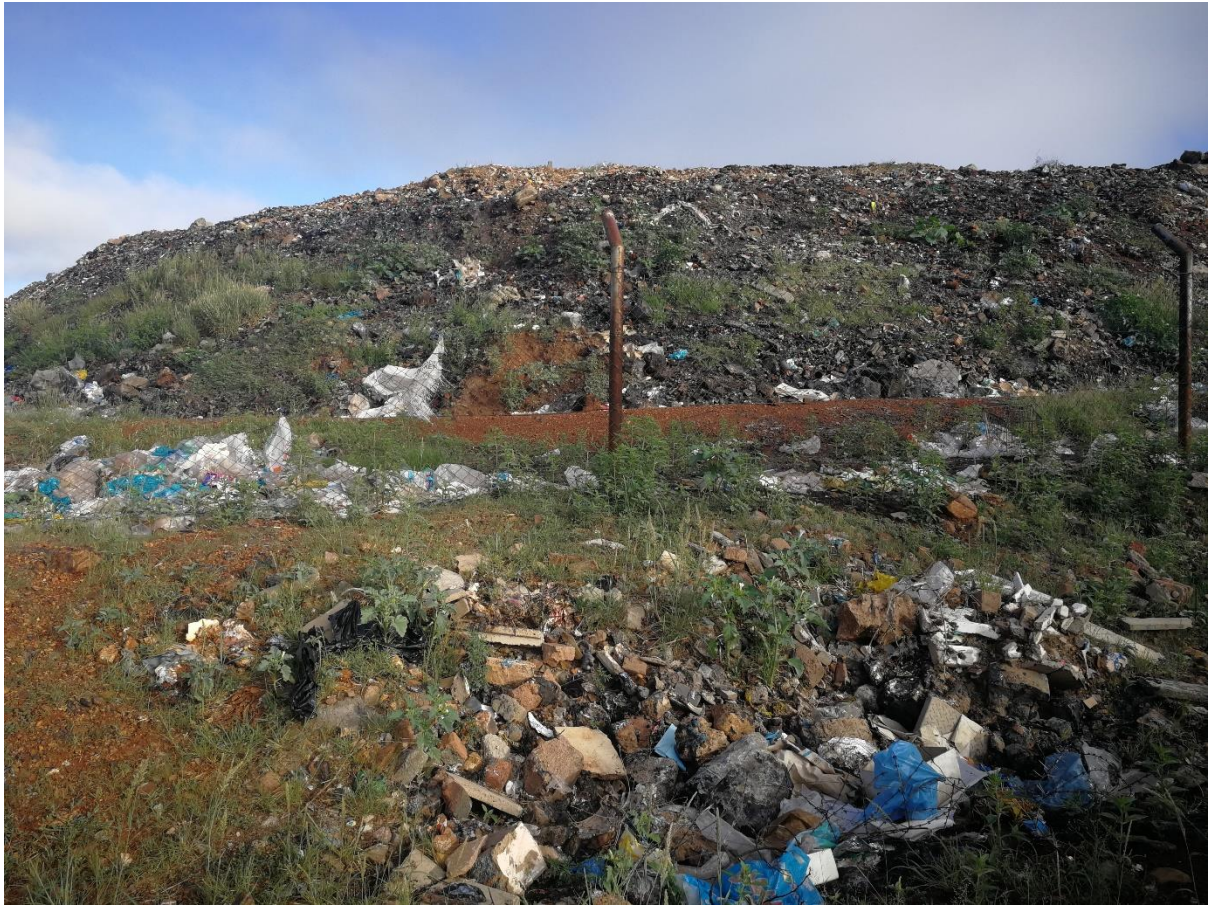
**Photo 38:** Stream Channel and associated Riparian Area for watercourse running along the northern boundary of the proposed development area, adjacent to the Kuruman Formal Landfill site. Clear signs of informal rubble dumping. Note the highly uneven landscape due to excavation activities several metres deep. Natural Kuruman Thornveld Vegetation. Direction: West

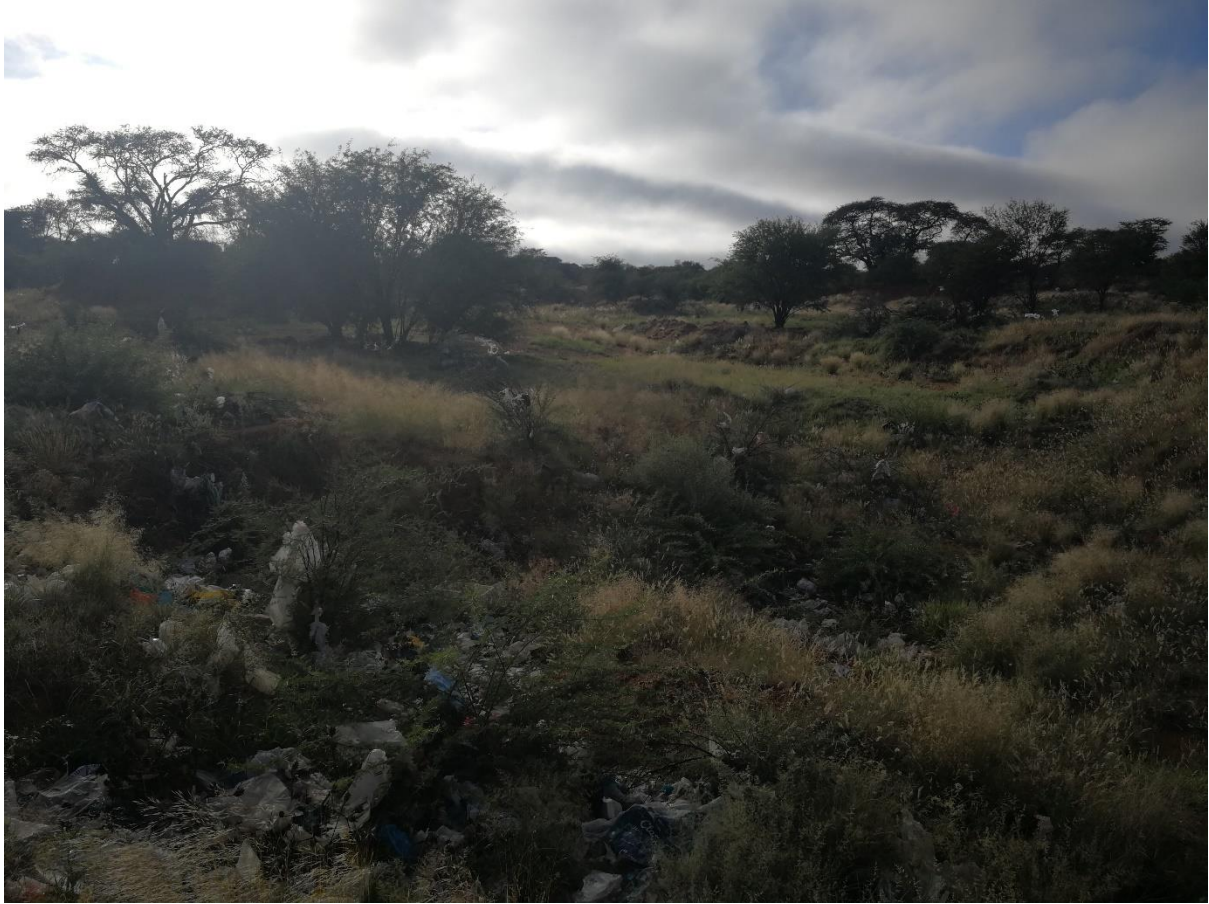
**Photo 39:** Stream Channel and associated Riparian Area for watercourse running along the northern boundary of the proposed development area, adjacent to the Kuruman Formal Landfill site. Clear signs of informal rubble dumping. Note the highly uneven landscape due to excavation activities several metres deep. Natural Kuruman Thornveld Vegetation. Direction: East

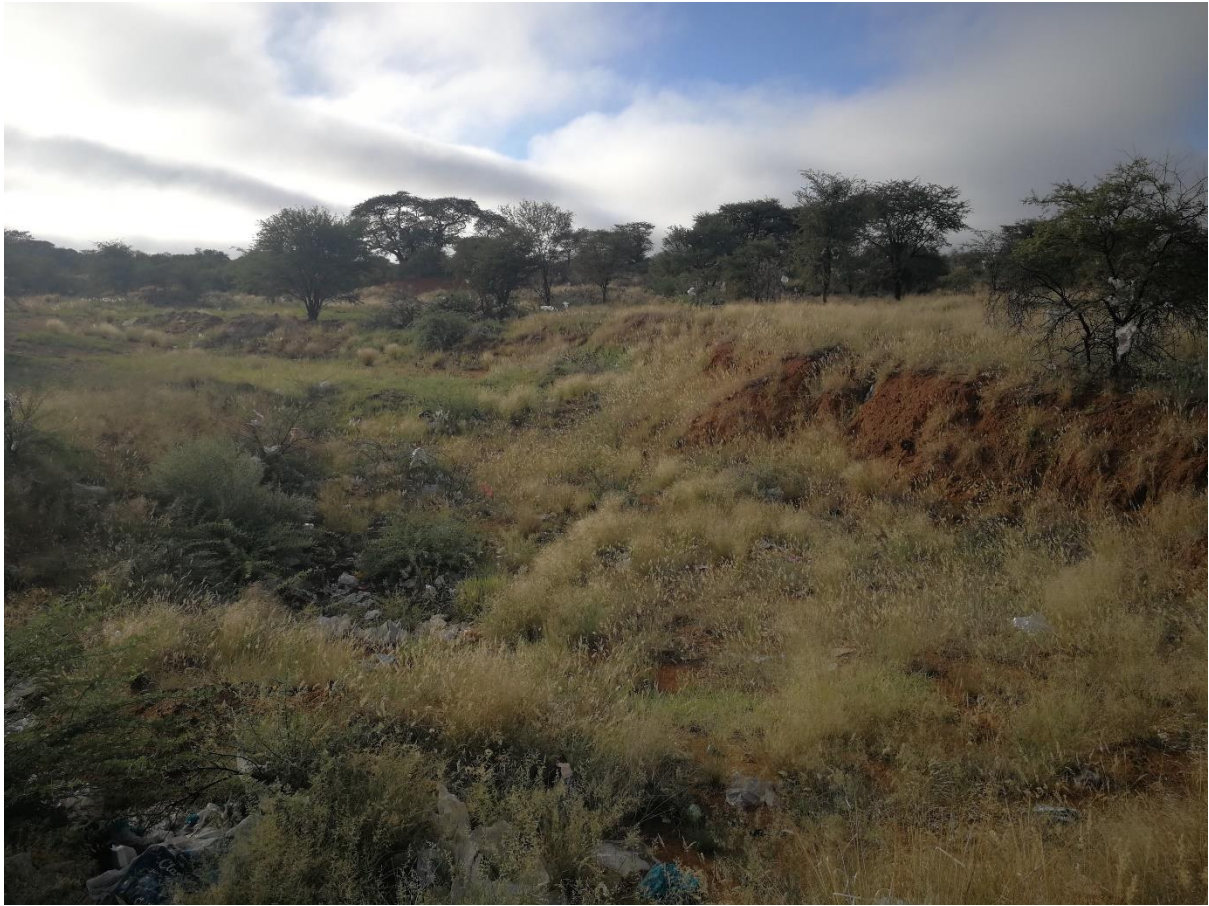
**Photo 40:** Stream Channel and associated Riparian Area for watercourse running along the northern boundary of the proposed development area, adjacent to the Kuruman Formal Landfill site. Clear signs of informal rubble dumping. Note the highly uneven landscape due to excavation activities several metres deep. Natural Kuruman Thornveld Vegetation. Direction: East

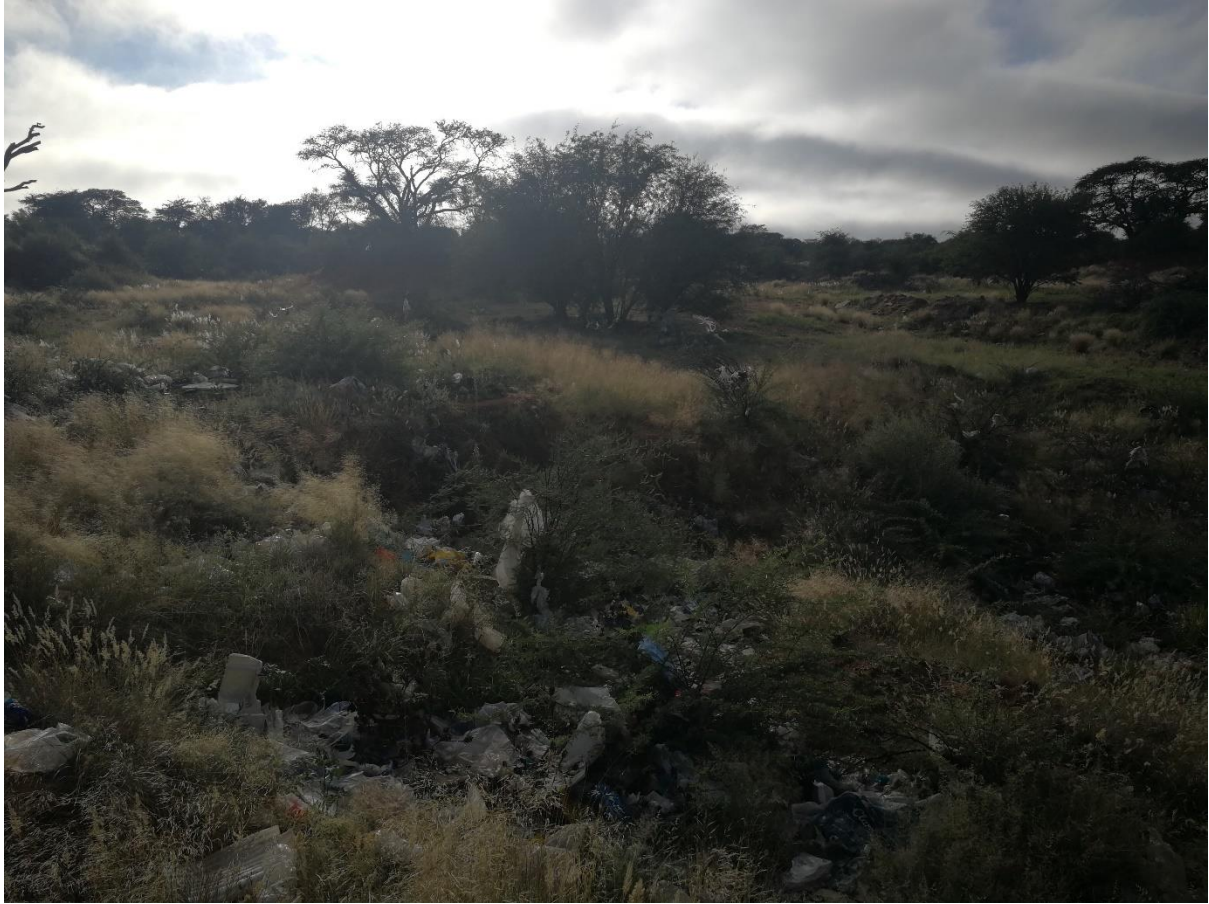
**Photo 41:** Stream Channel and associated Riparian Area for watercourse running along the northern boundary of the proposed development area, adjacent to the Kuruman Formal Landfill site. Clear signs of informal rubble dumping. Note the highly uneven landscape due to excavation activities several metres deep. Natural Kuruman Thornveld Vegetation. Direction: North-East

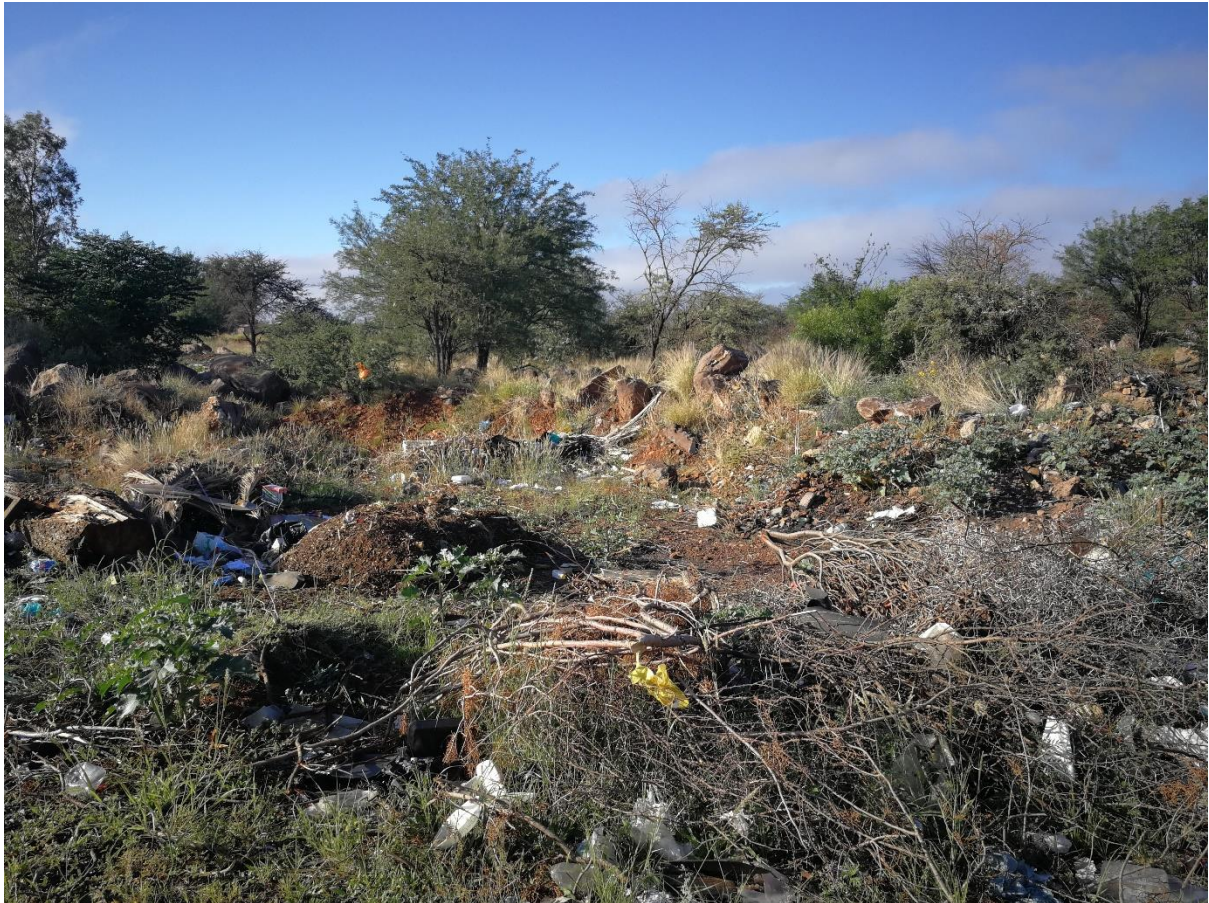
**Photo 42:** Example of informal dumping areas within the 1:100 Year Floodline of the watercourse running along the northern boundary of the proposed development area. Note the highly uneven landscape due to excavation activities several metres deep. Natural Kuruman Thornveld Vegetation. Direction: North

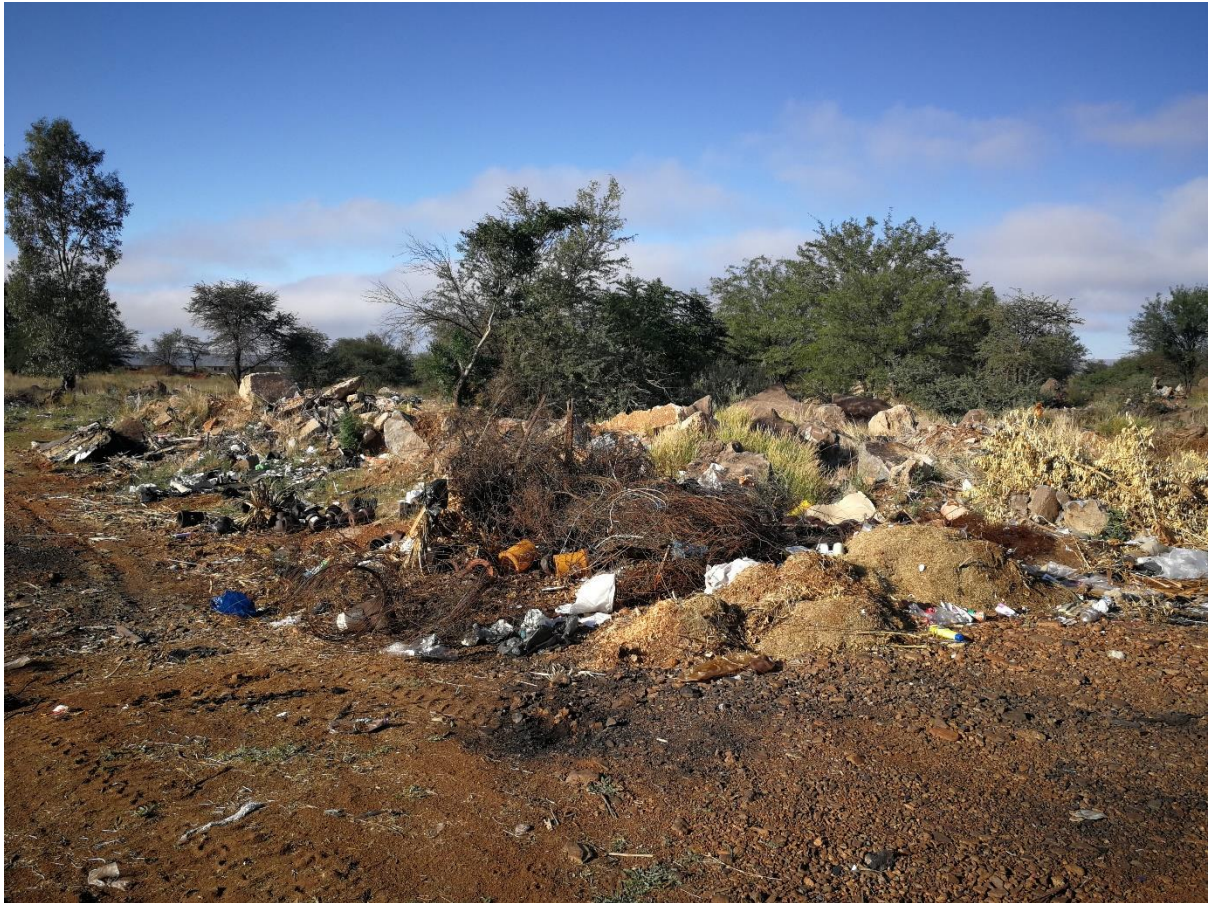
**Photo 43:** Example of informal dumping areas within the 1:100 Year Floodline of the watercourse running along the northern boundary of the proposed development area. Note the highly uneven landscape due to excavation activities several metres deep. Natural Kuruman Thornveld Vegetation. Direction: North

Given the observations made by the Author within this area during the Site Inspection, the Author concurs with this notion, as the severely degraded and excavated nature of the area along the northern portion of the property will cause severe developmental constraints.

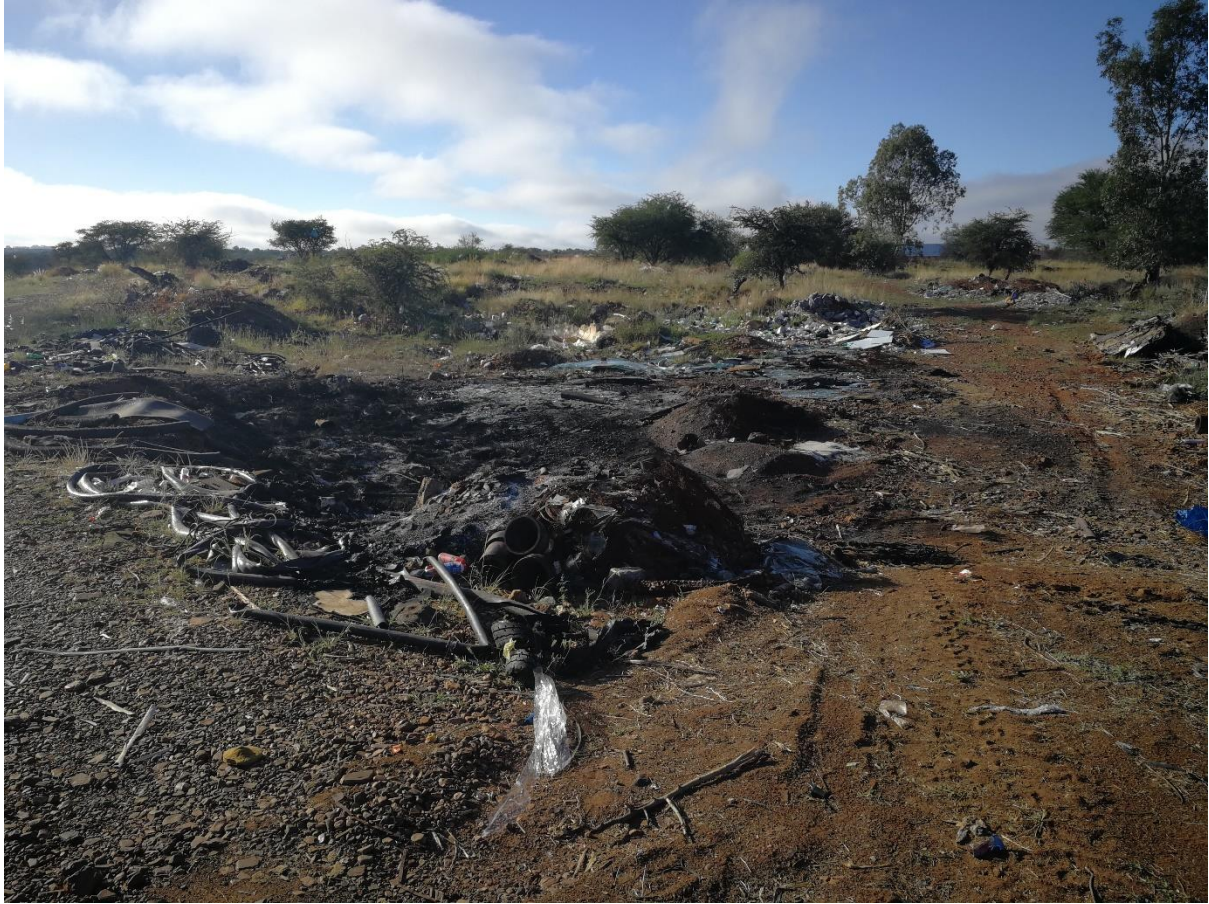
**Photo 44:** Example of informal dumping areas adjacent to gravel access road within the 1:100 Year Floodline of the watercourse running along the northern boundary of the proposed development area. Natural Kuruman Thornveld Vegetation. Direction: North

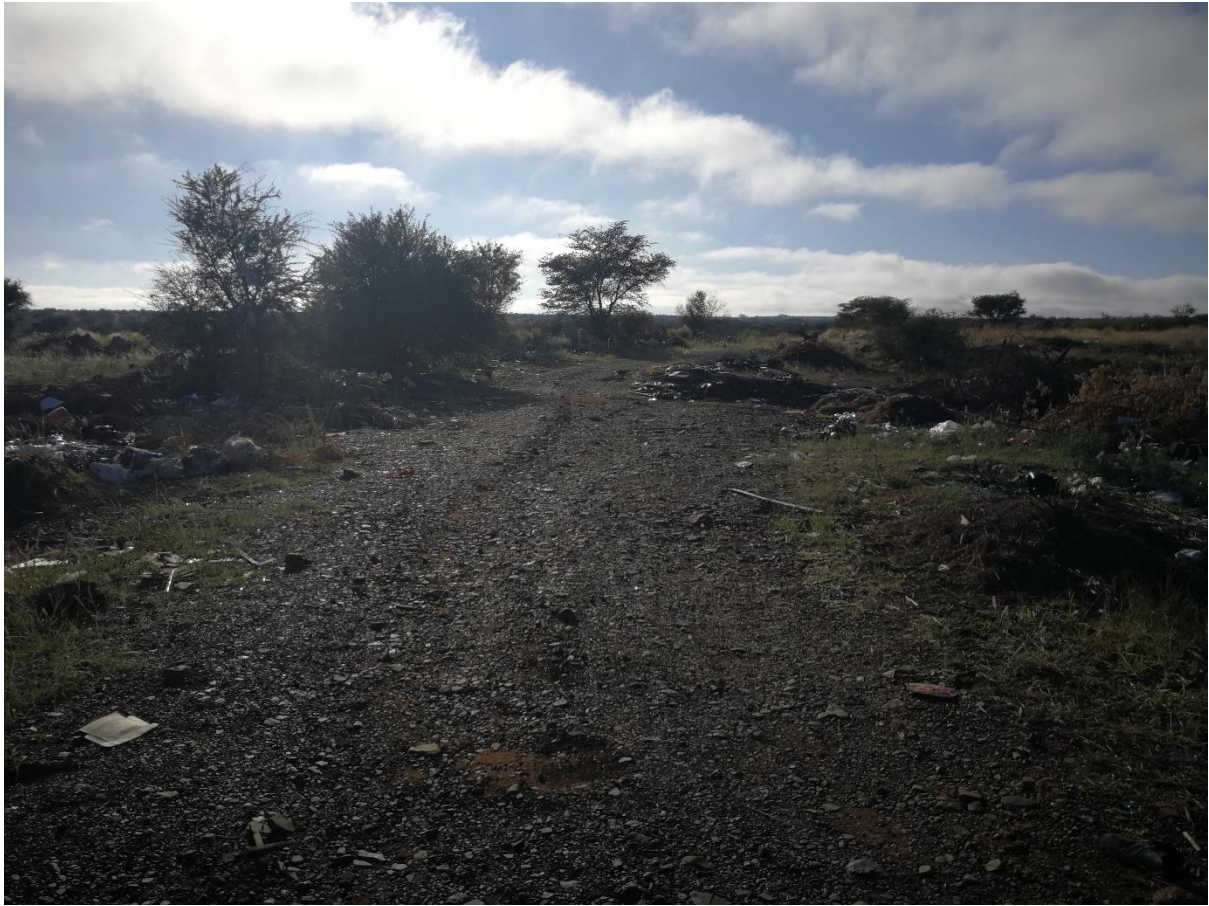
**Photo 45:** Gravel access road towards the concerned development area, running from the Kuruman Formal Landfill site in an Eastern direction crossing through the stream channel until it terminates at the sand quarry in the north-eastern corner of the proposed development area. Natural Kuruman Thornveld Vegetation. Direction: North-East
