**AQUATIC CONSTRAINTS ANALYSIS & DWS RISK ASSESSMENT MATRIX FOR  
THE PROPOSED WRENCHVILLE PHASE 2 LOW-COST HOUSING DEVELOPMENT,  
KURUMAN, NORTHERN CAPE PROVINCE.**

**08 JULY 2019**

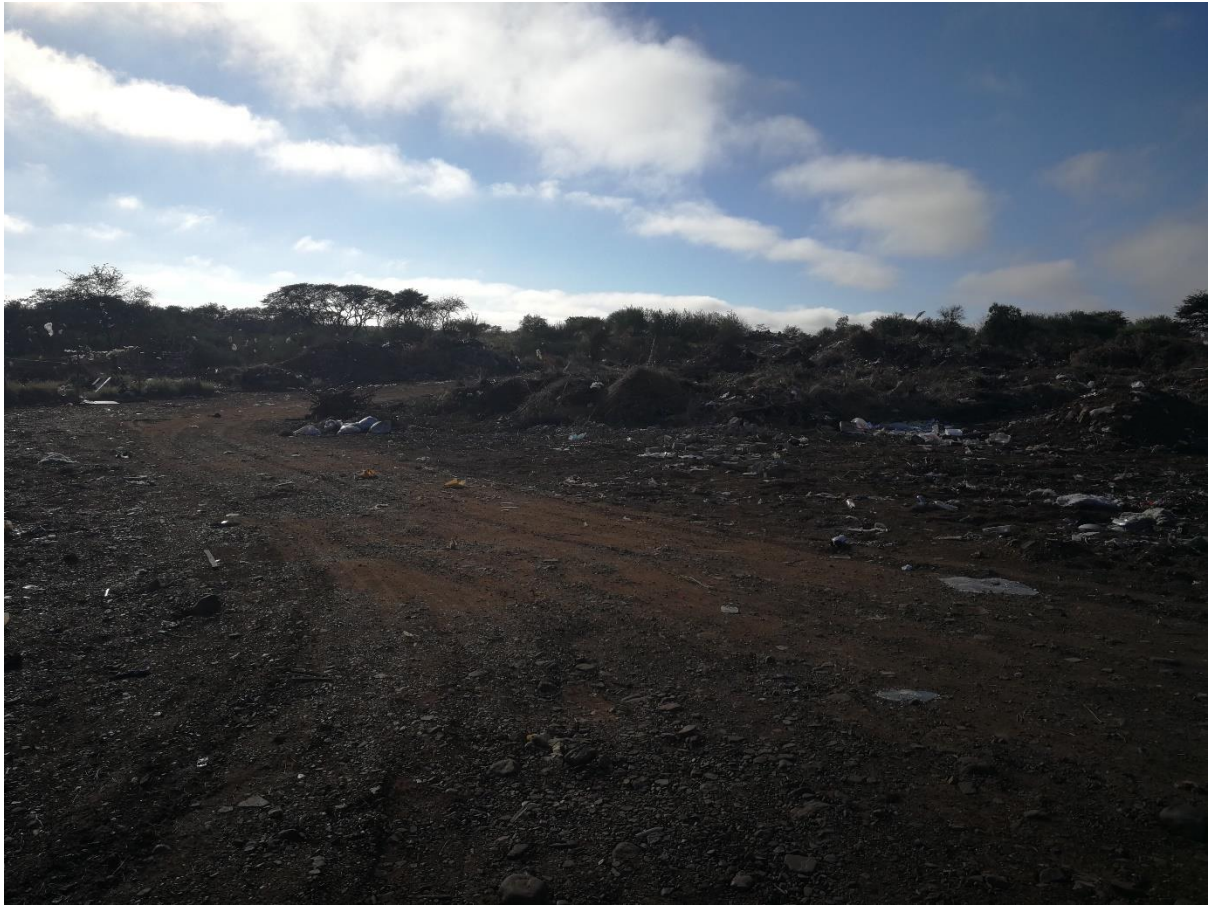
**Photo 46:** Gravel access road towards the concerned development area, running from the Kuruman Formal Landfill site in an Eastern direction crossing through the stream channel until it terminates at the sand quarry in the north-eastern corner of the proposed development area. Natural Kuruman Thornveld Vegetation. Direction: North-East

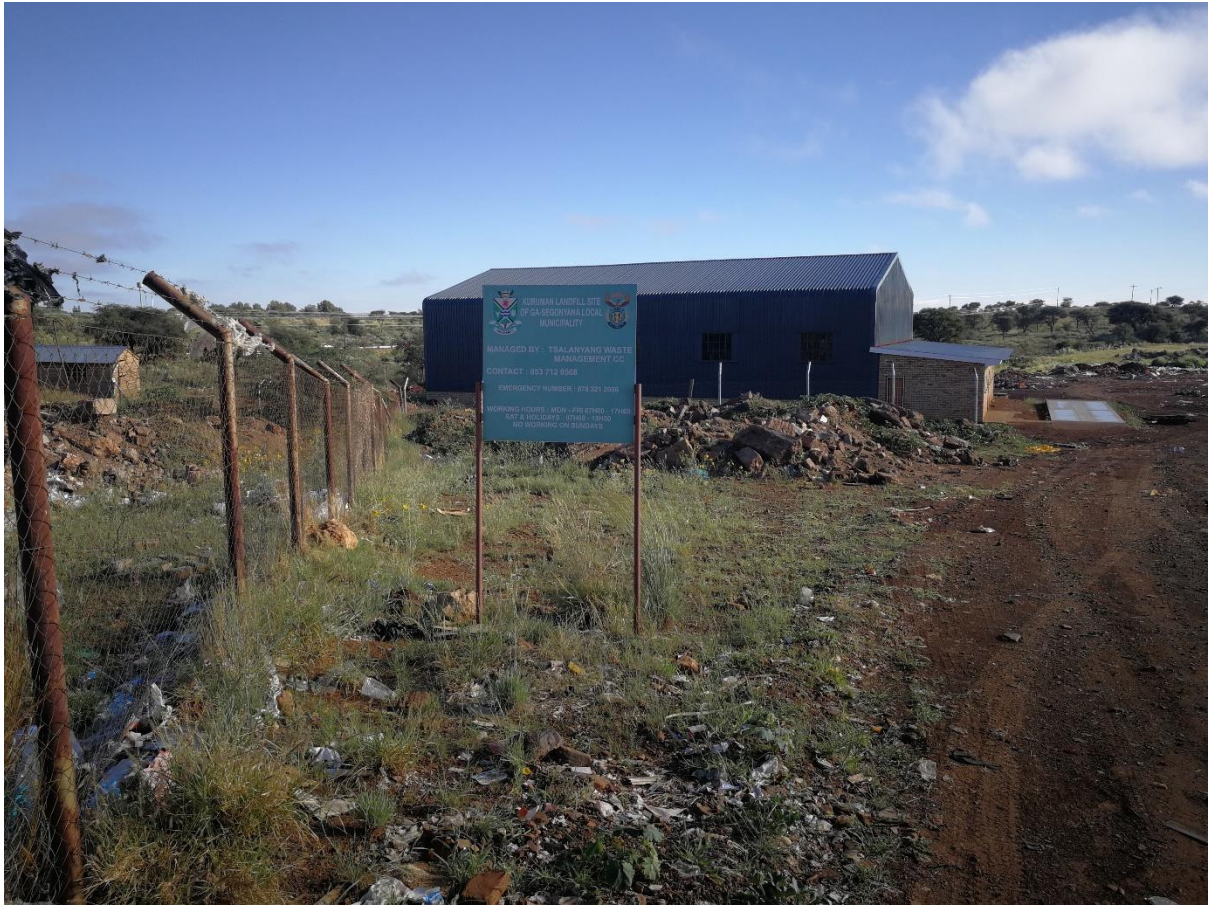
**Photo 47:** Formal Kuruman Landfill site. Direction: North-East

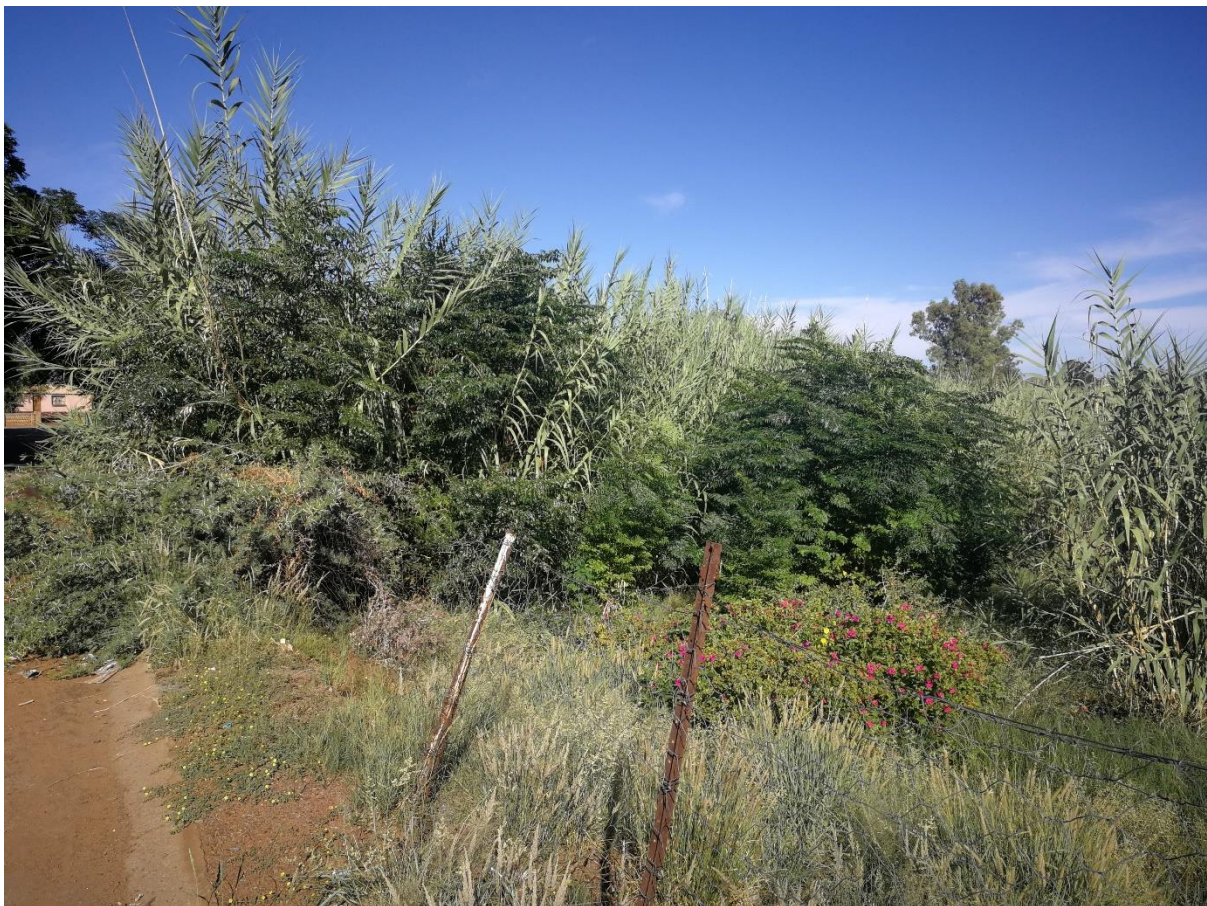
**Photo 49:** D41L-02299 flowing underneath Mossie Street in Wrenchville. Severely overgrown and disturbed. Direction: South-West

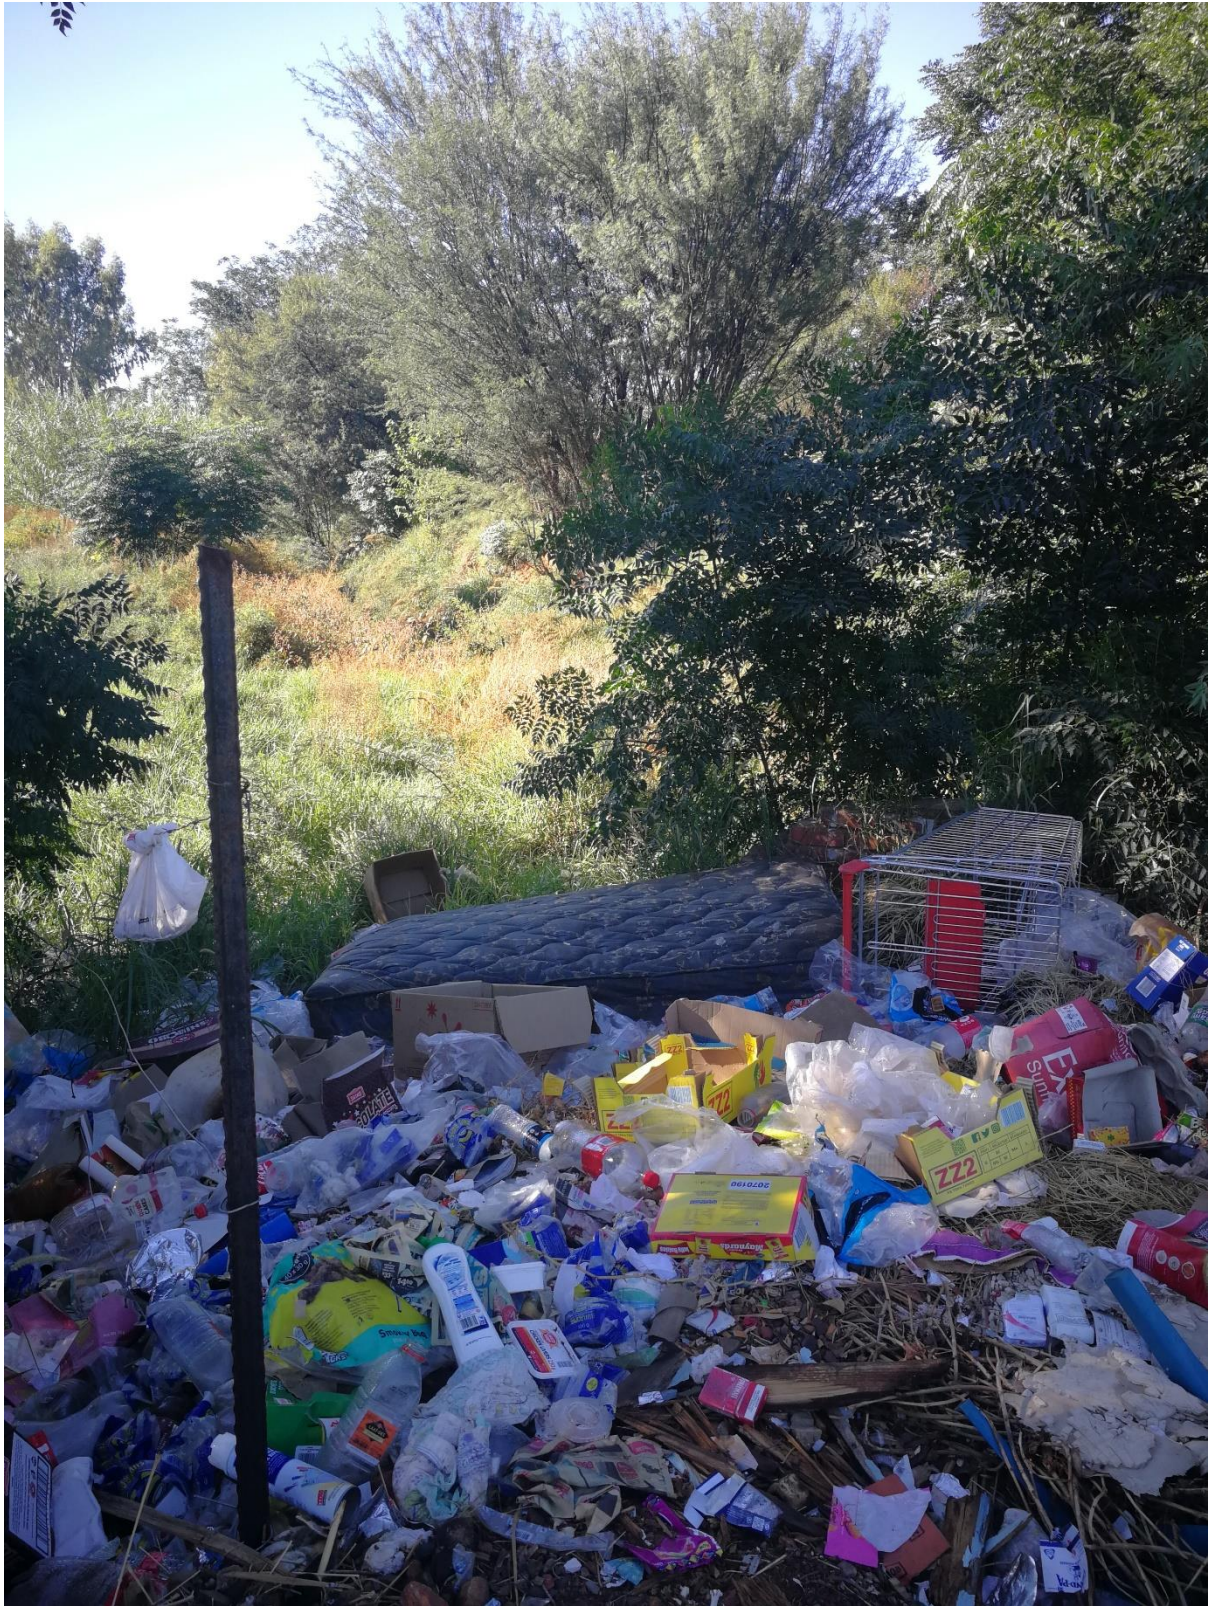
**Photo 50:** D41L-02299 culvert crossing underneath Mossie Street in Wrenchville. Severely overgrown and polluted. Direction: East.

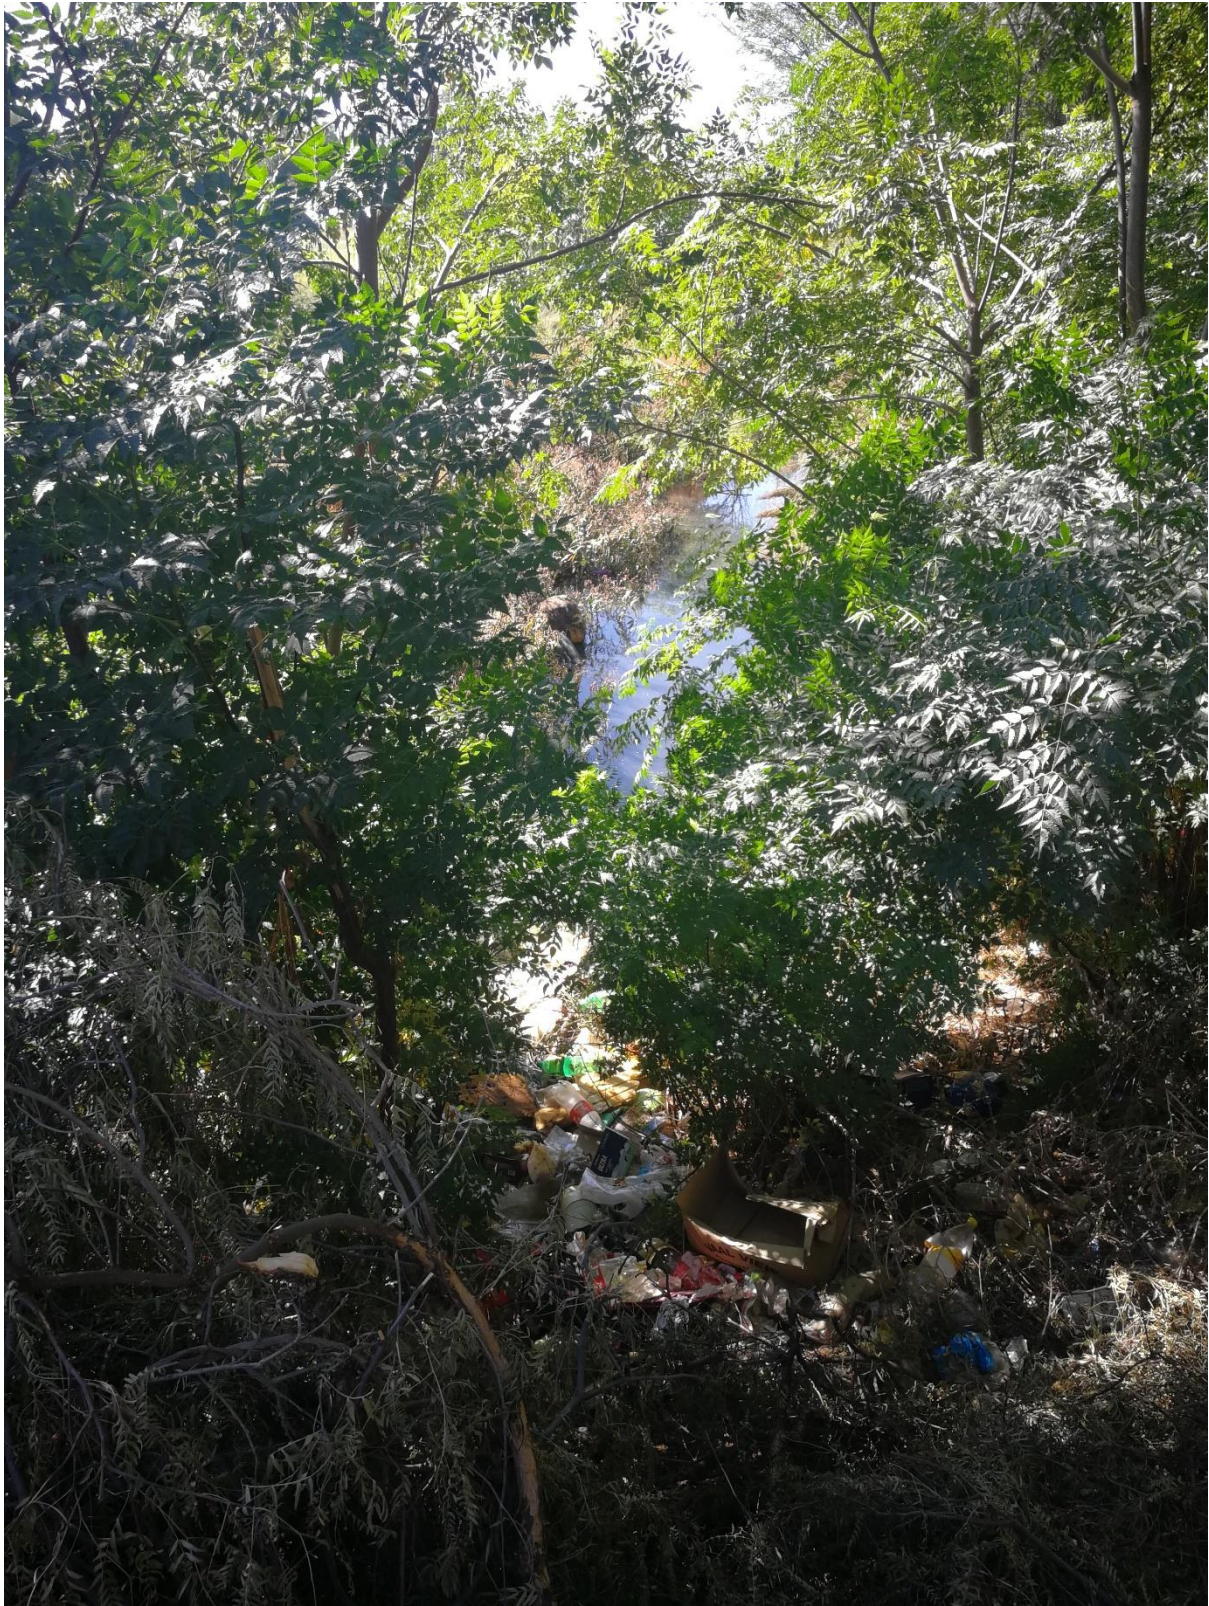
**Photo 51:** D41L-02299 culvert crossing underneath Mossie Street in Wrenchville. Severely overgrown and polluted. Direction: East.

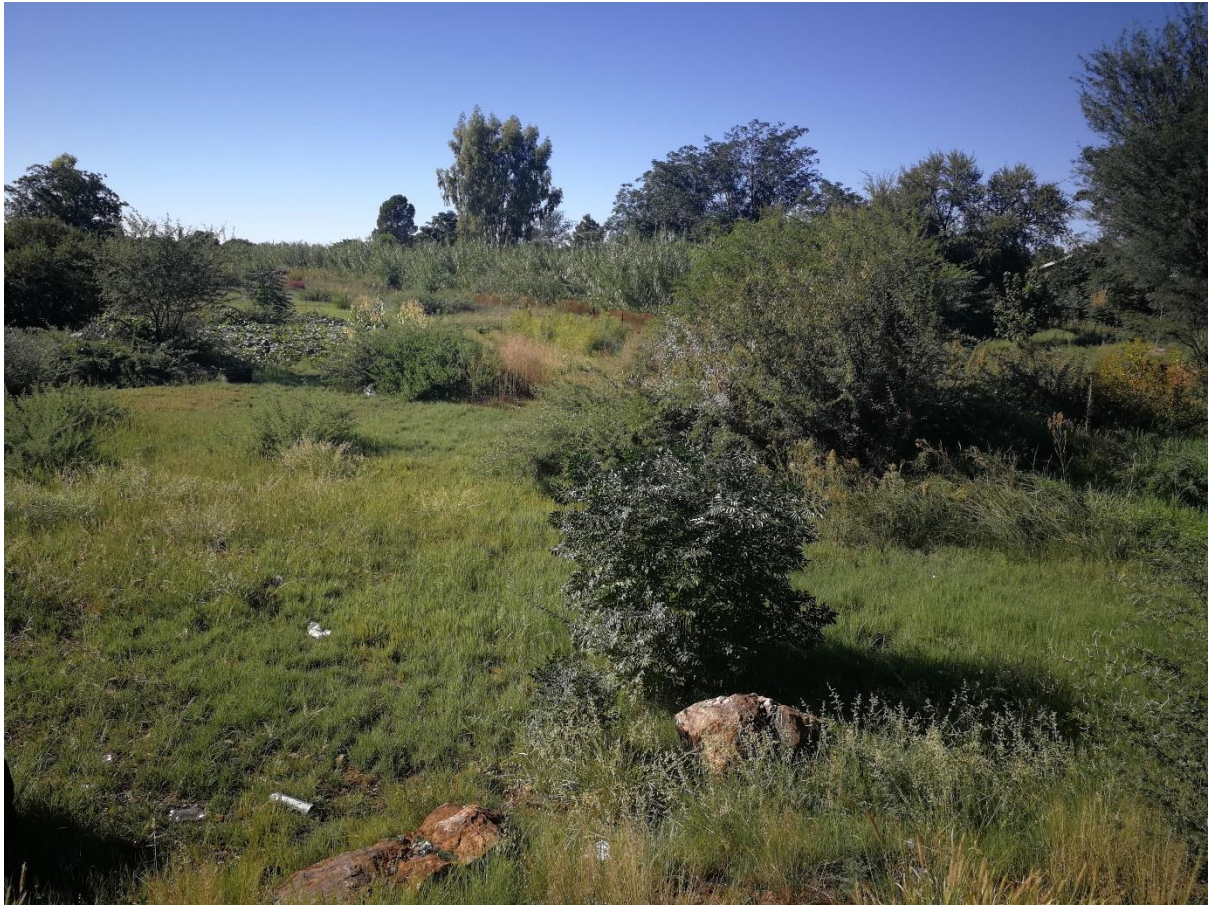
**Photo 52:** D41L-02299 flowing underneath Mossie Street in Wrenchville. Severely overgrown and disturbed. Direction: East

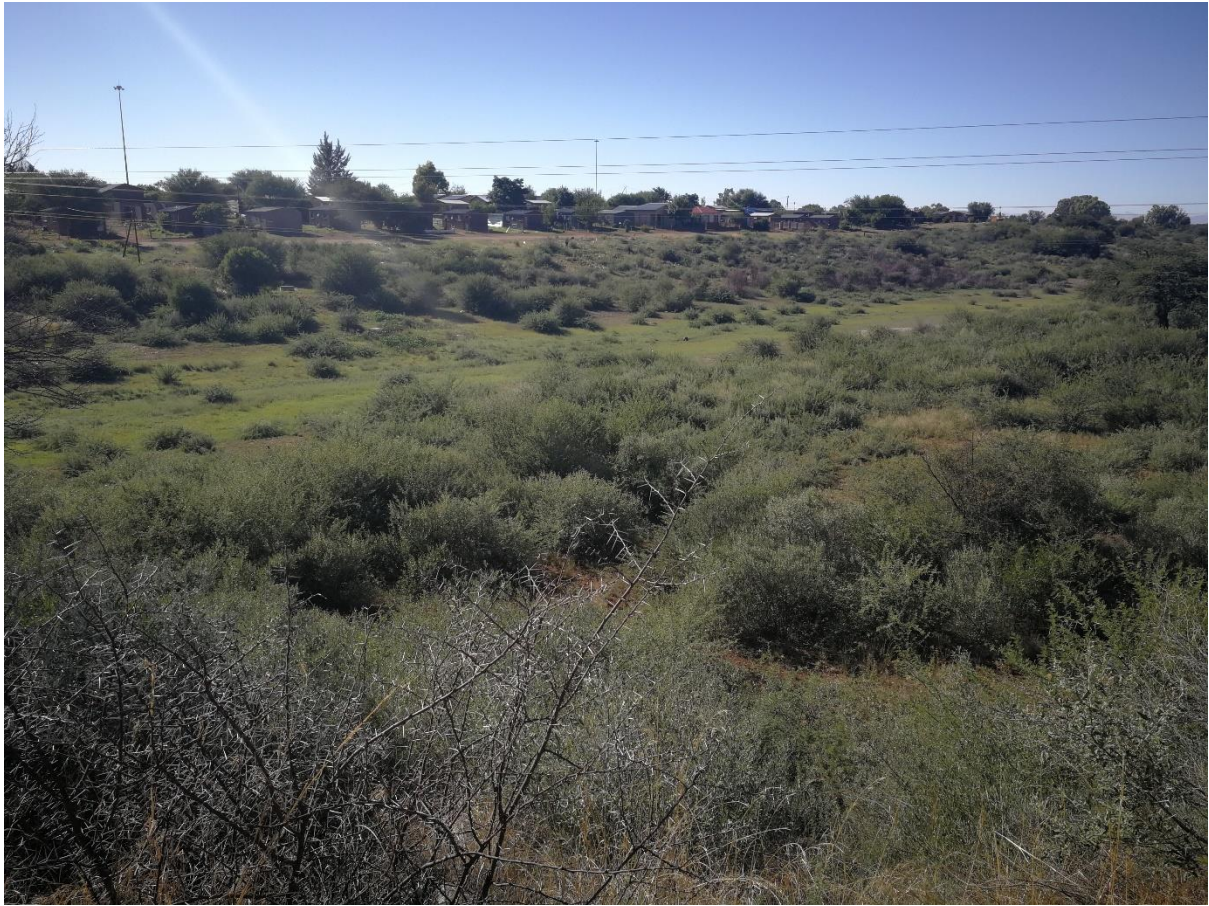
**Photo 53:** D41L-02299 flowing underneath Buitekant Street in Wrenchville. Direction: East

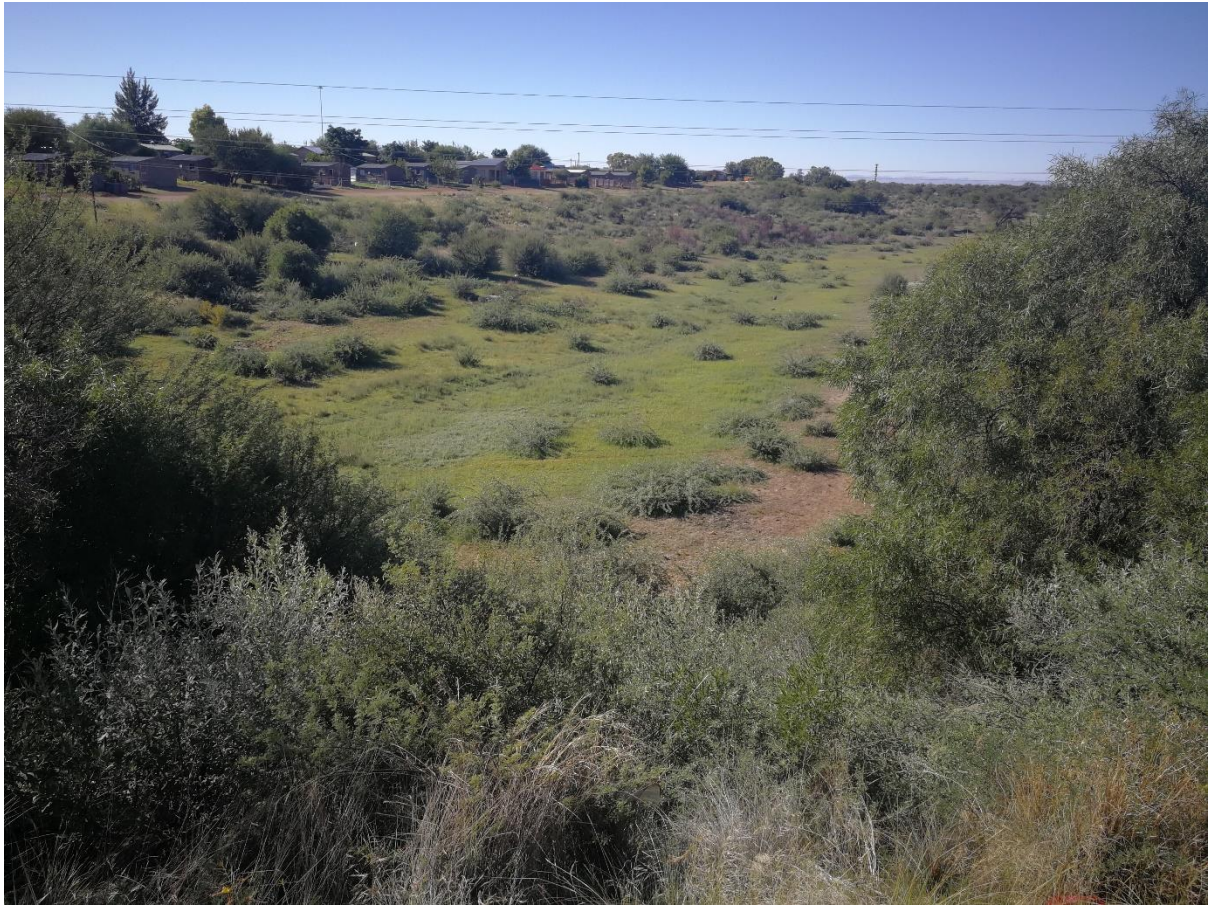
**Photo 53:** D41L-02299 flowing underneath Buitekant Street in Wrenchville. Direction: East

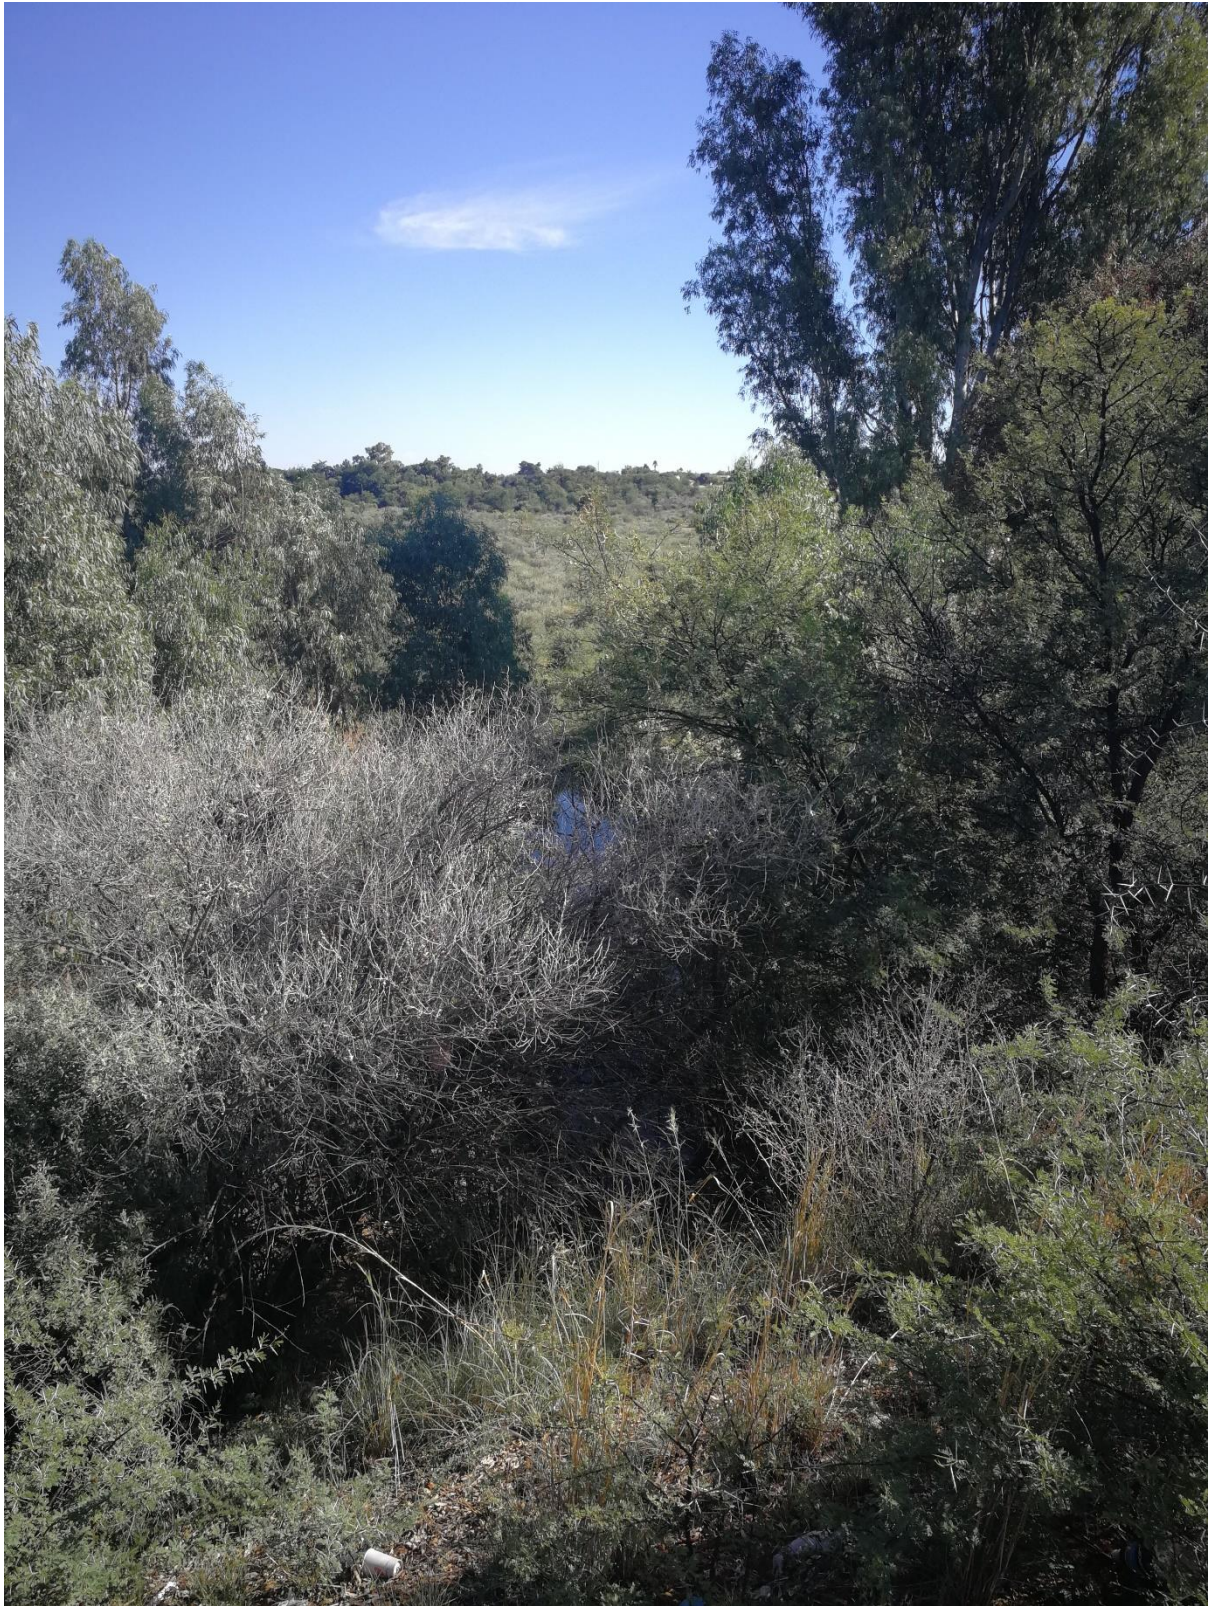
**Photo 54:** D41L-02299 flowing underneath Buitekant Street towards Wrenchville. Direction: West

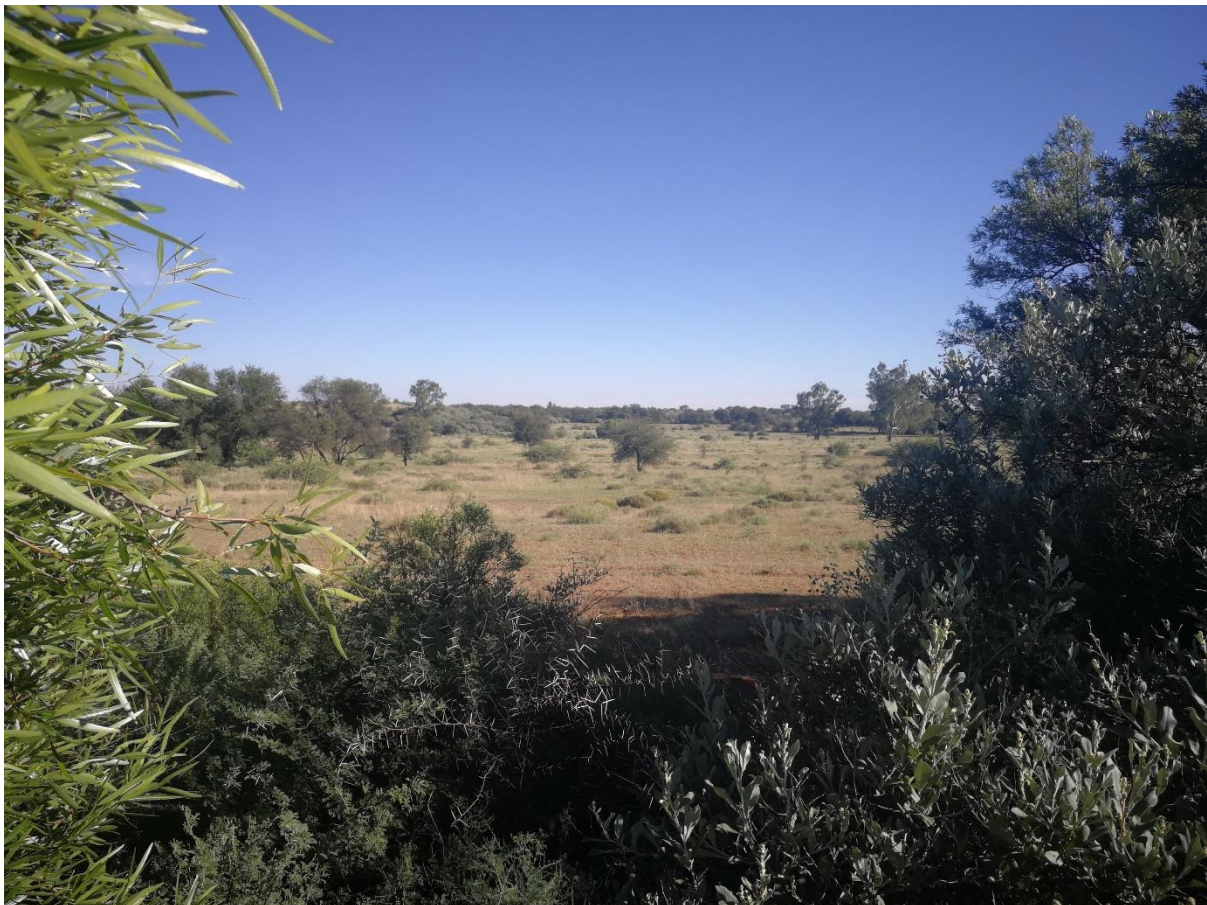
**Photo 55:** Natural Valley-Bottom Depression Wetland approximately 750m South-East of the proposed Wrenchville Phase 2 Low-Cost Housing Development adjacent to N14. Direction: North

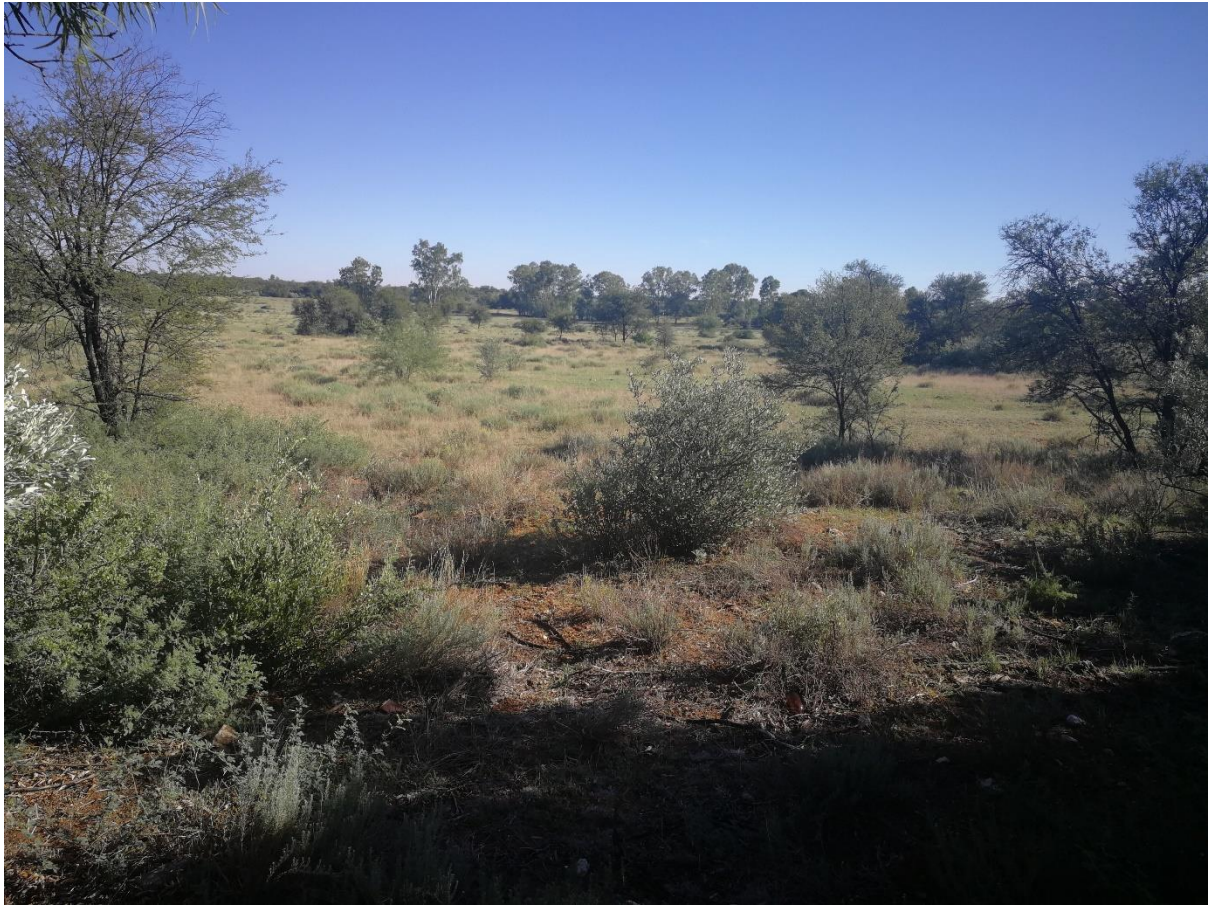
**Photo 56:** Natural Valley-Bottom Depression Wetland approximately 750m South-East of the proposed Wrenchville Phase 2 Low-Cost Housing Development adjacent to N14. Direction: North

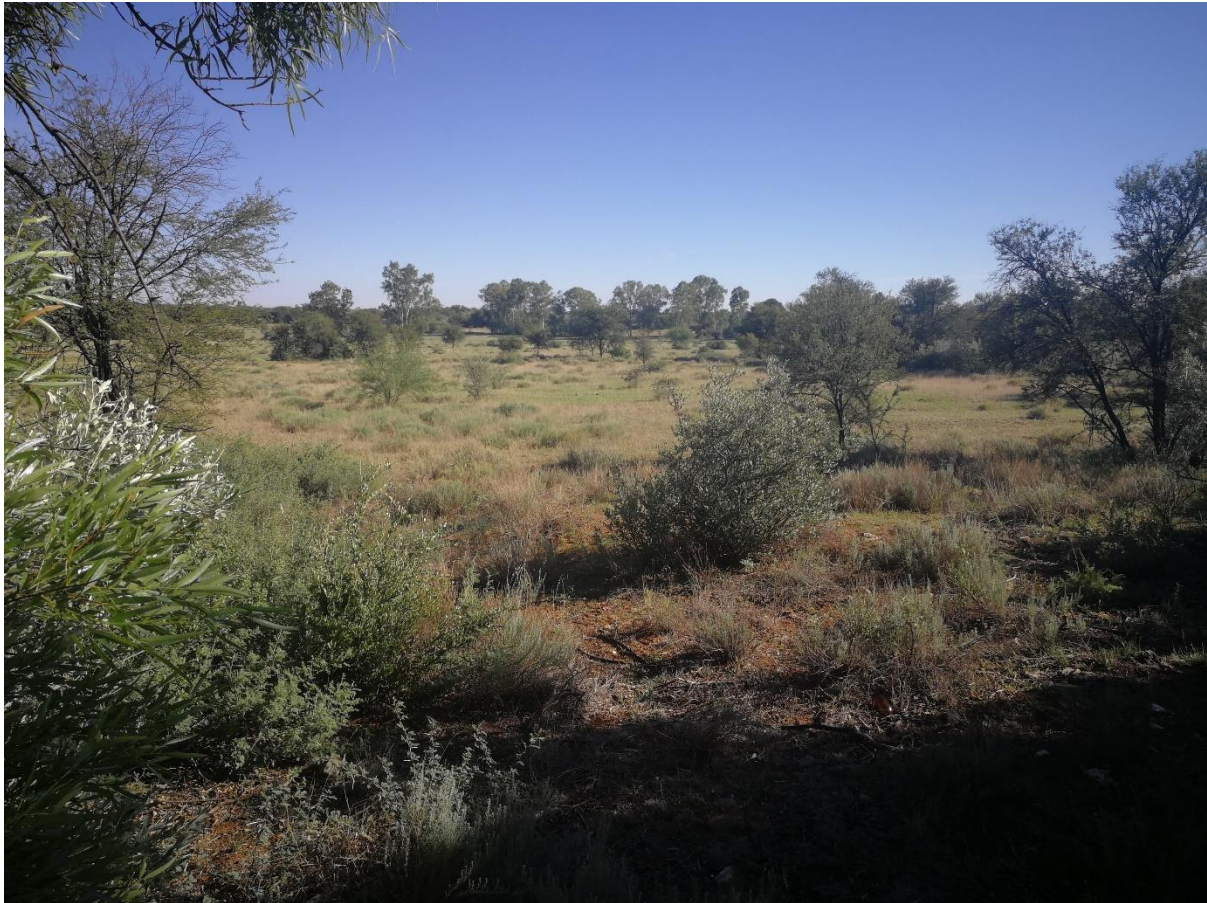
**Photo 57:** Natural Valley-Bottom Depression Wetland approximately 750m South-East of the proposed Wrenchville Phase 2 Low-Cost Housing Development adjacent to N14. Direction: North

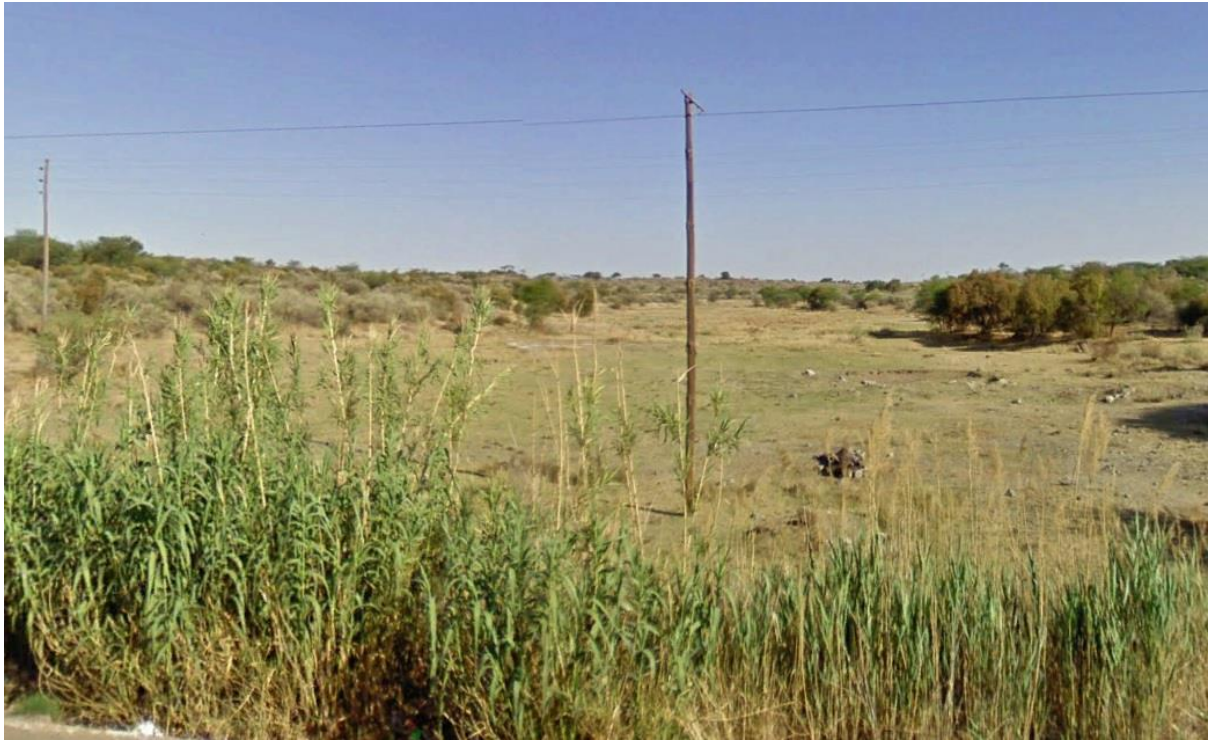
**Photo 58:** Natural Valley-Bottom Depression Wetland approximately 1.4 Km South of the proposed Wrenchville Phase 2 Low-Cost Housing Development adjacent to N14. Direction: South-East
