Savannah Environmental (Pty) Ltd

SITE LAYOUT PLAN DEVELOPMENT

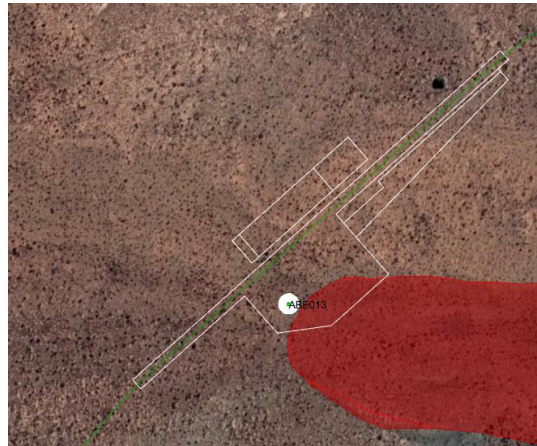
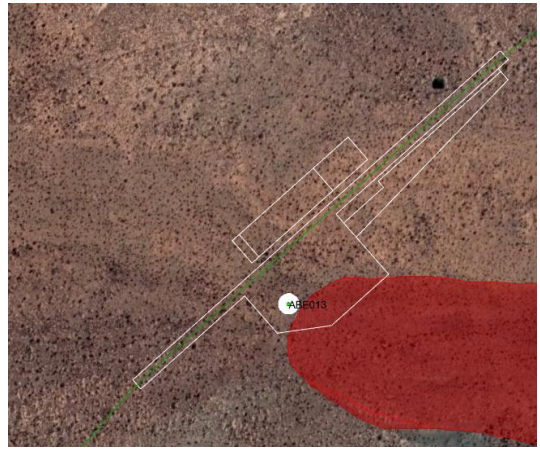
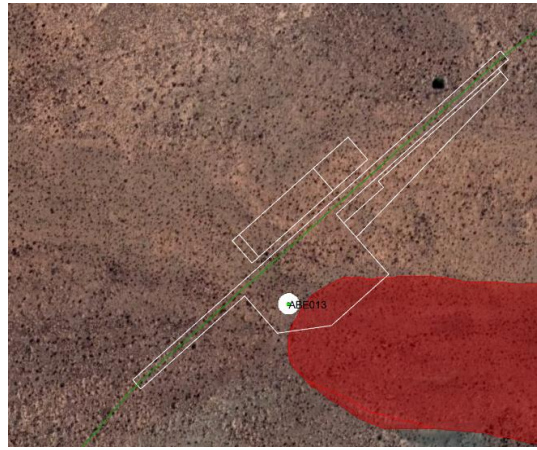
| Version # | Date | Informant Constraints | Comments | | | | | | | | |
|---|---|---|--|---|---|---|---|--|---|---|---|
| Preliminary Layout | | | | | | | | | | | |
| 1 | October 2020 | Lease areas | Boundaries of the lease areas as defined and agreed to with affected landowners | | | | | | | | |
| | | Desktop wind resource | Desktop wind resource data informed the optimum turbine placement | | | | | | | | |
| | | Avifaunal screening | An avifaunal specialist was appointed to conduct an initial site survey and report on any key priority species nesting within the project or neighbouring properties which may require buffering out large portions of the proposed project site. N | | | | | | | | |
| 2 | February 2021 | Met mast location | Suitable locations for the measurement masts were modelled based on the preliminary layout (Version#1) | | | | | | | | |
| 3 | March 2021 | Increase in turbine size to 120 | Considering the extent of upstream strengthening required need sufficient scale | | | | | | | | |
| 4 | September 2021 | Amendment to met mast locations | Following a site-visit undertaken by the resource technical team in May 2021, alternative measurement mast positions were identified. This had knock-on effects on the preliminary turbine layout which needed to be remodelled. | | | | | | | | |
| | | Avoidance of aquatic buffers | Refined aquatic buffers were available at this point and were considered in this iteration. | | | | | | | | |
| Draft BAR Layout | | | | | | | | | | | |
| 5 | July 2022 | Specialist constraints available at the time | All verified specialist constraints were available at this stage, except for avifauna, bats and ecology which at the time was pending further monitoring and/or verification. | | | | | | | | |
| | | 1 yr verified wind data | At the time, the project resource team had completed a year of the wind measurement campaign. The data obtained up to this point informed optimised turbine placement. | | | | | | | | |
| 6 | August 2022 | Final bat constraints | Based on 12-month monitoring campaign and sensitive feature verification | | | | | | | | |
| 7 | October 2022 | Final avifaunal constraints | Based on 12-month monitoring campaign and collision-risk modelling | | | | | | | | |
| 8 | November 2022 | Micro-siting of turbines 13, 46 and 112 outside of no-go areas | <table border="1"> <thead> <tr> <th>Turbine #</th> <th>13</th> <th>46</th> <th>112</th> </tr> </thead> <tbody> <tr> <td></td> <td>

| | | | Design Recommendation | Shift all infrastructure 18 m NW | Shift all infrastructure 130 m W OR Reflect and shift upwards | Shift 90 m S OR Reflect and shift upwards |
