REPORT NO. MK 18/480/rev.01

PHASE 1, INTERPRETIVE GEOTECHNICAL INVESTIGATION REPORT

PROPOSED TOWNSHIP DEVELOPMENT, AERORAND SOUTH, MIDDELBURG, MPUMALANGA

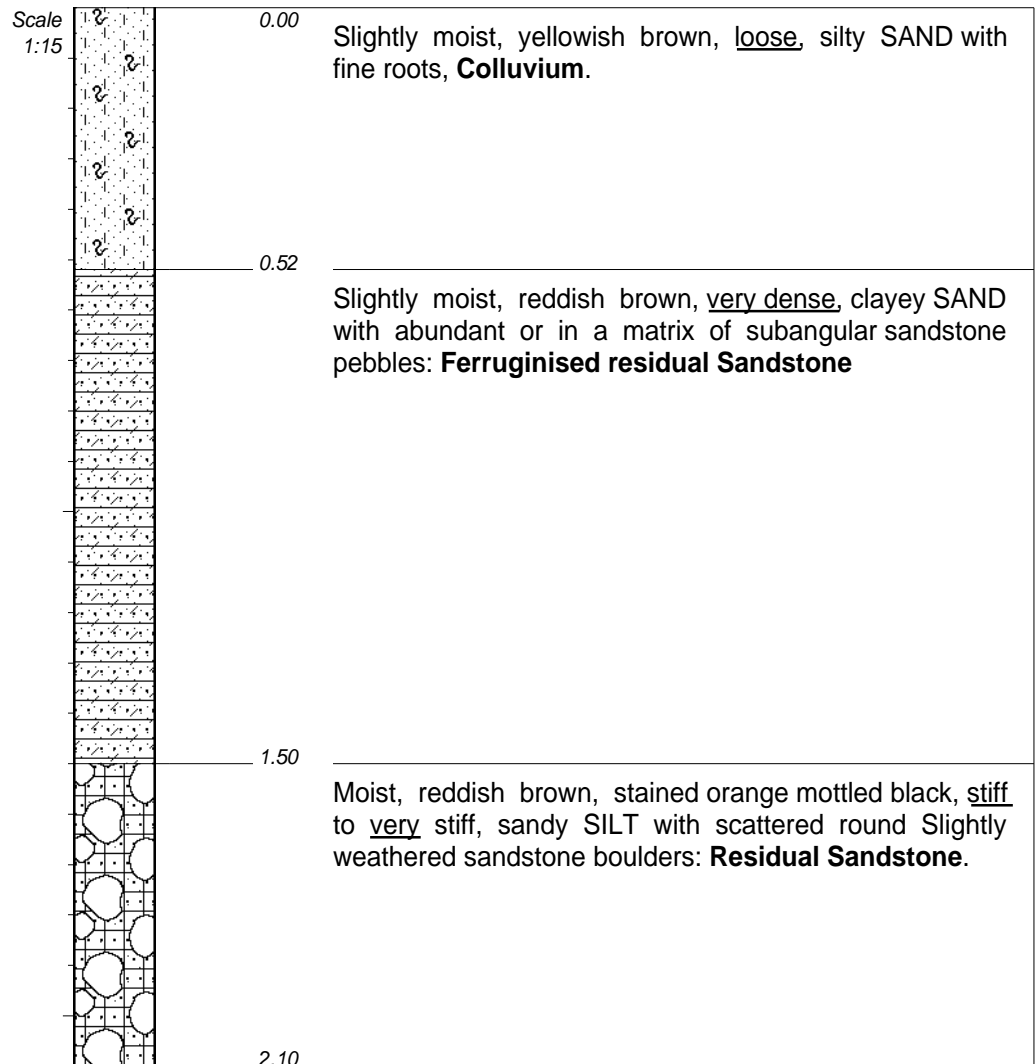
HOLE No: TP10

- 1) Slow advance of TLB at 2.1m.
- 2) No water seepage observed.
- 3) No sample taken.

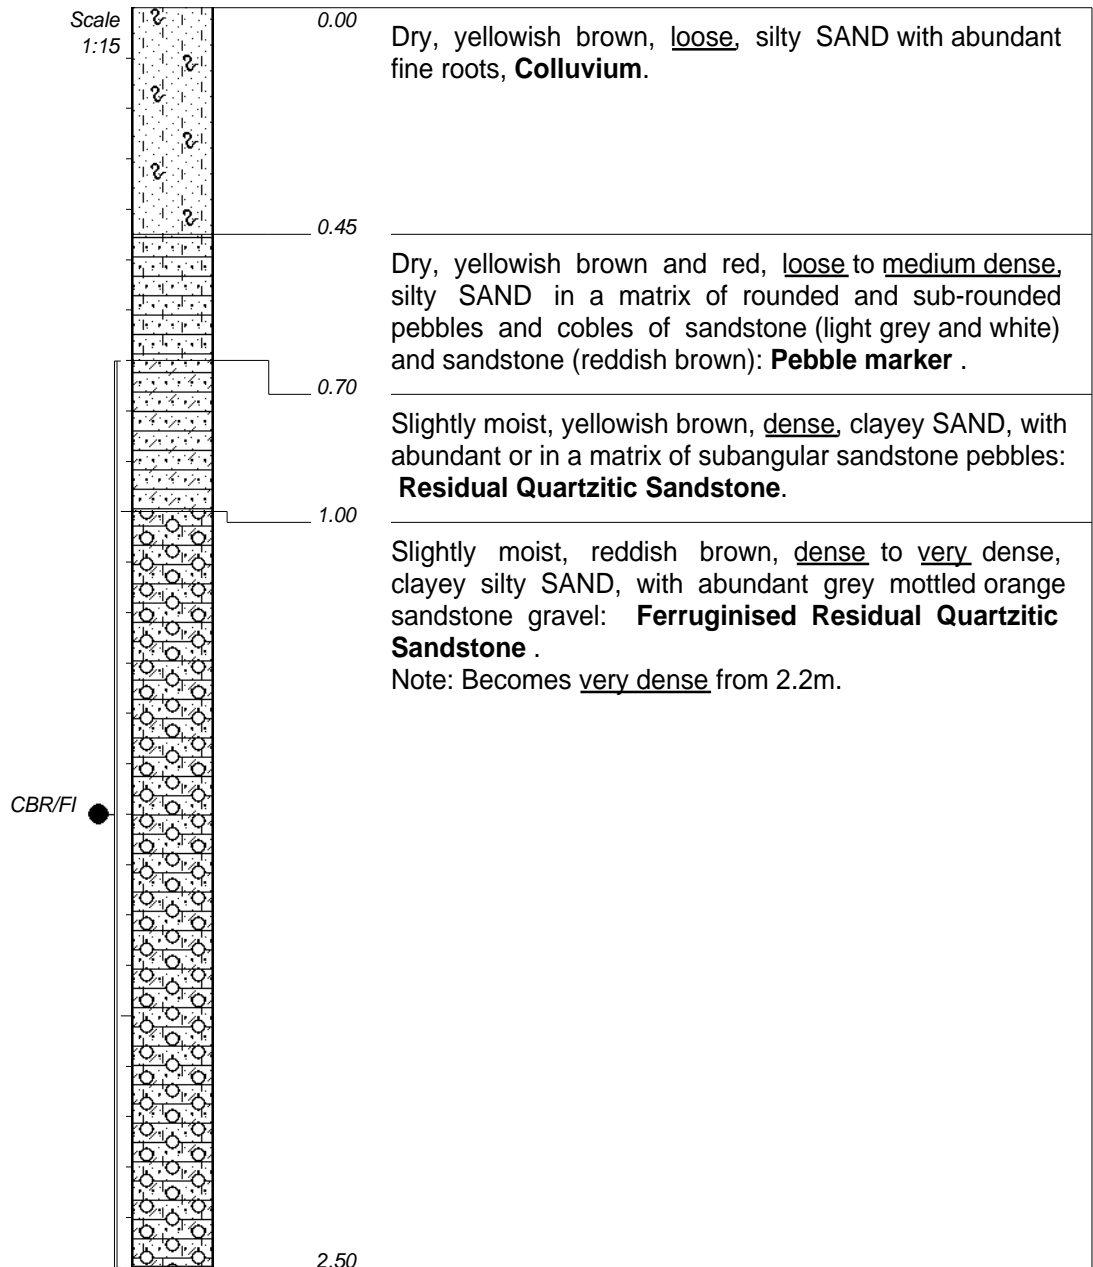
HOLE No: TP13

- 1) Refusal of TLB at 2.5m.
- 2) No water seepage observed.
- 3) Disturbed sample CBR/FI at 0.7--2.5m

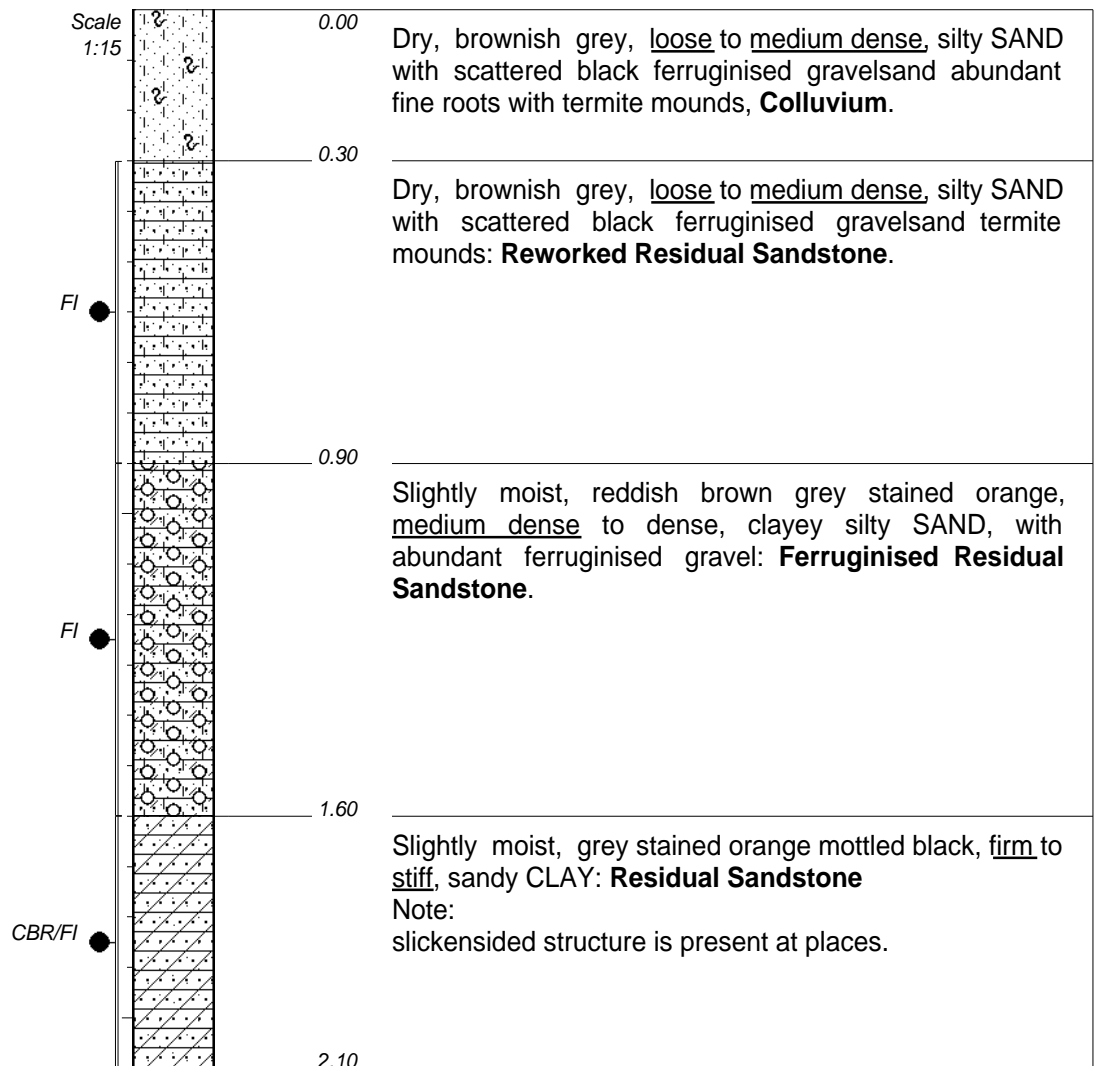
HOLE No: TP15

- 1) Refusal of TLB at 2.1m.
- 2) No water seepage observed.
- 3) Disturbed sample FI at 0.3--0.9m.
- 4) Disturbed sample FI at 0.9--1.6m.
- 5) Disturbed sample CBR/FI at 1.6--2.1m.

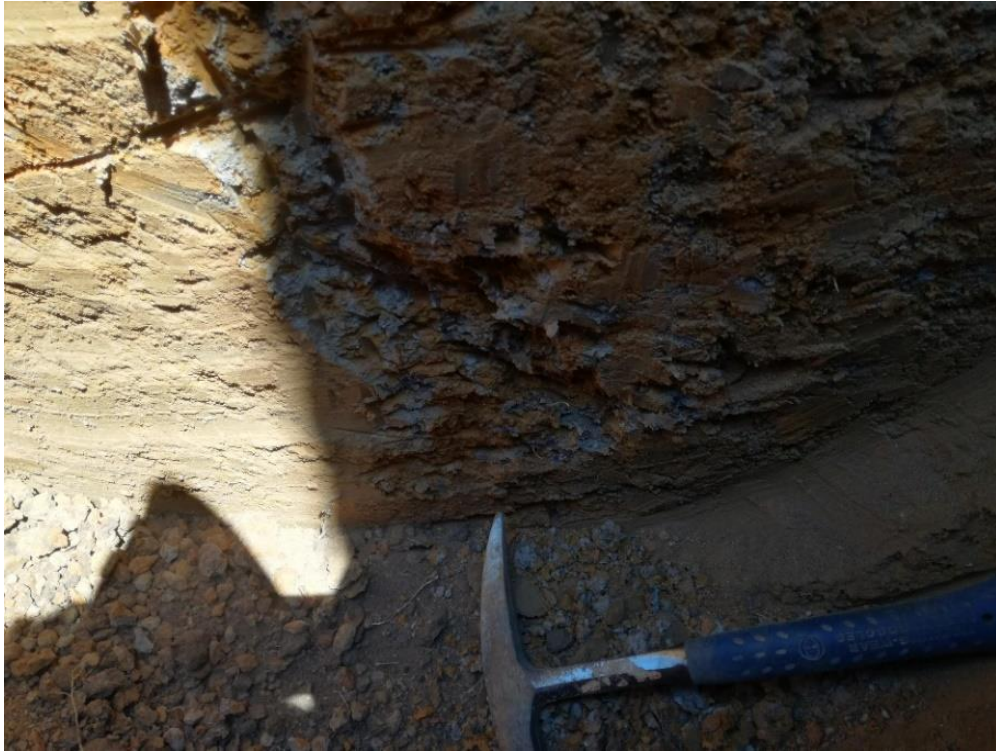
Figure 18 Typical Residual Sandstone at the bottom of TP15

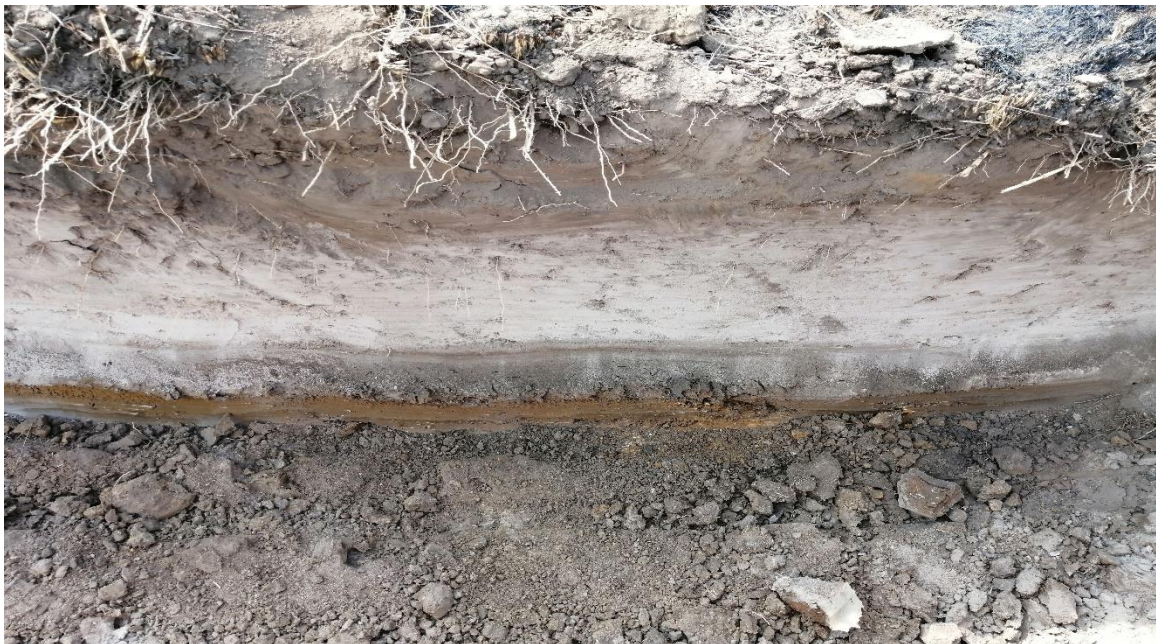
Figure 21: Grey alluvial material underlain by hardpan ferricrete encountered in TP29

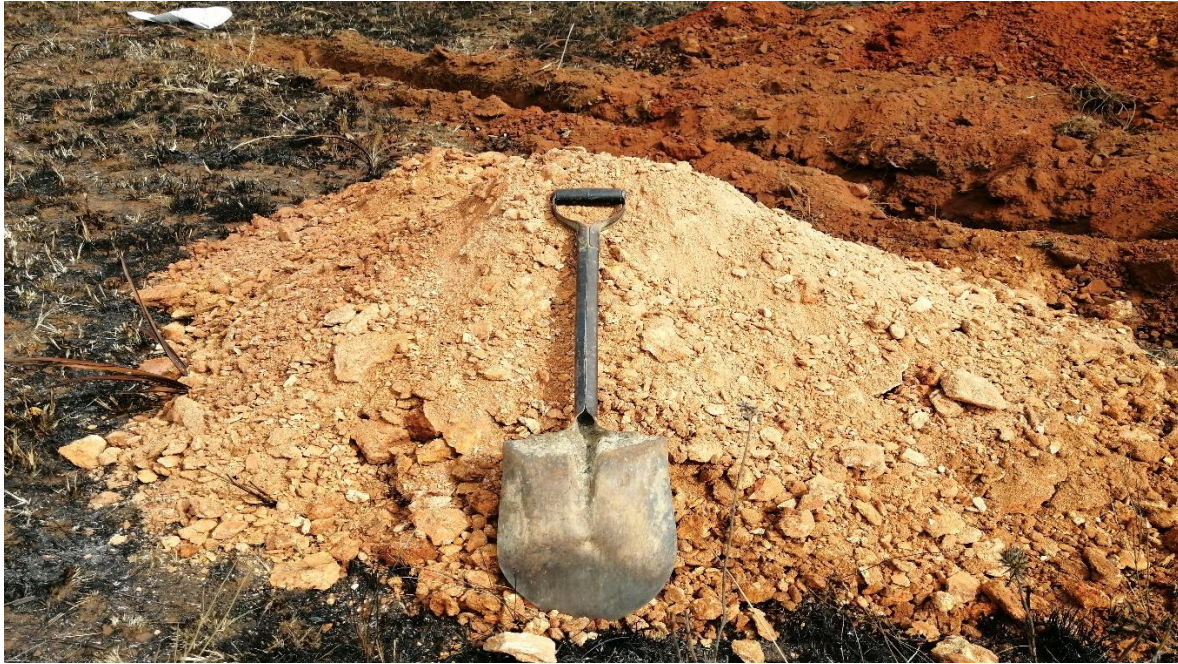
Figure 22: Yellow very dense to very soft rock shale encountered in TP28

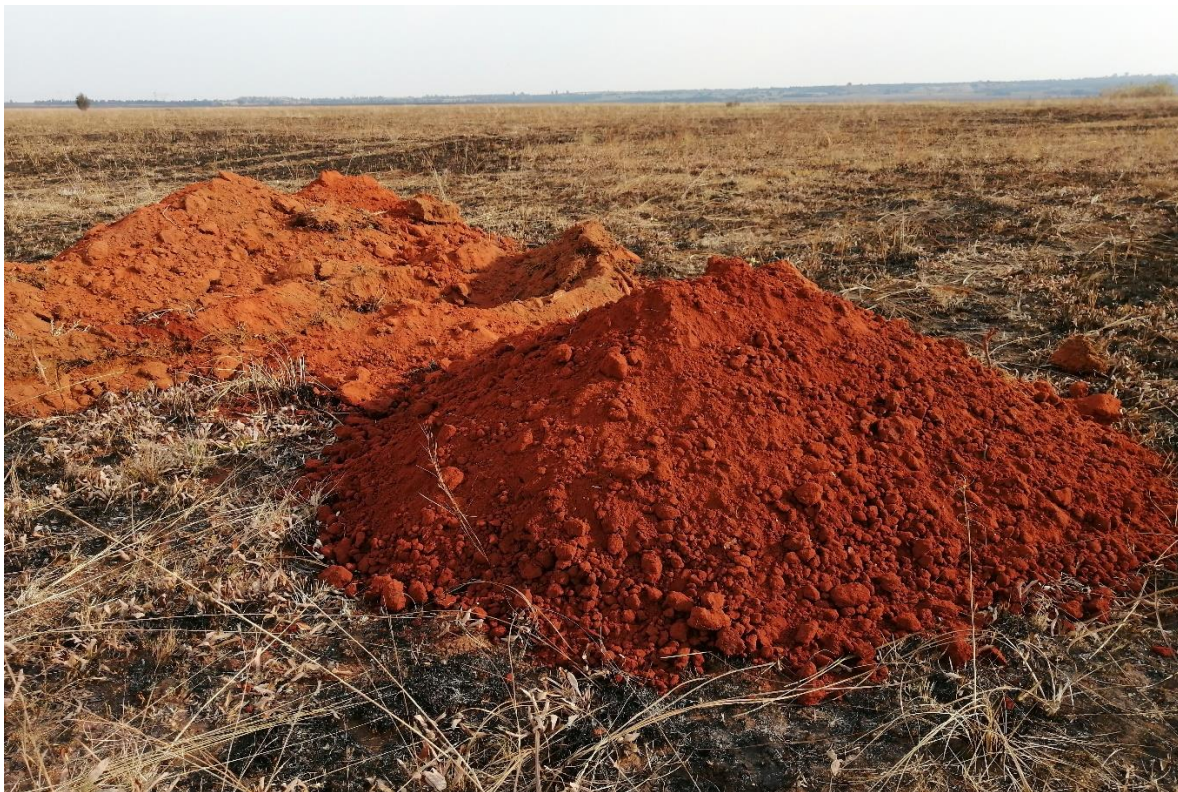
Figure 23: Orangey red transported material encountered in TP27, TP31, TP32 and TP34
