Report on the floristic and ecological assessment of the proposed expansion of the Alheit graveyard, Northern Cape Province.

October 2012

Vegetation and ecological assessment.

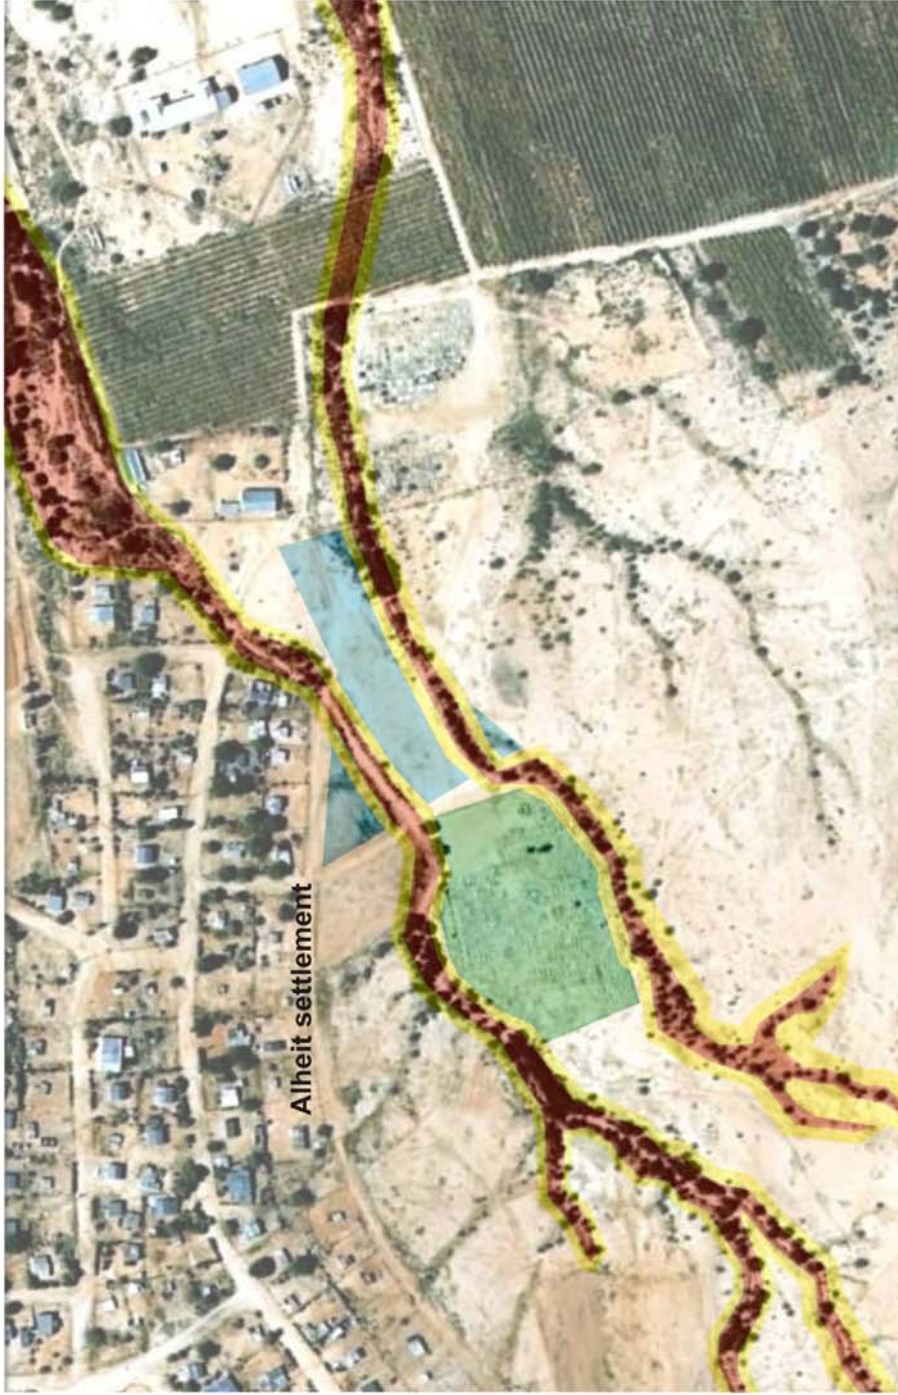
Layout of the proposed expansion of the Alheit graveyard.

Map 2: The approximate layout of the proposed expansion of the Alheit graveyard. The existing graveyard is also indicated. Note also the existing commercial vineyards to the east of the site. The drainage lines on the site is indicated in red and a buffer zone of 10m is also indicated along these drainage lines.

- The drainage lines on the site should be excluded from the layout (Map 2).
- A buffer zone of 20 meters should be respected from these drainage lines (Map 2).

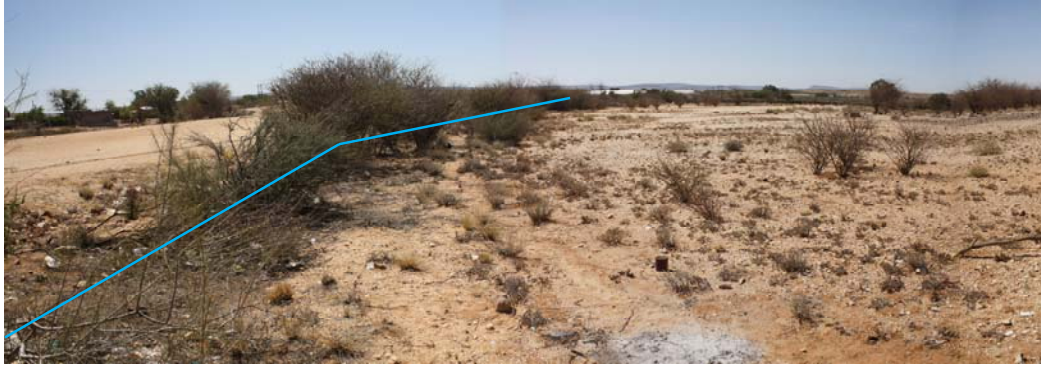
Figure 1: Panorama of the site as seen from the west towards the east. The southern drainage line is indicated in blue. Note the low percentage vegetation cover.

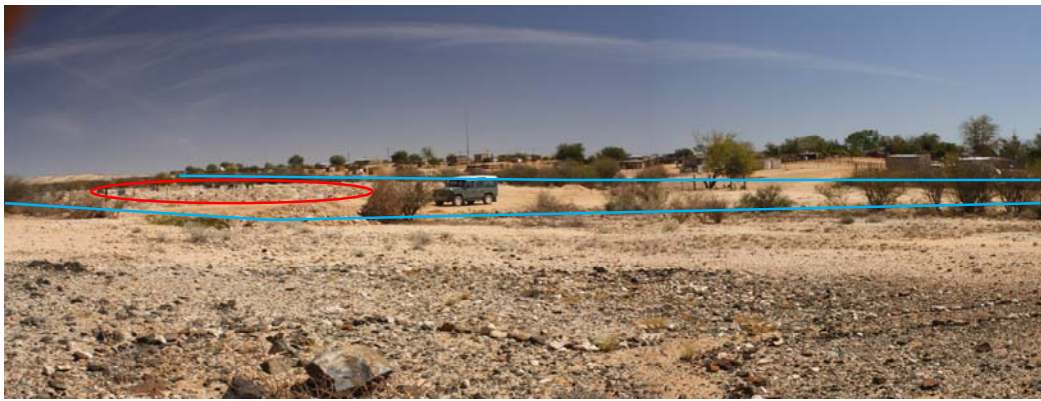
Figure 2: Panorama of the site as seen from the south towards the north west. Both drainage lines are indicated in blue. The existing graveyard is indicated in red.

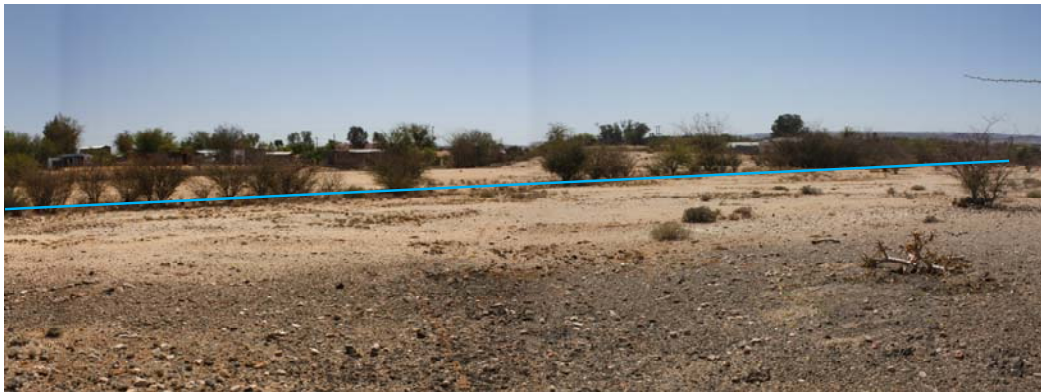
Figure 3: Panorama of the site as seen from the south towards the east. Note the low percentage vegetation cover. The southern drainage line is indicated in blue.

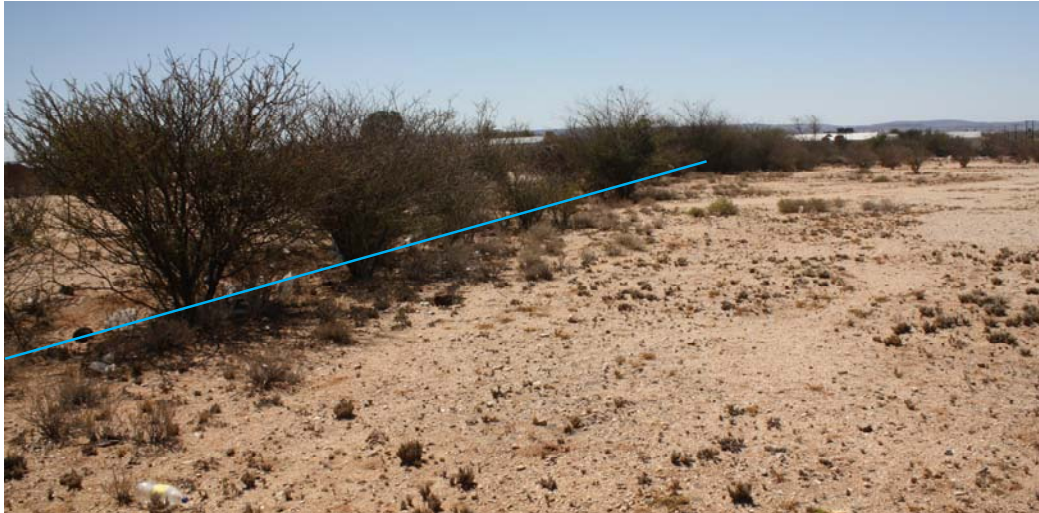
The drainage lines on the site are lined with small trees and shrubs. This is caused by the higher amounts of moisture that periodically flow through the drainage lines. Trees and shrubs along the drainage lines include *Parkinsonia africana*, *Phaeoptilum spinosum* and *Acacia melifera* subsp. *detinens*. *Tapinanthus oleifolius* is a common parasite plant on these trees.

Figure 4: The southern drainage line (blue line). Note the small trees that indicate increased moisture.

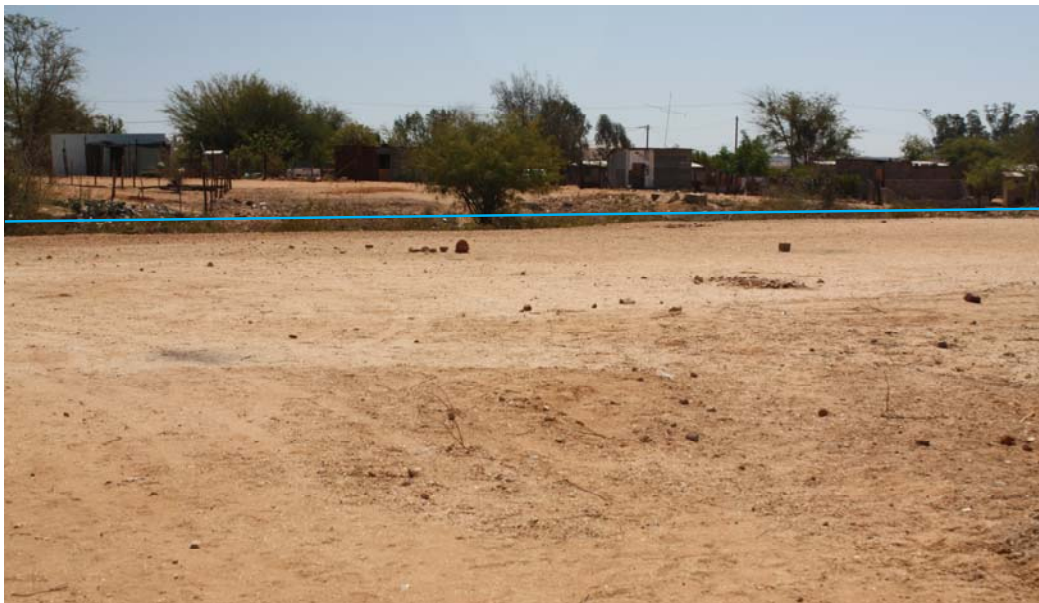
Large portions of the vegetation on the site have been cleared. As a result the percentage vegetation cover is very low. Vegetation on the site consists of dwarf shrubs and succulents. Due to the arid climate and the time of season several annual grasses and herbs may not be present. Dwarf shrubs and succulents that were found on the site include *Blepharis mitrata*, *Monechma genistifolium* subsp. *genistifolium*, *Salsola tuberculata*, *Zygophyllum simplex* and *Psilocaulon junceum*.

Figure 5: Area on the site that has been cleared of vegetation. The northern drainage line is indicated in blue.

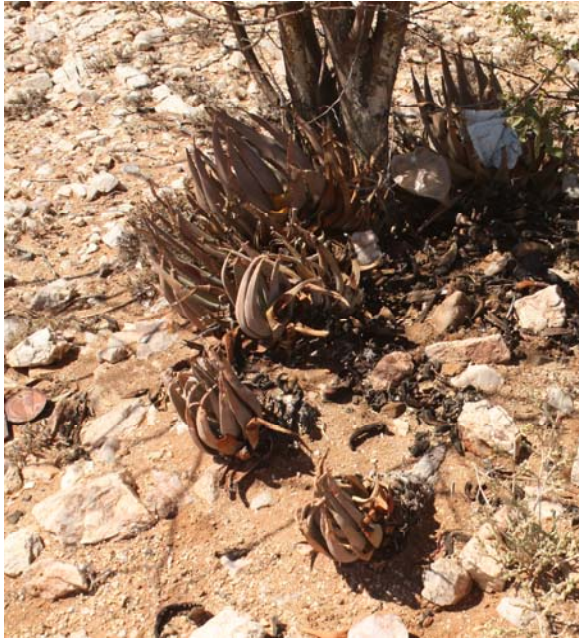
Two succulent species were noted in the area. These are *Aloe claviflora* and *Avonia papyraceae*. These species are protected in the Northern Cape Province. Both species has a wide distribution area and is not regarded as rare. They are not of a concern to the development; however, a permit must be acquired if any of these species are to be removed from the site.

Figure 6: The protected *Aloe claviflora* that is found in the area. A permit should be obtained for any specimens on the site that has to be removed prior to construction.

The area contains two protected succulent species, namely *Aloe claviflora* and *Avonia papyraceae*. These species are not rare and has a wide distribution area. However, permits should be acquired for those specimens on the site that are to be removed.

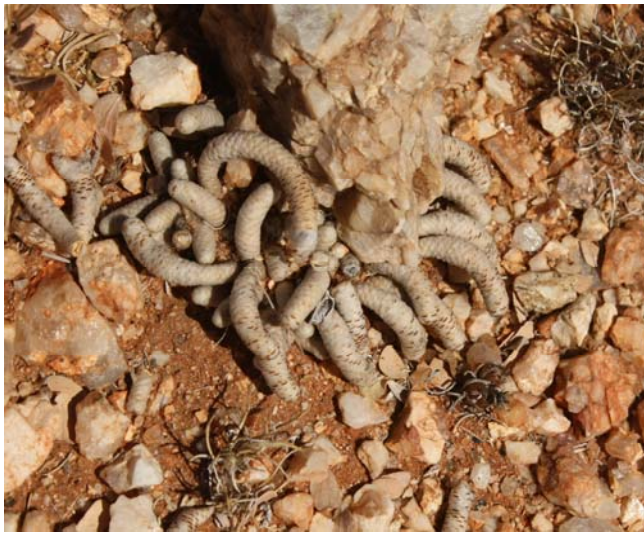
Figure 7: The protected *Avonia papyraceae* that is found in the area. A permit should be obtained for any specimens on the site that has to be removed prior to construction.
