# HERITAGE IMPACT ASSESSMENT FOR A PROPOSED PHOTOVOLTAIC ENERGY PLANT ON THE FARM HOEKPLAAS NEAR COPPERTON, NORTHERN CAPE

(Assessment conducted under Section 38 (8) of the  
National Heritage Resources Act (No. 25 of 1999) as part of an EIA)

**Jayson Orton**

**Archaeology Contracts Office**

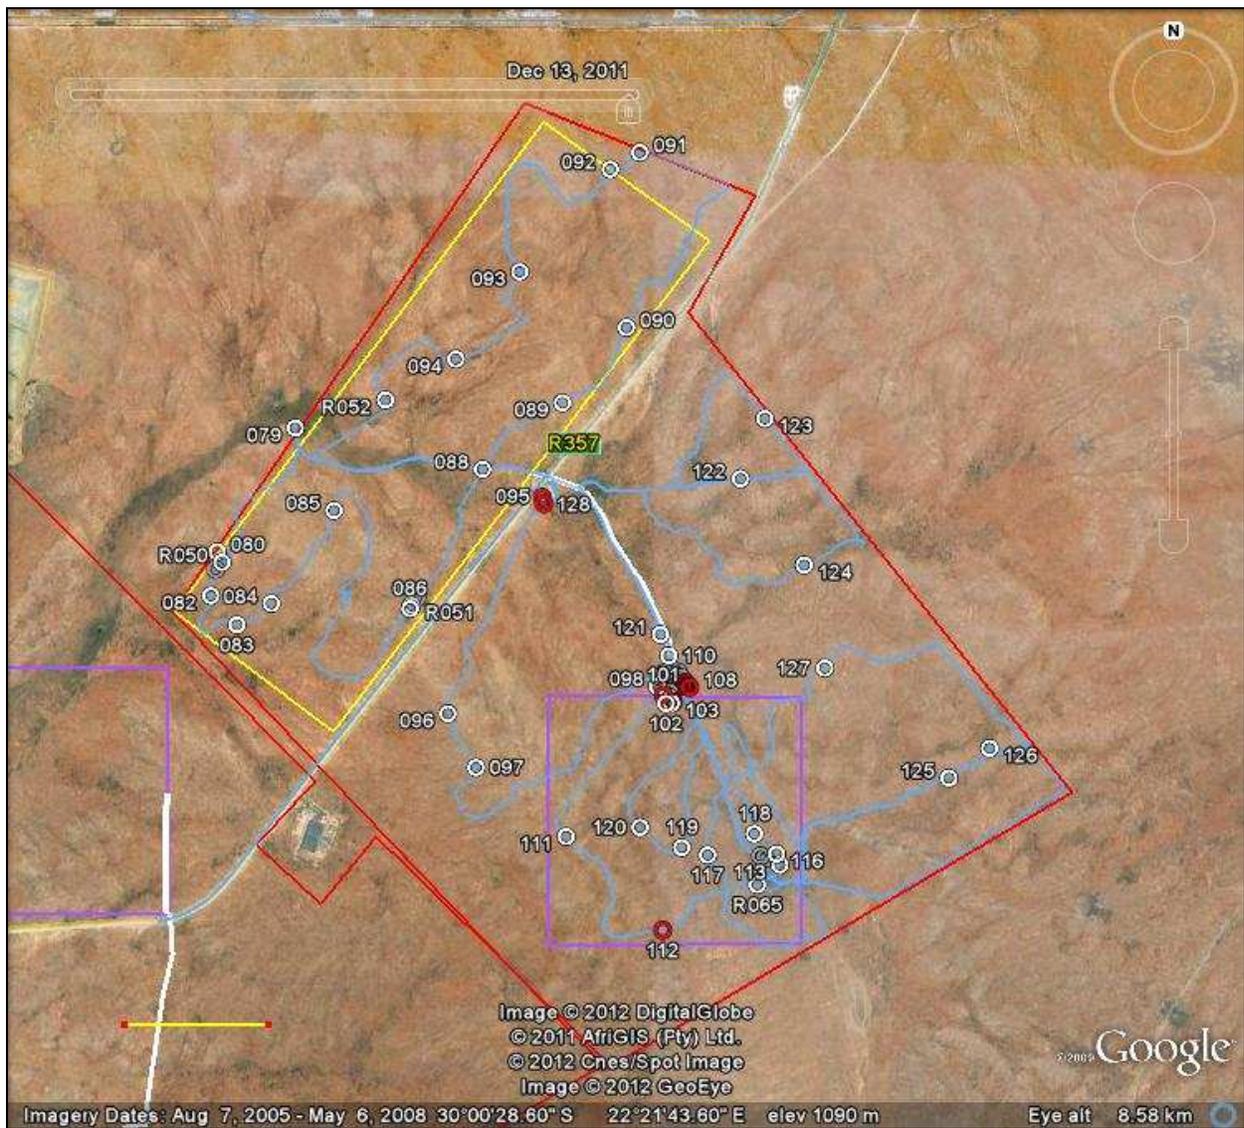
Figure 6 shows the distribution of archaeological resources recorded during the survey as well as the walk- and drive-paths taken. It can be seen that one large cluster of occurrences is situated at the large pan in the centre of the site, while the pan in the south-western area was archaeologically poor. The other revealed no good sites but there were a number of occurrences there. Over the remainder of the study area, most finds were examples of background scatter. While all the discrete sites relate to LSA occupations, the background scatter is almost all ESA and MSA. These two types of archaeological occurrences will be addressed separately.

**Figure 6:** Aerial view of the study area taken from Google Earth and showing the distribution of recorded archaeological occurrences by their field numbers. The yellow bar for scale at lower left is 100 m. (Red sites require mitigation, white ones do not.)

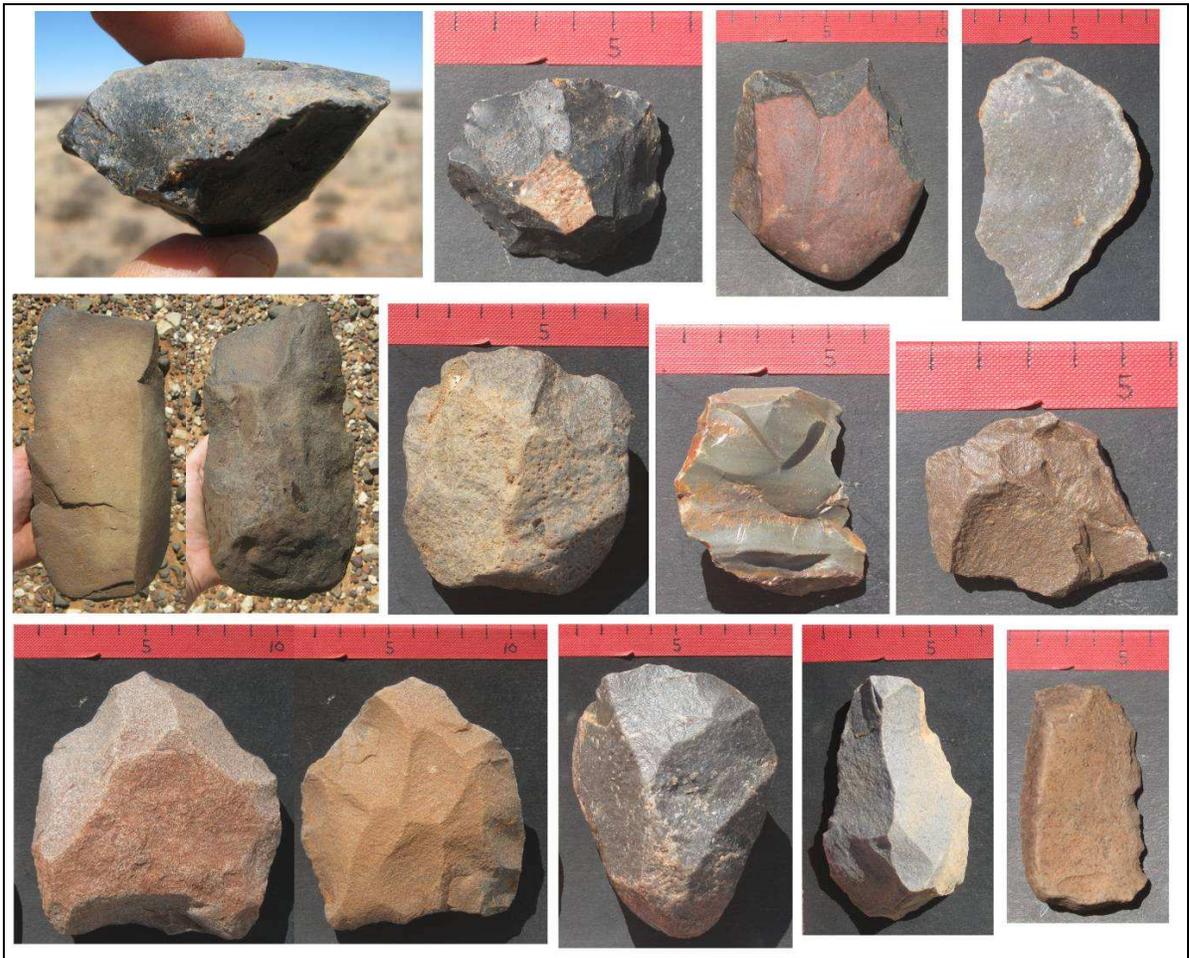
Artefacts were observed in low densities over much of the study area and Figure 7 shows a selection of these. Quartzite strongly dominates the background scatter but some cryptocrystalline silica (CCS) is present. Hornfels is absent. Weathering states vary indicating a vast span of time over which the artefacts have accumulated. Such finds have no discernible original context and have little to no archaeological value. Some places revealed slightly elevated frequencies of artefacts, but this is generally unrelated to human factors. GPS points were taken at such places and selections of artefacts were photographed. These appear in Figures 8 to 14. In one area a few LSA artefacts and some ostrich eggshell, essentially an ephemeral site (HKP2011/015), were located. Figure 10 shows the clear difference between these artefacts and the background scatter found in the same place. At one place an isolated lower grindstone was found. It had a flaked edge showing that it also doubled as a core (Figures 14 & 15). This large artefact is too heavy to carry around and must indicate that people camped at this spot in the past, perhaps leaving very few, if any, other traces of their passing. Other items of background scatter were also located here.

**Figure 7:** Selection of isolated artefacts from the background scatter on Hoekplaas showing the variability in materials and weathering states.

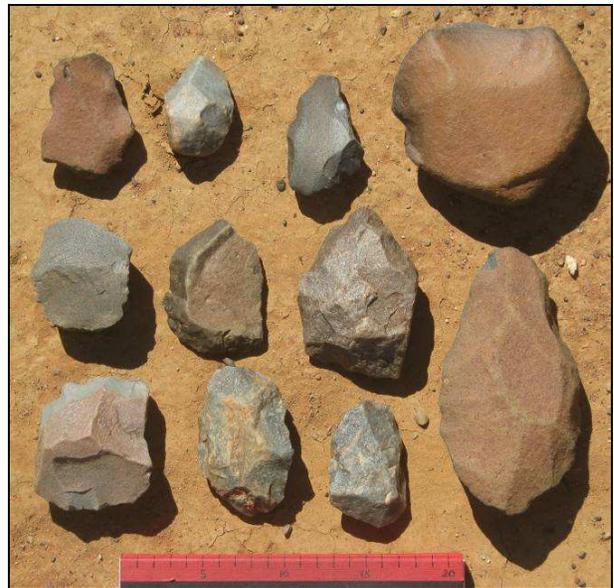
**Figure 9:** Artefacts from #086 including a hand-axe at lower right.

Among the background scatter were occasional hand-axes pertaining to the ESA. These were, without fail, heavily weathered testifying to the great length of time over which they have been exposed at the surface (Figures 16 & 17). Another bifacial artefact that cannot be classified as a hand-axe came from point #087 (Figure 17). It is less weathered than the complete hand-axes and may actually be a core, probably relating to the MSA.

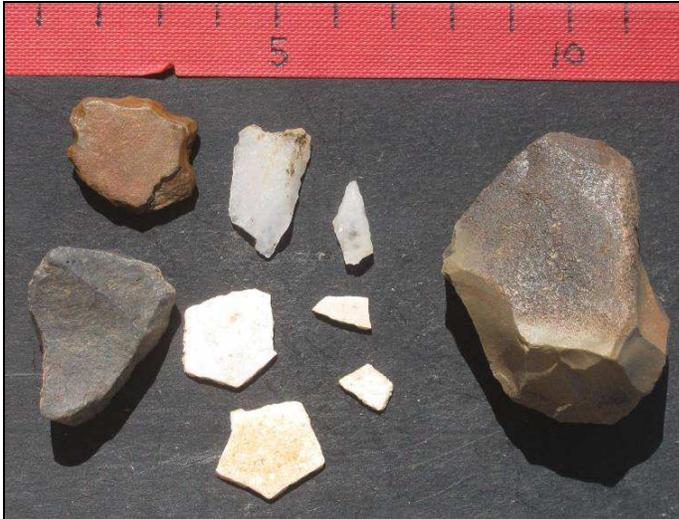
**Figure 10:** Artefacts and ostrich eggshell fragments from #R051. The three larger artefacts are background scatter While the quartz and eggshell are site HKP2011/015.

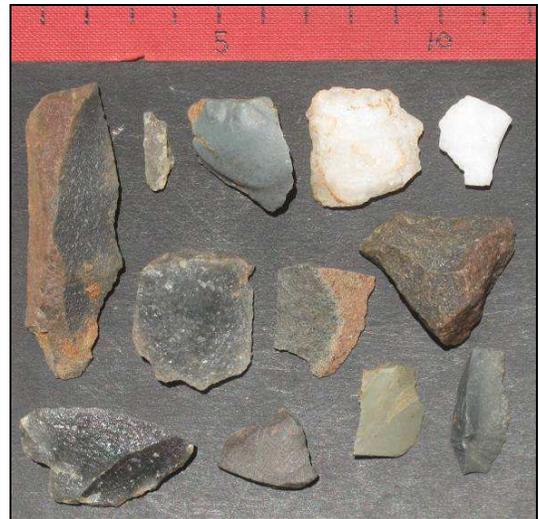
**Figure 11:** Artefacts of quartzite, quartz and CCS from #106.

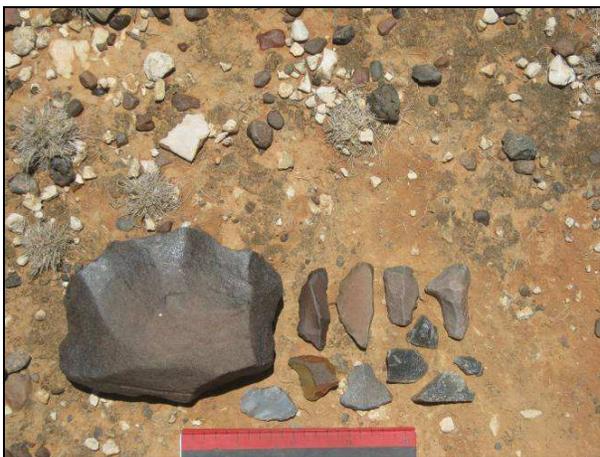
**Figure 12:** Artefacts from #097 and surface gravel.

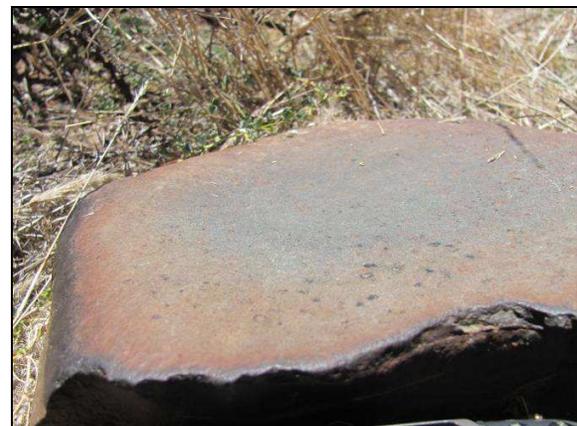
**Figure 15:** Polished surface and flaked edge of the lower grindstone from R056.

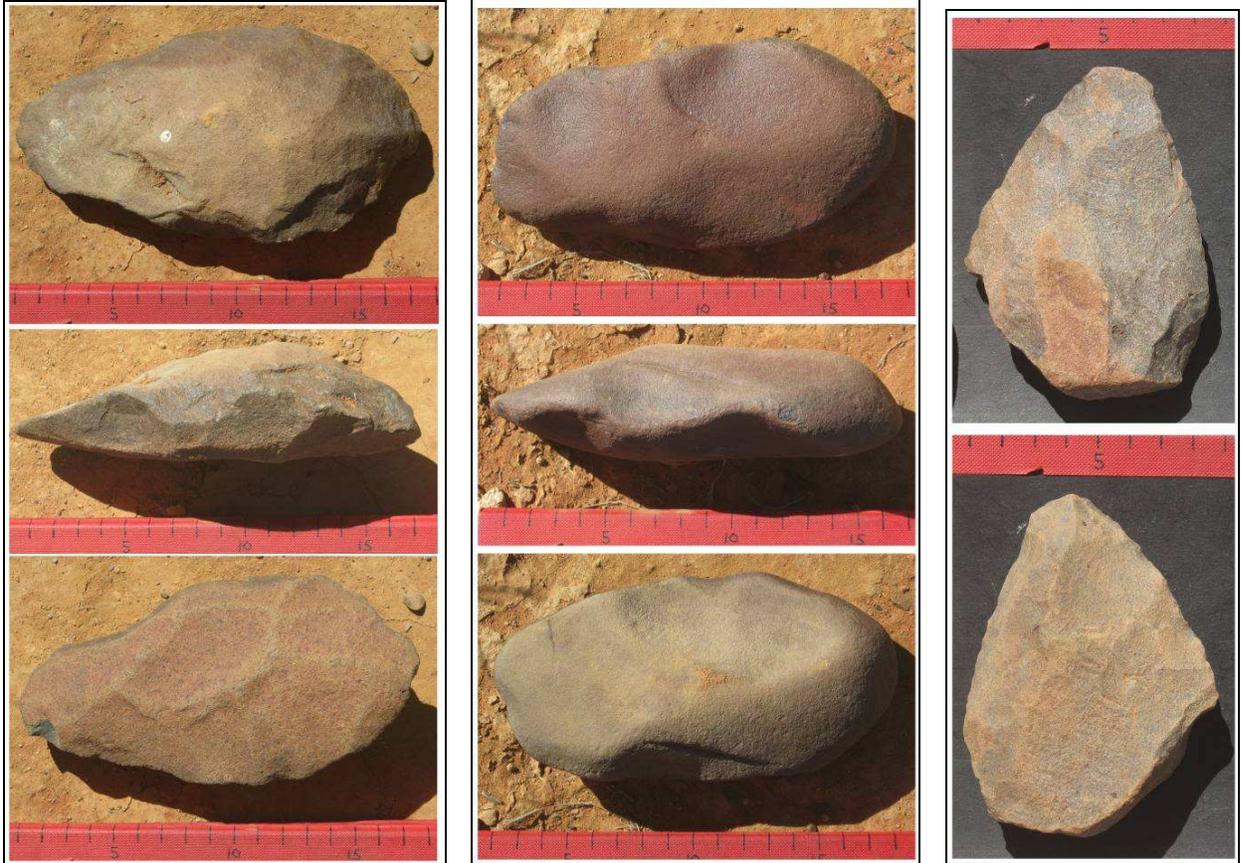
**Figure 16:** Hand-axe from #086. **Figure 17:** Hand-axe from #123. **Figure 18:** Bifacial artefact from #087.

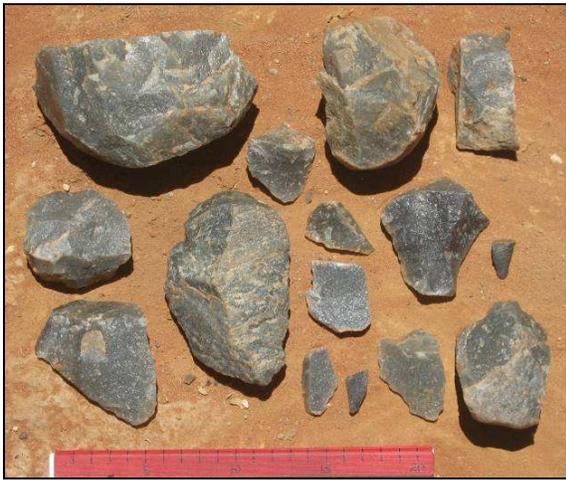
**Figure 19:** Artefacts from site HKP2011/001 (#094).

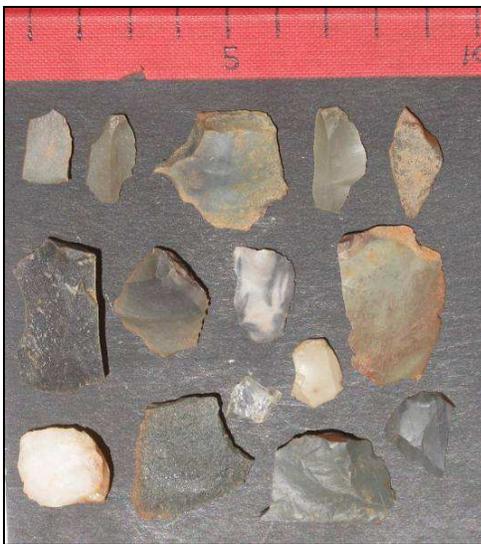
**Figure 21:** Artefacts from HKP2011/003. At least half the artefacts pictured are of CCS, and are microlithic supporting an ascription to the LSA.

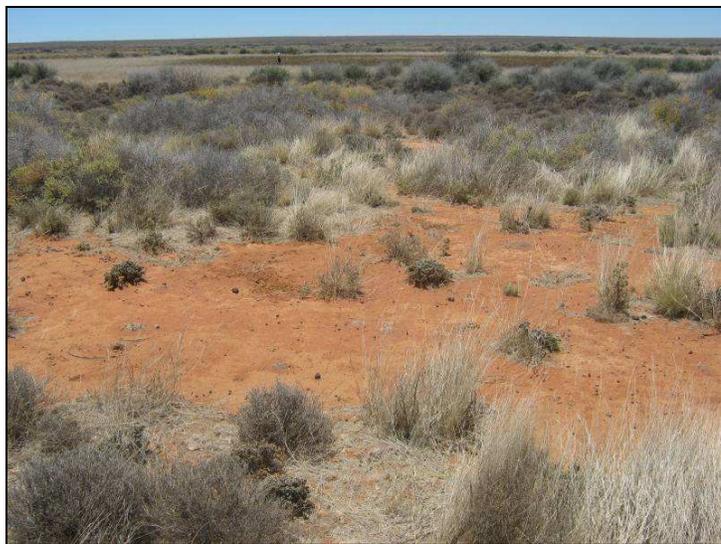
**Figure 22:** The situation of HKP2011/003 (#098 & #099). The site was found in a sandy patch close to the pan (visible in the background).

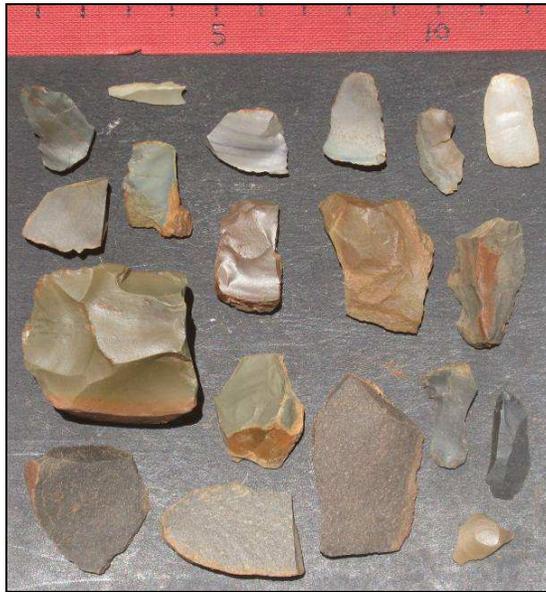
A good scatter of CCS, quartz and quartzite pertaining to the LSA was found at HKP2011/006 (#104) at the southern edge of the pan. This scatter included one of the few retouched pieces seen, a backed point (Figures 23 & 24). Perhaps the most significant LSA site located on this farm was HKP2011/008 (#107 & #108). The site was more dense than most of the others and, very unusually, included hornfels as a stone material (very little hornfels has been noted during surveys by the author in the Copperton area). A backed point was also noted here on hornfels. This is a long, thin, pointed stone artefact with a blunt edge opposing a sharp edge – similar to a knife blade. CCS was particularly abundant at point #108 and an anvil stone was also seen there (Figures 25 & 26). Anvils were used for resting cores on during flaking and perhaps offer a more direct clue that flaking was occurring at that particular point.

**Figure 23:** Artefacts from HKP2011/006 (#104). Most are in CCS including a backed point enlarged in Figure 23.

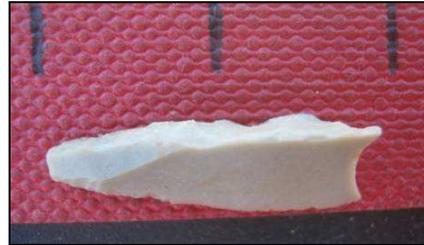
**Figure 24:** The CCS backed point from HKP2011/005. The upper edge in this view is backed.

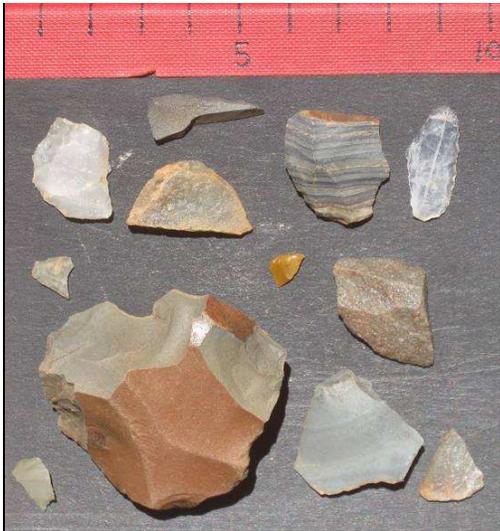
**Figure 25:** CCS, quartz and quartzite artefacts From HKP2011/008 (#107 & #108).

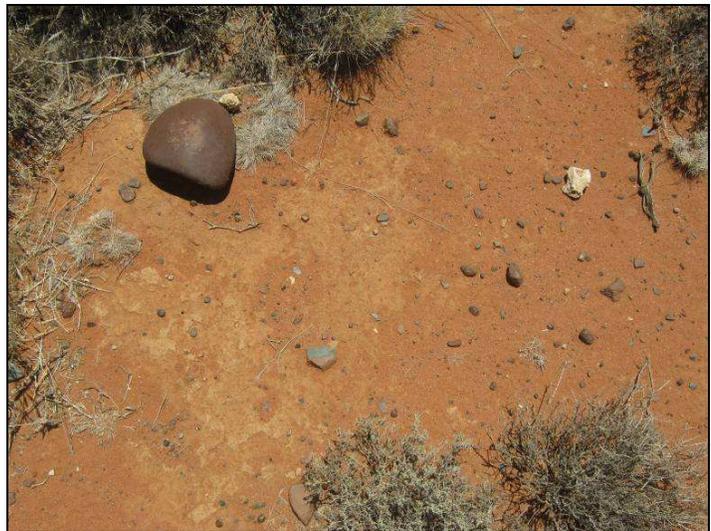
**Figure 26:** The anvil stone and surrounding artefact scatter at HKP2011/008. The damaged surface of the anvil is visible.

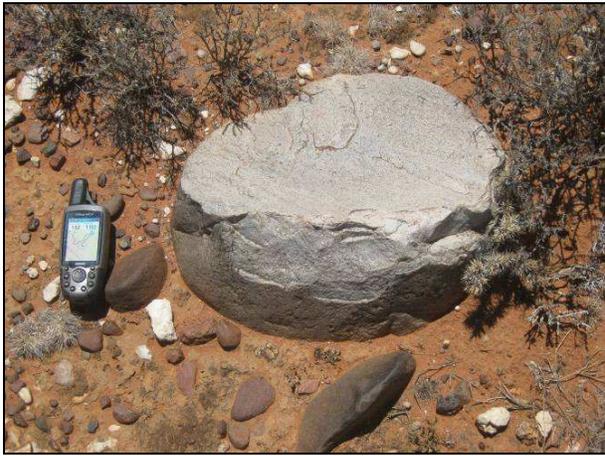
Although not really a site in terms of numbers of artefacts present, HKP2011/011 was singled out as a site due to the activity that was carried out here. At this point (#111) we found a flaked outcrop (or perhaps half-buried boulder) of quartzite (Figure 27). HKP2011/012 (#112) was unusual for the presence of bone (Figure 28). Only unidentifiable fragments were noted, however. Also noted on this site were some ostrich eggshell fragments and one CCS endscraper.

**Figure 27:** The flaked quartzite outcrop at HKP2011/011 (#111).

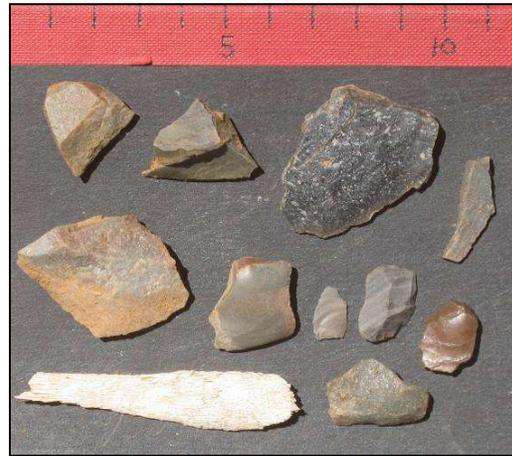
**Figure 28:** Artefacts and a bone fragment from HKP2011/012 (#112).

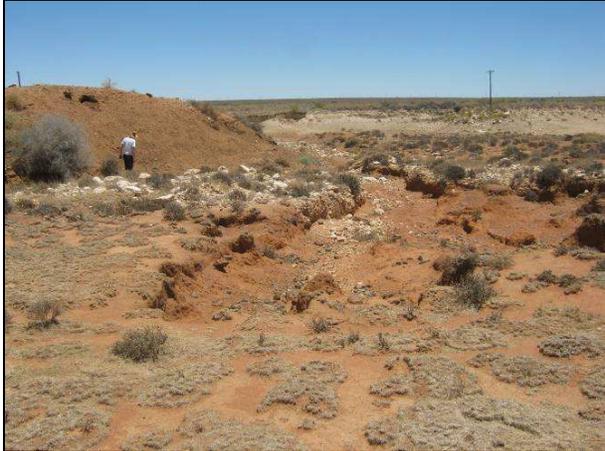
The only MSA site found was at HKP2011/002 (#095 & #128). This was at the pan alongside the road that is now a quarry for road gravel (Figure 29)<sup>1</sup>. This site is by far the most significant archaeological occurrence found as it preserves buried MSA stone artefacts and faunal remains (Figure 30). The former included numerous blades, while the latter was represented only by multiple fragments of a single large tooth that appears to be from an equid (horse or zebra; T. Steele, pers. comm. 2011; Figures 31 & 32). This is interesting in light of the fact that Kibberd (2006) found this group of animal to be most frequent in his MSA collection from Bundu Pan discussed in Section 5 above. The buried MSA clearly originates from a gravel lag deposit which has, over time, become buried some 0.3 m to 0.5 m below present surface. This deposit is evident in section in the erosion gully that now leads into the pan (Figure 33). Also significant here is the likely presence of LSA material that presumably comes from above the MSA. This included a few stone artefacts in quartz. A few fragments of slag were found amongst the MSA artefacts in the erosion gully and these indicate some sort of metal-working, whether prehistoric or historic one cannot tell.

**Figure 29:** HKP2011/002 (#095) was found in the erosion gully leading into the pan.

<sup>1</sup> With this important site now on record SAHRA should be aware that it might be lost through further quarrying. The appropriate local authorities should be informed by SAHRA that this borrow pit needs protection or mitigation. This does not in any way affect the present development proposal.

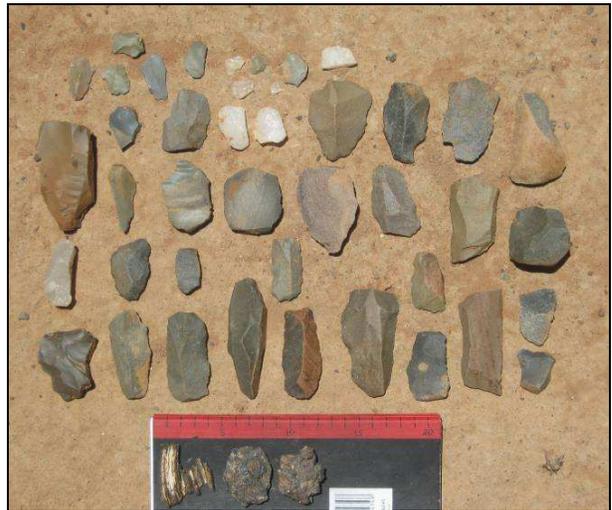
**Figure 30:** Artefacts (on the ground), tooth and slag fragments (on the book) from HKP2011/002.

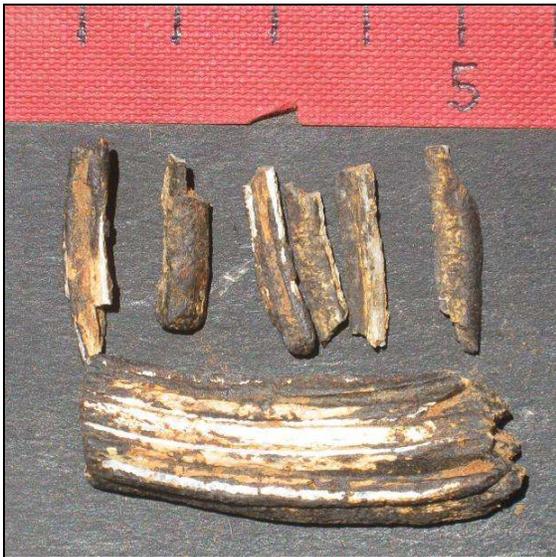
**Figure 31:** The equid tooth from HKP2011/002.

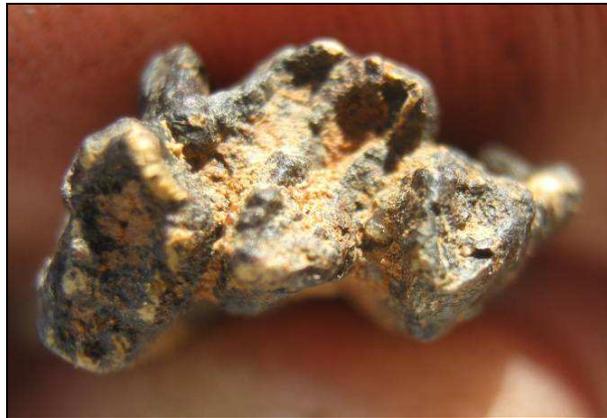
**Figure 32:** Upper occlusal of the HKP2011/002 tooth.

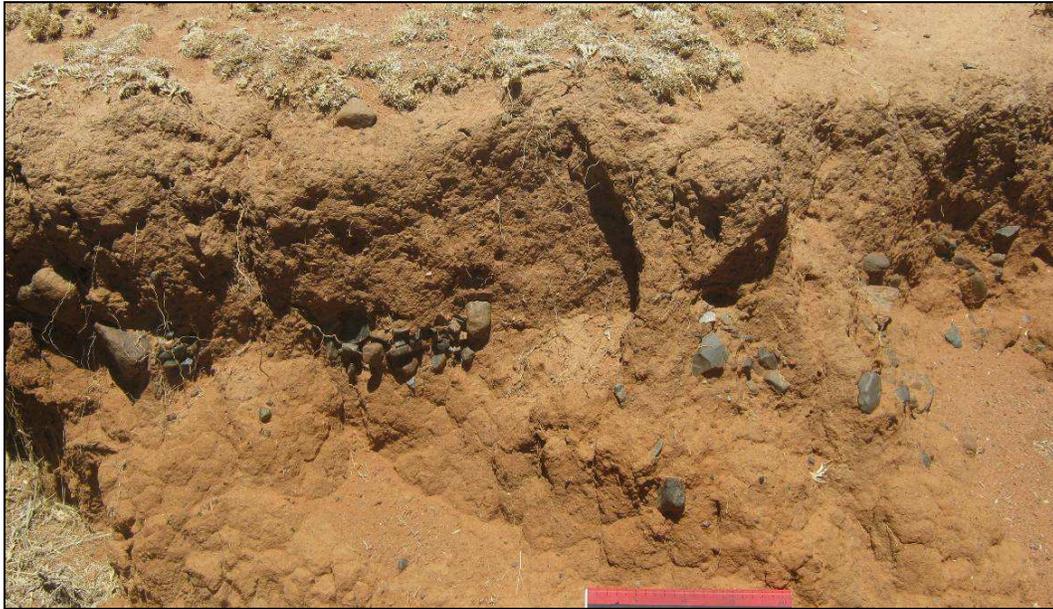
Further from the erosion gully the numbers of artefacts appeared to drop off and it is clear that the site does not extend far beyond the south-western edge of the excavated area. However, artefacts are present over a wide area and a beautiful unifacial point of some 80 mm length was noted at #128 (Figure 34).

**Figure 33:** The buried gravel lag deposit containing artefacts as revealed in the side of the erosion gully. The length of the book is 0.21 m.

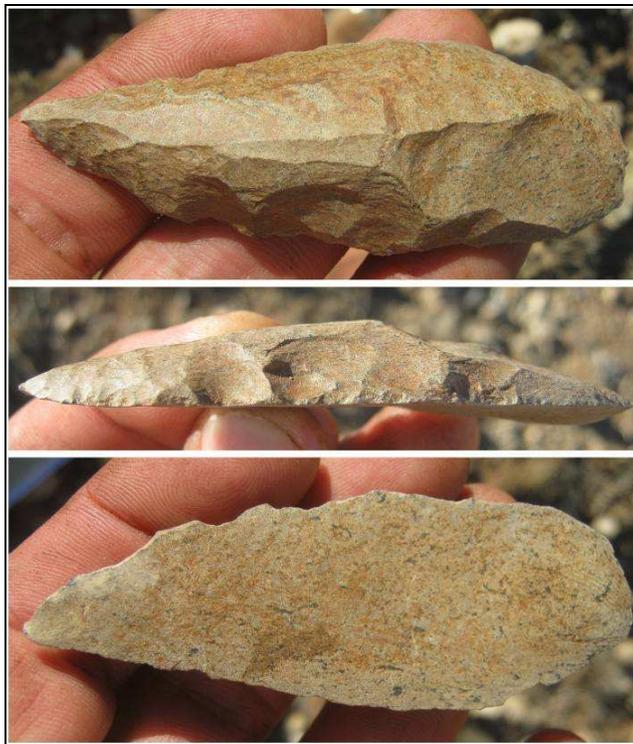
**Figure 34:** Dorsal, edge and ventral views (top to bottom) of the unifacial point found at HKP2011/002 (#128).

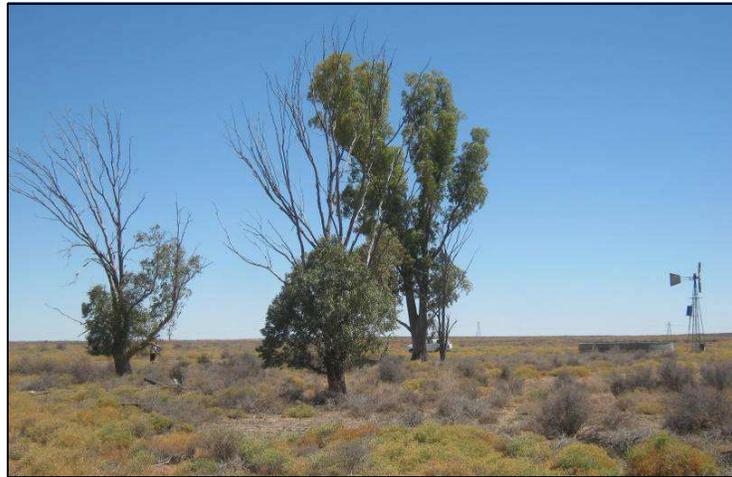
Only one cultural landscape was noted but it is of very low significance. It is composed of an ephemeral pan with gum trees, a windmill, water troughs and an old cement dam alongside it. All these elements are likely 20<sup>th</sup> century in age (Figure 35). This heritage resource was labelled HKP2011/013. The trees were probably planted to provide shade for small stock since there is no evidence of any settlement in the vicinity. For the rest, the study area is open, undeveloped farm land crossed only by a few fences.

Figure 35: View of the gum trees, windmill and cement dam at HKP2011/013.

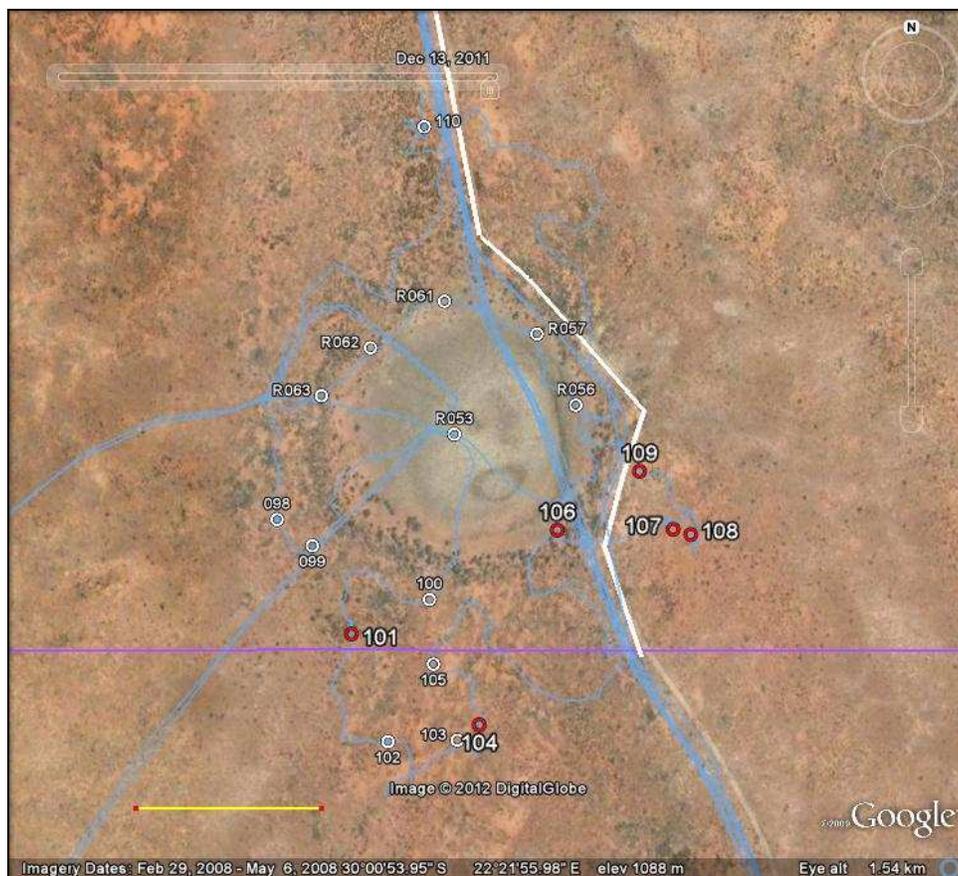
Only HKP2011/004 and HKP2011/006 fall within or very close to the footprint of Alternative 1 (Figure 35), while none are affected by Alternative 2. Alternative 1 also comes within 100 m of the pan to the north of the proposed facility (Figure 35) and some testing of subsurface deposits would also be needed there in addition to the archaeological mitigation. Should the planned access road running past the pan be constructed then site HKP2011/009 (#109) should also be mitigated through excavation as it lies immediately alongside the present road.

**Figure 35:** Aerial view of the vicinity around the pan in the centre of Hoekplaas. Alternative 1 lies to the south of the purple line and the yellow bar for scale at lower left is 100 m. The white line is the access road.

suggested that a buffer of approximately 100 m from the edge of any pans be employed. Furthermore, access roads would require surface sites to be mitigated but no subsurface testing is required for roads passing close to the pan.
