**AQUATIC SPECIALIST INPUT
TO THE
ENVIRONMENTAL IMPACT
ASSESSMENT:
PROPOSED PV2-11 PHOTOVOLTAIC
ENERGY PLANTS ON
FARM HOEKPLAAS NEAR COPPERTON,
NORTHERN CAPE**

**MAY 2013
FINAL**

PREPARED FOR: AURECON South Africa Pty (Ltd)

PREPARED BY: James MacKenzie
MacKenzie Ecological & Development Services
Email: bjoriver@vodamail.co.za

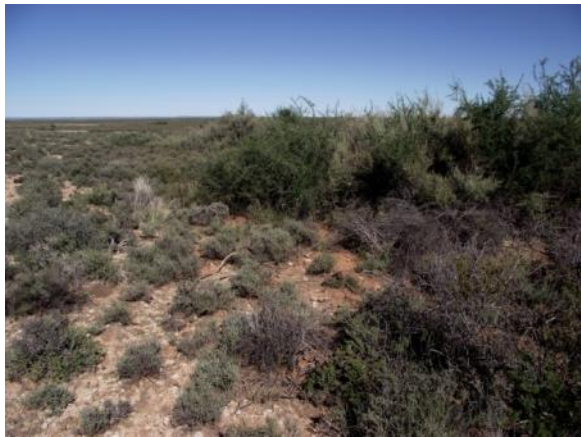
Hp6	Confirmed drainage line (seasonal to ephemeral). Characterised by <i>L. hirsutum</i> , <i>L. cinereum</i> , <i>Rhigozum trichotomum</i> , <i>Asparagus bechuanicus</i> , <i>Monechma incanum</i> , <i>A. congesta</i> , and <i>C. glauca</i> .	Yes
Hp7	Seasonal drainage line with distinct sandy unconsolidated channel bed. Characterised by <i>G. fruticosus</i> , <i>L. cinereum</i> , <i>R. trichotomum</i> , <i>A. bechuanicus</i> , <i>A. congesta</i> , and <i>C. glauca</i> .	Yes
Hp8	Seasonal stream with sandy unconsolidated channel bed and distinct riparian zone. According to the landowner this stream flows most years for short periods. Characterised by <i>Searsia pendulina</i> , <i>L. hirsutum</i> , <i>L. cinereum</i> , <i>R. trichotomum</i> , <i>A. bechuanicus</i> , <i>A. congesta</i> , and <i>C. glauca</i> .	Yes
