## **ANNEXURE C7**

### **SPECIALIST ASSESSMENTS**

**AQUATIC SPECIALIST INPUT  
TO THE  
ENVIRONMENTAL IMPACT  
ASSESSMENT:  
PROPOSED PV2-11 PHOTOVOLTAIC  
ENERGY PLANTS ON  
FARM HOEKPLAAS NEAR COPPERTON,  
NORTHERN CAPE**

**MAY 2013  
FINAL**

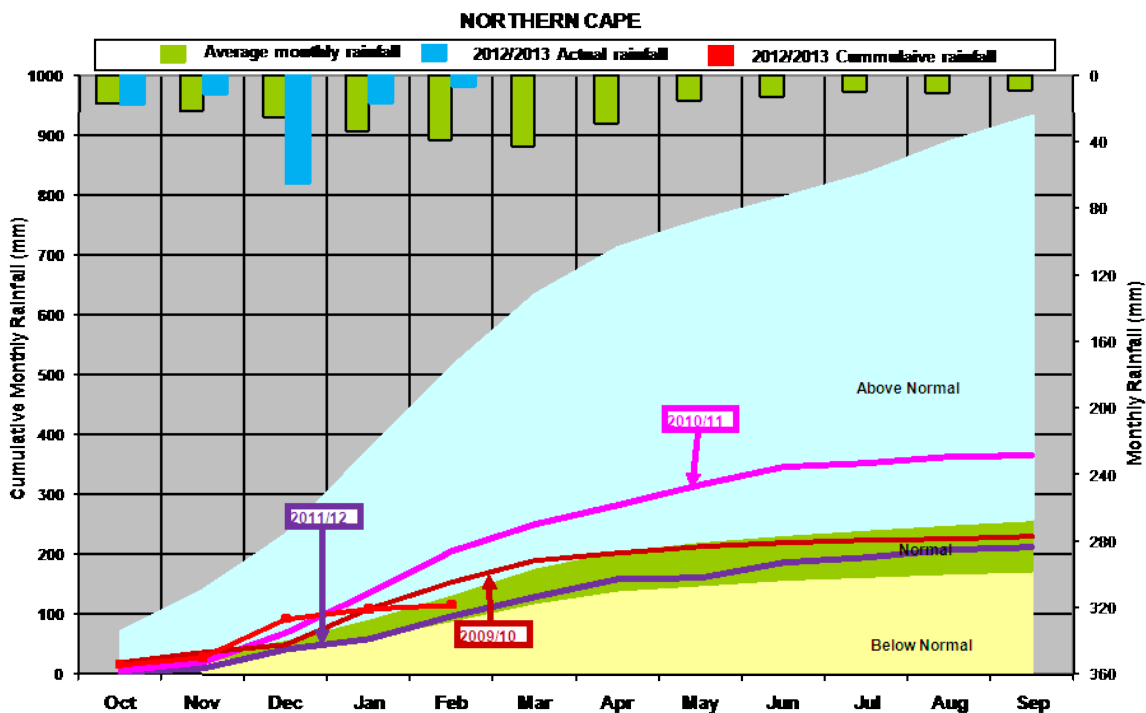
Figure 2.1 Rainfall summary and characteristics of the Northern Cape in general (Department of Water Affairs data)

The study area occurs in the Northern Cape near the town of Copperton within the D54D quaternary catchment and the Lower Orange DWA water management area (part of the Hartbees River system). The area is well known for endorheic pans<sup>2</sup> and depressions (Nel *et al.*, 2011, Allan *et al.*, 1995). The study area lies within the Nama Karoo Level 2 Ecoregion (26.04) described by Kleynhans *et al.* (2005, 2007), the Namib-Karoo-Kaokoveld Deserts and Shrublands WWF Terrestrial Ecosystems (Olson *et al.*, 2004). Mean annual precipitation is approximately 137mm with peaks in late summer, usually March (DIVA GIS data, Fig 2.1, Mucina & Rutherford, 2006). Soils are generally base-rich, weakly structured and shallow, mostly Glenrosa and Mispah forms, with lime a feature of the landscape. Soils drain freely, usually with <15% clay and have characteristic high levels of salt (Mucina & Rutherford, 2006).

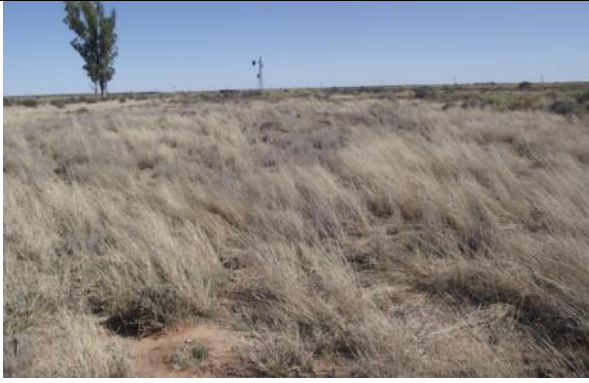
**Table 3.2 Photographs (taken in Nov 2011) of all features investigated on the farm Hoekplaas. Feature codes and descriptions correspond to those in a Table 3.1.**

owner this pan can hold water for up to 6 months of the year and he has witnessed Flamingos visiting the pan (before the construction of the Kamfer Dam near Kimberley).	
Hp3	Less developed than Hp3, nevertheless this feature is a grassed endorheic pan which holds rain water on occasion.	Yes
Hp4	Endorheic seasonal pan. Outer ring consists of a shrub zone (dominated by <i>Gomphocarpus fruticosus</i> , <i>Lycium hirsutum</i> , <i>L. cinereum</i> , <i>Salsola sp</i> and <i>Asparagus bechuanicus</i> ) and the pan floor is grass or herbs ( <i>Aristida congesta</i> , <i>Chloris virgata</i> , <i>Centropodia glauca</i> and <i>Solanum sp</i> ).	Yes
Hp5	Endorheic seasonal grassed pan that also forms part of a larger drainage line. Dominant species are <i>Aristida adscensionis</i> , <i>A. congesta</i> , <i>Eragrostis annulata</i> , <i>E. bicolour</i> , <i>Enneapogon desvauxii</i> , <i>C. glauca</i> , <i>Brachiaria glomerulata</i> , and <i>Lycium cinereum</i> .	Yes
