PROPOSED PV SOLAR ENERGY FACILITIES ON DU PLESSIS DAM FARM NEAR DE AAR

Soil and Agricultural Assessment Report

Issue Date: 28th August 2013
Revision No.: 1.3
Project No.: 12014

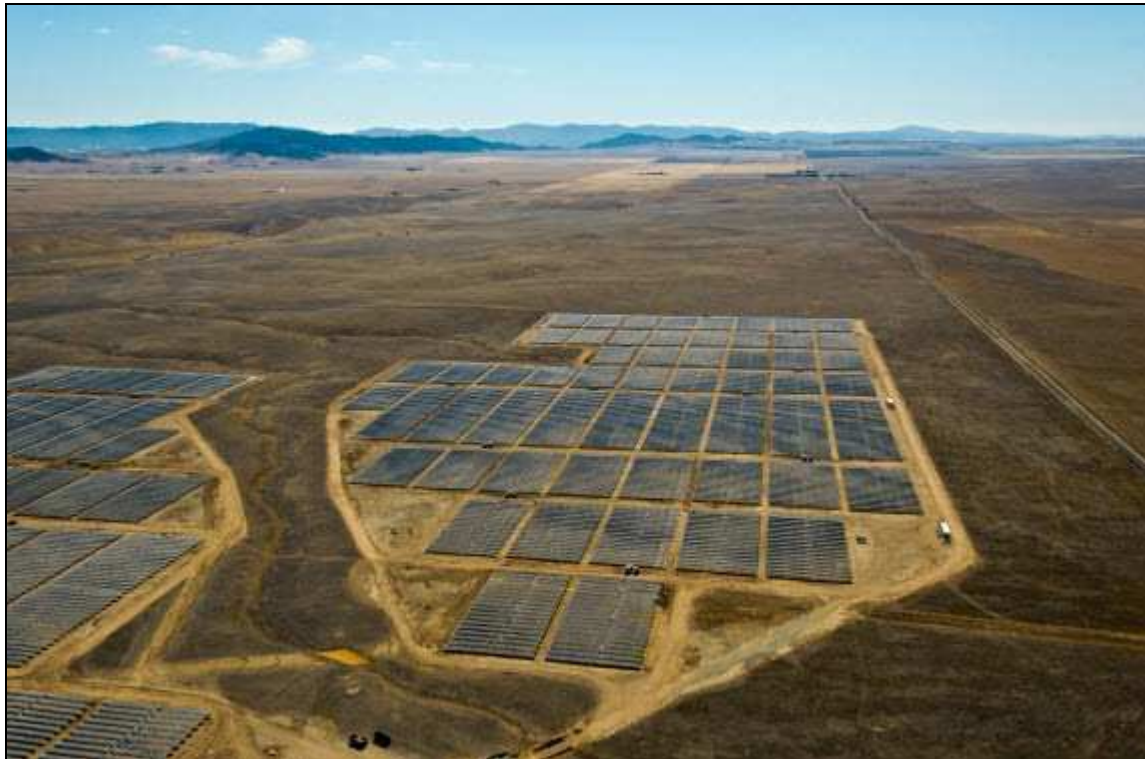
Figure 1: Example of a PV facility in a landscape similar to De Aar (image courtesy of Mulilo, cited in **Aurecon, 2013**).

Photovoltaic solar energy facilities use light energy from the sun to generate electricity through a process known as the PV effect. The PV cells absorb light energy which energises the electrons to produce electricity. **Figure 1** depicts a typical PV facility in a landscape similar to De Aar. The proposed PV panels are approximately 2m wide and 1m long. These panels are arranged into modules that are durable and can last up to 25 years, due to the sturdiness of the structure and few

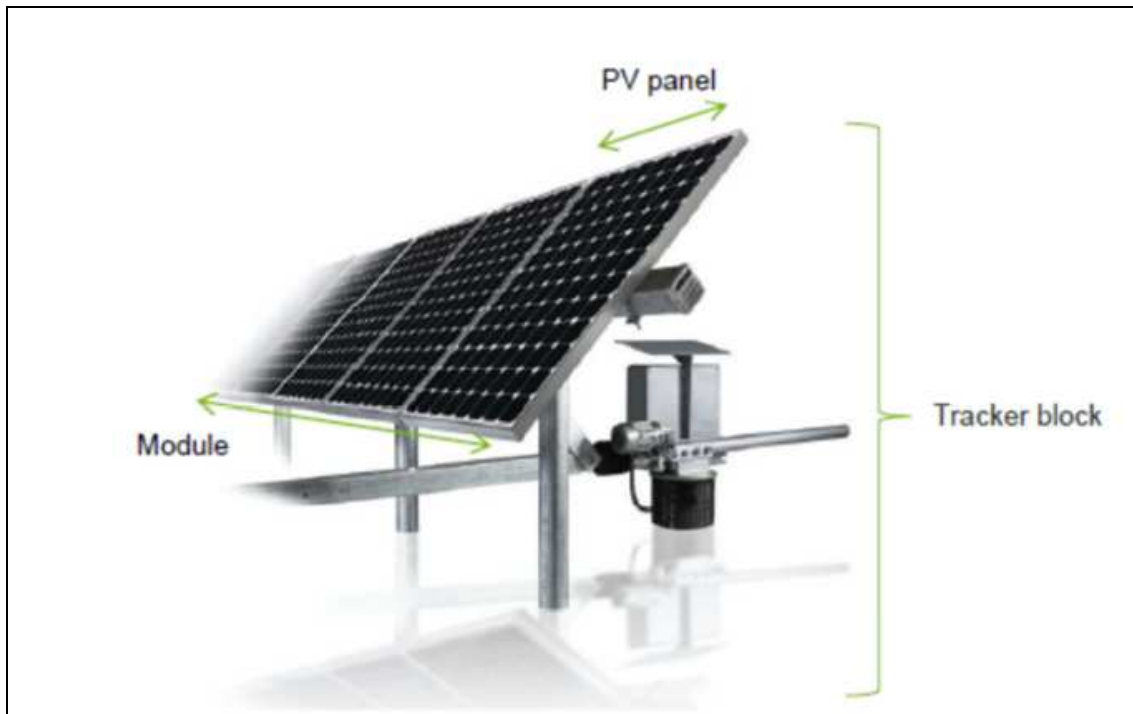
Figure 2: Single axis tracking system (image courtesy of Mulilo cited in **Aurecon, 2013**)

moving parts. The PV modules (which will include a number of PV panels) will be physically mounted to a galvanized steel rotation tube, single axis tracking system to ensure ground connection from the module frames to the structure. The PV modules, fixed to the tracking system, are arranged into tracker blocks as indicated in **Figure 2**. These tracker blocks will be uniformly aligned to facilitate efficient sun-tracking. The dimensions of a tracker block range between 88m and 113m in an east to west direction and 35m to 38m in a north-south direction (**Mulilo, 2013** cited in **Aurecon, 2013**).

The supports of the frame will be fixed on top of the steel piles. Since there is existence of rock (dolerite and siltstone) at shallow depths, the steel piles would be embedded into a concrete pile. However, the final design of the foundations will depend on the geotechnical conditions of the site which will be determined at a later stage (**Aurecon, 2013**).

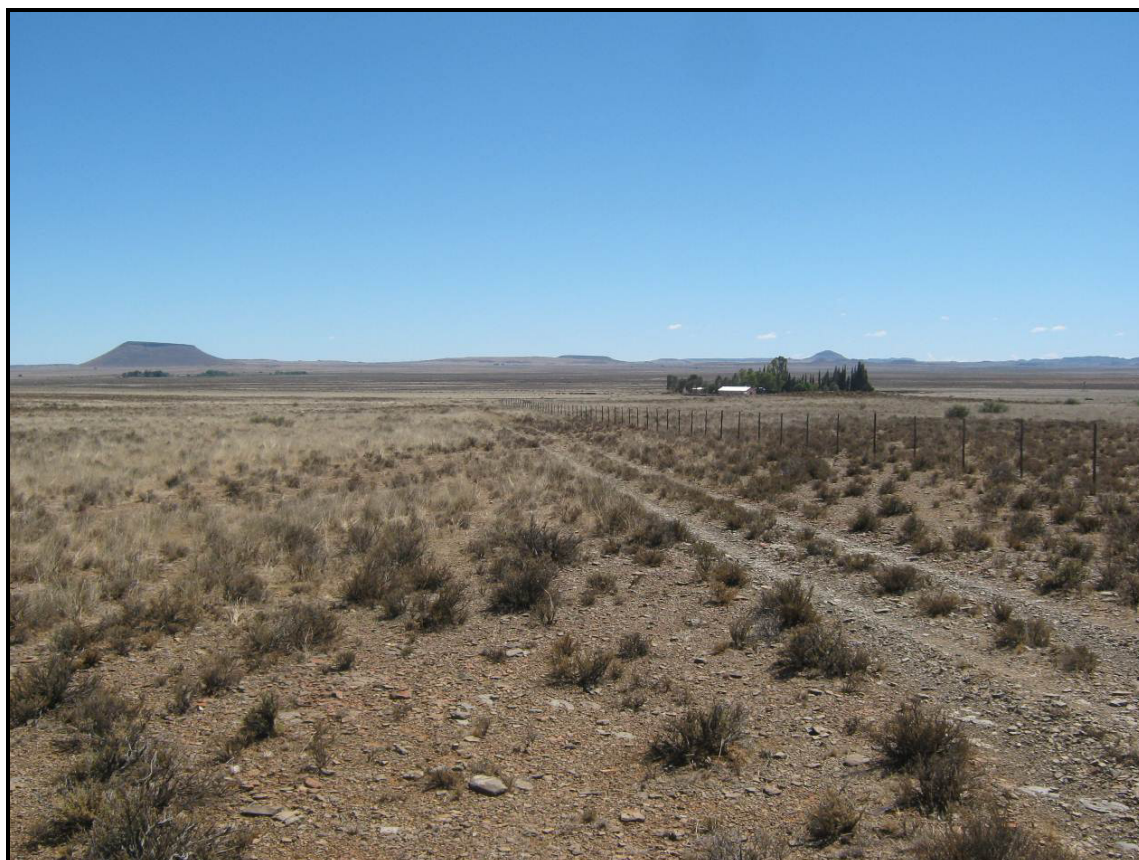
Figure 15: Shallow, rocky soils dominate large areas of the Du Plessis Dam Site

The Mispah soil form falls within the lithic soil group. Lithic soils are associated with shallow soils where parent rock is found close to the soil surface. The Mispah soil form dominates large areas of all three sites. The A-horizon varied from reddish-brown to ivory in colour and was generally 10-20 cm deep, directly overlying various hard rock materials. In many instances surface rocks are clearly visible

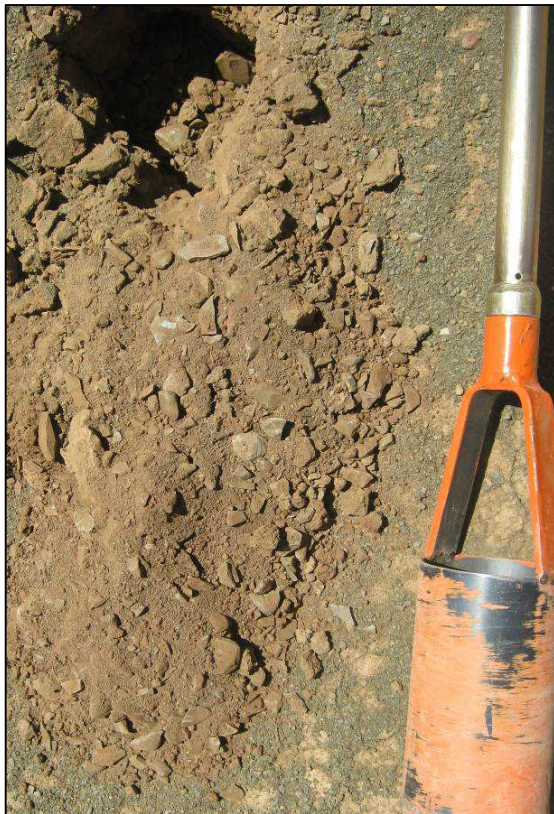
Figure 16: A shallow Glenrosa form encountered on the Du Plessis Dam Site

The shallow Orthic A horizon overlies a Lithocutanic B-Horizon, which contains a high proportion of weathering rocks (**Figure 16**). The B-Horizon is generally limiting to plant roots but gaps between the weathering rock fragments can be opened by larger tree roots and thus the land use potential of this soil can be higher than expected. The Lithocutanic B generally contained a high proportion of shale. The Lithocutanic B merges into solid rock layers which are limiting to plant roots and generally found between 20 and 50 cm below the soil surface. Surface rocks were evident across the land surface where this soil form was found. Large portions of the sites contained non-contiguous bands of Lithocutanic B horizons and hard rock which lead to large areas being classified as a Mispah and Glenrosa complex.

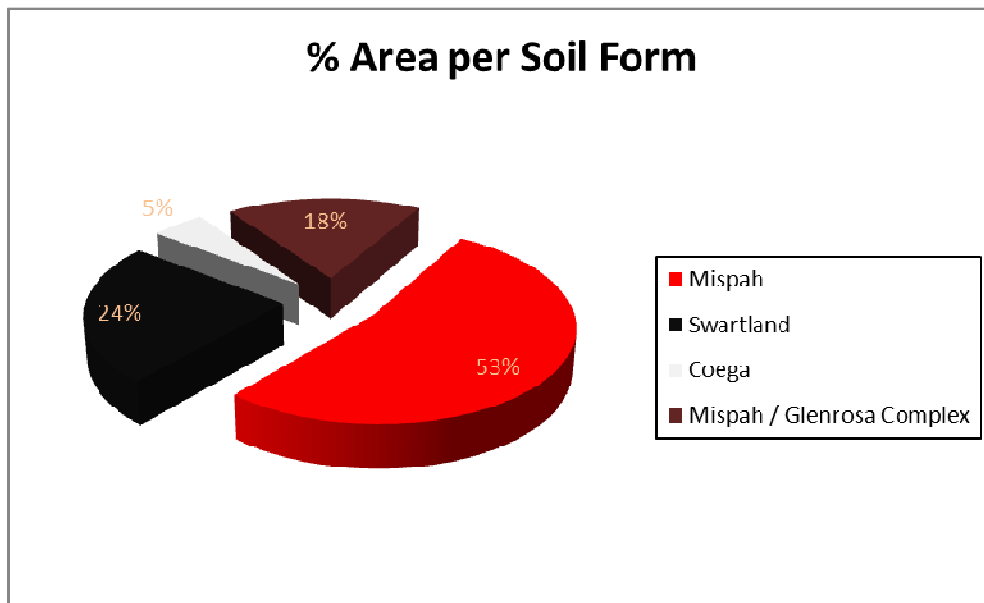
Figure 20: Graph showing the percentage area per soil form

The soils identified on the Du Plessis Dam Site are predominantly shallow and rocky with a low agricultural potential. Rocky soils (Mispah and Glenrosa Forms) cover 71% of the surveyed area (**Figure 20**) while shallow duplex soils (Swartland) cover 24%. Most soils contained a layer that was limiting to plant growth and these layers included rock, saprolite, hard pan carbonate and strongly structured cutanic horizons.

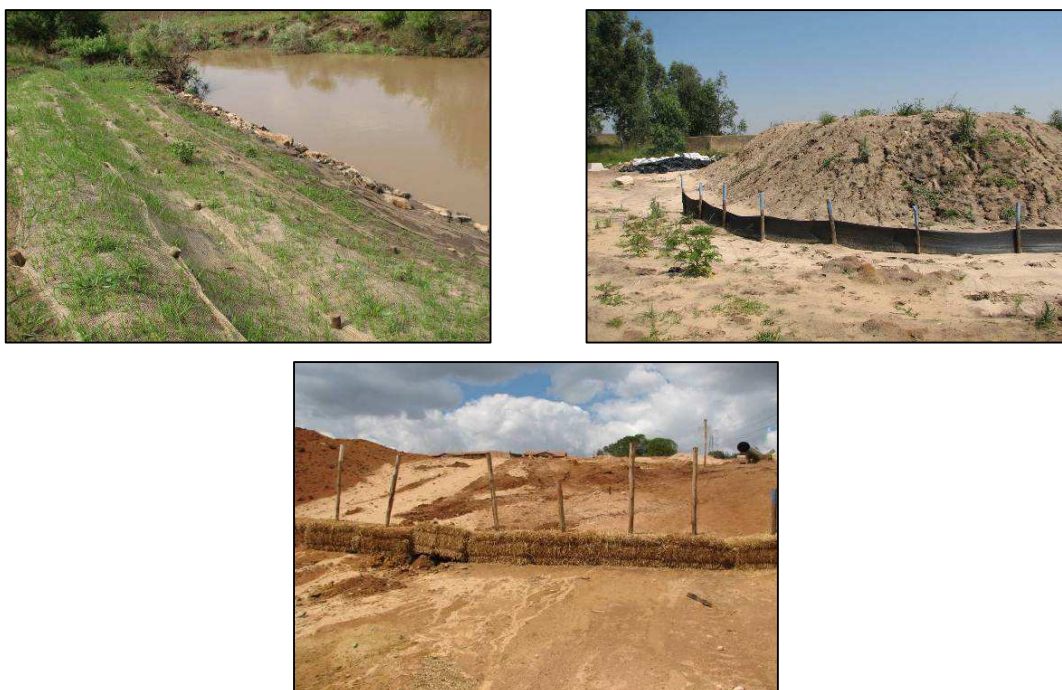
Figure 25: Typical soil erosion mitigatory measure: BioJute Installation (**top left**); a silt fence protecting a stockpile (**top right**) and pegged hay bale wall used to reduce runoff velocities (**bottom**)

Storm water control and wind screening should be undertaken to prevent soil loss from the site. All embankments shall be protected by a cut off drain to prevent water from running down the face of the embankment, resulting in soil erosion. Typical erosion control measures such as the installation of silt fences, hay bales, EcoLogs™ and Bio Jute™ are recommended if erosion problems are noted during construction and operation phases (**Figure 25**).
