Annexure One

Heritage Statement/motivation

Erven 10773 and 10772 Woodstock

Historic Jewish Cemetery corner Albert and Lower Church Street: Rebuilding and repair of collapsed boundary walls on the eastern and northern lateral boundary

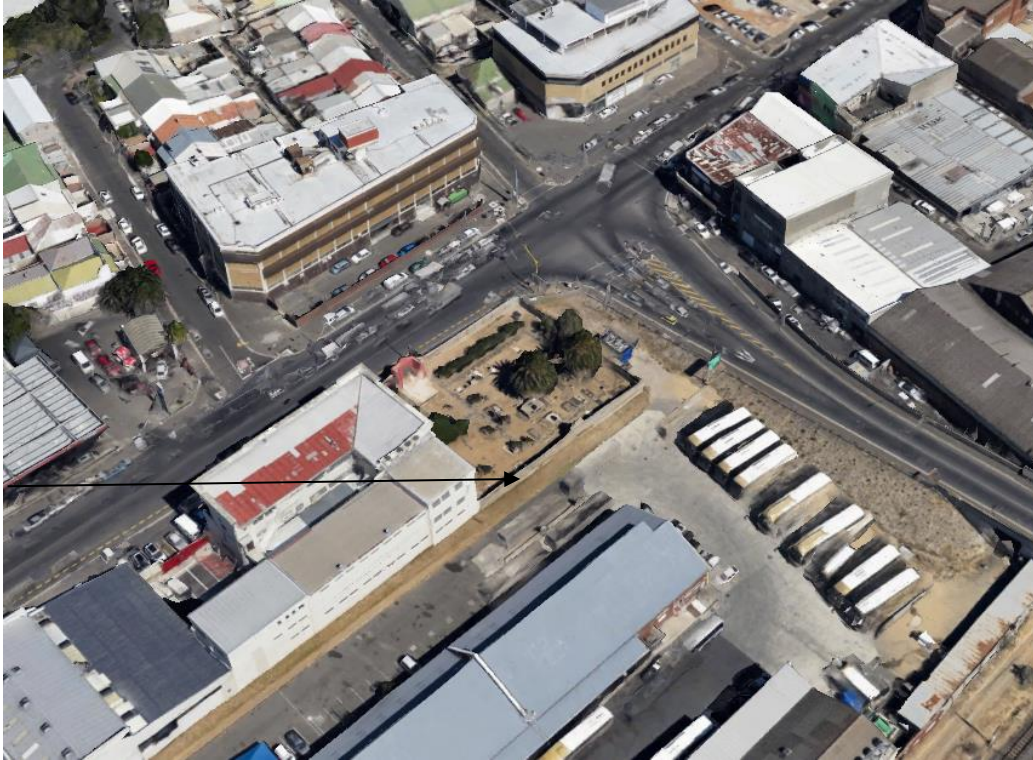
Fig 4. The northern boundary wall which requires repair rebuilding and a security fence.

The northern boundary wall is showing signs of severe deterioration. Because of its isolated position it is vulnerable to access to the interior of the cemetery.

The proposal is for the collection of the collapsed stone and retention for re-use; and the rebuilding of the historic stone wall on the boundary with careful attention paid to the character of the mortar used. The proposal involves the placement on a security fence behind the stone wall for security purposes.

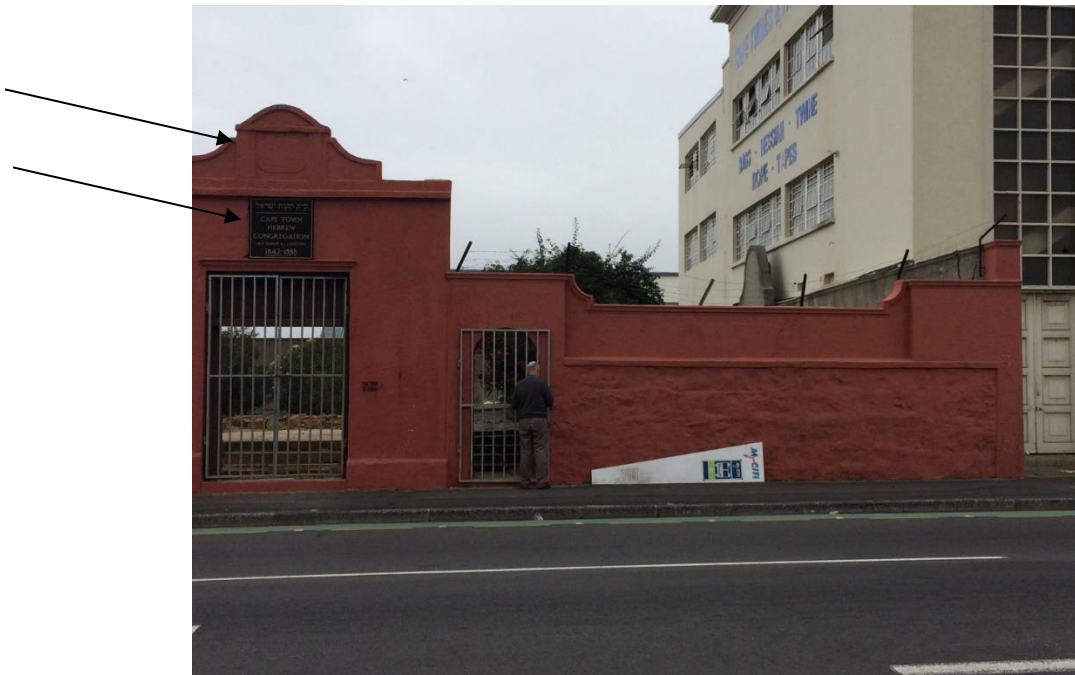
Fig 6. Entrance of Jewish Cemetery Albert Road Woodstock showing the entrance and evidence of the old walled surrounds. The plaque (arrowed) above the gate reads Cape Town Hebrew Congregation: Old Albert Road Cemetery 1854-1888

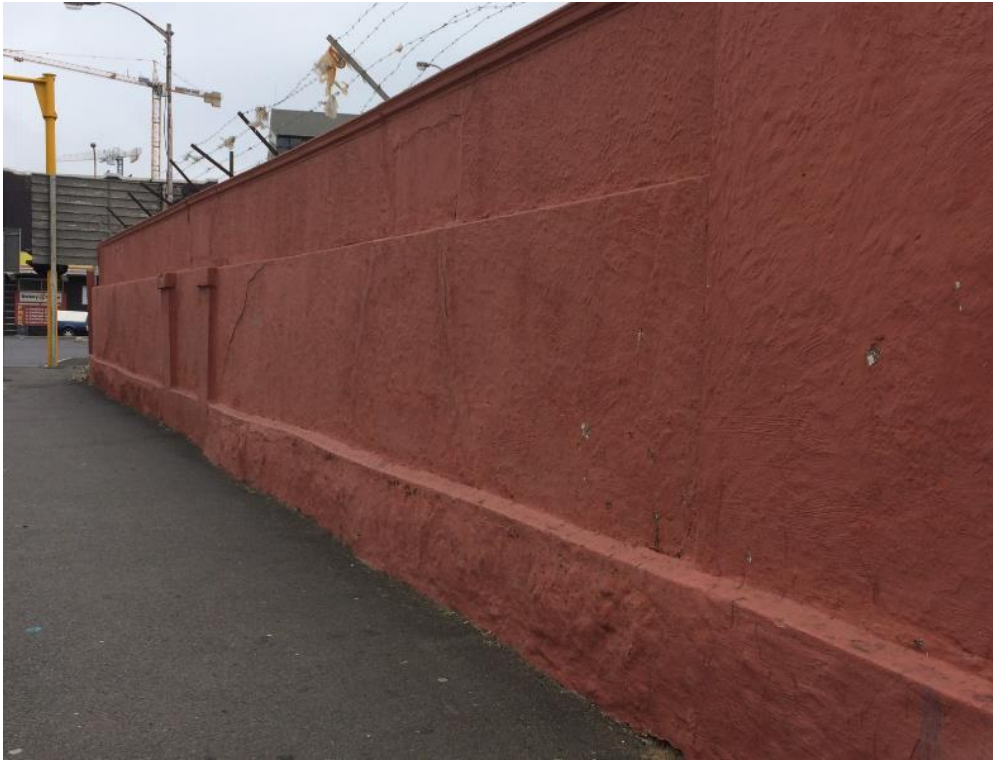
The early walls appear to have been about a metre in height set on a stone plinth and, constructed largely of stone which was later plastered. The walls enclose the entire cemetery and

at the centre of each of the interior walls is a gable mirroring the Albert Road entrance. The early walls have subsequently been raised, plastered and painted.

The height of the wall on both the eastern and northern edges were raised at one point using cement bricks thus affecting the structural integrity of the historic wall.

Fig 7. The cemetery walls with a stone base plastered early walls and raised height. Also shown is a potential earlier entrance.

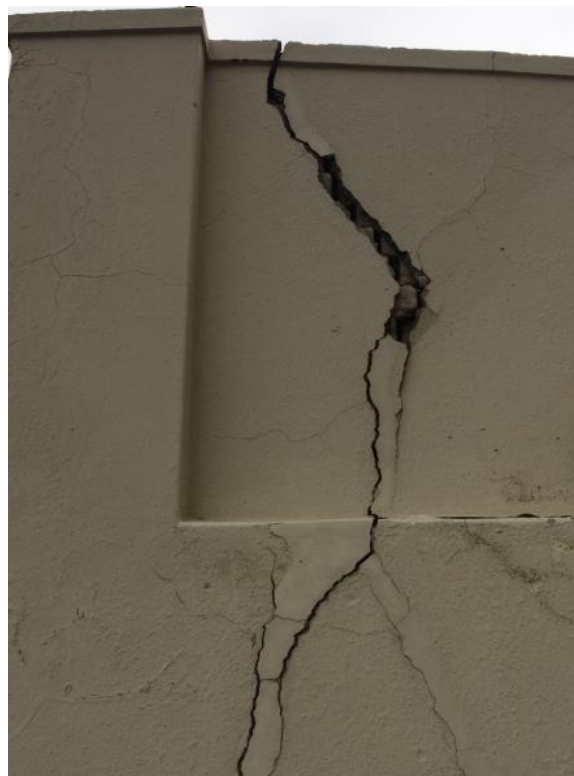
Both historic portions of the eastern and northern walls are in an advanced state of decay. The southern section of the boundary wall containing the cemetery entrance has been painted and maintained although the south eastern corner has cracked and collapsed in parts.

Fig 8. Cracks at the south eastern edge appearing before June 2018 Sections of this wall subsequently collapsed (see Fig 9)

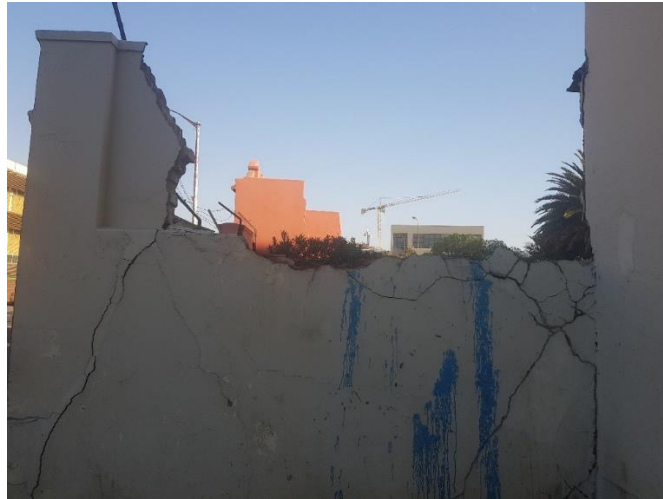
An inspection of wall surfaces show cracks which appeared over time and which have been filled. There is evidence of moisture penetration which may have weakened the structural integrity of the walls. It is this later walling along the Albert Road lateral boundary which has collapsed due to the heavy rains ofc2018.

Fig 9. The collapsed lateral portion of the wall off Albert Road

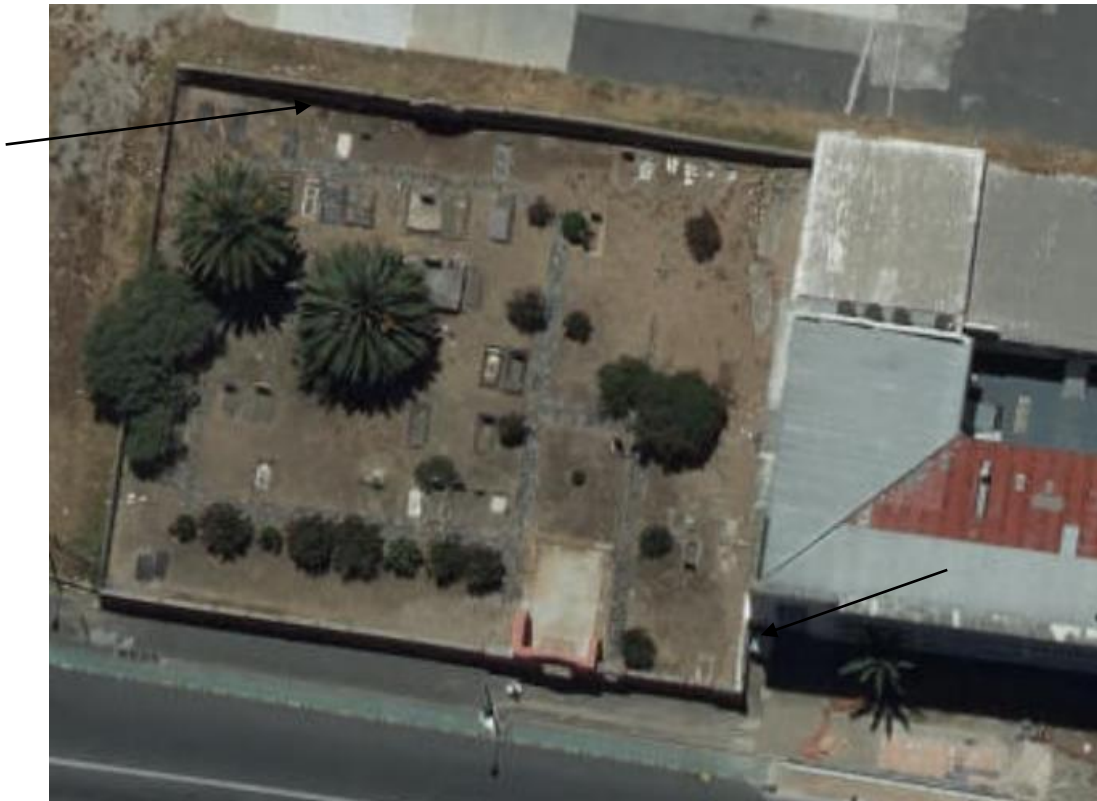
Fig 10 The cemetery interior showing its walled nature the entrance and the regular nature of the grave arrangement. The eastern and northern portions of the wall are arrowed.

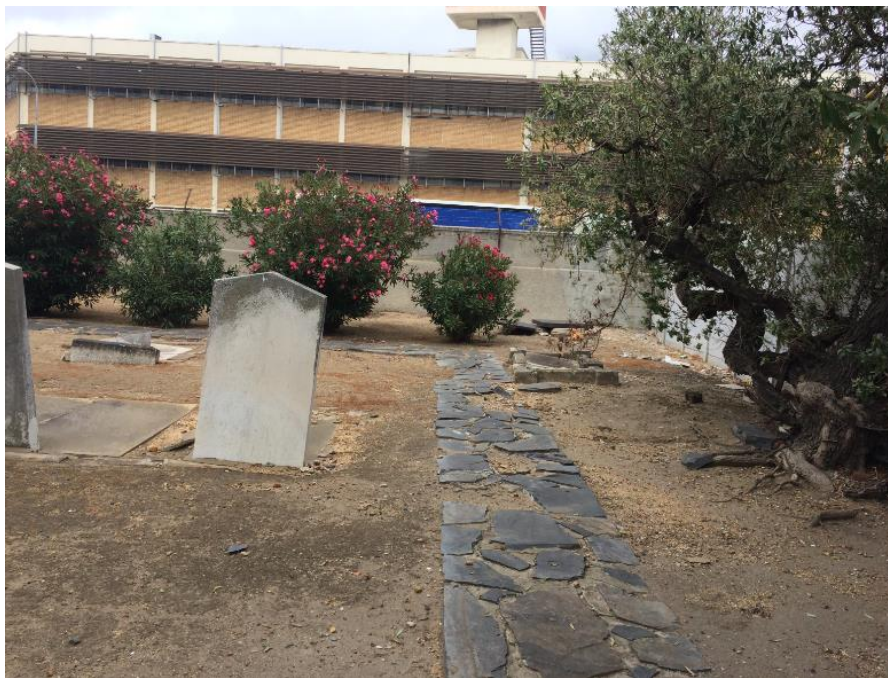
Fig 11. The avenues of old slate and the gravestones of the early Capetonians. June 2018.

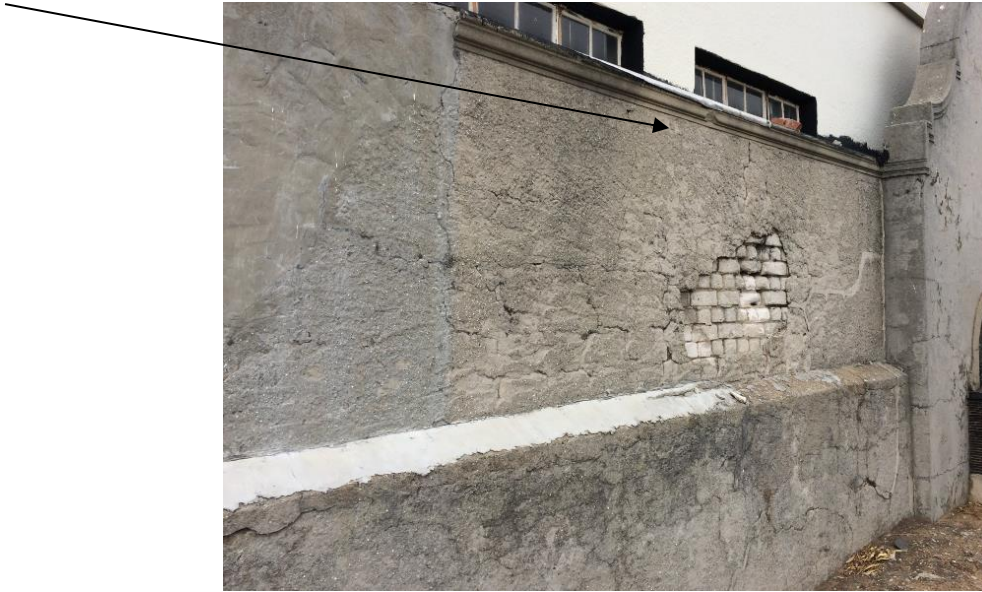
Fig 12 Wall along the eastern lateral boundary showing proximity to the adjacent building for the July 2018 collapse. June 2018

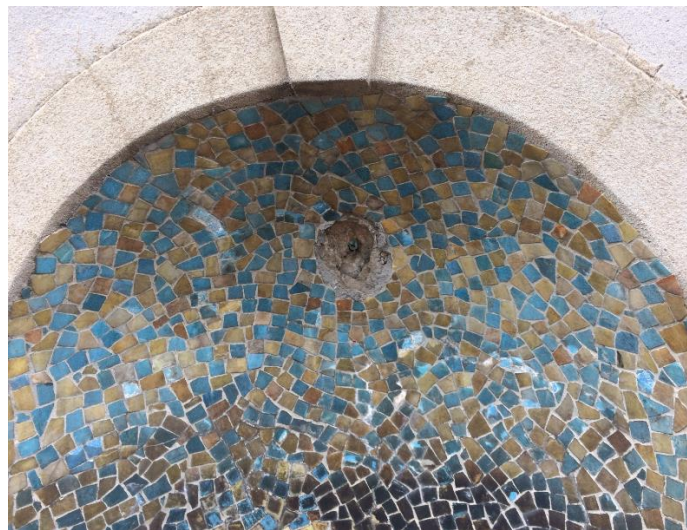
Fig 13. The fountain, a traditional feature of a Jewish cemetery, which is to be retained as part of the restoration proposal. June 2018

- Restore fountain
- Footings of stone walls to be to engineer's specifications
- Further discussion to be undertaken and advice sought regarding the pattern and type of stone which will be informed by analysis of the stone wall on either side of the fountain currently plastered (Zone C)

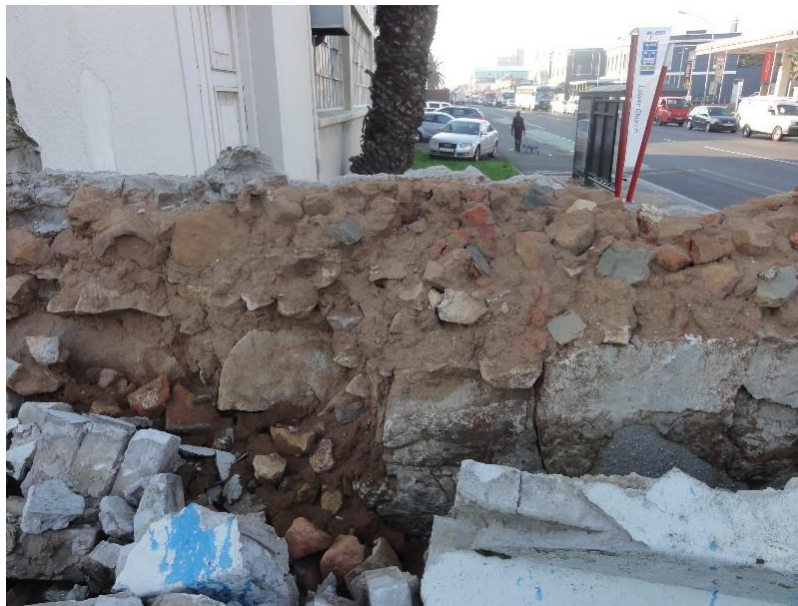
During July 2018 heavy rains caused a lateral portion of the wall, after showing signs of cracking and subsistence, to collapse (see Fig 4 and fig 5). This was on the eastern edge of the site against the common boundary with the office building. Water and damp had collected rendering the wall particularly the extended portion, unstable. The collapse revealed the present of the old stonework and the clay and sand mortaring. Temporary hoarding was put in place to protect the

Fig 14 July 2018 wall collapse of eastern boundary wall.

No archaeology or disturbance of any burial ground is permitted within the graveyard according to Jewish custom. Of interest however are the paving stones on the central walkway indicating previous use – possibly from the nearby (demolished) Craig’s Tower. The collapsed walls reveal early stone walls with early clay-based mortar. (See Fig 12).

Such porous qualities have contributed to the collapse with water penetration.

- Sort clean and re-use the cement bricks which were part of the wall which collapsed
- Remove plaster from walls identified A-B on either side of the fountain (washing feature) in diagram, photograph the stone walls so that the pattern can be replicated in the reconstruction of the walls

- Demolish walls on either side of wall areas A-B, clean concrete bricks and stones on site
- Waterproof site A-B to engineer's specification.
- Once waterproofed commence construction in stone wall area C. This wall is to reflect the significance of the historic stone walls

- Balance of wall identified as D to be constructed out of the salvaged concrete blocks.

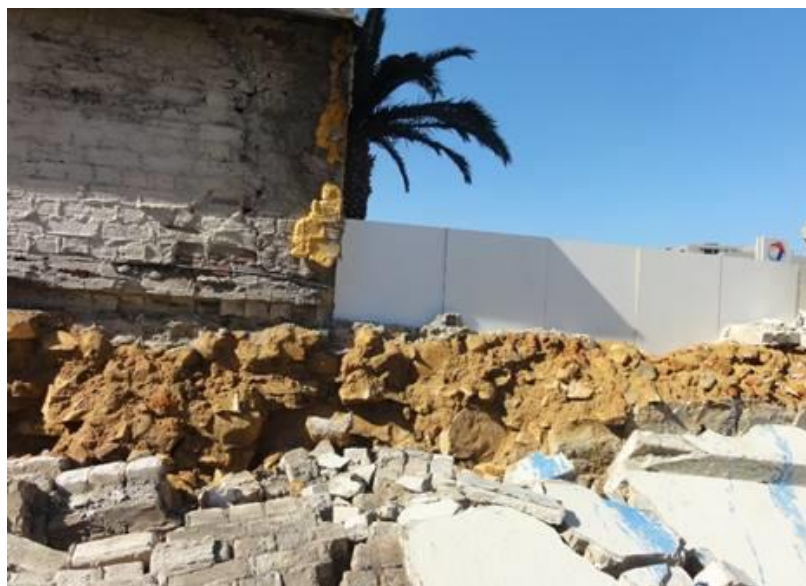
cemetery of vandalism and illegal ingress. As the collapse resulted in bricks falling on the graves, they were cleared collected and packed away on site, awaiting the new proposals. HWC was informed on 1 August 2018 with a request to conduct a site visit.

Fig 15 temporary boarding in place July 2018.

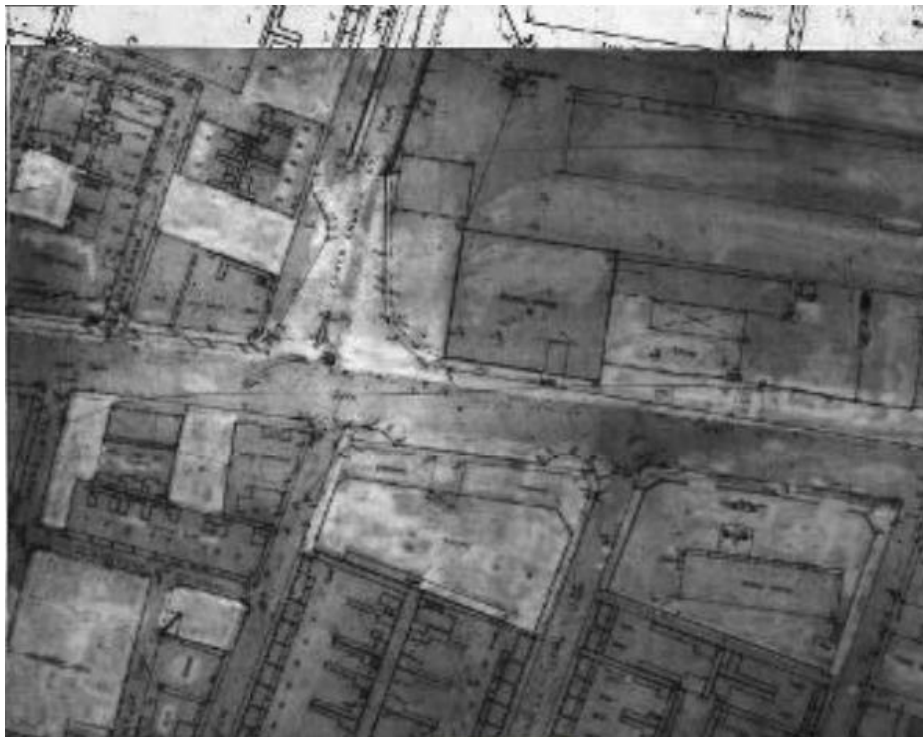
Fig 17. Early changes to the context of the cemetery 1945 showing the Church Street Albert Road intersection newly built. The cemetery is shown as walled with the current entrance in place. The office block to the east is present.

It has remained in the same ownership since 1849. The boundaries of the site and the presence of the graves have remained the same since then. The major changes which has affected the context of the cemetery have been the extension and expansion of the Church Street Bridge and the Albert Road intersection, and the fact that a commercial and residential area to the south have grown up around it (See Fig 14 aerial photograph of changes to the context)
