WEST COAST RESOURCES - NAMAQUALAND MINES ENVIRONMENTAL IMPACT ASSESSMENT

ESTUARINE SPECIALIST STUDY REPORT

For the Amendment of an Environmental Management Programme and Environmental Impact Assessment in Support of a Mining Right held by West Coast Resources (Pty) Ltd over the Namaqualand mines, Northern Cape Province

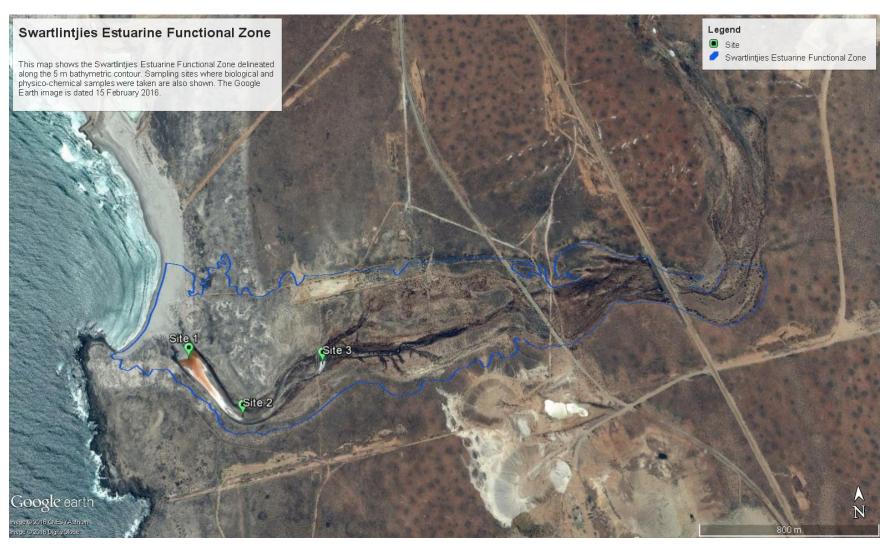
Figure 1 The Swartlintjies Estuarine Functional Zone showing biological and physico-chemical sampling sites (Source: Contour lines provided by WCR).

The Swartlintjies Estuary has been classified as a small ephemeral river outlet and is not considered one of the 289 functional estuaries in South Africa (Van Niekerk & Turpie, 2012). Using the NBA definition for delineating the extent of the Swartlintjies Estuary would result in a very small and meaningless management unit, which is not practically implementable. Consequently, the extent of the estuary, i.e. the EFZ, was determined according to the 5 m contour above mean sea level (MSL) (Figure 1).

Hypersaline conditions prevailed at all three sites within the EFZ (Figure 1), with conductivity ranging from 147-172 mS/cm (> 100 ppt salinity) (Table 2). The primary reason for hypersalinity is the regular intrusion of seawater during spring tides. Seawater enters the riverbed and remains trapped behind the berm, evaporating slowly and leaving salts behind. This is combined with the fact that episodic floods no longer reach the estuary due to obstructions to flow in the lower catchment and the EFZ. The little surface water runoff that occurs within the EFZ during rainfall events between April and September are not enough to temporarily dilute the water. Rainfall also carries salts from sediments outside the EFZ into the riverbed, which is responsible for the saline conditions within the dry flood plain (saltmarsh vegetation dominates in the main river channel). Generally, the Namaqualand area experiences higher evaporation rates than precipitation, which naturally leads to the formation of salt pans (Heinecken, 1980; RSA DWA, 2009). Lastly, it is possible that the abandoned slimes dam north of the estuary leaches additional salt into the riverbed. A saltpan is present in the river bed below the abandoned slime dam (Figure 3).

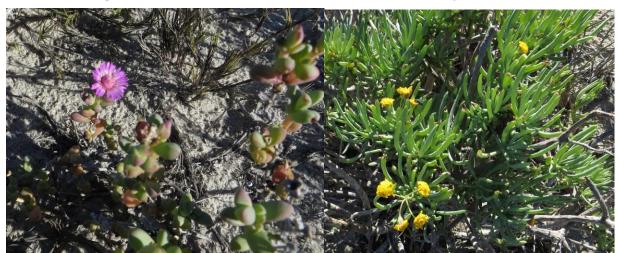
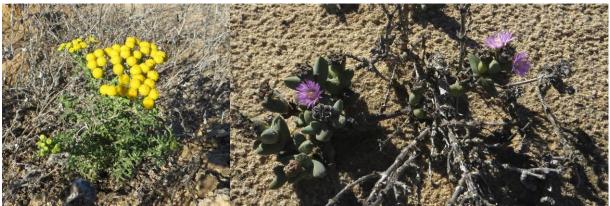
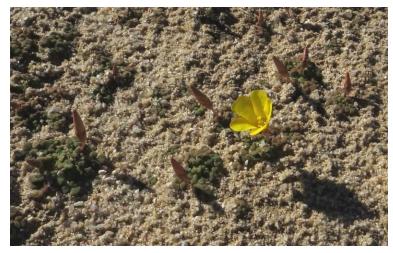
Figure 10 Photos of flowering terrestrial plants in the Swartlintjies Estuarine Functional Zone. The Photos were taken on 22 June 2016.

the field trip with some species being in flower (Figure 10).

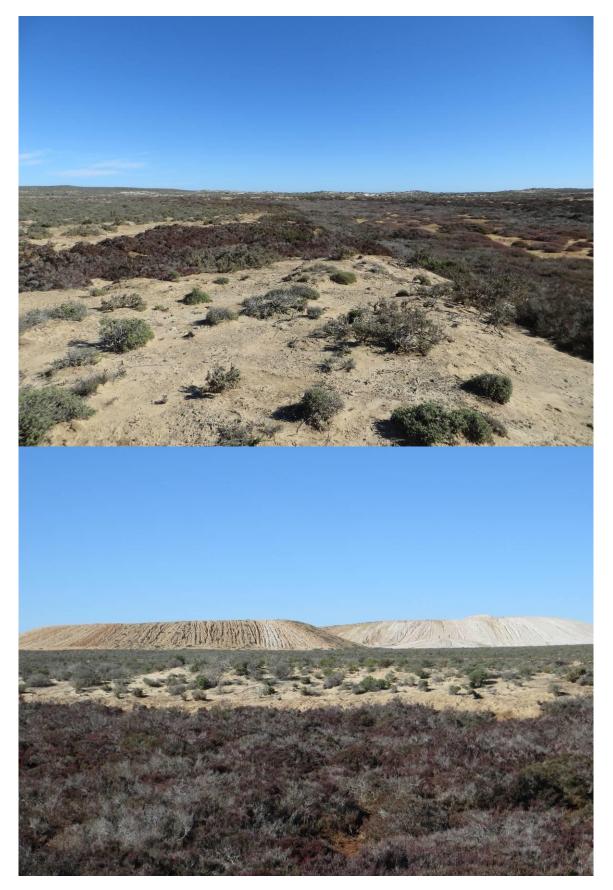
Figure 12 The river channel is shown by the red saltmarsh vegetation (*Sarcocornia natalense and Sarcocornia pillansii*). Transitional vegetation with a mix of saltmarsh and shrub can be seen on elevated ground.

Figure 12). Away from the main river channels, less pronounced channels could be found which were characterised by transitional vegetation with a mix of salt marsh species and various shrubs types (Figure 9 and Table 3). A variety of succulent shrubs was found on ground slightly elevated relative to the old channels (as little as 0.5 m) and included species such as *Othonna cylindrica, Drosanthemum luderitzii* and *Amphibolia rupis-arcuatae* (Figure 13). Prior to mining activities in the area, the Swartlintjies River came down in flood unhindered during episodic rainfalls, creating a braided flood plain with channels of varying depths (Section 10.3.1). These channels were then colonised during dry periods, creating a biodiverse habitat that reflects the topographic mosaic of the floodplain. This shows that the episodic flooding of the Swartlintjies River is an important ecological process for maintaining biodiversity of the Swartlintjies EFZ. The elevated edges of the floodplain transitioned to the surrounding vegetation type, namely Namaqualand Coastal Duneveld to the northwest and south of the EFZ.

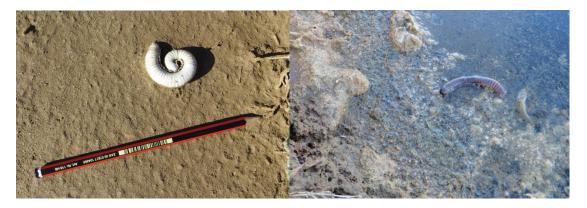
Figure 14 Photos of dead millipedes in the dry flood plain (bleached) and drowned in shallow hypersaline water. Photos were taken on 22 June 2016.

During the ECRU survey in 1980, Heinecken (1980) found a hydrophilid beetle (*Berosus spretus*) at the saline pools in the estuary. The bladder grasshopper (*Pneumoridae*) and a tenebrionid beetle were collected in the vicinity of the estuary. Casts of the marine crabs *Guinusia chabrus* and *Ovalipes punctatus* were found at the edges of the dry estuary, which were likely washed into the estuary by the springtide or when the mouth had been opened artificially at the beginning of the year. Dead millipedes were found in the dry floodplain and in on the edges of the hypersaline water Figure 14.
