**UNIVERSITY OF ZULULAND**

BUILDING/S:	Tourism and Recreation, B-Lab
ARCHITECT/S:	Piet Van den Berg
DATE:	c.1960
CURRENT USE:	Academic buildings

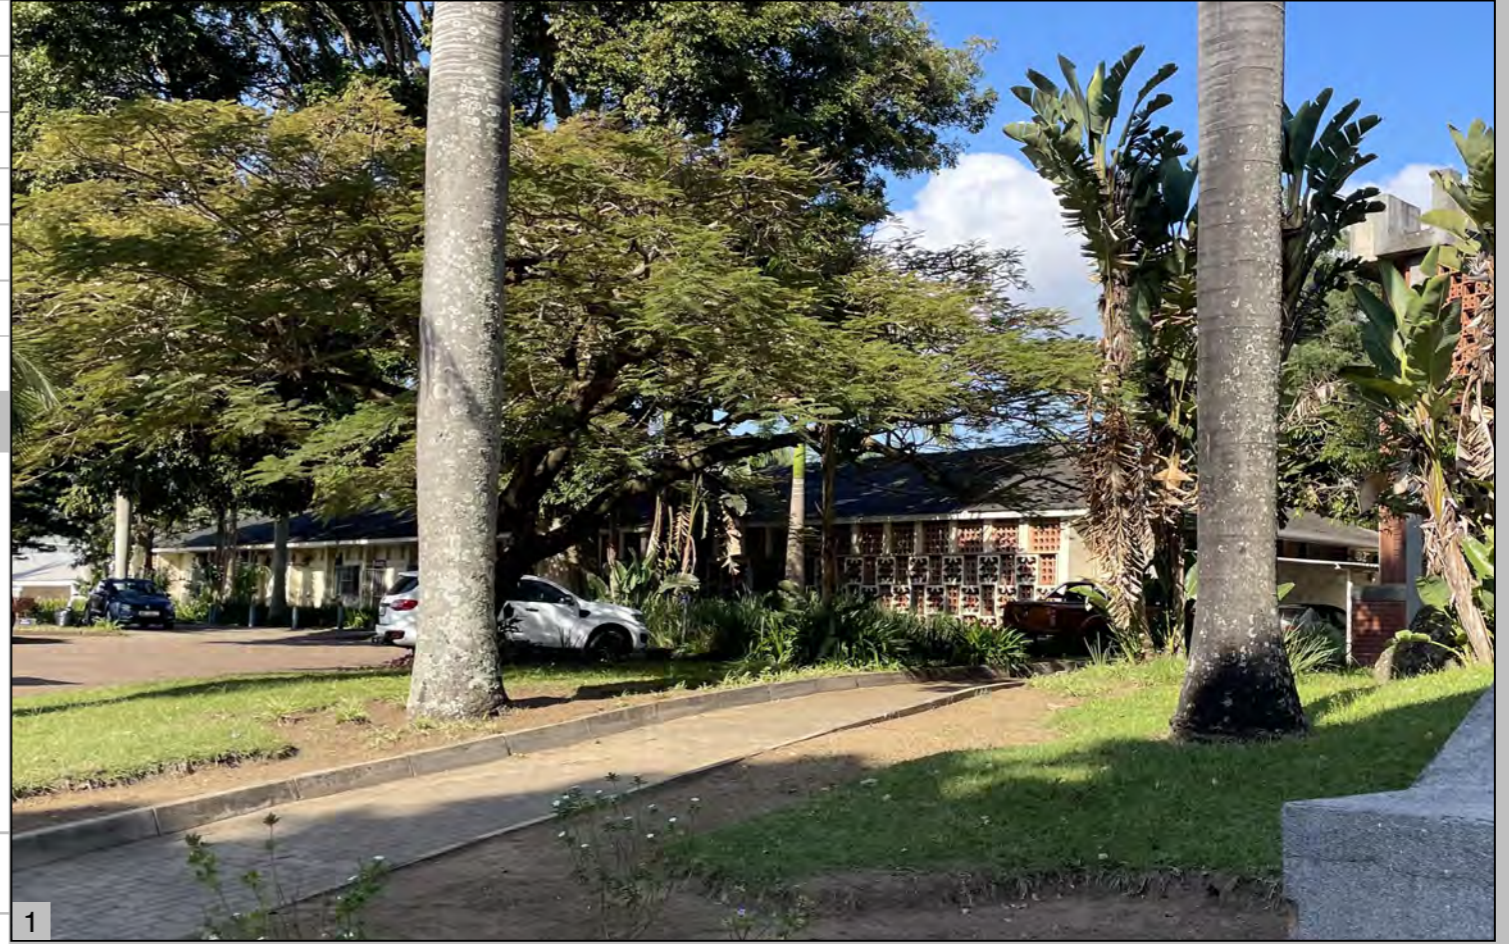
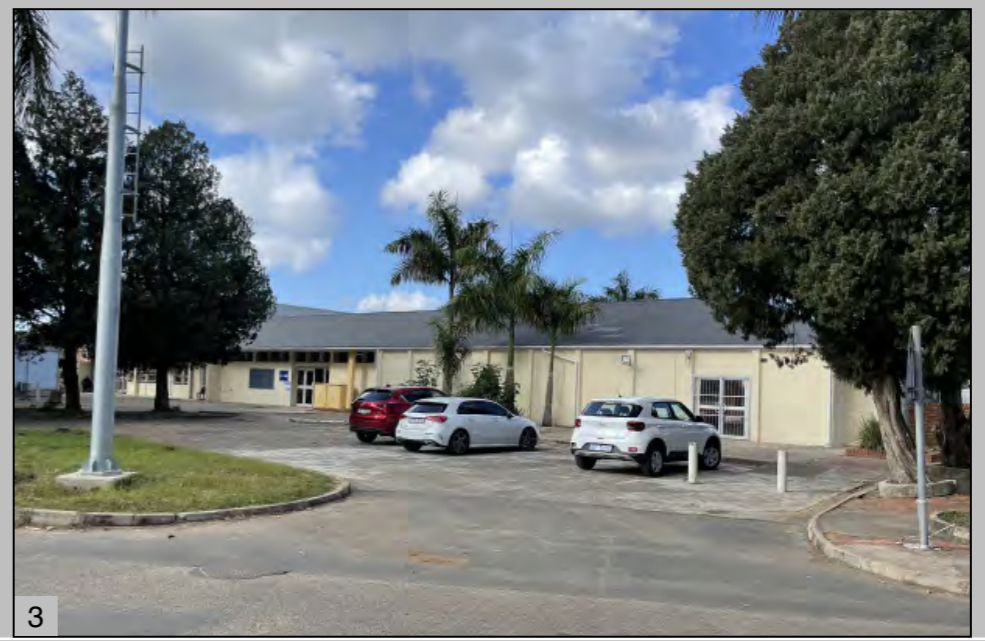
**SITE & STRUCTURE DESCRIPTION:** These single storey rather modest “bungalow” type buildings with decorative brise-soleils, plasterwork patterns are the first academic buildings constructed on the university campus. The architect of the spatial development plan and earlier buildings on the UniZulu campus was Piet van den Berg, who also designed the University-college of the North (Turfloop), now the University of Limpopo. These buildings add to the spatial significance of the main university avenue. The brise soleil along the facade of the B-Lab building has been removed.

**PHYSICAL CONDITION:** Good.

IMAGES: 1 - Tourism and Recreation Building  
 2 - Tourism and Recreation Building  
 3 - B-Lab Building showing removed brise-soleil

**OPPORTUNITIES & THREATS:** Alterations to the structure should be controlled by the heritage guidelines. The building has a strong presence on the main academic avenue. The brick screen should be reinstated along the facade of the B-Lab building (preferably repurposed from the demolished residences) to match others along the avenue.

**RECOMMENDATION:** The building should be formally listed as Grade IIIB. Trees of stature along academic avenue should be retained.

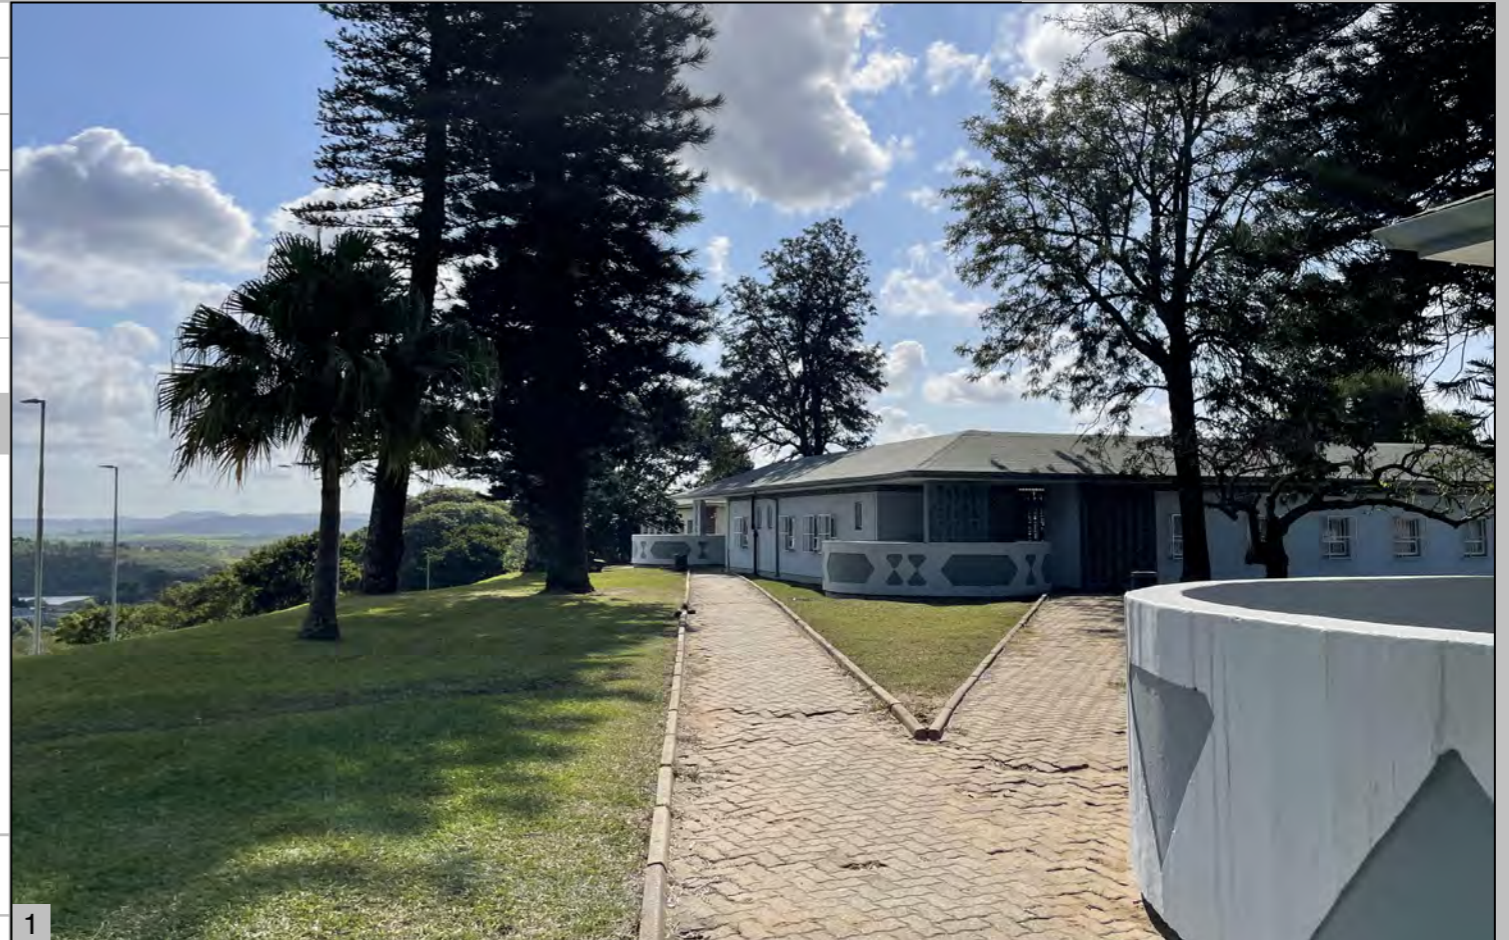
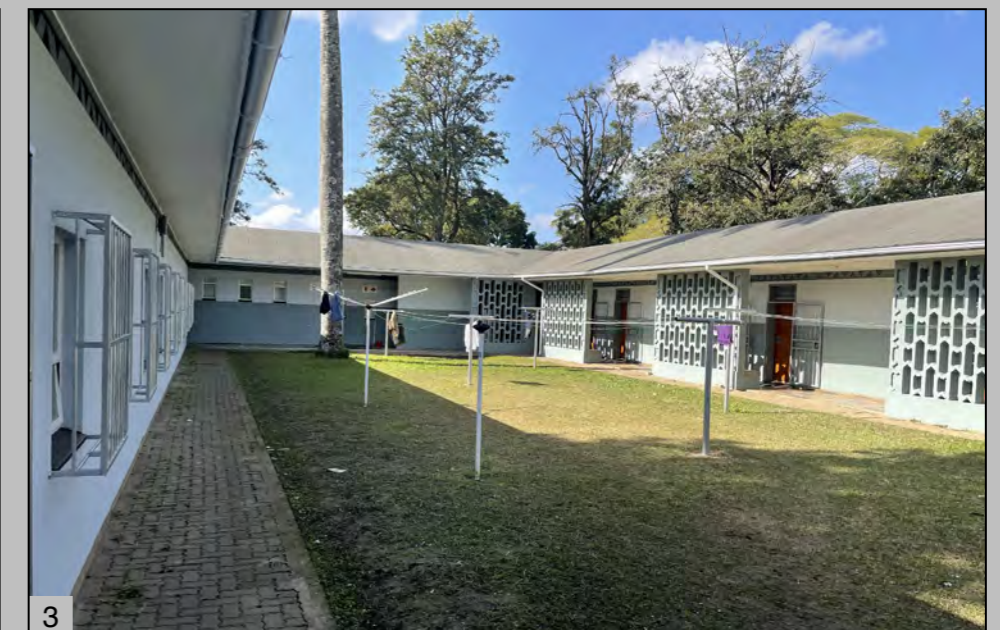
SITE & STRUCTURE DESCRIPTION:	These two buildings are the first residential buildings constructed on the university campus. Single storey rather modest “bungalow” type buildings with decorative brise-soleils, plasterwork patterns, and some with internal courtyards and circular lapas at the building entrances. The spatial relationship between the bungalows and the valley below are important to retain.
PHYSICAL CONDITION:	Good.
STATEMENT OF SIGNIFICANCE:	These buildings were the first residential buildings constructed on the UniZulu campus. They are both architecturally intact and play a significant role to the contextual environment. The buildings have associated significance with the earlier “bantú” education laws.
PROPOSED GRADING:	Grade IIIB
OPPORTUNITIES & THREATS:	Alterations to the structure should be controlled by the heritage guidelines. These buildings have a strong presence along the western edge of the university, overlooking the valley below.

IMAGES: 1 - External facades of the two earlier residences  
 2 - Passageways with built-in benches and brise-soleil  
 3 - Internal courtyard

RECOMMENDATION:	The building should be formally listed as Grade IIIB. Trees of stature should be retained.
REFERENCES:

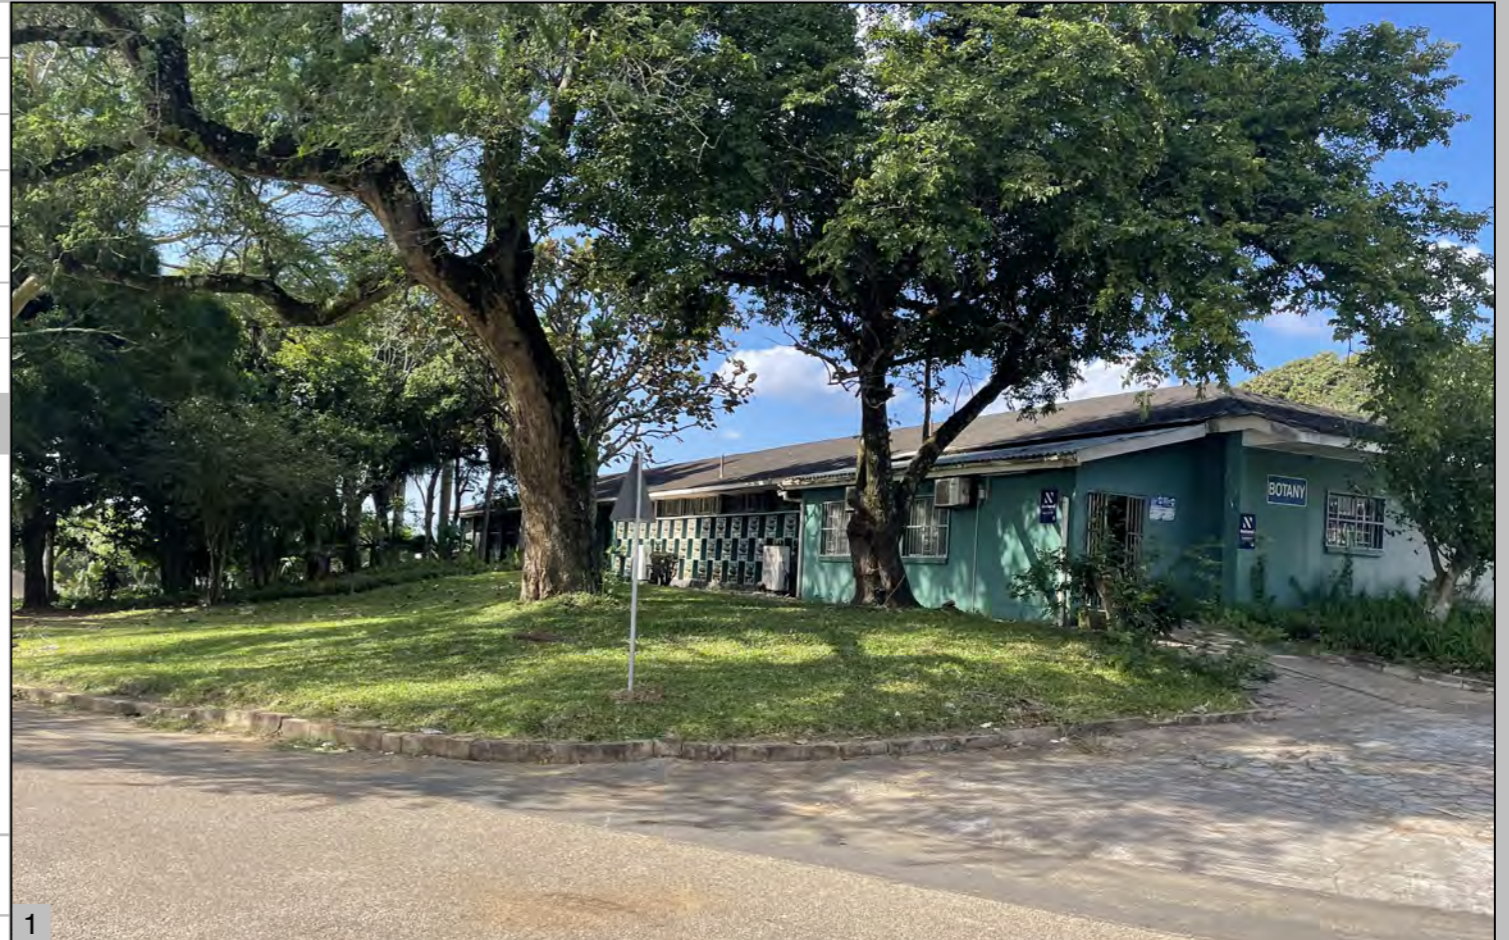
**SITE & STRUCTURE DESCRIPTION:** These single storey rather modest “bungalow” type buildings with decorative brise-soleils, plasterwork patterns are the first academic buildings constructed on the university campus. The architect of the spatial development plan and earlier buildings on the UniZulu campus was Piet van den Berg, who also designed the University-college of the North (Turfloop), now the University of Limpopo. These buildings add to the spatial significance of the main university avenue, with large green expanses and mature trees between the buildings and the street. The brise-soleil along the front of the Botany building has been removed and replaced with a new street-facing addition.

**PHYSICAL CONDITION:** Good.

**IMAGES:** 1 - Botany building with front addition. Green expanse and mature trees between building and avenue.  
2 - Internal passage leading from front of building to back exit  
3 - Brise-soleil with laminated wooden beams

**OPPORTUNITIES & THREATS:** Alterations to the structure should be controlled by the heritage guidelines. The building has a strong presence on the main academic avenue. The brick screen should be reinstated along the facade of the Botany building (preferably repurposed from the demolished residences) to match others along the avenue.

**RECOMMENDATION:** The building should be formally listed as Grade IIIB. Trees of stature along academic avenue should be retained.

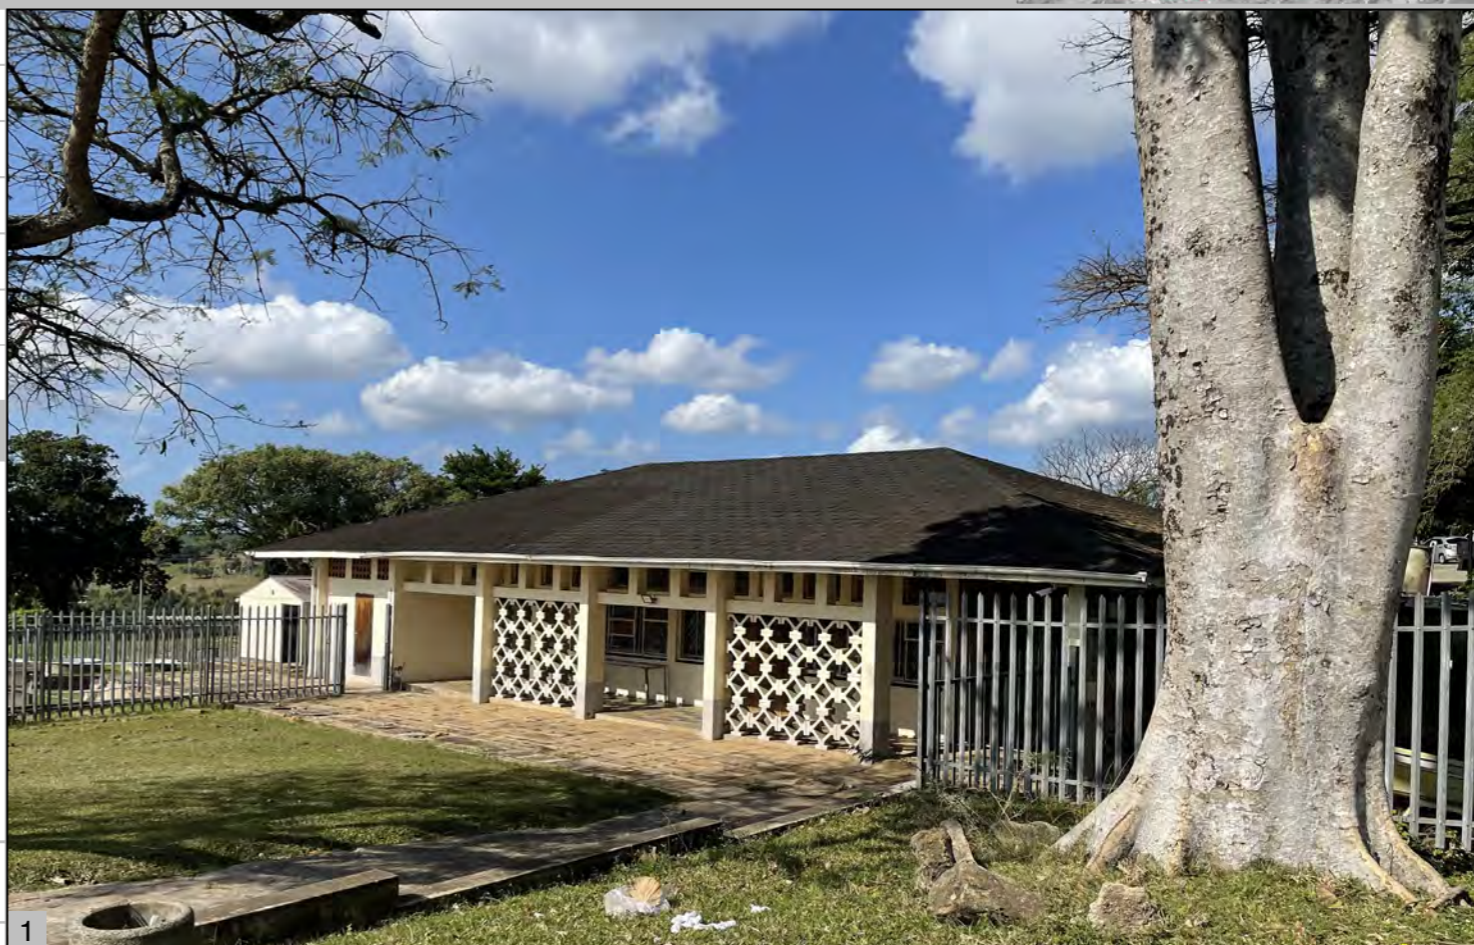
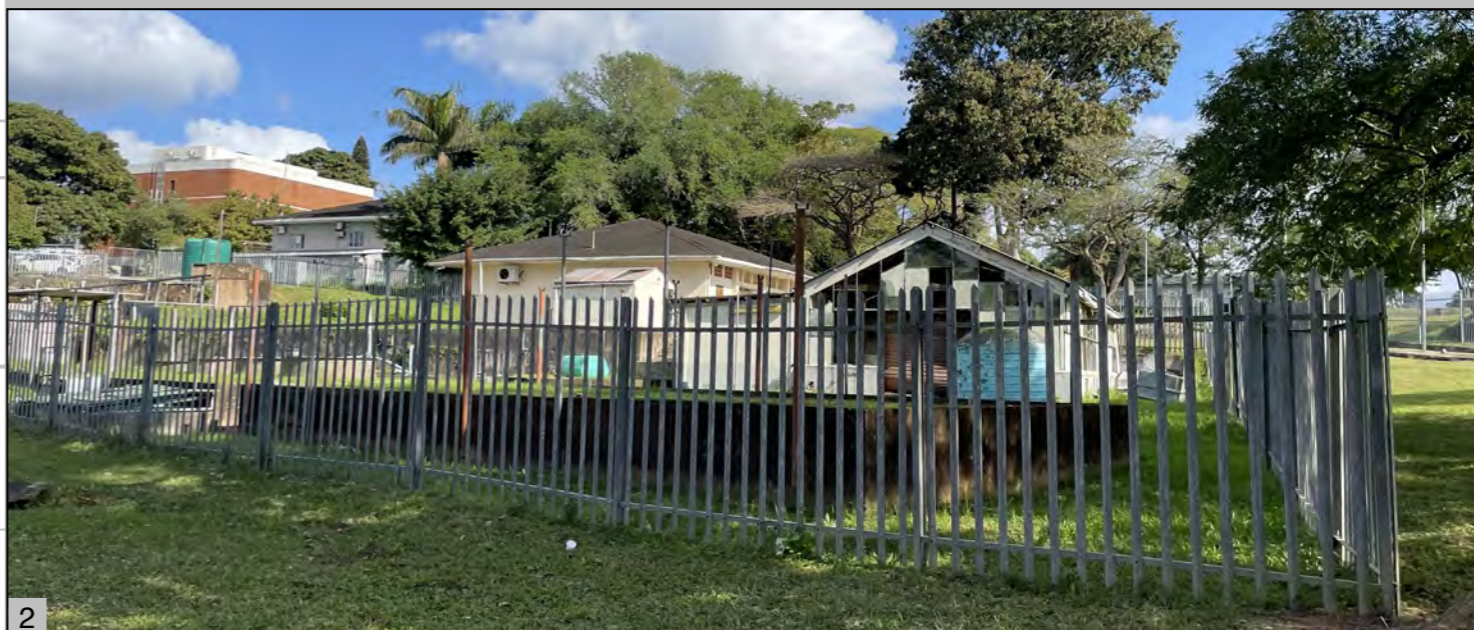
IMAGES: 1 - Agricultural building  
 2 - Outbuilding

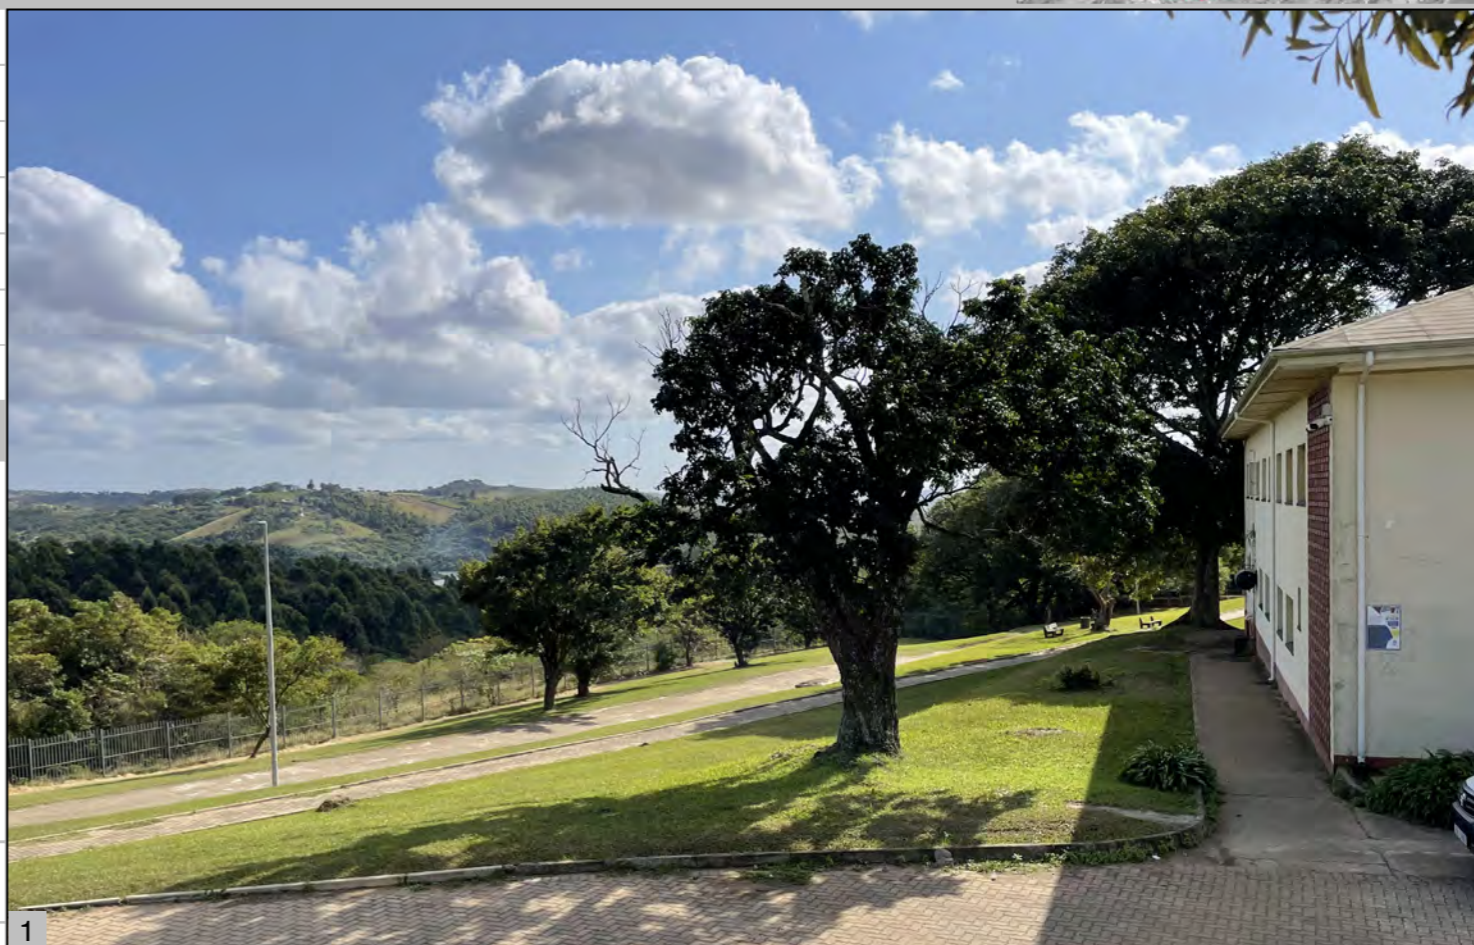
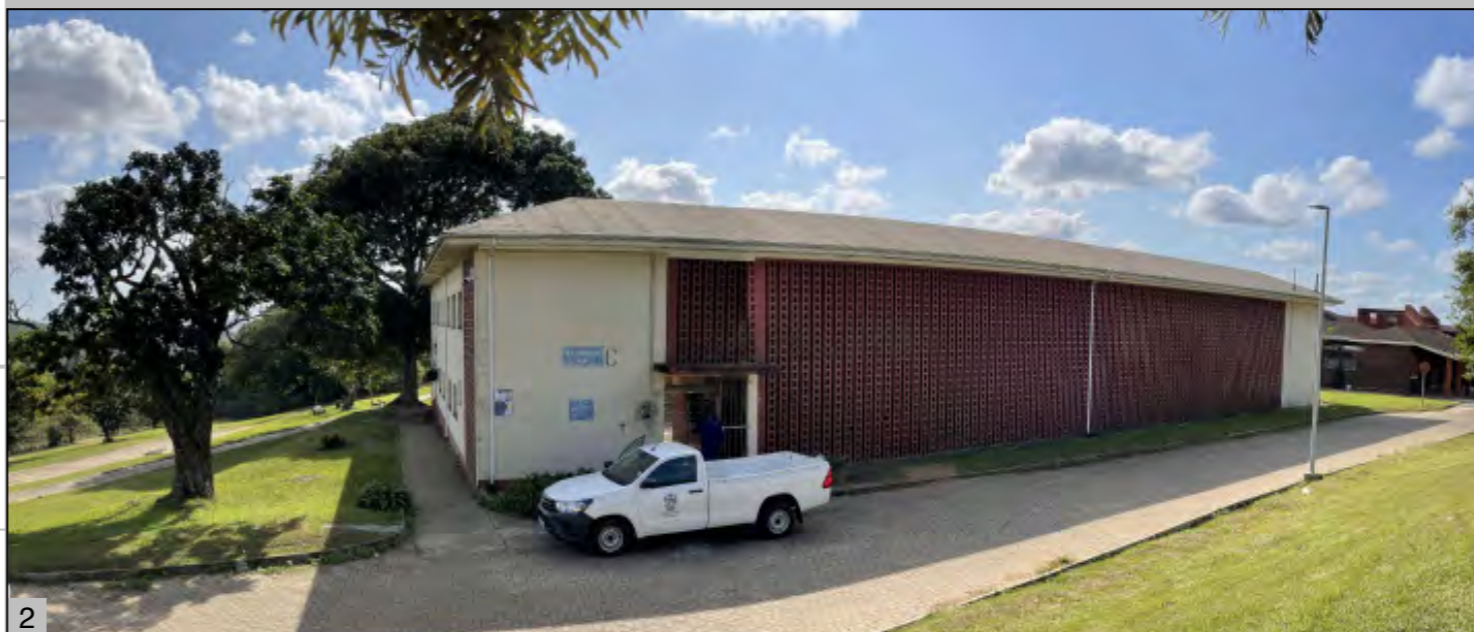
SITE & STRUCTURE DESCRIPTION:	Double and triple storey residential buildings overlooking the valley below. These residences are plastered rectangular buildings with central courtyards and square-patterned briese-soleils. These buildings are located alongside the oldest residential buildings, overlooking the valley below.
PHYSICAL CONDITION:	Good.
STATEMENT OF SIGNIFICANCE:	These buildings are amongst the oldest on the university but hold no inherent significances.
PROPOSED GRADING:	Grade IIIC
OPPORTUNITIES & THREATS:	These buildings have a strong presence along the western edge of the university, overlooking the valley below. These buildings can be replaced but it is important to retain the contextual relationship between the building position and the valley below.
RECOMMENDATION:	The building should be formally listed as Grade IIIC. Trees of stature should be retained.
REFERENCES:

IMAGES: 1 - Residential building with green expanse and mature trees  
 2 - Residential building showing briese-soleil facade

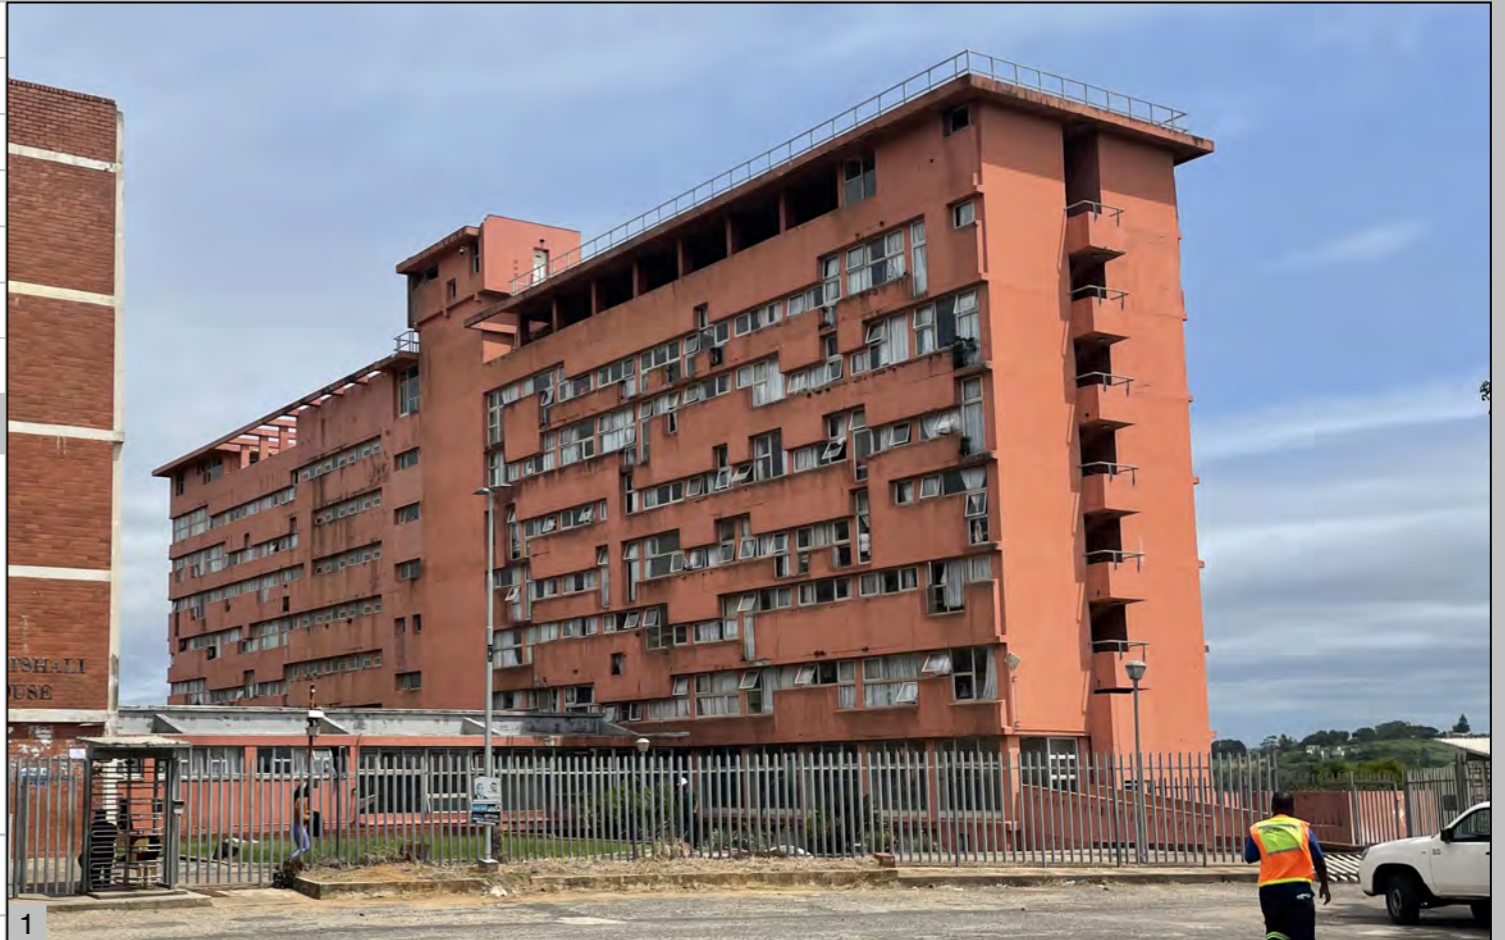
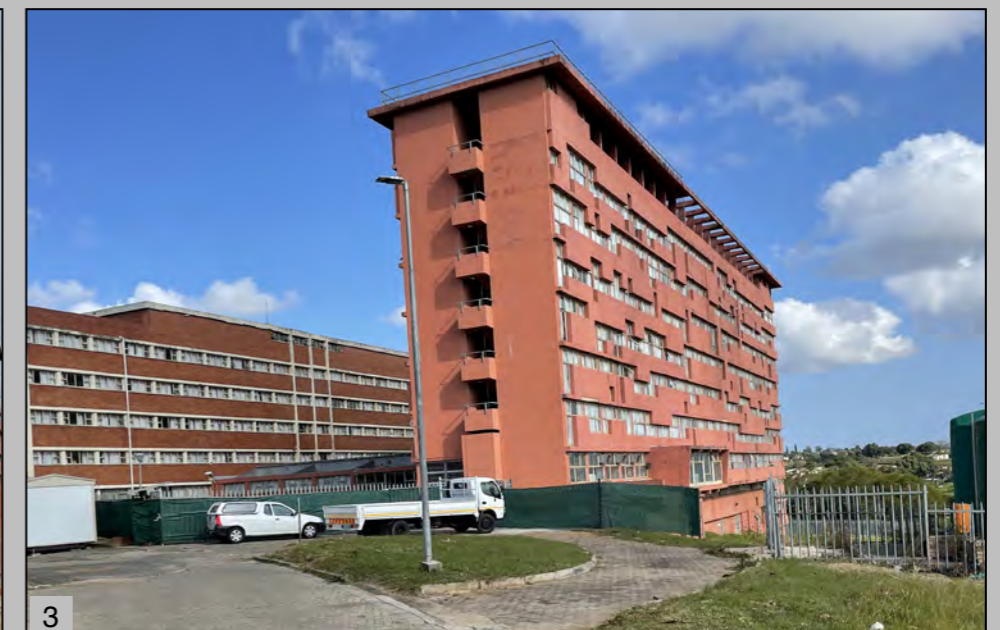
**SITE & STRUCTURE DESCRIPTION:** Ten storey residential block with elaborately patterned windows on northern and southern facades. This building, like those constructed prior to it, has overhanging eaves and a brightly painted plastered exterior. This building is located at the extreme western end of the university campus.

**PHYSICAL CONDITION:** Medium.

IMAGES: 1 - Southern facade  
 2 - Western facade  
 3 - Northern facade

**RECOMMENDATION:** Despite being older than 60, this building shows little heritage value and should therefore be graded as Not Conservation Worthy.

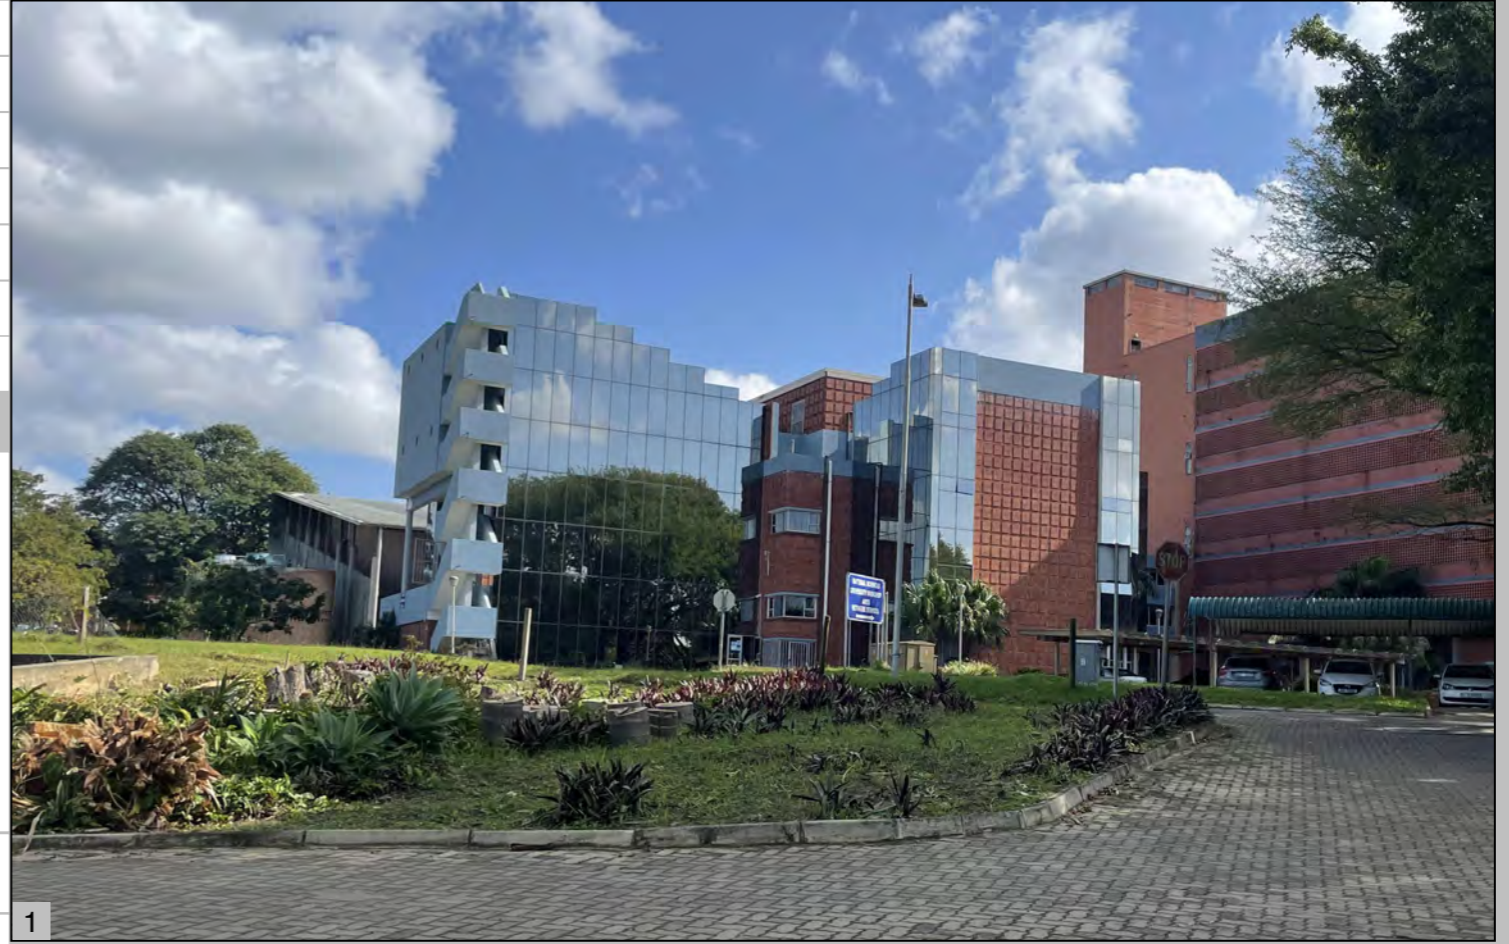
SITE & STRUCTURE DESCRIPTION:	Glass, exposed brick and plastered brick building along southern university road. The building has a Cross-shaped building plan.
-------------------------------	--

PHYSICAL CONDITION:	Good.
---------------------	-------

IMAGES: 1 - Western facade  
2 - Northern side of building, with pedestrian avenue located between Arts Lecture Halls and Arts Block  
3 & 4 - Southern facade along the southern avenue

RECOMMENDATION:	The building is not older than 60, and should be graded Not Conservation Worthy.
-----------------	--

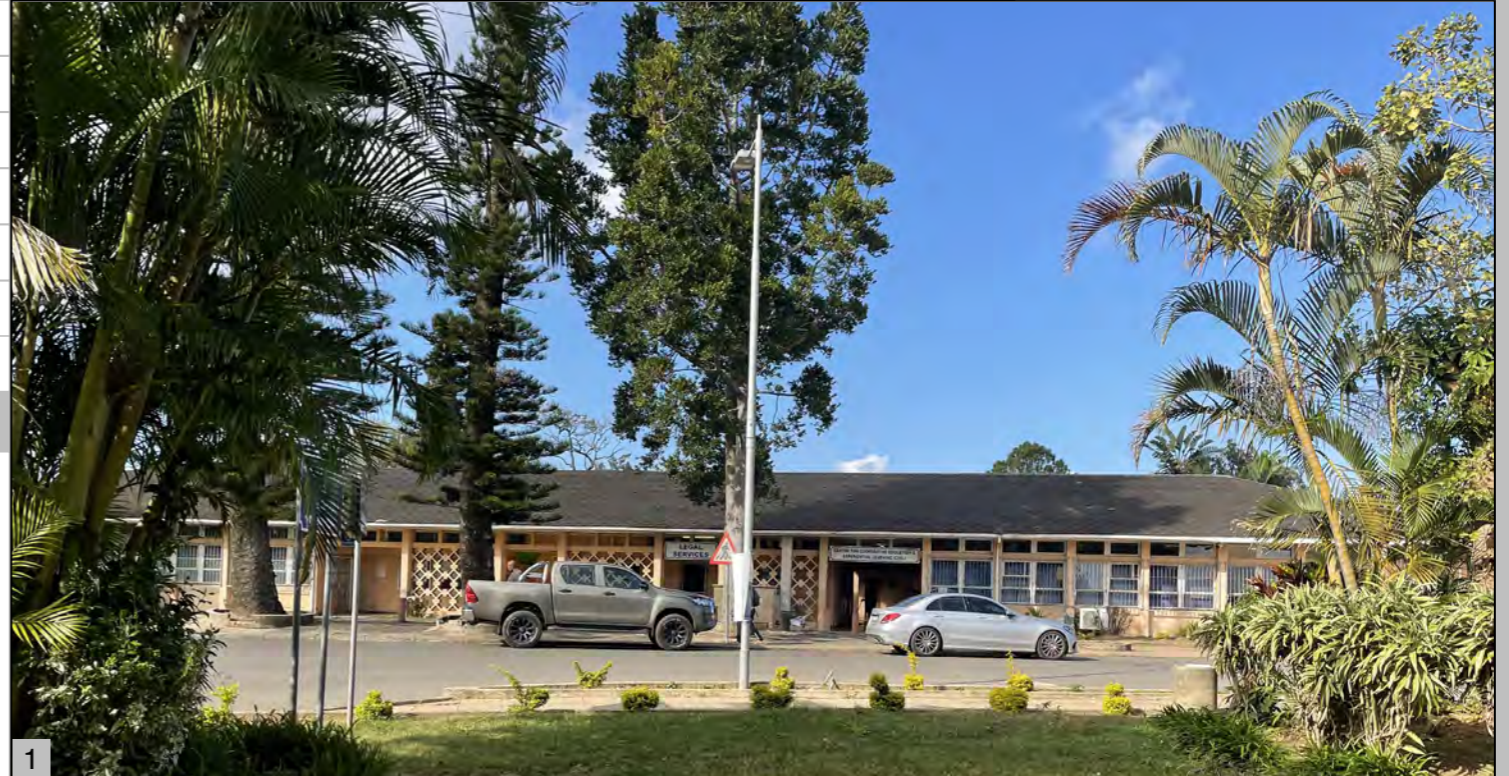
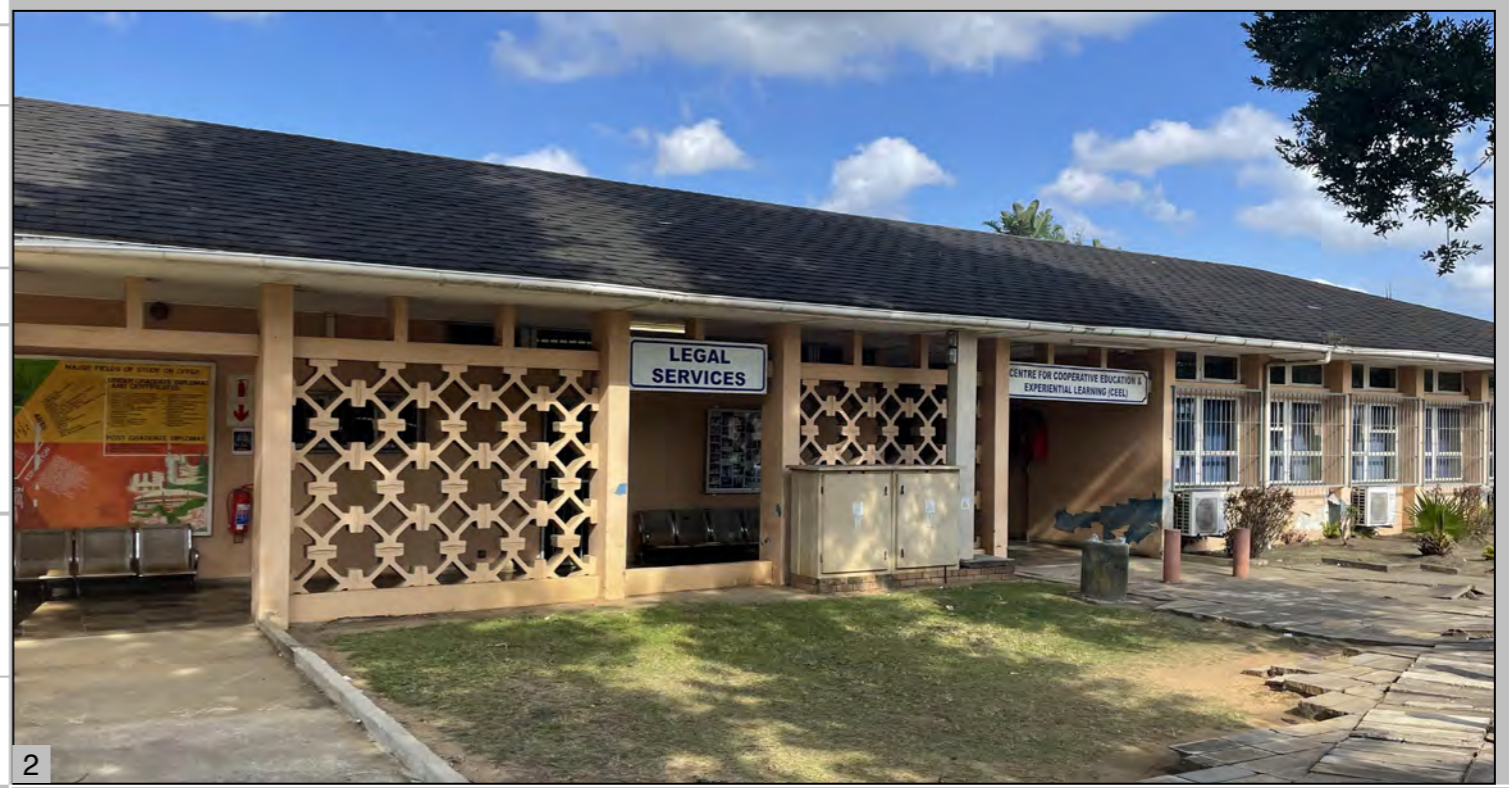
**PHYSICAL CONDITION:** Good.

IMAGES: 1 - Facade facing the university avenue  
 2 - Detail of facade, showing the brise-soleil

**RECOMMENDATION:** The building should be formally listed as Grade IIIIC. Trees of stature along academic avenue should be retained.

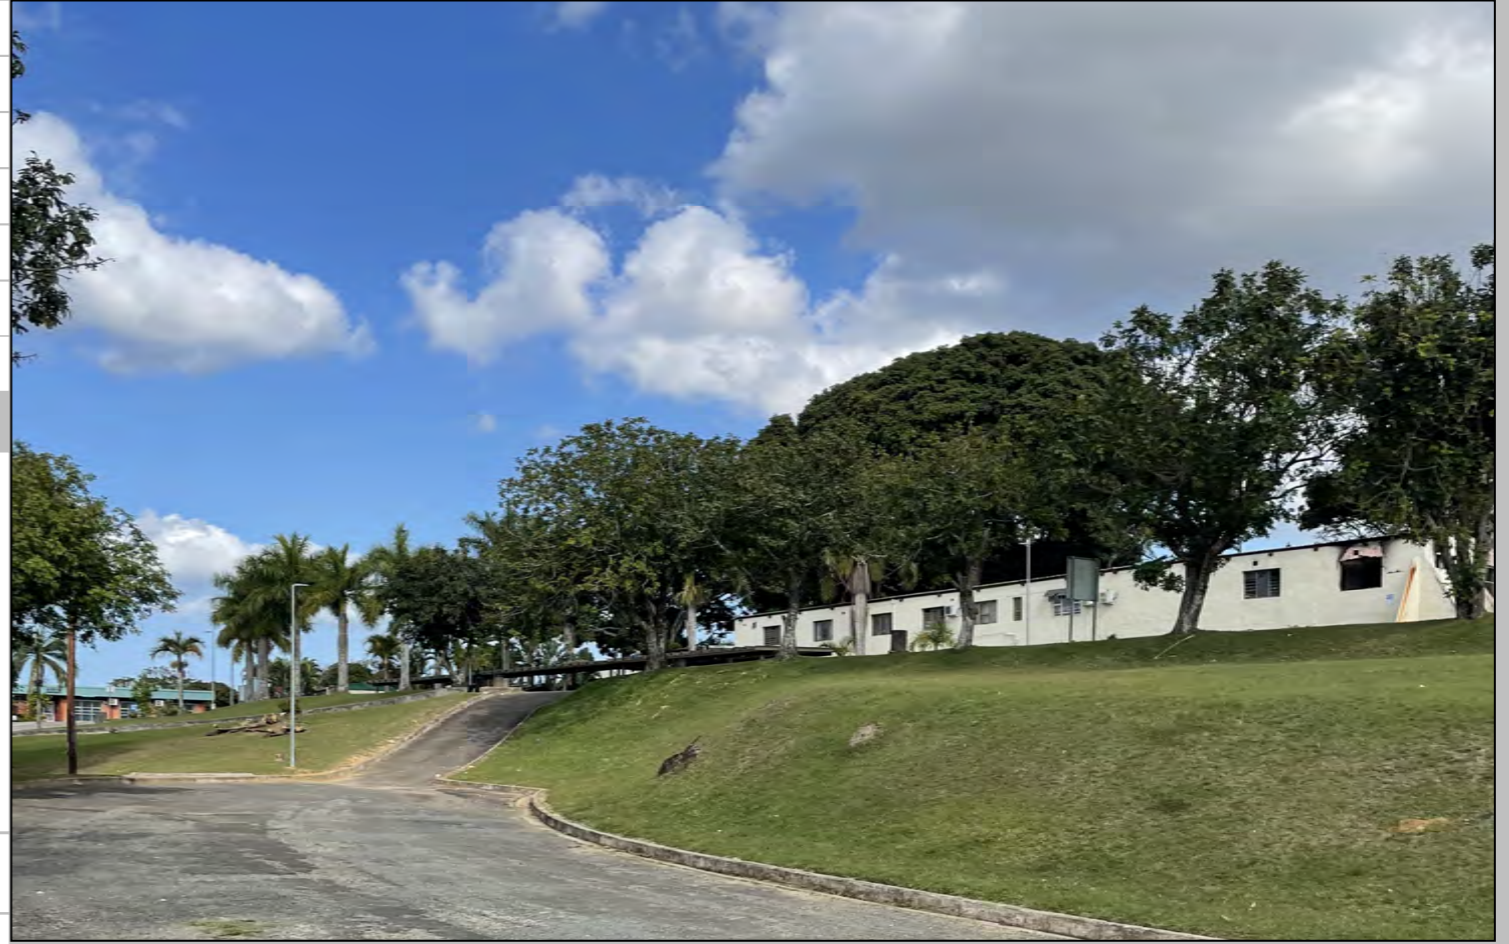
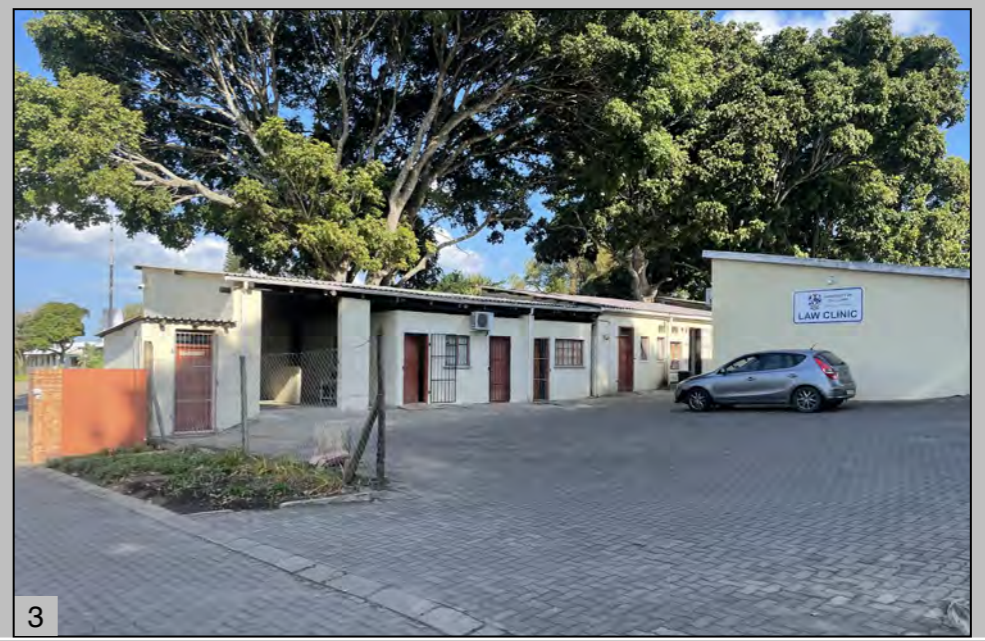
SITE & STRUCTURE DESCRIPTION:	A series of single storey plastered building clusters located close to the university entrance.
PHYSICAL CONDITION:	Medium.
STATEMENT OF SIGNIFICANCE:	N/A
PROPOSED GRADING:	Not Conservation Worthy
OPPORTUNITIES & THREATS:	
RECOMMENDATION:	Despite being older than 60, these buildings show little heritage value and should therefore be graded as Not Conservation Worthy.
REFERENCES:

IMAGES: 1 - Front building, as seen from road next to King Bekhuzulu Hall  
 2 - Oldest portion of open store on left of image, with Law Clinic Buildings on the right  
 3 - Facilities Management Offices

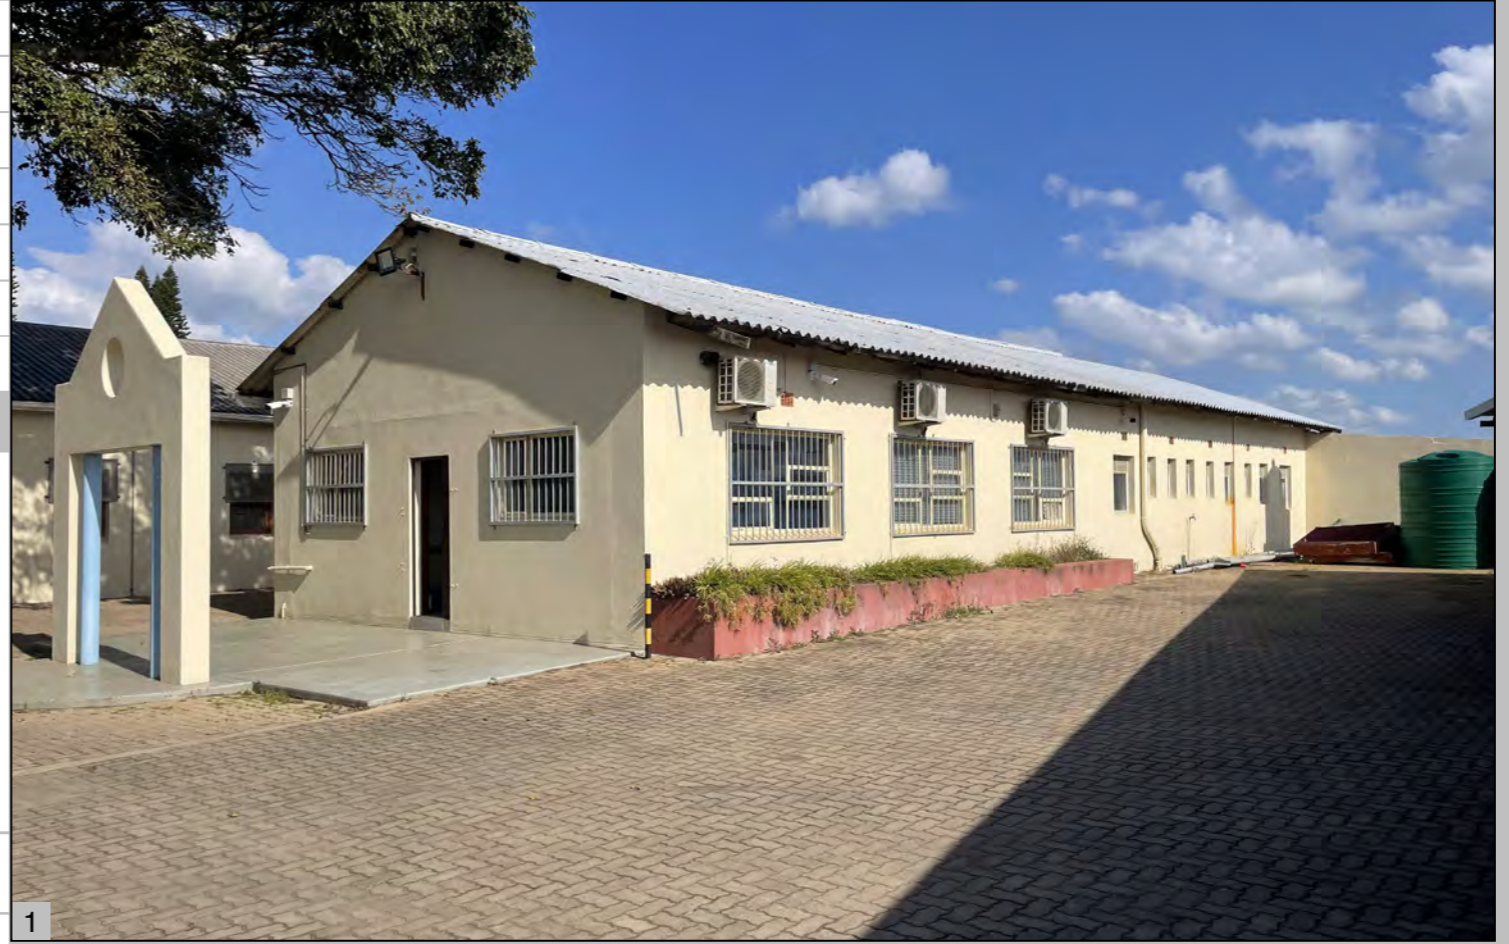
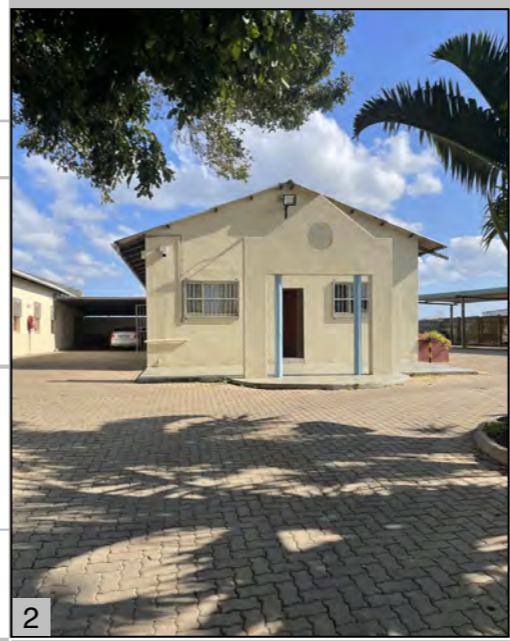
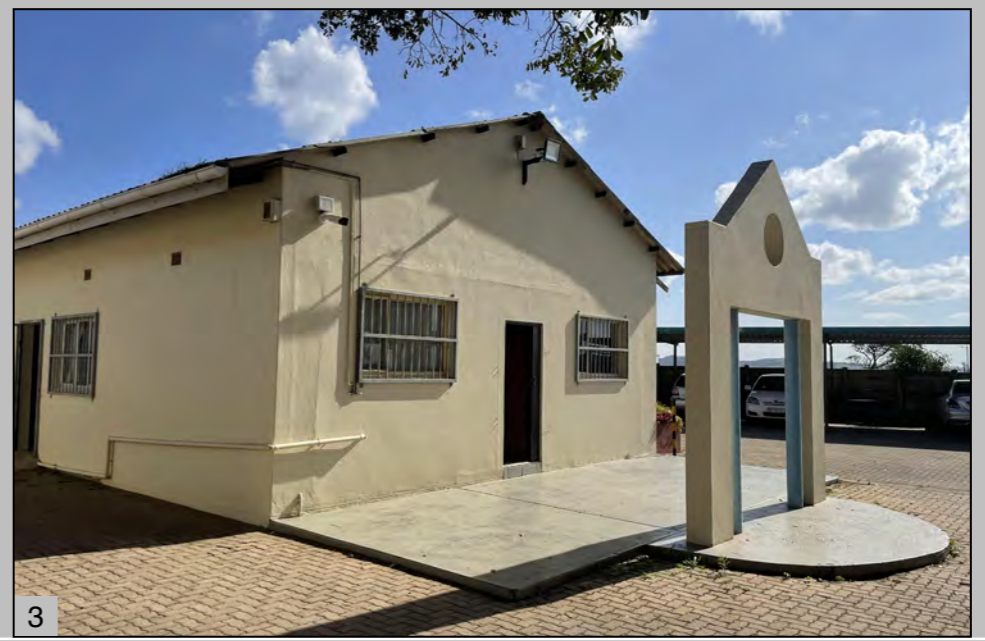
IMAGES: 1 - Northern Facade  
 2 - Western Facade  
 3 - Southern Facade
