**UNIVERSITY OF ZULULAND**

BUILDING/S:	Tourism and Recreation, B-Lab
ARCHITECT/S:	Piet Van den Berg
DATE:	c.1960
CURRENT USE:	Academic buildings

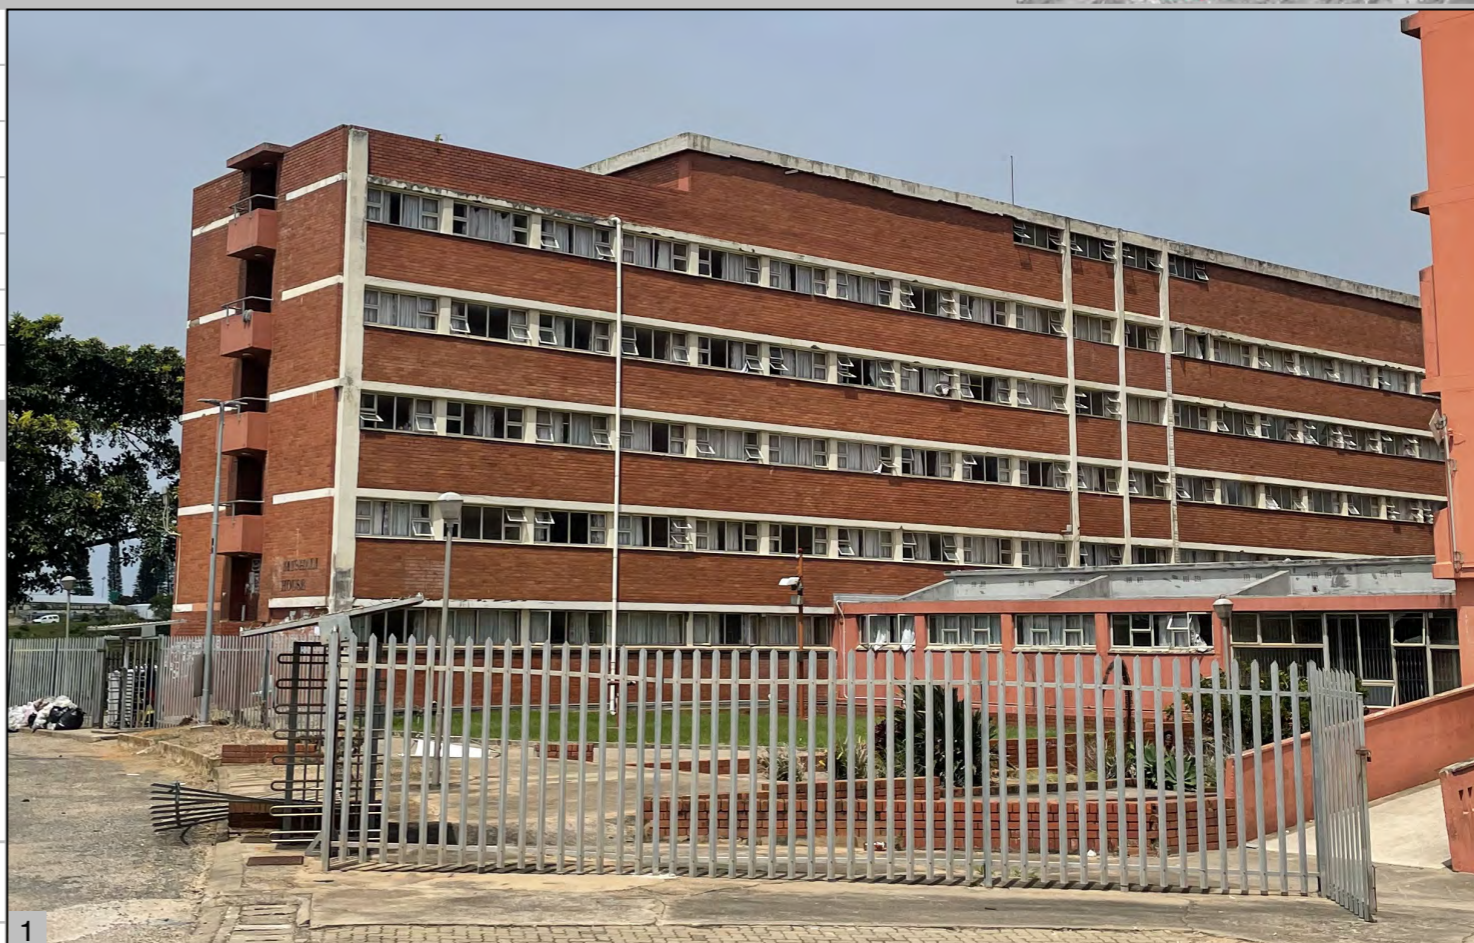
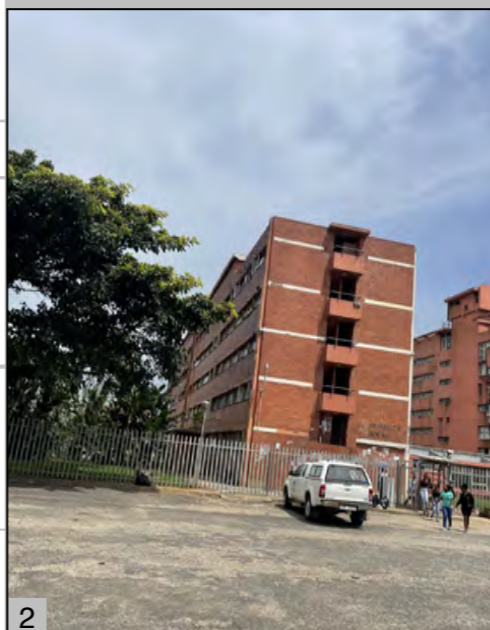
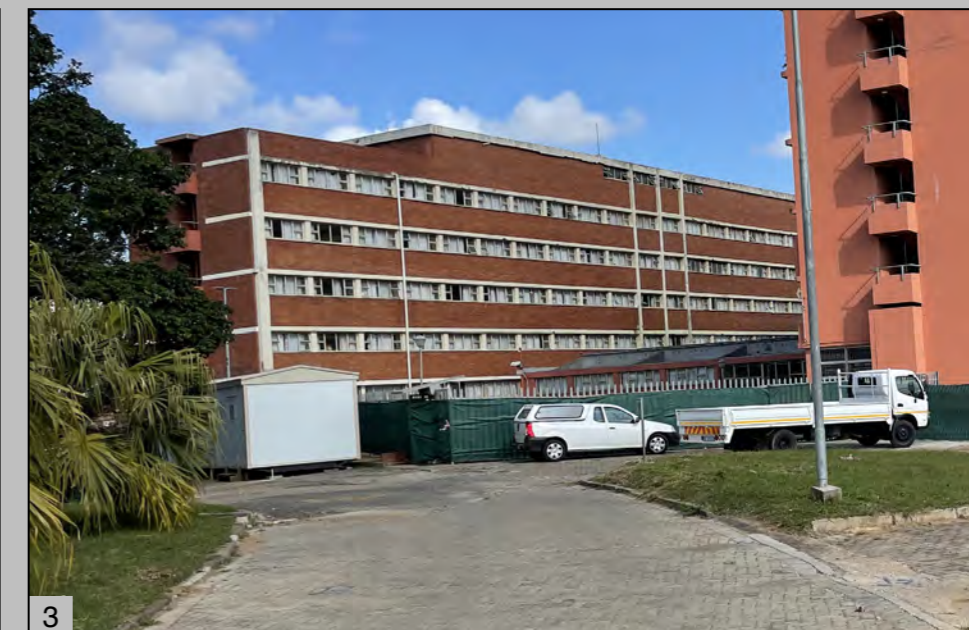
IMAGES: 1 - Northern Facade of main building, with single storey link  
 2 - Western Facade, with balconies  
 3 - Northern Facade

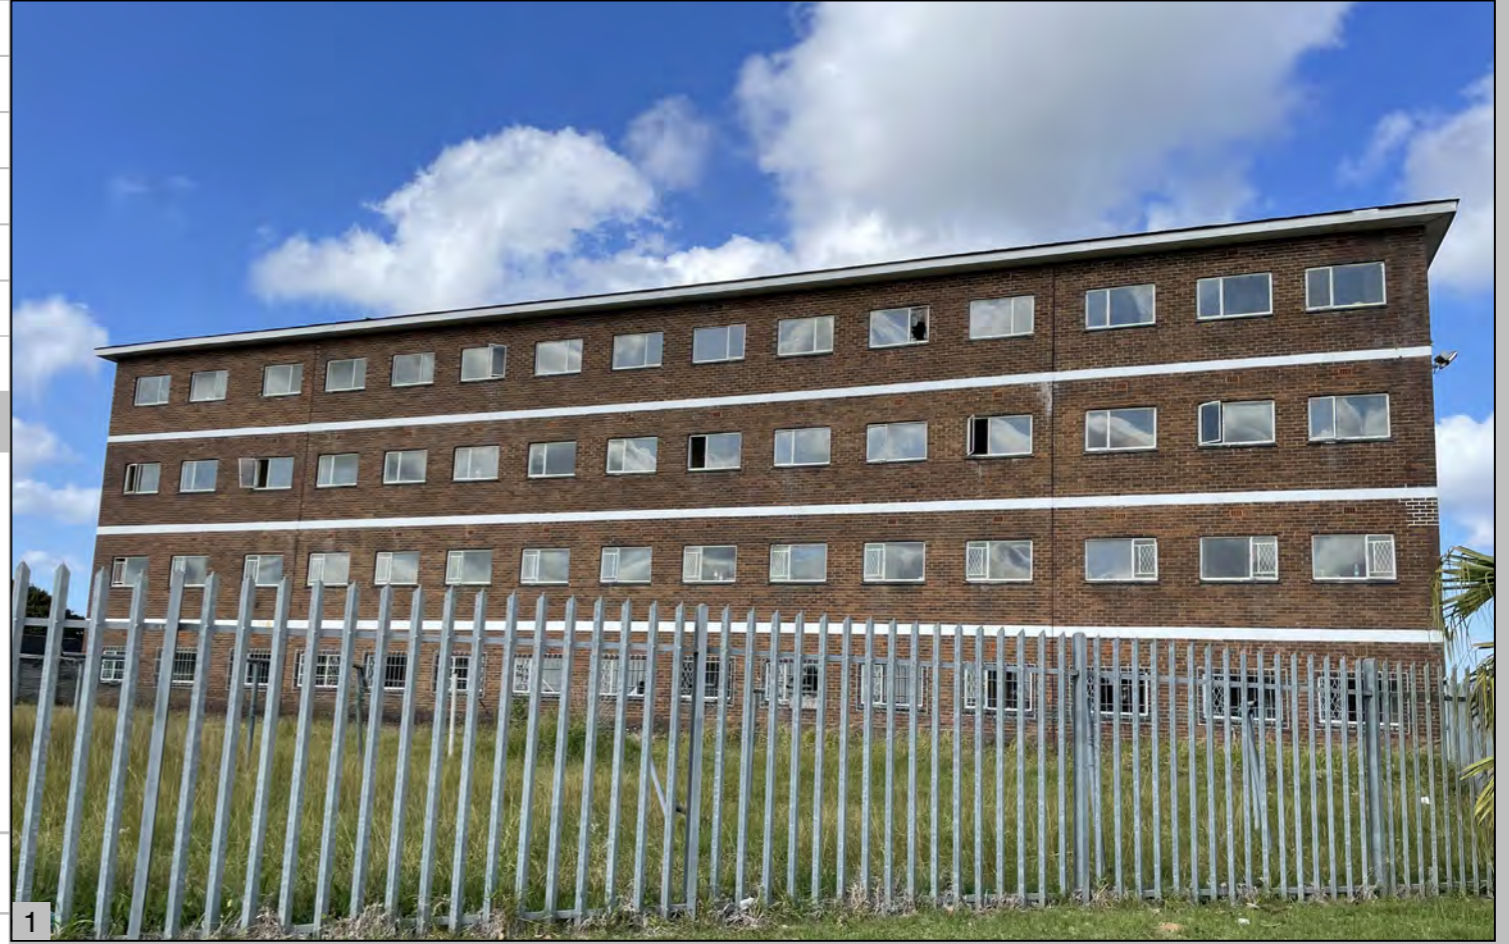
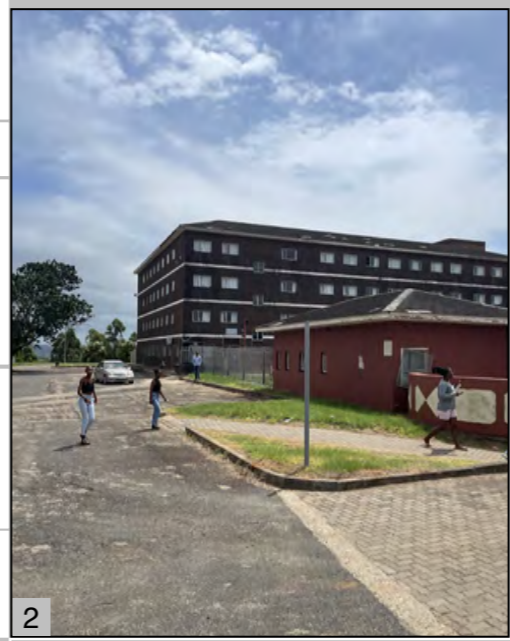
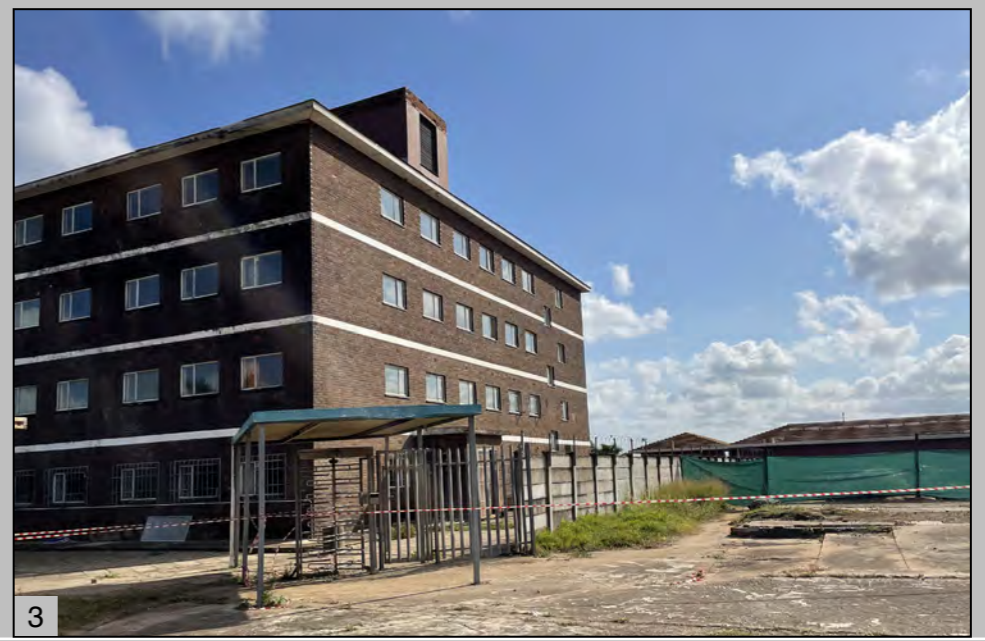
SITE & STRUCTURE DESCRIPTION:	Four storey exposed dark brick building, with central courtyard. Located alongside older western residences.
PHYSICAL CONDITION:	Good.
STATEMENT OF SIGNIFICANCE:	N/A.
PROPOSED GRADING:	Not Conservation Worthy
OPPORTUNITIES & THREATS:	
RECOMMENDATION:	These buildings are Not Conservation Worthy.
REFERENCES:

IMAGES: 1 - Northern Facade  
 2 - Eastern and Southern Facade  
 3 - Southern and Western Facade

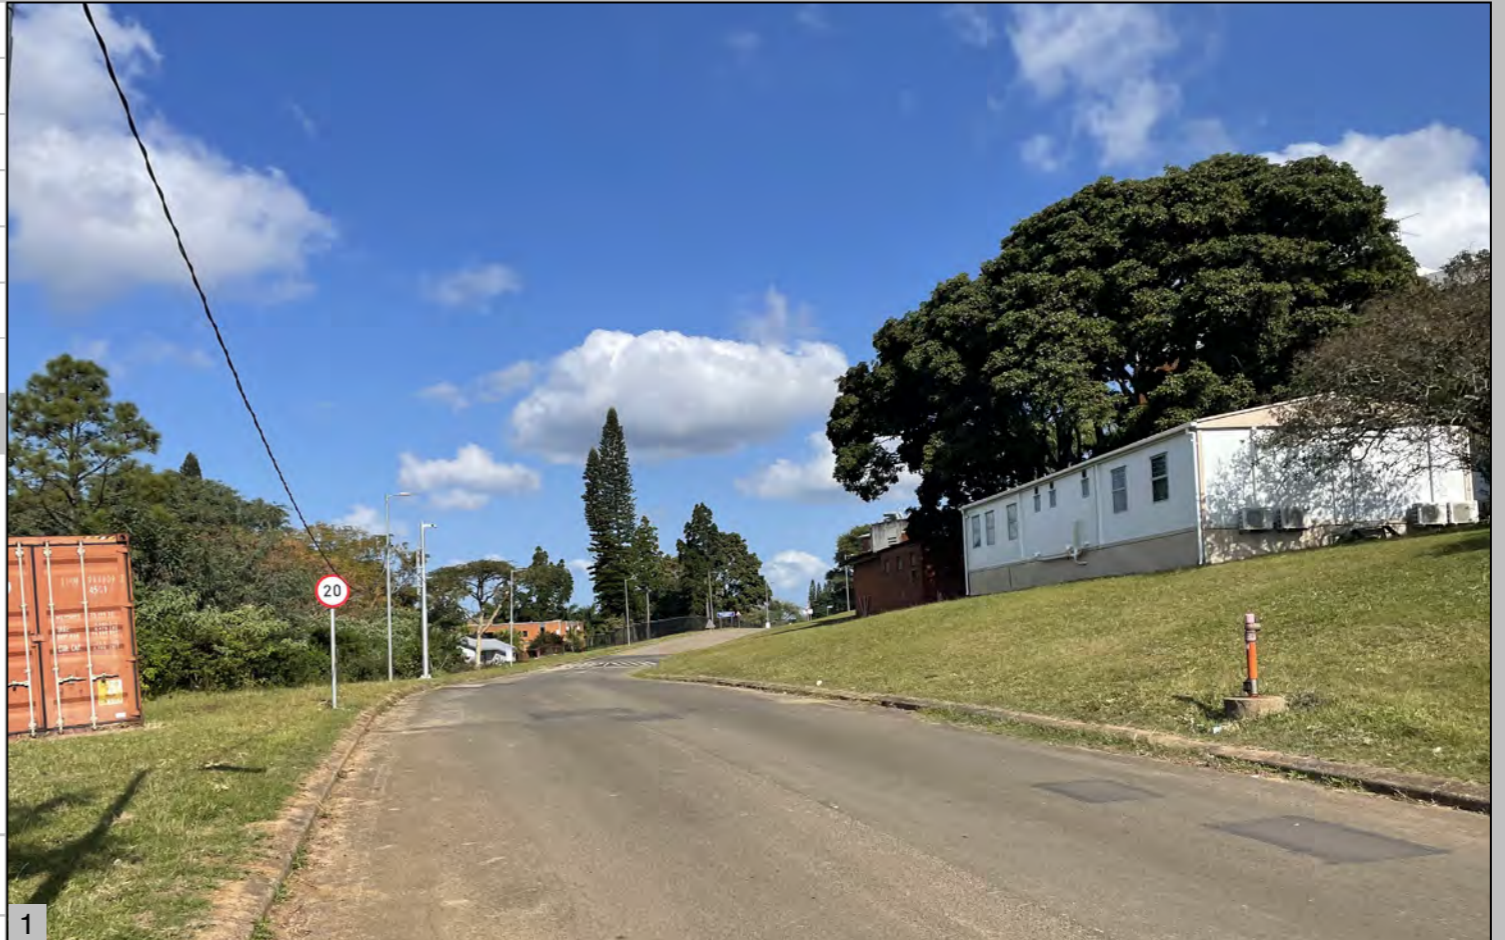
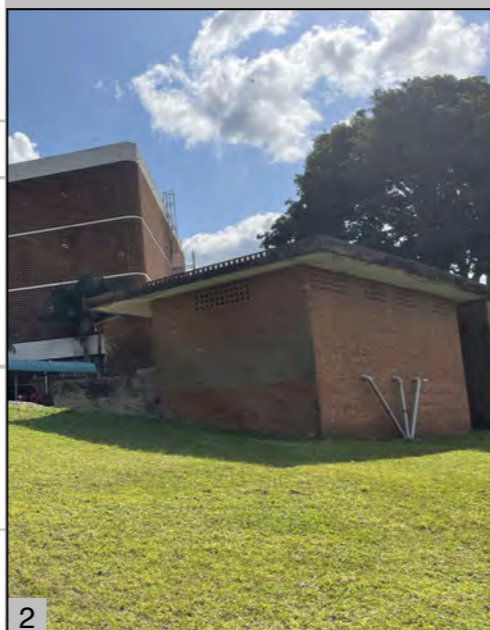
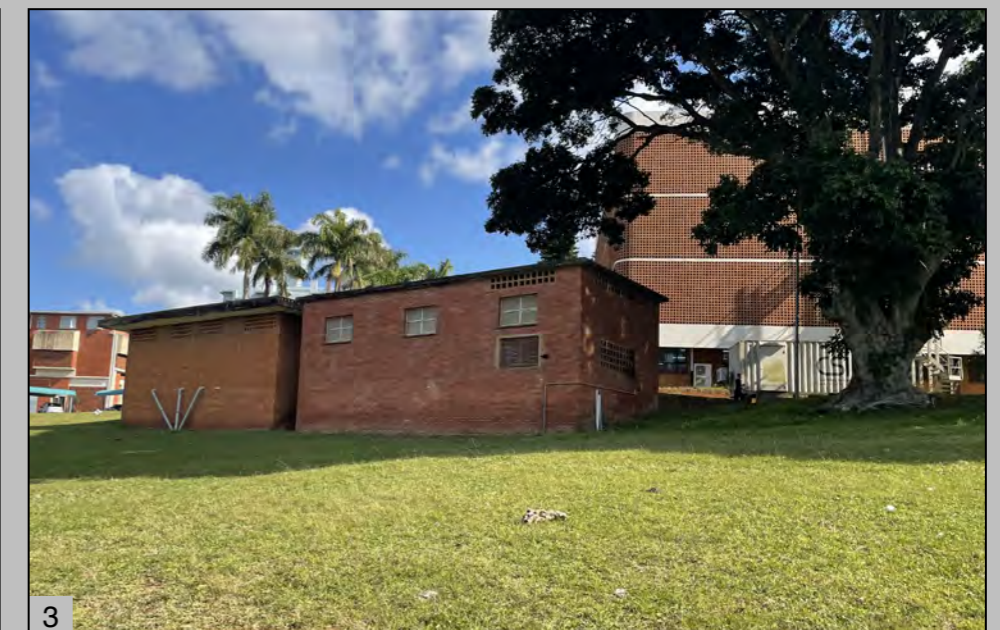
SITE & STRUCTURE DESCRIPTION:	Exposed brick buildings with overhanging eaves and temporary building along southern end of looping university road.
PHYSICAL CONDITION:	Good.
STATEMENT OF SIGNIFICANCE:	N/A.
PROPOSED GRADING:	Not Conservation Worthy
OPPORTUNITIES & THREATS:	
RECOMMENDATION:	These buildings are Not Conservation Worthy.
REFERENCES:

IMAGES: 1 - View of buildings to the right of image  
 2 - Building 1, with overhanging eaves and perforated brick.  
 3 - Building 1

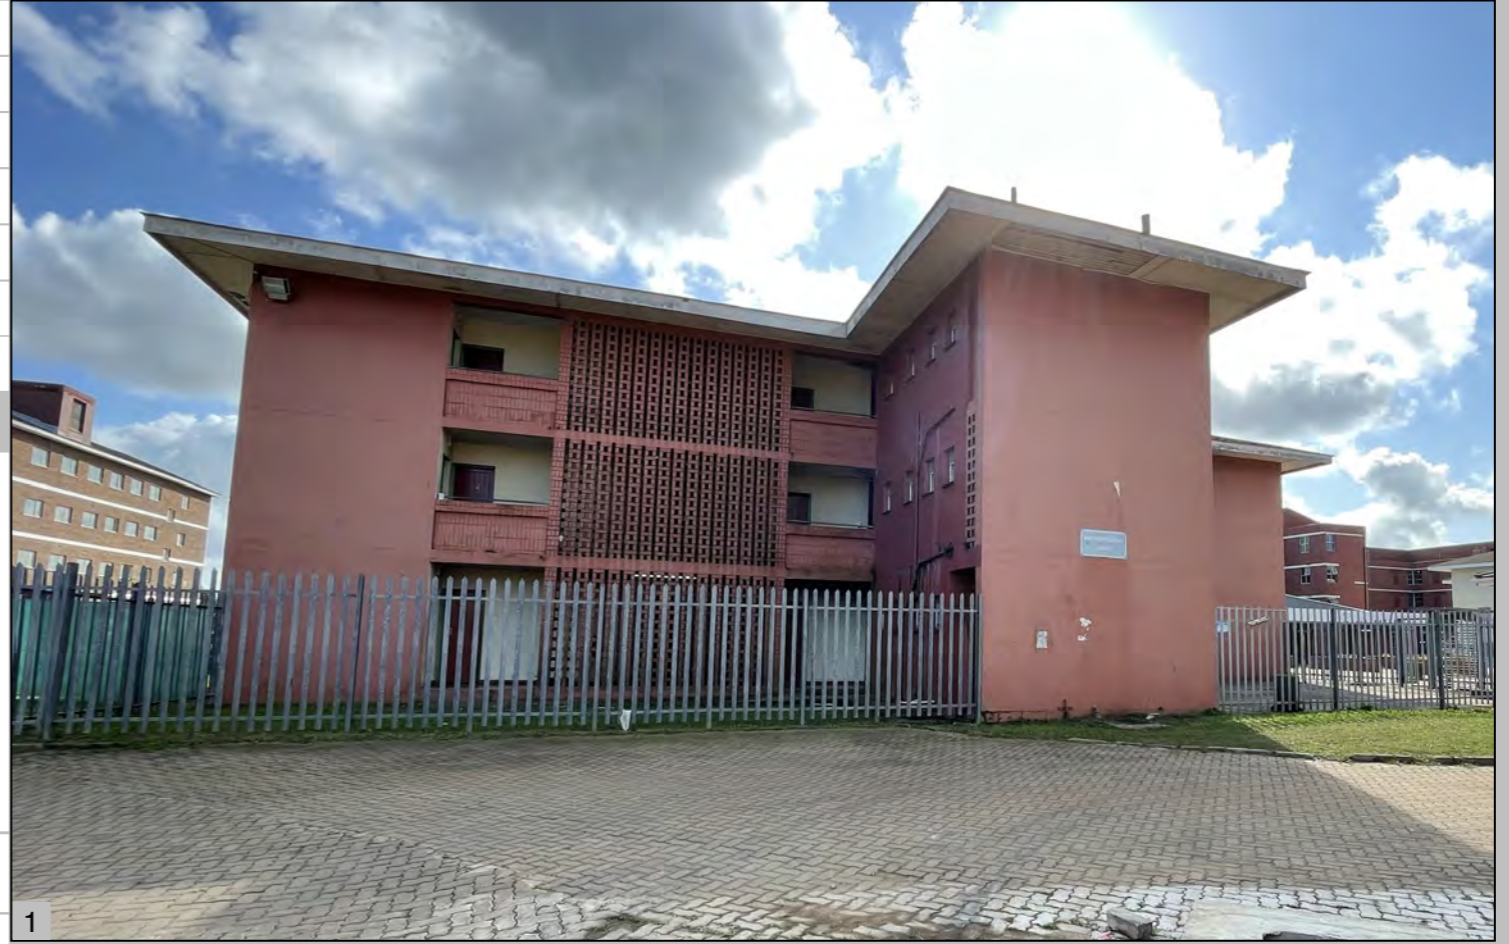
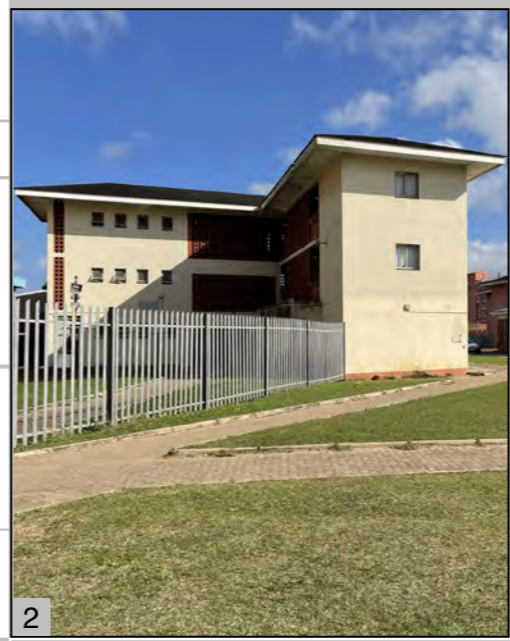
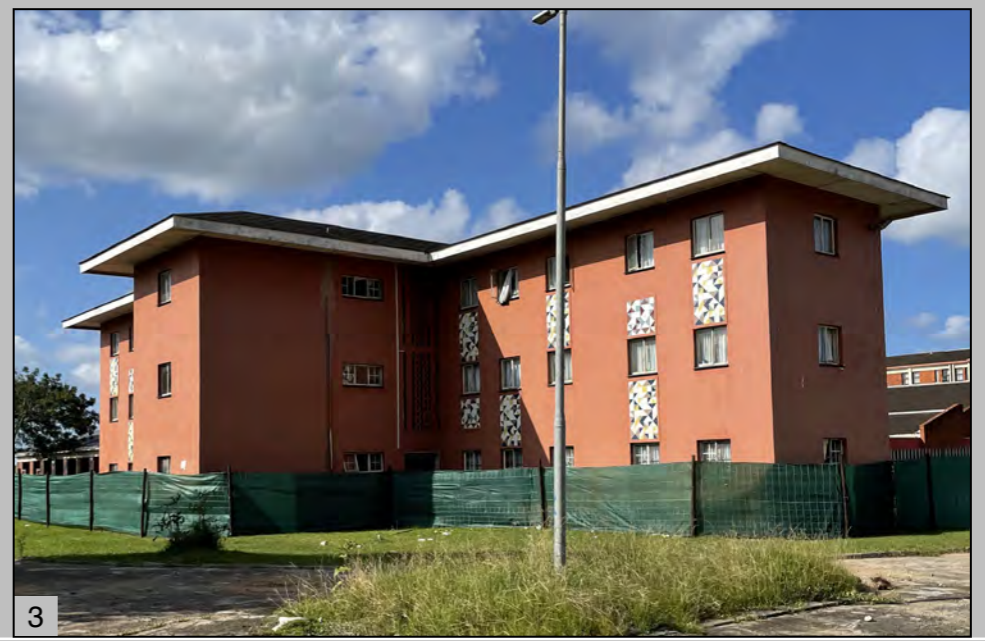
SITE & STRUCTURE DESCRIPTION:	Triple storey residential buildings located on western end of campus. These residences are plastered wing shaped buildings with overhanging eaves, square-patterned briese-soleils and patterned tiling.
PHYSICAL CONDITION:	Good.
STATEMENT OF SIGNIFICANCE:	These buildings are amongst the oldest on the university but hold no inherent significances.
PROPOSED GRADING:	Not Conservation Worthy
OPPORTUNITIES & THREATS:	
RECOMMENDATION:	These buildings are Not Conservation Worthy.
REFERENCES:

IMAGES: 1 - Southern facade of Khethomthandayo House  
 2 - Western facade of other residential building  
 3 - Northern facade of Khethomthandayo House

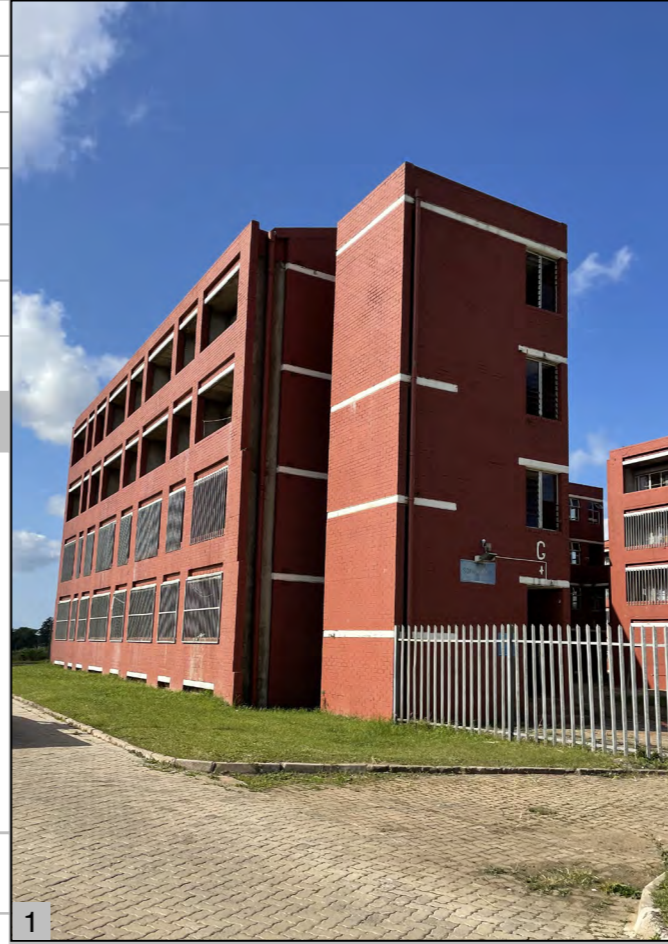
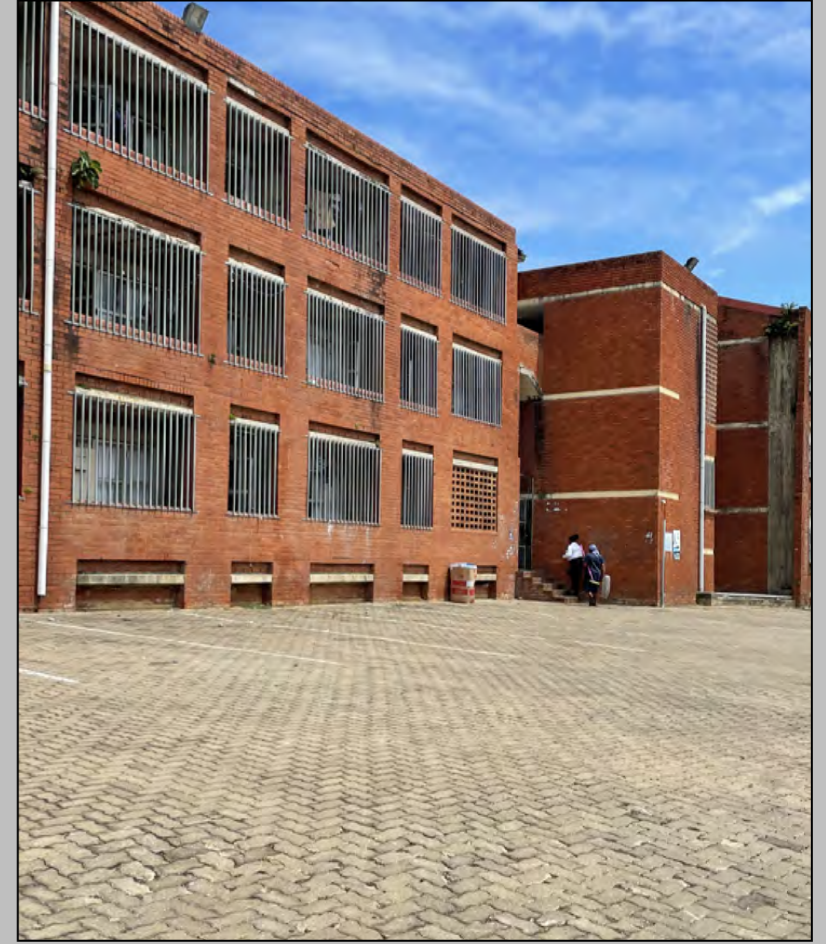
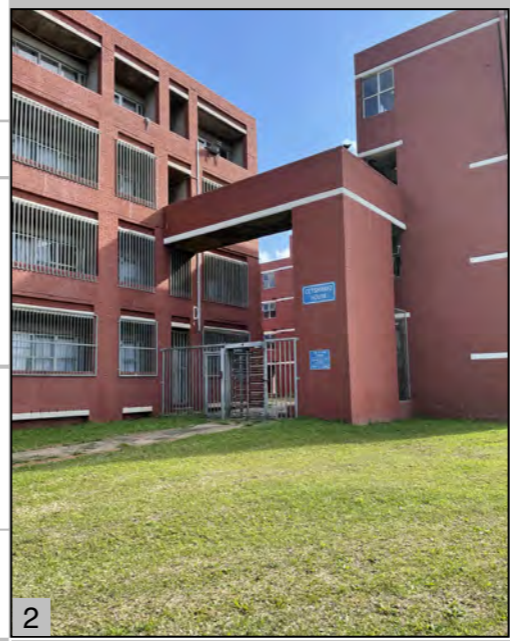
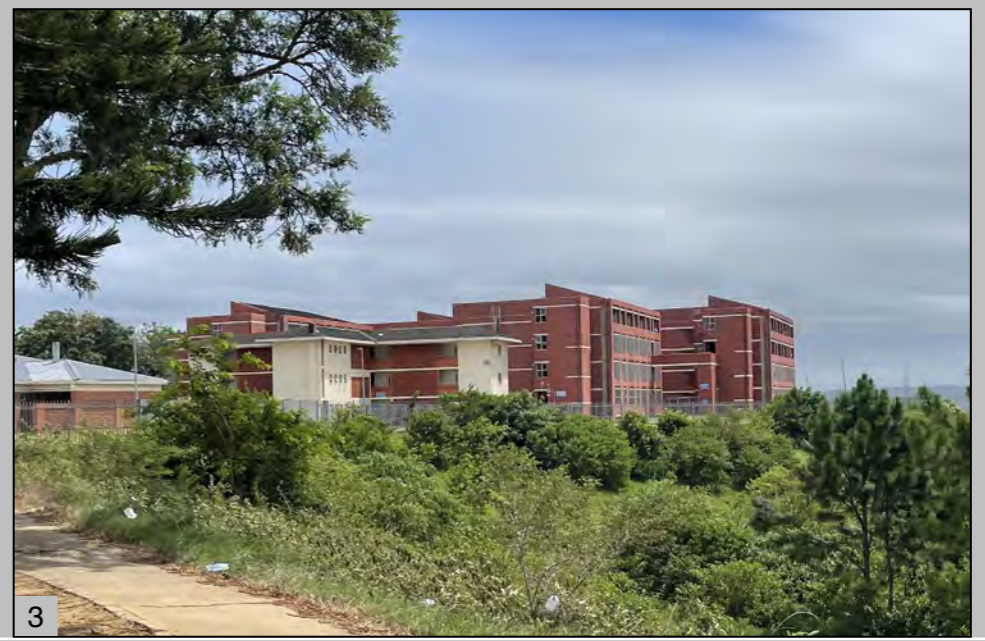
IMAGES: 1 - Block C Northern Facade  
 2 & 3 - Block D Southern Facade  
 3 - Southern view towards residences

SITE & STRUCTURE DESCRIPTION:	Triple and four storey residential exposed brick buildings, with large fenced openings facing onto the valley on either side.
PHYSICAL CONDITION:	Good.
STATEMENT OF SIGNIFICANCE:	N/A
PROPOSED GRADING:	Not Conservation Worthy
OPPORTUNITIES & THREATS:	
RECOMMENDATION:	These buildings are Not Conservation Worthy.
REFERENCES:

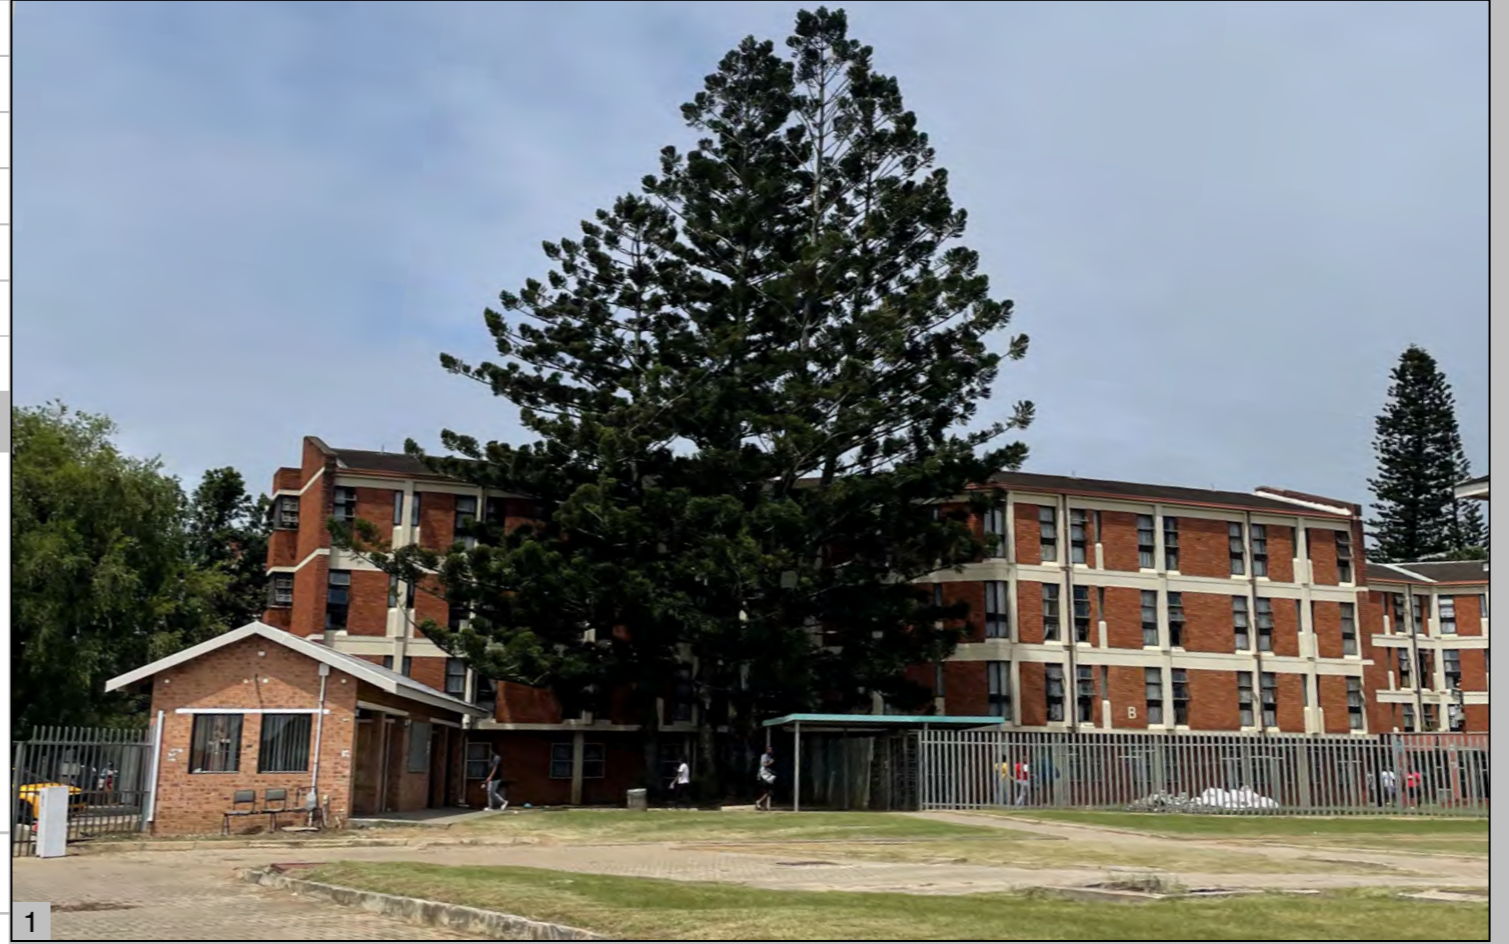
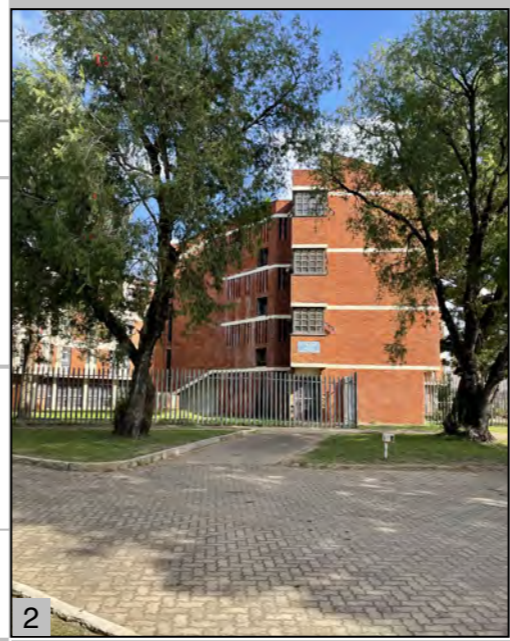
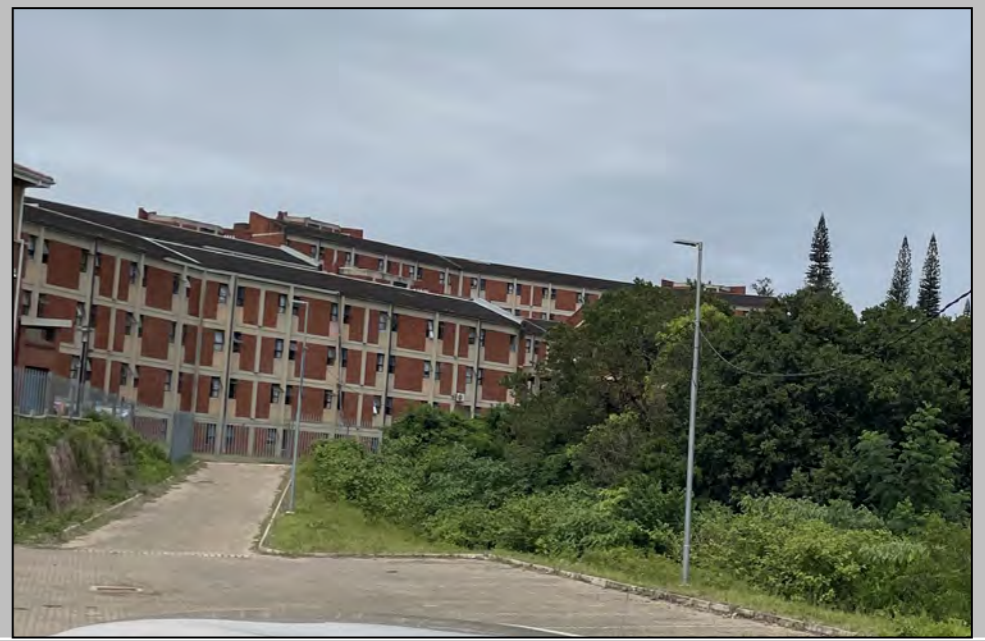
IMAGES: 1 - Northern facade of Ruth First House on Western Residence side  
 2 - Eastern facade of Ruth First House on Western Residence side  
 3 - Northern facades of residences on Eastern Residence side

SITE & STRUCTURE DESCRIPTION:	Four storey residential buildings overlooking the valley below. These residences are exposed brick buildings, with plastered detailing.
PHYSICAL CONDITION:	Good.
STATEMENT OF SIGNIFICANCE:	N/A
PROPOSED GRADING:	Not Conservation Worthy
OPPORTUNITIES & THREATS:	
RECOMMENDATION:	These buildings are Not Conservation Worthy.
REFERENCES:

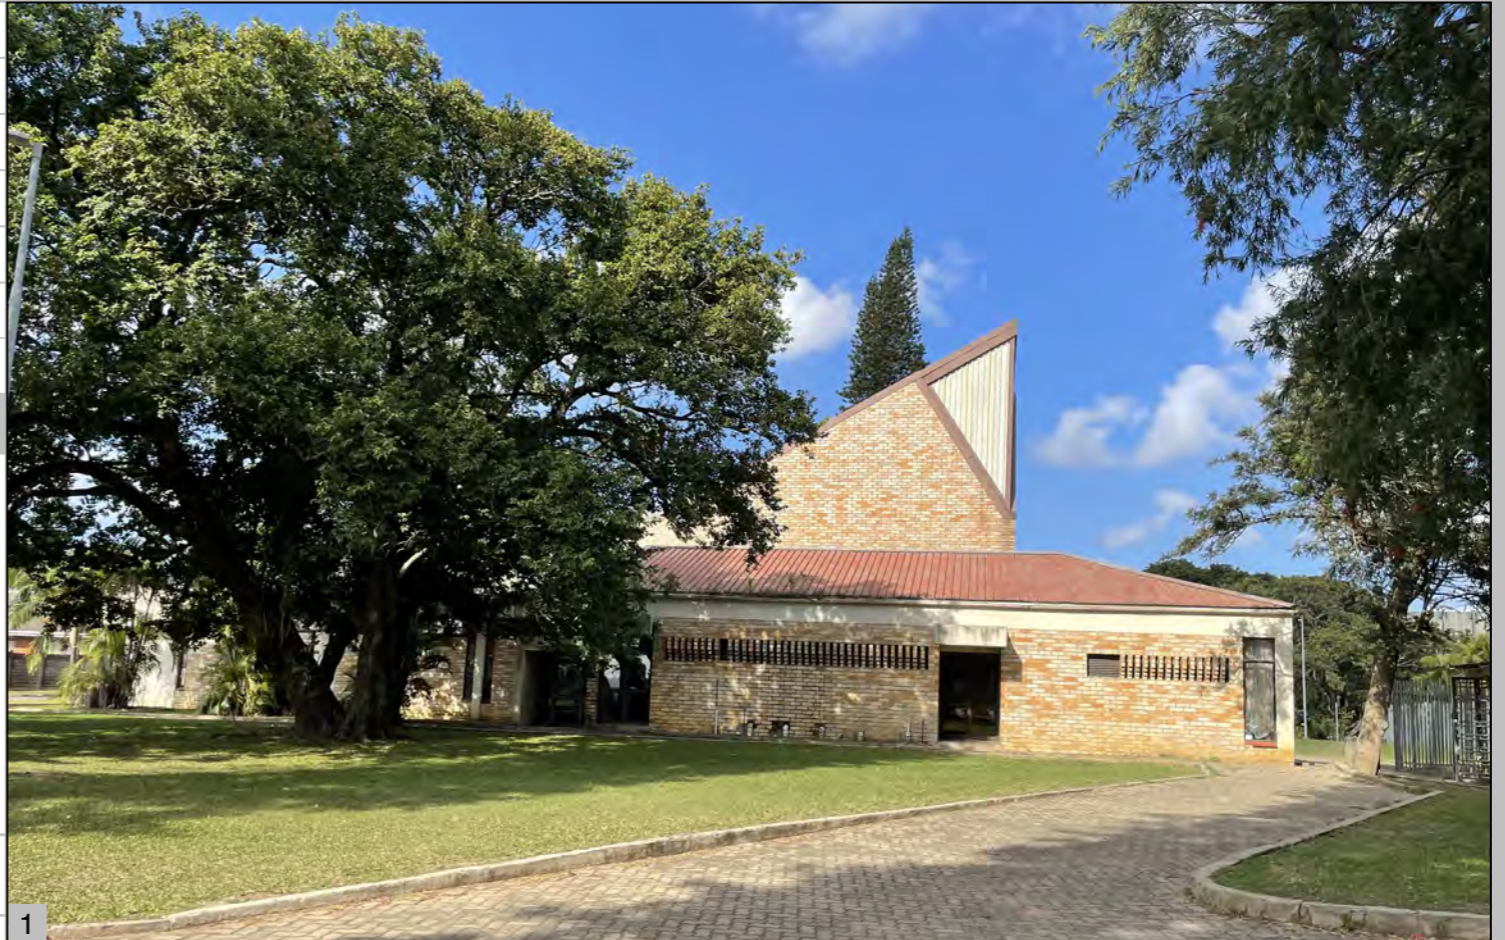
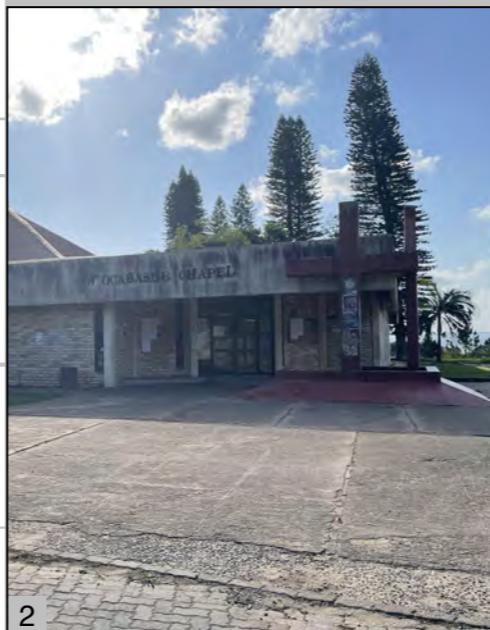
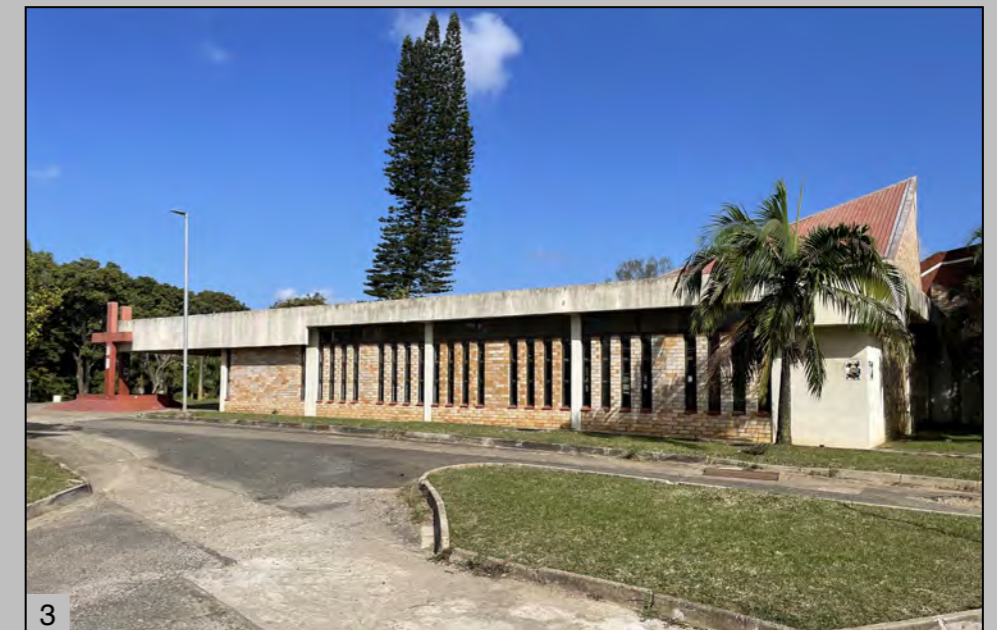
IMAGES: 1 - Northern facade  
2 - Southern facade  
3 - Eastern facade

SITE & STRUCTURE DESCRIPTION:	Single-storey exposed brick chapel, with exposed concrete beam detail and narrow window openings.
PHYSICAL CONDITION:	Good.
STATEMENT OF SIGNIFICANCE:	This is the only chapel located on campus, and a good examples of Regionalist architecture.
PROPOSED GRADING:	Grade IIIB
OPPORTUNITIES & THREATS:	Alterations to the structure should be controlled by the heritage guidelines. The building has a strong architectural presence.
RECOMMENDATION:	Despite not being older than 60, this building should be formally listed as Grade IIIB. Trees of stature surrounding this building should be retained.
REFERENCES:

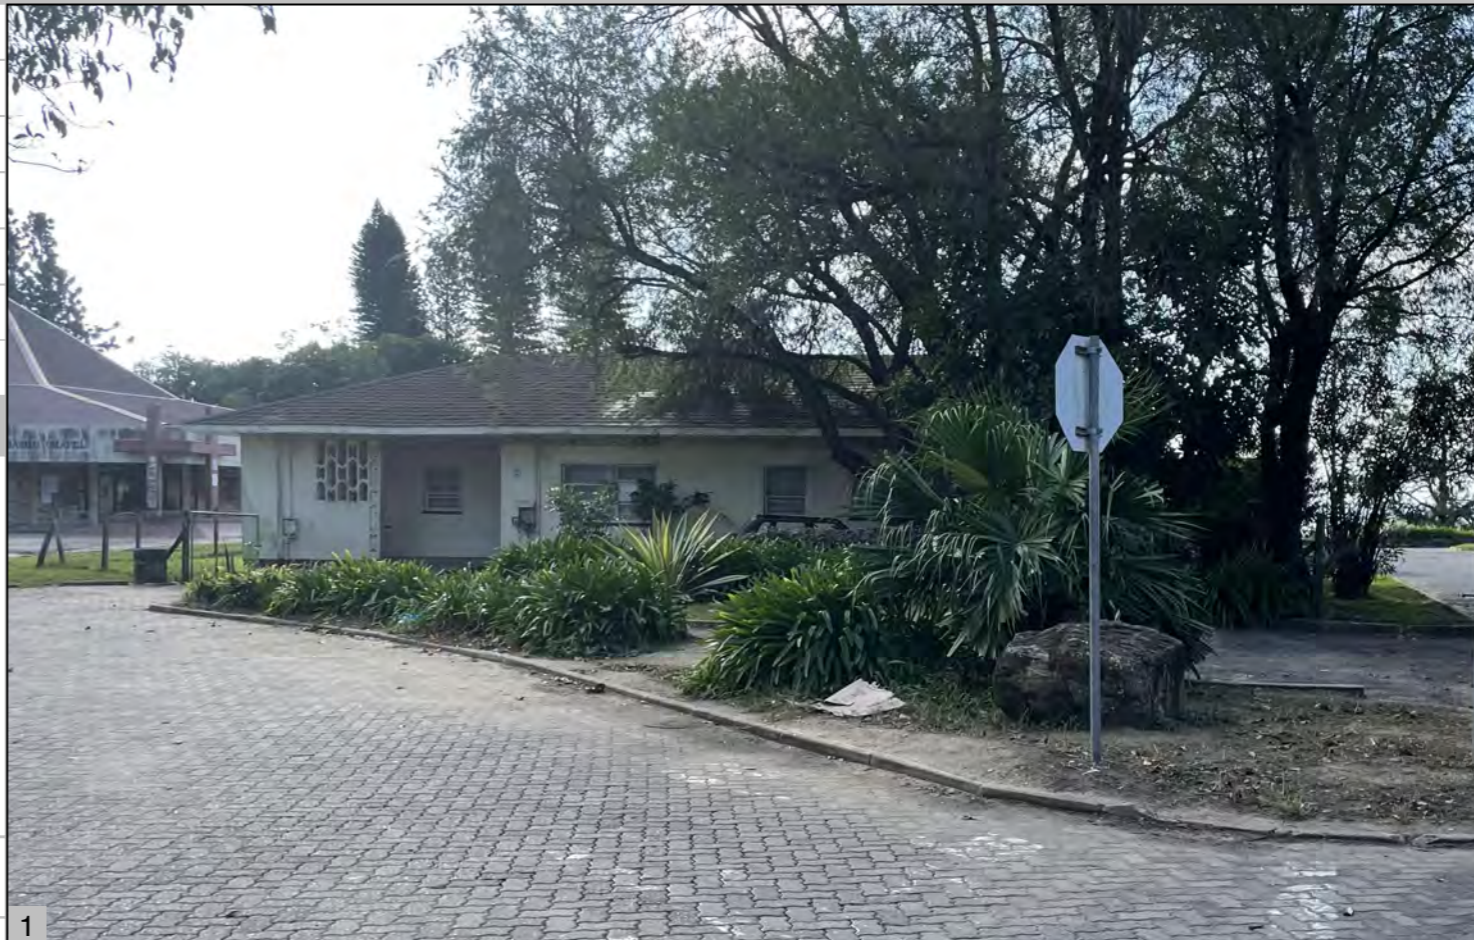
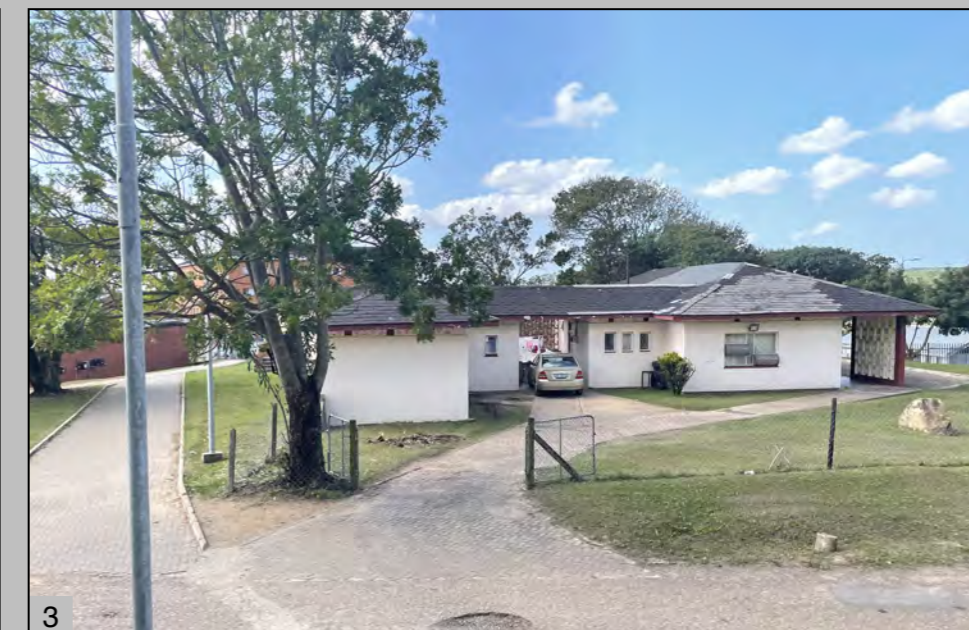
**SITE & STRUCTURE DESCRIPTION:** These single storey modest “bungalow” type buildings with decorative brise-soleils, plasterwork patterns match the first academic buildings constructed on the university campus. They were constructed for the wardens on campus at the time, and part of the first collection of buildings constructed on the university campus. The building cluster on the eastern end is still in good condition, while part of the building cluster on the western end has been burned internally recently.

**PHYSICAL CONDITION:** West Residence - Derelict; East Residence - Good.

IMAGES: 1 - Western Residence Warden's House  
 2 - Western Residence Warden's House, showing recently burned building  
 3 - Eastern Residence Warden's House

**RECOMMENDATION:** The buildings located on the eastern residence end should be graded IIIC.

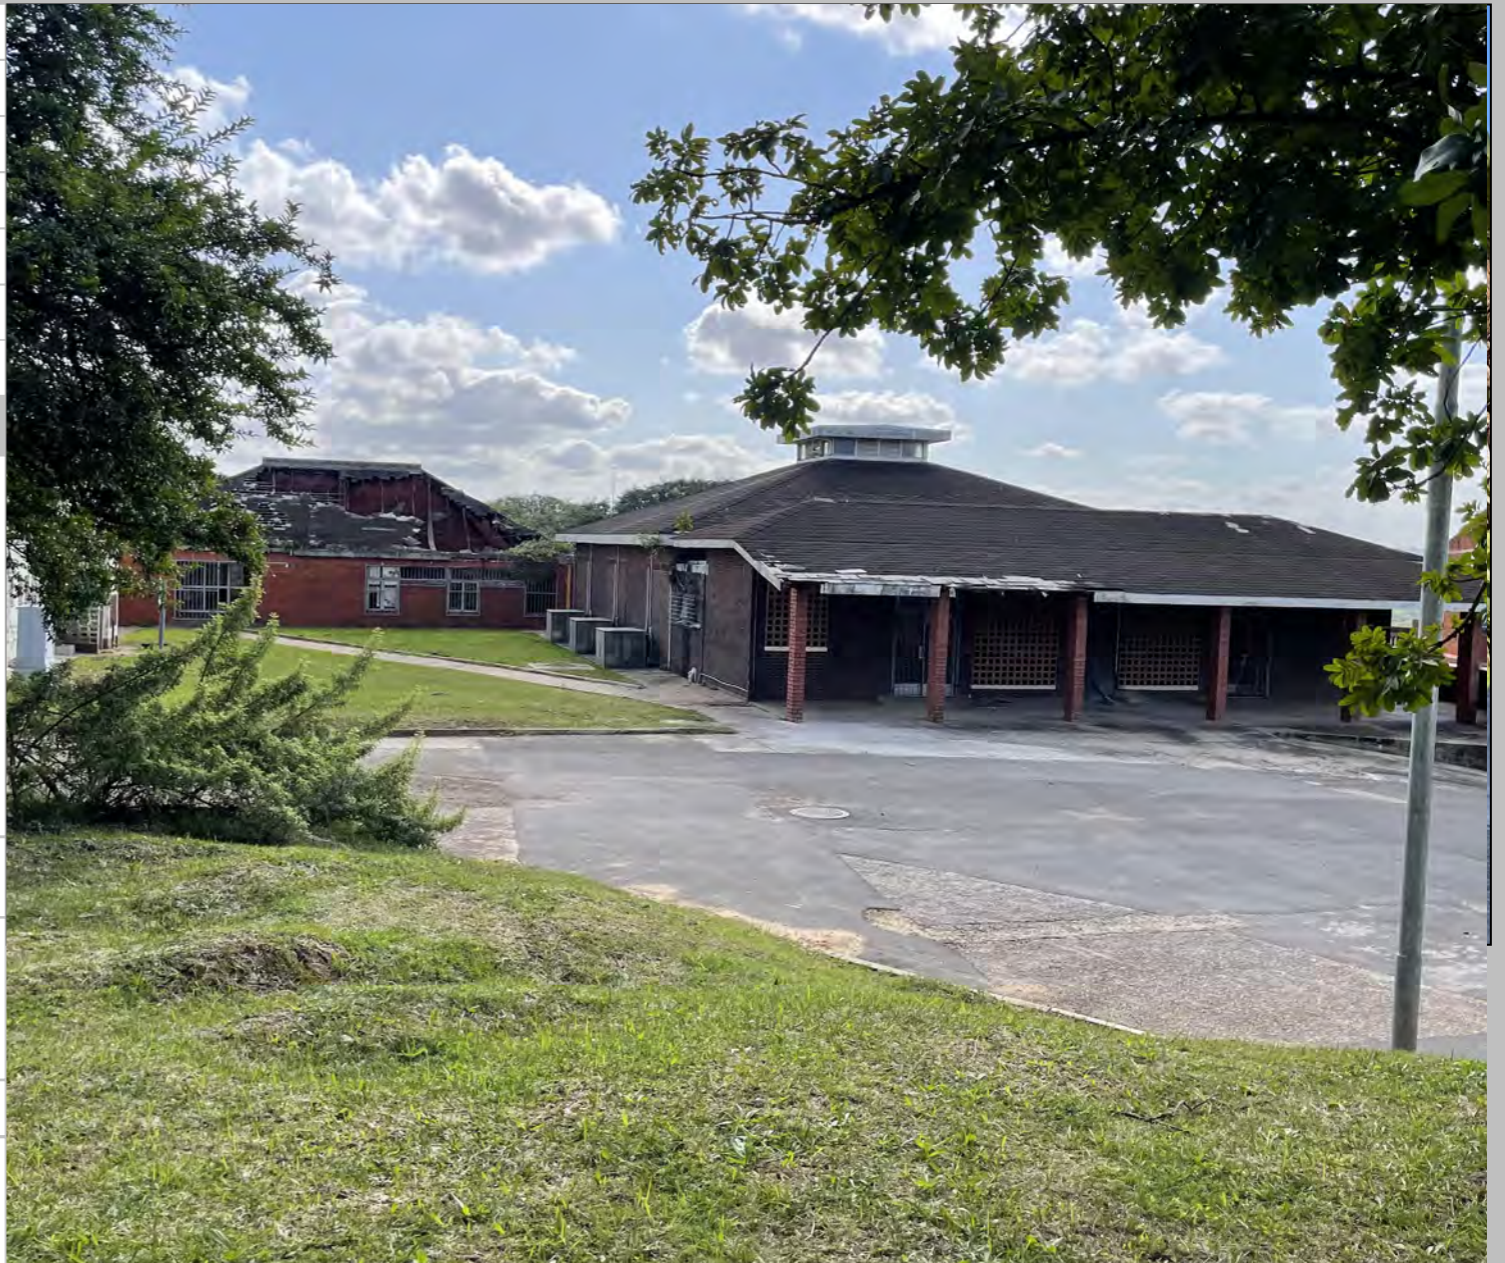
SITE & STRUCTURE DESCRIPTION:	These single storey exposed brick buildings are located centrally within the eastern residence area.
PHYSICAL CONDITION:	Derelict
STATEMENT OF SIGNIFICANCE:	N/A
PROPOSED GRADING:	Not Conservation Worthy
OPPORTUNITIES & THREATS:	
RECOMMENDATION:	These buildings are Not Conservation Worthy.
REFERENCES:

IMAGES: 1 - Southern view towards buildings, showing broken down roof.
