**UNIVERSITY OF ZULULAND**

BUILDING/S:	Tourism and Recreation, B-Lab
ARCHITECT/S:	Piet Van den Berg
DATE:	c.1960
CURRENT USE:	Academic buildings

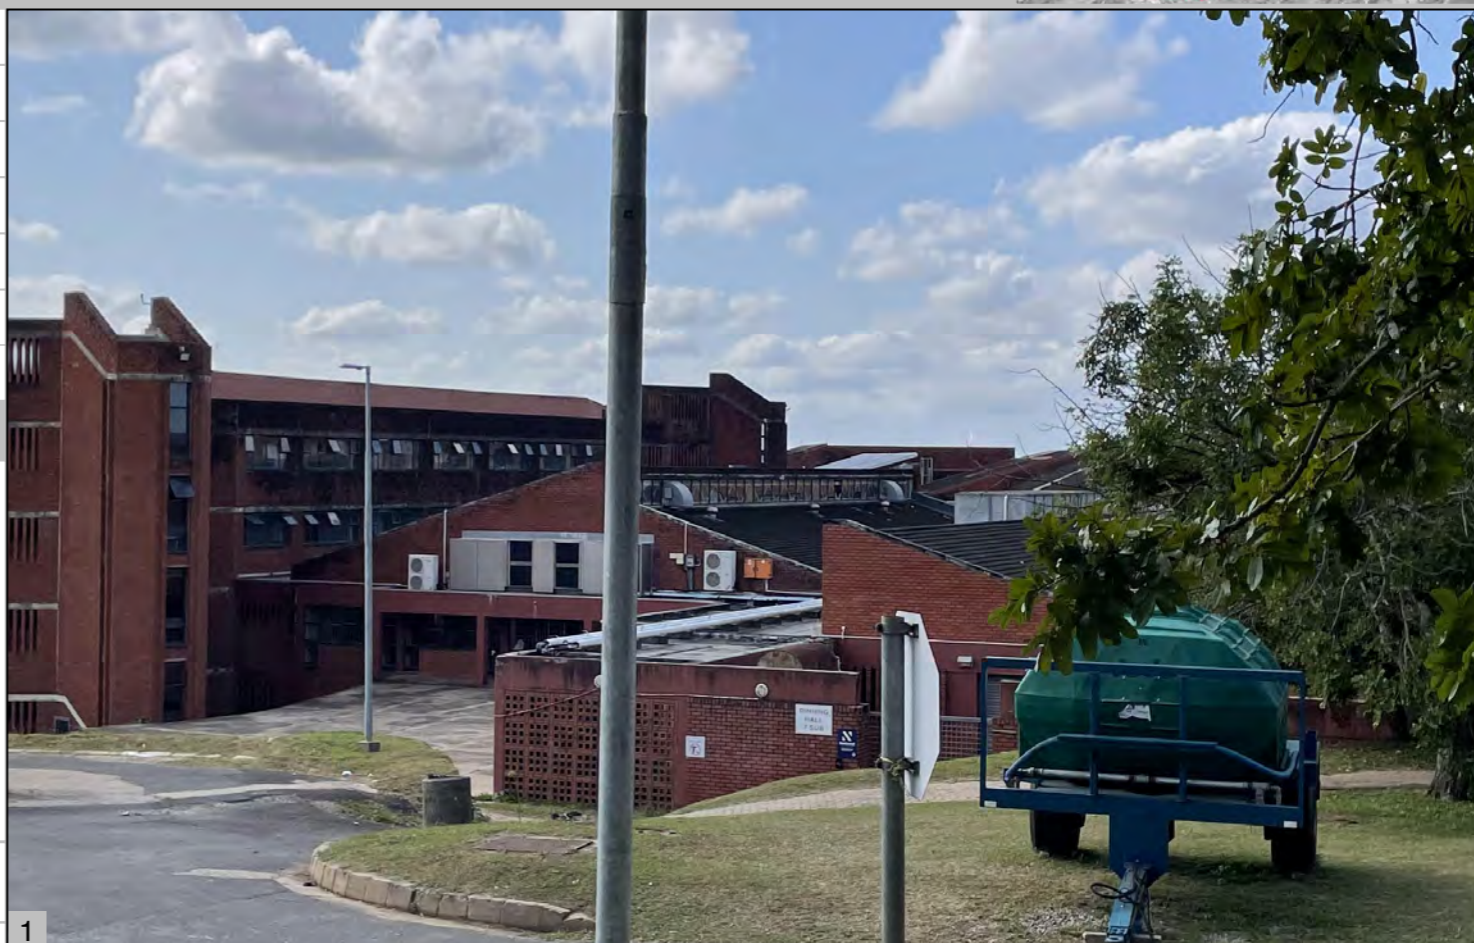
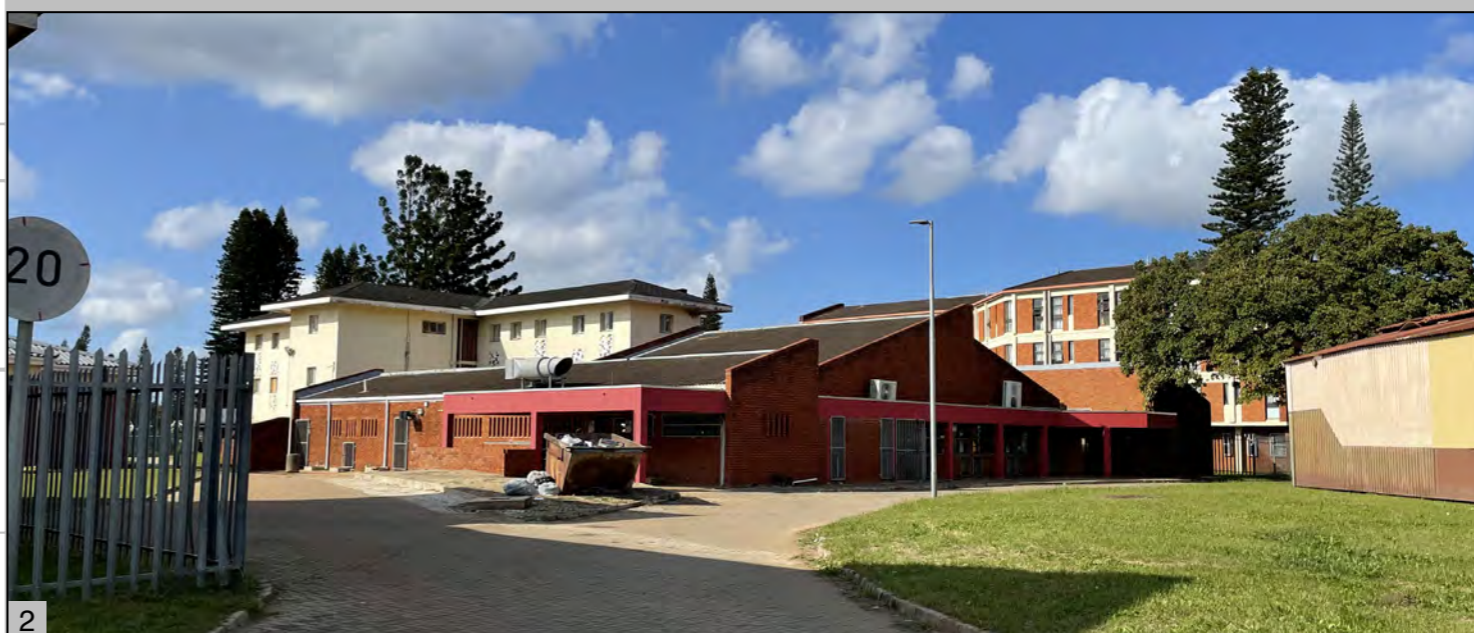
IMAGES: 1 - Buildings on Eastern Residence side  
 2 - Buildings on Western Residence side

**PHYSICAL CONDITION:** Good

**RECOMMENDATION:** These buildings are Not Conservation Worthy.

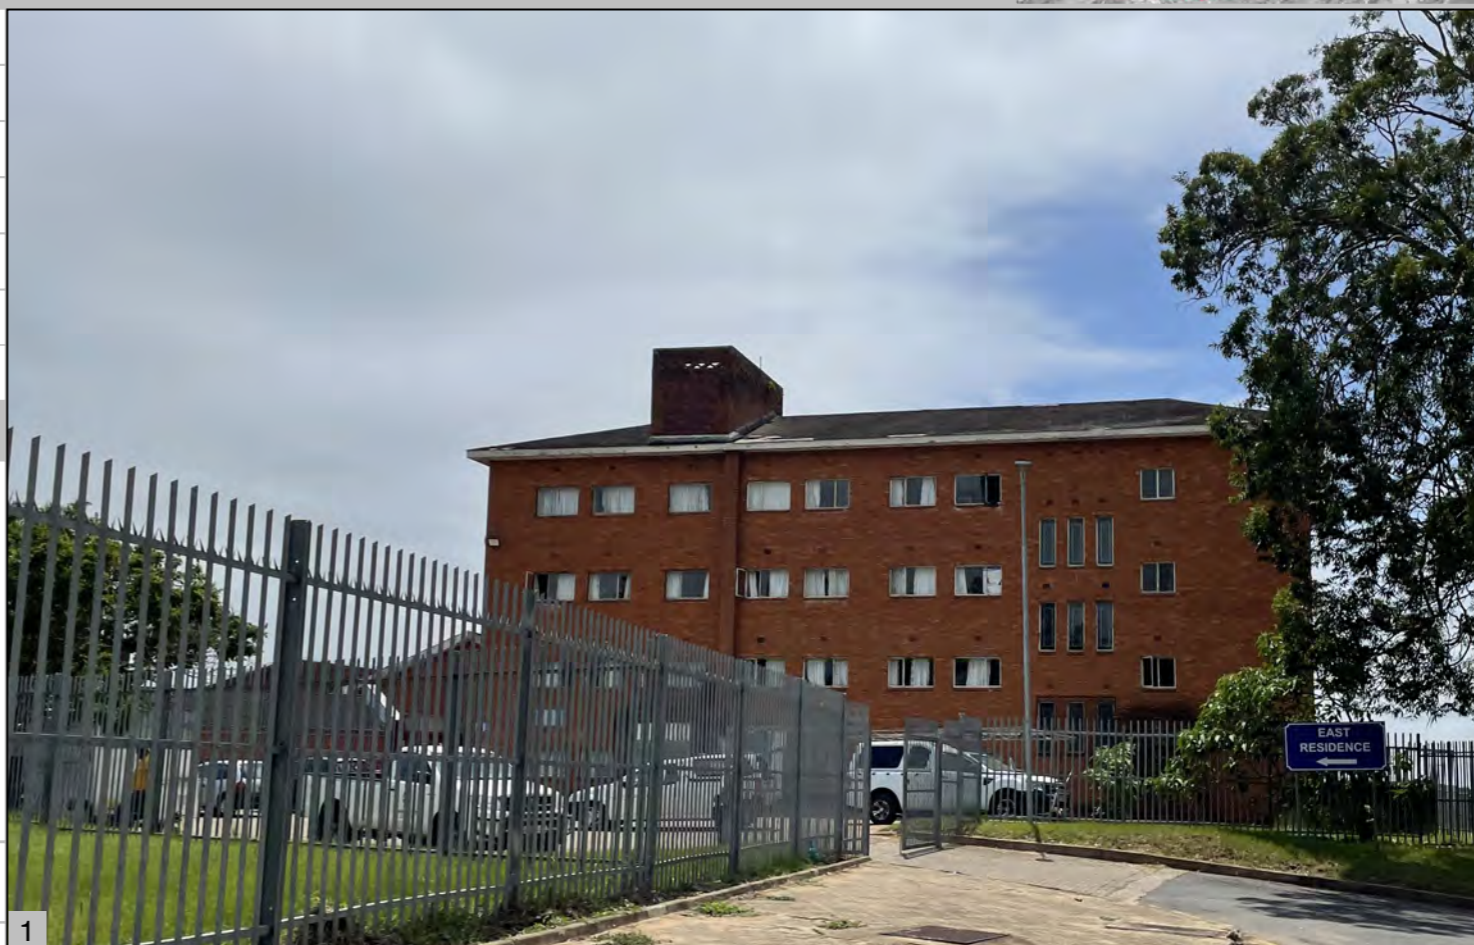
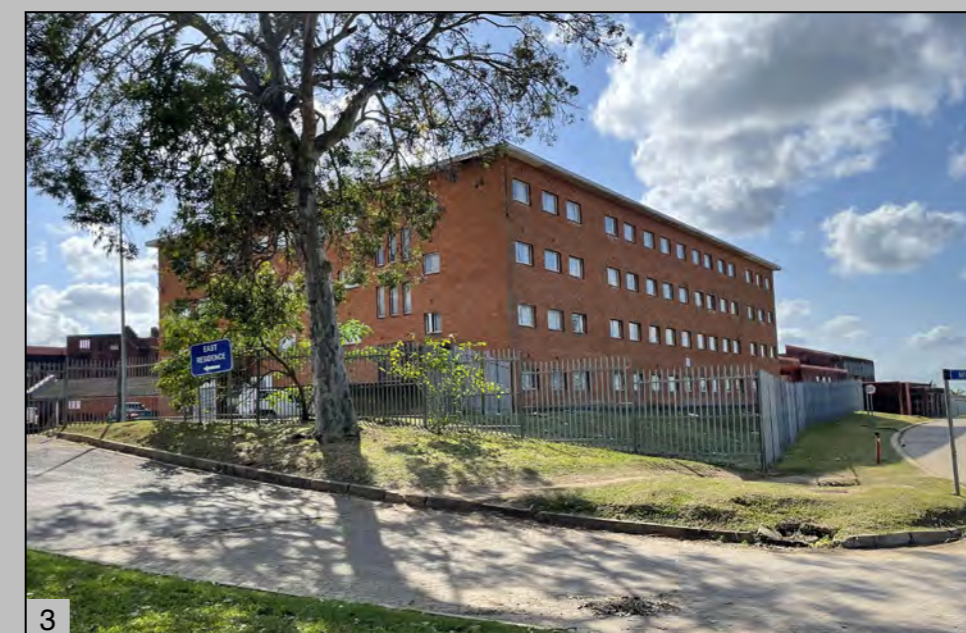
SITE & STRUCTURE DESCRIPTION:	Four storey exposed brick building, with central courtyard. Located at the back entrance to the western residences.
PHYSICAL CONDITION:	Good.
STATEMENT OF SIGNIFICANCE:	N/A.
PROPOSED GRADING:	Not Conservation Worthy
OPPORTUNITIES & THREATS:	
RECOMMENDATION:	These buildings are Not Conservation Worthy.
REFERENCES:

IMAGES: 1 - Eastern facade  
2 - Eastern facade showing perforated brick detail at the top of the stairwell  
3 - Southern facade

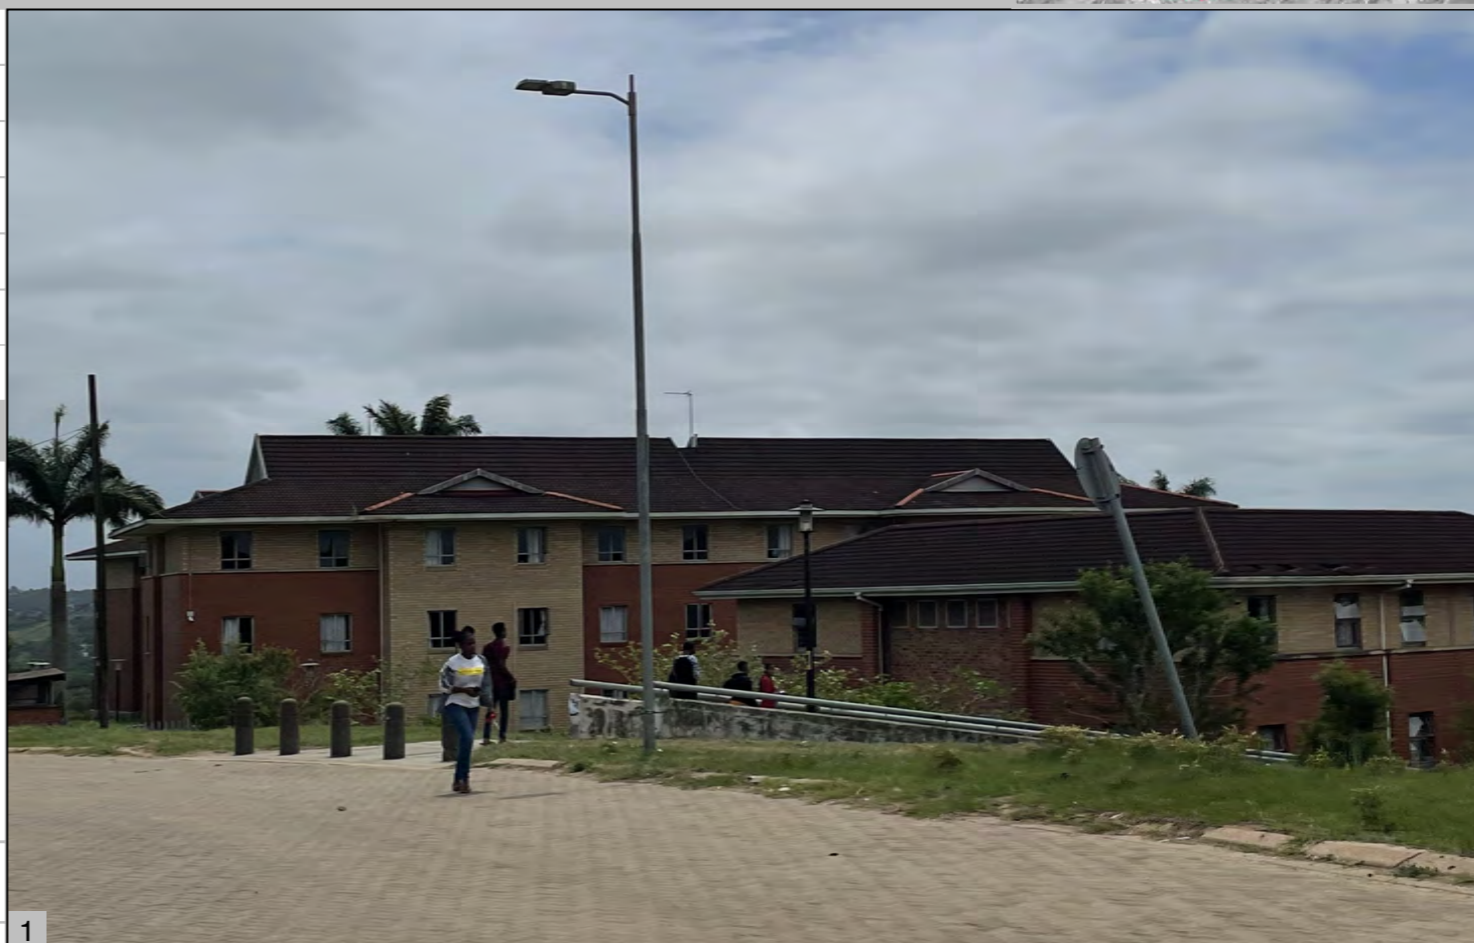
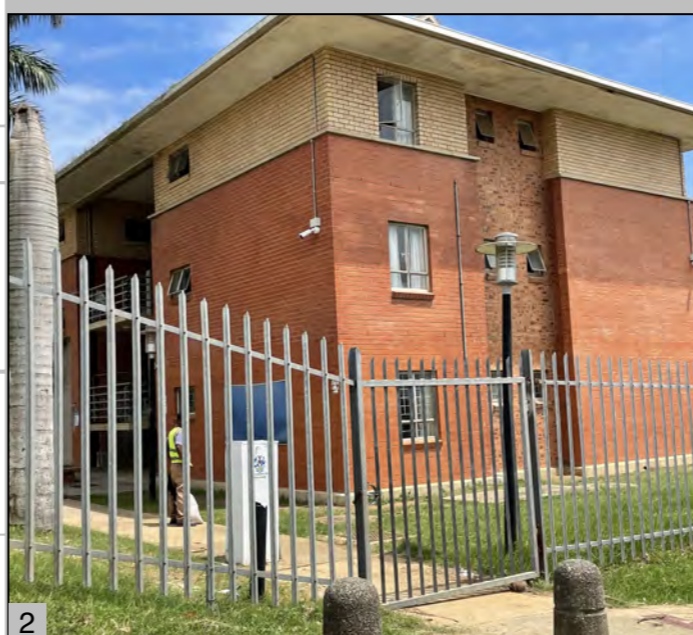
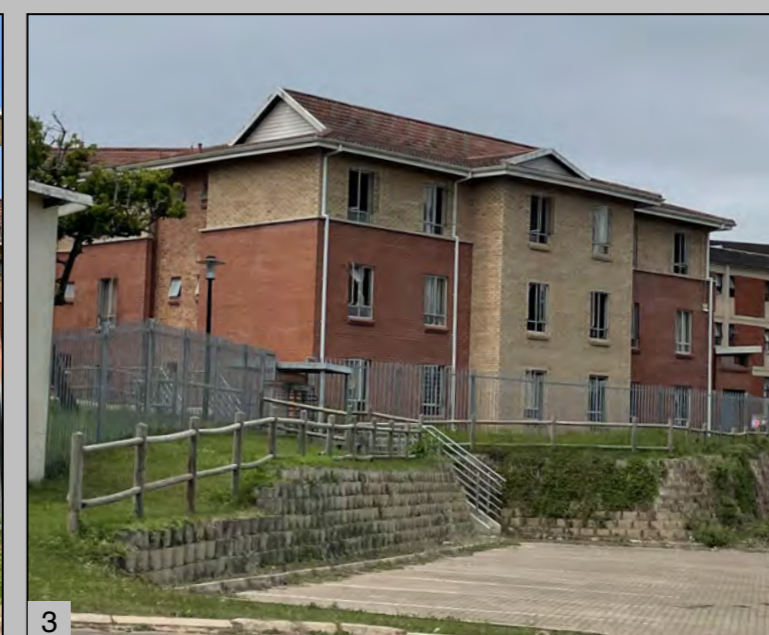
**IMAGES:**  
 1 - Southern view towards buildings  
 2 - Western view towards building  
 3 - Northern view towards buildings

**PHYSICAL CONDITION:** Good.

**RECOMMENDATION:** These buildings are Not Conservation Worthy.

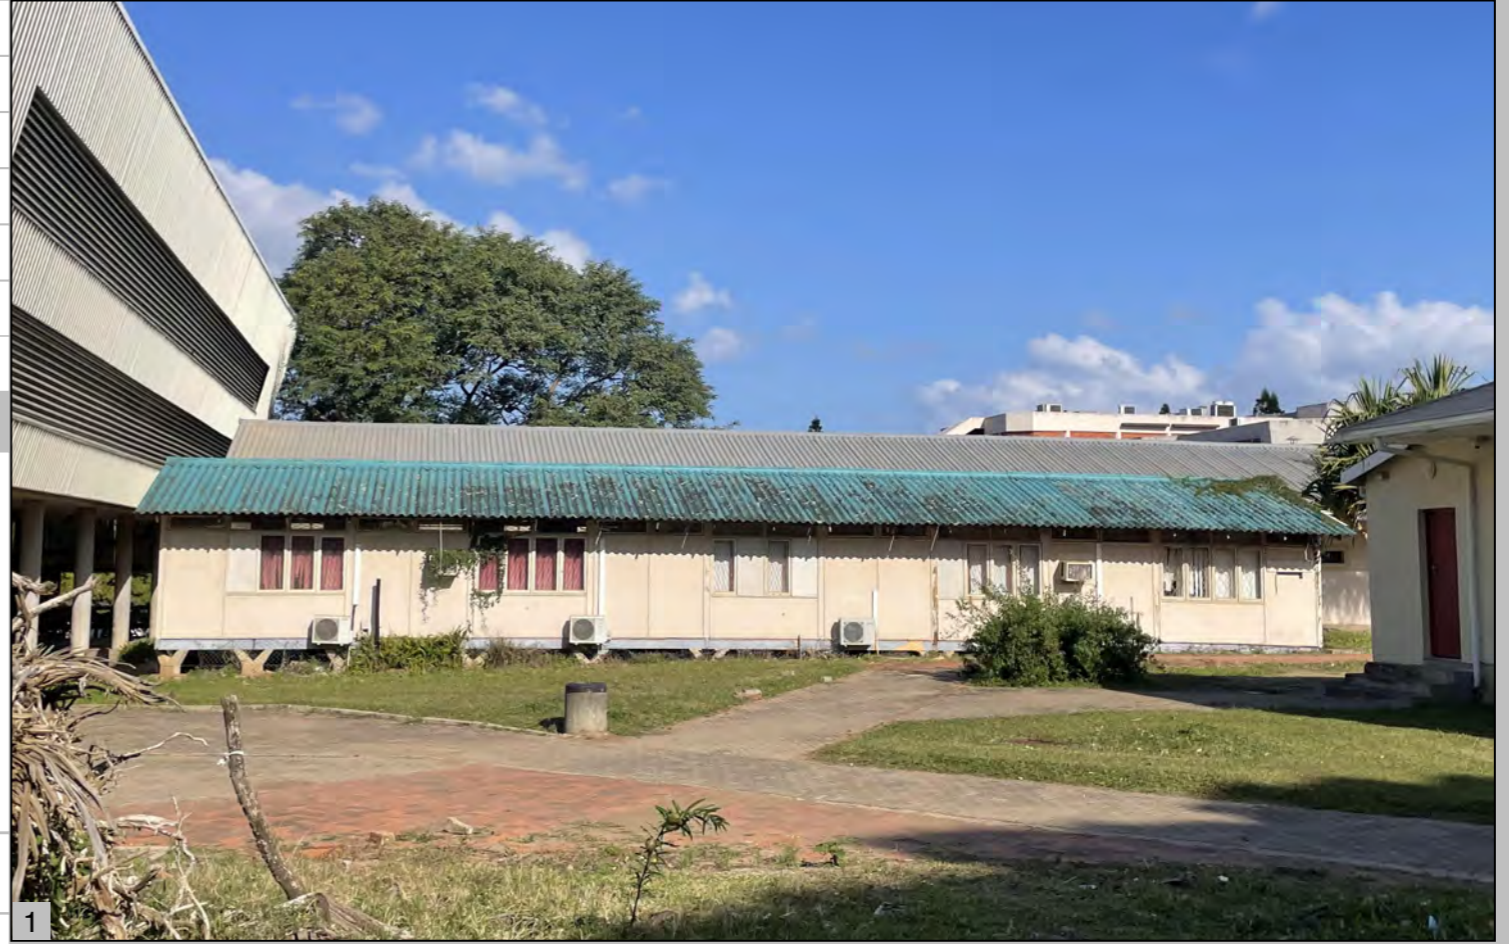
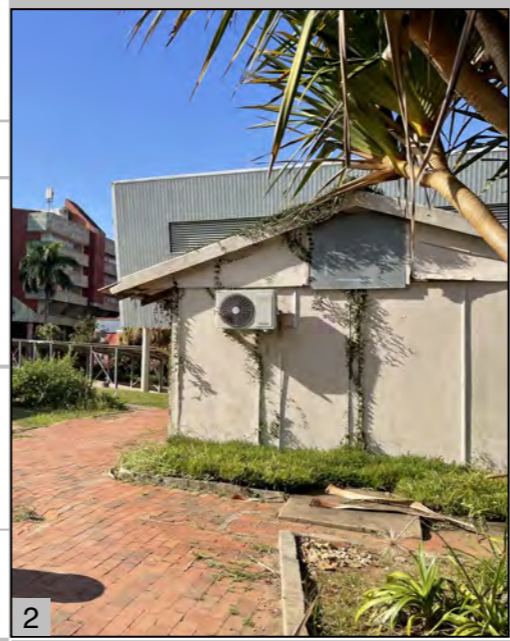
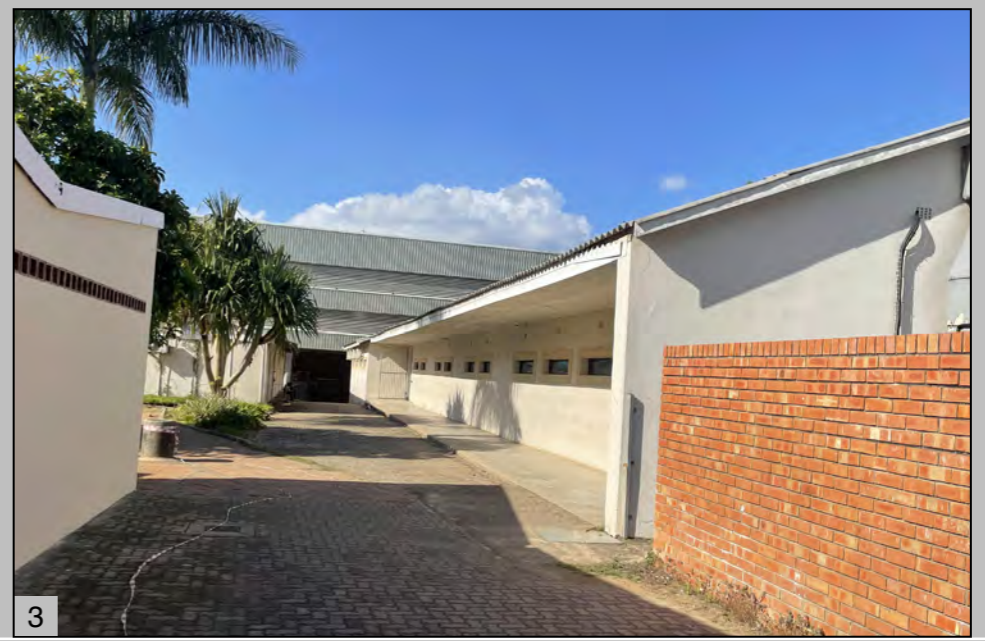
IMAGES: 1 - Northern facade of building 1  
 2 - Western facade of building 1  
 3 - Northern facade of building 2

SITE & STRUCTURE DESCRIPTION:	A single storey plastered building, along with a temporary construction office. Located central to the academic core, between the Education Faculty and the Geography Building.
PHYSICAL CONDITION:	Medium.
STATEMENT OF SIGNIFICANCE:	N/A
PROPOSED GRADING:	Not Conservation Worthy
OPPORTUNITIES & THREATS:	
RECOMMENDATION:	These buildings are Not Conservation Worthy.
REFERENCES:

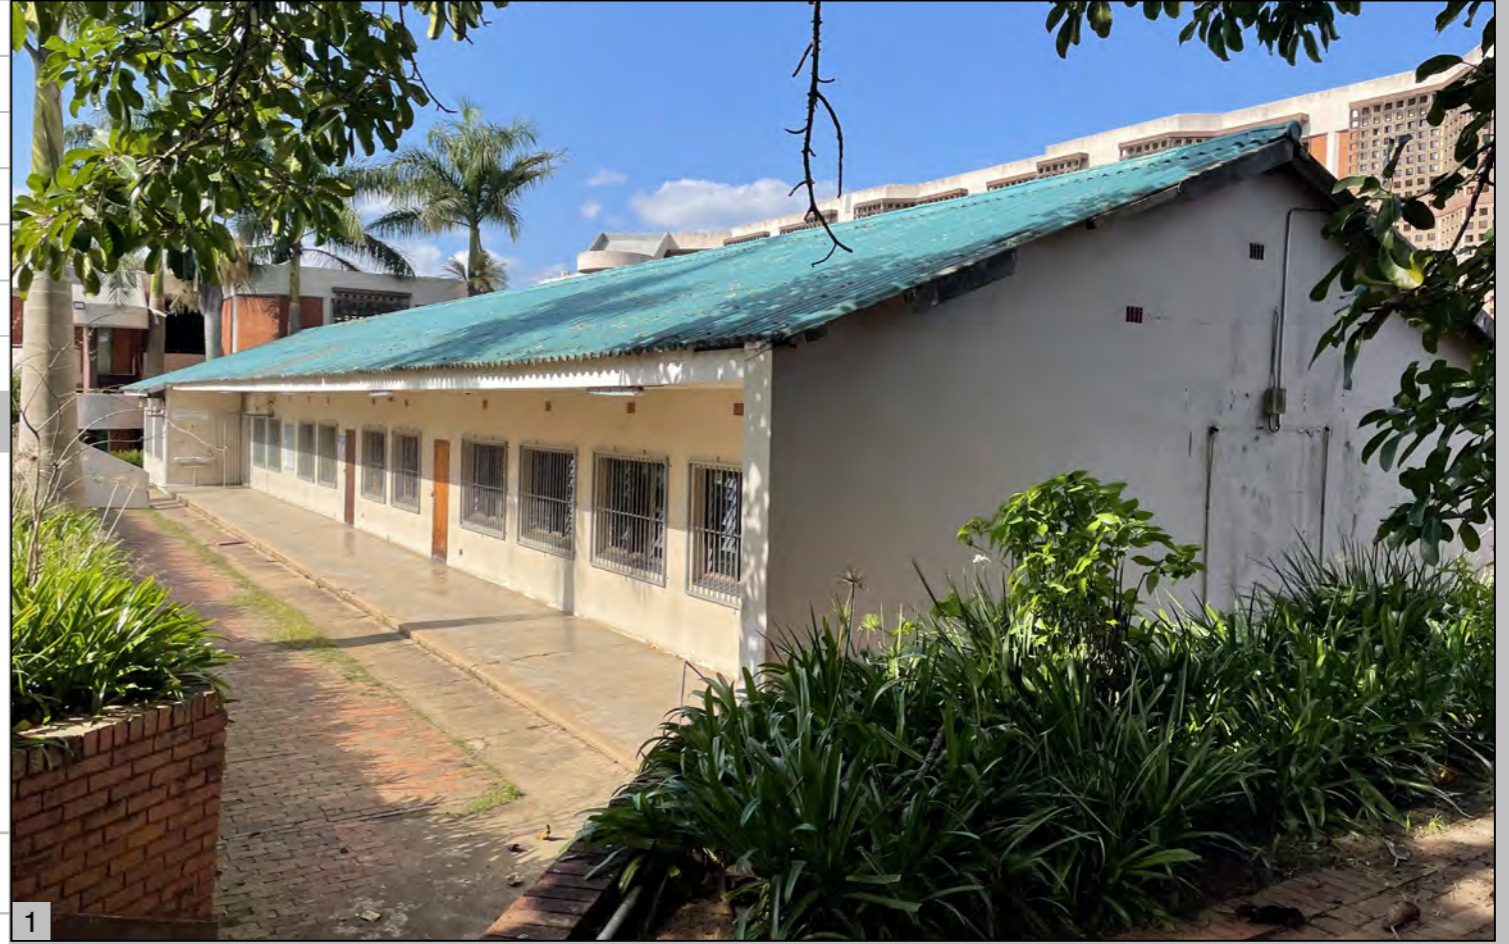
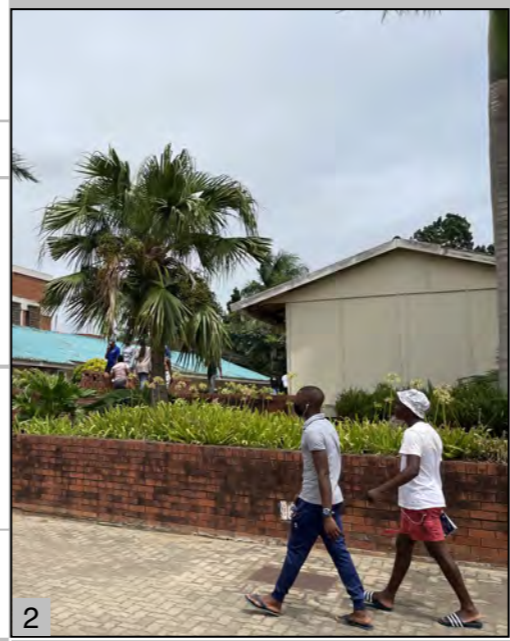
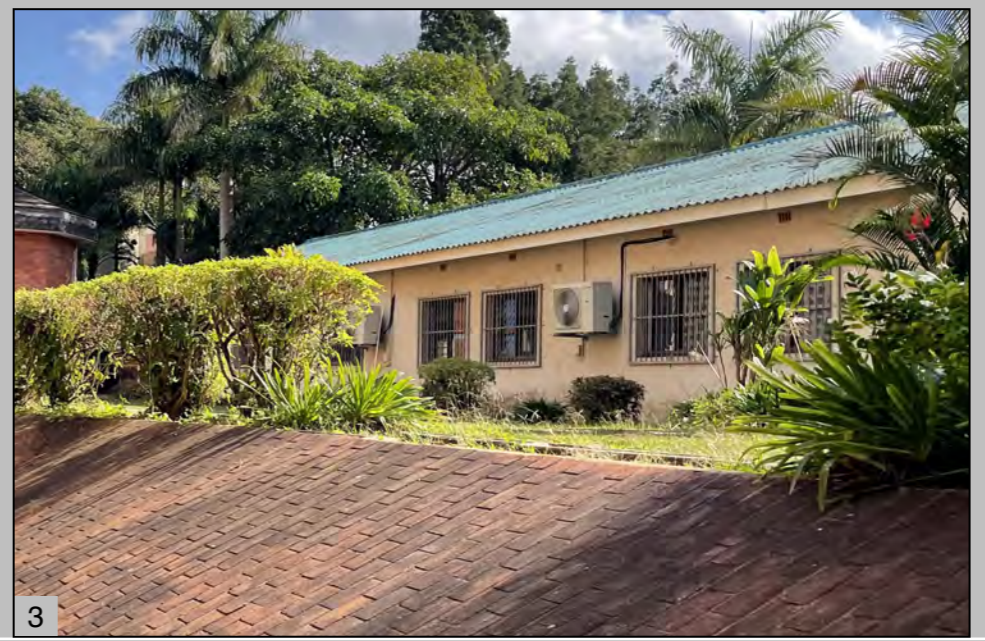
IMAGES: 1 - Northern facade  
 2 - Western facade  
 3 - Southern facade

SITE & STRUCTURE DESCRIPTION:	A simple single storey plastered building. Located central to the academic core, between the Education Faculty and the Botany Building.
PHYSICAL CONDITION:	Good.
STATEMENT OF SIGNIFICANCE:	N/A
PROPOSED GRADING:	Not Conservation Worthy
OPPORTUNITIES & THREATS:	
RECOMMENDATION:	This building should be graded Not Conservation Worthy.
REFERENCES:

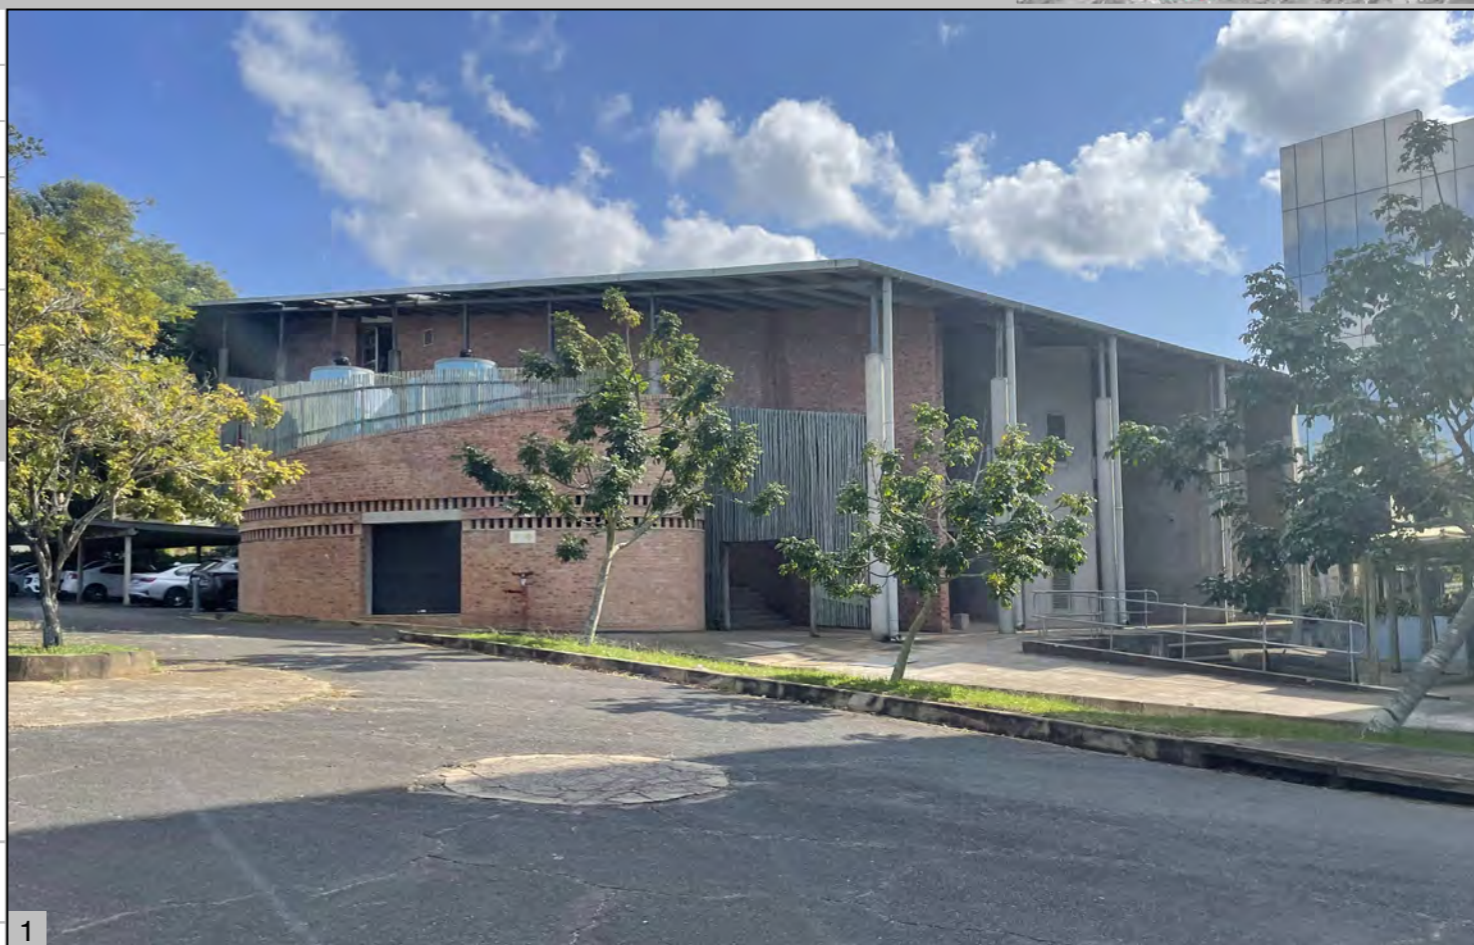
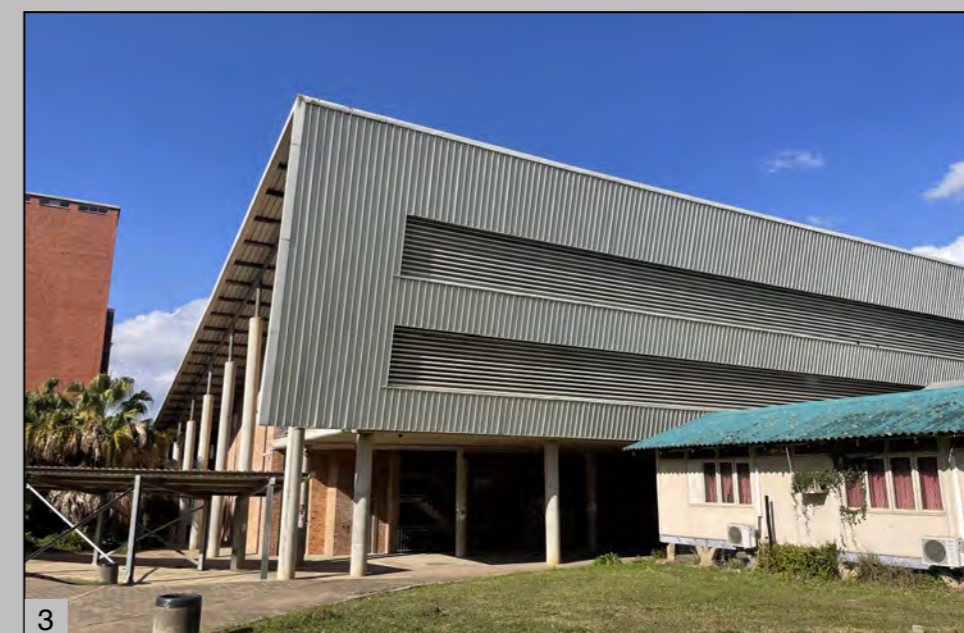
IMAGES: 1 - Southern facade of new Lecture Hall  
 2 - Pedestrian walkway between southern street and Library  
 3 - North Western view of Lecture Hall

**PHYSICAL CONDITION:** Good.

**RECOMMENDATION:** This building is Not Conservation Worthy.

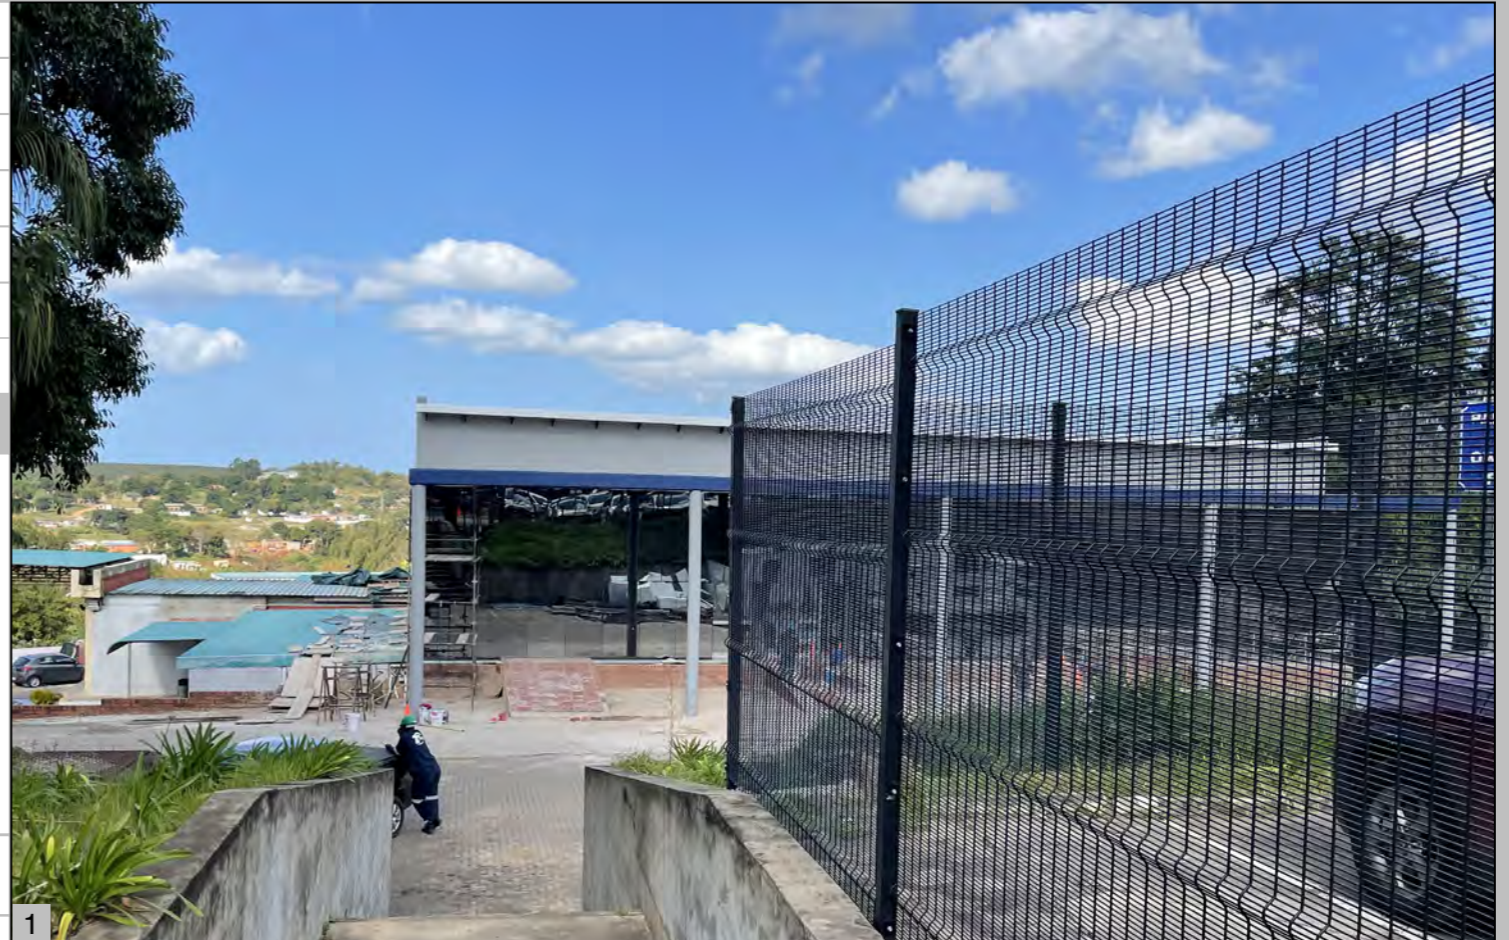
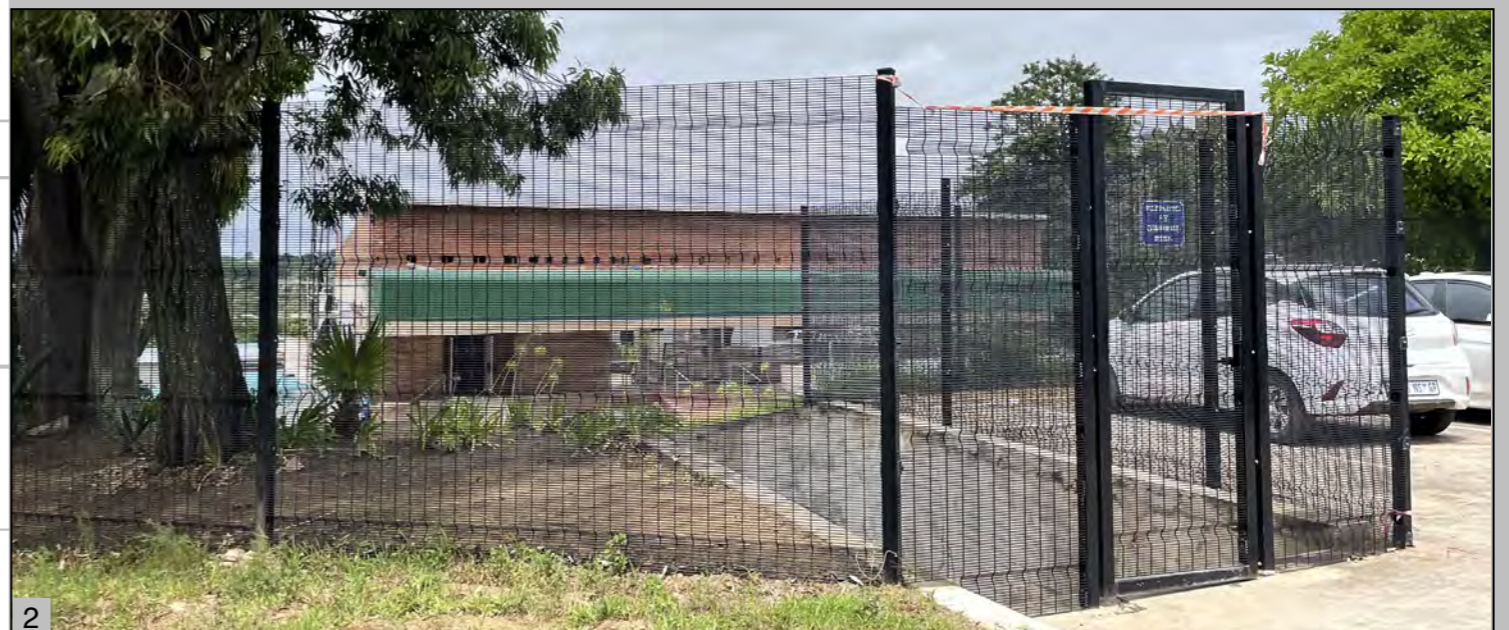
IMAGES: 1 - Northern view of Store taken in July 2022  
 2 - Northern facade of store, taken in March 2022

**PHYSICAL CONDITION:** Good.

**RECOMMENDATION:** This building should be graded Not Conservation Worthy.

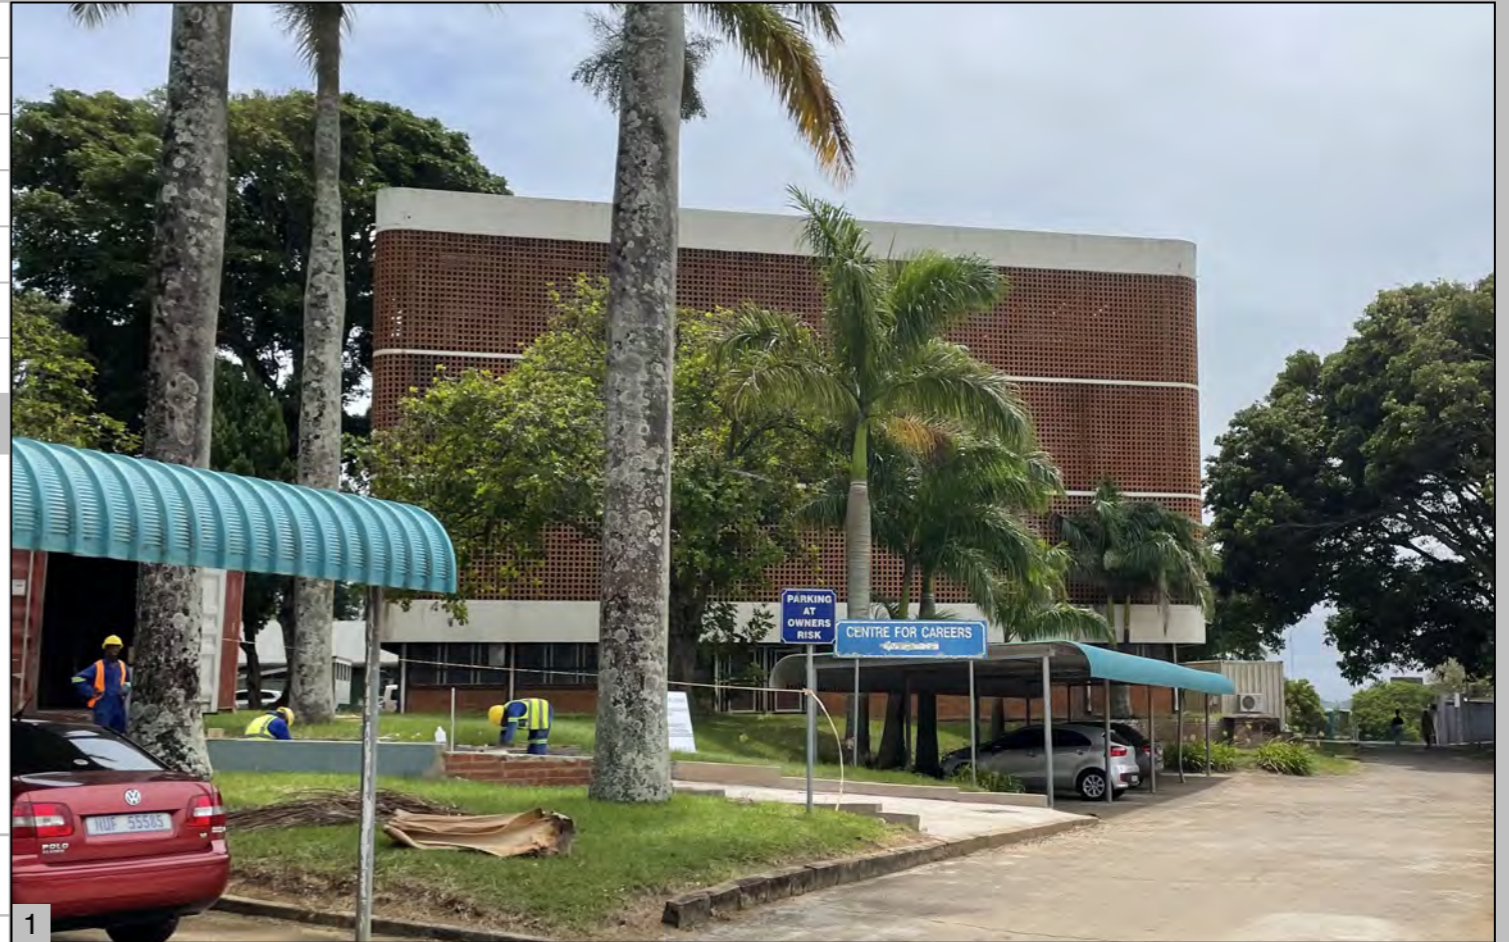
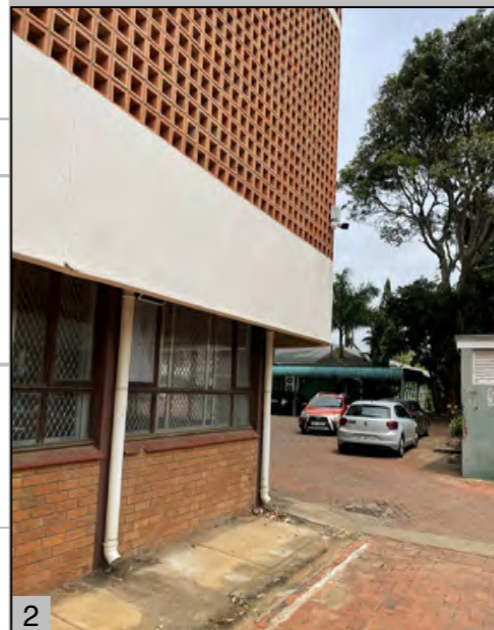
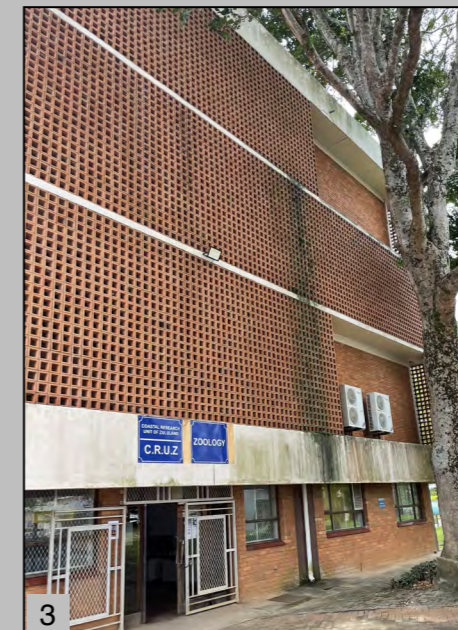
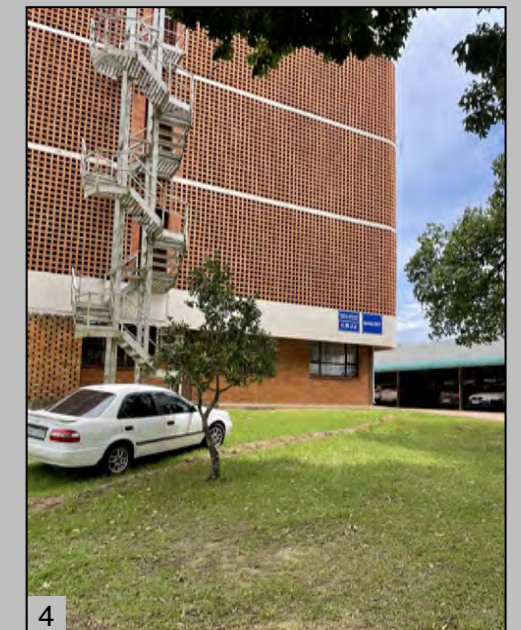
IMAGES: 1 - Southern facade  
 2 - Detail of screen over ground floor base  
 3 - Western facade  
 4 - Eastern facade, with steel firestair

RECOMMENDATION:	Despite not being older than 60, this building should be formally listed as Grade IIIC.
-----------------	---

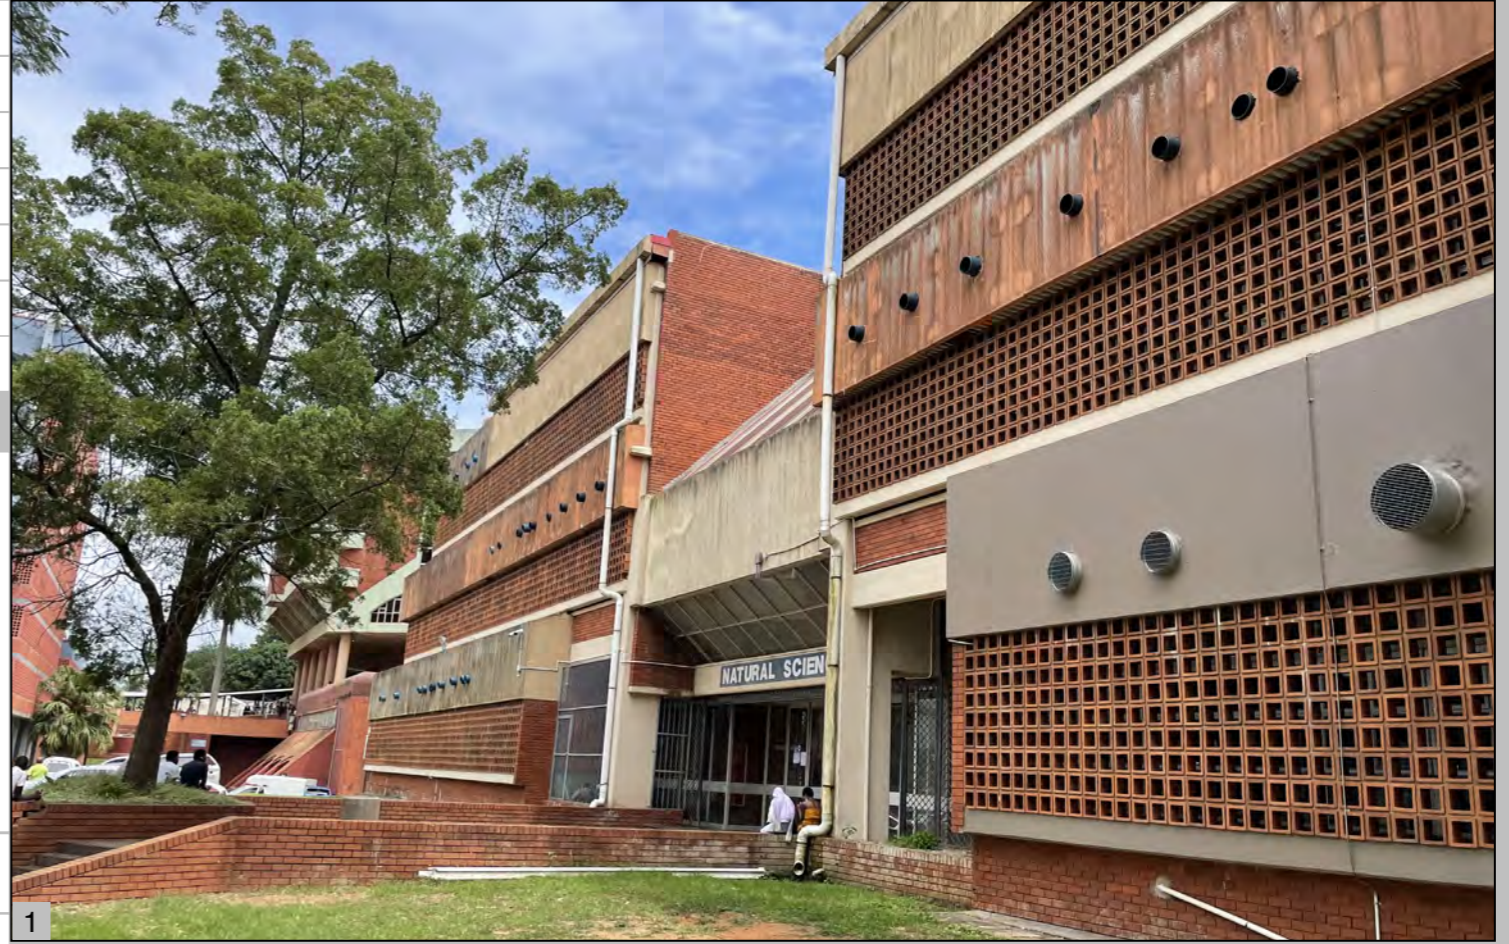
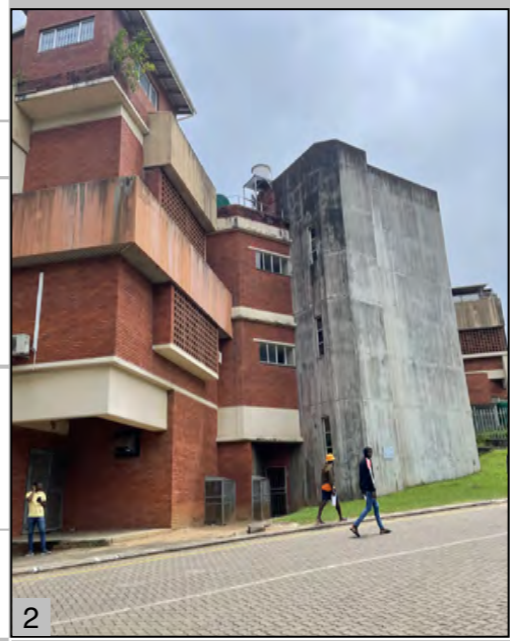
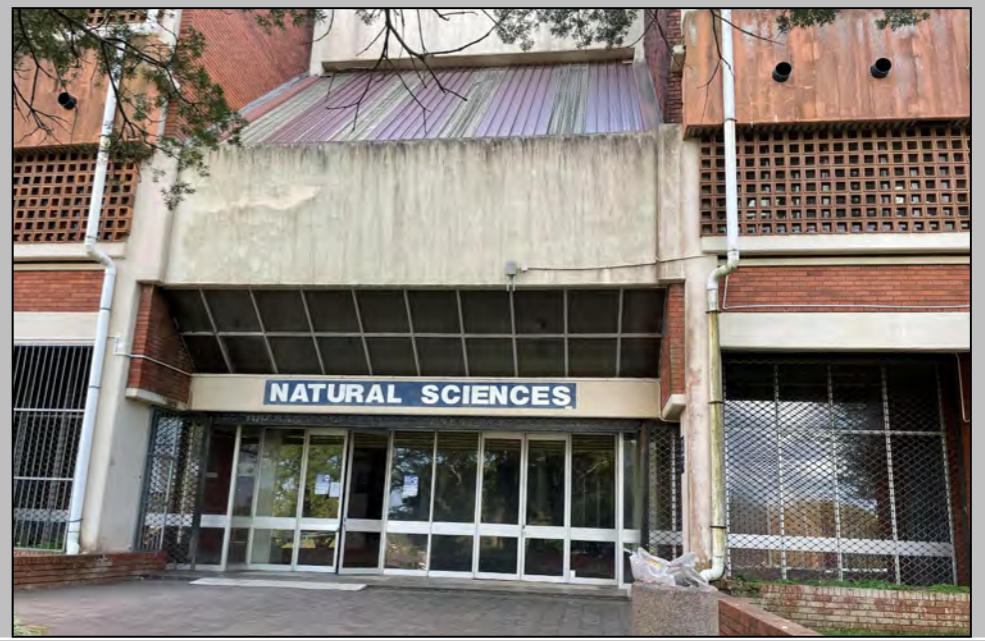
IMAGES: 1 - Front of southern facade  
 2 - East facing perforated brick portion and concrete core  
 3 - Building entrance, with concrete beam above

**RECOMMENDATION:** This building should be graded IIIC, despite it not being older than 60.
