**UNIVERSITY OF ZULULAND**

BUILDING/S:	Tourism and Recreation, B-Lab
ARCHITECT/S:	Piet Van den Berg
DATE:	c.1960
CURRENT USE:	Academic buildings

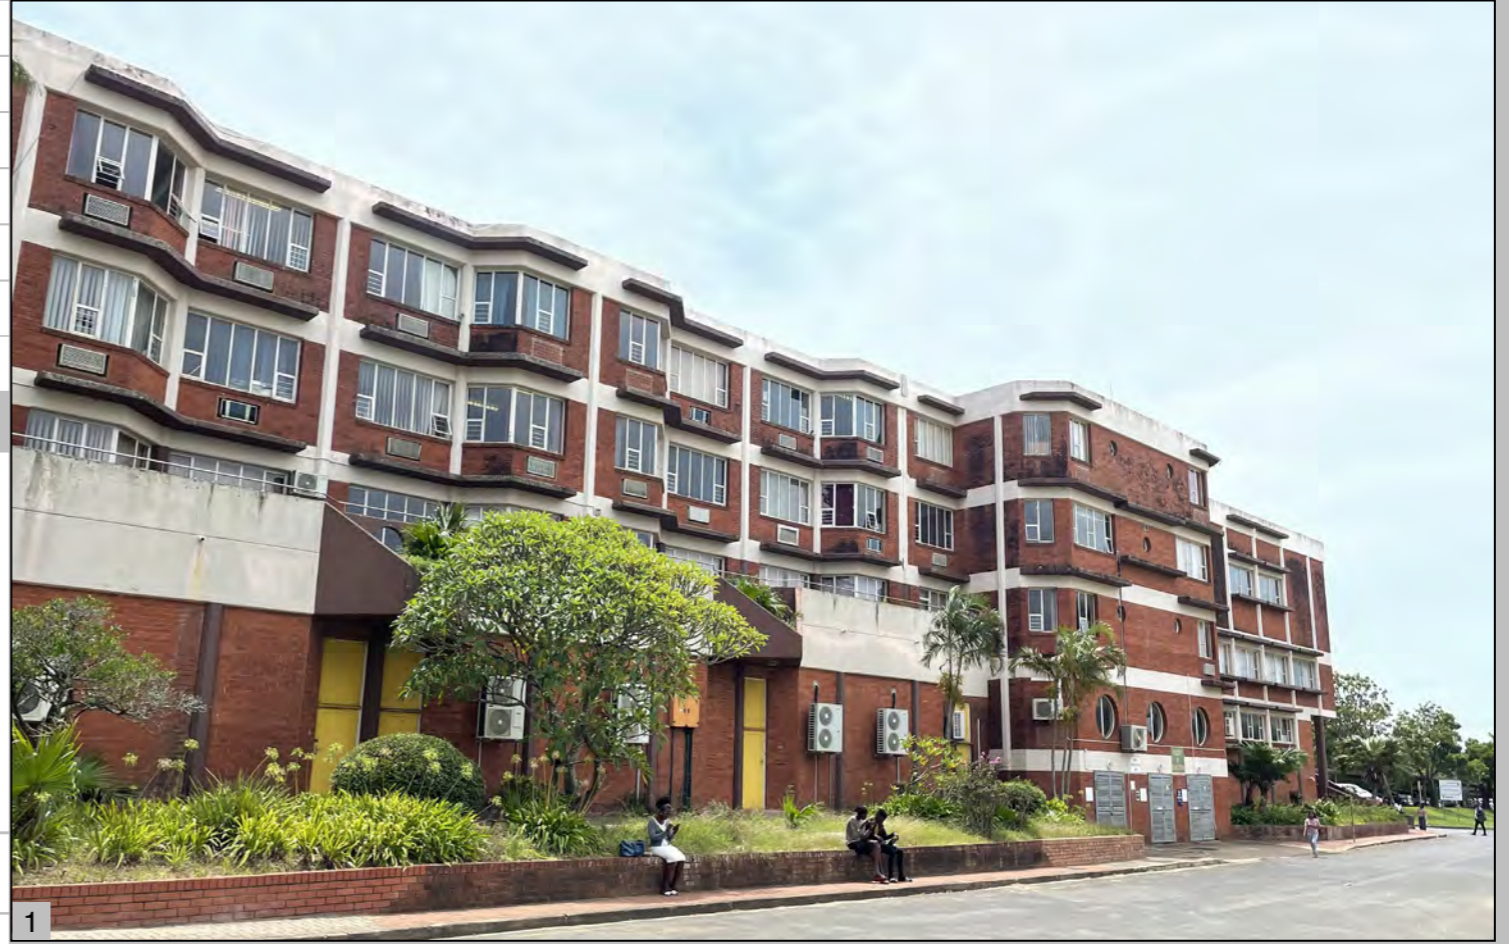
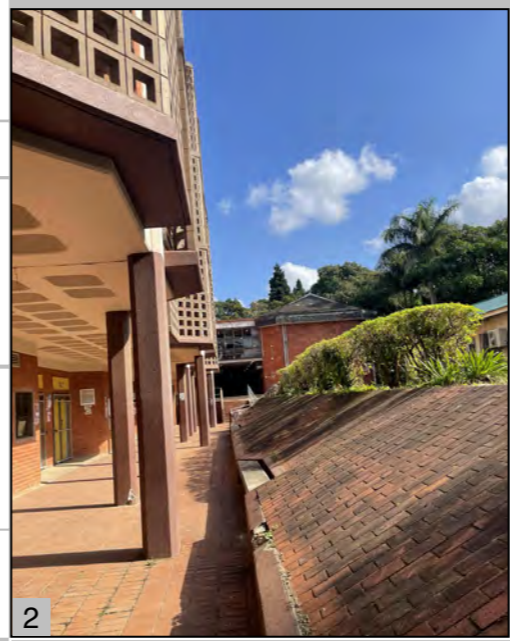
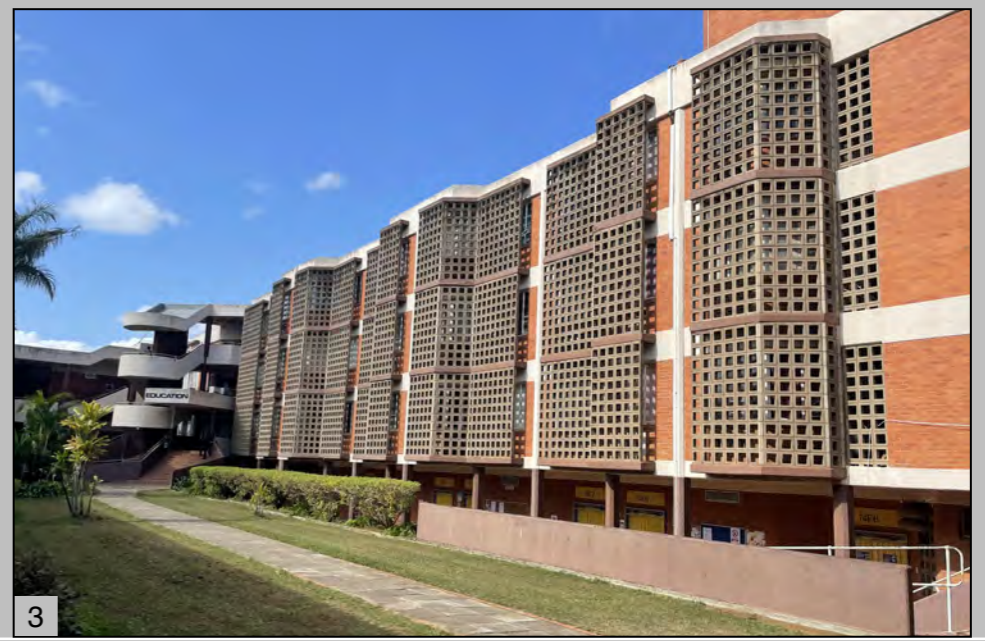
SITE & STRUCTURE DESCRIPTION:	The education faculty is constructed of exposed brick, suspended square-patterned brise-soleil screens and exposed concrete. Located along the southern side of the academic core.
PHYSICAL CONDITION:	Good.
STATEMENT OF SIGNIFICANCE:	The education faculty is a good example of Brutalist architecture on the university campus. The brutalist building is not older than 60 but contributes significantly to the architectural history of South African Universities, as they represent a particular moment in time both, globally and locally.
PROPOSED GRADING:	IIIB
OPPORTUNITIES & THREATS:	Alterations to the structure should be controlled by the heritage guidelines.
RECOMMENDATION:	This building should be graded IIIB, despite it not being older than 60.
REFERENCES:

IMAGES: 1 - Tourism and Recreation Building  
 2 - Tourism and Recreation Building  
 3 - B-Lab Building showing removed brise-soleil

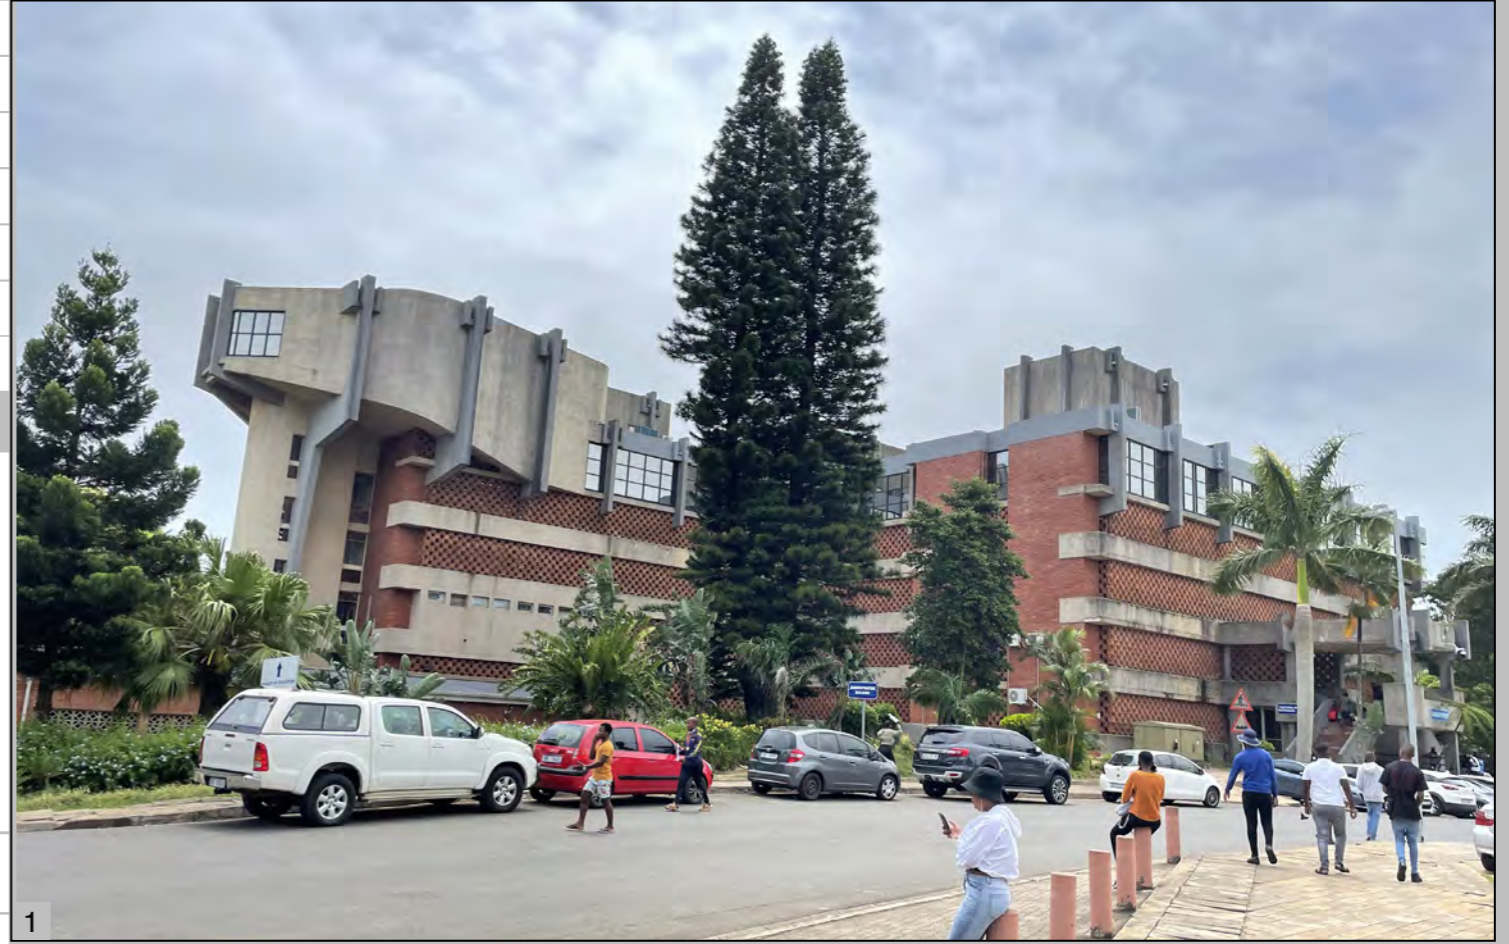
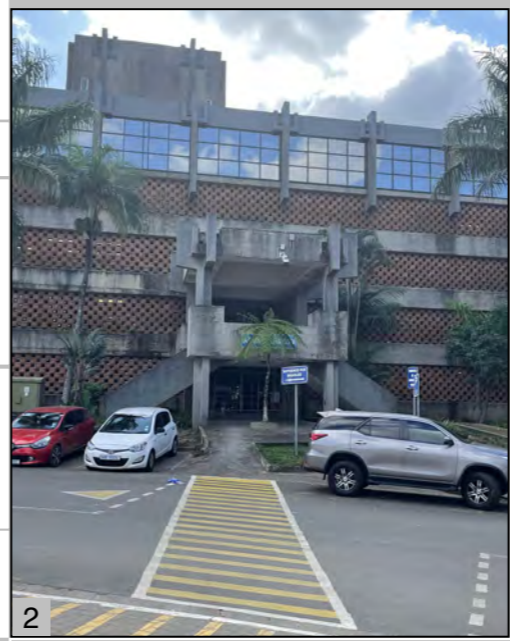
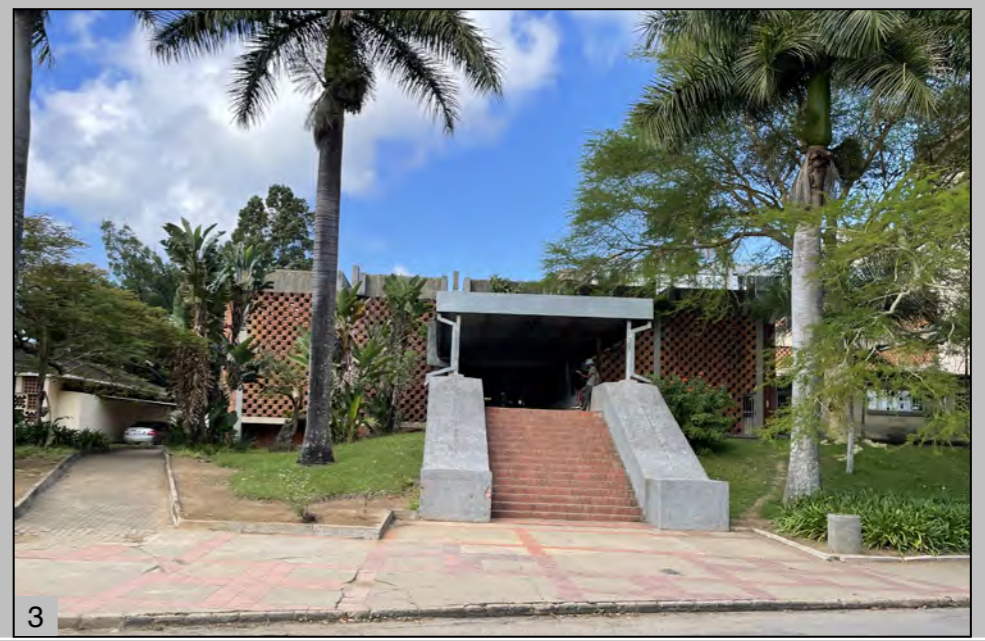
IMAGES: 1 - Southern view of Admin Block  
 2 - Entrance to Admin Block  
 3 - Northern facade of Student Registration

**RECOMMENDATION:** This building should be graded IIIB, despite it not being older than 60.

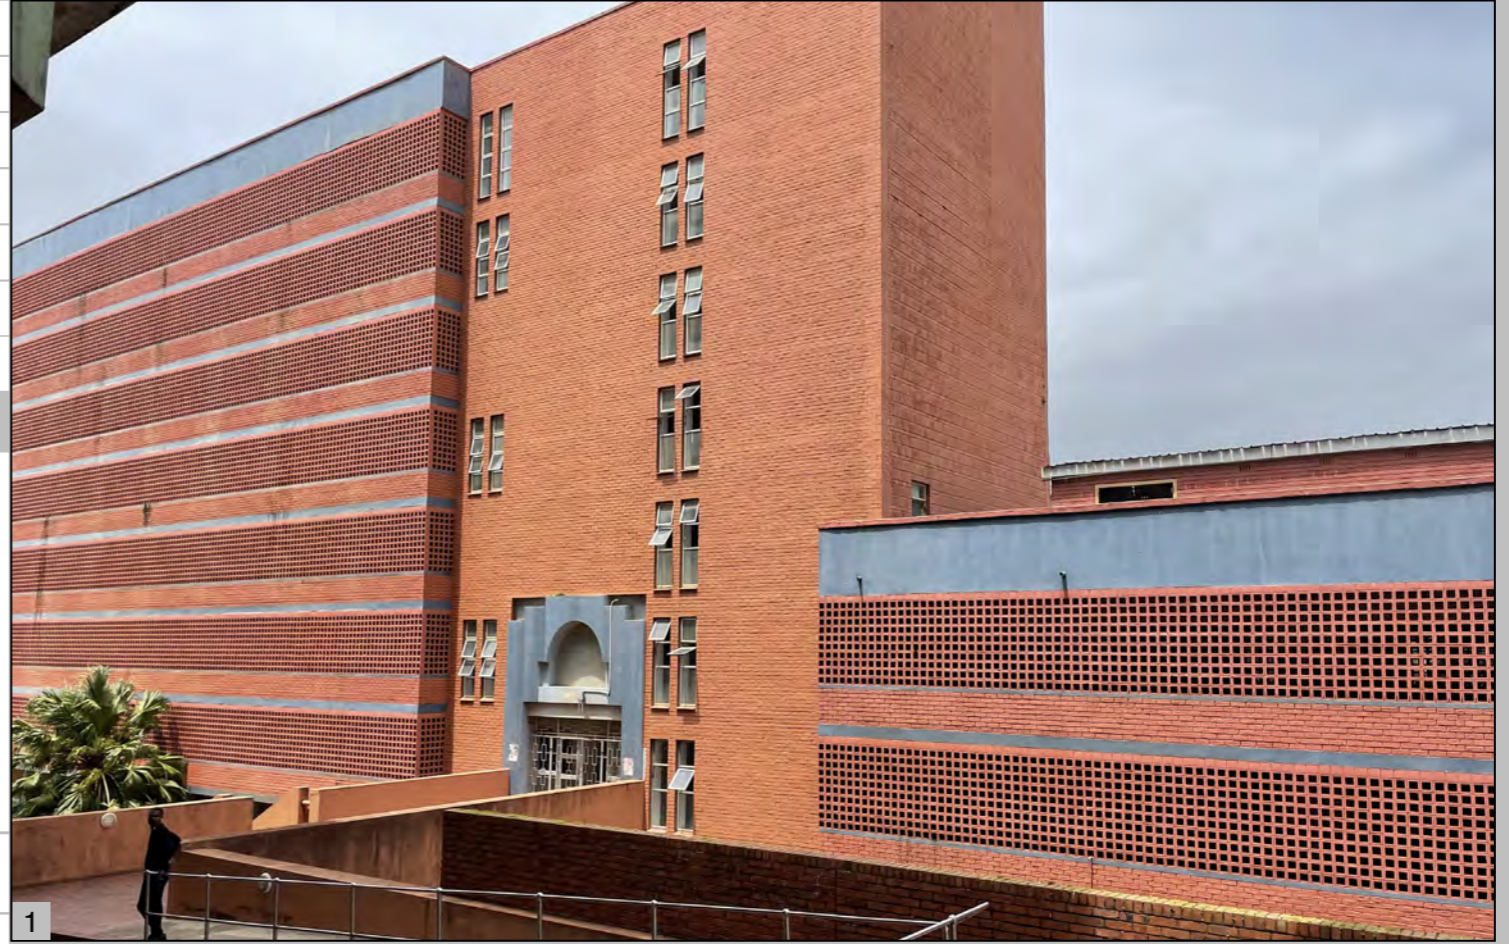
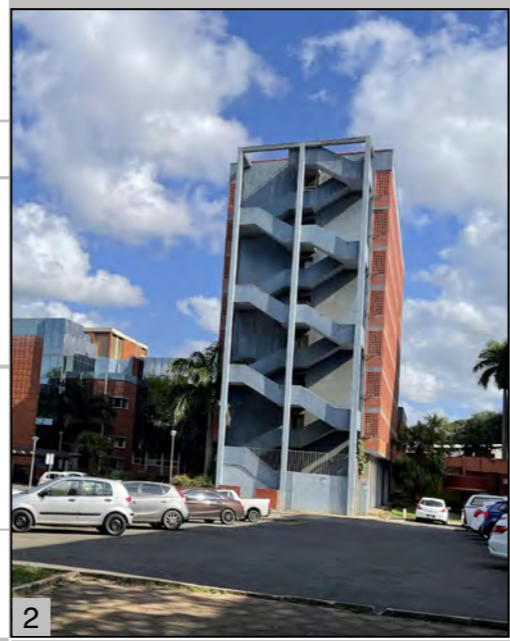
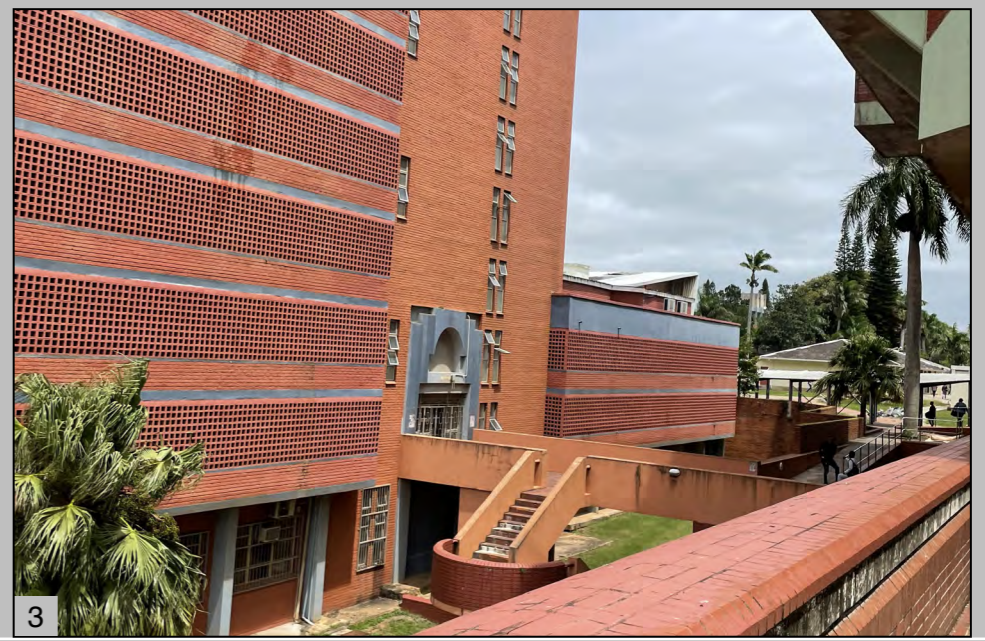
SITE & STRUCTURE DESCRIPTION:	The Arts Block is constructed of exposed brick, square-patterned briese-soleil, and painted concrete. Located towards the eastern end of the academic core.
PHYSICAL CONDITION:	Good.
STATEMENT OF SIGNIFICANCE:	A good example of Regionalist architecture.
PROPOSED GRADING:	IIIC
OPPORTUNITIES & THREATS:	Alterations to the structure should be controlled by the heritage guidelines.
RECOMMENDATION:	This building should be graded IIIC, despite it not being older than 60.
REFERENCES:

IMAGES: 1 - Northern facade with interesting brick detailing  
 2 - Eastern facade, with blue concrete external stair  
 3 - Northern facade with staircase leading to ground level

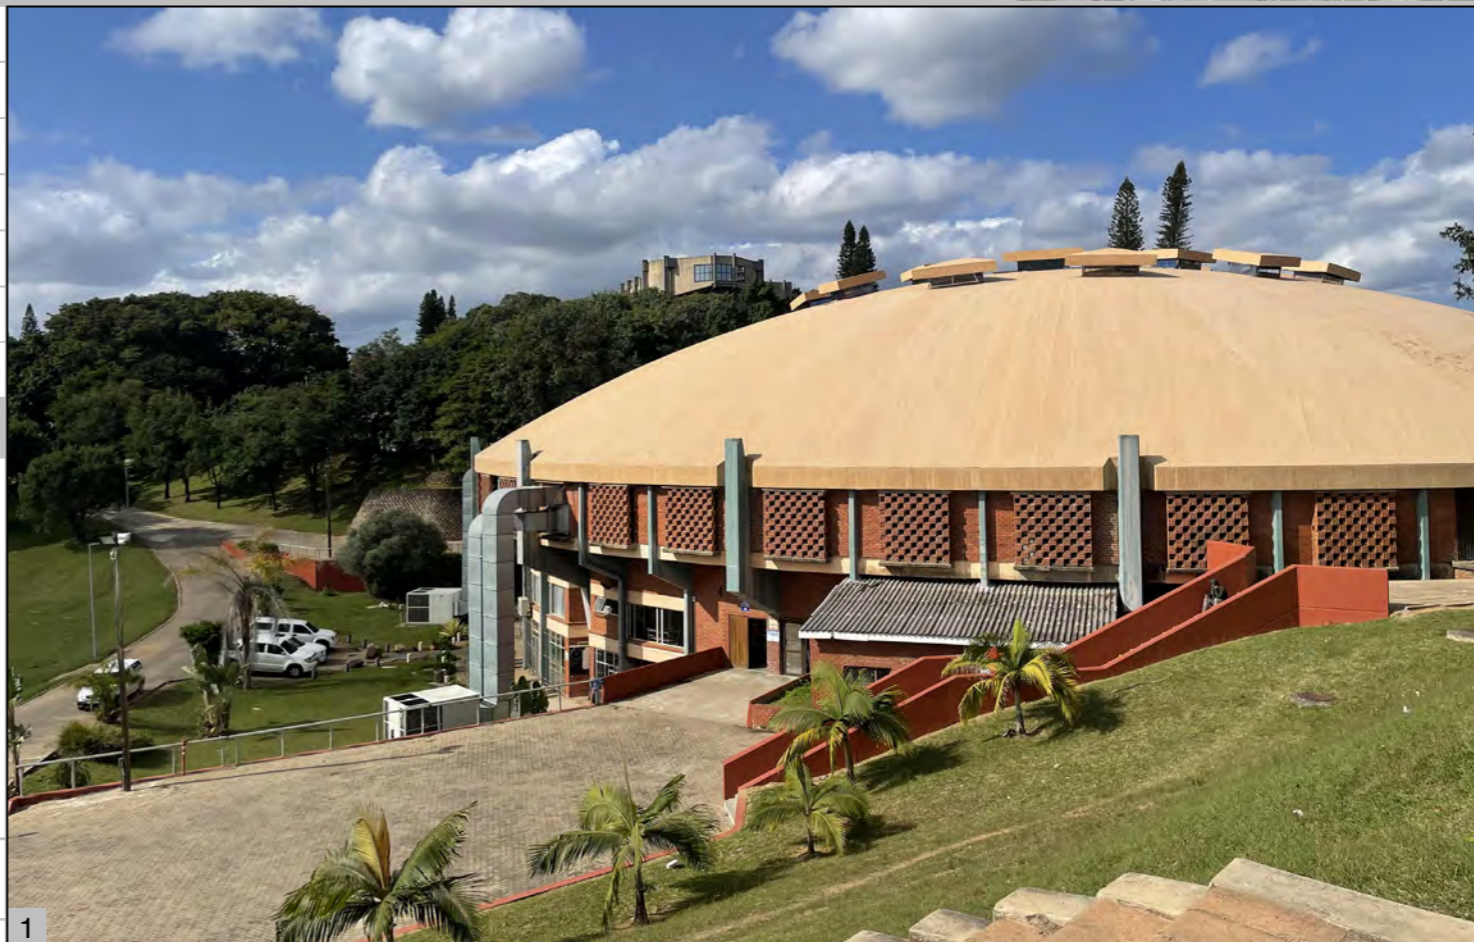
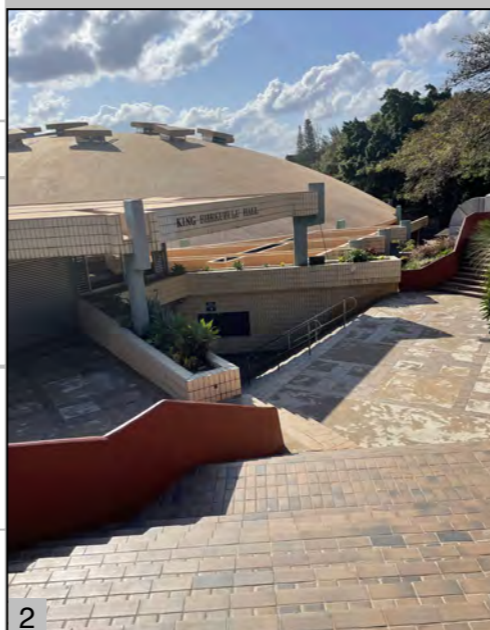
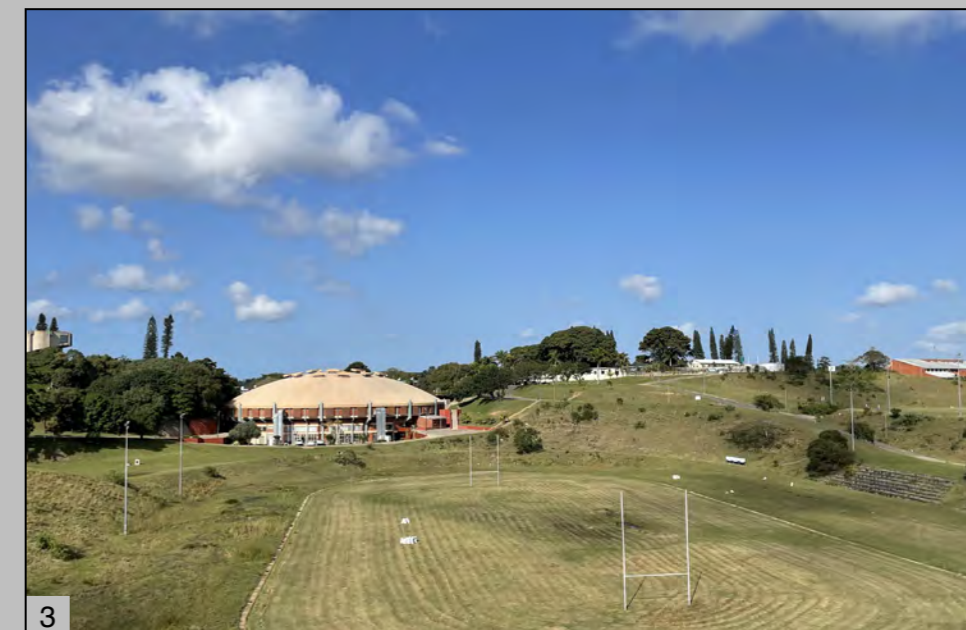
IMAGES: 1 - Western view of Bhekuzulu Hall, showing the stepped site  
 2 - Southern entrance to the Hall  
 3 - View from opposite end of the sports field, showing the lower northern view of the Hall

**RECOMMENDATION:** This building should be graded IIIA, despite it not being older than 60.

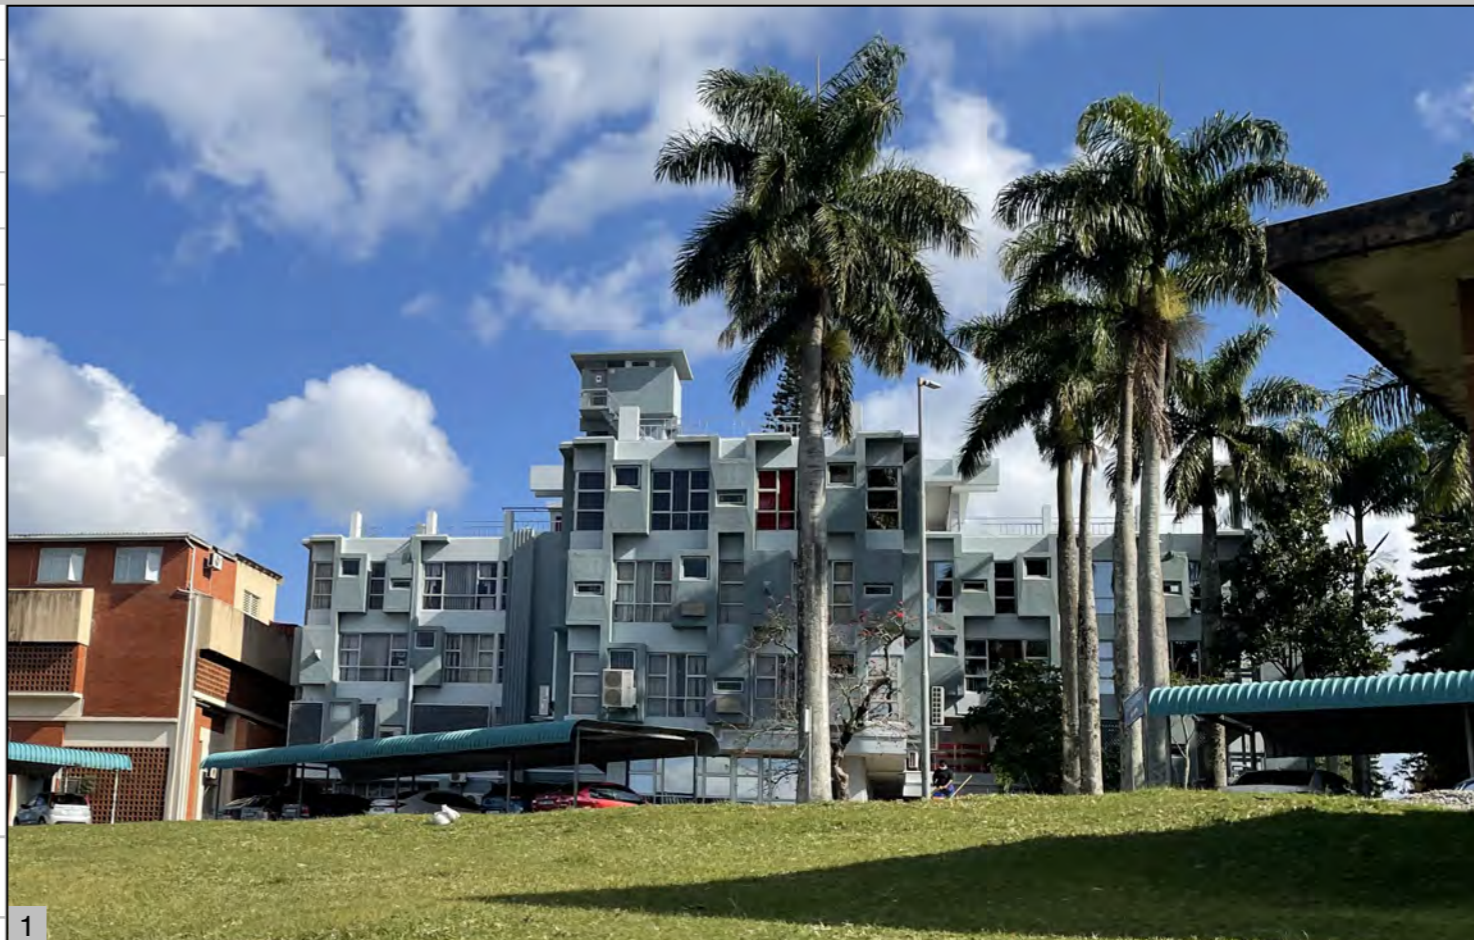
SITE & STRUCTURE DESCRIPTION:	Five storey building with elaborately patterned windows on all facades. This cross-shaped building has a brightly painted plastered exterior, with protruding elements. Located towards the eastern end of the academic core.
PHYSICAL CONDITION:	Good.
STATEMENT OF SIGNIFICANCE:	Although similar to the residential building within the western residence, this building is in far better condition and contributes to the architectural quality of the university.
PROPOSED GRADING:	Grade III C
OPPORTUNITIES & THREATS:	Alterations to the structure should be controlled by the heritage guidelines.
RECOMMENDATION:	The building should be formally listed as Grade III C.
REFERENCES:

IMAGES: 1 - Eastern facade of building  
2 - Detailing of stepped facade  
3 - Northern building facade, as seen from internal street

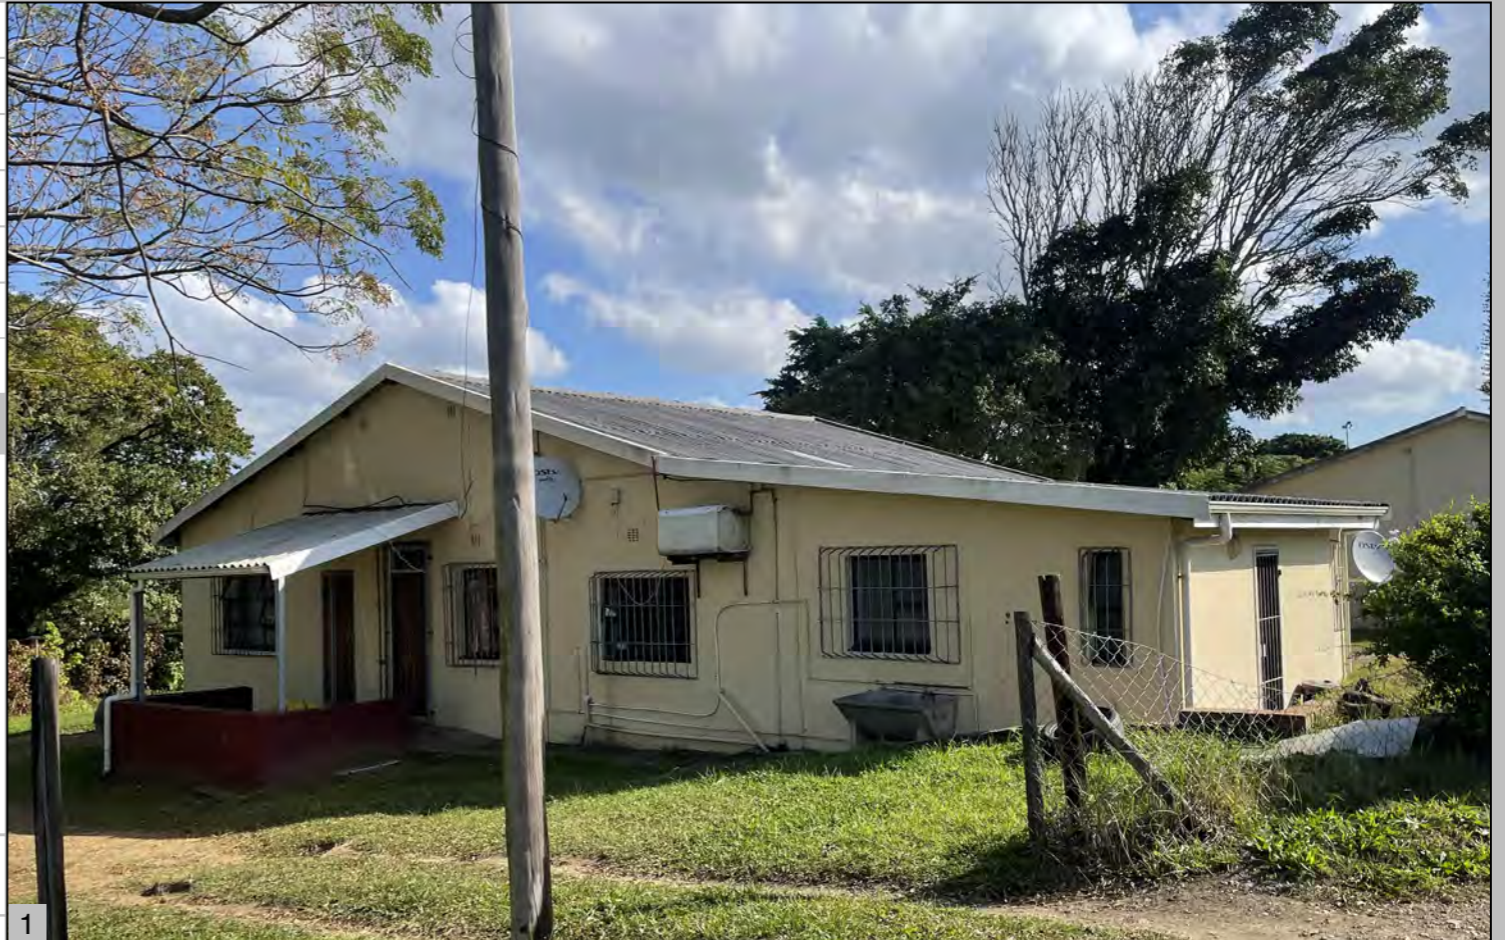
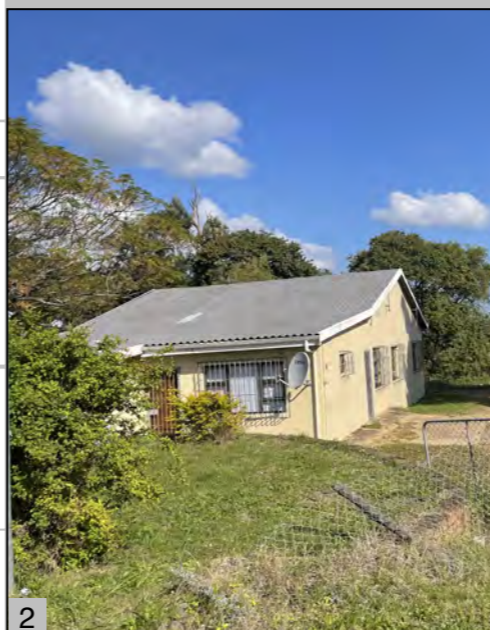
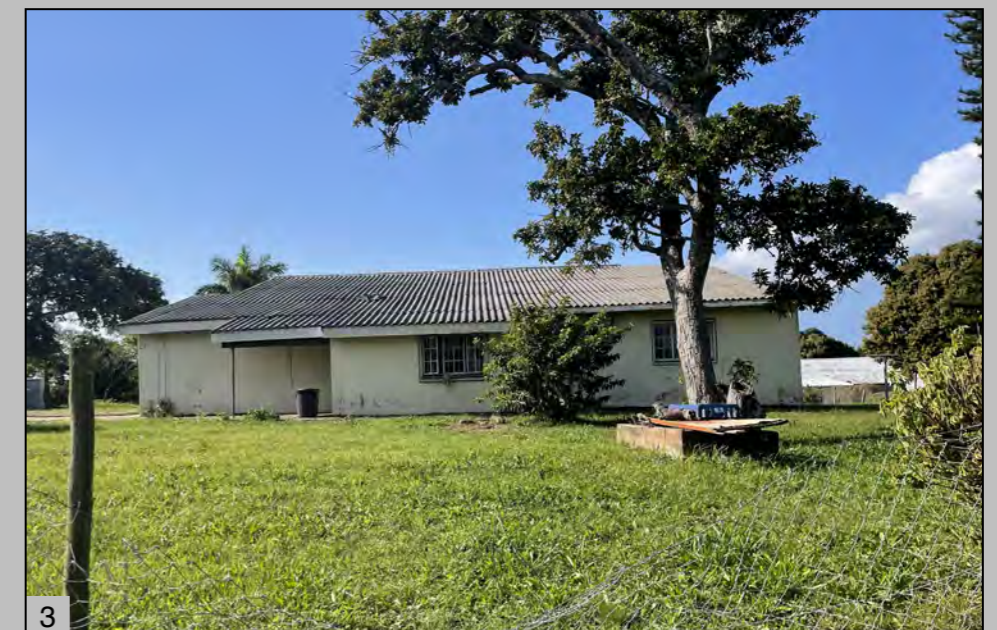
IMAGES: 1, 2 & 3 - Staff residences with vast grass expanses and fences between properties.

**RECOMMENDATION:** This building should be graded Not Conservation Worthy.

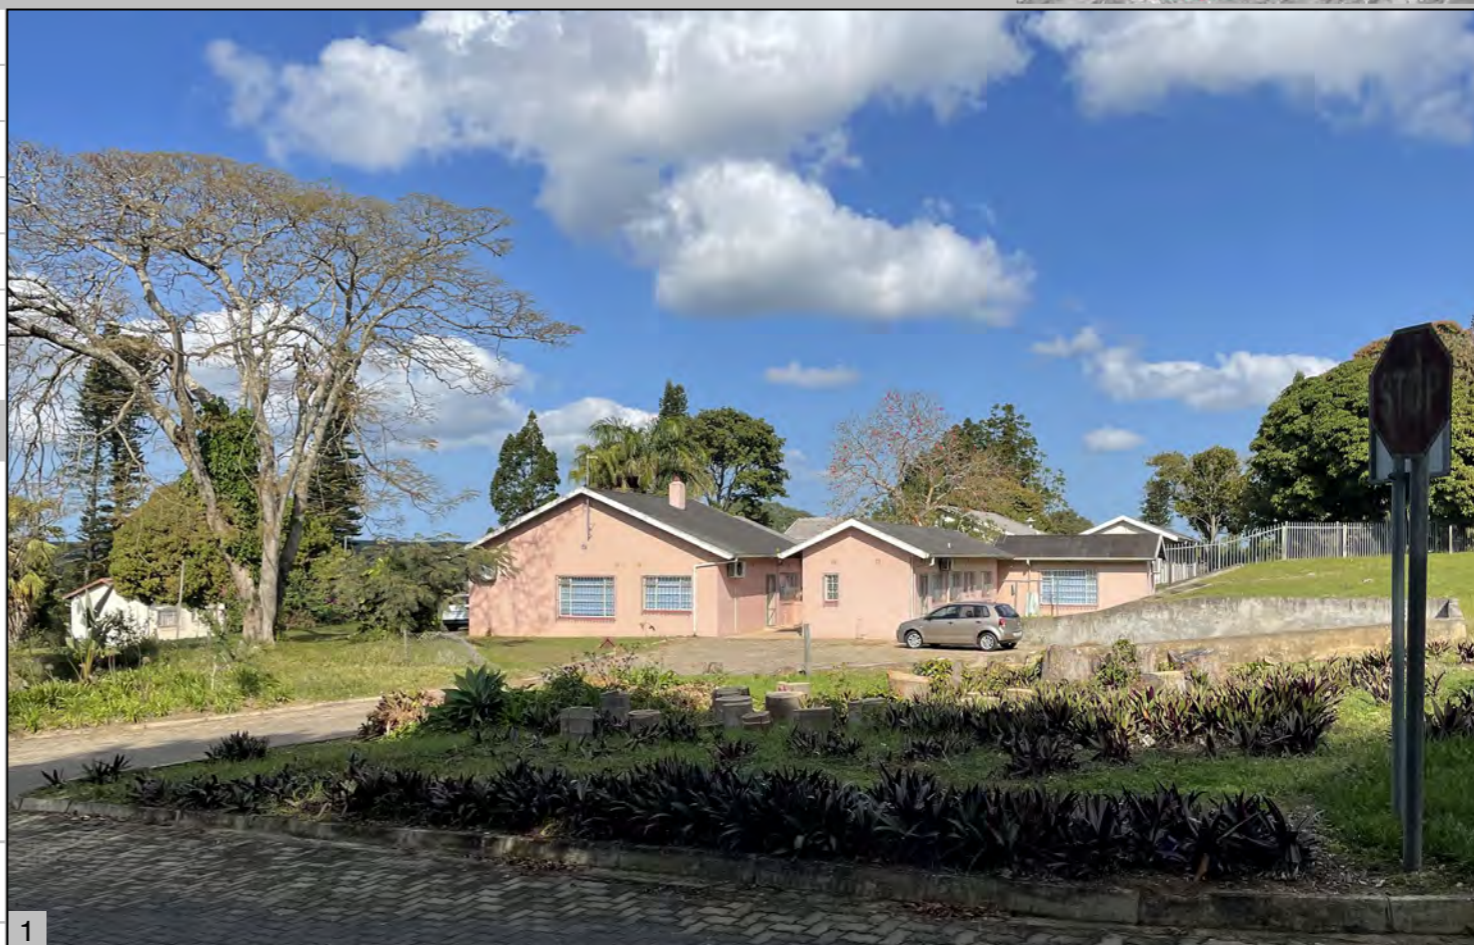
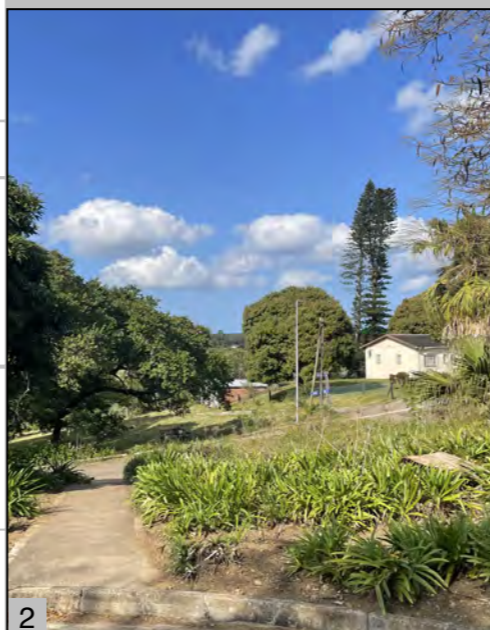
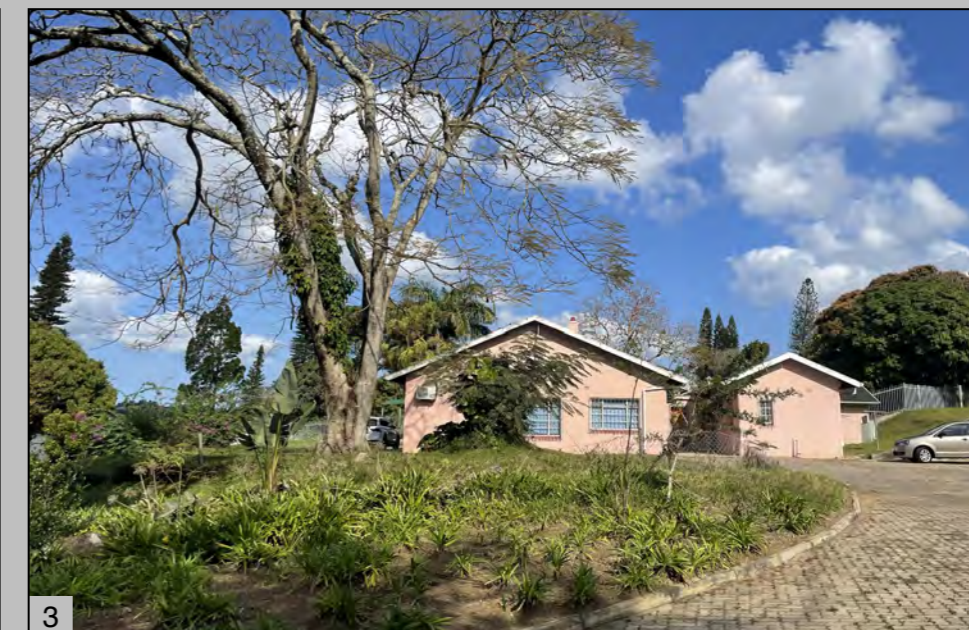
IMAGES: 1, 2 & 3 - Staff residences with gardens and paved driveway

**RECOMMENDATION:** This building should be graded Not Conservation Worthy.

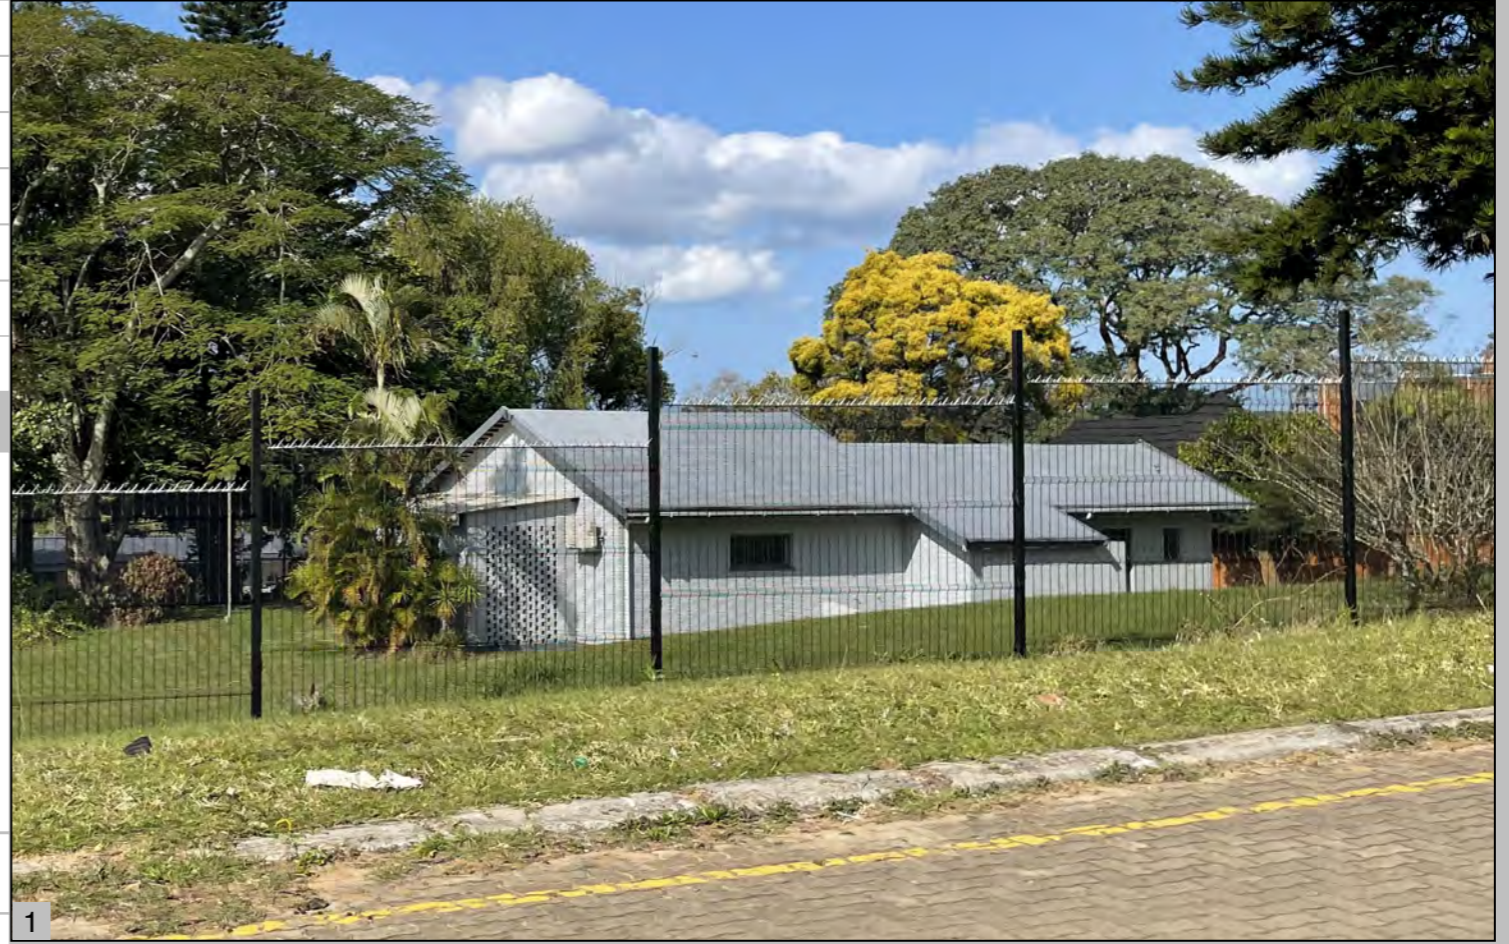
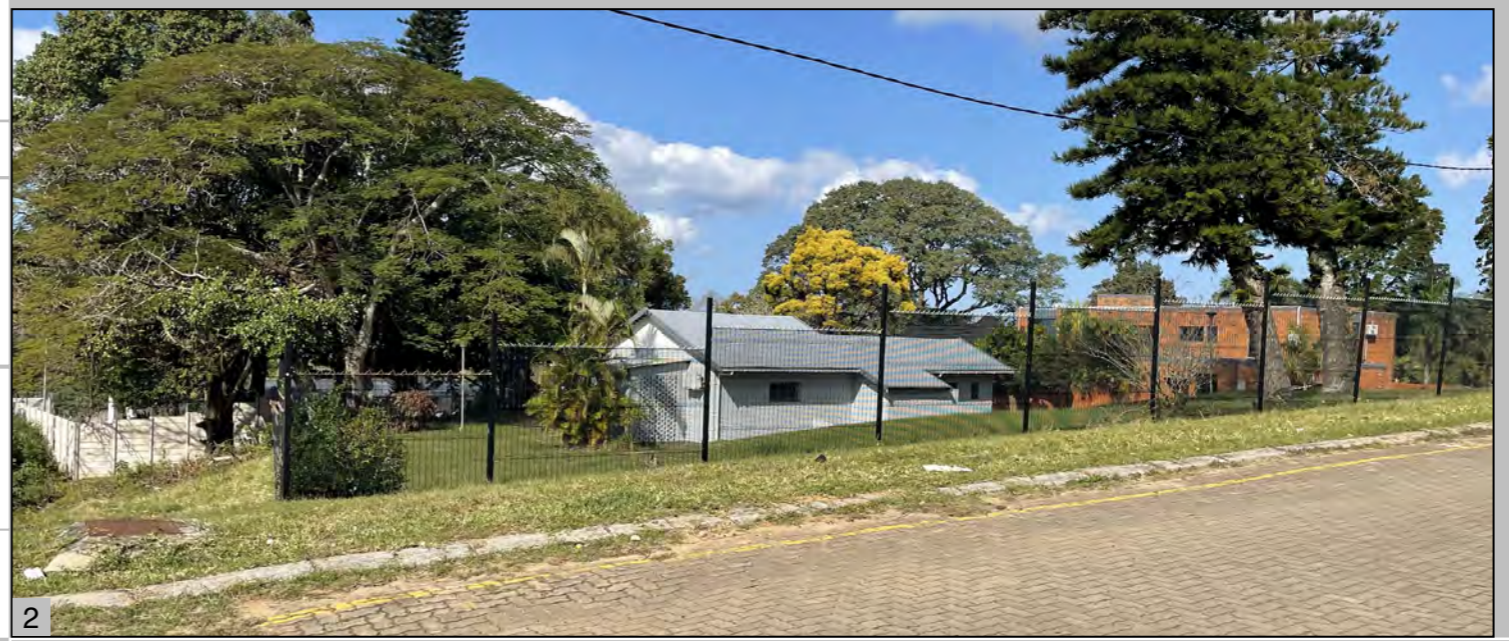
IMAGES: 1 & 2 - Buildings amongst the trees, as seen from university road

**RECOMMENDATION:** This building should be graded Not Conservation Worthy.

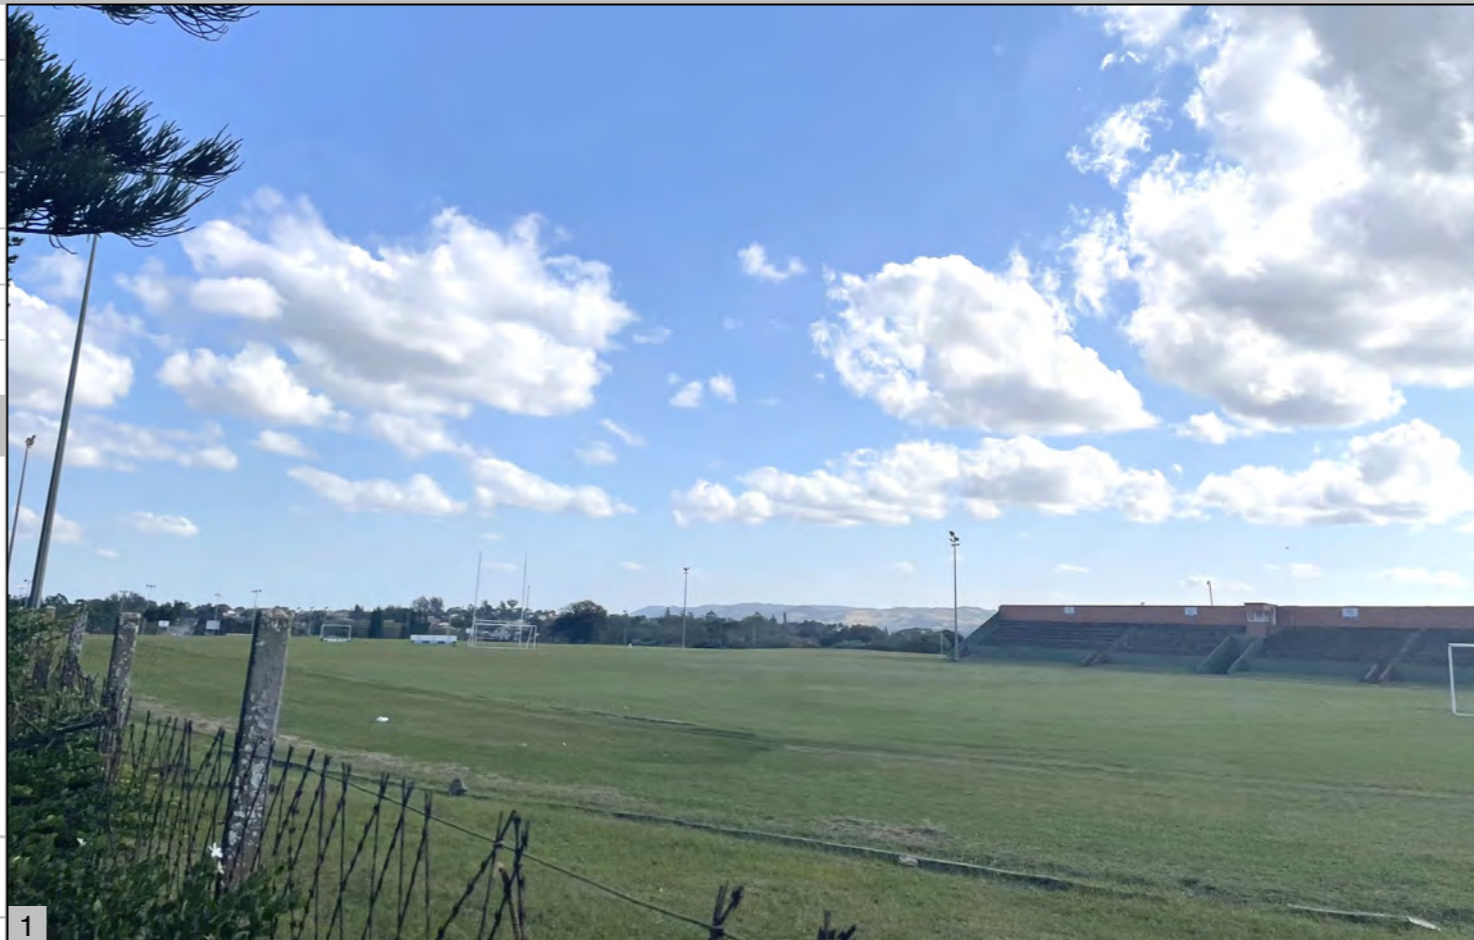
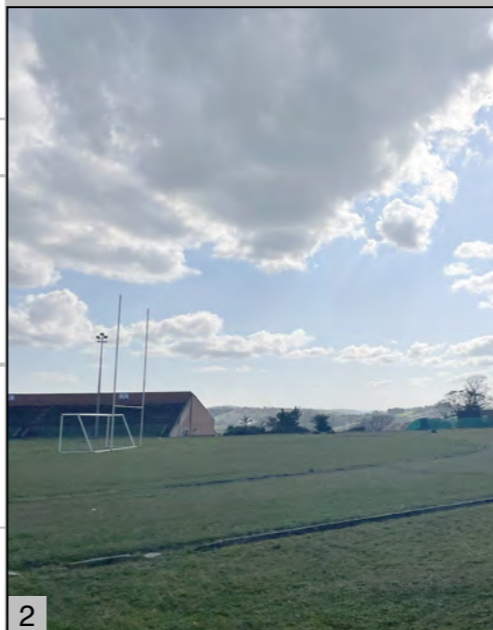
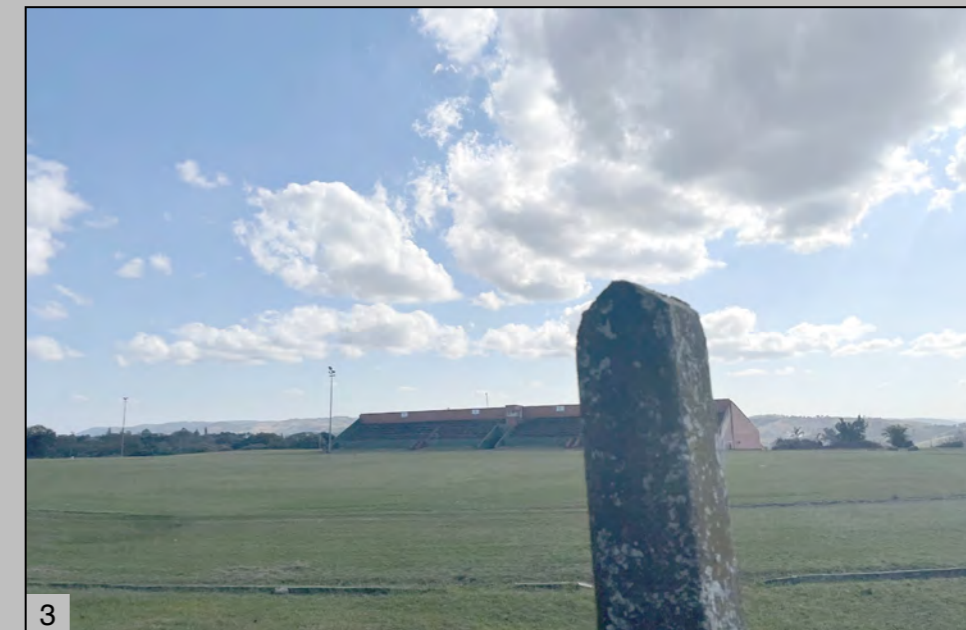
SITE & STRUCTURE DESCRIPTION:	The Human Movement Sciences is constructed of exposed brick and painted concrete. The southern side of the building has been designed as seating that faces onto the soccer field. Located towards the entrance of the university.
PHYSICAL CONDITION:	Good.
STATEMENT OF SIGNIFICANCE:	A good example of Regionalist architecture.
PROPOSED GRADING:	IIIC
OPPORTUNITIES & THREATS:	
RECOMMENDATION:	This building should be graded IIIC.
REFERENCES:

IMAGES: 1, 2 & 3 - Building seen from university avenue across the soccer field
