**UNIVERSITY OF ZULULAND**

BUILDING/S:	Tourism and Recreation, B-Lab
ARCHITECT/S:	Piet Van den Berg
DATE:	c.1960
CURRENT USE:	Academic buildings

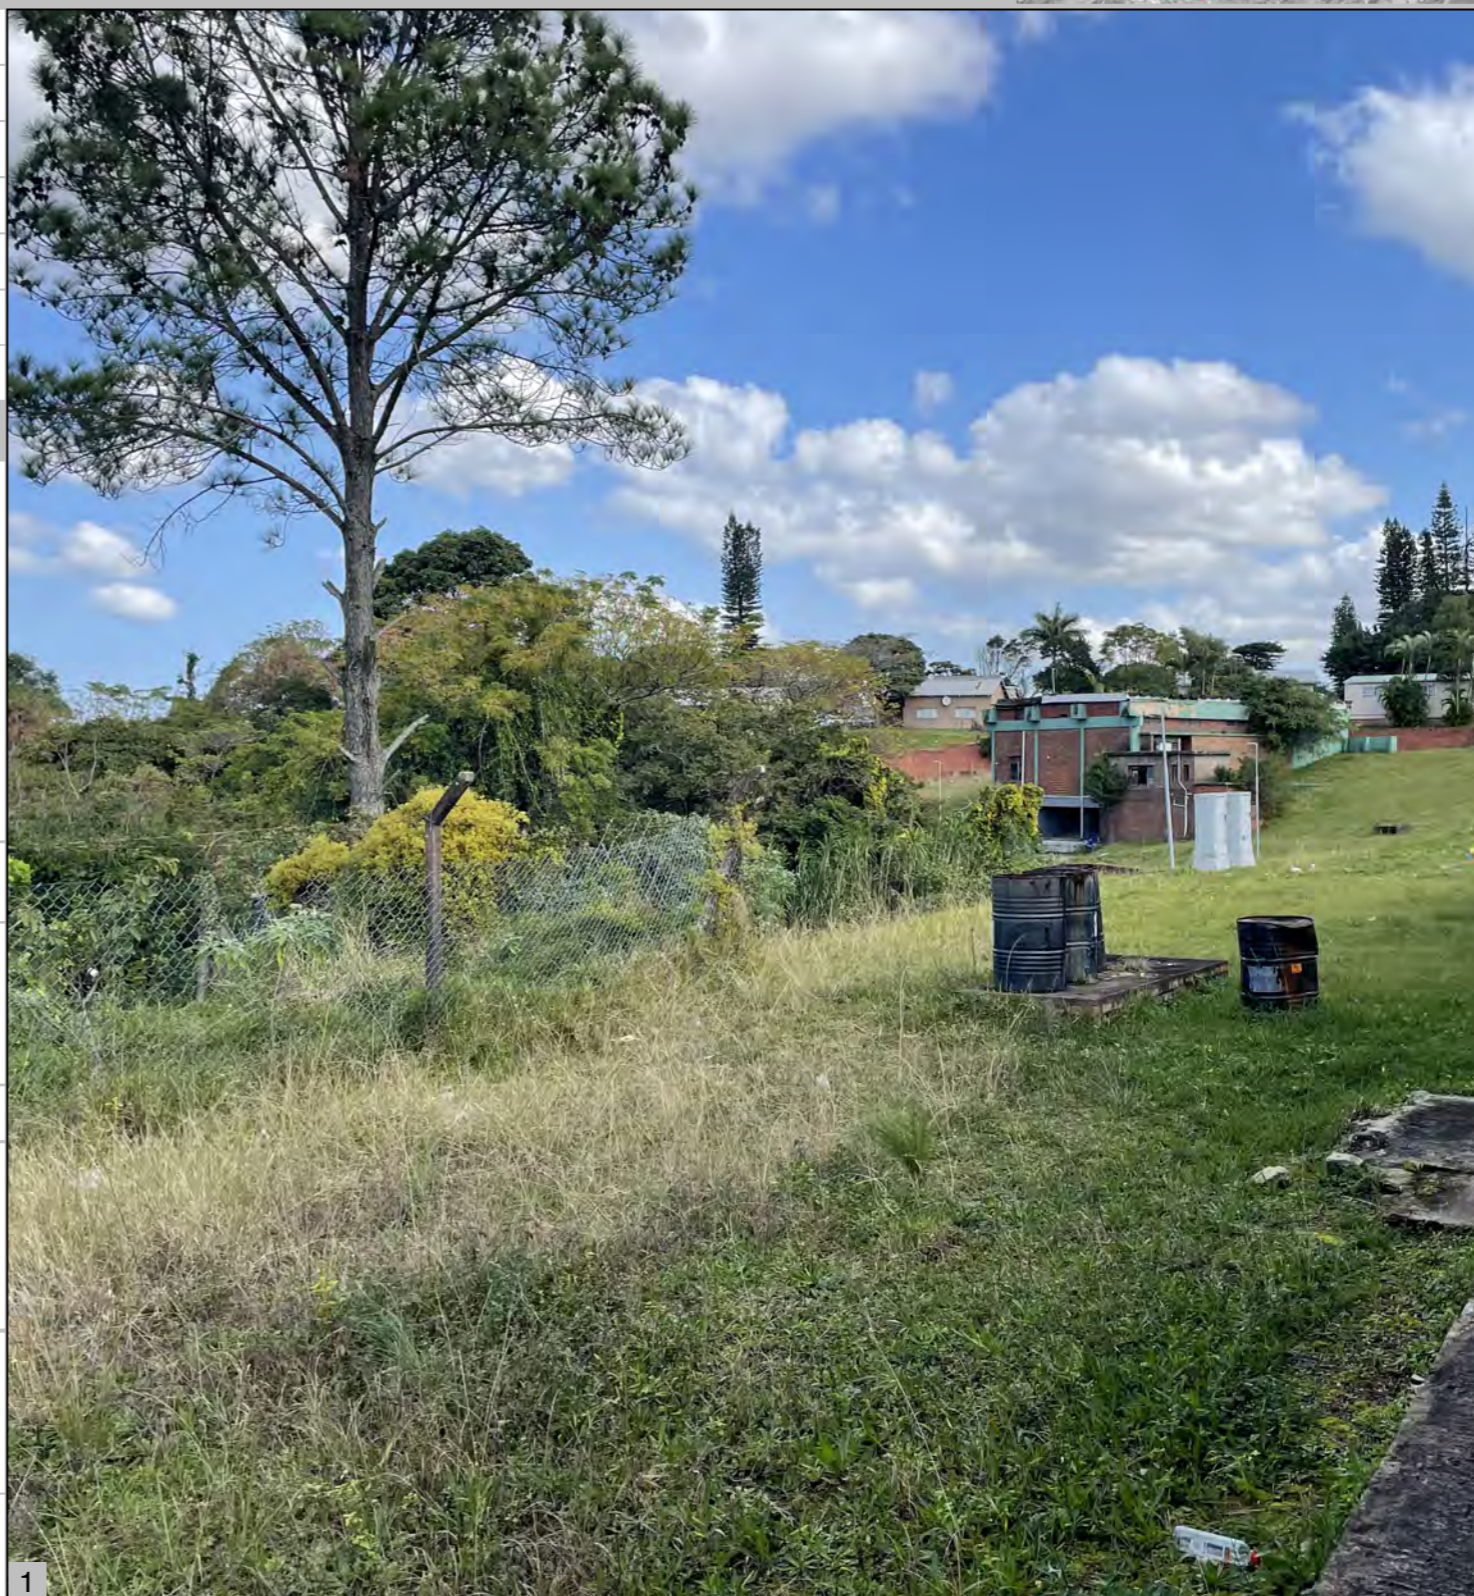
**PHYSICAL CONDITION:** Good.

IMAGES: 1 - Western view of building, showing back facade

**RECOMMENDATION:** This building should be graded Not Conservation Worthy.

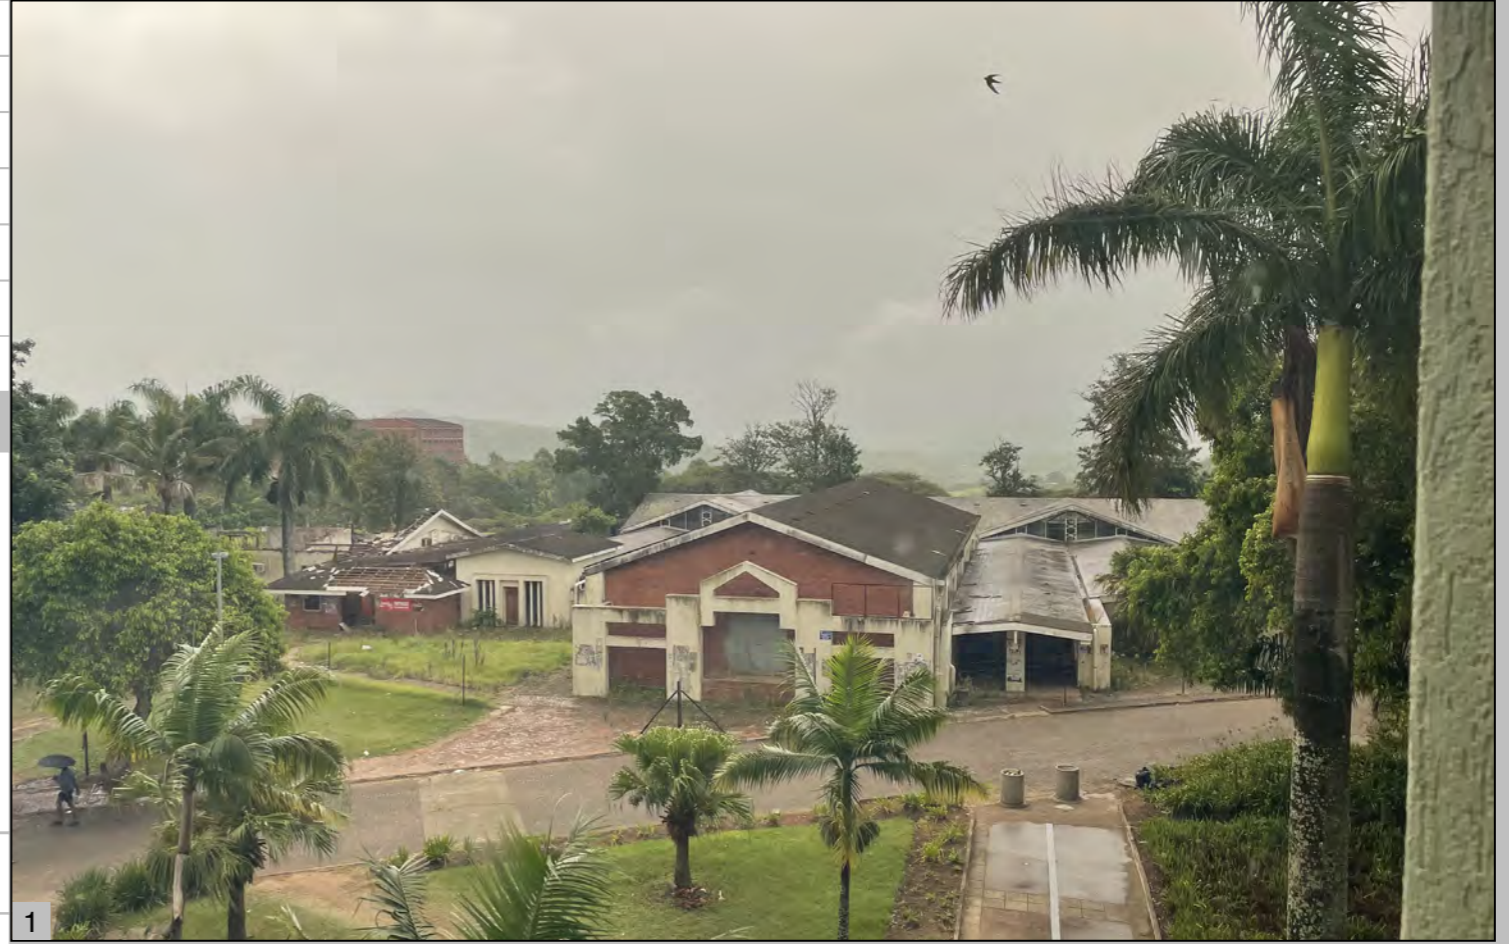
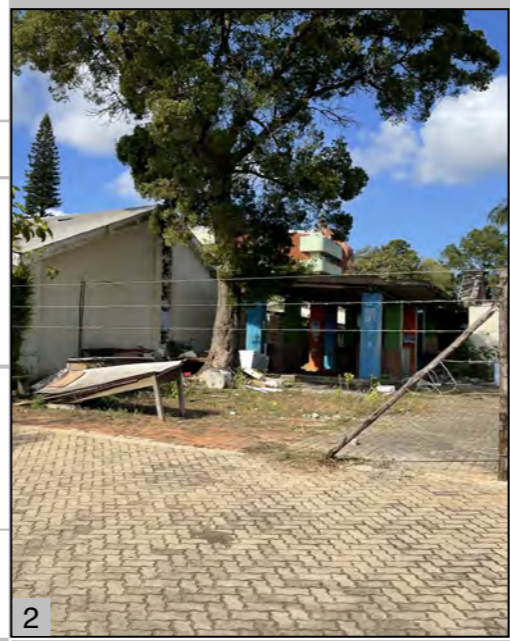
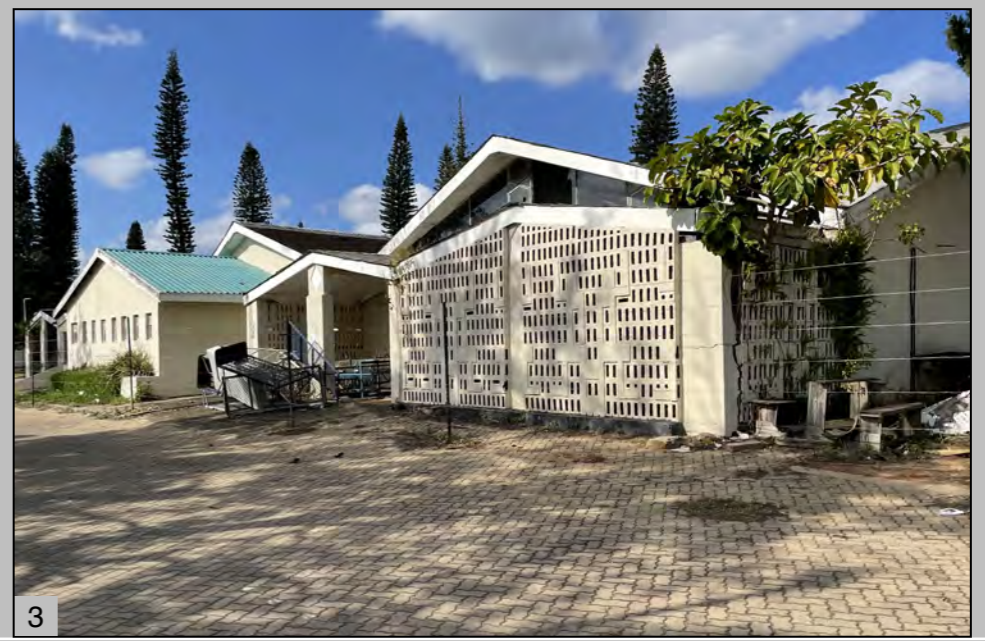
SITE & STRUCTURE DESCRIPTION:	These single storey modest Student Centre and SRC buildings, with decorative brise-soleils and plasterwork patterns match the first academic buildings constructed on the university campus. This cluster of buildings were constructed as part of the first collection of buildings constructed on the university campus. Many of the buildings are in bad condition and not worthy of restoration or retention.
PHYSICAL CONDITION:	Burned down and derelict.
STATEMENT OF SIGNIFICANCE:	The buildings were amongst the first constructed on the UniZulu campus.
PROPOSED GRADING:	Not Conservation Worthy
OPPORTUNITIES & THREATS:	
RECOMMENDATION:	This building should be graded Not Conservation Worthy.
REFERENCES:

IMAGES: 1 - Southern view of derelict student centre, as seen from the library  
 2 - Northern side of building, showing pedestrian link to main avenue  
 3 - Northern end of building

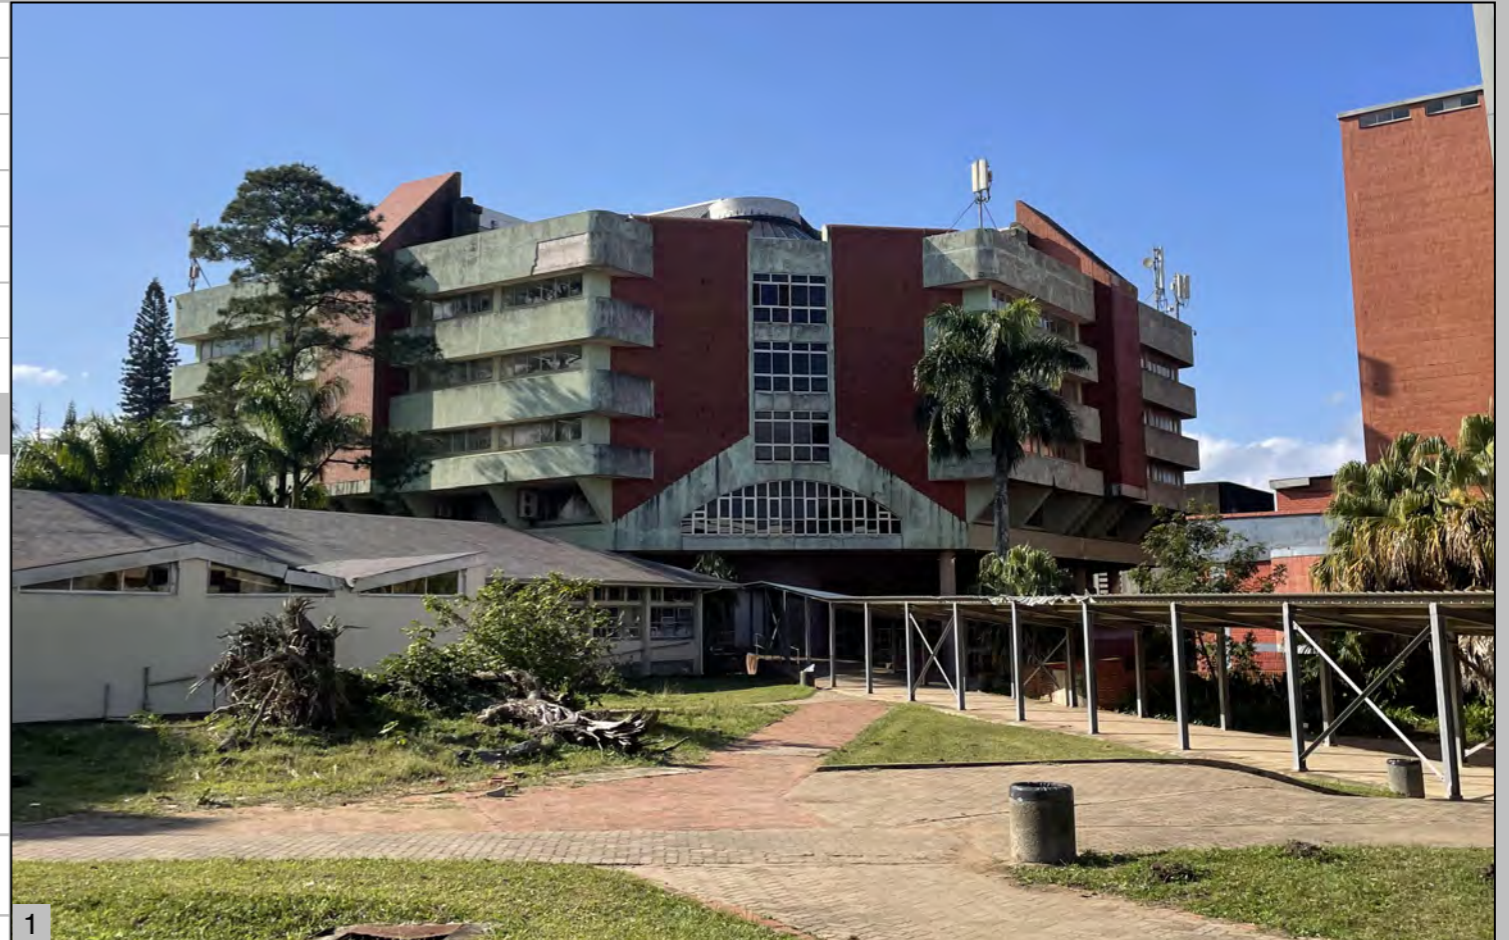
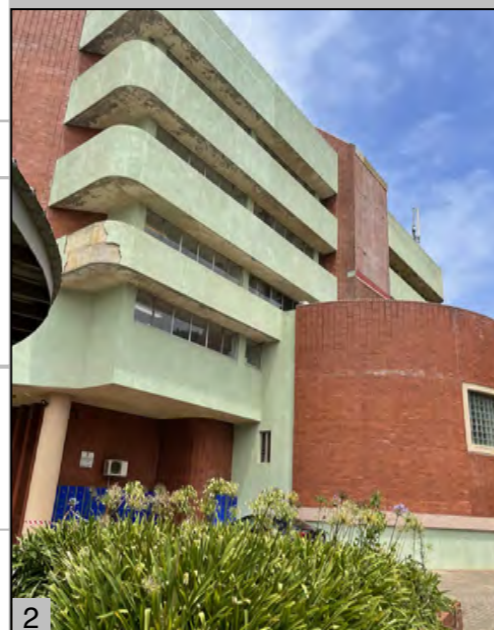
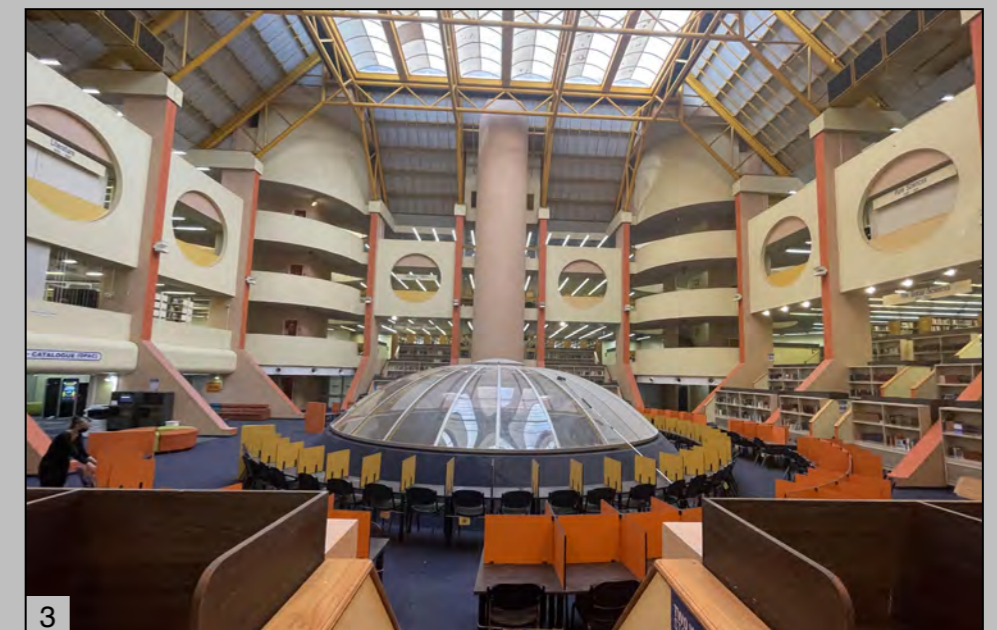
**PHYSICAL CONDITION:** Good.

IMAGES: 1 - Southern view of Library from pedestrian pathways  
 2 - Detail of building  
 3 - Post-modern interior of library

**RECOMMENDATION:** This building should be graded IIIA.
