Annexure 6.3 Interior annotated photographs

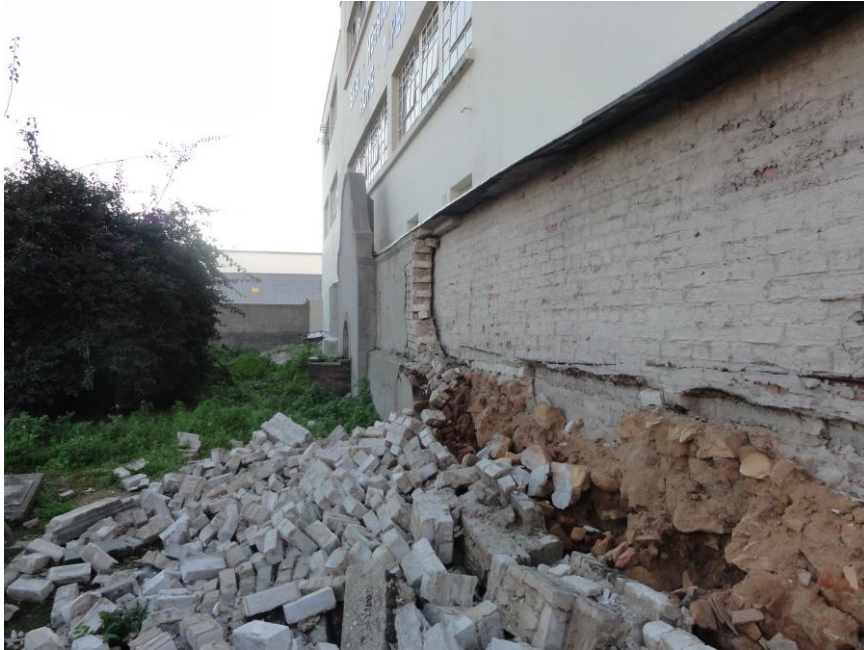
Fig 1. View of the eastern wall looking towards the northern wall. This show the collapse of the cement bricks built on top of the old stone wall. The cement bricks have been cleared.

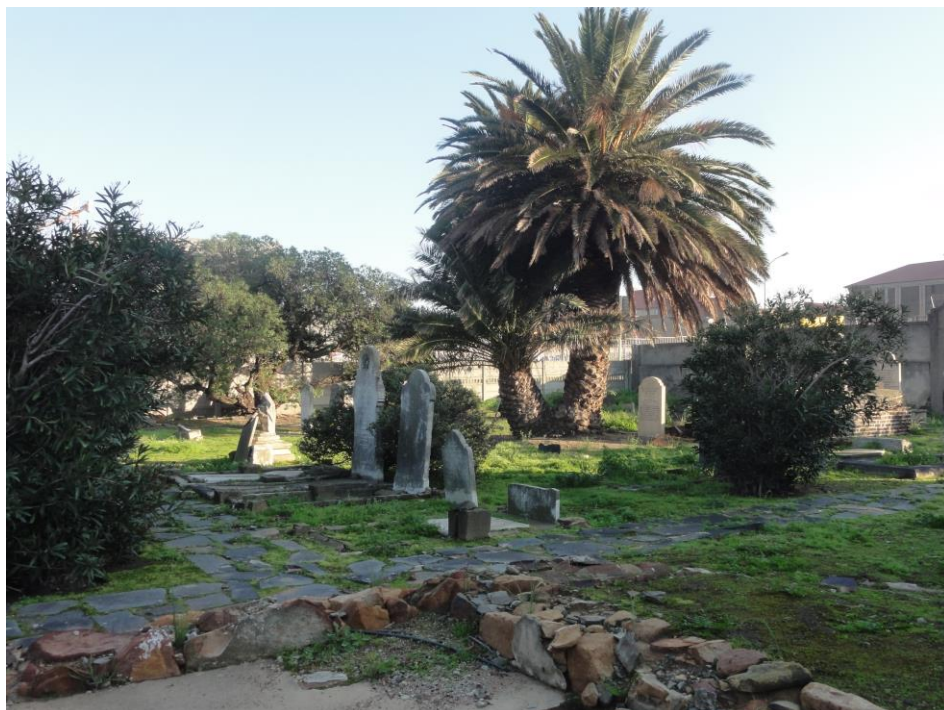
Fig 2. View of the interior of the cemetery looking towards lower Church Street and the bridge. Certain paths are created from old stone. There is a list of those buried at the cemetery although sometimes the gravestones are illegible because of age.

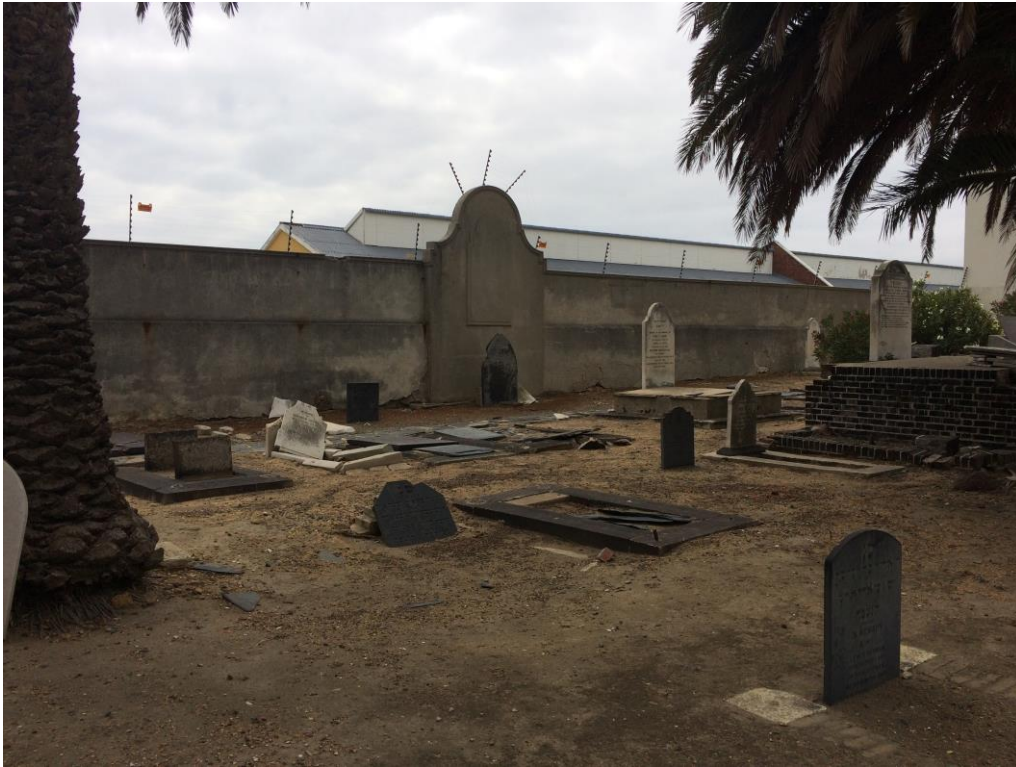
Fig 3. photograph of the interior of the cemetery looking towards the north wall (2022) which has now partially collapsed.

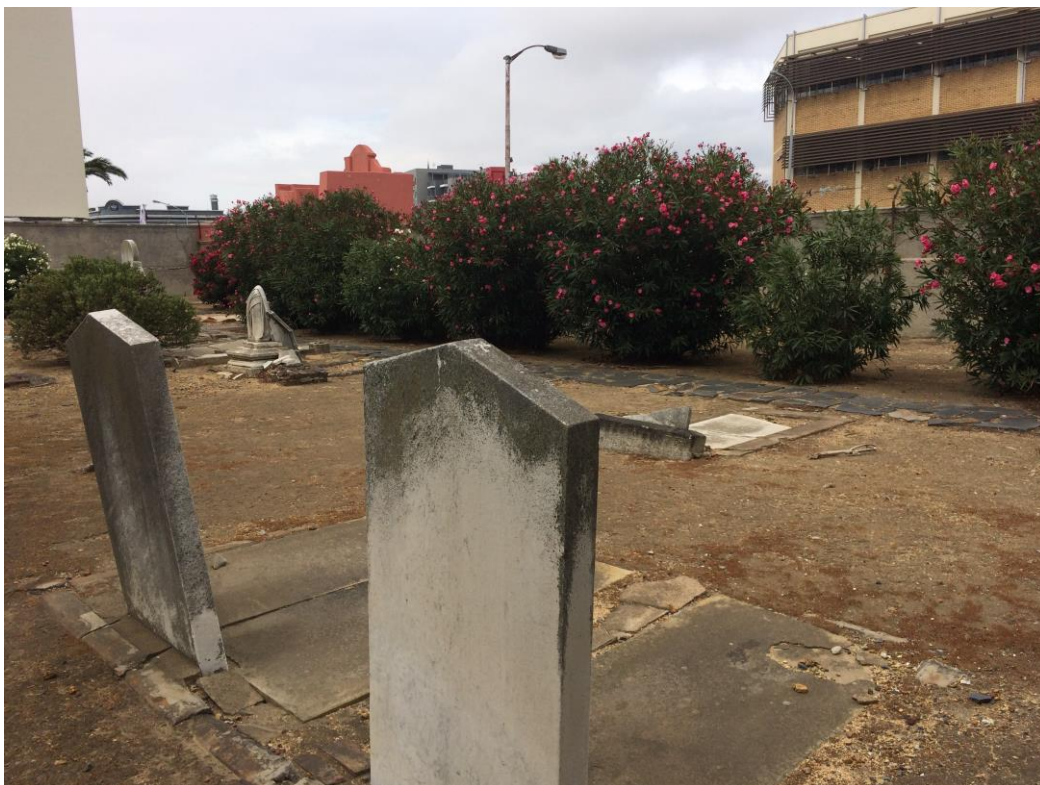
Fig 4. View of the interior of the cemetery looking south-east towards Albert Road. The area is partially screened from the traffic noise by a row of oleanders.

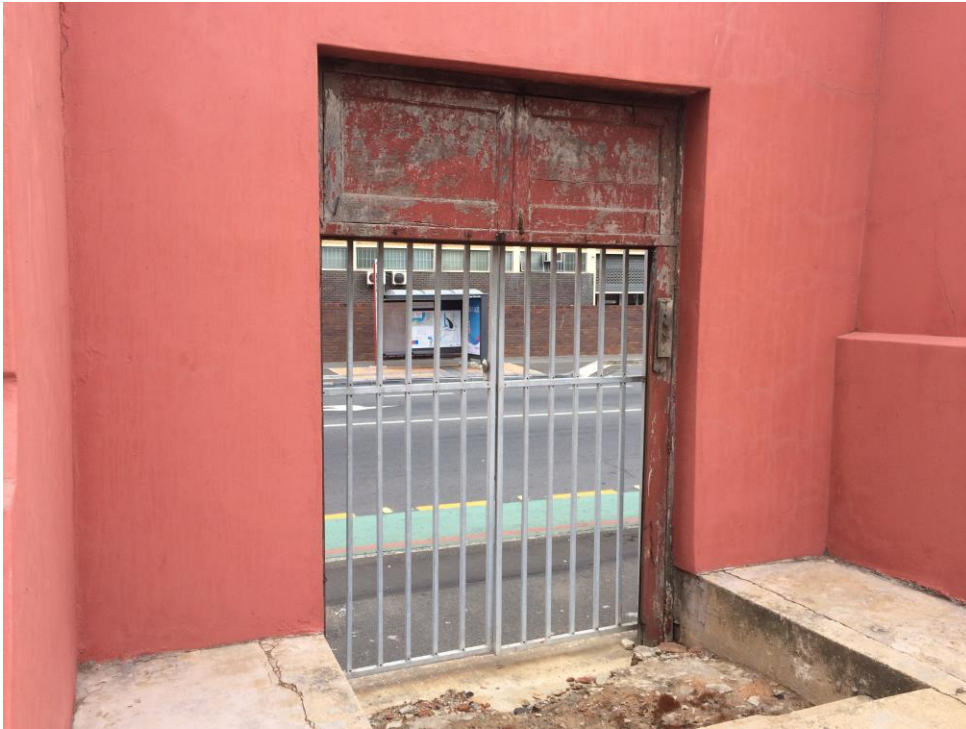
Fig 5. The Cemetery entrance off Albert Road with security gate.

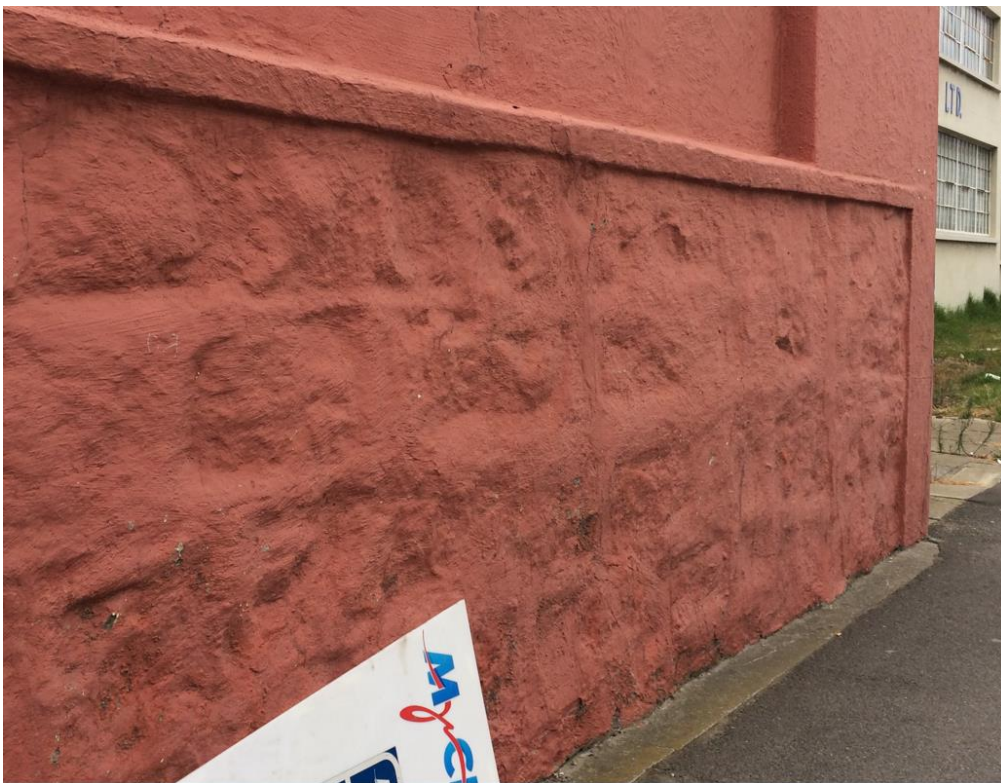
Fig 6. The old stone perimeter wall off Albert Road.
