# REHABILITATION AND FLOODPLAIN RESTORATION PLAN

## MONTANASPRUIT UPGRADE

Prepared for:  
TGM CONSULTING  
For  
City of Tshwane Metropolitan Municipality

Prepared by:  
Strategic Environmental Focus (Pty) Ltd  
P.O. Box 74785  
LYNWOOD RIDGE 0040  
Tel. No.: (012) 349-1307  
Fax. No.: (012) 349-1229  
e-mail: sef@sefsa.co.za

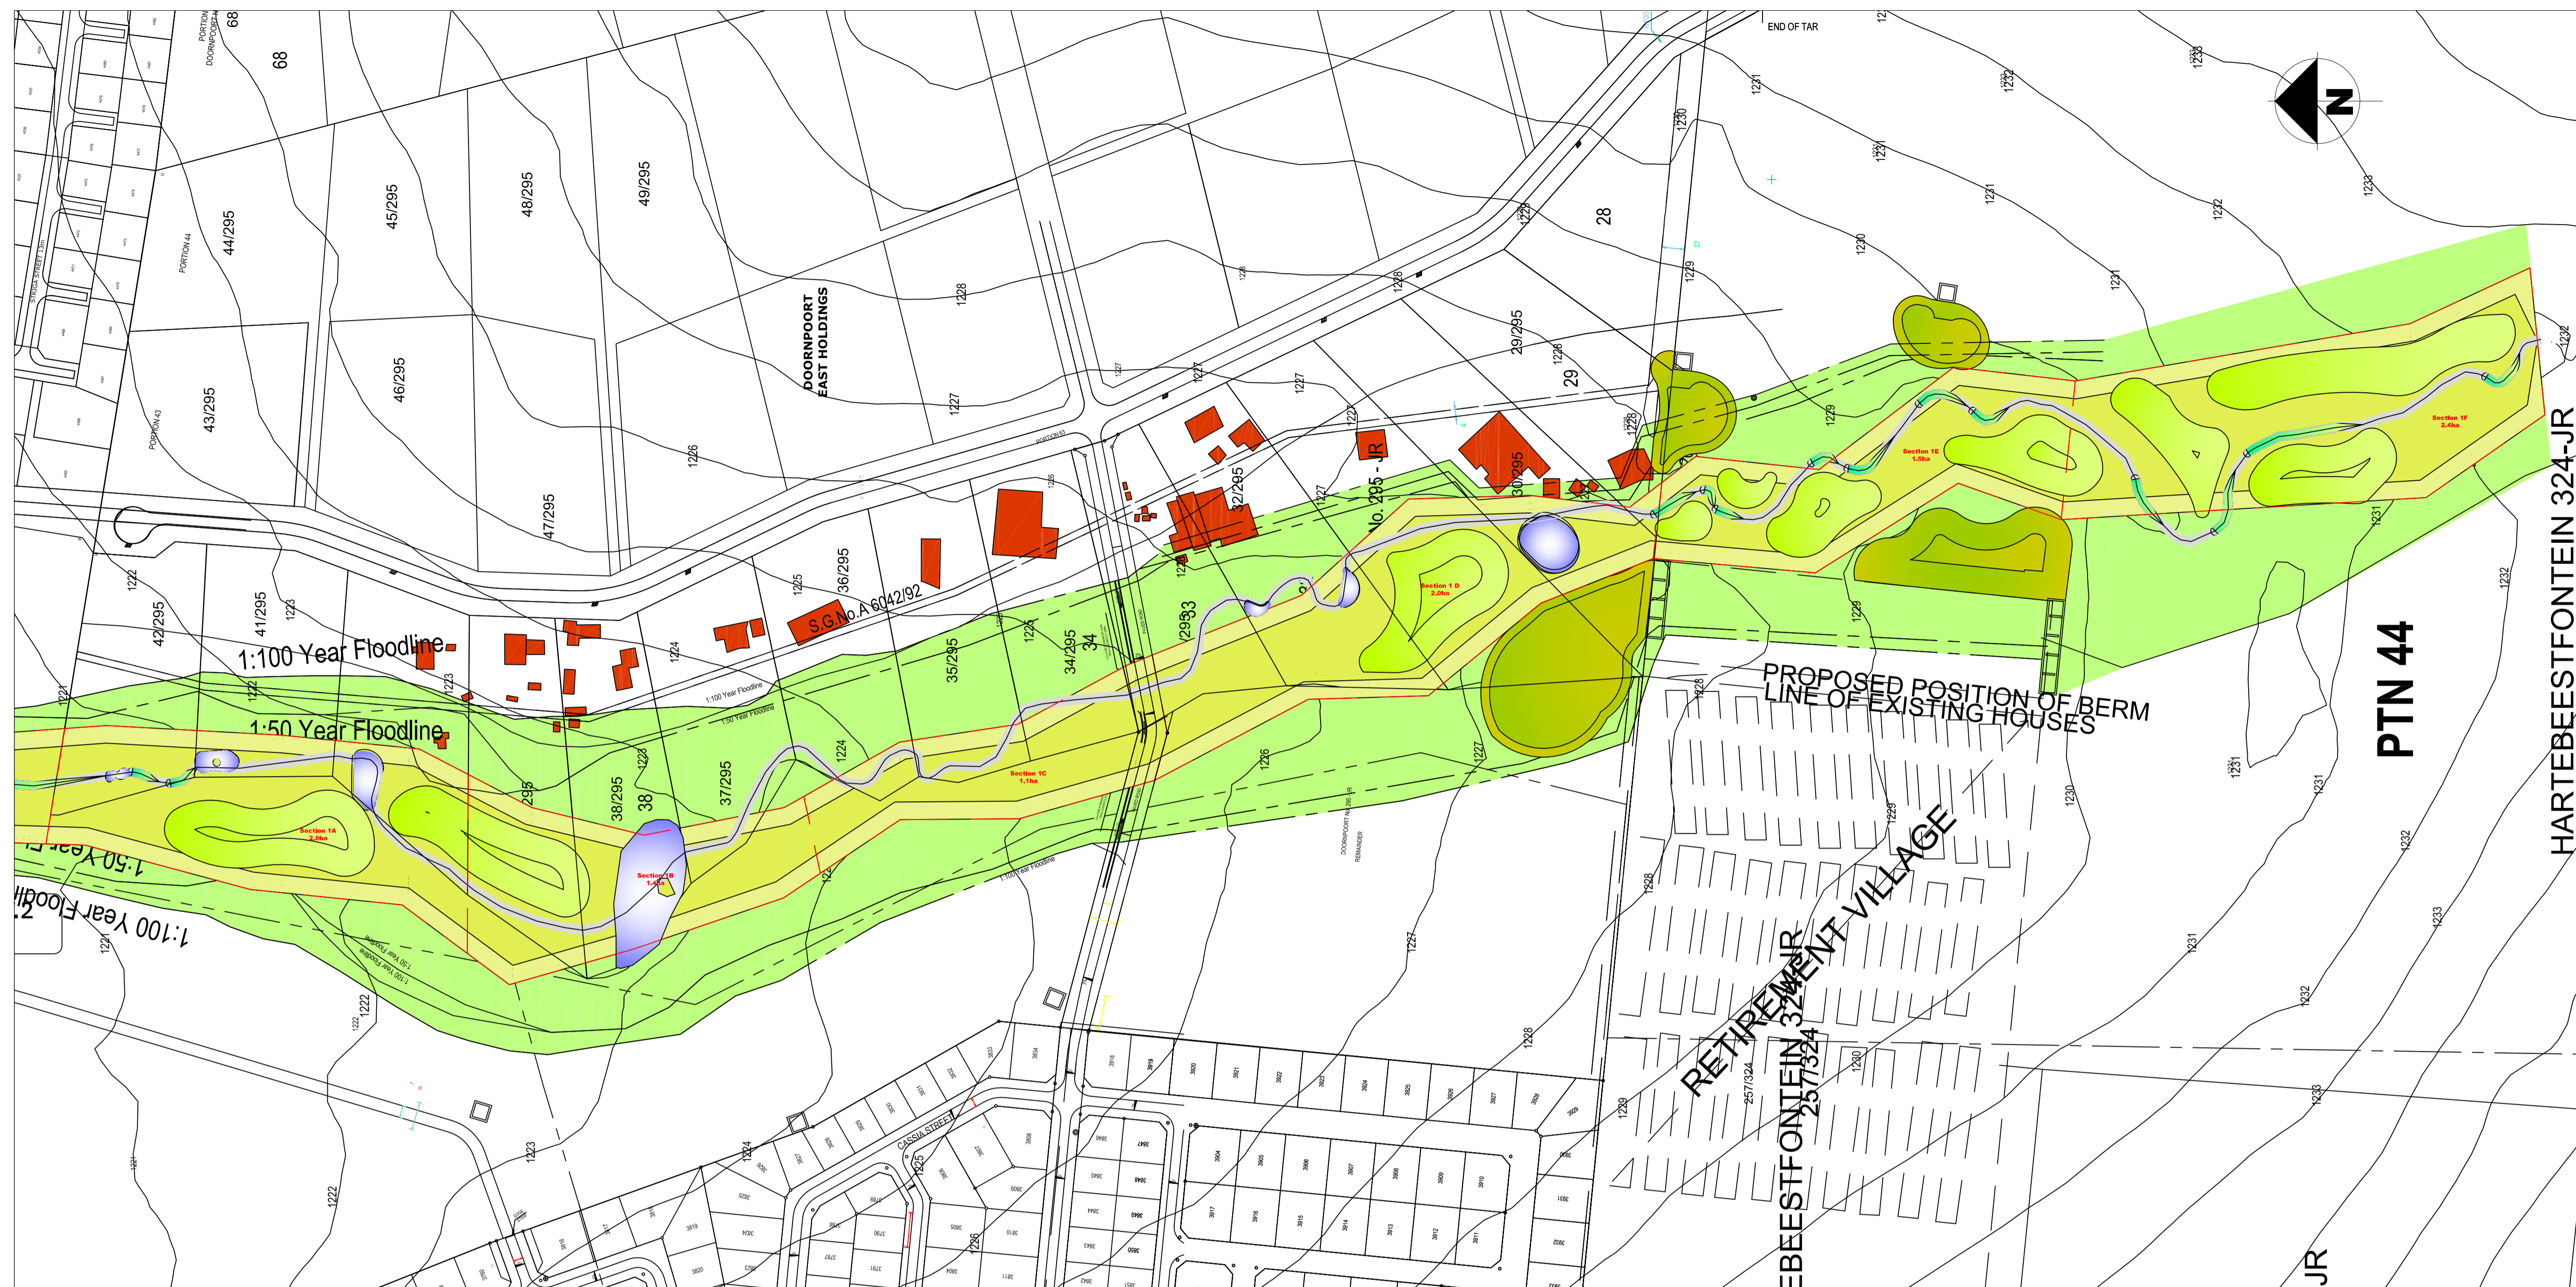
### REHABILITATION AREAS SCALE 1:200

- ### REHABILITATION INTERVENTIONS
- Shallow attenuation feature within widened channel max 300mm depth & 1:50 slope. See Detail 1.
  - Shallow attenuation feature outside of widened channel max 500mm depth & 1:20 slope. See Detail 2.
  - Armoxflex lining along existing watercourse alignment.
  - Aquatic refuge along Armoxflex lined watercourse. See Detail 3.
  - Widened channel along Montan Spruit watercourse.
  - Existing small dams and pools to be retained as permanent aquatic refuges.
  - Proposed silt traps at stormwater pipe and channel outlets.

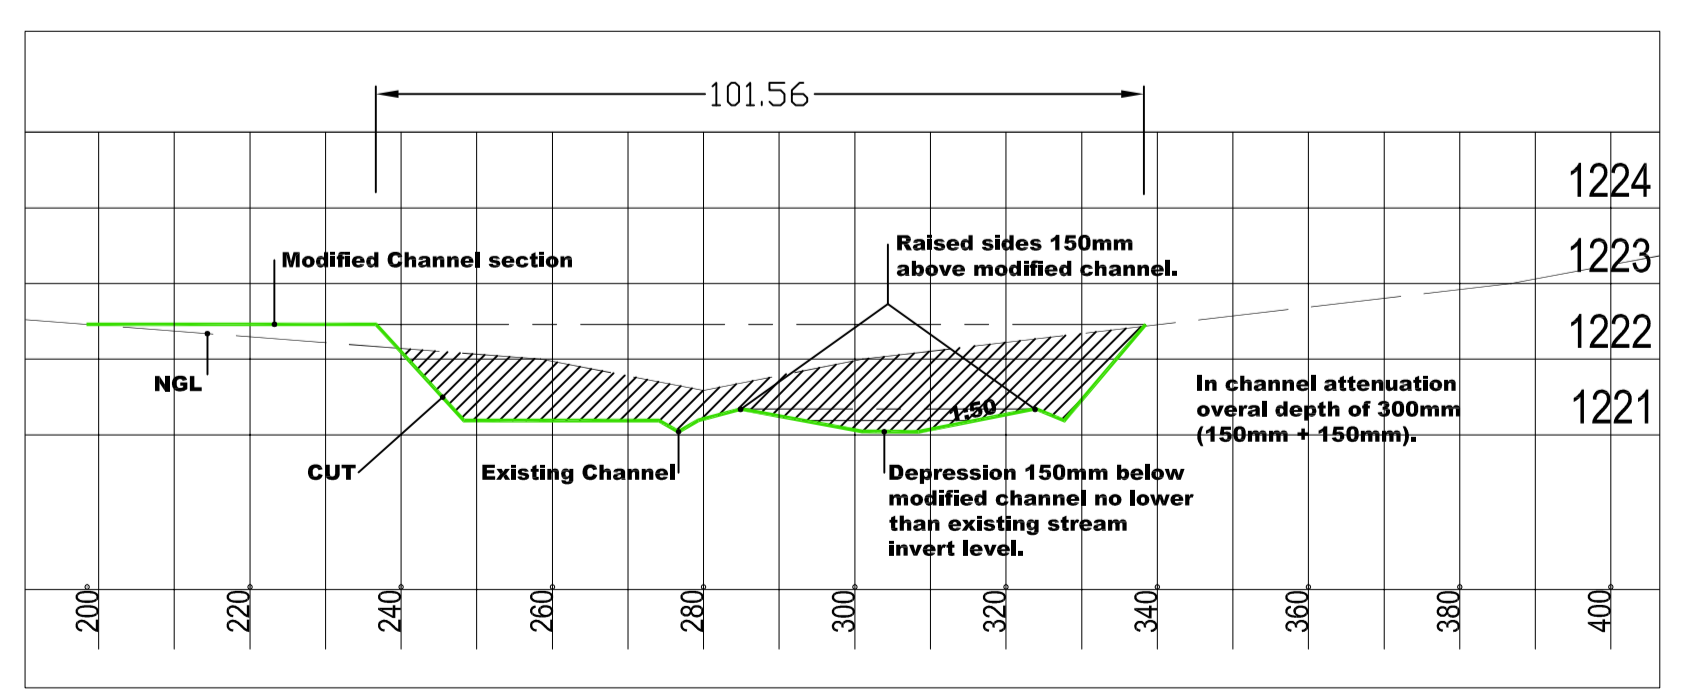
**Typical section**  
**Scale: Hor 1:1000 - Vert 1:100**  
**DETAIL 1:**  
**IN CHANNEL ATTENUATION**

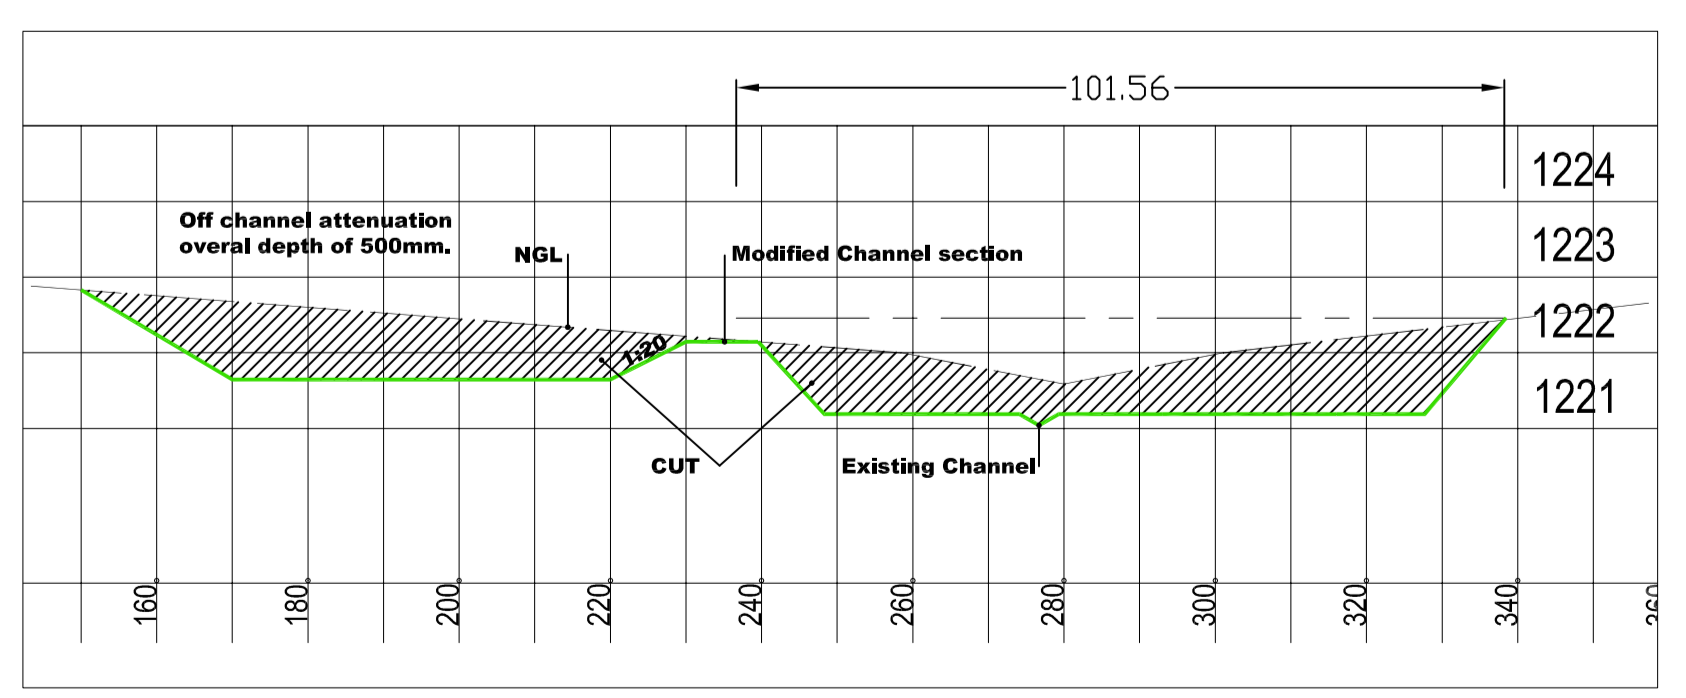
**Typical section**  
**Scale: Hor 1:1000 - Vert 1:100**  
**DETAIL 2:**  
**OFF CHANNEL ATTENUATION**

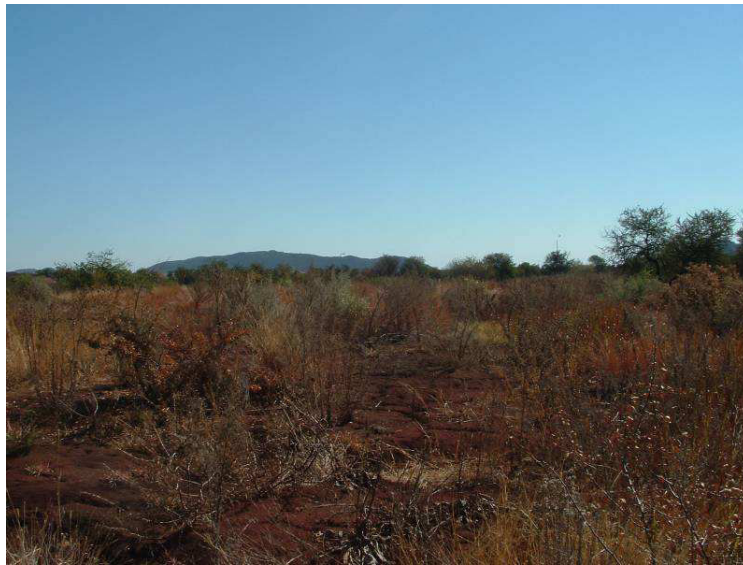
**Photograph 4: Floodplain invaded by pioneers**

- The functionality of this system has been and continues to be degraded which was confirmed by a Riparian Vegetation Index [RVI] assessment.
- The flooding on site has caused vegetation removal and has opened a niche (within the floodplain) for colonisation by exotic pioneer plants.
