# **CONFINEMENT OF MONTANASPRUIT**

## **REVIEW** **REHABILITATION PLAN**

**Review of the Existing Rehabilitation Plan for the Proposed Confinement  
of the 1:100 Year Floodplain of the Montanaspruit on Portions 28 to 42,  
137 & 138 of Doornpoort 295 JR, City of Tshwane, Gauteng Province**

**JULY 2019**

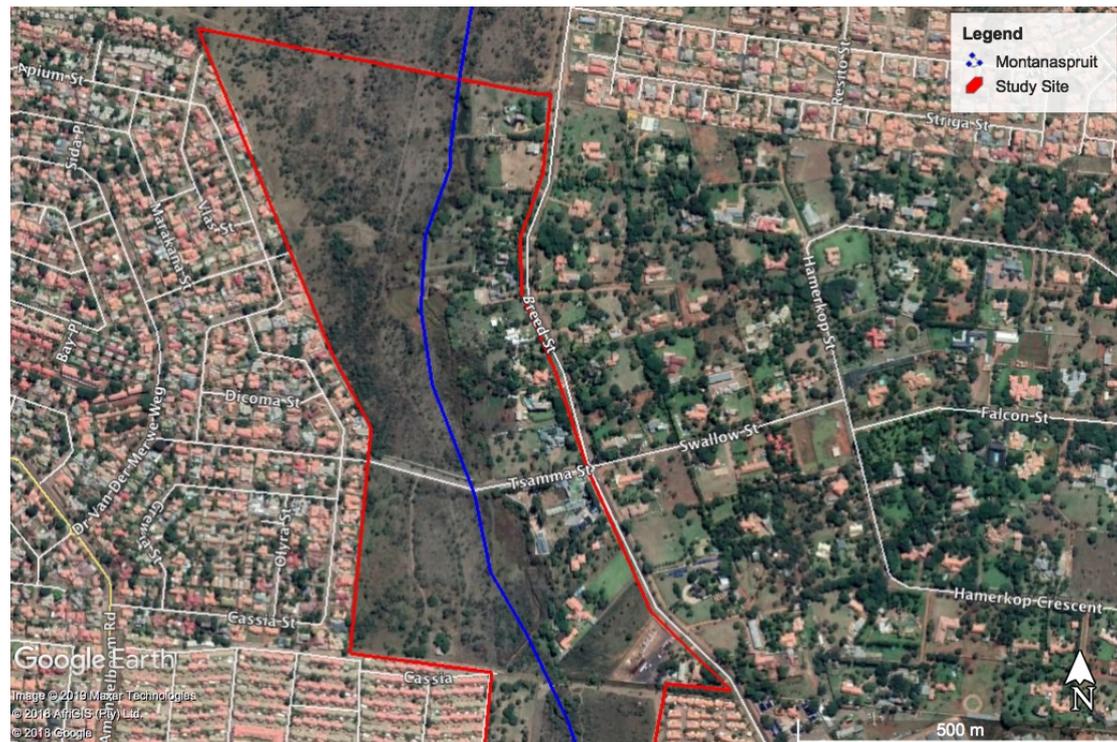
Figure 2: Study site and Montanaspruit

Over the past 11 to 12 years (2007 – 2019) the areas to the south (in particular) and to the east of the study site have increased in terms of urbanisation, while areas in the north have not altered much as can be seen in satellite images taken over the years. The Montanaspruit (Montana Stream) is the only watercourse that flows through the study area, from south to north (Figure 2). The rehabilitation focuses in particular on the study area where upgrade and construction activities on the Montanaspruit will be centered. The fundamental reason for the proposed project of confining the Montanaspruit (and thereby also reducing the floodlines and floodplains of the stream) is to alleviate the flooding of nearby properties and streets. Many of the proposed upgrade and confinement activities will take place directly within the watercourse, riparian area and floodplains. These activities will lead to disturbances and alterations of the characteristic of the watercourse. It was therefore imperative that a rehabilitation plan is compiled and that findings and recommendations are implemented as part of the project.

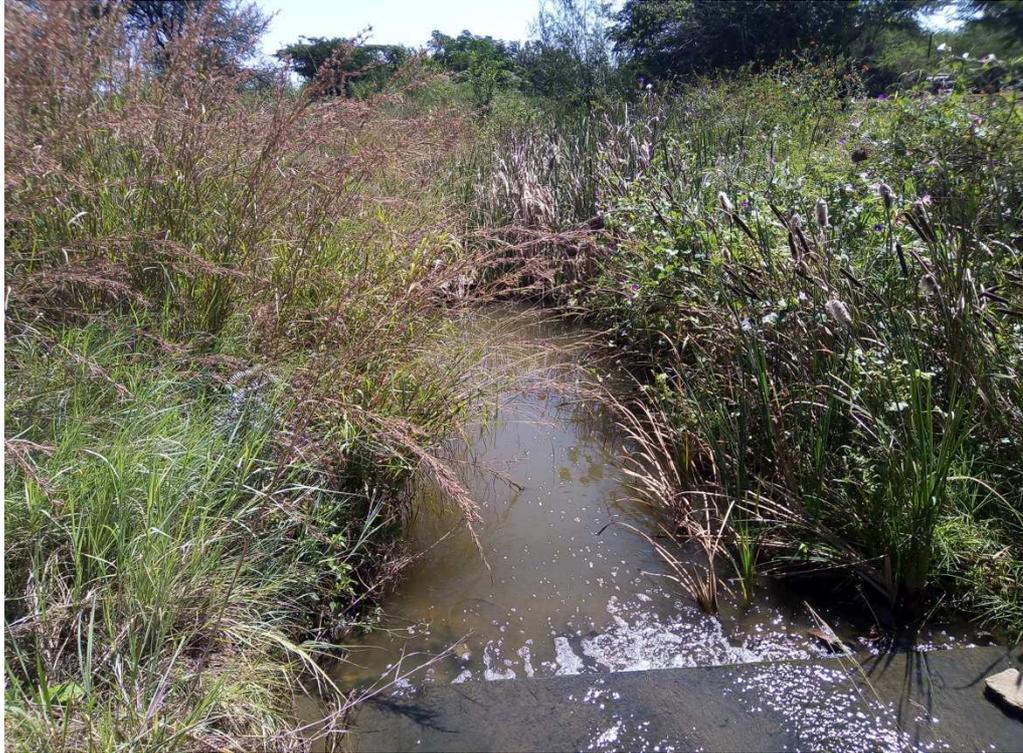
**Photo 3: Stream showing dense grasses and rushes along the banks and in the riparian zone**

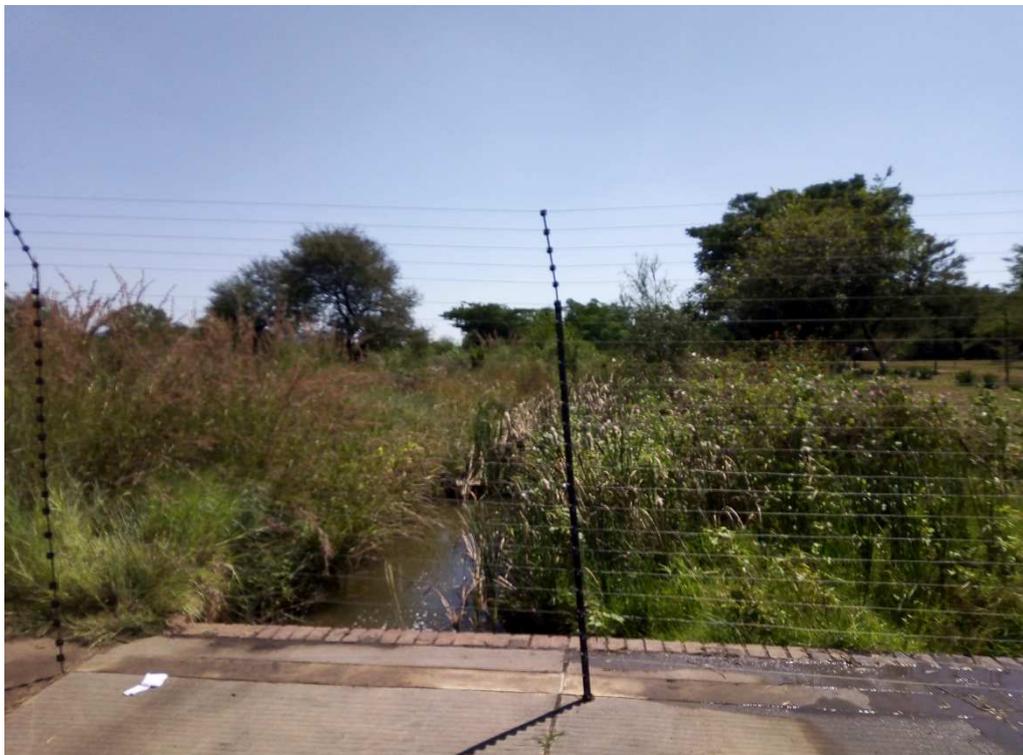
**Photo 4: Low-level bridge and road crossing over Montanaspruit (Tsamma St)**
