**An ecological assessment regarding the
Environmental and Water Use Authorisation for
remedial work required on the SAPPI Ngodwana
Dam (Mpumalanga).**

**The Present Ecological State of the water courses in the
proposed project area: Ecological Risk Assessment Process**

**DR ANDREW DEACON
August 2020**

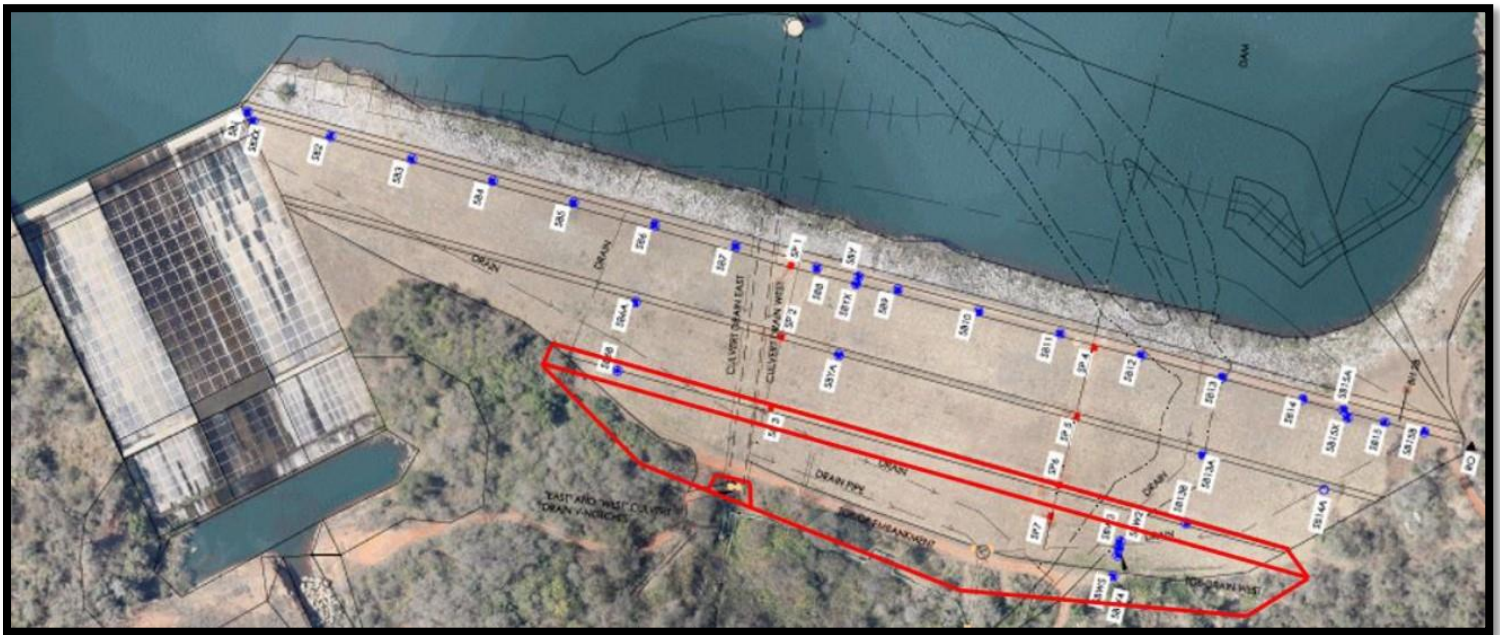
Figure 2: The proposed stabilising berm (red polygon) on downstream face of the Ngodwana Dam wall (Hagen, 2019).

1. Stabilizing berm (Figure 2) on the downstream face of the main embankment to RL 941.3 m, including approximately 30 000 m³ of earthworks, a new internal drainage system (sand & gravel filters, rock toe and drain pipes with inspection concrete manholes) and gabion retaining walls.
2. Subsoil pipe drains above the berm of 133 m length with inspection concrete manholes.
3. Raising of the right flank embankment to prevent overtopping and failure during large floods and to improve the stability of the embankment (earthworks to be confirmed).

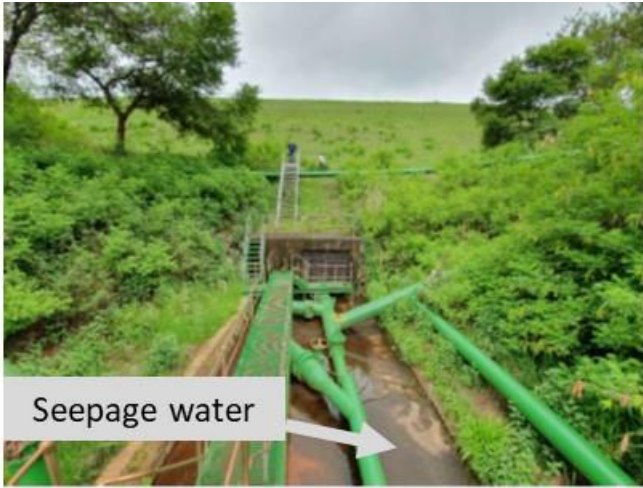
Figure 3: Outlet conduit exit at embankment toe (20 November 2019). Seepage was noted emanating from sides of conduit monitored at v-notch weirs.

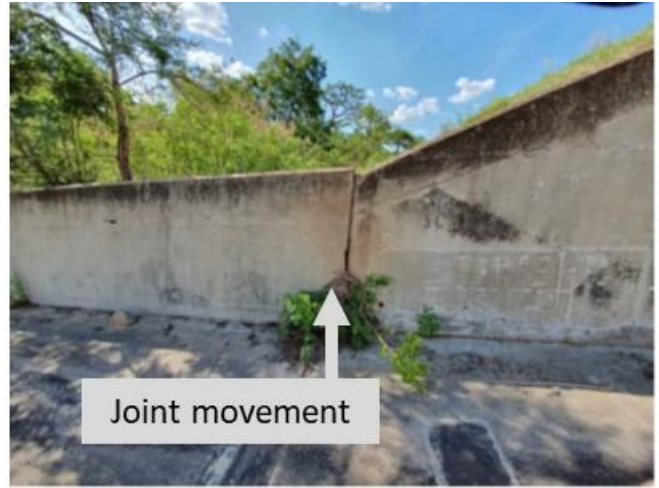
Figure 4: Spillway right training wall joint movement likely caused by tree roots (19 November 2019).

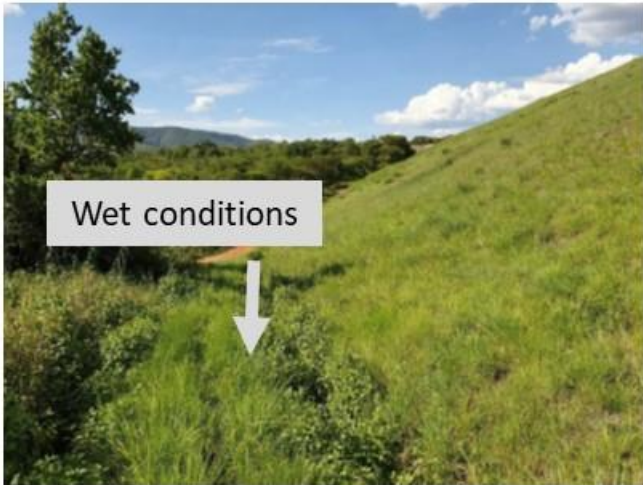
Figure 5: Downstream toe on lower left flank (19 November 2019). Note wet conditions which could be attributed to high phreatic surface within embankment.

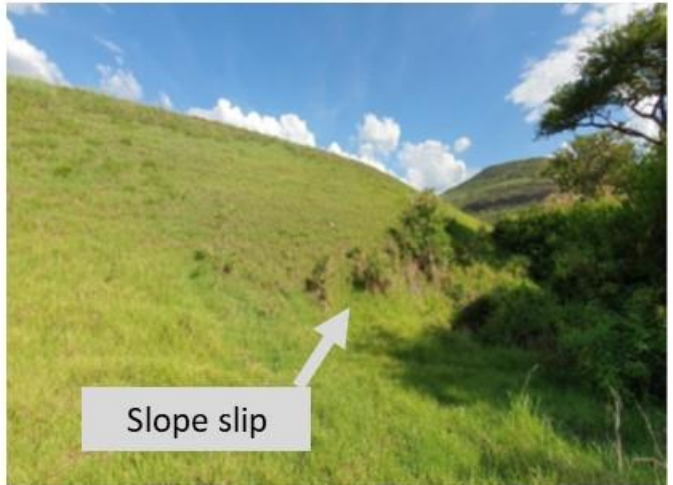
Figure 6: Downstream face of breaching section (fuseplug embankment) on right flank showing local slip (19 November 2019).

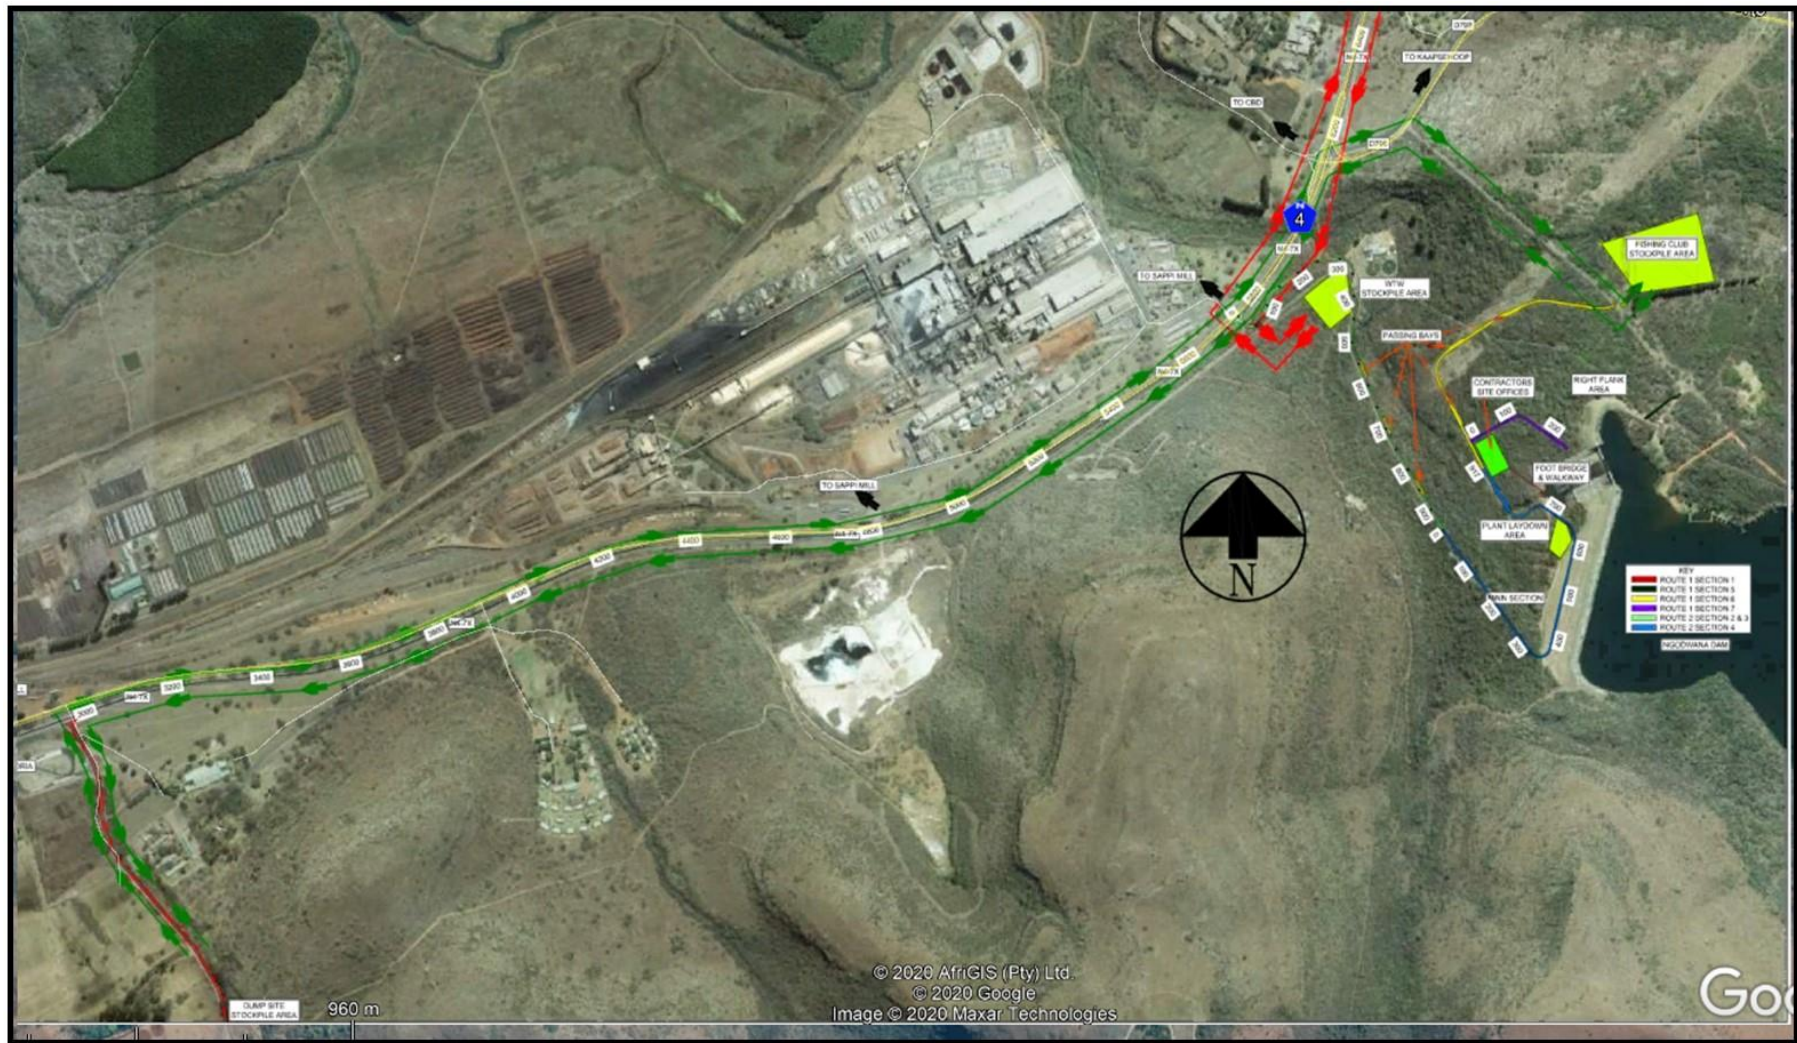
Figure 8: Infrastructure setup involved in the proposed Ngodwana Dam rehabilitation project.

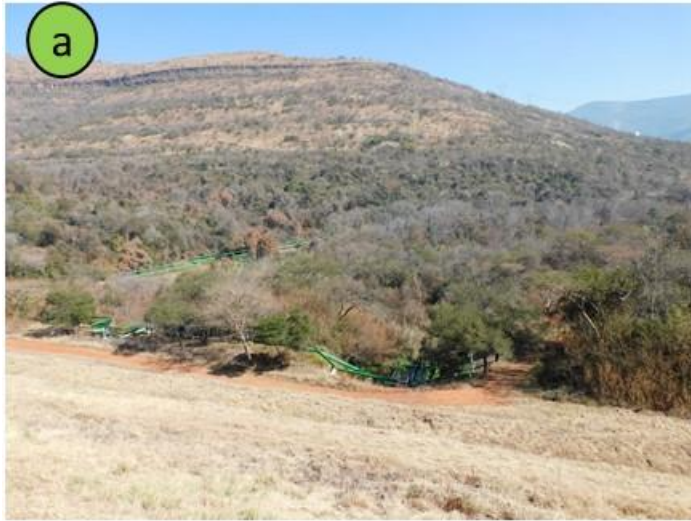
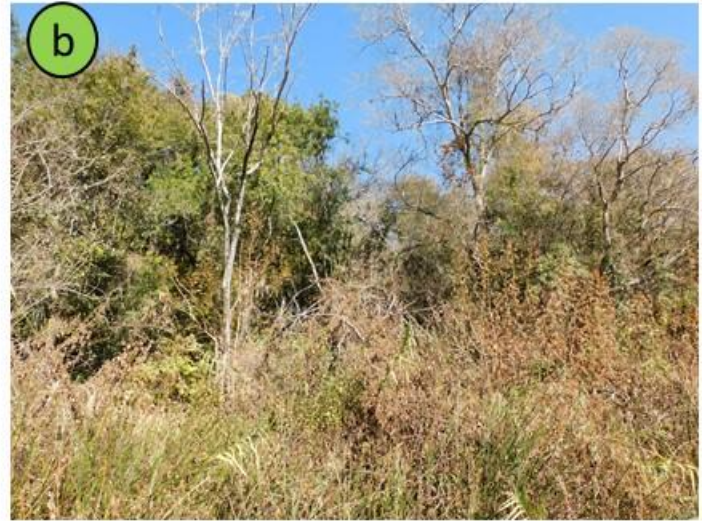
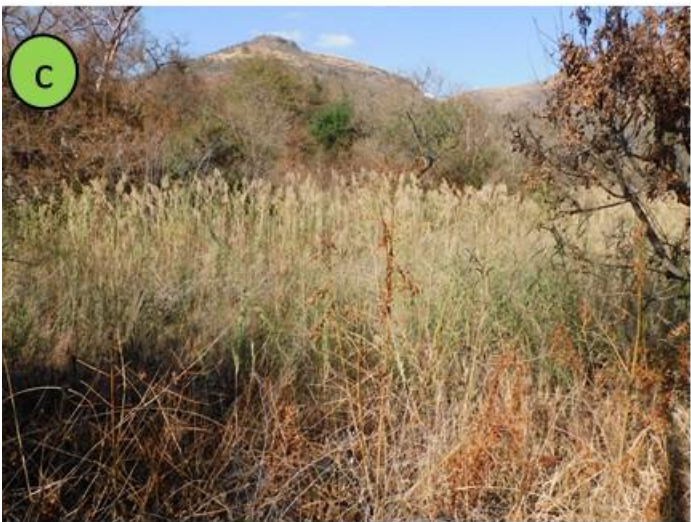
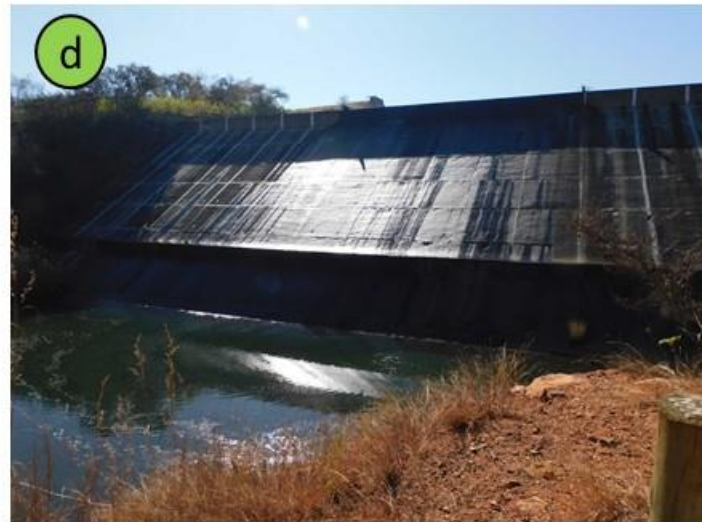
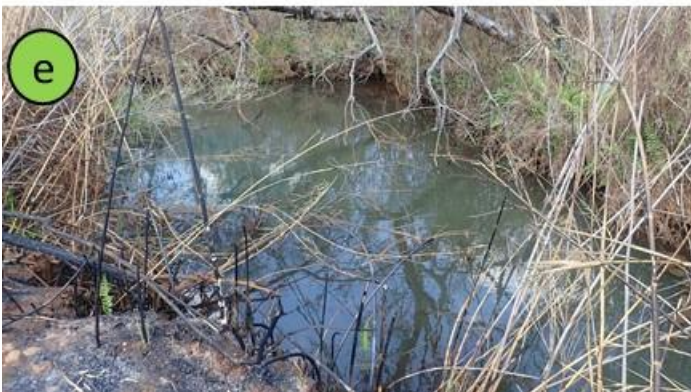
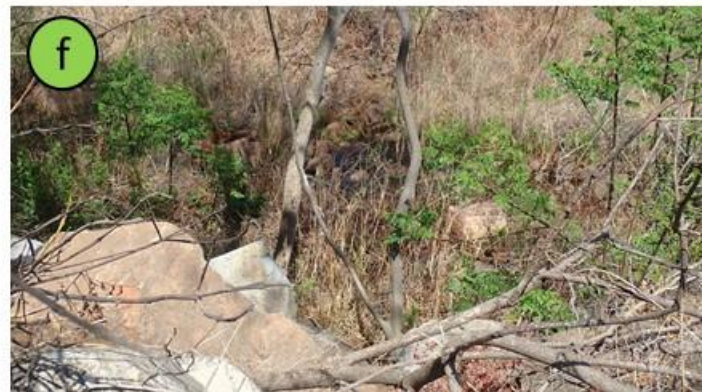
Figure 28: The entire area below the Ngodwana dam wall.

- 28a.** A view of the area below the dam wall.
- 28b.** The lush wetland vegetation in the seepage wetlands.
- 28c.** The overgrown river bed of the Ngodwana River.
- 28d.** The spillway over the dam wall.
- 28e.** The river reach below the spillway.
- 28f.** The Ngodwana River lower down towards the N4.

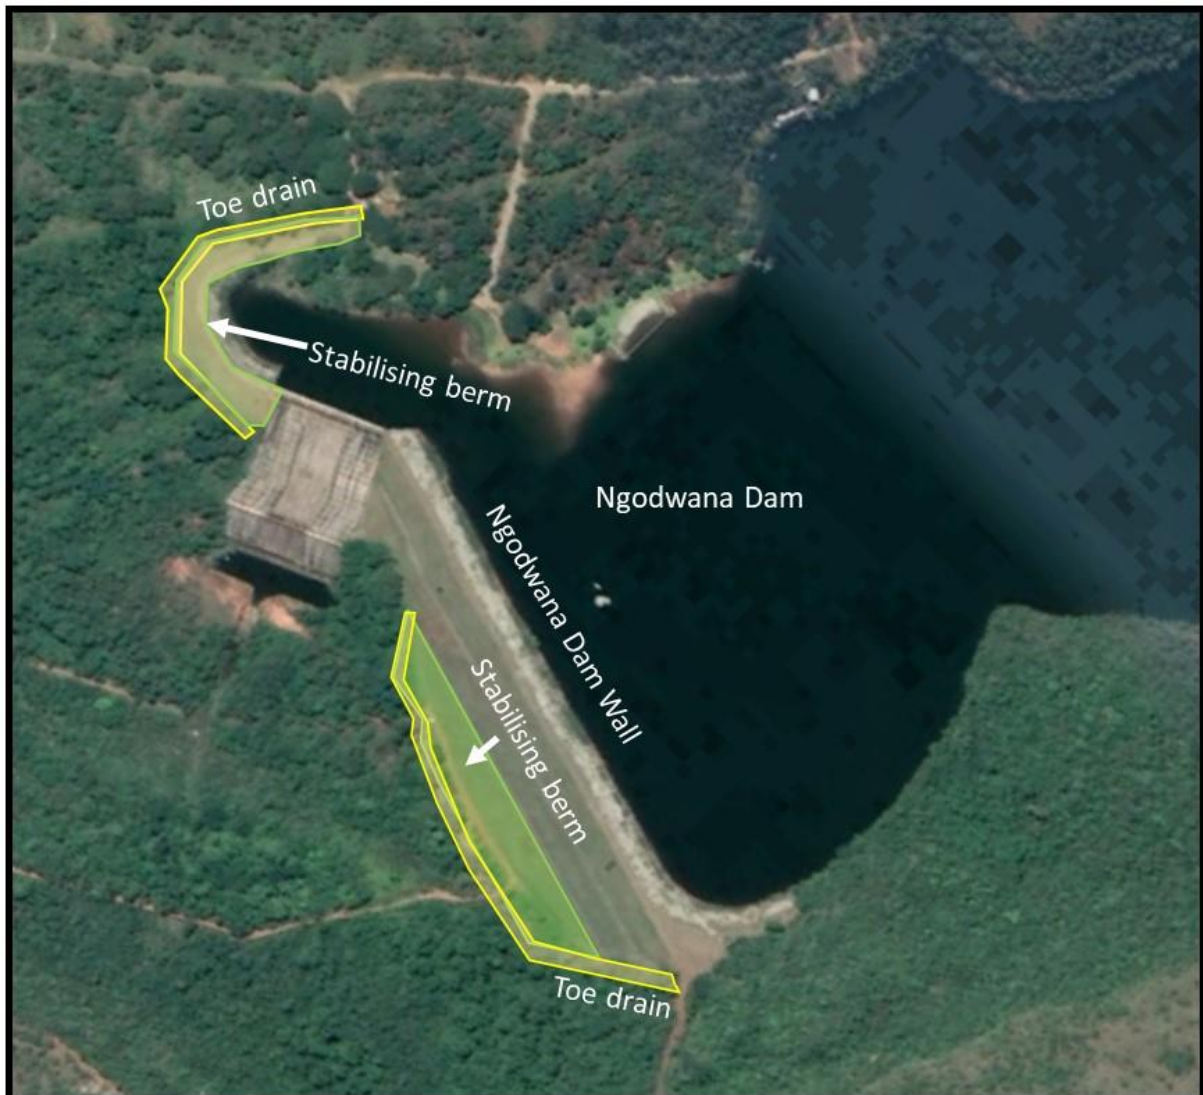
Figure 37: Dam wall berm and toe drain to be stabilised.

1. Stabilizing berm (Figure 37) on the downstream face of the main embankment to RL 941.3 m, including approximately 30 000 m³ of earthworks, a new internal drainage system (sand & gravel filters, rock toe and drain pipes with inspection concrete manholes) and gabion retaining walls.
2. Subsoil pipe drains above the berm of 133 m length with inspection concrete manholes.

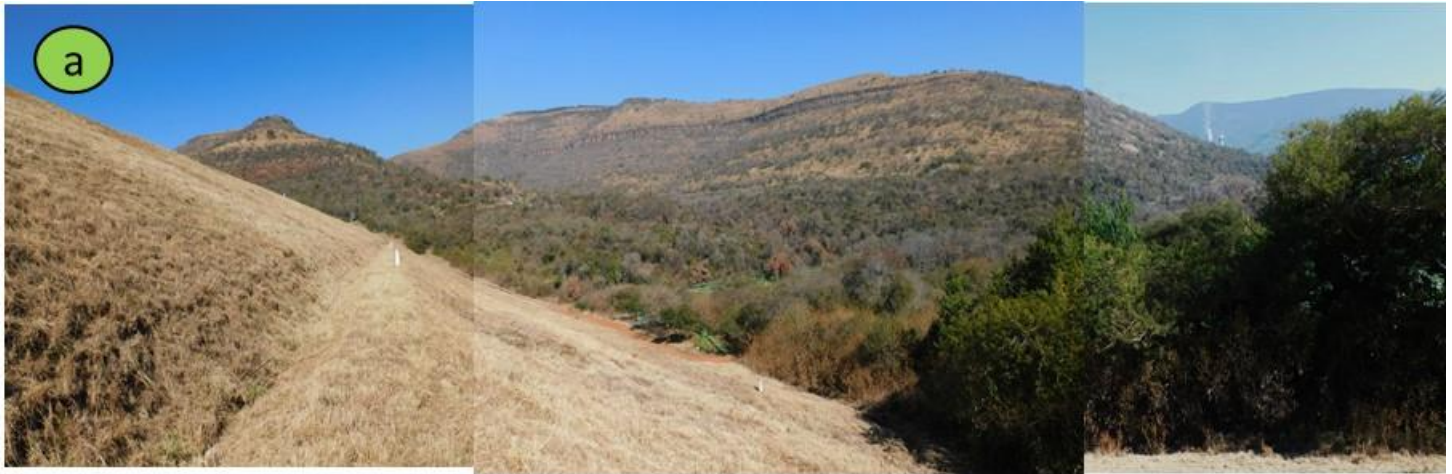
Figure 38:

38a. A panoramic view of the area below the dam wall (July 2020).

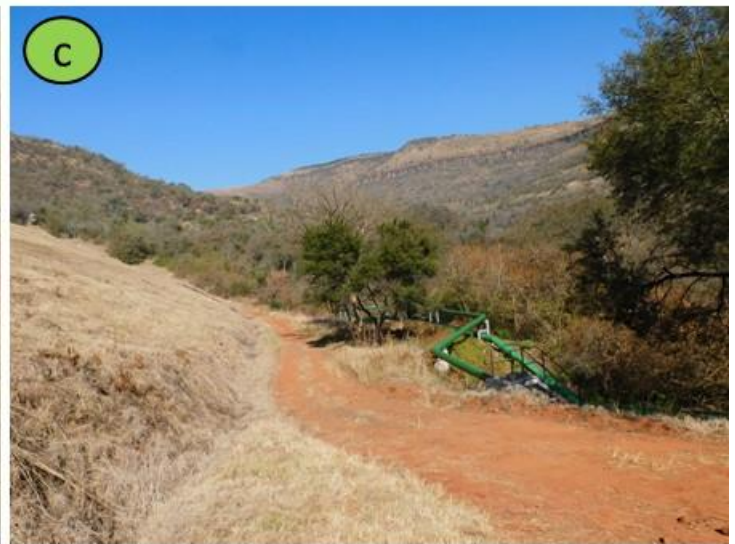
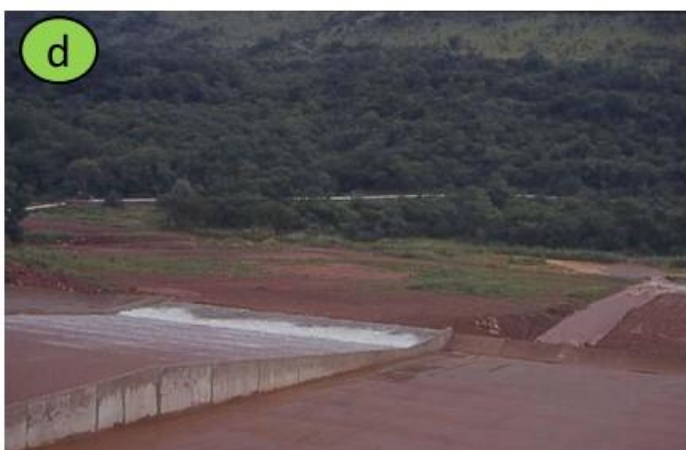
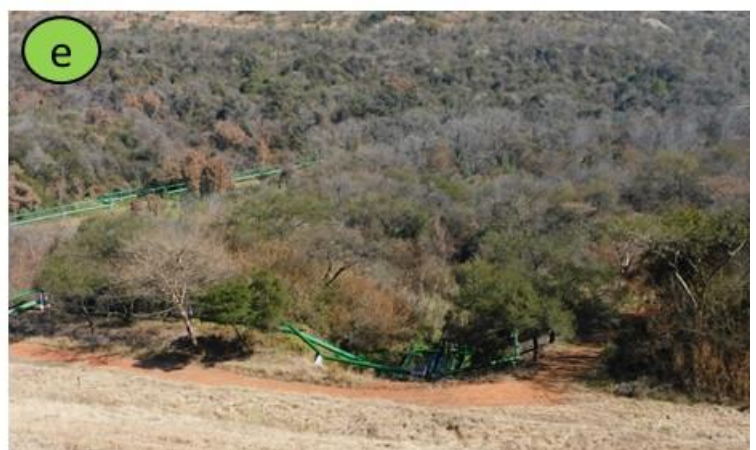
38c. The area below the dam wall (July 2020). Note how the denuded area illustrated in Figure 38b recovered. The vegetation that established in the denuded area is about 60% indigenous and 40% alien invaders.

38d. and 38e: Two photos taken from the Gondwana Dam wall: Photo 38d) during the period when the wall was constructed (early 1980s) and photo 38e) July 2020 during the current survey period.

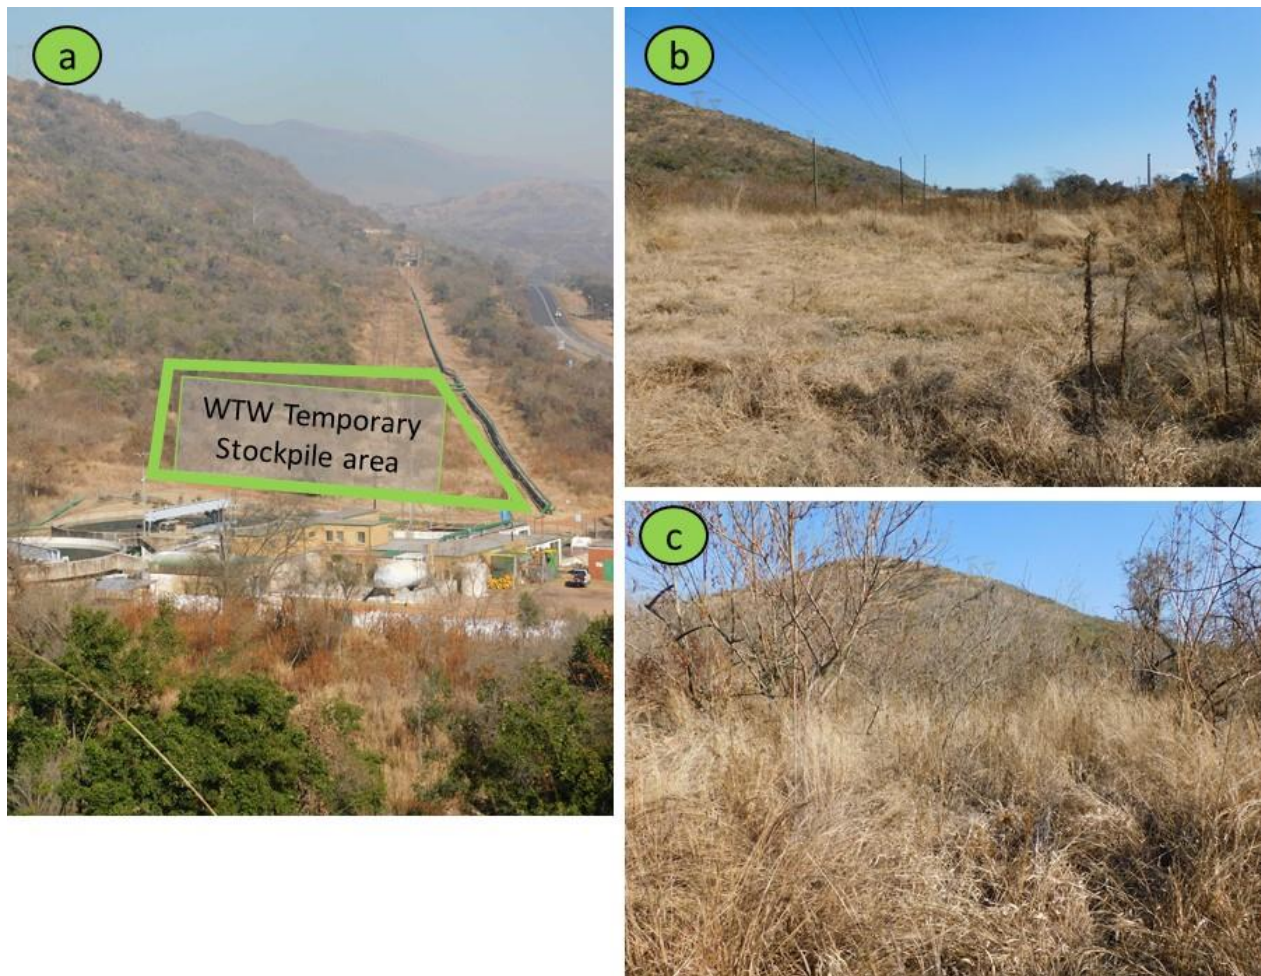
Figure 40:

40a. The WTW Temporary Stockpile near the N4 (Figures 8 and 9).

40b and 40c. The low woodland area which is earmarked for the stockpile area.

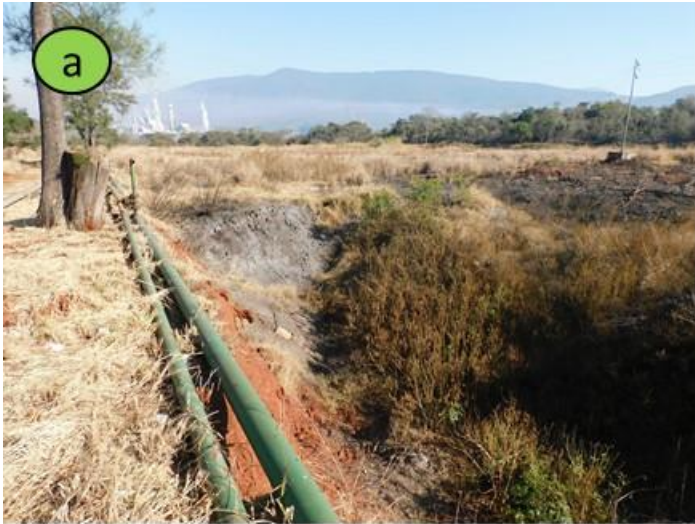
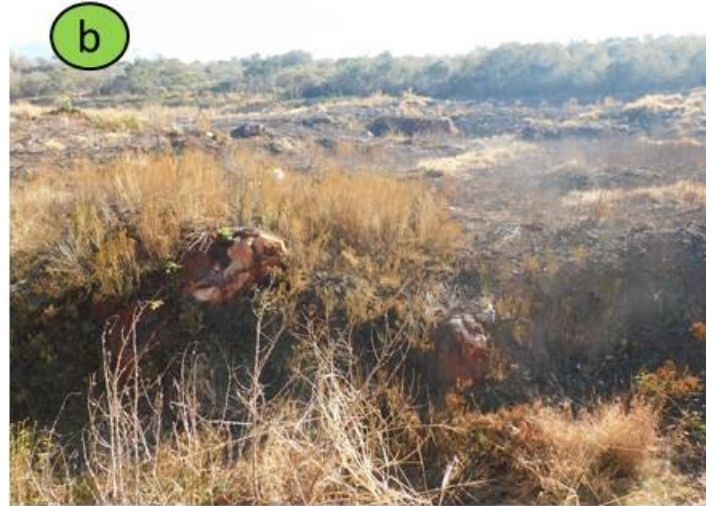
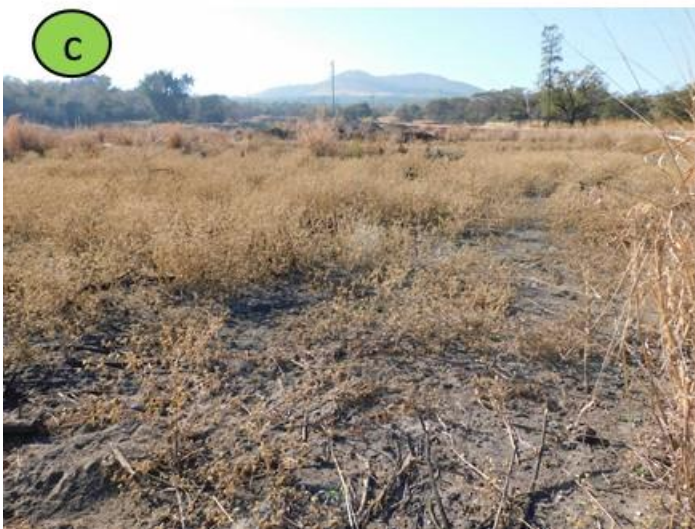
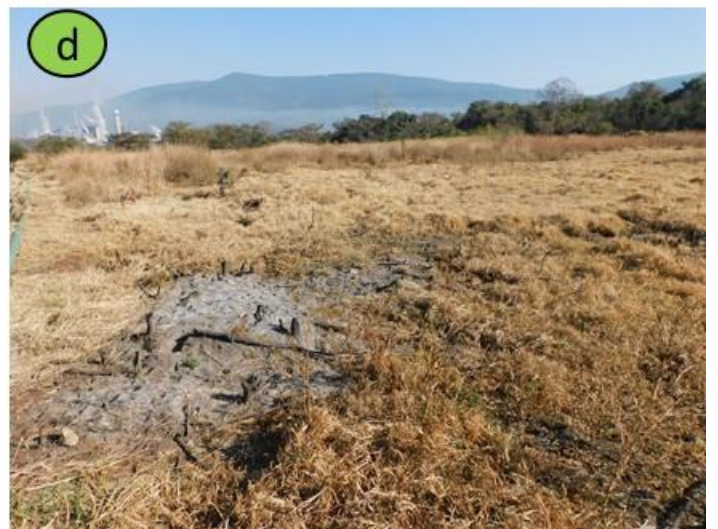
Figure 41:

41a-41d. The Fishing Club Temporary Stockpile is planned on an area with no ecological value – old mining/dumping area (Figures 8 and 9).

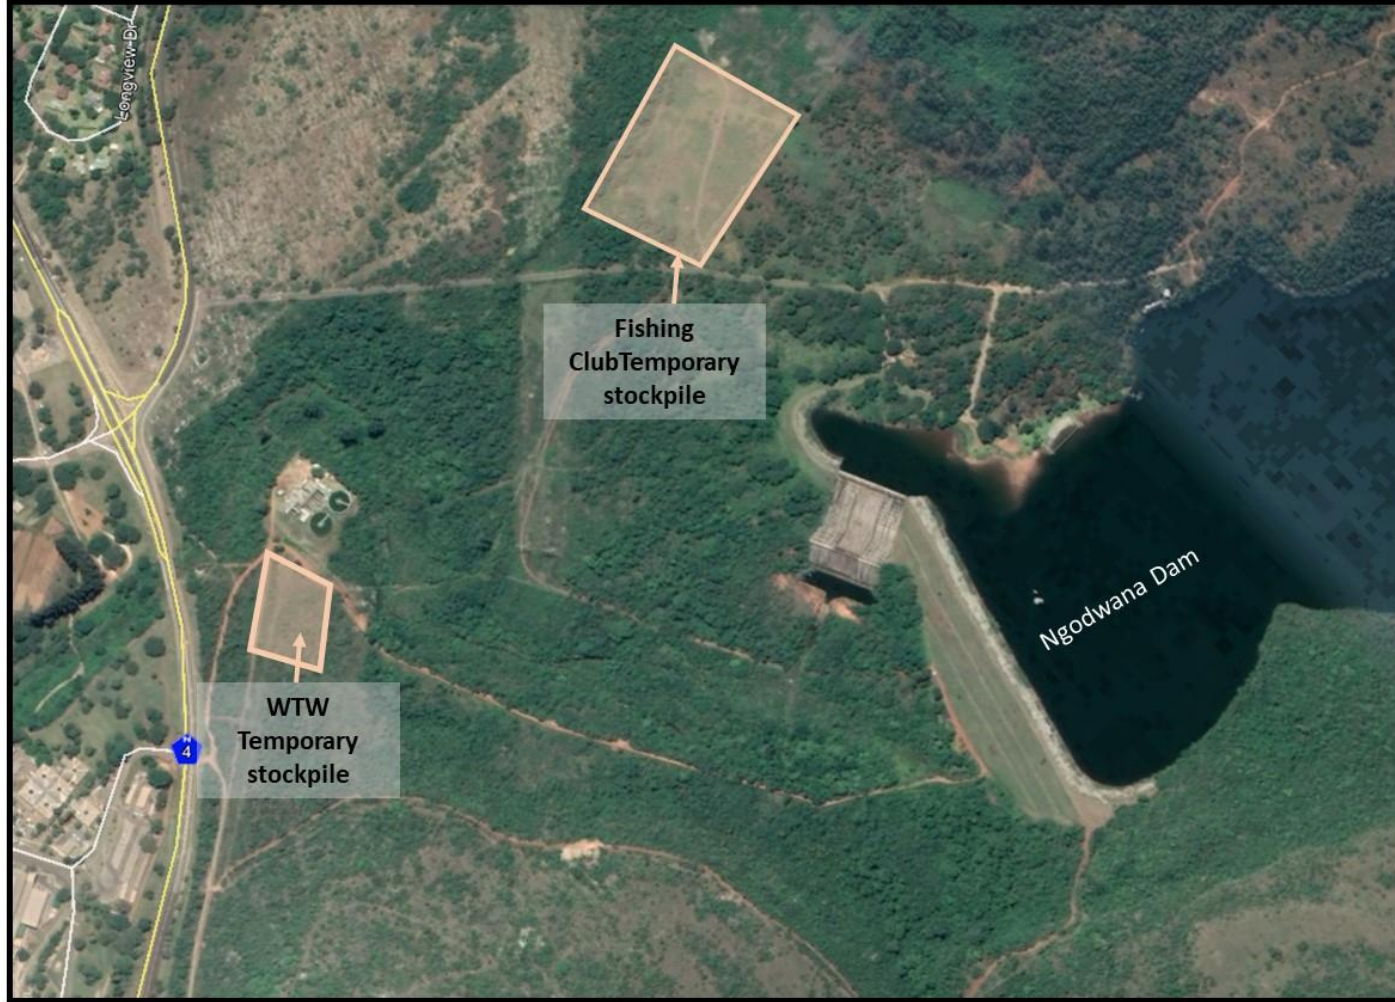
Figure 42: This figure shows the locations of the two temporary stockpile areas.

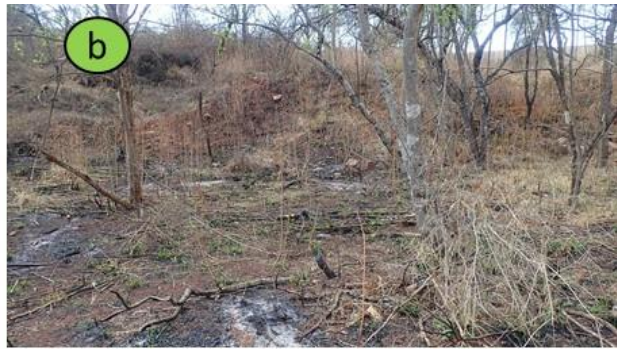
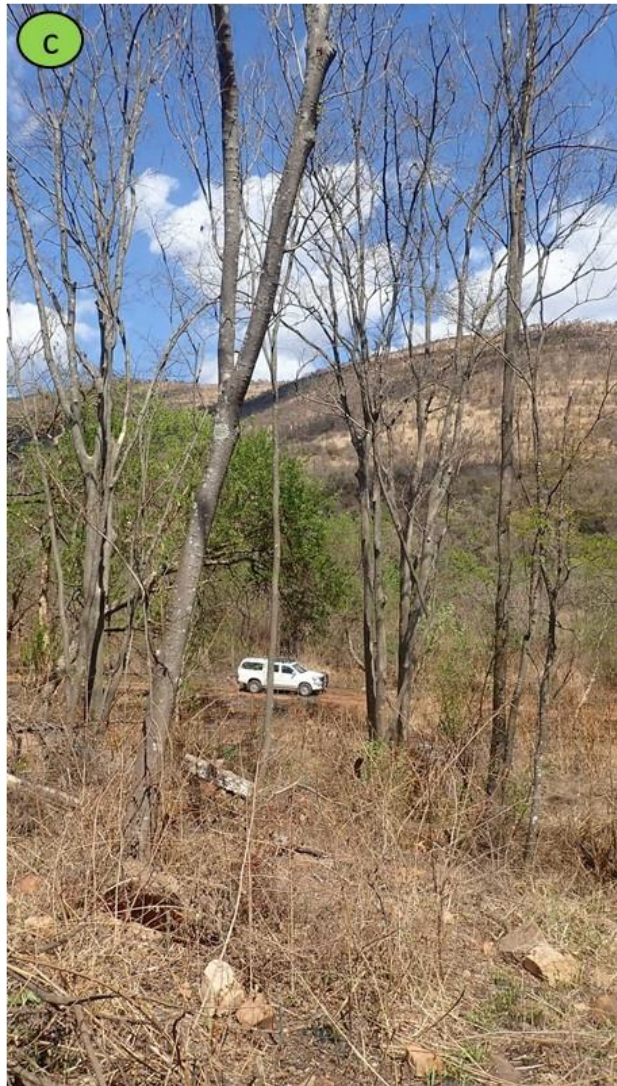
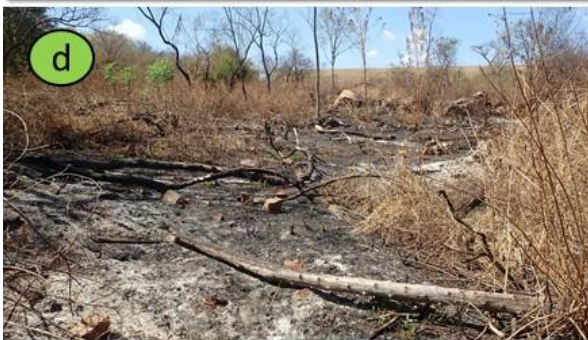
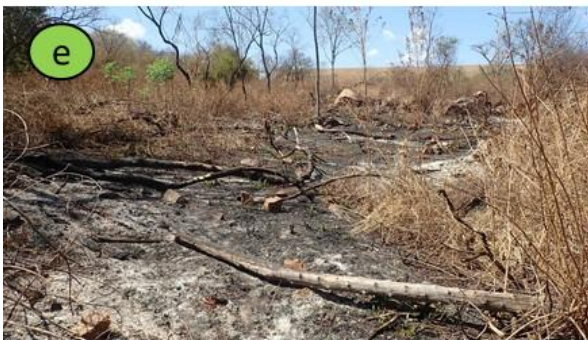
Figure 44:

44a. The proposed #4 Haul route to the Northern spillway retaining wall (Figures 8 and 9).

44b to 44e. Photos of the area identified as the best route – signs of previous activities indicate historical human interference, however a small number of trees will have to be removed for the route clearing.

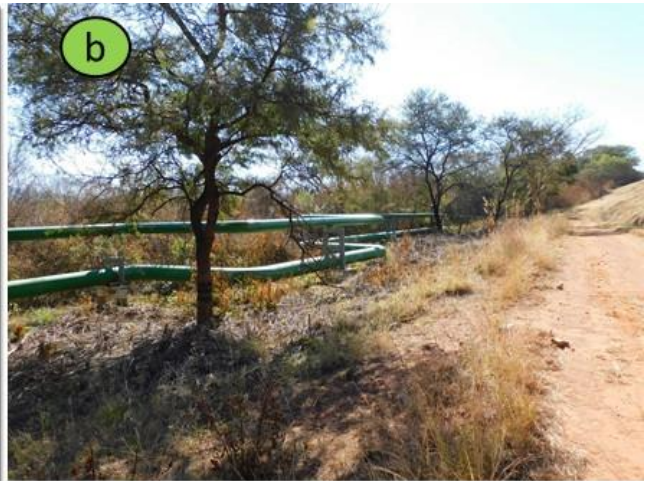
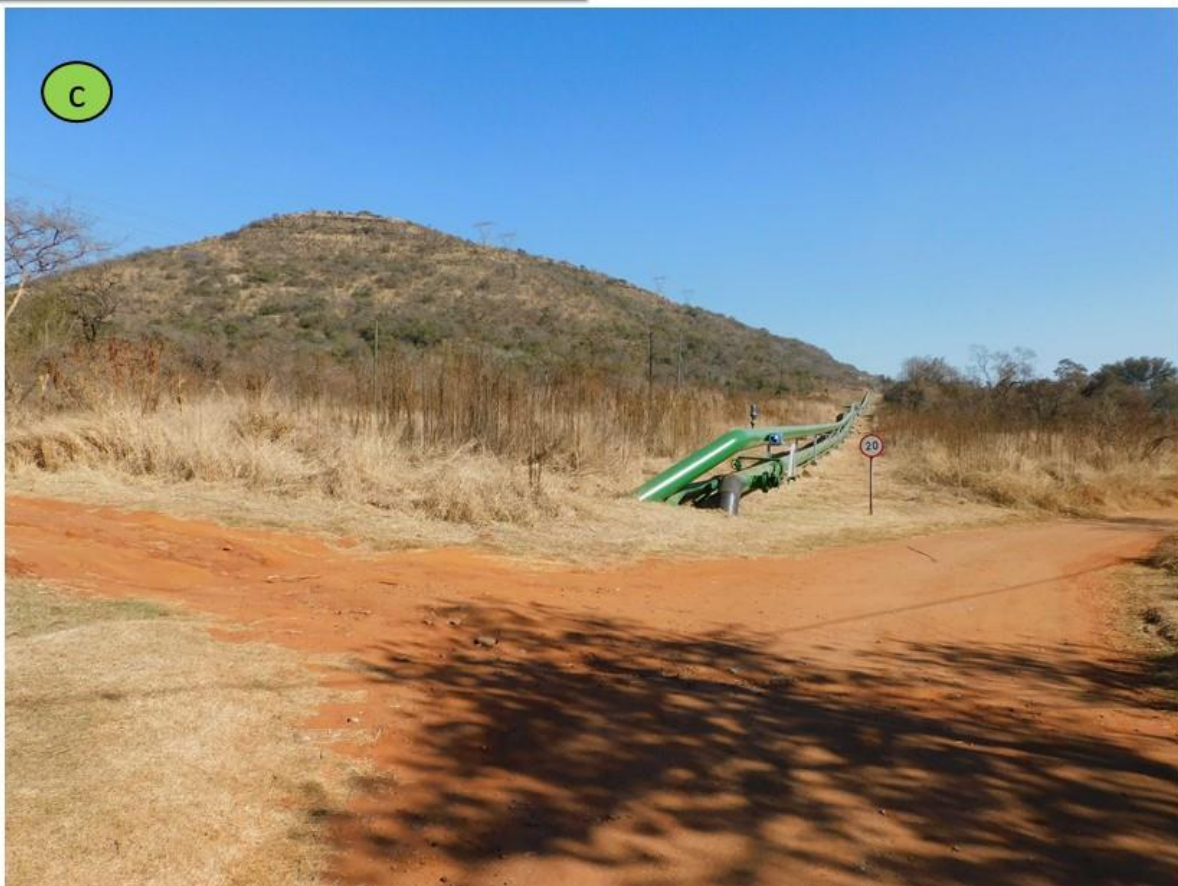
Figure 45:

45a. The proposed #5 Haul route past the SAPPI's Water Treatment Works (WTW) (Figures 8 and 9).

45b and 45c. Photos of the existing road past the SAPPI's Water Treatment Works (Figures 8 and 9).

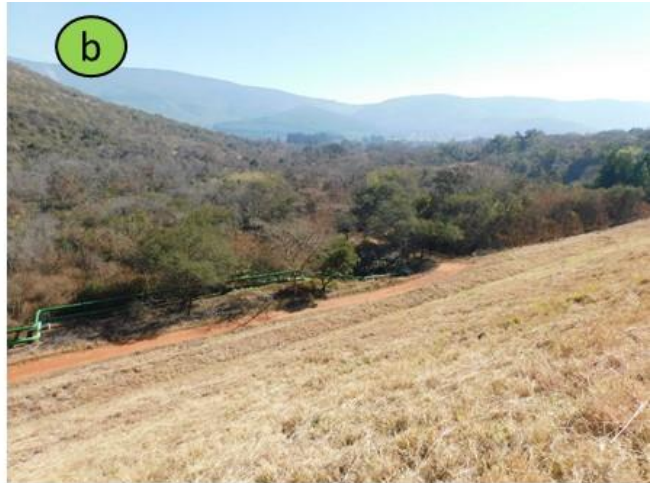
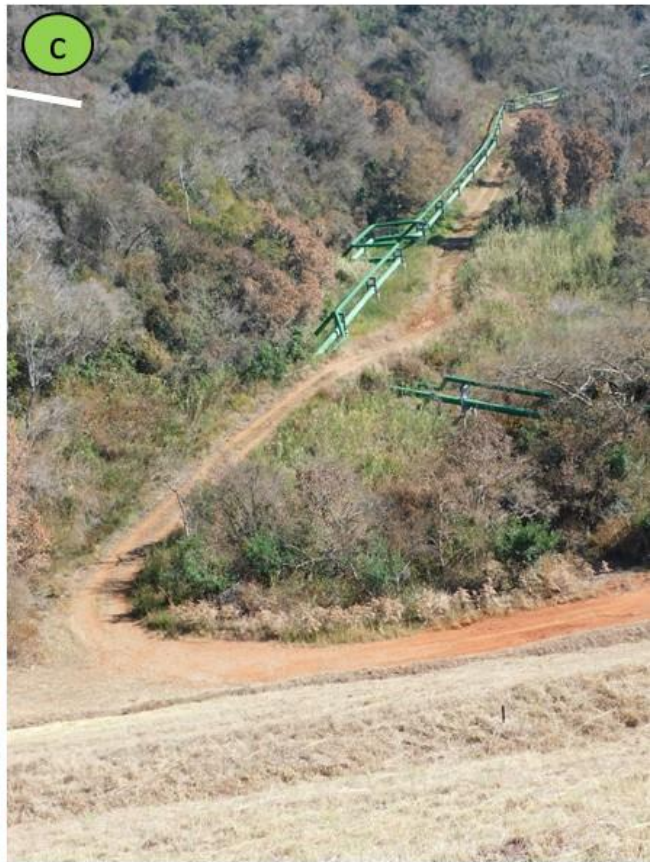
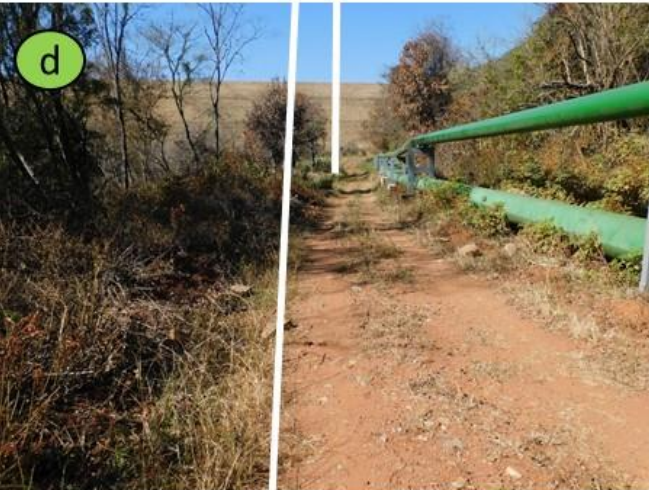
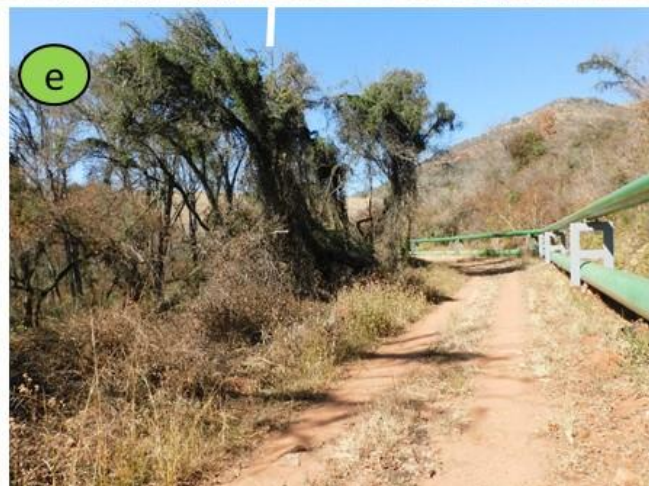
Figure 47:

47a. The proposed new #5 Haul route up the embankment of the dam (Figures 8 and 9).

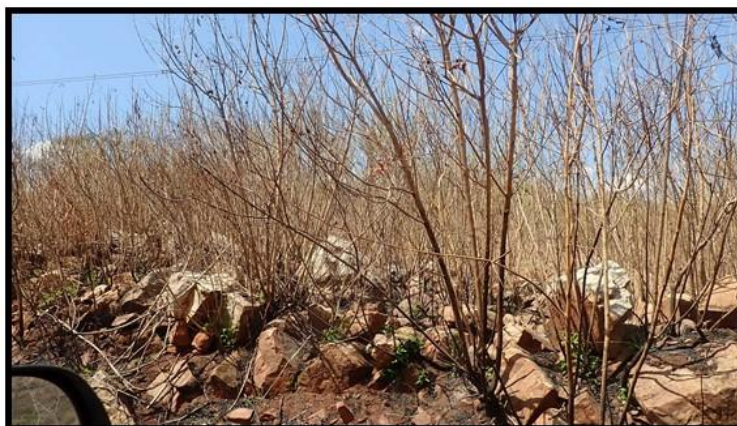
Figure 51: The alien invader, yellow bells (*Tecoma stans*) is abundant in many places in the project area.

The disturbance to the vegetation and soils, during the clearing and preparation phase, could increase the risk of alien plant invasion, especially where soils are exposed. Loss of habitat adjacent to roads and pipelines may result in an increase in alien invasive plant species. Roads and traffic may facilitate the invasion of weeds and exotic plants as seeds attached to undercarriages in mud and dirt may bring seeds from a large potential catchment and move them across the landscape rapidly.
