## Environmental Management Program (EMPr)

# PROPOSED SHOPPING CENTRE AND ASSOCIATED SERVICES ON THE REMAINDER AND ERF 1, 2, 3, 4, 5, AND 6 OF PORTION 22; AND PORTION 26 OF THE FARM EKANGALA 610 JR WITHIN THE CITY OF TSHWANE METROPOLITAN MUNICIPALITY

# EKANGALA SHOPPING CENTRE – EMPR

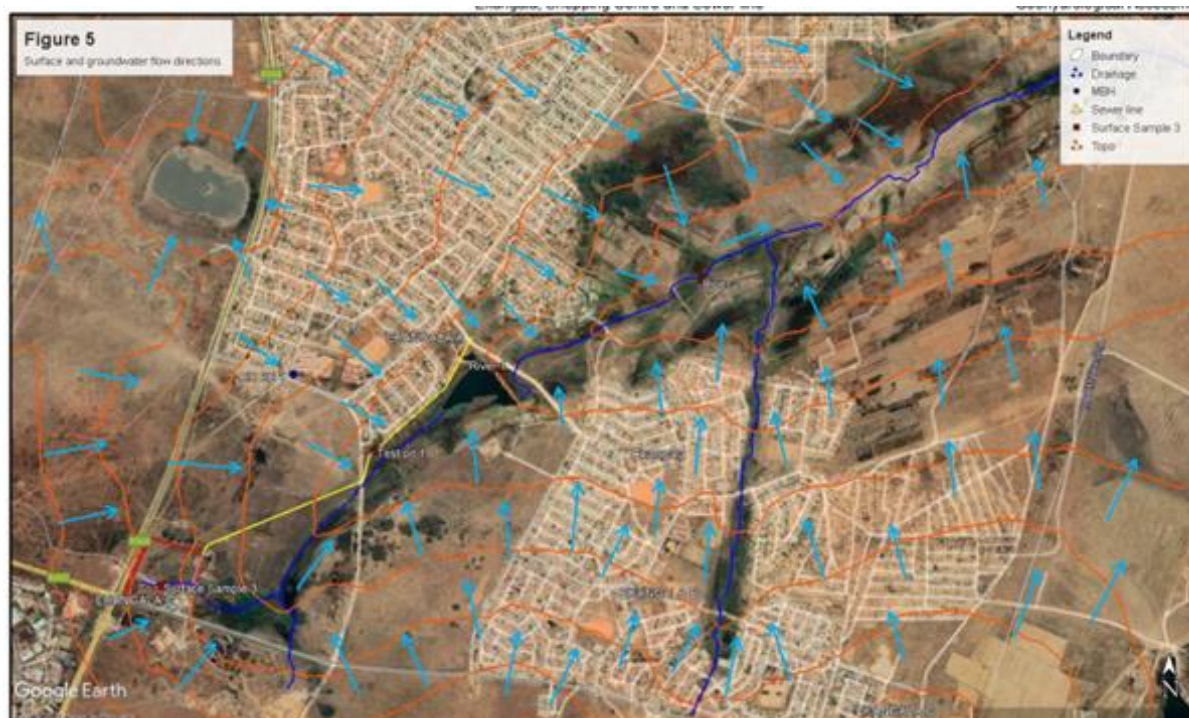
Figure 3: Groundwater flow direction

The groundwater and surface water flow directions will in general be from the topographic high areas in the village site towards the topographical low areas in the east and north east, towards the Grootspuit drainage system which drains towards the north east.

It is expected in a fractured and weathered aquifer that the groundwater contours to a large degree will follow the surface contours. It can therefore also be expected that in general the groundwater flow will mimic the surface water flow. The surface contours can be used as indicator in which direction groundwater flow will be.

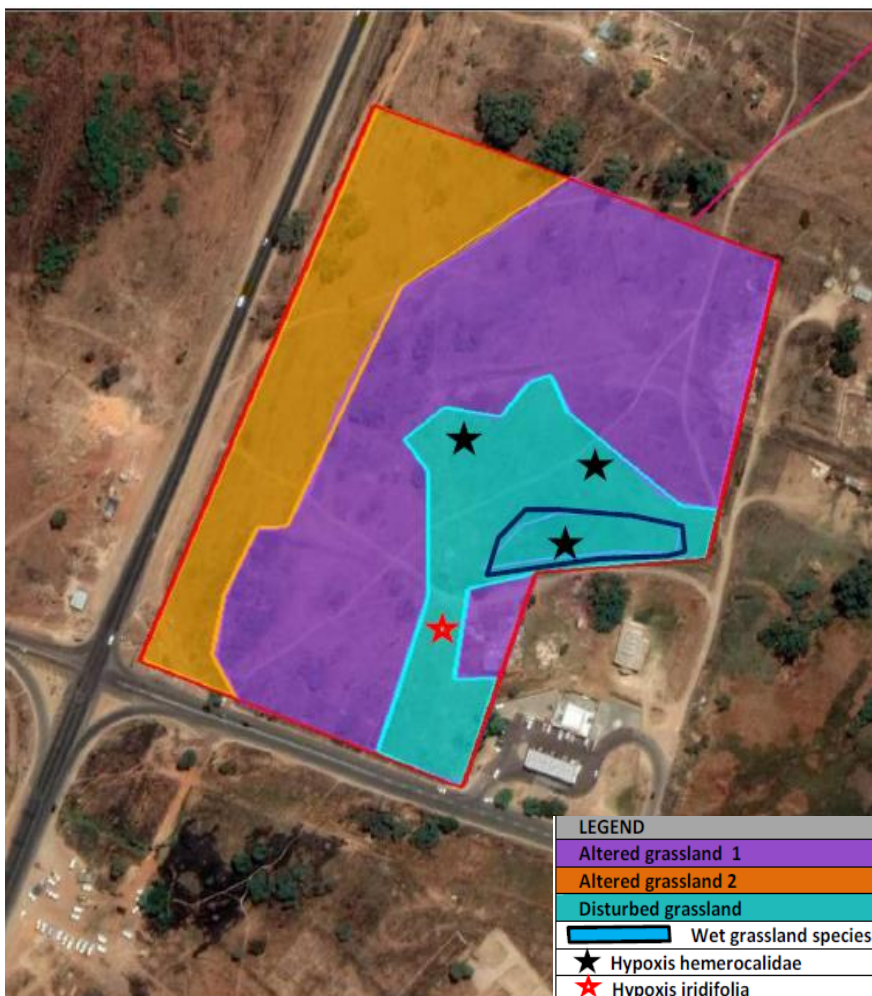
Figure 5: Vegetation unit map

Three Vegetation units were identified within and around the study area:

**10.3.6.1 Disturbed grassland:** This grassland was observed towards the centre and south of the site. Mostly natural grassland species were found in the 1.3-hectare piece of grassland but with a moderate to low species richness. The vegetation cover was further found to be low, which has left the soil exposed to raindrop impact and erosion. The dominance of *Stoebe vulgaris* further indicated that the vegetation has been disturbed

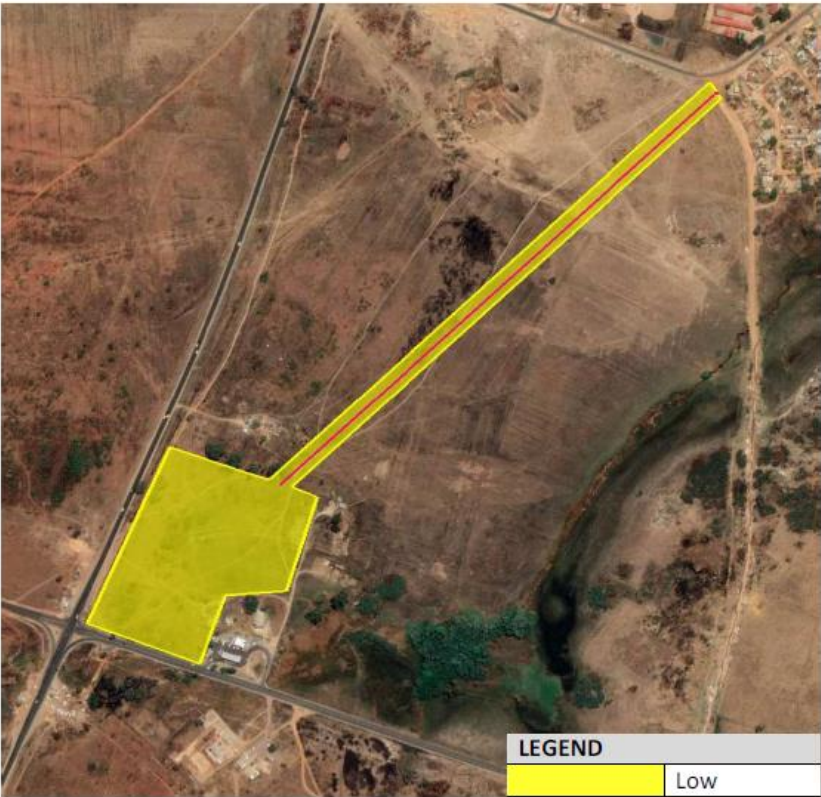
**Figure 8: Sensitivity map**

The site also does not lie adjacent or in close proximity to a protected area or similar of conservation concern (i.e. ridge or natural habitat). The site does however lie just upslope of a water course,

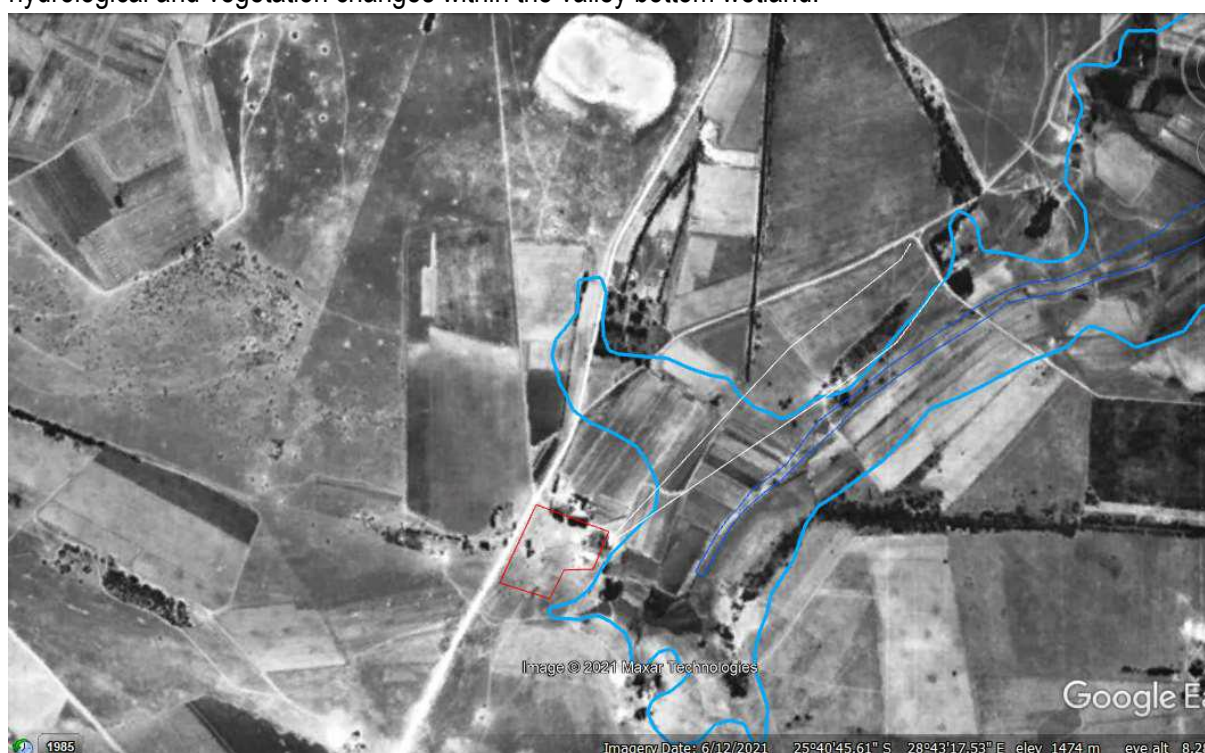
**Figure 10: Historic image taken in 1962 overlaid in Google Earth shows the extent of agriculture within HGM 1 Ecological Importance and Sensitivity**

The Present Ecological Class for **HGM 1** (seepage wetland) is a **category D** (largely modified with a large loss of natural habitats and basic ecosystem functions that has occurred). Distribution and retention patterns of water within the wetland has been negatively affected through agriculture, historic imagery reveals intensive agriculture production taking place in the previous century including drainage channels as well as ploughing against the contour to increase run off from fields.

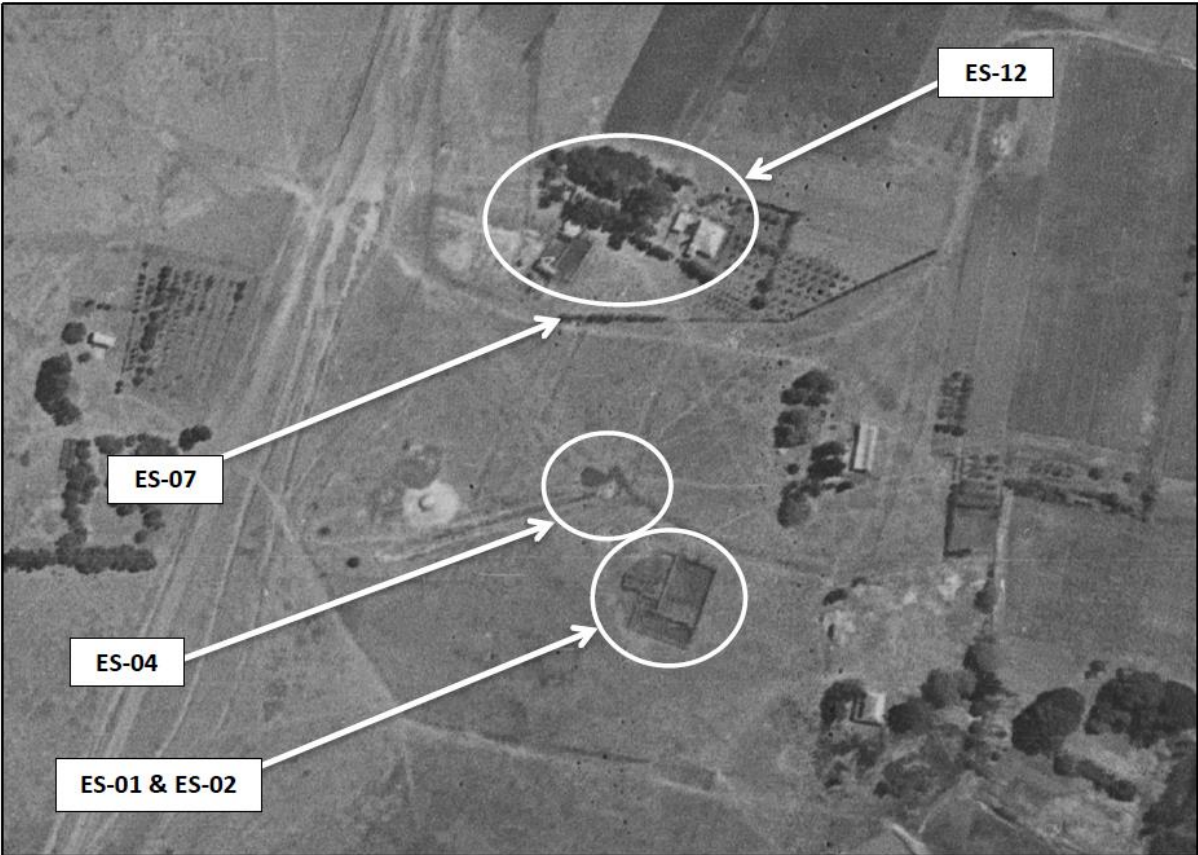
**Figure 12** below depicts a section of the 1939 aerial photograph. A cluster of livestock enclosures appear to be directly associated with the structural remains identified at sites ES-1 and ES-2. A structure is depicted at sites ES-04. The structure appears to be associated with a long furrow-like feature. One possibility is that this furrow-like feature was used as a cattle dip. A stonewall with planted trees is depicted at site ES-7. At ES-12, a farmstead comprising a farm dwelling and at least two associated structures are depicted.

Figure 13: Depiction of the proposed shopping complex footprint area and surroundings on the 1939 aerial photographs.

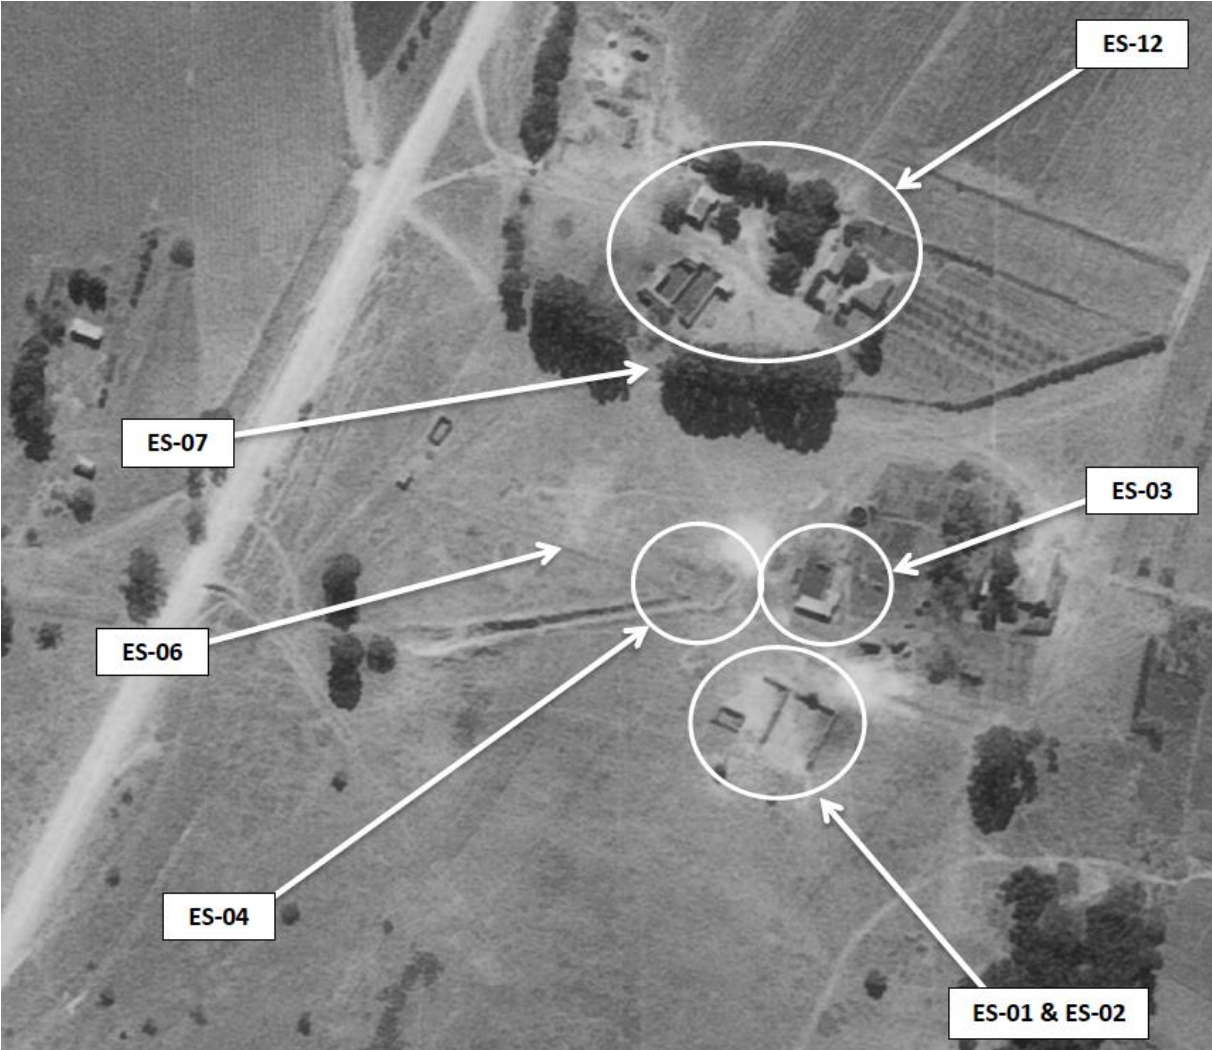
Figure 13 depicts a section of the 1964 aerial photograph. A cluster of livestock enclosures appear to appear to be directly associated with the structural remains identified at ES-01 and ES-02. A shed with associated livestock enclosure is depicted at site ES-03. A structure is depicted at ES-04. The structure appears to be associated with a long furrow-like feature. One possibility is that this furrow-like feature was used as a cattle dip. What appears to be a low stone-wall or fence is depicted at site ES-06. A stonewall with planted trees is depicted at sites ES-07. At ES-12, a farmstead comprising a farm dwelling and several associated structures is depicted. These structures also include sheds and livestock enclosures.

Figure 14: Depiction of the proposed shopping complex footprint and surroundings on the 1964 aerial photograph

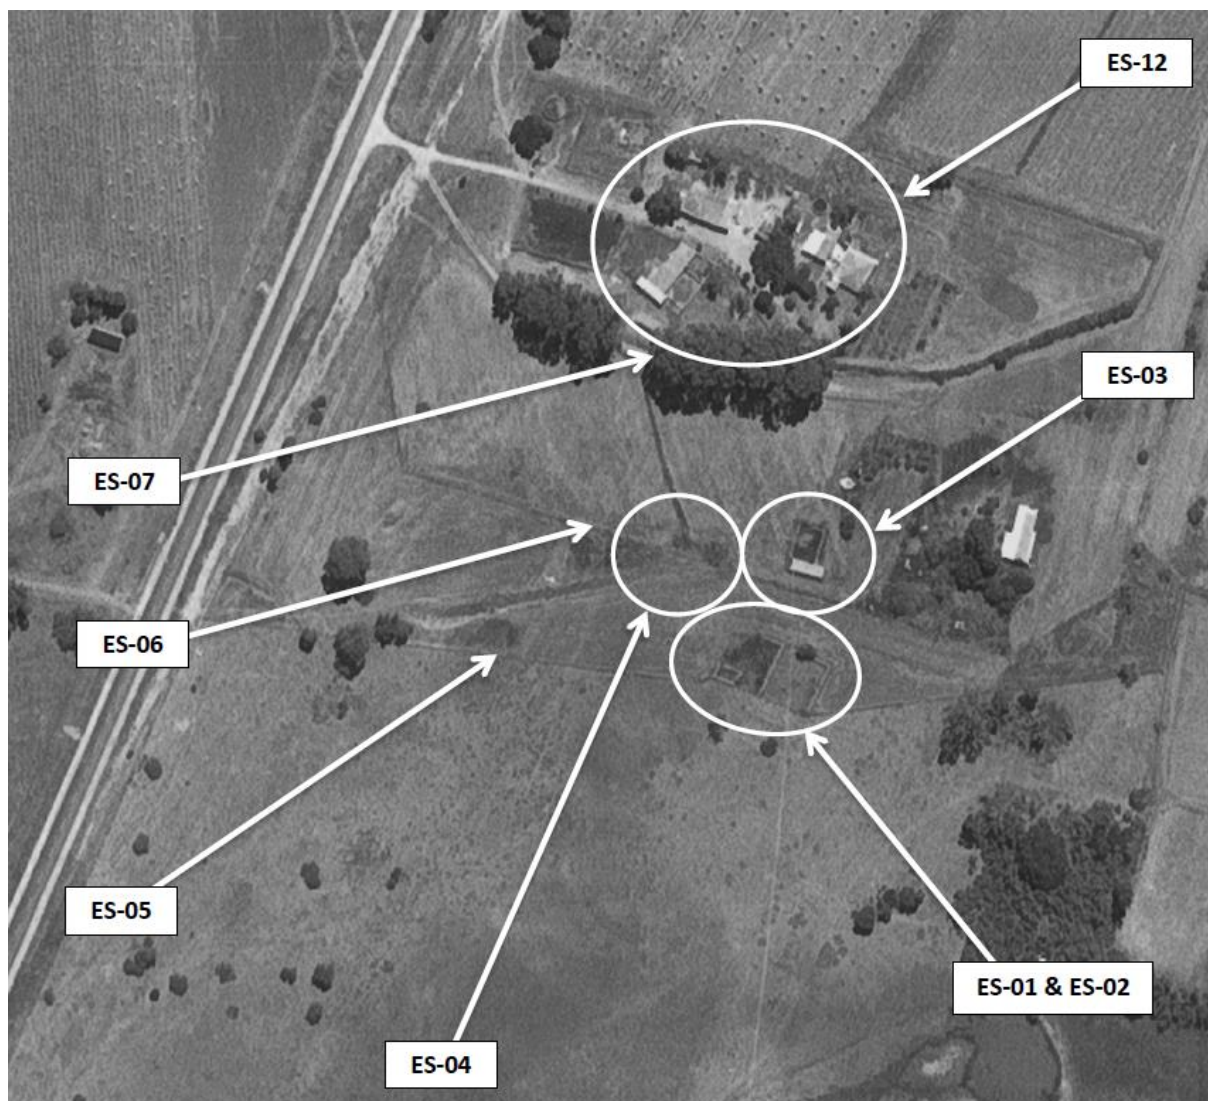
Figure 14 depicts a section of the 1980 aerial photograph. A cluster of livestock enclosures appear to be directly associated with structural remains identified at sites ES-01 and ES-02. A shed with associated livestock enclosure is depicted at site ES-03. A structure is depicted at site ES. The structure appears to be associated with a long-like feature. One possibility is that this furrow-like feature was used as a cattle dip. What appears to be low stone-walls or fences are depicted at sites ES-05 and ES-06. A stonewall with planted trees is depicted at sites ES-07. At ES-12, a farmstead comprising a farm dwelling and numerous associated structures is depicted.

Figure 15: Depiction of the proposed shopping complex footprint area and surroundings on the 1980 aerial photograph

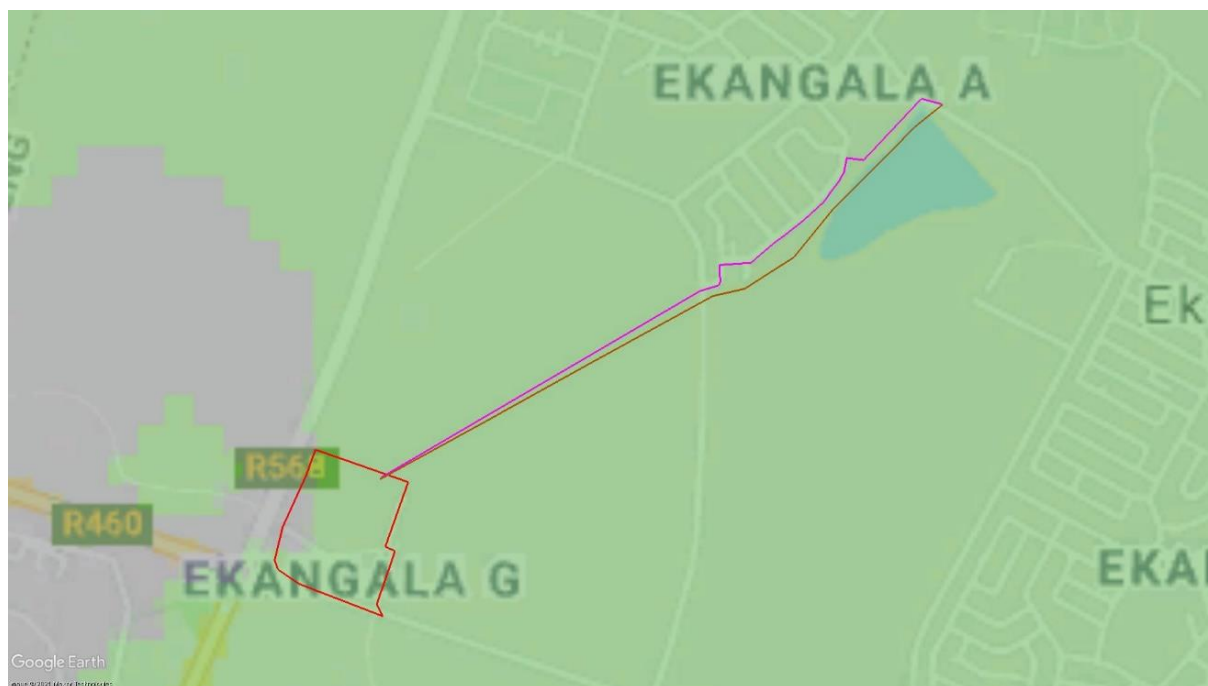
Figure 16: Palaeontological Sensitivity map

According to the PalaeoMap on the SAHRIS database, the Palaeontological Sensitivity of the site is considered to be Moderate. As such, it is recommended that a palaeontological desktop study be undertaken.
